Preserving Fort Jefferson

Preserving Fort Jefferson provides a unique challenge to National Park Service employees and contractors. The remote marine environment, the logistical difficulties, and the size of the fort conspire to make restoring the fort seem daunting. However, highly skilled contractors are now hard at work to insure that Fort Jefferson will be preserved for future generations.

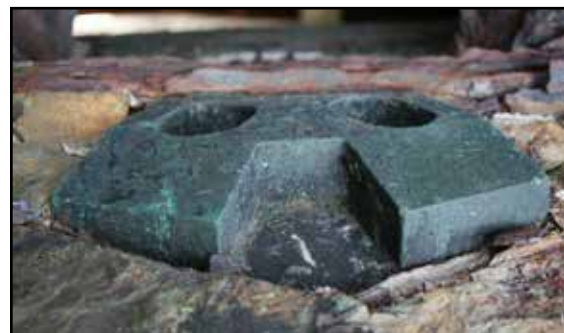
Original Bronze Strike Plate

During use, the shutters were unlocked from the bronze strike plate below. Upon firing the cannon, gases escaping from the muzzle the moment before the egress of the shot would momentarily throw the shutters open. The shutters were carefully balanced so that they would swing freely and ‘rebound’ into the closed position.

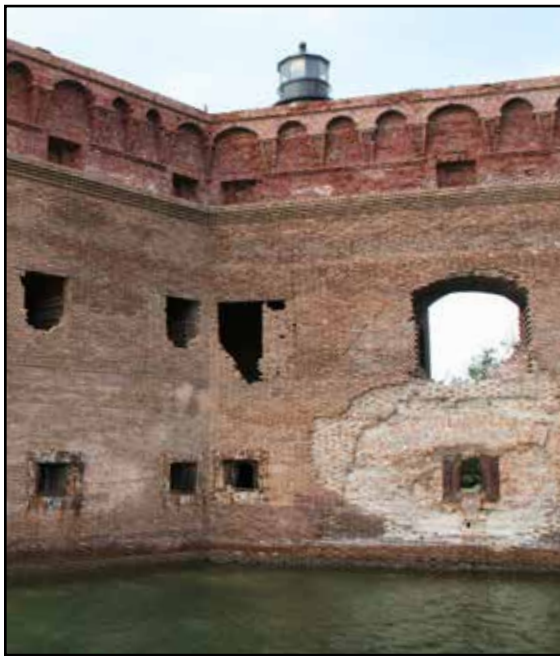
Pre-Treatment

Unfortunately, the very metal that provided valuable protection to soldiers under fire proved devastating to the fort itself. In a salt-water environment, the wrought-iron quickly began to rust and expand. As the iron rusted, it pushed

the brick apart, causing serious structural damage to Fort Jefferson’s walls. A walk around the moat shows where large sections of the fort walls have collapsed into the moat. This is largely caused by the rusting shutter system.

Dry Tortugas National Park has initiated a multi-phased, multi-year preservation project to stabilize Fort Jefferson. The scope of this project is to carefully remove the existing brick surrounding the embrasure (cannon) openings on the lower level in order to gain access to the original iron elements. When possible, original bricks will be cleaned and set aside for reuse.

Next, crews will remove all of the rusted iron elements from the original Totten shutters and stabilize the exterior walls of Fort Jefferson by rebuilding the scarp (fort) wall. Concrete made of local sand and coral - just as used in the original construction - historic bricks salvaged during demolition and new replacement bricks are being used to preserve the historic appearance of the walls. In addition, the parapet and upper tier embrasure openings will be stabilized

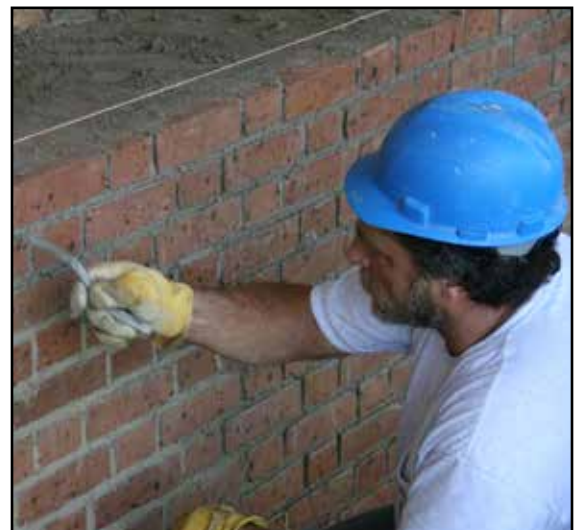
Masonry crew member tooling the joints

through selective brick replacements and re-pointing of the mortar joints.
