Environmental Studies of Ambler Transportation Corridor, Alaska

Final Report

**Prepared for the
Alaska Industrial Development and Export Authority**

**Report INE/WERC 15.14
December 2015**

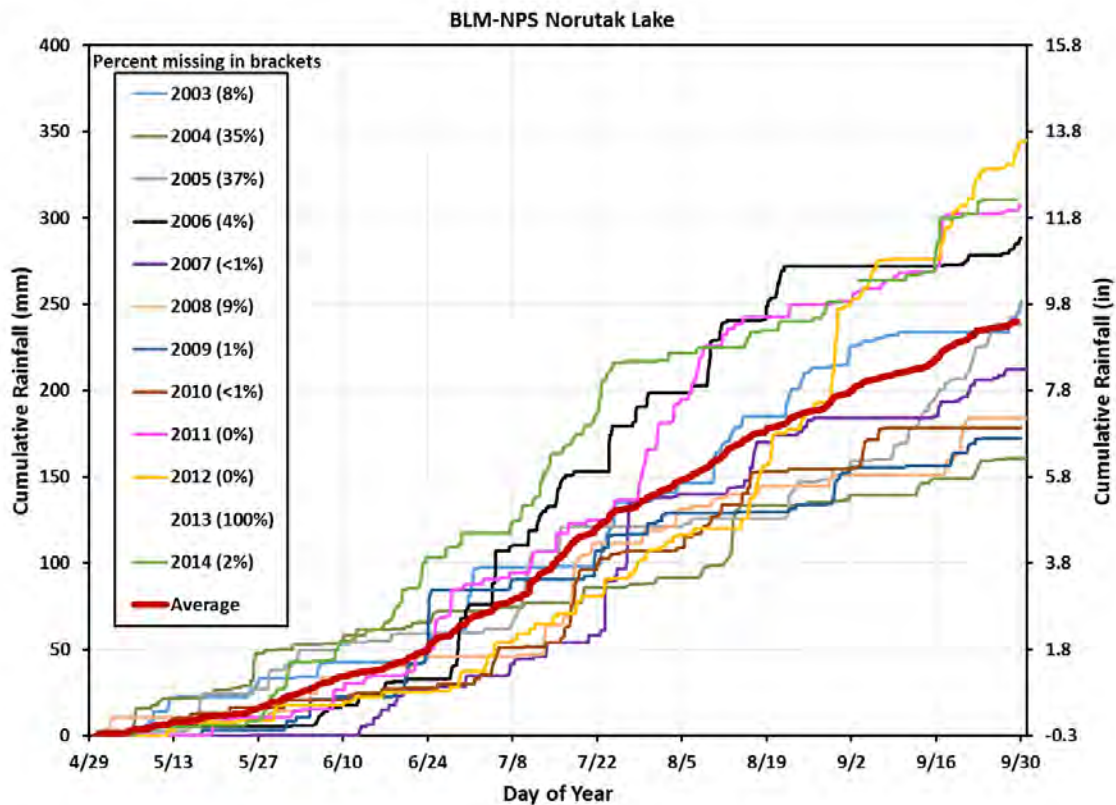
Figure 8. Warm season cumulative precipitation at Norutak Lake for 11 years; the average is indicated by the bold red line.

The U.S. Department of Interior, Bureau of Land Management, has operated a warm season precipitation gauge at Norutak Lake (66°49.73'N, 154°19.28'W; 244 m, 800 ft) since 2003. This unattended site is approximately in the middle of the study area, on the southern boundary in the lowlands. The record for this site is relatively good except in 2013, when no data were collected. Still, the existing data (Figure 8) from this site give a good indication of the range and timing that can be expected in terms of warm season precipitation. The wettest summer, 2012, received almost 350 mm (14 in.), and the driest summer, 2004, received about 150 mm (6 in.). A plot of the cumulative average over the warm season for the 11-year record is shown in Figure 8. The average at summer's end is 240 mm (9.4 in.), with the steepest slope (most intense rainfall) occurring in July.

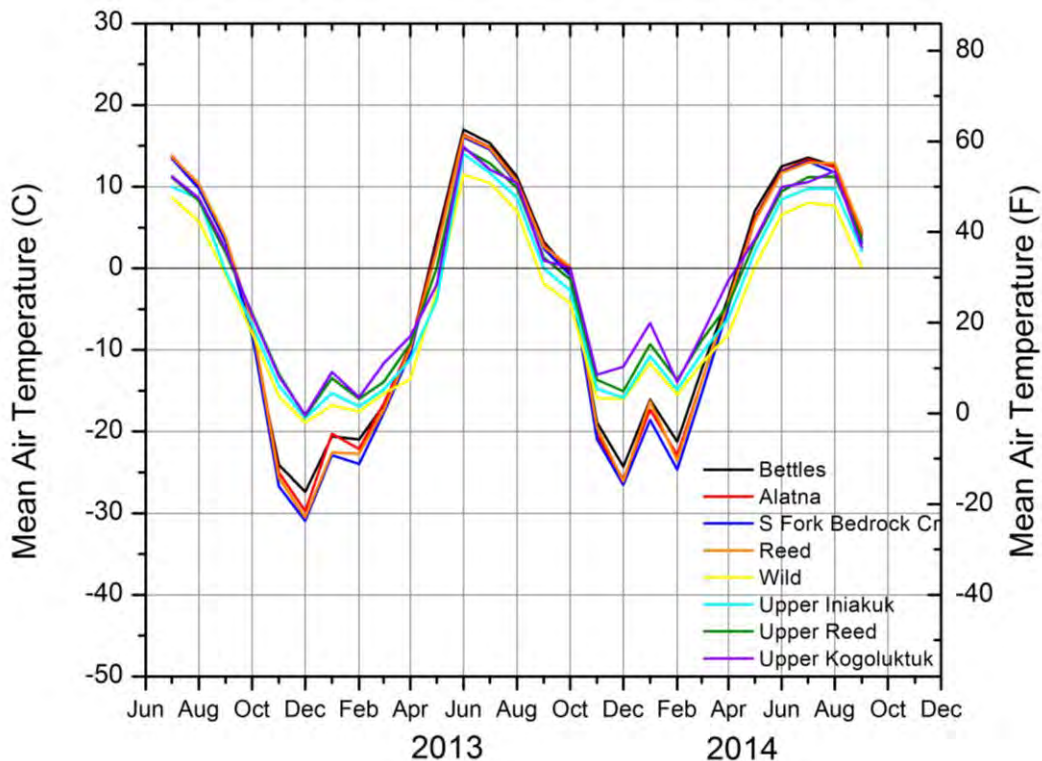
Figure 9. Mean monthly air temperature at stations in the Ambler network.

with the four lowland stations (Bettles, South Fork Bedrock Creek, Alatna, and Reed). Mean monthly air temperature was calculated for each month (Figure 9). The warmest months are June or July, and the coldest months are December, January, or February. In the study area, the coldest temperature in the lowlands was recorded in December 2012 at -47.1°C (-53°F) (Bettles); the warmest temperature was 31.2°C (88°F) (also in Bettles) in June 2013. Thus, in the warm season, the air temperature decreases with elevation, and in the cold season, an air temperature inversion occurs, with colder temperatures in the areas of low elevation. In the mountain region, the coldest temperature was -31.0°C (-24°F) (Wild) in January 2013, and the warmest temperature was 28.3°C (83°F) (Upper Kogoluktuk) in June 2013. The transition from the warm season to the cold season and vice versa occurs in early October (beginning of snow accumulation) and mid-April (ablation). The trend in air temperature data collected for over 30 years at Bettles, Wiseman, and Chandalar Shelf (reported in the Climatology section) has similar trends as the short-term air temperature data presented here, with cooler temperatures in the mountains in summer, and warmer temperatures in the mountains in winter.

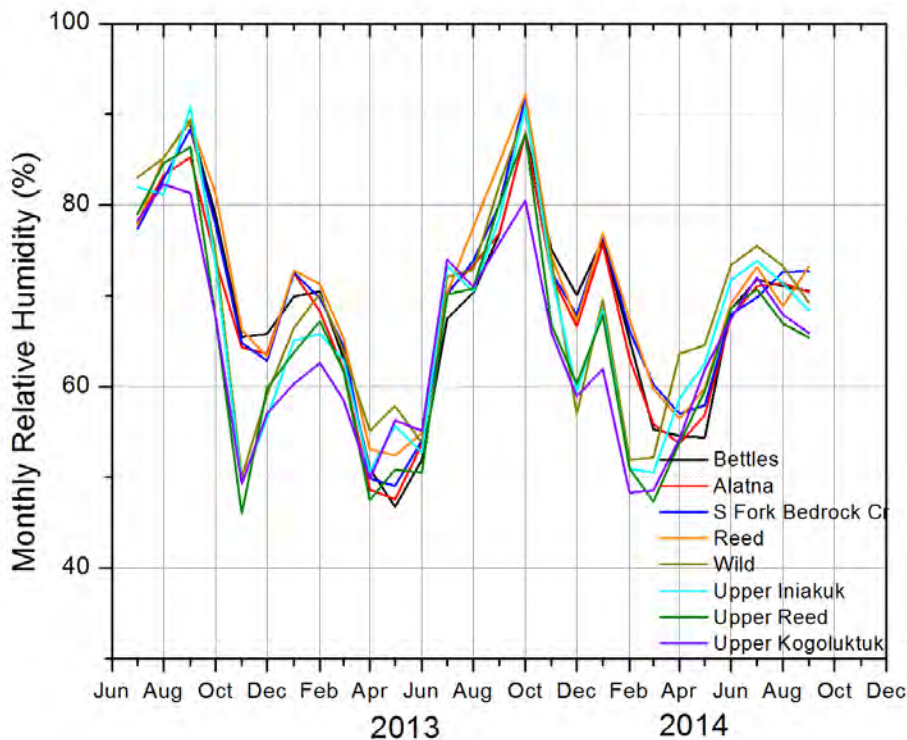
Figure 10. Mean monthly relative humidity during the period of observation at all 8 meteorological sites.

10, the average monthly relative humidity is plotted for a little over 2 years, from July 2012 to September 2014. The general trend is for high relative humidity (~80%) in the summer months with lower values (~50–70%) in the cold months. For both years, an initial drop in early winter, followed by a small rise in November/December and ending with another drop occurs in late winter. Part of this small mid-winter blip in relative humidity matches a small blip in mid-winter air temperature. It is not clear if other factors induce this variation in relative humidity. For a similar study on the Central Alaska North Slope, there was mid-winter variation in relative humidity, but nothing that matches the relative humidity pattern on the south side of the Brooks Range. The major difference in relative humidity on the north and south sides of the Brooks Range is that the relative humidity is generally higher on the north side in winter than on the south side. The months with the least monthly precipitation are in late winter and into spring (February, March, and April), and therefore it is not surprising that these months are prone to low relative humidity. Note that at low temperatures, although the relative humidity is high, there little moisture is in the atmosphere even at saturation (thus the term *relative*).

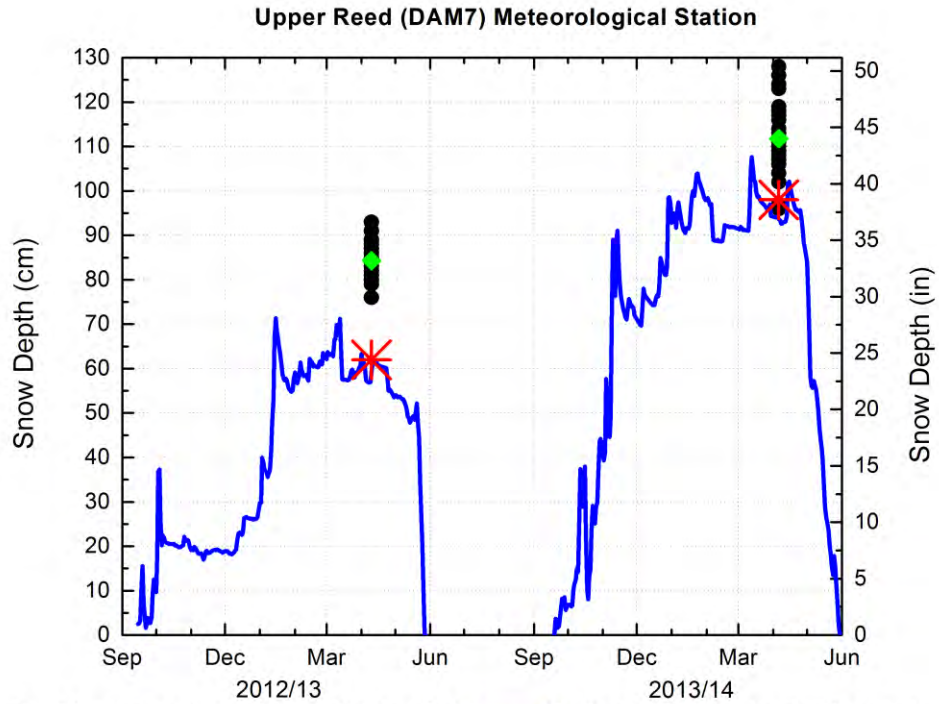
Figure 25. Upper Reed (DAM7) meteorological station daily (hourly averaged) recorded SR50 sensor snow depths, observed snow depth under the sensor at time of visit, 50 snow survey depths measured near sensor, and average of 50 depths, 2012–2014.

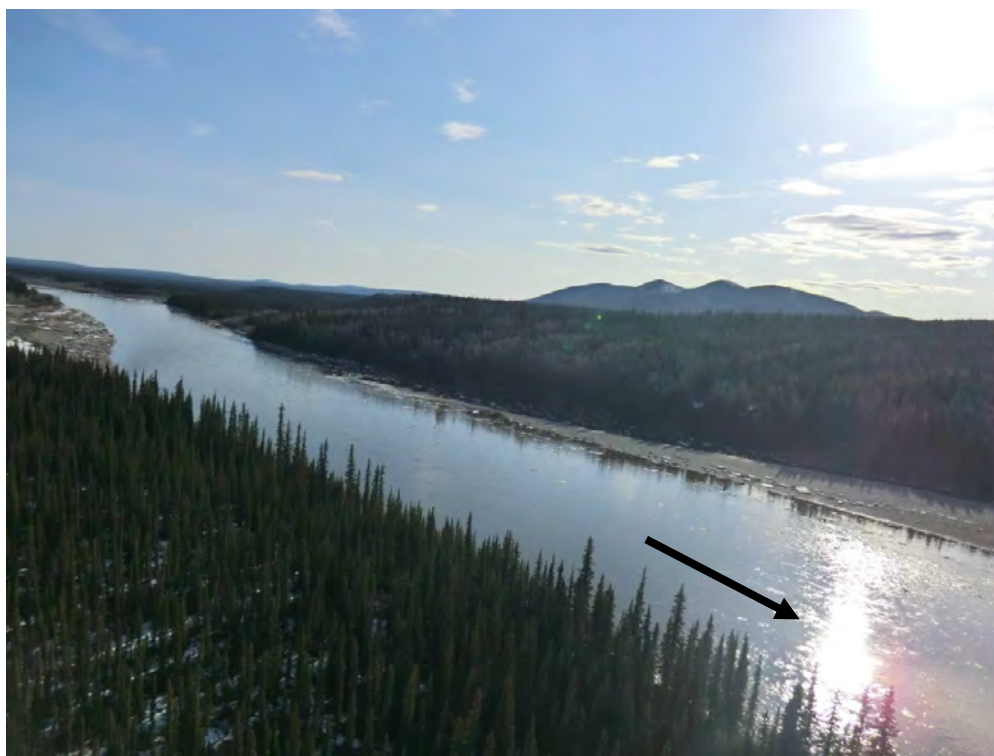
Figure 44. Koyukuk River near Old Bettles on May 17, 2012, before peak flow. Ice is observed at the edge of the river, below the cutbank. The arrow indicates the direction of flow. Old Bettles is located about a half-mile downstream from the location of the photograph.

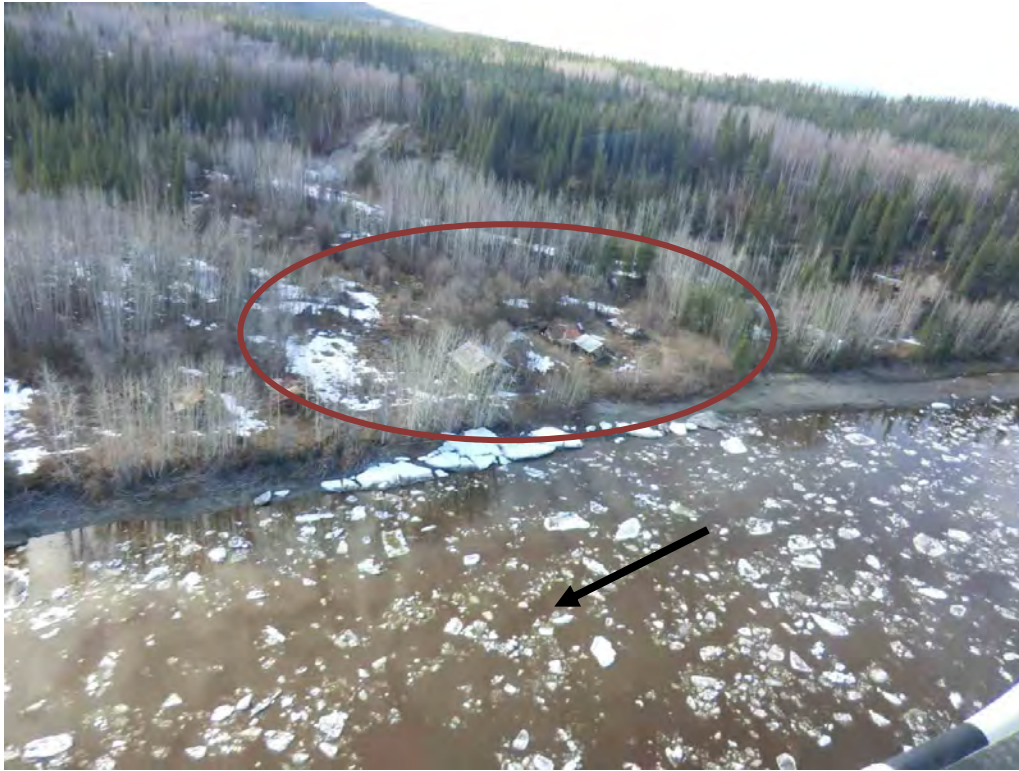
Figure 45. Koyukuk River near Old Bettles (circle) on May 17, 2012, a week before peak flow, showing ice chunks at the river's edge (below the cutbank) and floating in the water. The river already appears turbid.

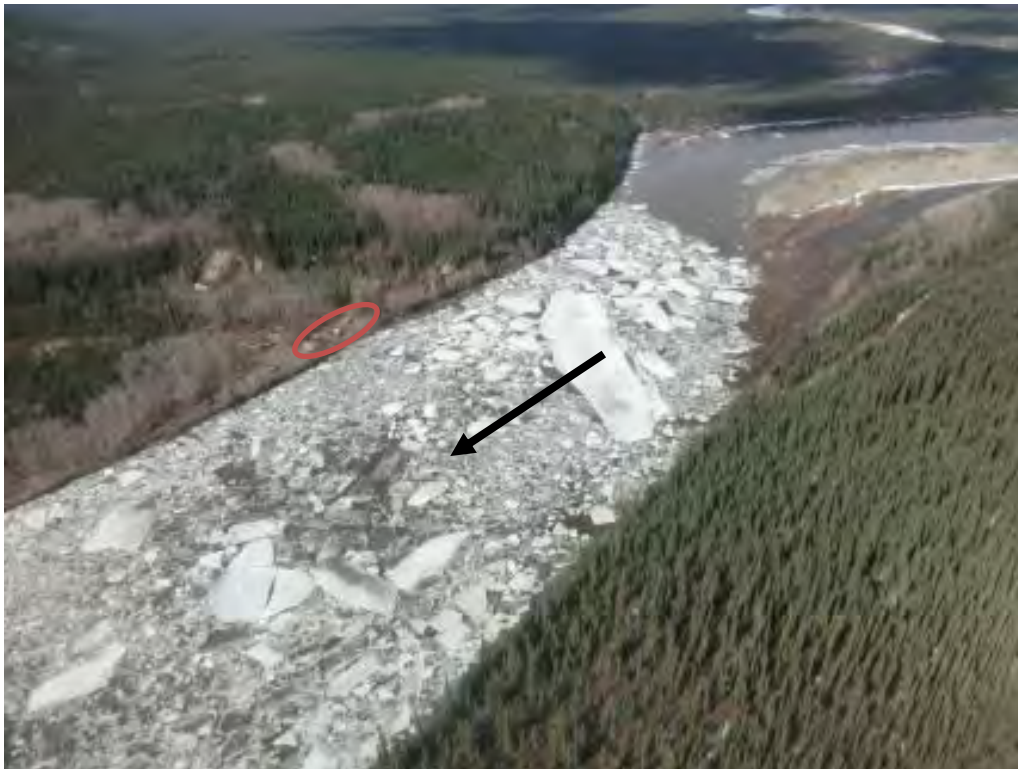
Figure 52. Ice jam, during the afternoon, in front of Old Bettles (oval) on May 25, 2013.

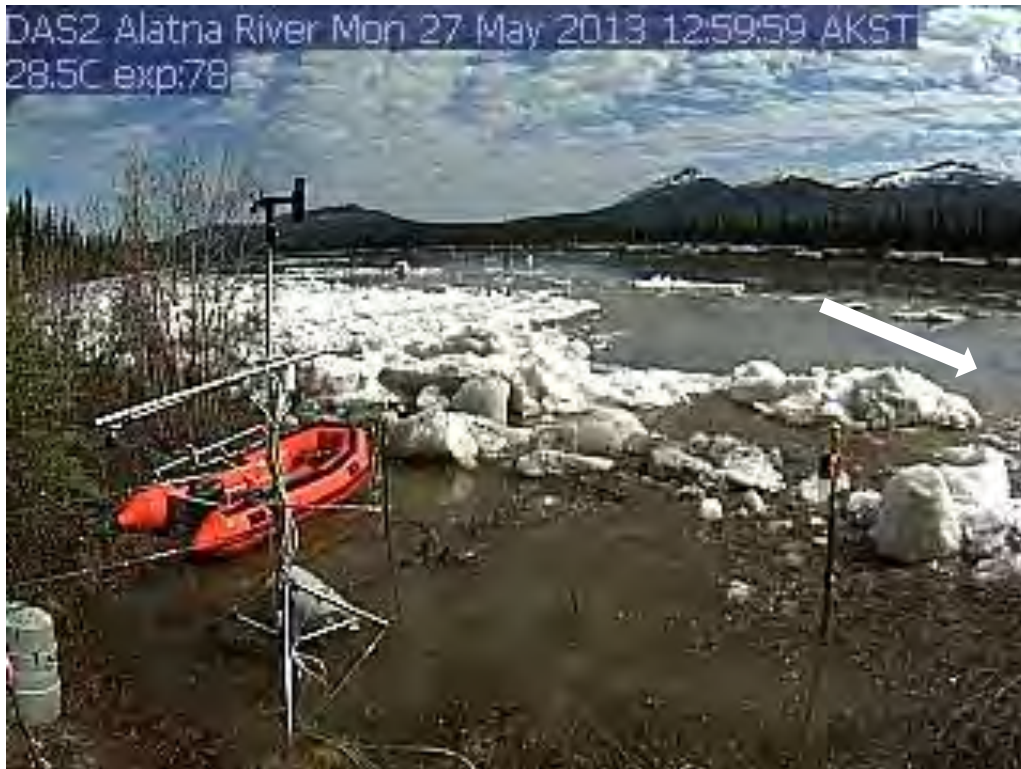
Figure 80. Alatna River is over bankfull on May 27, due to ice conditions.

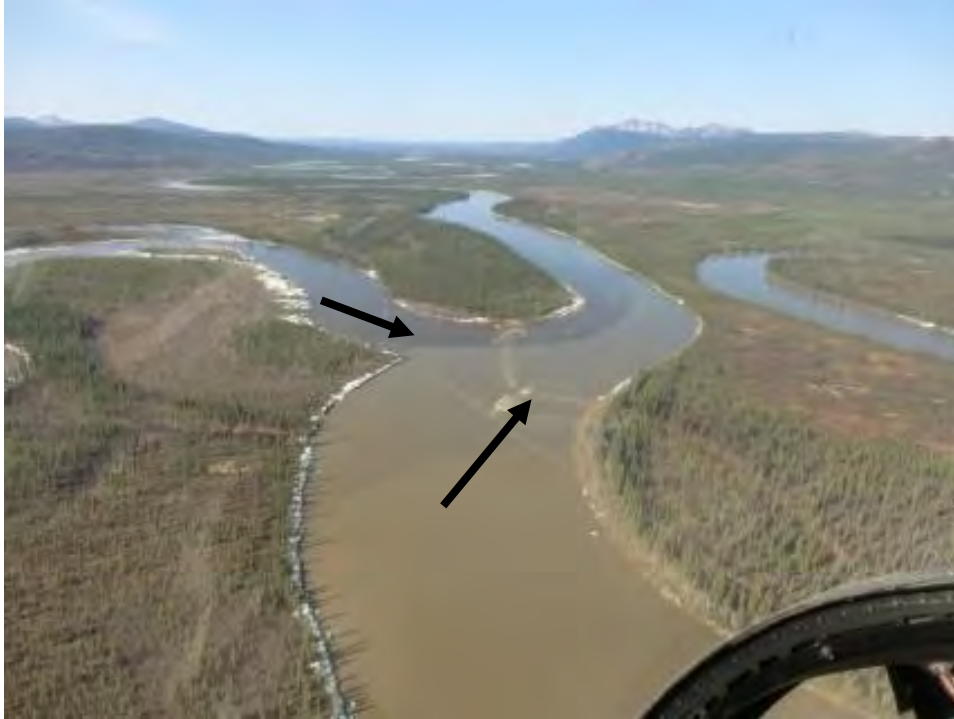
Figure 81. Confluence of the Malamute Fork of the Alatna River (dark colored water coming in on left) and Alatna (silty water) on May 28, 2013. Interface between streams is well defined. The gauging site for the Alatna is a short distance downstream.

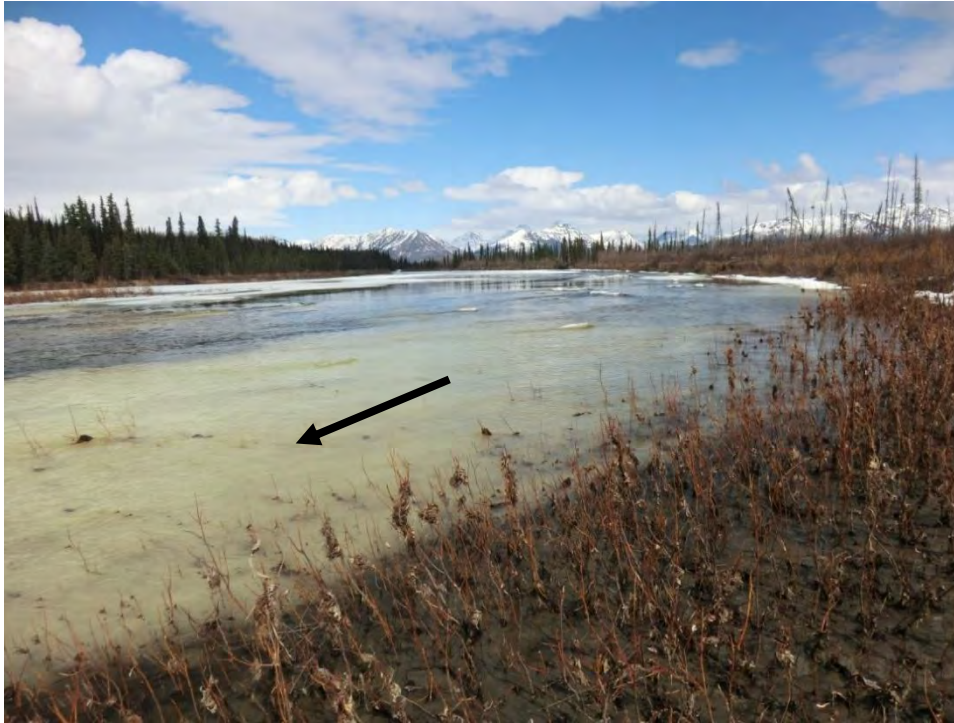
Figure 125. Flow over ice (near the bank) on May 24, 2013, facing north. Active flow conditions in the middle of the channel. Arrow indicates flow direction.

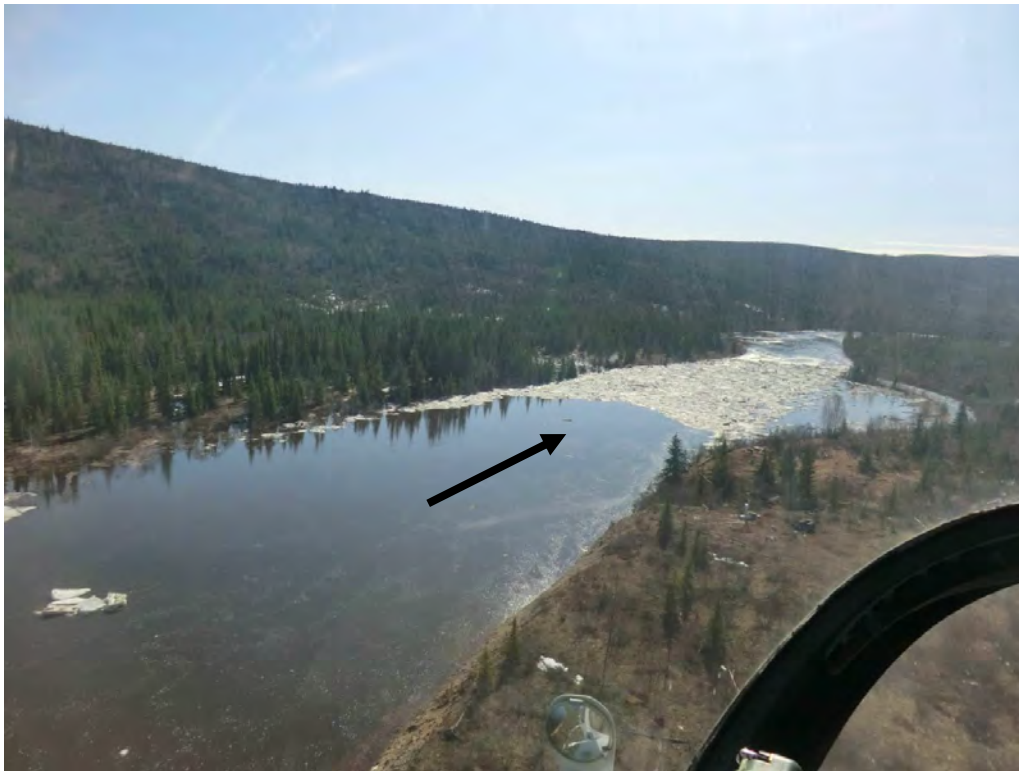
Figure 161. Ice jam at the Reed River on the morning of May 27, 2013. River conditions are bankfull above the ice jam.

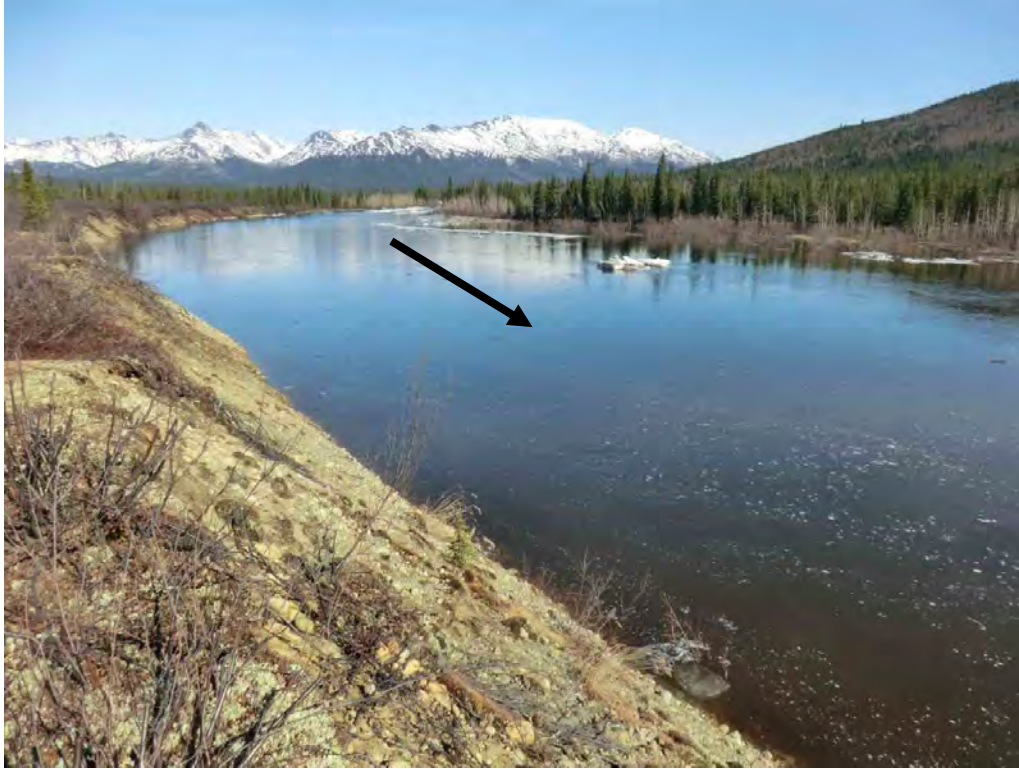
Figure 162. Backwater in front of the station due to an ice jam on the Reed River on May 27, 2013. River conditions are bankfull.
