NATIONAL REGISTER OF HISTORIC PLACES NOMINATION, GLACIER NATIONAL PARK

STRUCTURE NAME: Lower Nyack Snowshoe Cabin STRUCTURE NUMBER: 620

Lower Nyack Snowshoe Cabin (addendum), Flathead County, MT.

Building Interior

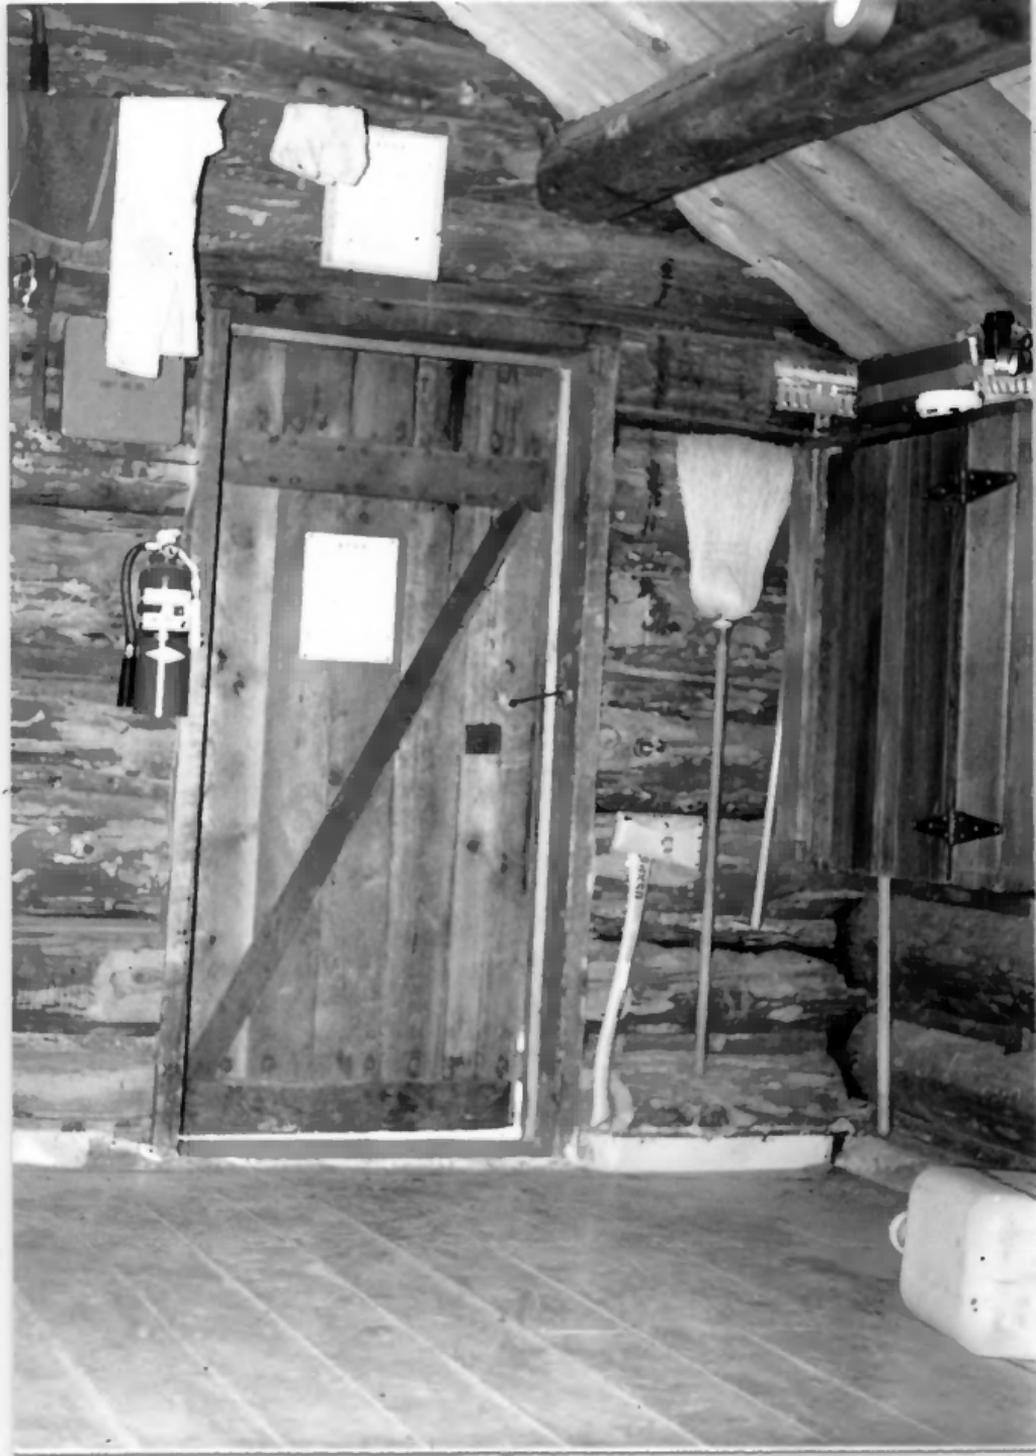
Figure 1

Furnishings are standard: two metal bedsprings, bedding storage boxes, wooden chairs, a Coleman stove, two Coleman lanterns suspended from ceiling hooks, snowshoes, trail maintenance tools, and a large wall-mounted cabinet with fold out table. A second cupboard, located near the door, is constructed of 5" tongue-and-groove boards secured with long metal hinges. The large wood stove, placed on four bricks and paired with a modern movable sheet metal screen, appears to be a relatively modern addition: scars in the flooring indicate the original stove placement.

PHOTO NUMBER	BUILDING NAME AND NUMBER	DESCRIPTION
1	Lower Nyack Snowshoe Cabin (#620)	Interior-stove
2	Lower Nyack Snowshoe Cabin (#620)	Interior-door and cupboard unit

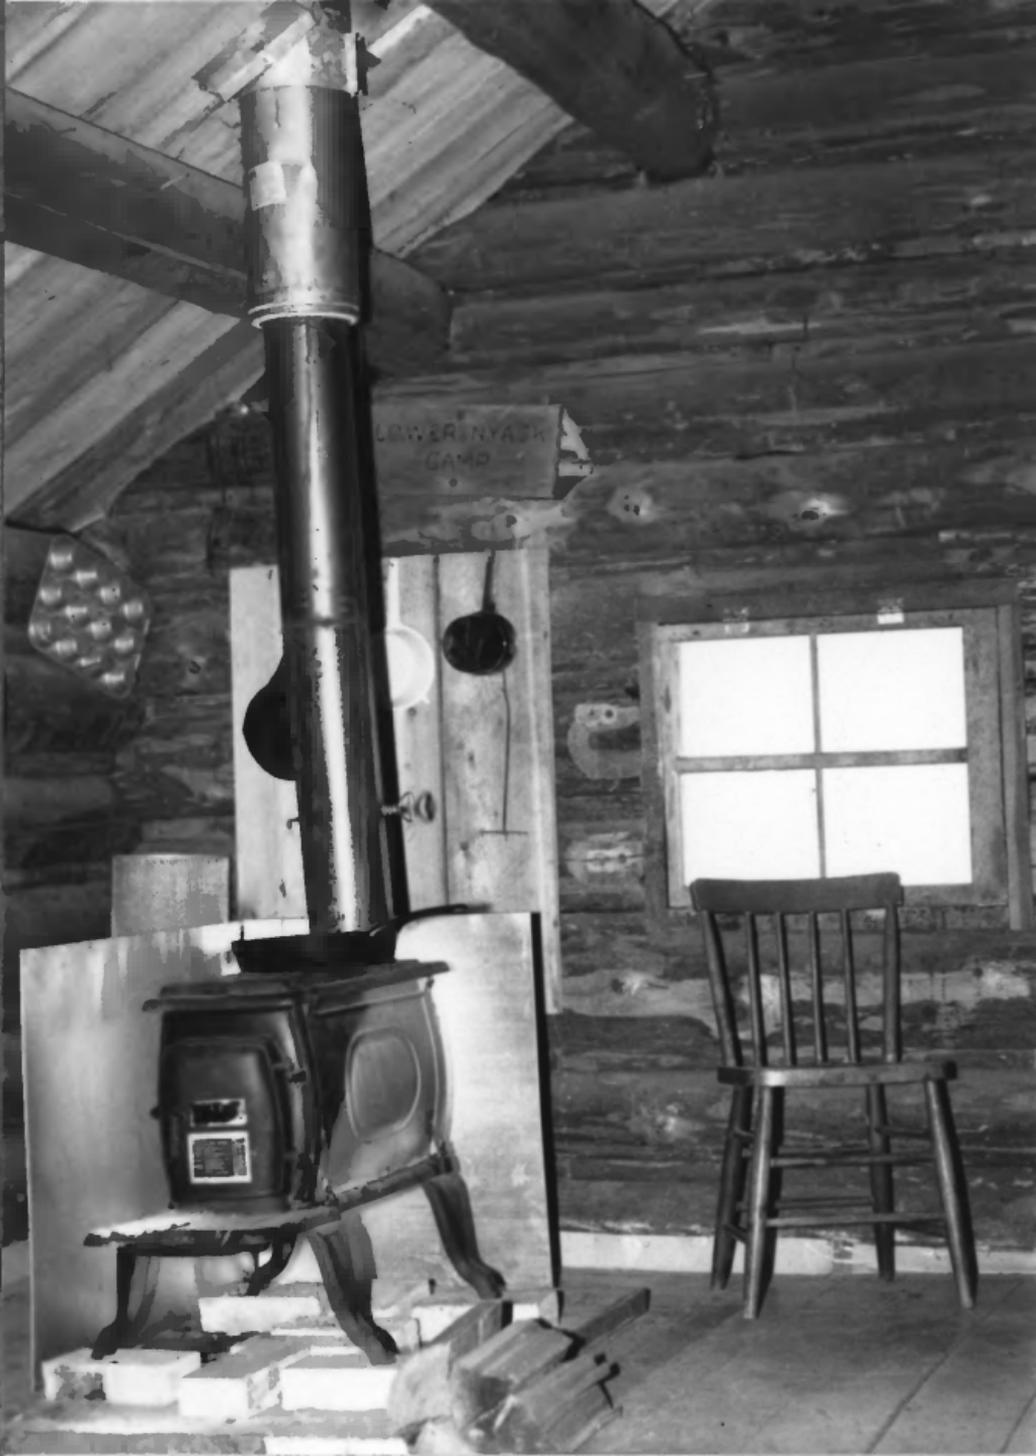
Figure 2

This one-room backcountry building, a day's hike north from the Theodore Roosevelt Highway, matches the basic patrol cabin design except for its larger size (18' x 14"). The sole entry, facing south to Nyack Creek, is constructed of alternating planks (creating a board-and-batten appearance) on the exterior and five 6" vertical

planks, secured with a diagonal brace, on the interior. Large metal hinges extend completely across the door and along the adjacent log wall. Seven-inch shiplap, painted grey, covers the floor; half-round sill logs act as baseboards. A trap door, also constructed of 7" shiplap and opened with a sunken circular pull, provides access to the root cellar. (This root cellar is lined with cement and screened against rodents. Two large shelving units filled with canned food dominate the space.) Interior walls are log, chinked with split saplings. The ceiling is open to the roof, exposing the five log purlins and heavy roof planks.
