NATIONAL REGISTER OF HISTORIC PLACES NOMINATION, GLACIER NATIONAL PARK

STRUCTURE NAME: Upper Kintla Lake Patrol Cabin STRUCTURE NUMBER: 613

Upper Kintla Lake Patrol Cabin (addendum), Flathead County, MT.

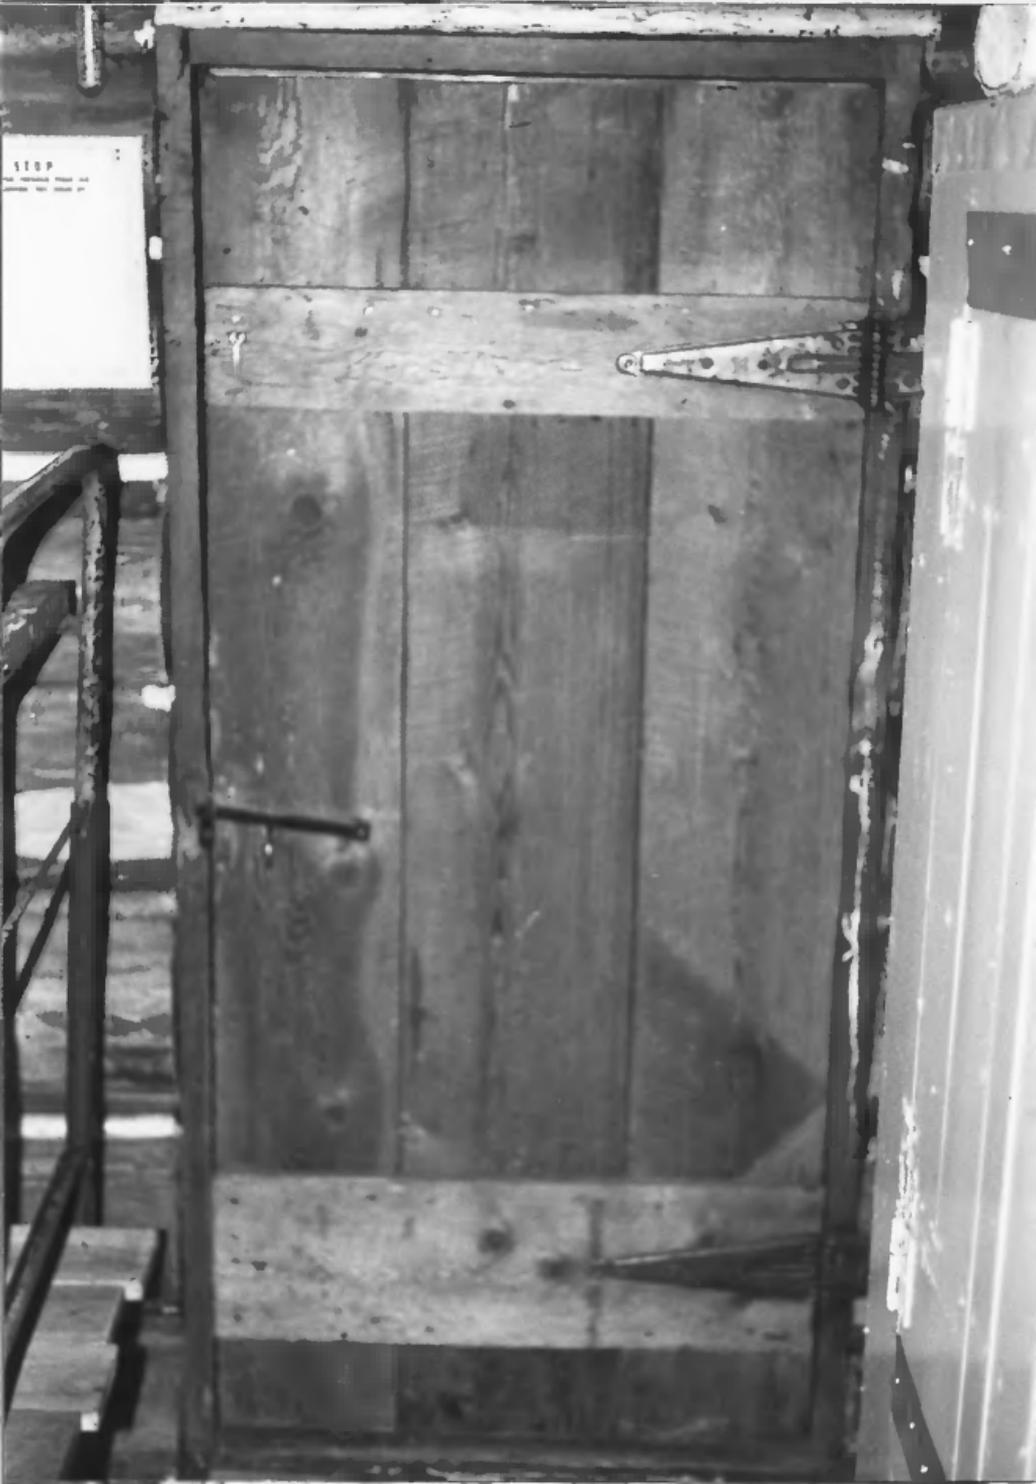
Figure 1

Interior

Door

A heavy door, constructed of three 8"-12" planks secured with horizontal braces, provides access to this simple one-room cabin where 7" planks, painted grey, cover the floor. The trap door to the concrete-lined cellar

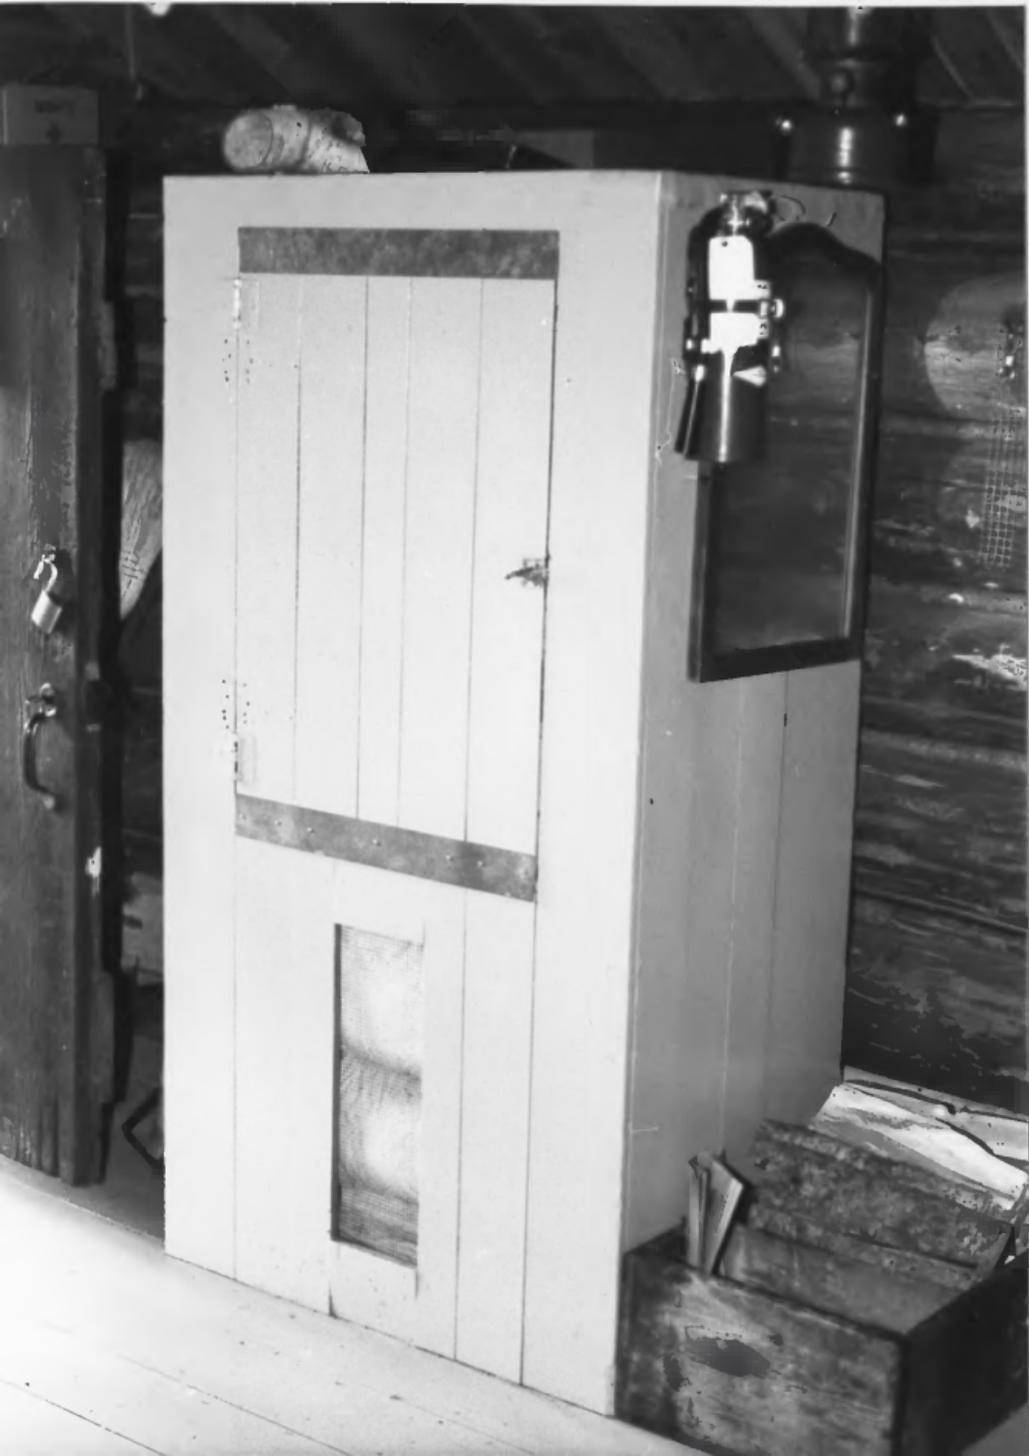
Figure 2

Interior

Cabinet

is located just off-center, near the wood box. The ceiling is open to the roof exposing the log purlins and roof planks. Full logs, chinked with sapling, form the interior walls. Furnishing include a standard wall-mounted cupboard with hinged table top/door and a tall standing cupboard constructed of shiplap planks and holding folded up mattresses (a variation on the standard rodent-proof bedding boxes). A set of metal bunkbeds is located just to the right of the door and a folding bed rests against the east wall near floor space shared with the hinged table top. Coleman lanterns hang from the ceiling and a woodstove provides both heat and a cooking surface.
