NATIONAL REGISTER OF HISTORIC PLACES NOMINATION, GLACIER NATIONAL PARK

STRUCTURE NAME: Upper Lake McDonald Ranger Station STRUCTURE NUMBER: 58
 Historic District/Residence

UPPER
LAKE McDONALD
RANGER STATION
HISTORIC DISTRICT

Upper Lake McDonald Ranger Station Historic District (addendum), Flathead County, MT.

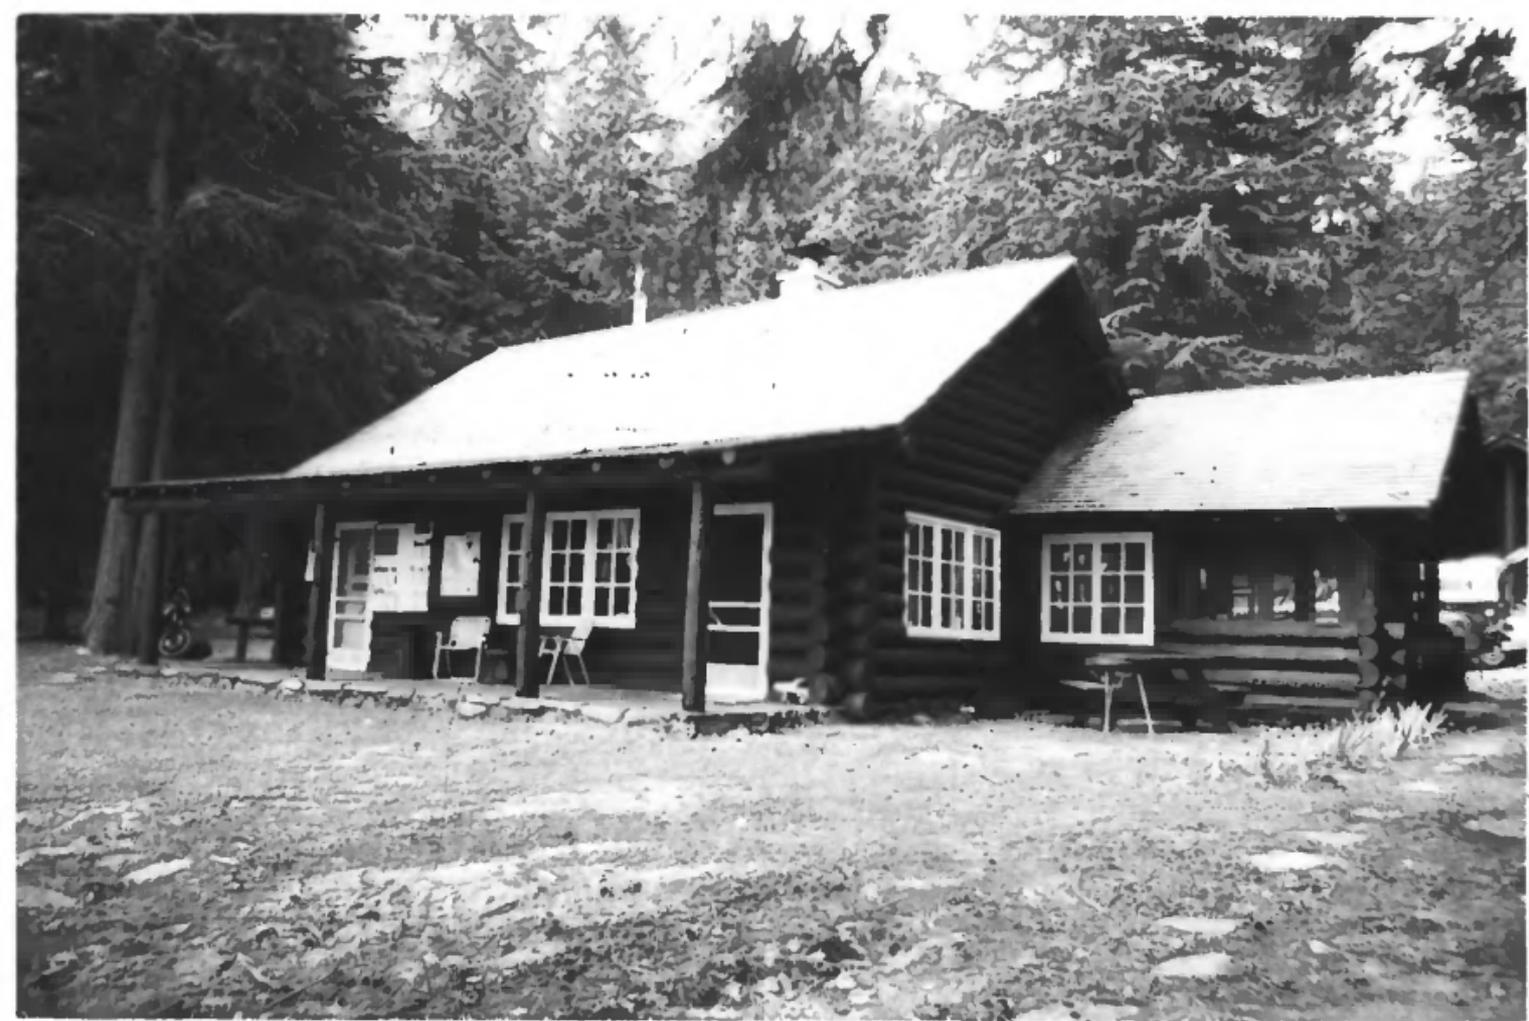
PHOTO NUMBER: 1

NAME: Ranger Station--Upper Lake McDonald

The Upper Lake McDonald Ranger Station is a one-story, rectangular, log structure measuring 35x47', with an attached room at the northeast corner. The gable roof is covered with wood shingles and features a central, random-coursed ashlar chimney. The roof line extends south to form a full shed porch on four posts, with a flagstone patio. Grooved, saddle-notched logs are through the gable ends, with no exterior chinking. The interior walls are hewn logs. There are louvered ventilators in the gable ends. Fenestration includes framed four- to six-light casements, and two entries face south to the lake. The structure rests on a concrete foundation and is in good condition. This ranger station is a well-preserved example of rustic, Park Service-designed log architecture. It is similar in plan to stations at Belly River and Sherburne, with modifications of overall dimensions, fenestration, and porch features to accommodate space requirements and site demands. The building is architecturally significant and is a contributing element of the site.

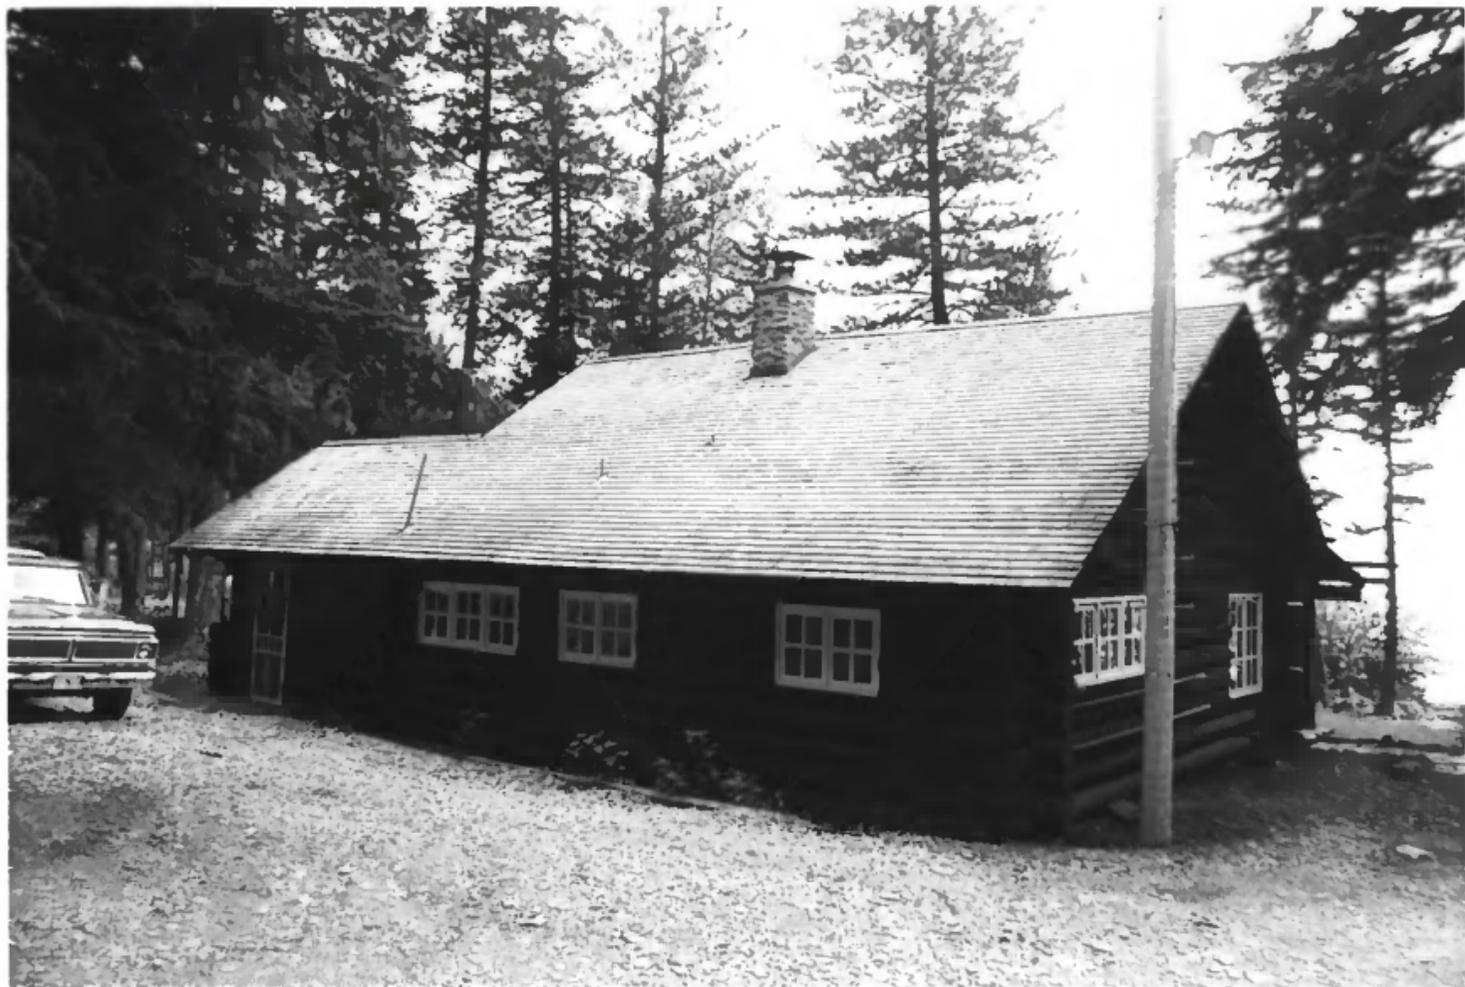
PHOTO NUMBER: 2

NAME: Ranger Station--Upper Lake McDonald

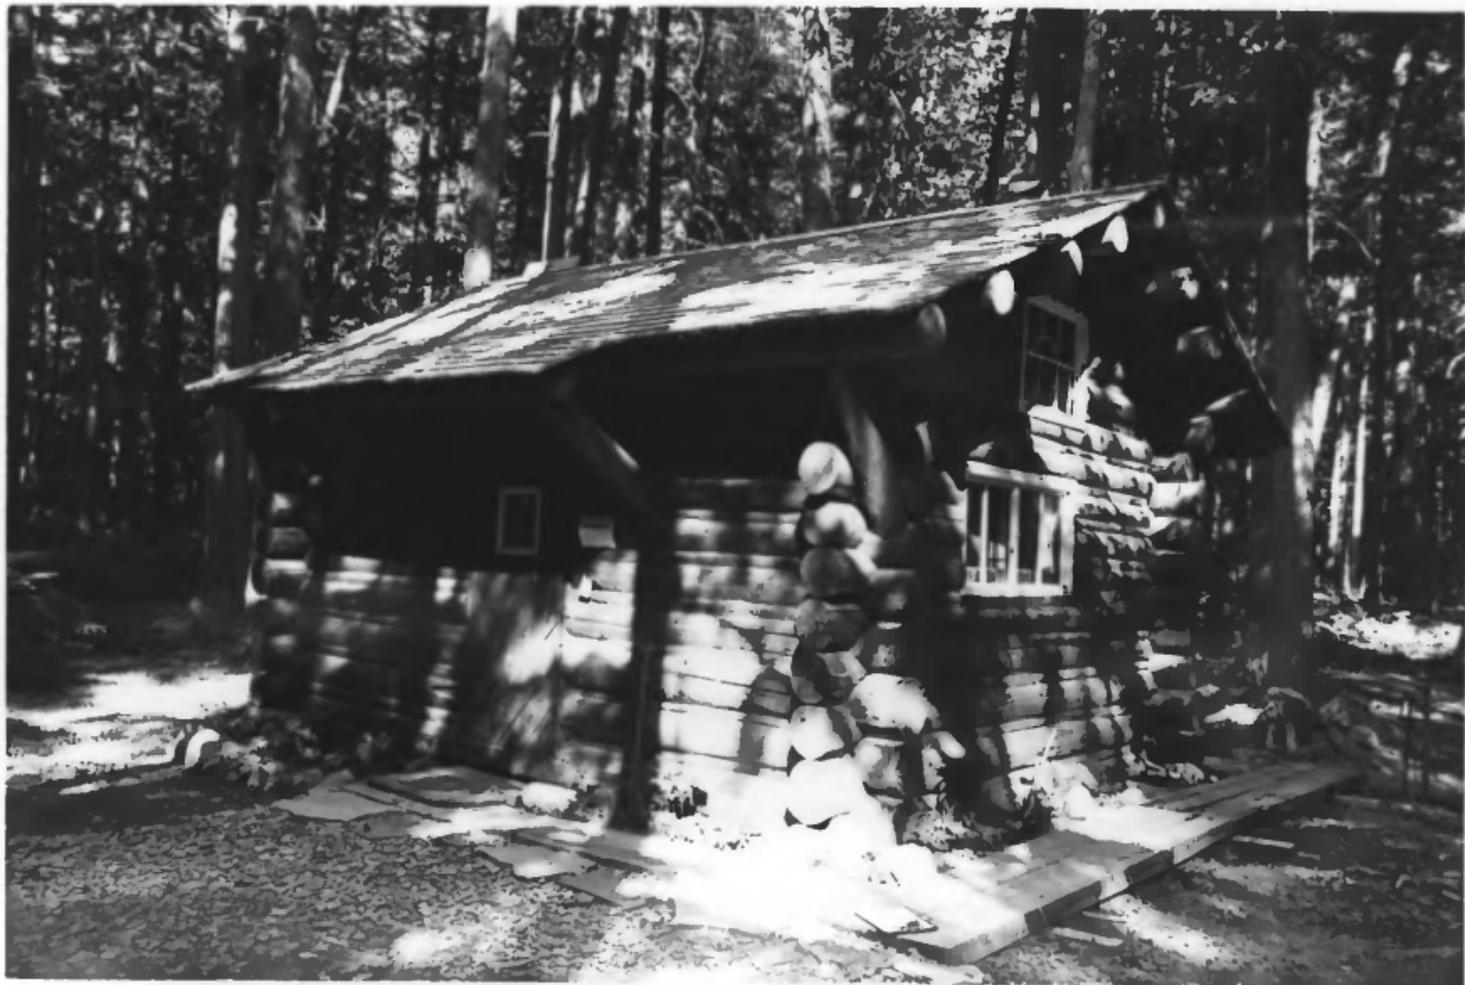
PHOTO NUMBER: 3

NAME: Cabin (Former Fire Cache)--Upper Lake
McDonald Ranger Station Historic District

The structure is a one-story, rectangular log cabin with a gable roof, measuring 23x19'. The logs are saddle notched with wood strip chinking and square-cut crowns protected by eaves. The wood-shingled roof has nine log purlins. The roof flares to a slight over-door supported by log brackets, and there are log brackets on the eave corners. Framed fenestration has six-light casements in the gable ends and four-light sliding windows on the main floor. There is a newer, frame shed addition to the rear (east), measuring 6.5x10'. There is no apparent foundation. The structure is in fair to good condition, with some decay in two lower crowns on the north wall and roof shingles in poor condition with moss covering. The fire cache is an excellent example of local log craftsmanship, featuring saddle-notched and grooved logs. Its conversion to a fireguard cabin and minor alterations have not compromised the structure's integrity. However, since it is less than 50 years old and does not possess outstanding architectural or historical significance, it must be considered to be a non-contributing structure in the Historic District.

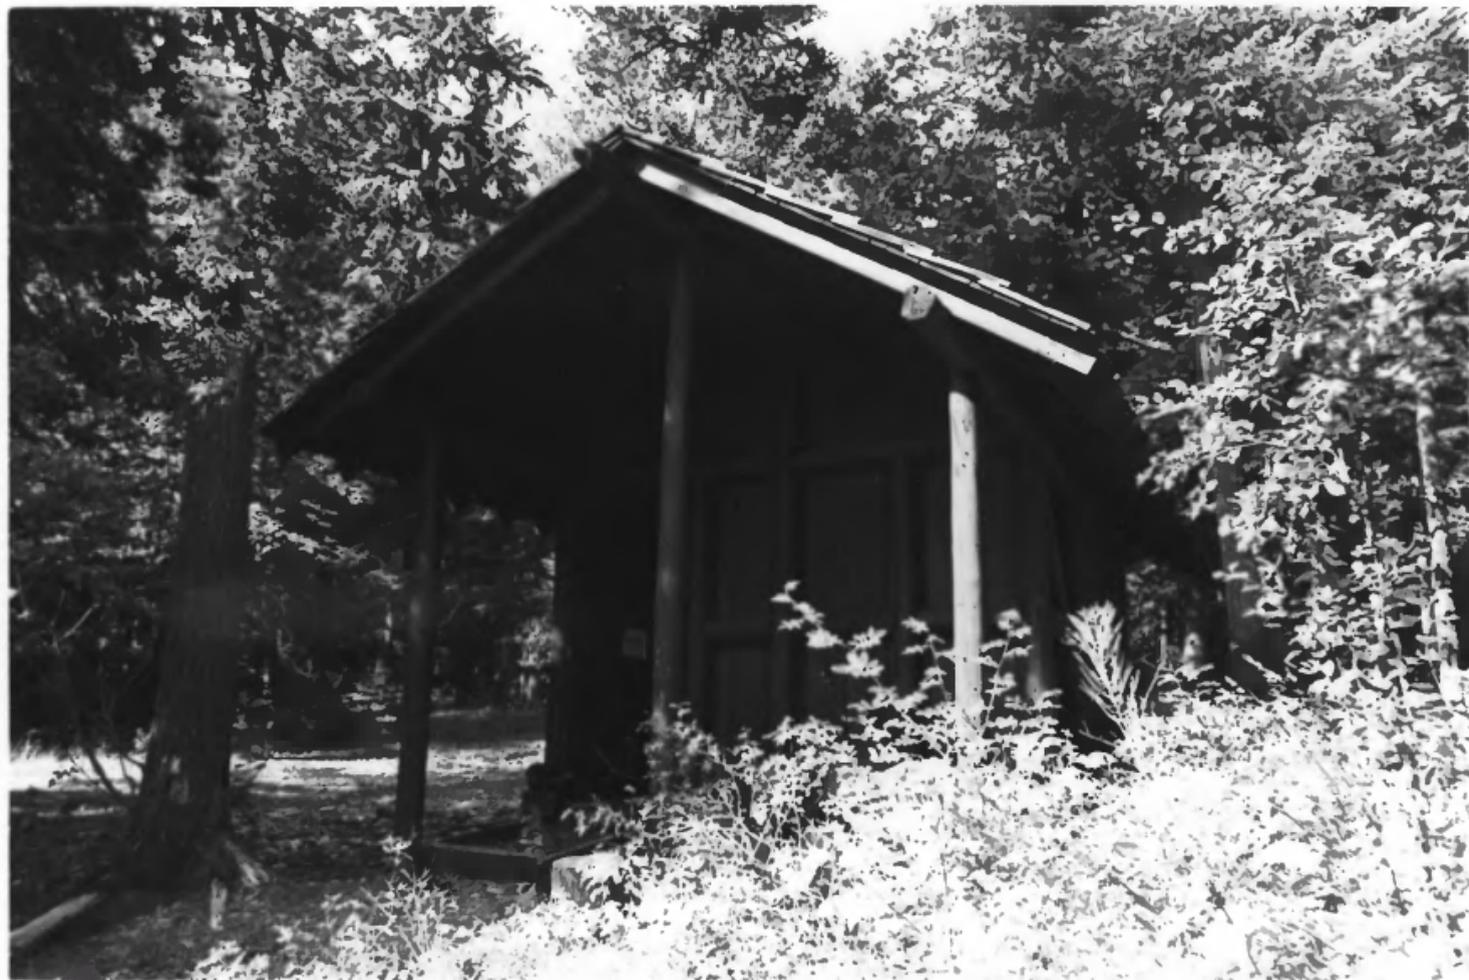
PHOTO NUMBER: 4

NAME: Woodshed--Upper Lake McDonald

The structure is a one-story, rectangular shed, measuring 25x16.5'. The wood-shingled gable roof has exposed rafter end tips of lumber and extends to the south, supported by three poles. Walls are timber-out framing with vertical board walls. The structure rests on a concrete pad foundation in the front, and rests on the ground and is slightly bermed to the rear. There is a solid wood door to the south and wood-shuttered windows to the east and west. The structure is in fair to good condition, with moss-covered shingles. Framing and walls appear to be in good condition. The scale, materials, and design of this woodshed are compatible with the more significant buildings of the ranger station. It contributes to the overall architectural significance of the site.

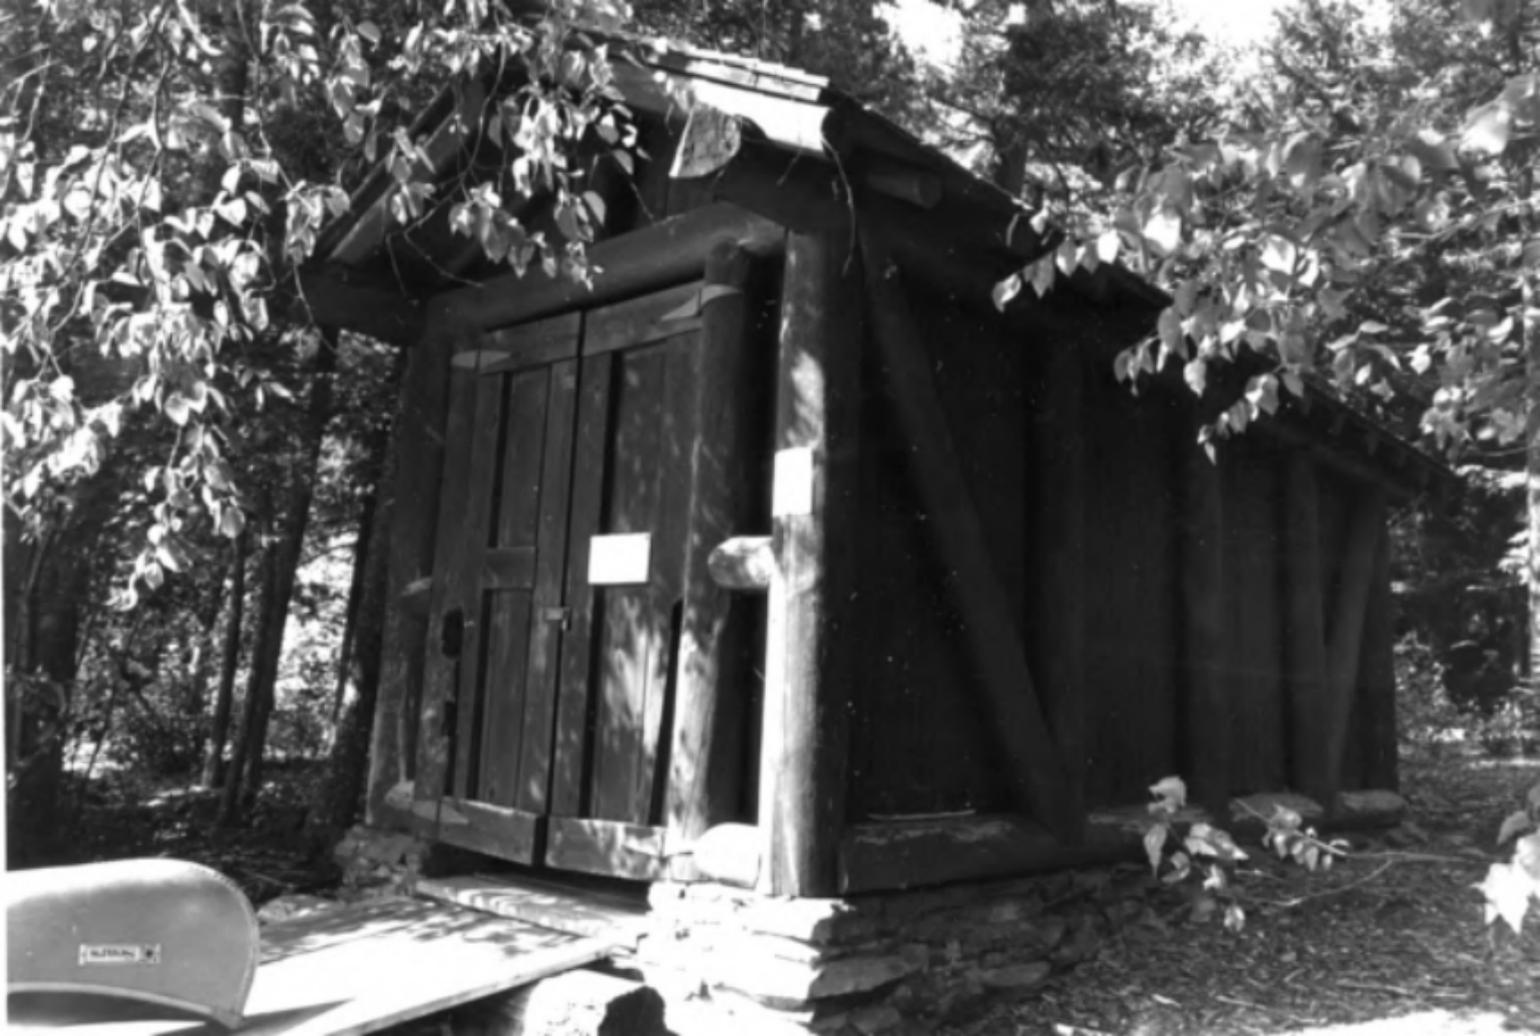
PHOTO NUMBER: 5

NAME: Boathouse--Upper Lake McDonald

The boathouse is a one-story, rectangular structure, measuring 14x26'. The timber-out frame construction has vertical board walls and double front doors with a ramp on timbers leading to the lake. The slabstone masonry foundation has cement mortar. The gable roof has wood shingles, three extended crown purlins, and covered pole rafter ends. The structure is in good condition, with some deterioration of the exterior ridge log. Inclusion of the boathouse at the Upper Lake McDonald Ranger Station makes this one of the most diverse stations (no other complex has both boathouse and barn). The scale, materials, and design of this boathouse are compatible with the more significant buildings of the ranger station. It contributes to the overall architectural significance of the site.

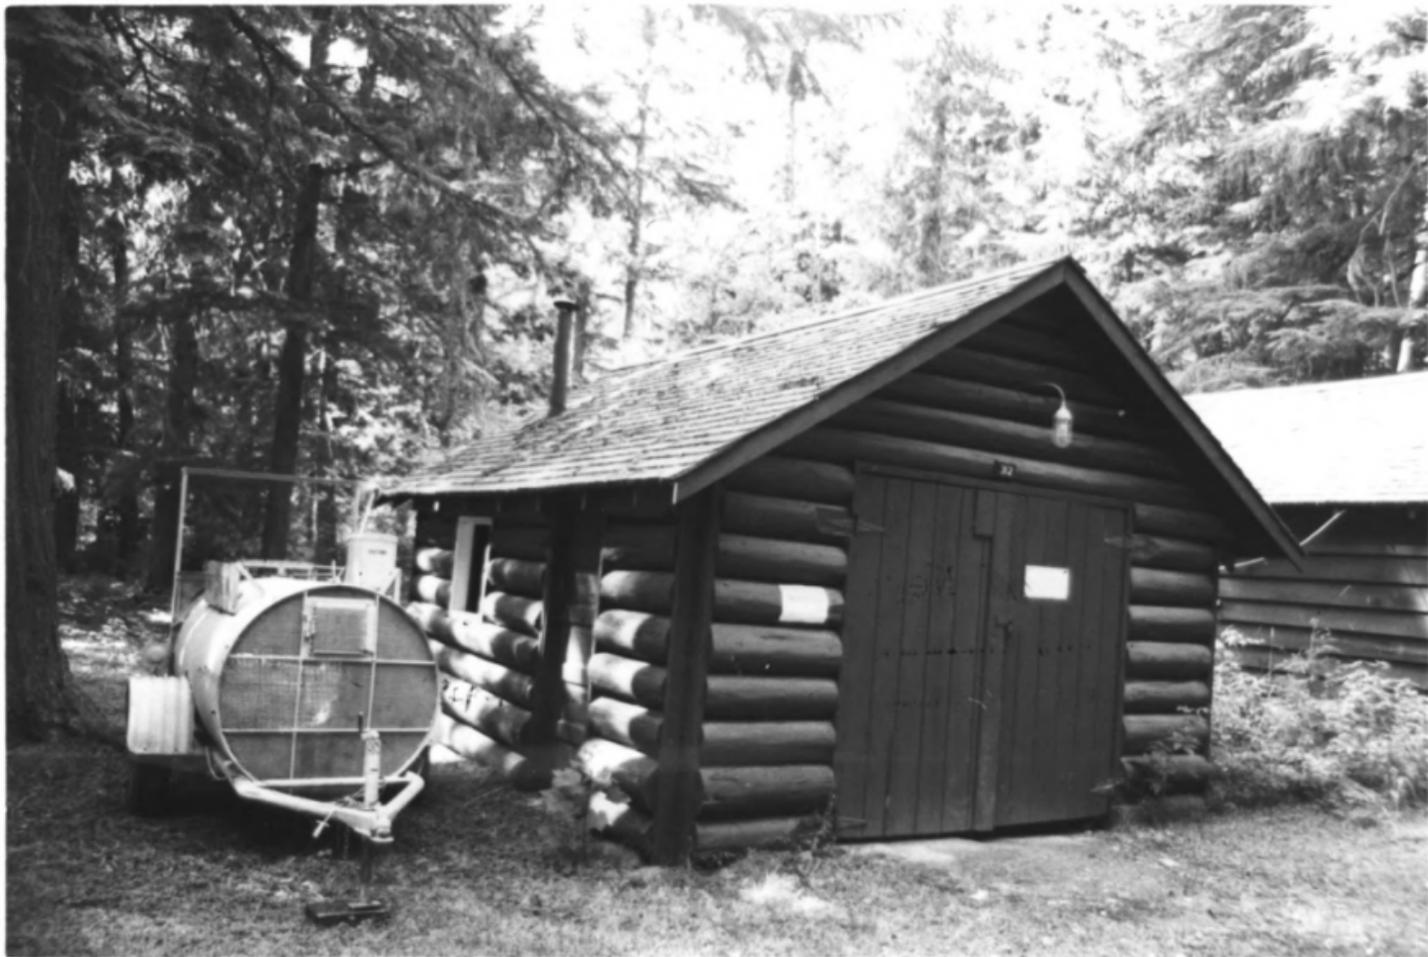
PHOTO NUMBER: 6

NAME: Garage--Upper Lake McDonald

The structure is a one-story, rectangular, gable-roofed log garage, measuring 22x18' and resting on a wood beam alignment foundation with interior concrete floor. Unnotched logs are nailed to corner V-upright lumber. Framed fenestration includes four-light casements to the north, south, and west, and double entry doors centered to the east. The wood-shingled roof has exposed rafters beneath the eave and a metal stovepipe through the roof. There is a five-panel solid entry door to the south. The structure is in good condition. The scale, materials, and design of this garage are compatible with the more significant buildings of the ranger station. It contributes to the overall architectural significance of the site.

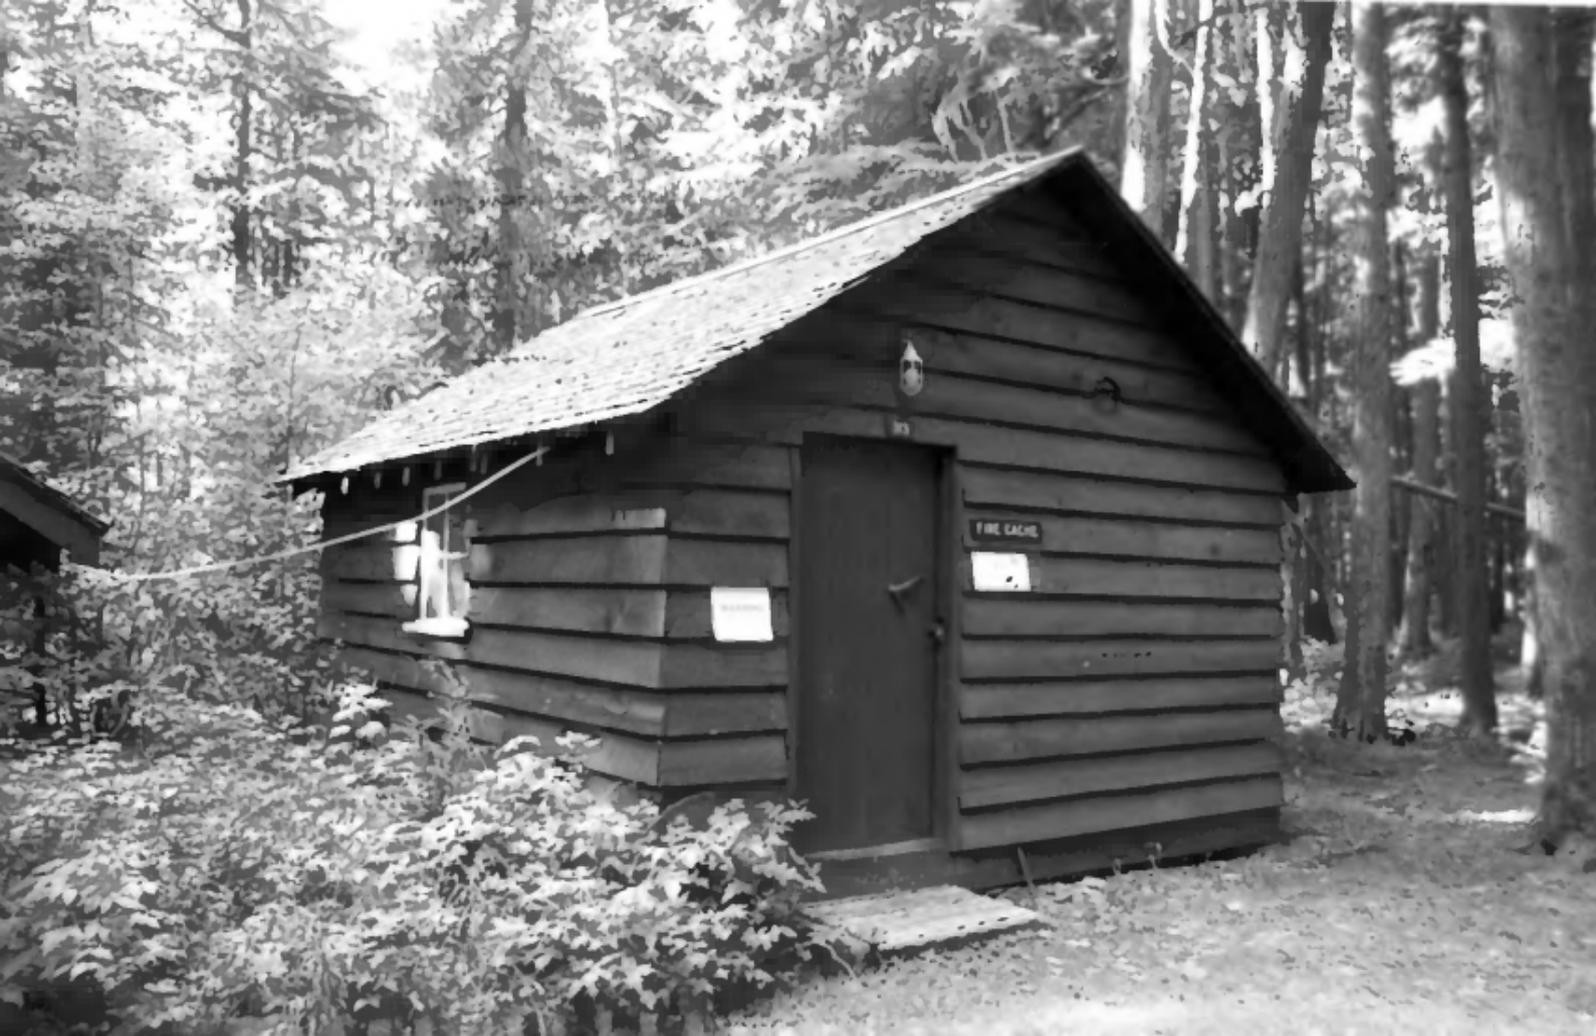
PHOTO NUMBER: 7

NAME: Fire Cache--Upper Lake McDonald

This fire cache is a one-story, frame, rectangular, gabled structure on a corner stone pad foundation. Horizontal lapboard walls are through to the gable ends. There are four-light framed casement windows to the south and north, and a solid wood door is off-set on the east facade. The wood-shingled roof has rafter ends under the eave. There is a treble-light overdoor and a wood stoop. The structure measures 20x17' and is in good condition. The scale, materials, and design of this fire cache are compatible with the more significant buildings of the ranger station. However, since it is less than 50 years old and does not possess outstanding architectural or historical significance, it must be considered to be a non-contributing structure in the Historic District.

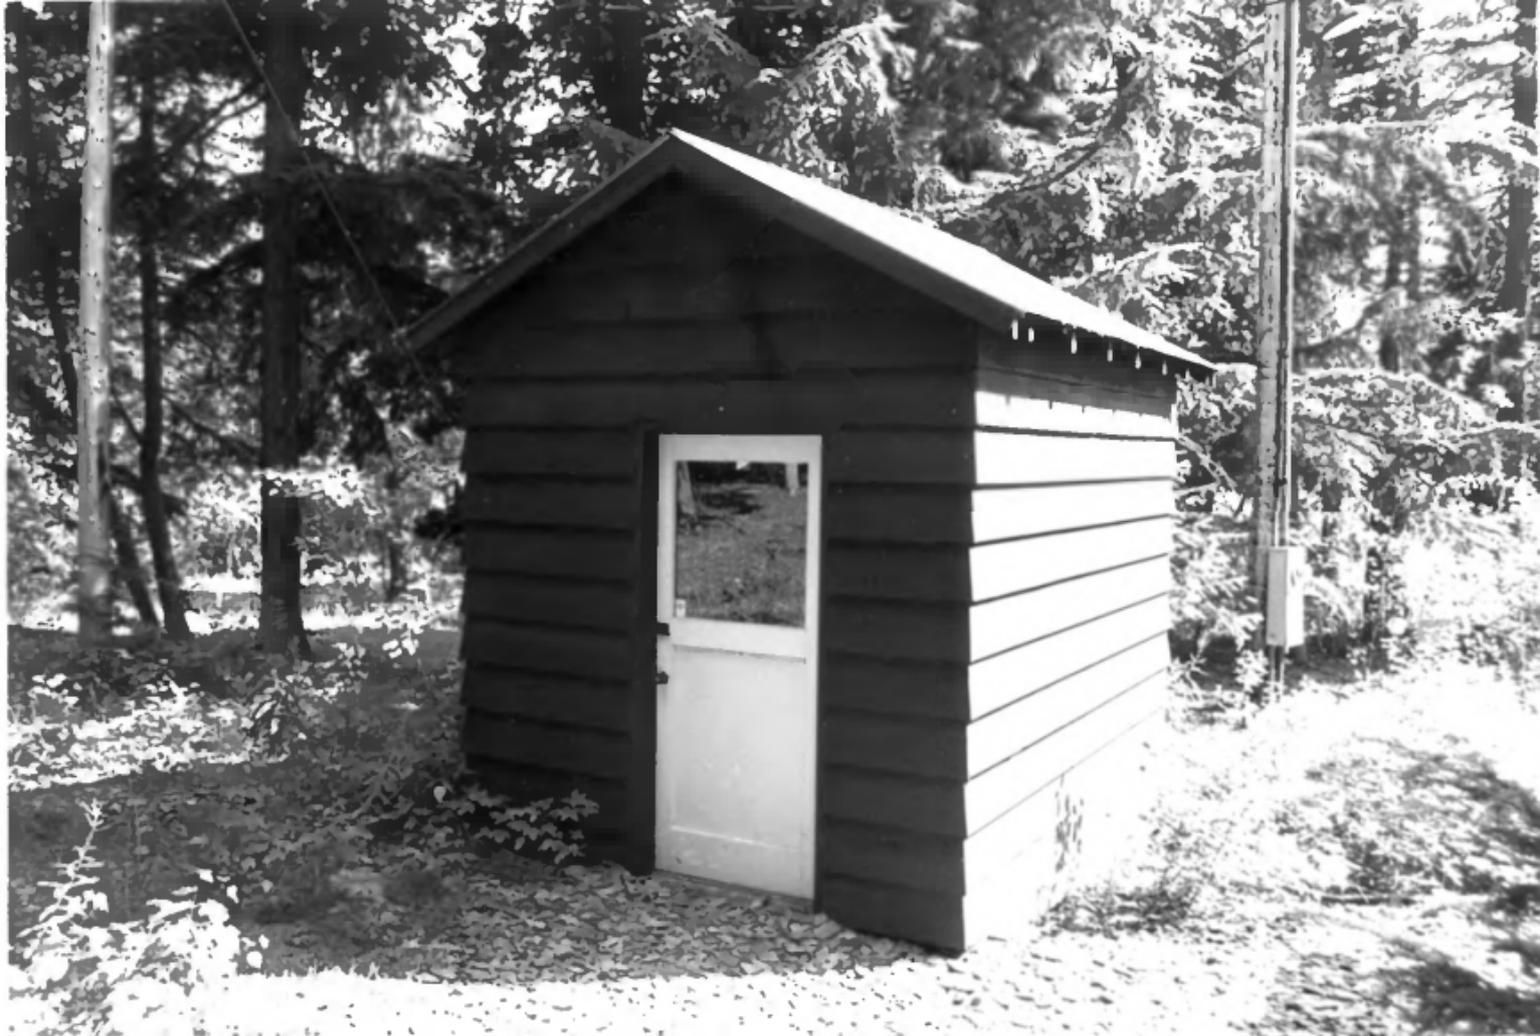
PHOTO NUMBER: 9

NAME: Pump House--Upper Lake McDonald

This recently constructed pumphouse is a one-story, rectangular structure on a concrete foundation, with a corrugated metal gable roof and lapboard walls. The structure measures 11x14' and is in good condition. This building is compatible with the more significant buildings of the ranger station and is a neutral, noncontributing element of the site.

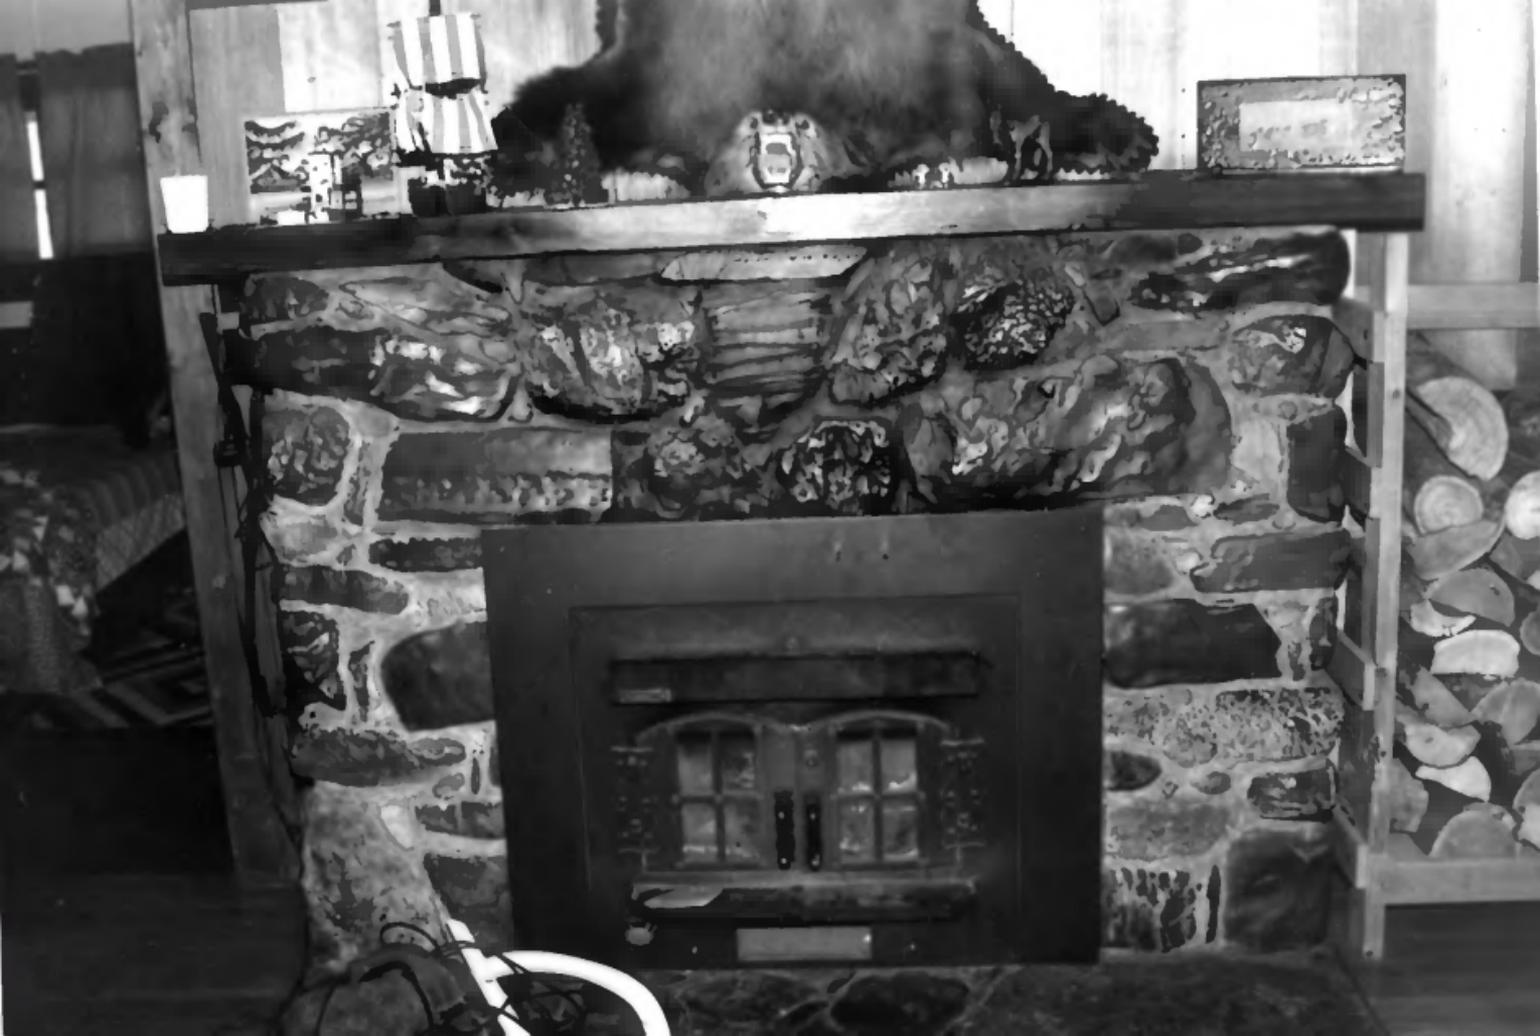
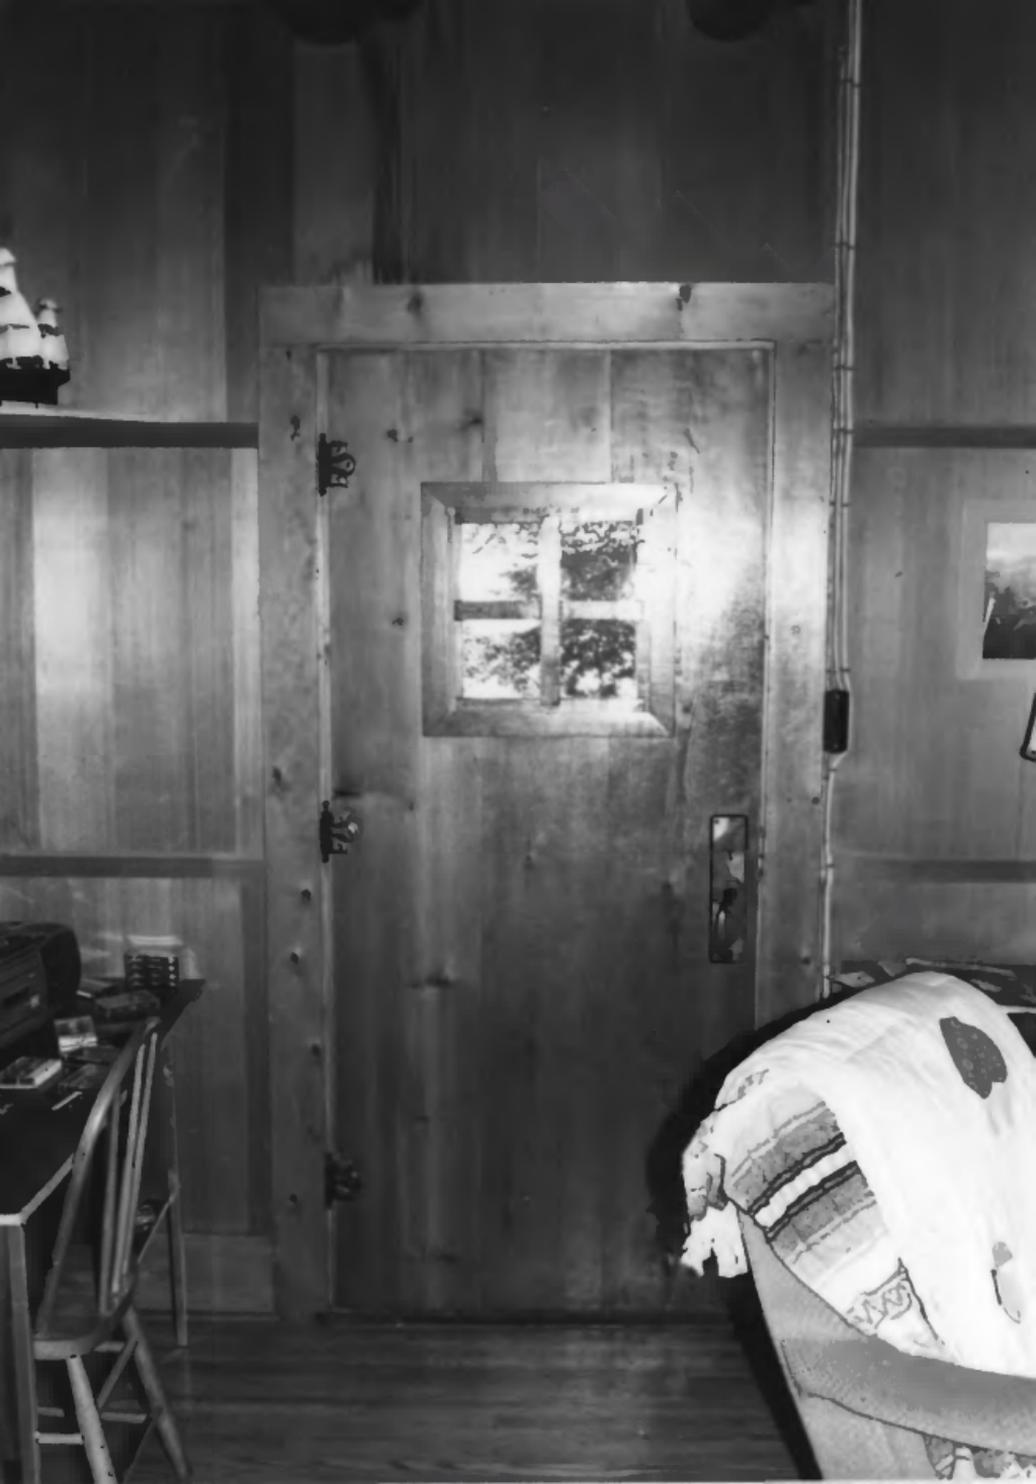
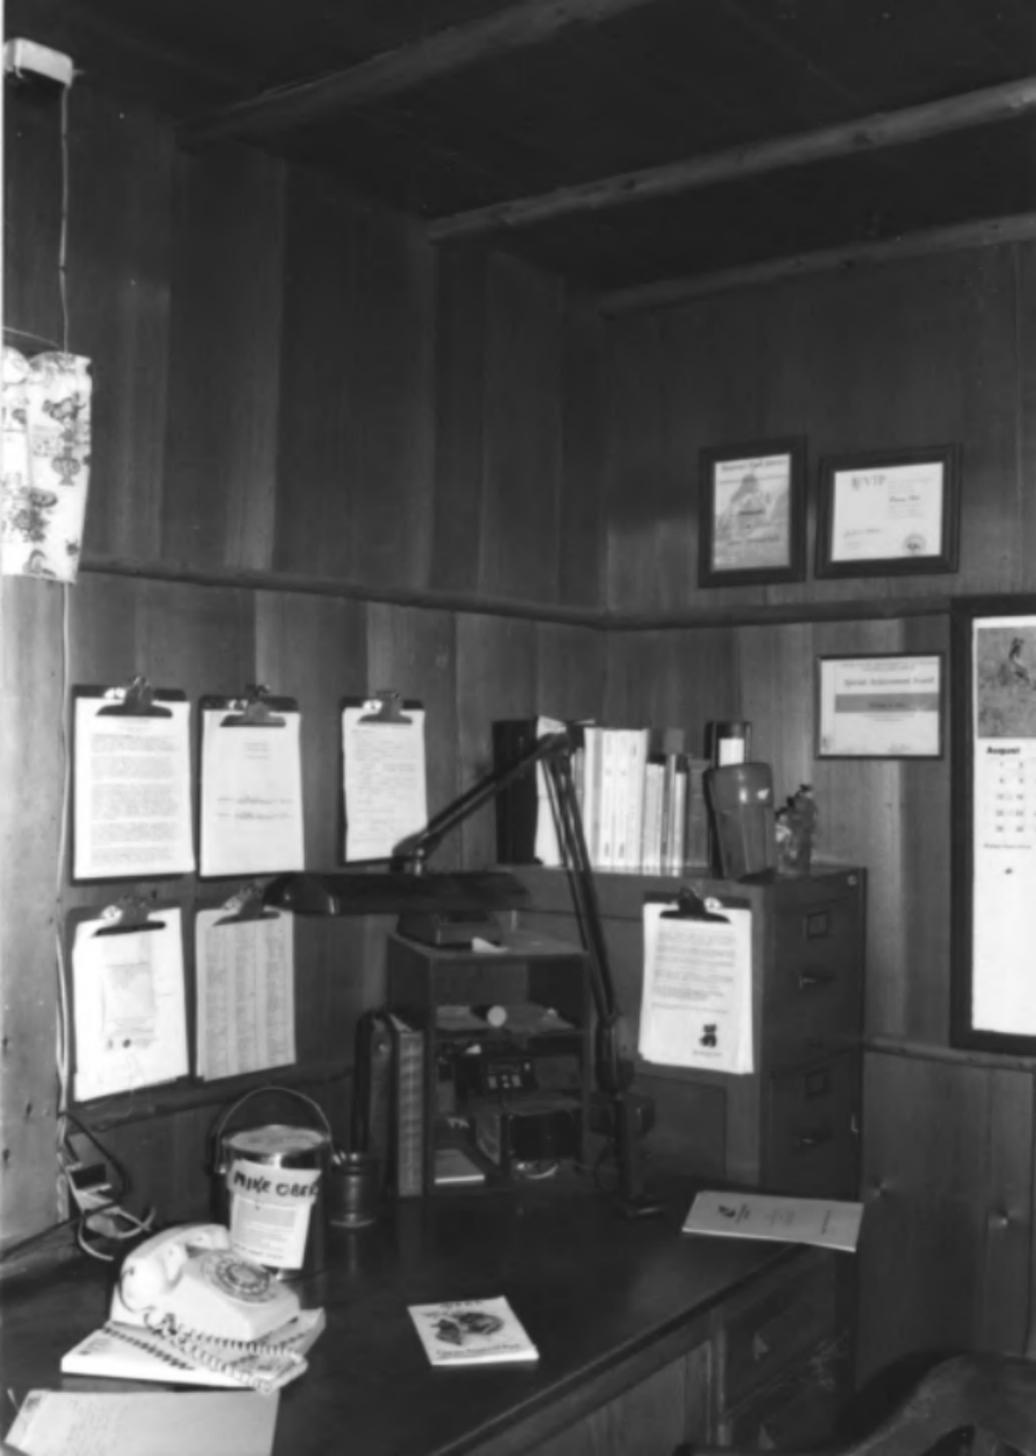
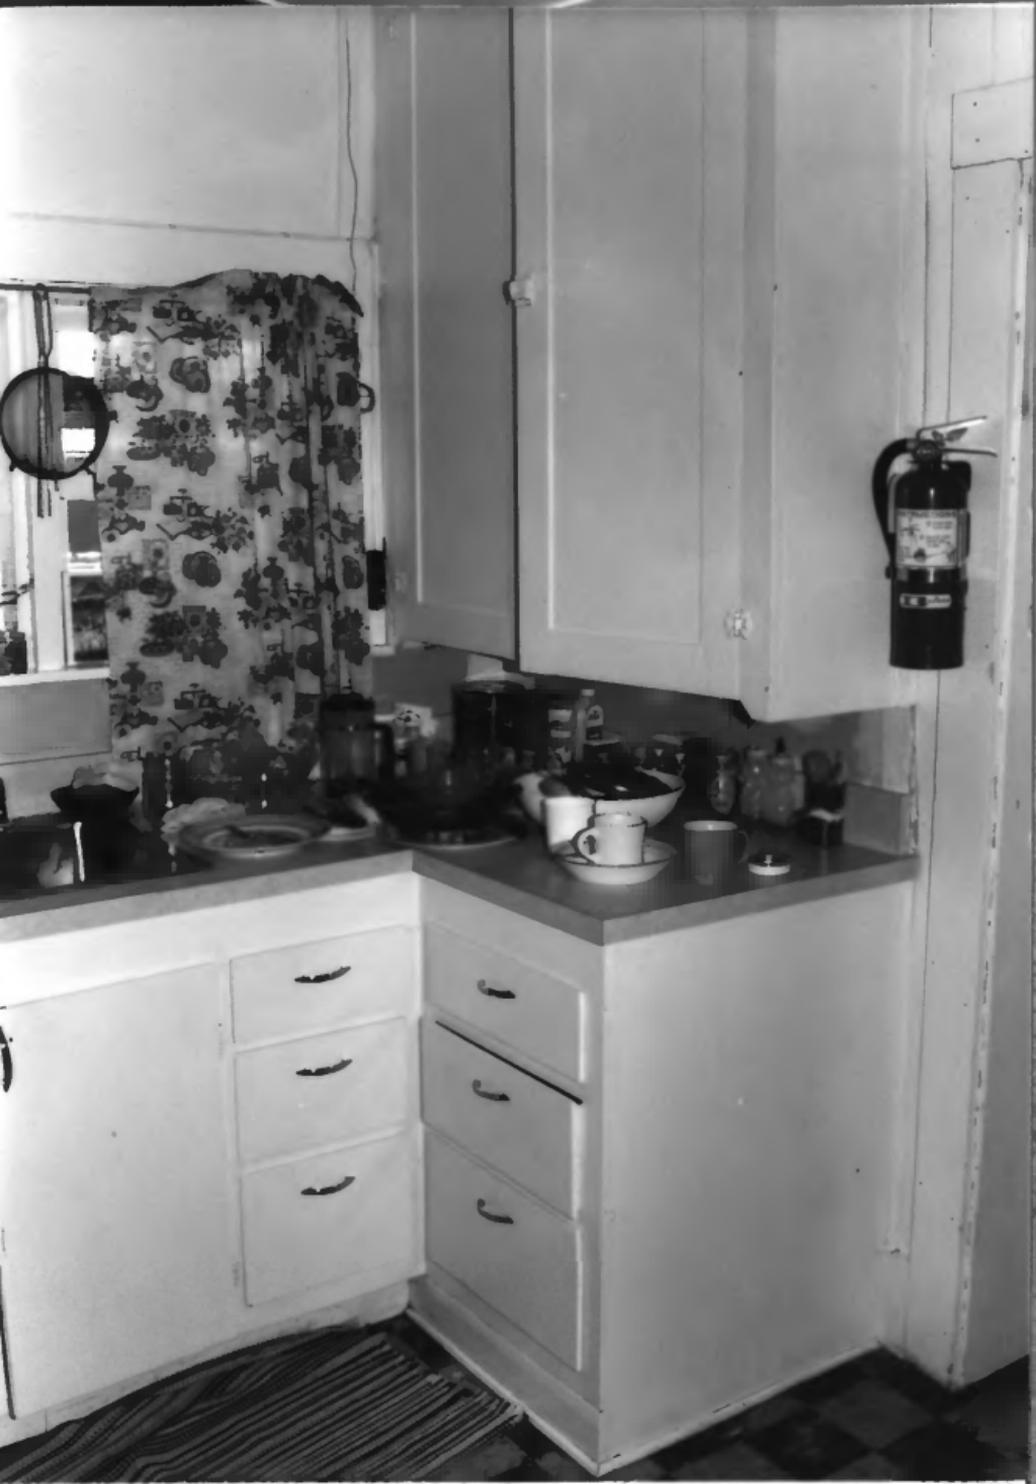
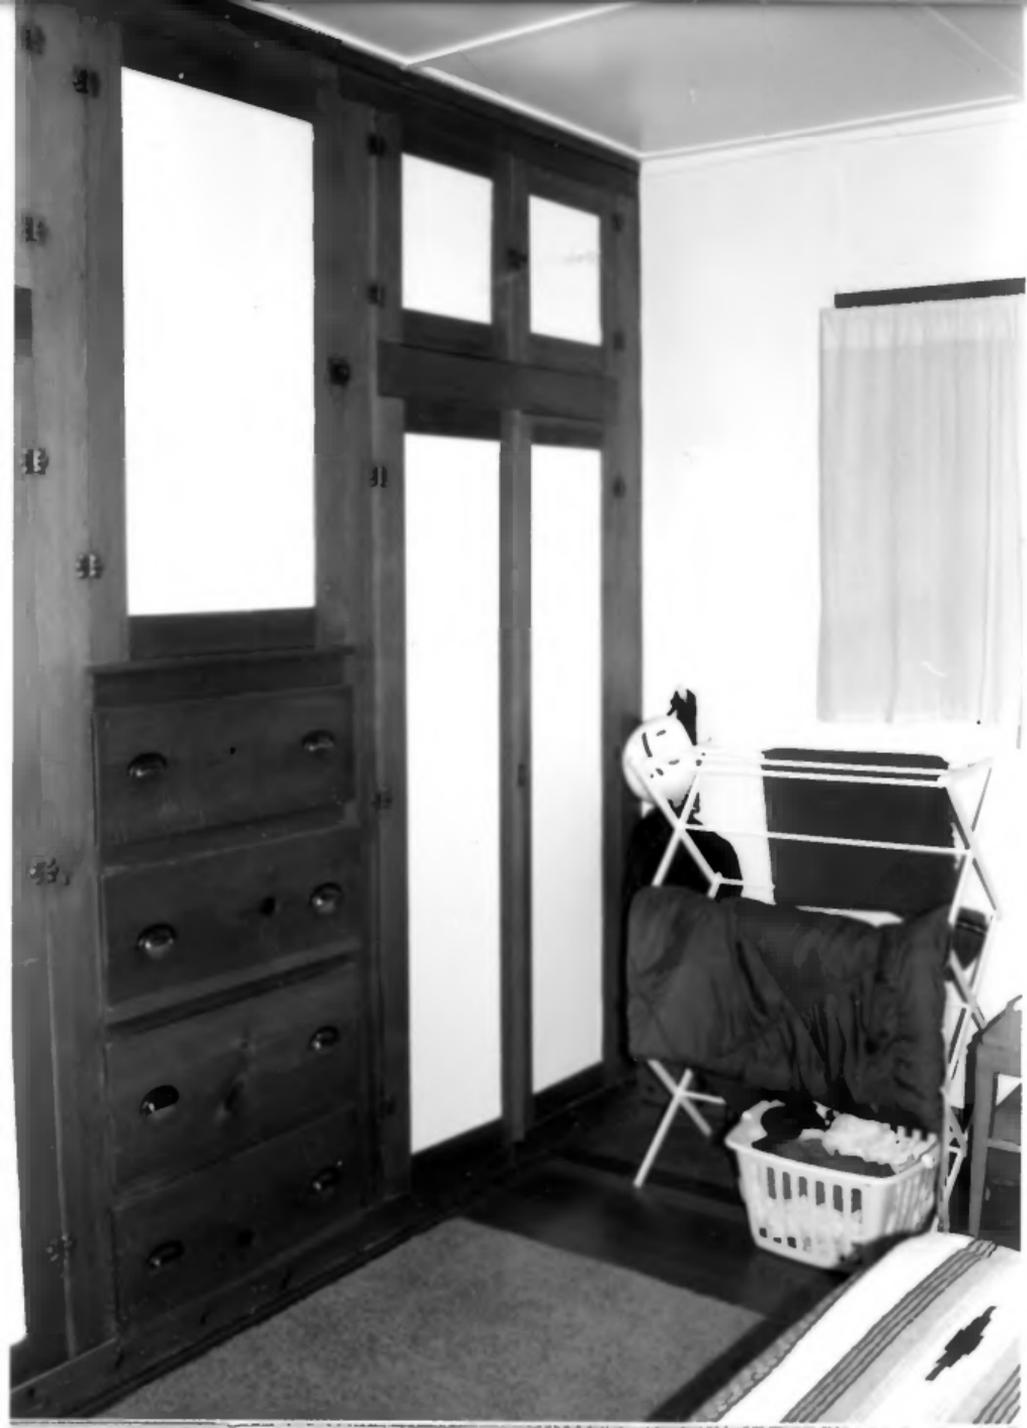
Ranger Station HS 58

Interior

Constructed — and still used — as an office and residence, this building features distinct administrative and domestic spaces. An exterior entrance provides direct access to the small office that forms the southwest corner of the building. A second entrance leads directly to the private living room, from which branches the kitchen and the single bedroom. A small pantry/dining area is located between the kitchen and the screened side porch. A small bathroom is located between the kitchen and bedroom and is accessible from both. With minor variations, this floorplan matches that found in the Sherburne Ranger Station and the Belly River Ranger Station and reflects the park service’s increased reliance (1920s) upon standard plans. The building retains all dominant interior design elements, including much of the built-in cabinet work, cedar siding, wood floors, paneled doors with original hardware, and stained 4"-6" window surrounds, door surrounds, and baseboards. Plastic electric-wire conduit is exposed; light switches are dated. These features postdate the early 1950s, when the building did not yet have electricity. Individual rooms are described below.

varnished 2" inch oak flooring remains exposed. Walls are finished with cedar siding, each section — or shake — approximately 3' long, laid vertically and finished with narrow (2") horizontal frame battens; this siding is unique to this ranger station — located in a cedar grove — and conforms to rustic architecture's principal tenant to subordinate resources to their surroundings. Although the ceiling is dropped, log purlins remain exposed, topped with cedar planks. Stained 6" rough-cut knotty pine forms the baseboards. Door and window surrounds, also stained pine, are 4" and are butt-jointed rather than mitered. A fireplace, centered within the interior wall, is constructed of glazed irregularly-shaped lake stone; a floor level hearth is also lake stone and a 4" wood plank, darkly stained, forms the mantle. A modern metal fire insert represents the only modern incongruous feature in this spectacular room. There is no door between the living room and the kitchen. Two-panel varnished doors lead from the living room to the office and to the bedroom.

The office is unmodified. Like the living room, narrow oak planks cover the floor and pole purlins, topped with cedar planks, form the low ceiling. Cedar siding covers the walls; in contrast to the frame battens in the living room, the horizontal battens are formed of small 1/2 round poles. A ribbon of six-light by six-light casement windows line the west elevation of the office; combined with the original stained window surrounds, this fenestration forms a dominant design element. A built-in pine and cedar cupboard, with original hardware, is located in the northeast corner of the room. The four-light exterior door matches that found in the living room.

The single bedroom features 4" fir floors, varnished. Molding matches that found in the office and living room and, in conjunction with the numerous multi-light windows, forms a dominant design element. A bank of built-in cupboards lines the south wall. These cupboards retain the original hardware and are stained, in stark contrast to the painted plywood panels that cover the walls and ceiling.

Painted plywood panels with 2" battens cover the walls and ceiling of the kitchen. Molding, 4"-6", is also painted. The built-in cupboard units are of two different styles: doors of upper units are paneled and feature original hardware, painted. Doors and drawers on lower units are unpaneled and feature simple stainless steel pulls — a design prevalent in the park. The formica countertop and stainless steel sink are modern, as is the electric range (replacing the original coal-fired stove) and the refrigerator (replacing the original kerosene refrigerator). The small (6" square) linoleum tiles extending from the kitchen to the breakfast nook are not original yet appear to have been in place for years.
