NATIONAL REGISTER OF HISTORIC PLACES  
REGISTRATION FORM

historic name: Snake River Land Company Residence and Office

**Snake River Land Company Office and Residence/aka Buffalo Dorm (Building #117), constructed ca. 1926.**

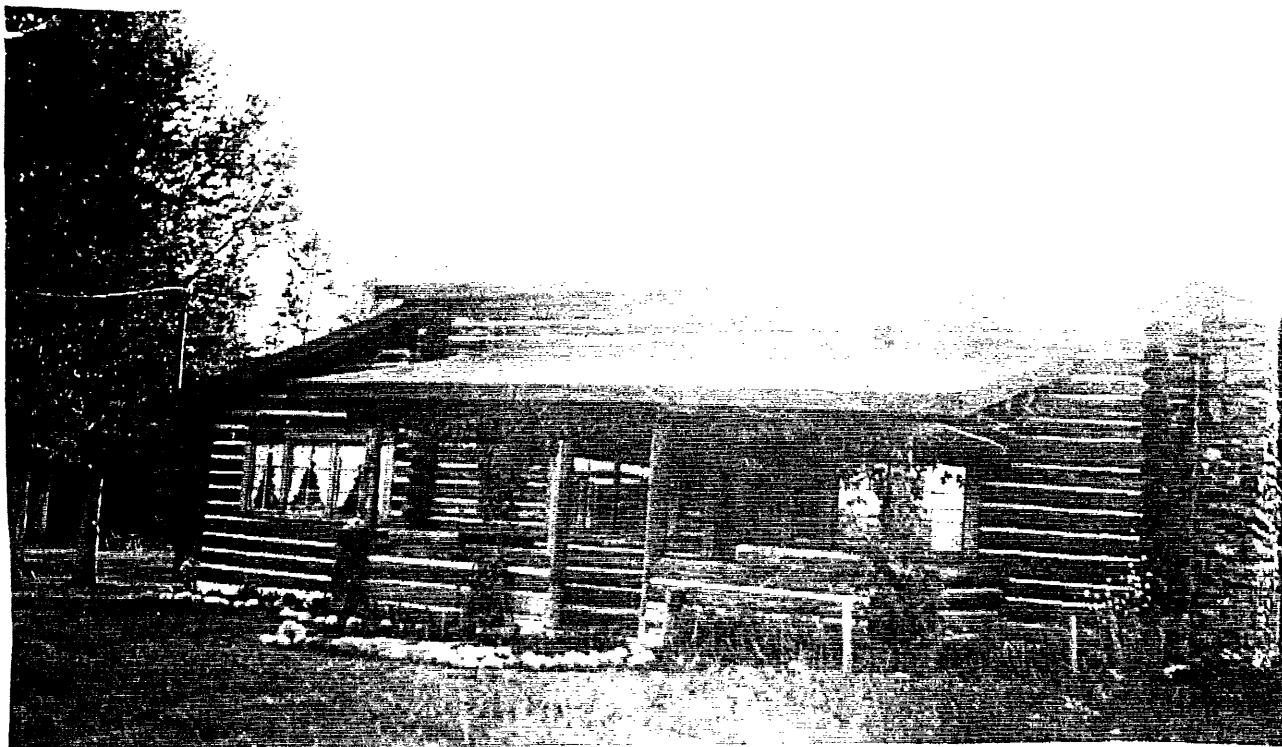
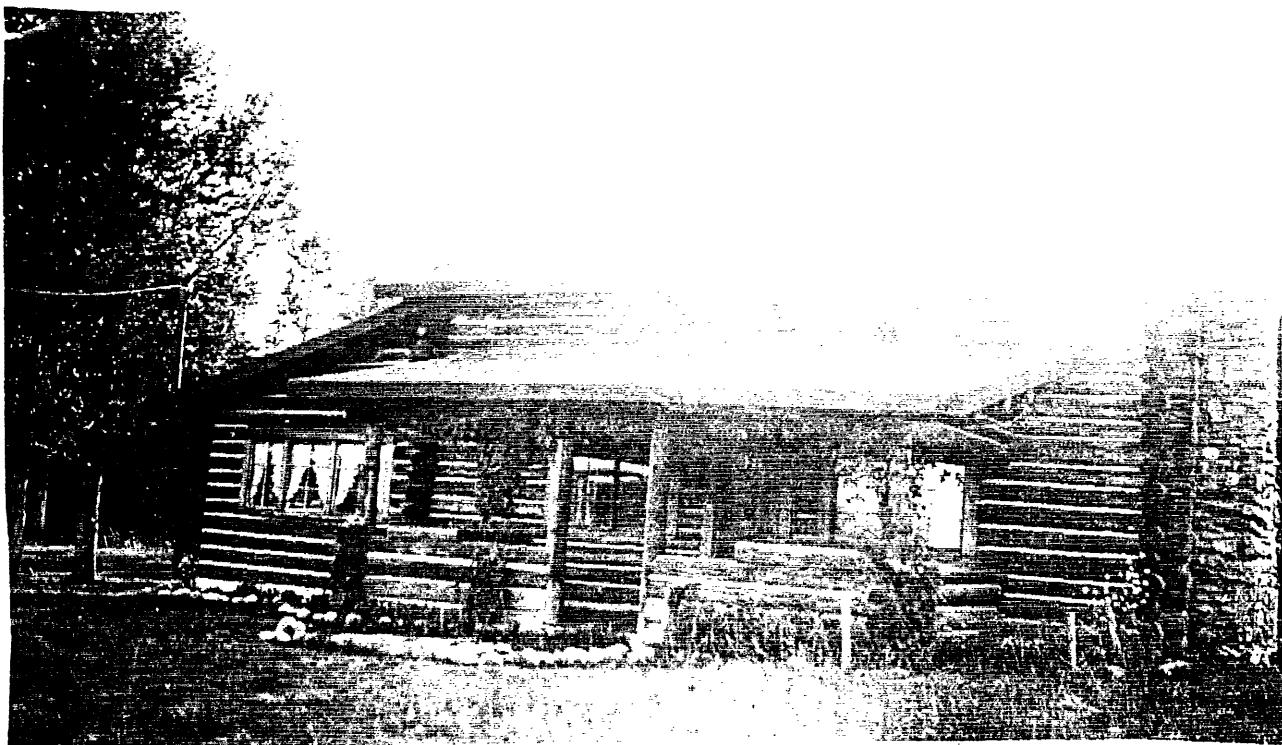
SRLC Hdqtrs/Buffalo Dormitory 1931  
• Sam Allan Personal Photograph Collection

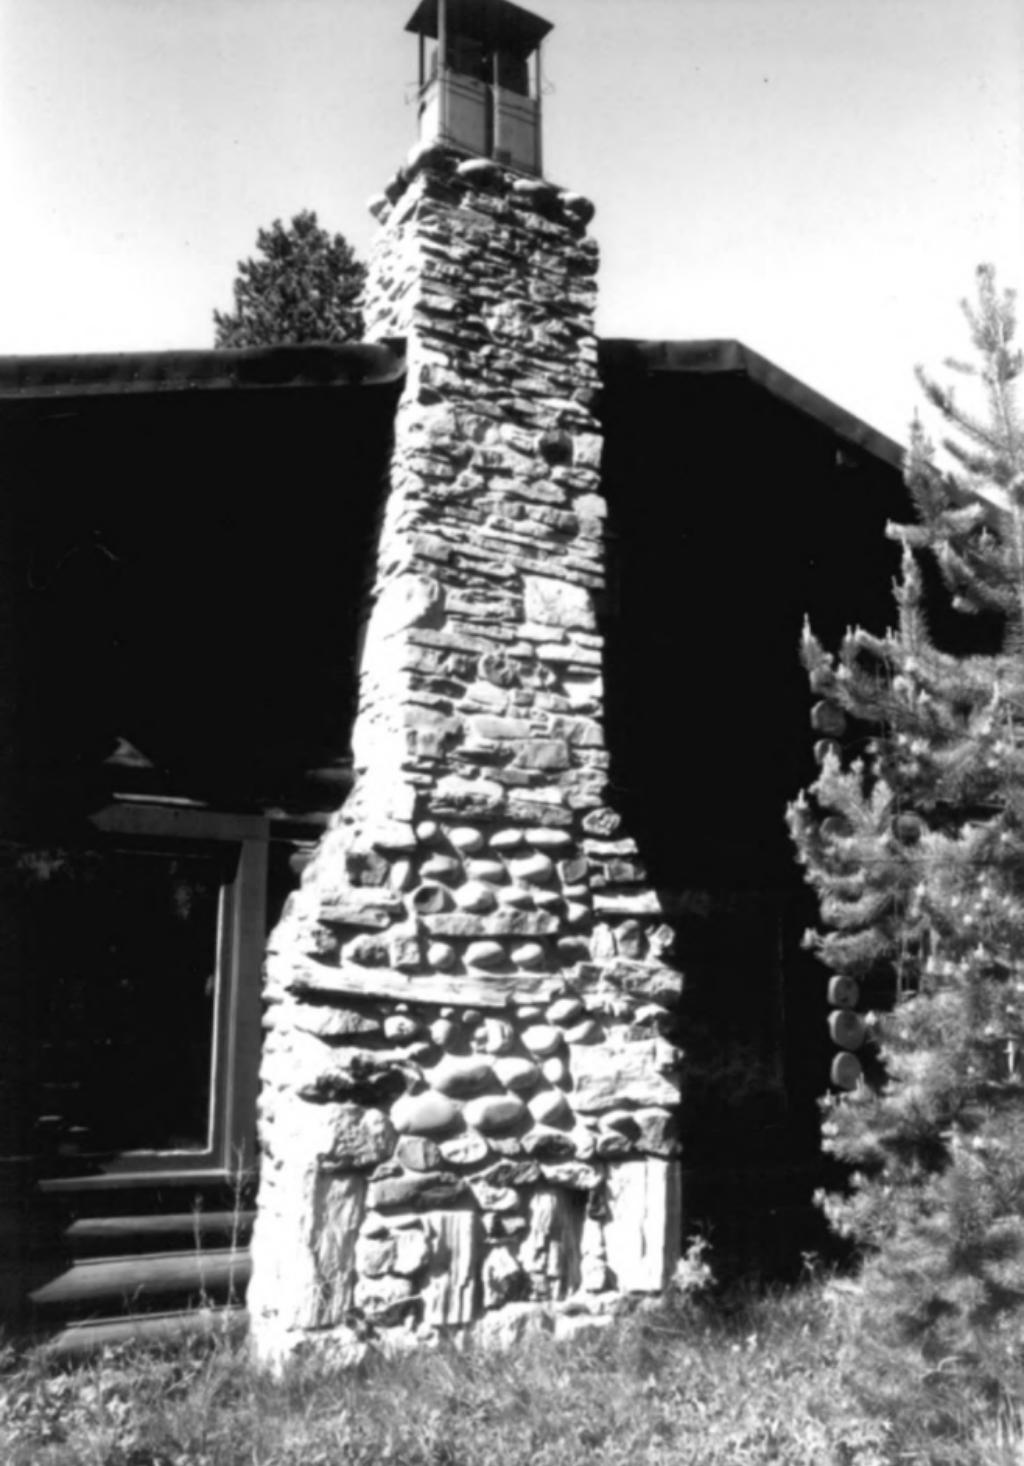
Sec Residence + Office  
GRTE/117

GRTE, Teton Co., Wyo  
Photographer: HRA, 1995  
View to S  
Location of neg NPS, Denver, Co

Building #117, best known in the park as "Buffalo Dorm," is a one and one-half story log building constructed on a concrete foundation. The irregular shape results from several historic additions. The original component of this building appears to have consisted of the central gable roofed rectangle (one-and-one-half stories in height), with one-story, shed-roofed wings on the east and west sides. Latter additions include a log component with a shed roof that covers the entire length of the south elevation of the one-and-one-half-story block, and a smaller gable-roof log component that is attached to the west wall of the shed-roof addition. A small frame enclosure has also been added to the northeast corner of the building.

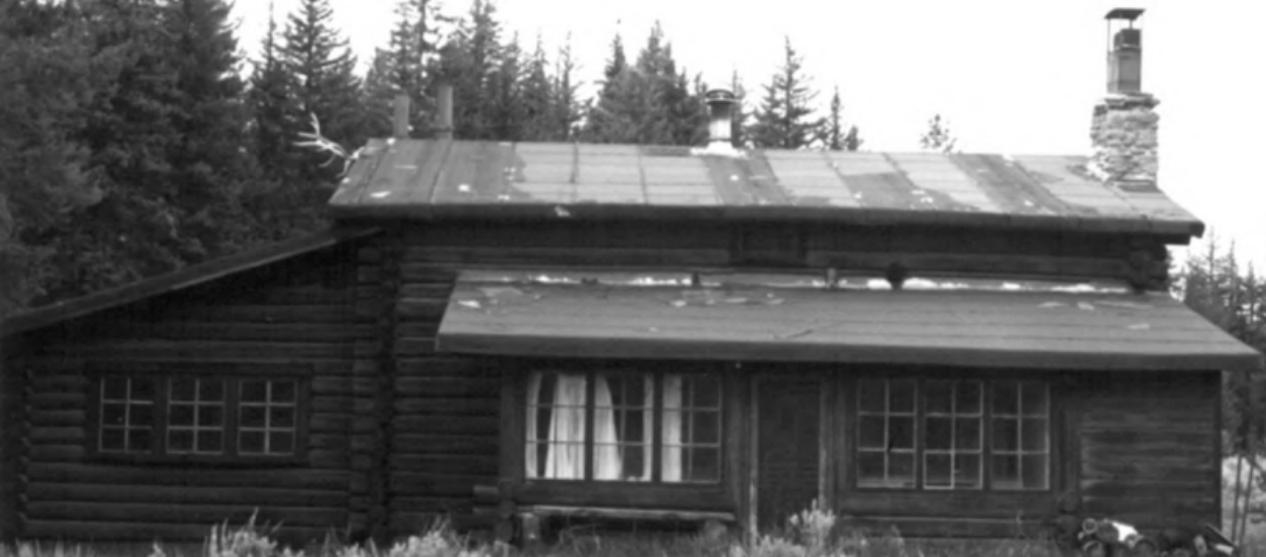
SLC Residence + Office  
GRTE/117

GRTE, Teton Co., Wyo  
Photographer: HRA, 1995  
View to W  
Location of negs: NPS, Denver, CO  
JCB wq #11

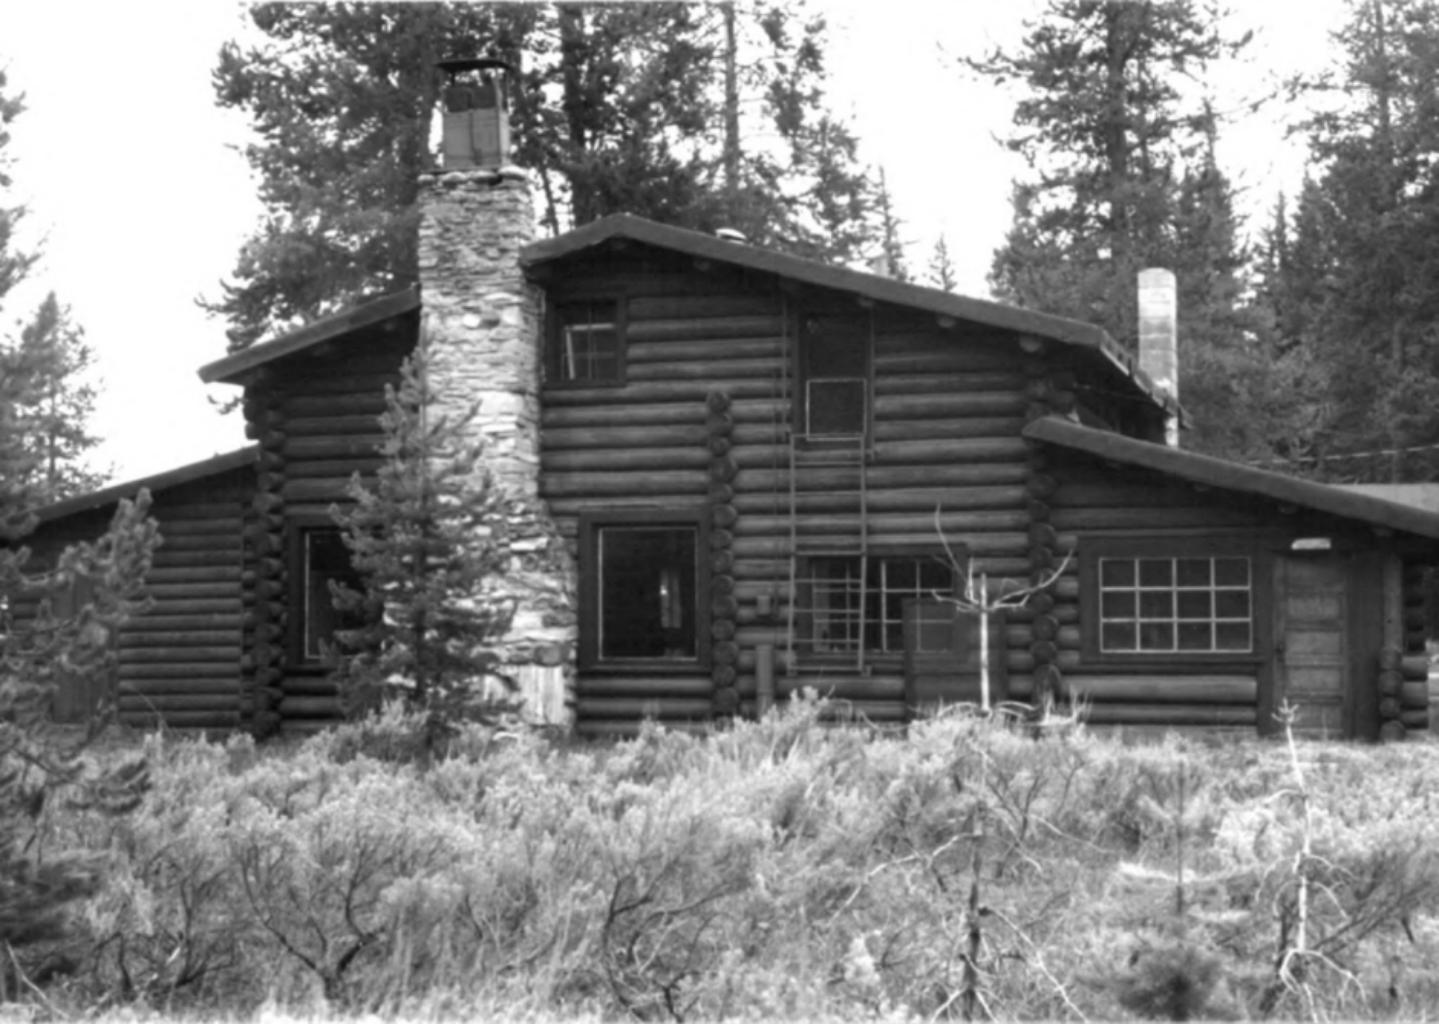
SPIC Residence + Office

QRT E, Teton Co., WY  
Photographer: HRA, 1995  
View to S

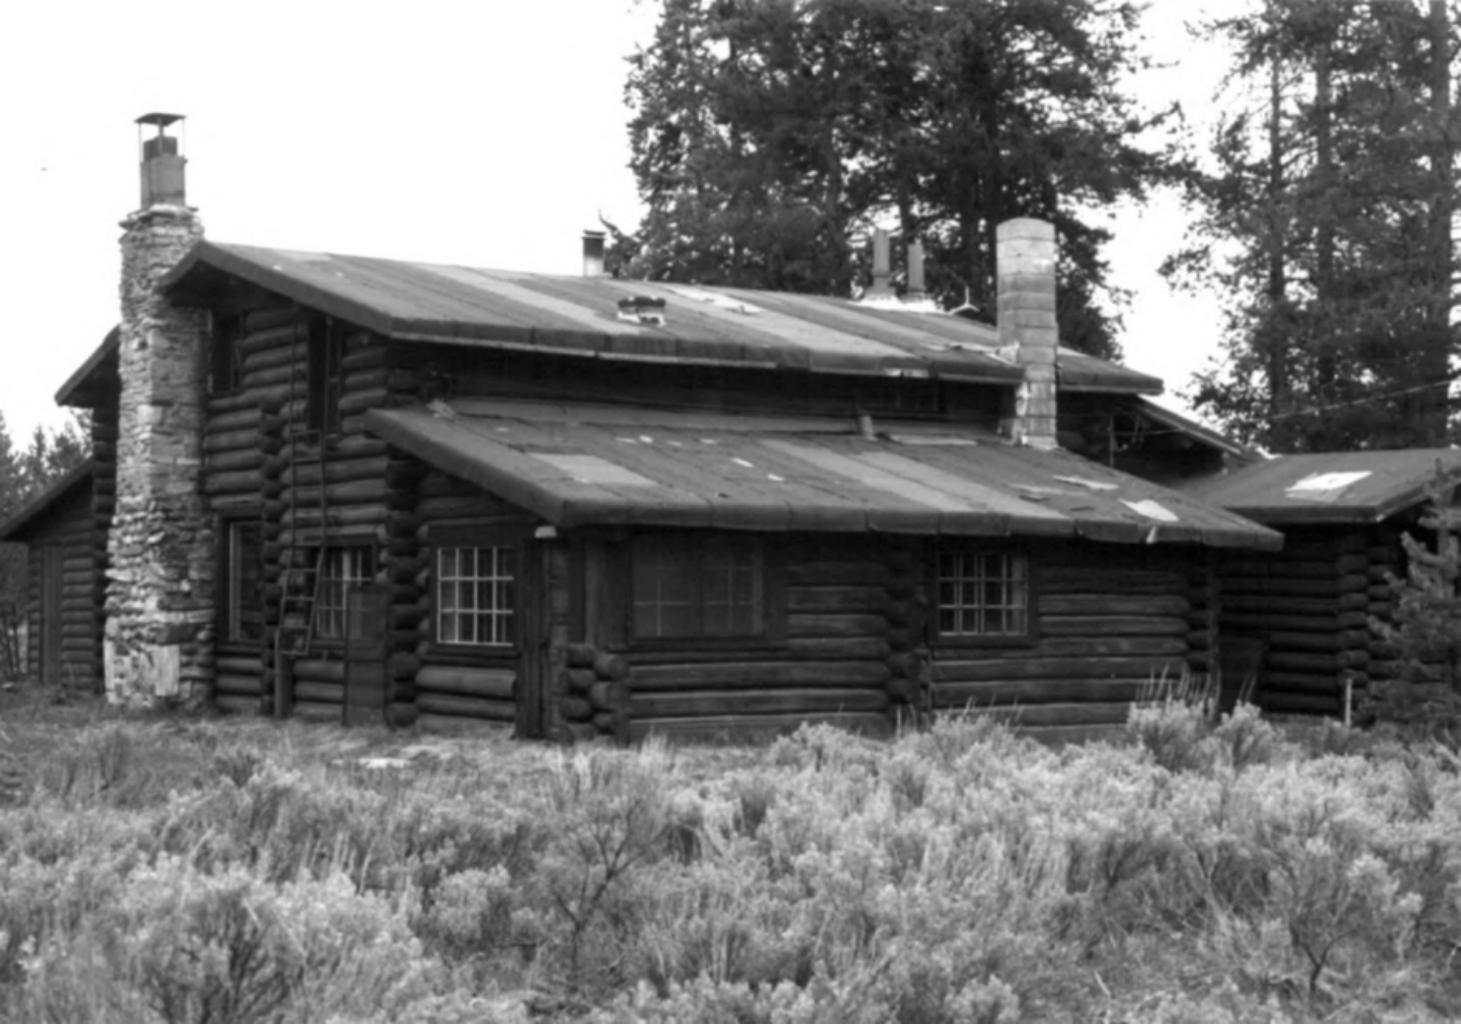
SERC Residence + Office

View to SE

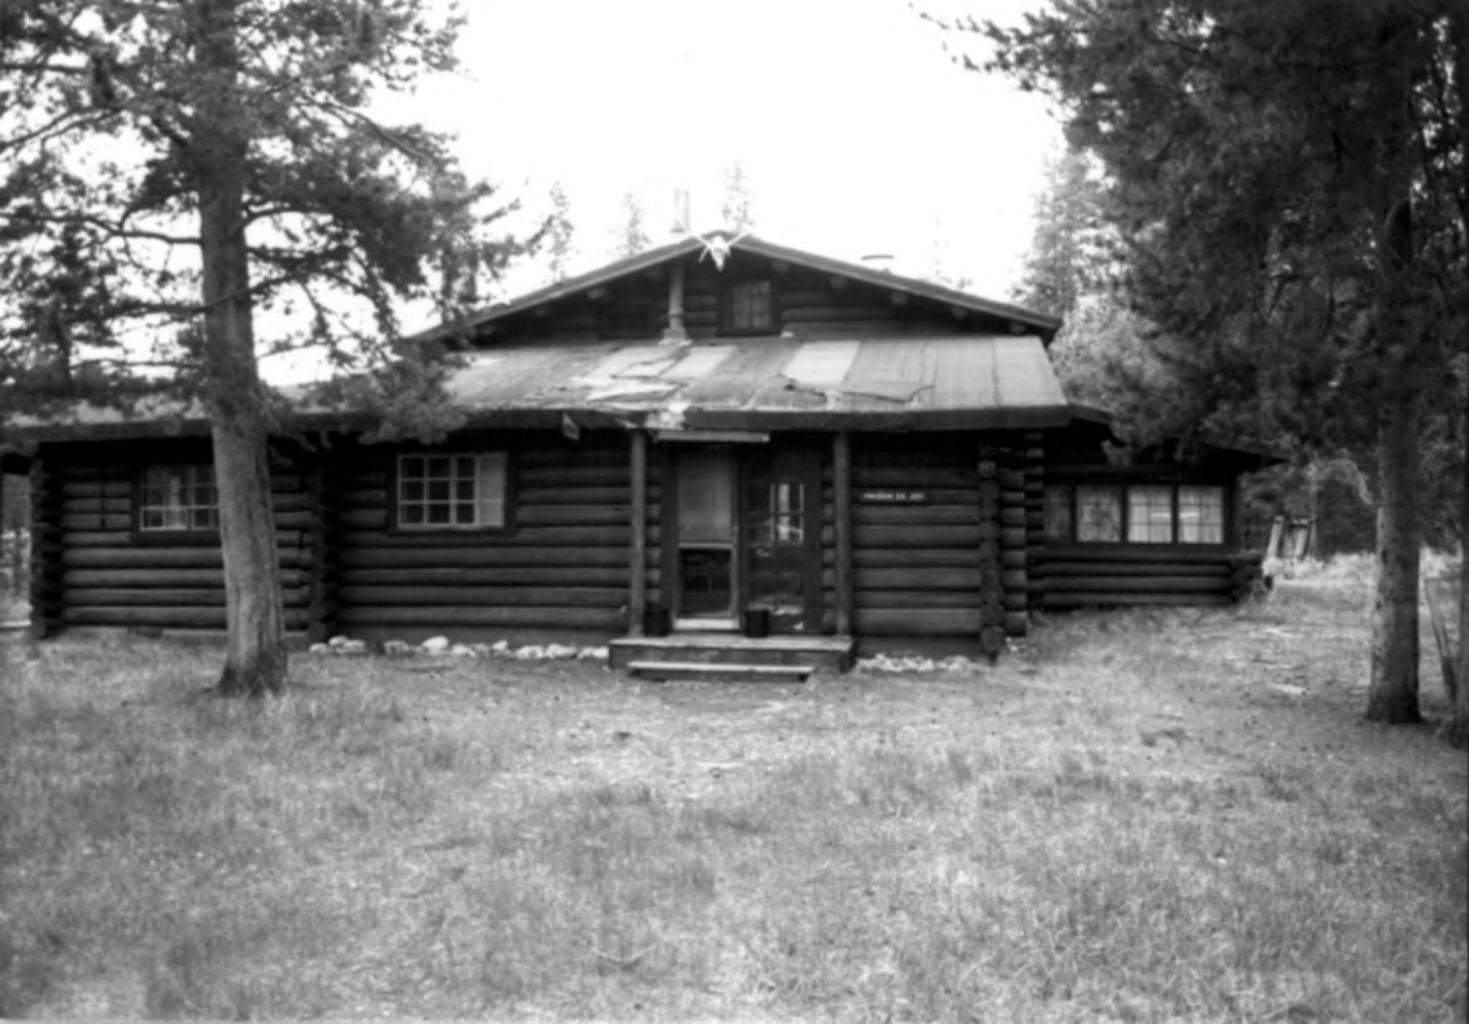
SEL Residence - off Lake Buffalo  
GRTE/117 Darm)

GRTE, Teton Co., WY  
Photographer: HRA, 1995  
View to N

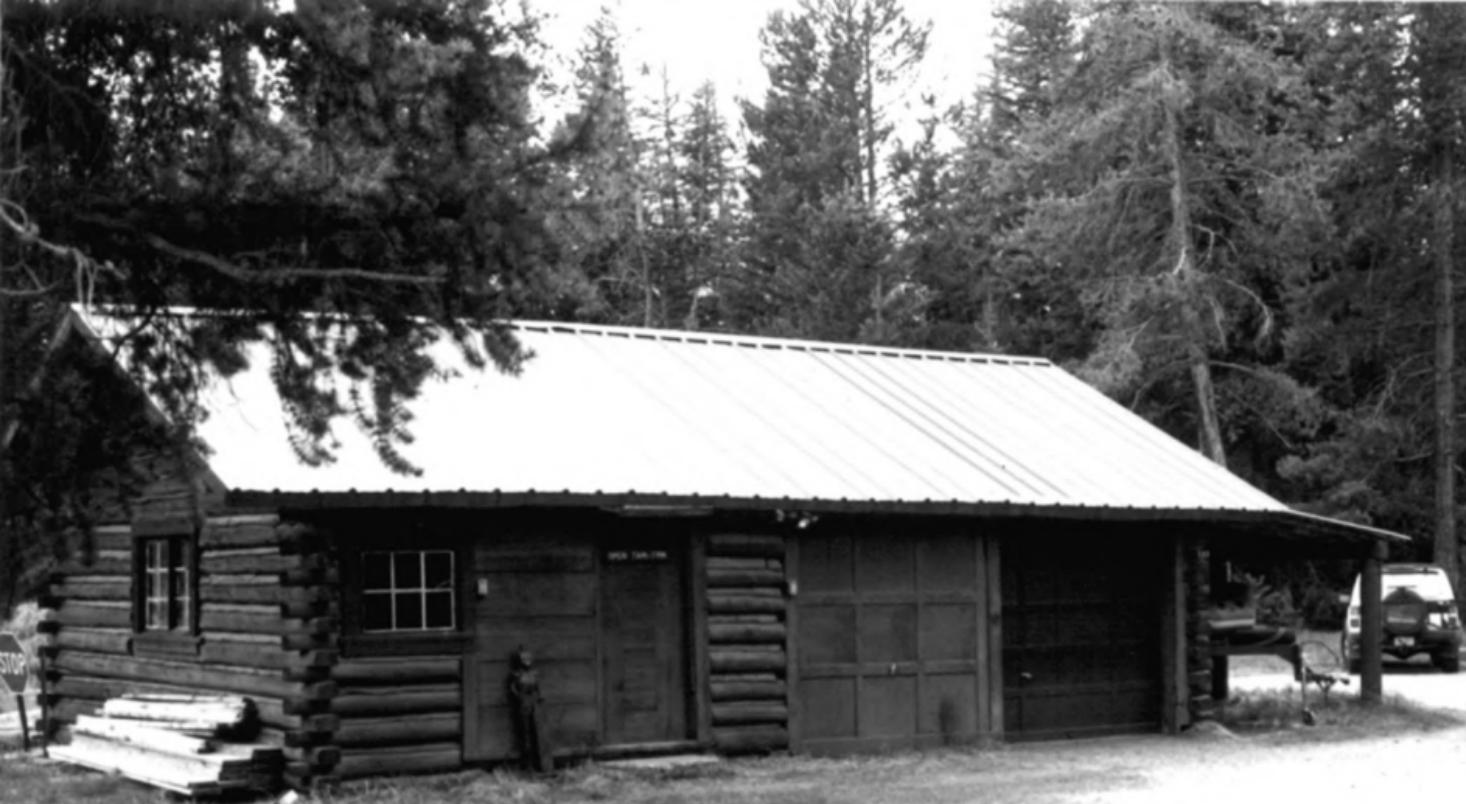
River Cache @ ~~site~~ Residence + Office

View to SW

The historic garage, currently used as a river cache, is a one-story log building with a long rectangular footprint constructed on a concrete-wall foundation. Wall logs (stained dark brown) are square notched and daubed with concrete that is held in place with lath stops. Enamored metal panels, placed over rolled roofing, cover the side-gable roof. All doors and windows are wood frame, and are trimmed with painted 5" boards.

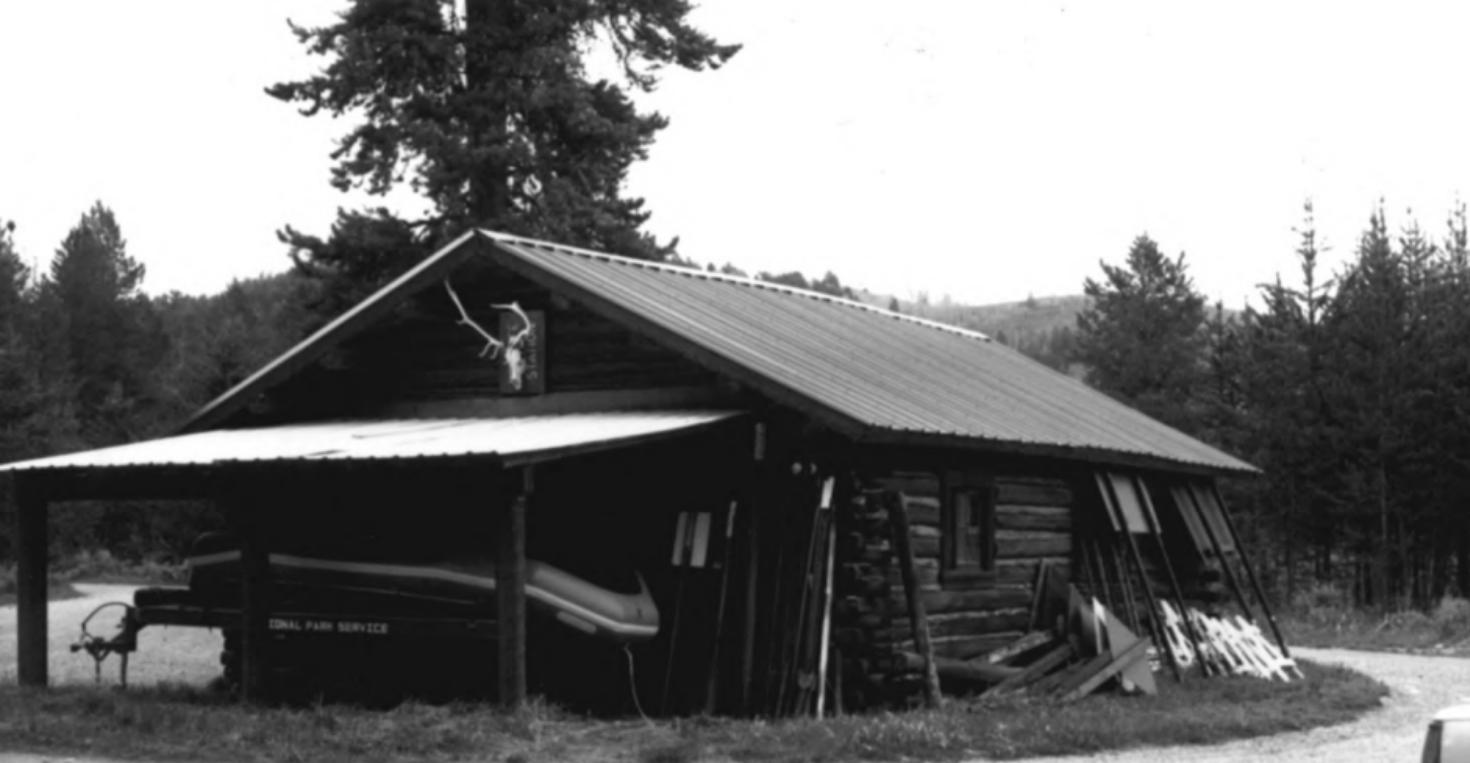
River Cache @ SMC Residence + Office  
GRTE/122  
~~Buffalo Ranching H.D.~~

View to NE

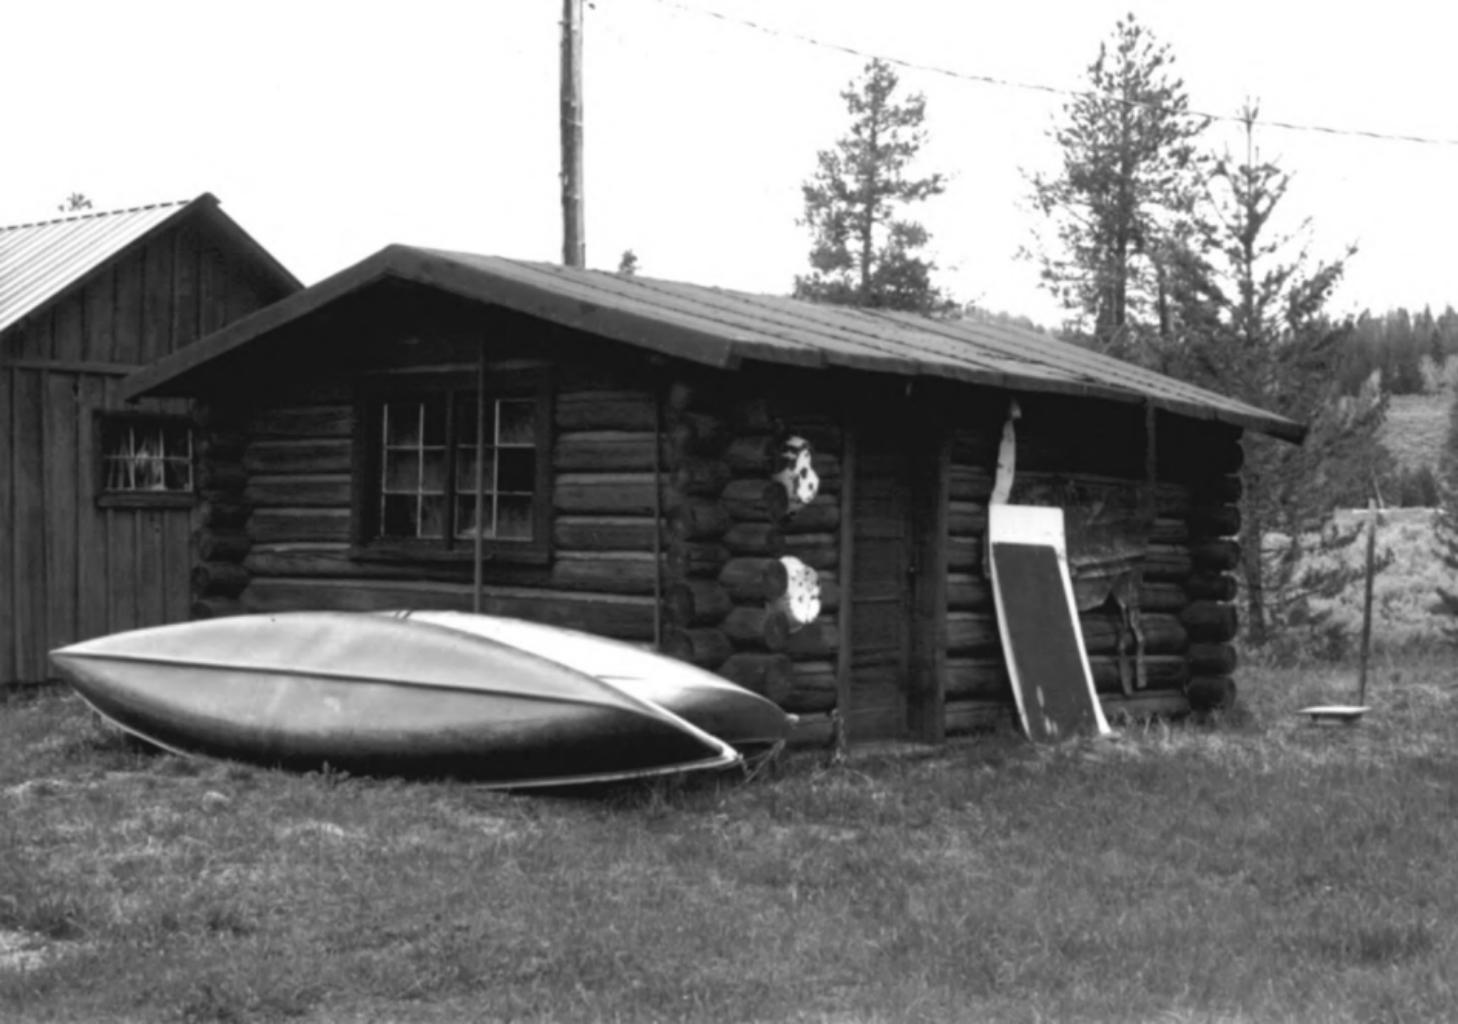
Sign shed @ service residence - office  
GRTE/121

View to NW

The historic blacksmith shop, currently used by the NPS as a sign shed, is a simple one-story log building with a rectangular footprint constructed on a concrete-wall foundation. Logs are ventral saddle notched with cement daubing held in place with lath stops. Log ends are cut flush and all log surfaces are stained dark brown. Rolled asphalt covers the gable roof and the fascia boards. All doors and windows are wood frame, trimmed with 5" butt-joint trim, and are painted brown.

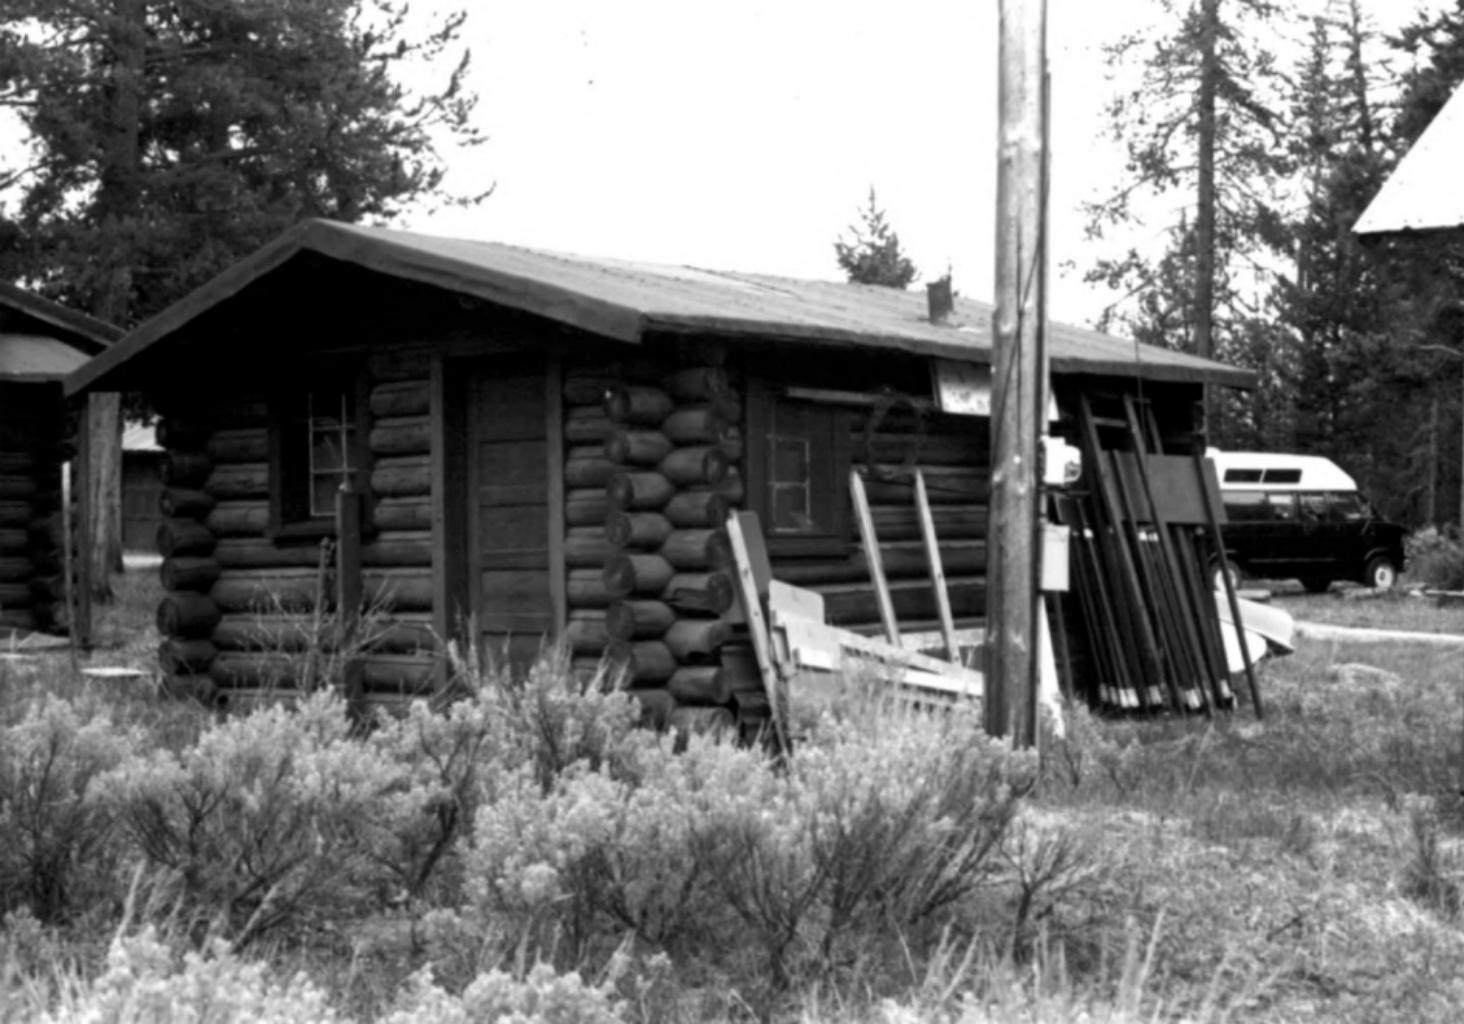
Sign Shd @ sec Residence + Office  
GRTE/121

View to SE

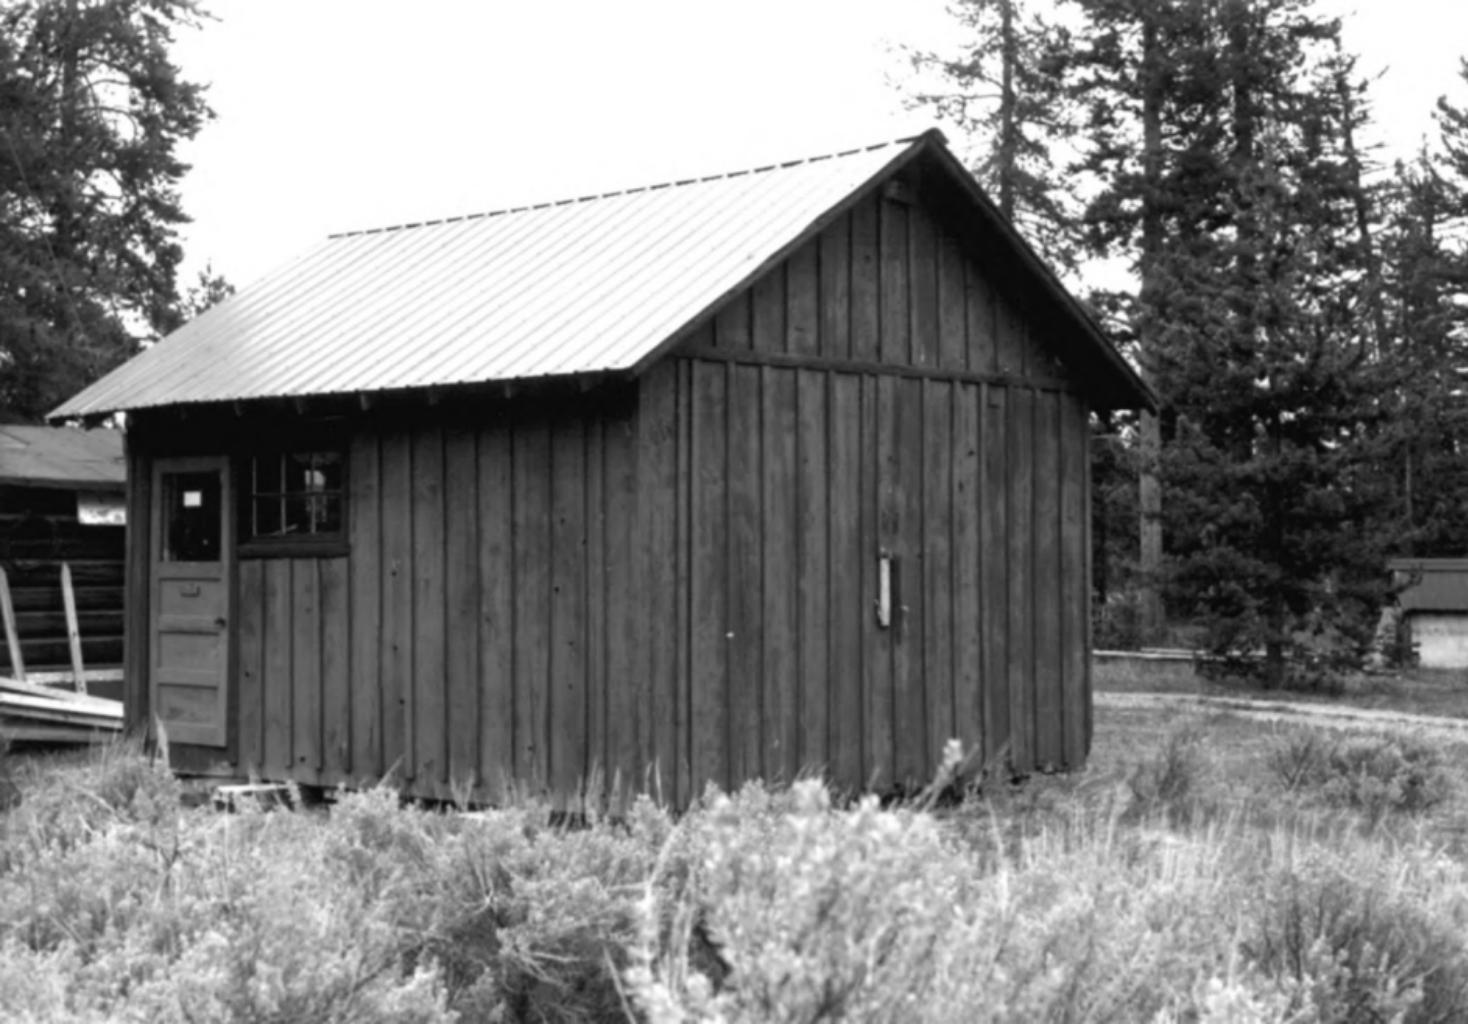
Fire Cache @ SRIC Residence + office  
GRTE / BD - 1

View to SE

The fire cache is a one-story wood-frame building with a rectangular footprint. The building rests on wooden skids. Board-and-batten siding (12" boards, 2" battens), painted dark brown, covers the exterior walls and enameled metal panels cover the side-gable roof. All windows and doors described below are wood-frame, trimmed with dark-stained 4" boards.

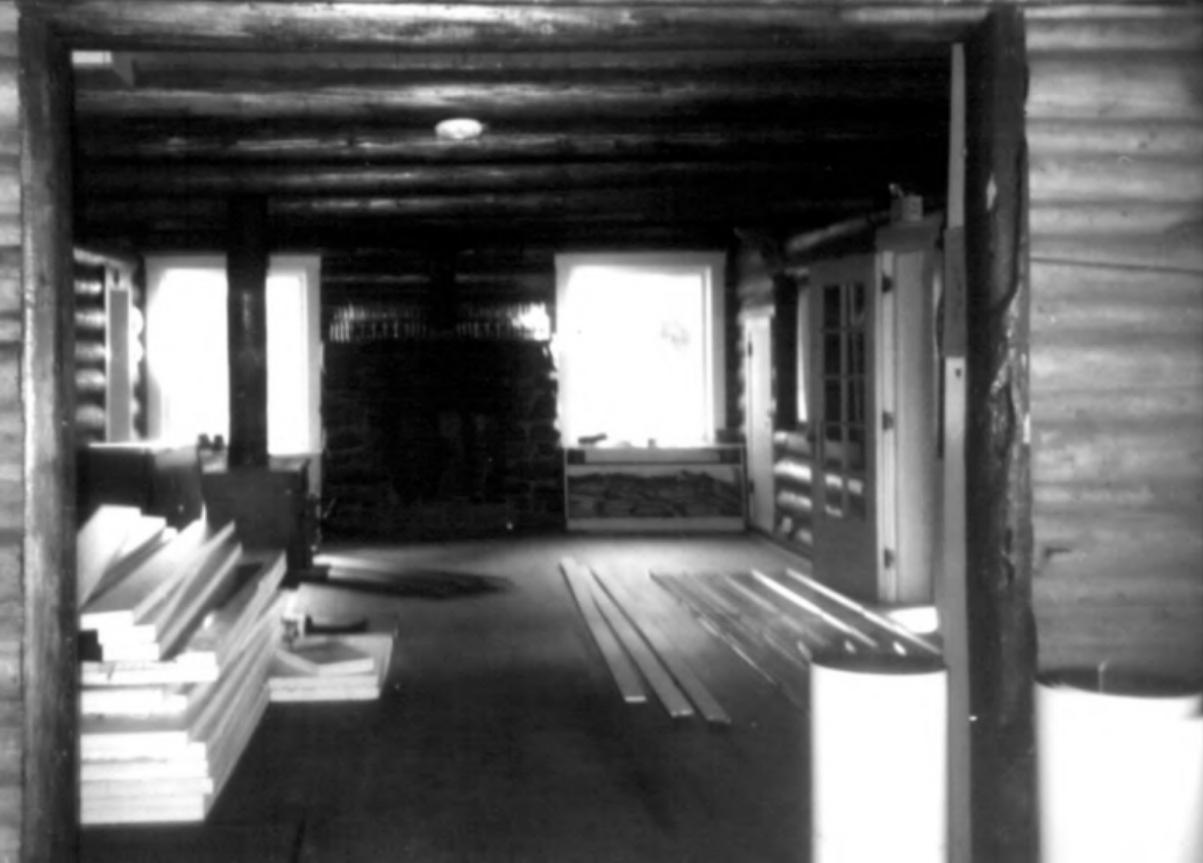
SERC Residence + Office

View to Detail

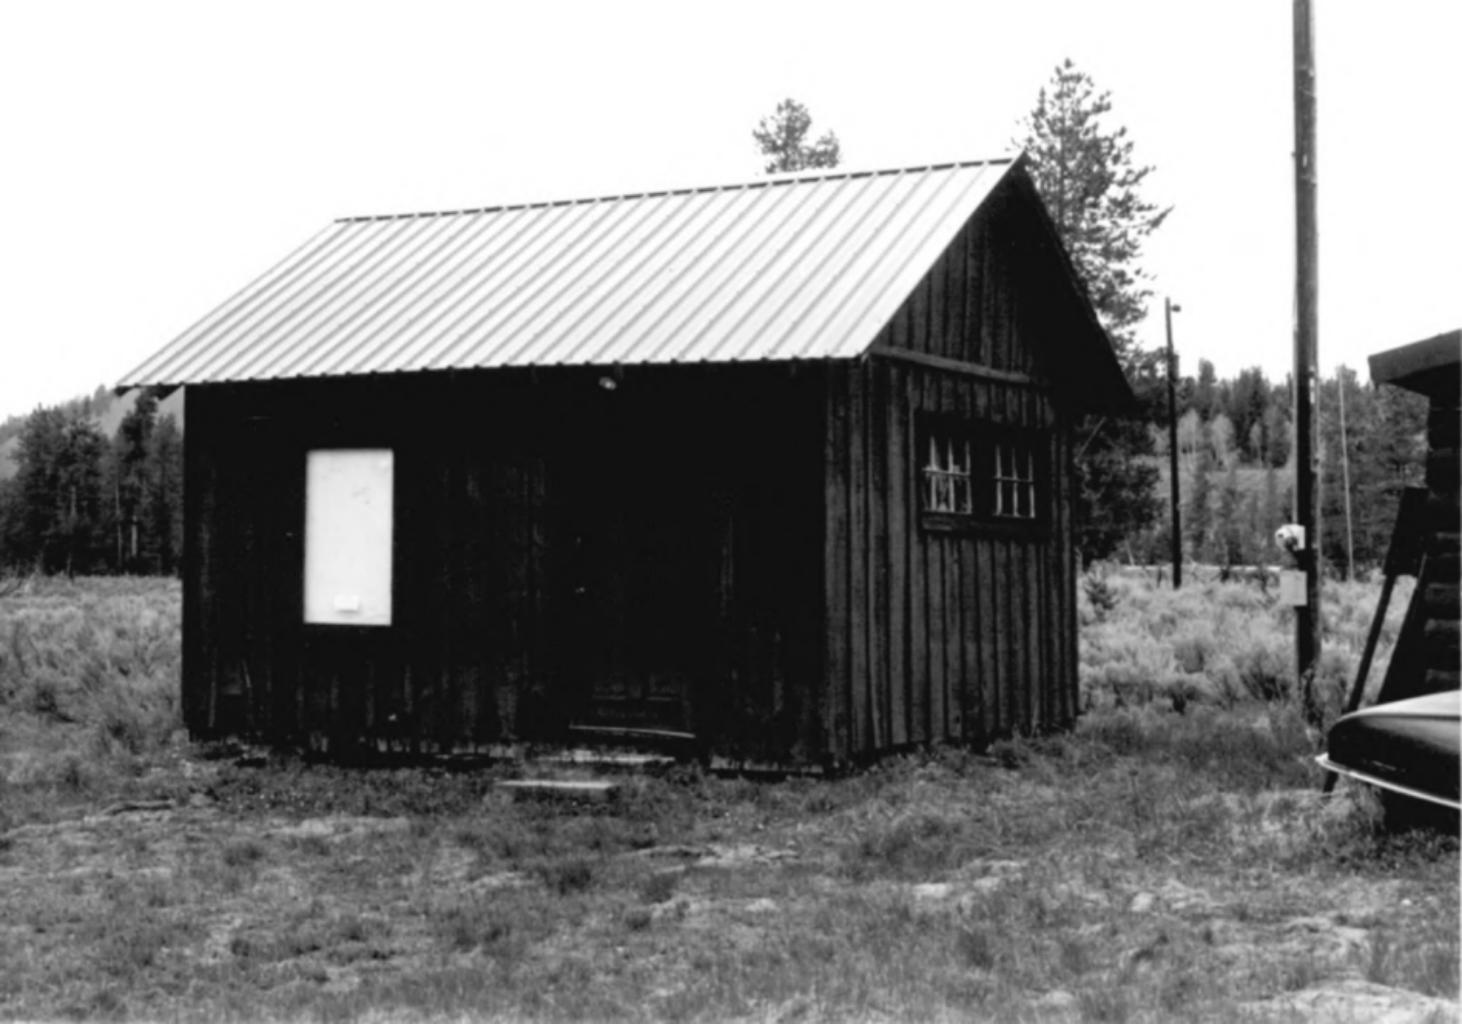
Fire Cache @ SRIC Residence + Office  
GRTE / BD-1

View to NW

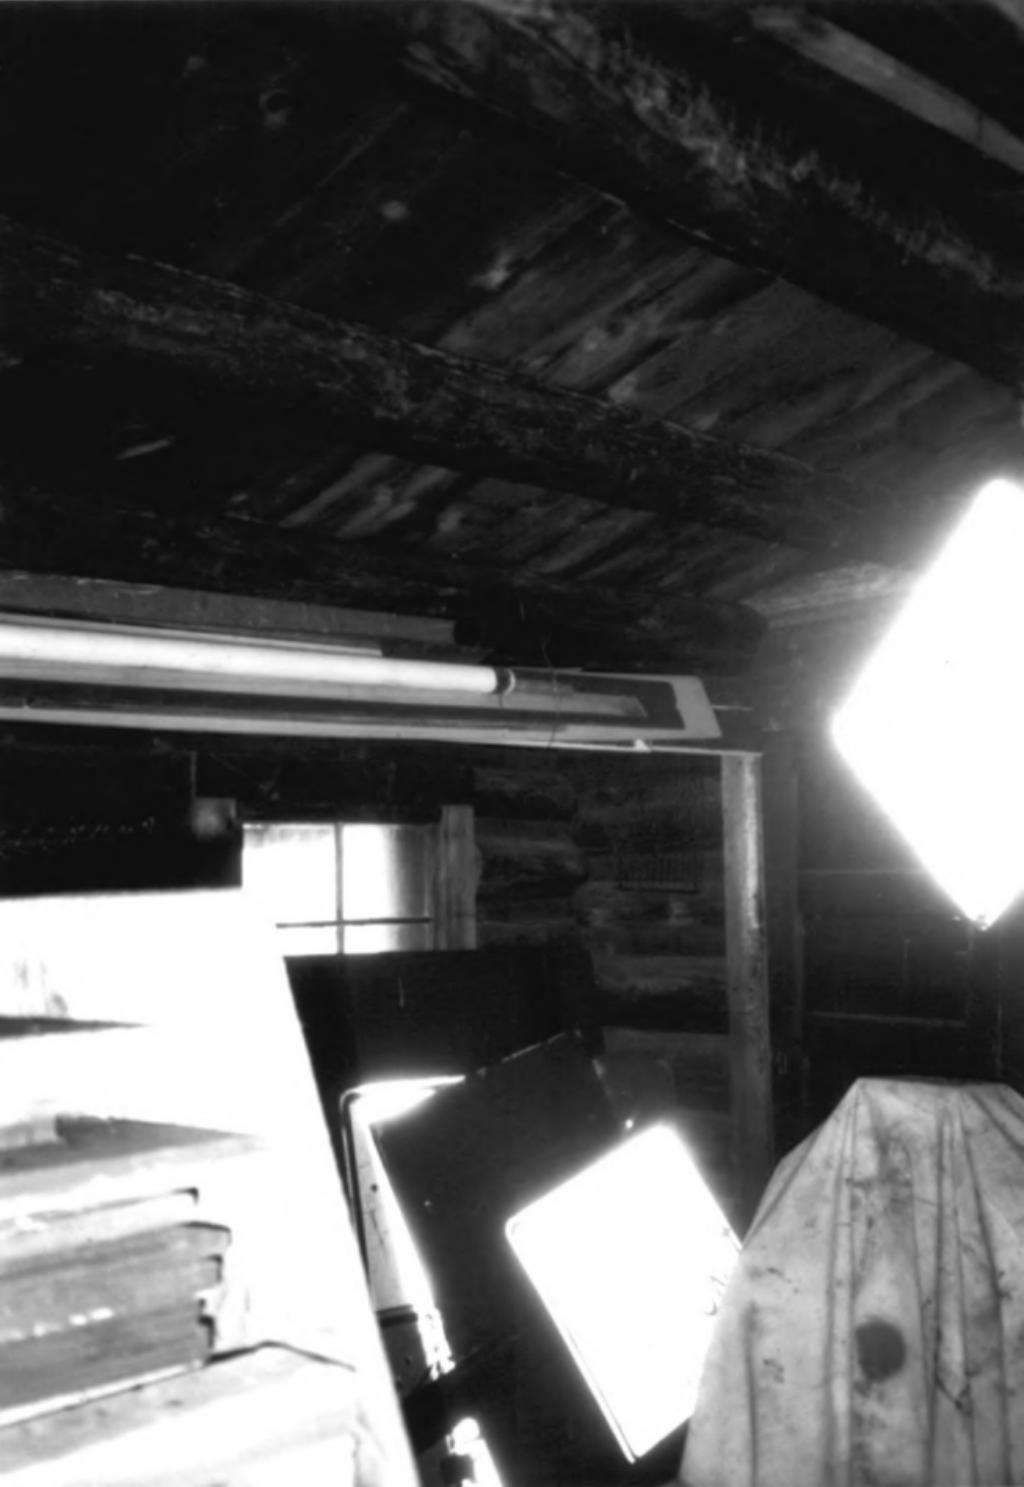
Log Stred @ SELC Resdence -  
GRTE/121 OFF.C

View to NW

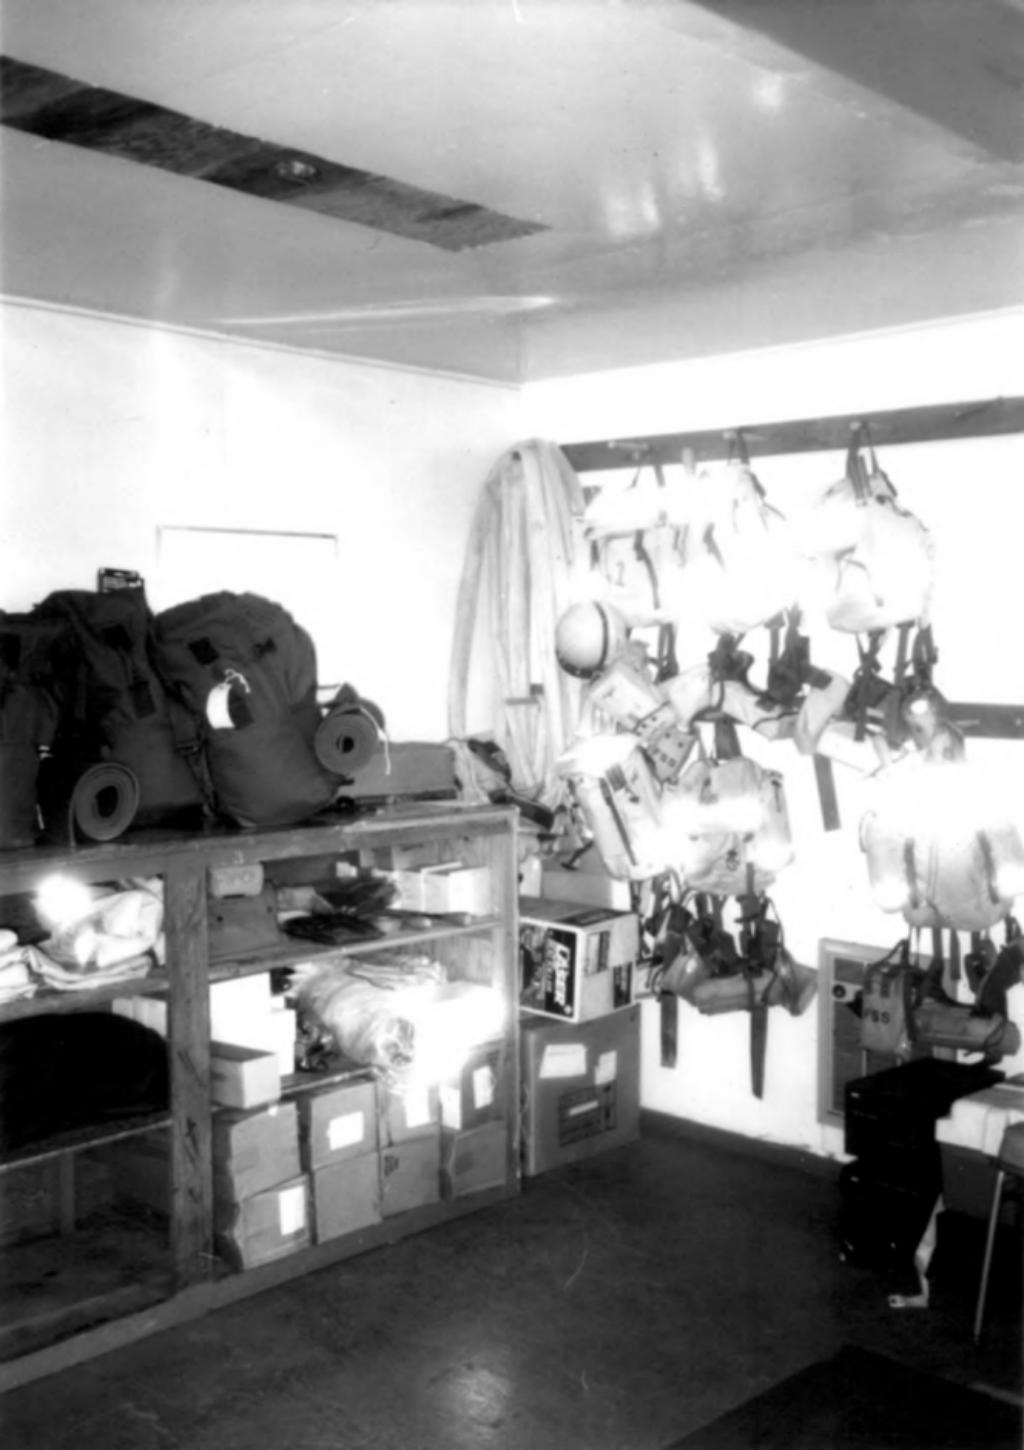
Fire Cache @ S.E.C Residence +  
GRTE / BD - B1  
~~Buffalo Mountain H.A.~~

Photographer: HRA, 1995  
View to NW
