NATIONAL REGISTER OF HISTORIC PLACES  
REGISTRATION FORM

historic name: Snake River Land Company Residence and Office

**Snake River Land Company Office and Residence/aka Buffalo Dorm (Building #117), constructed ca. 1926.**

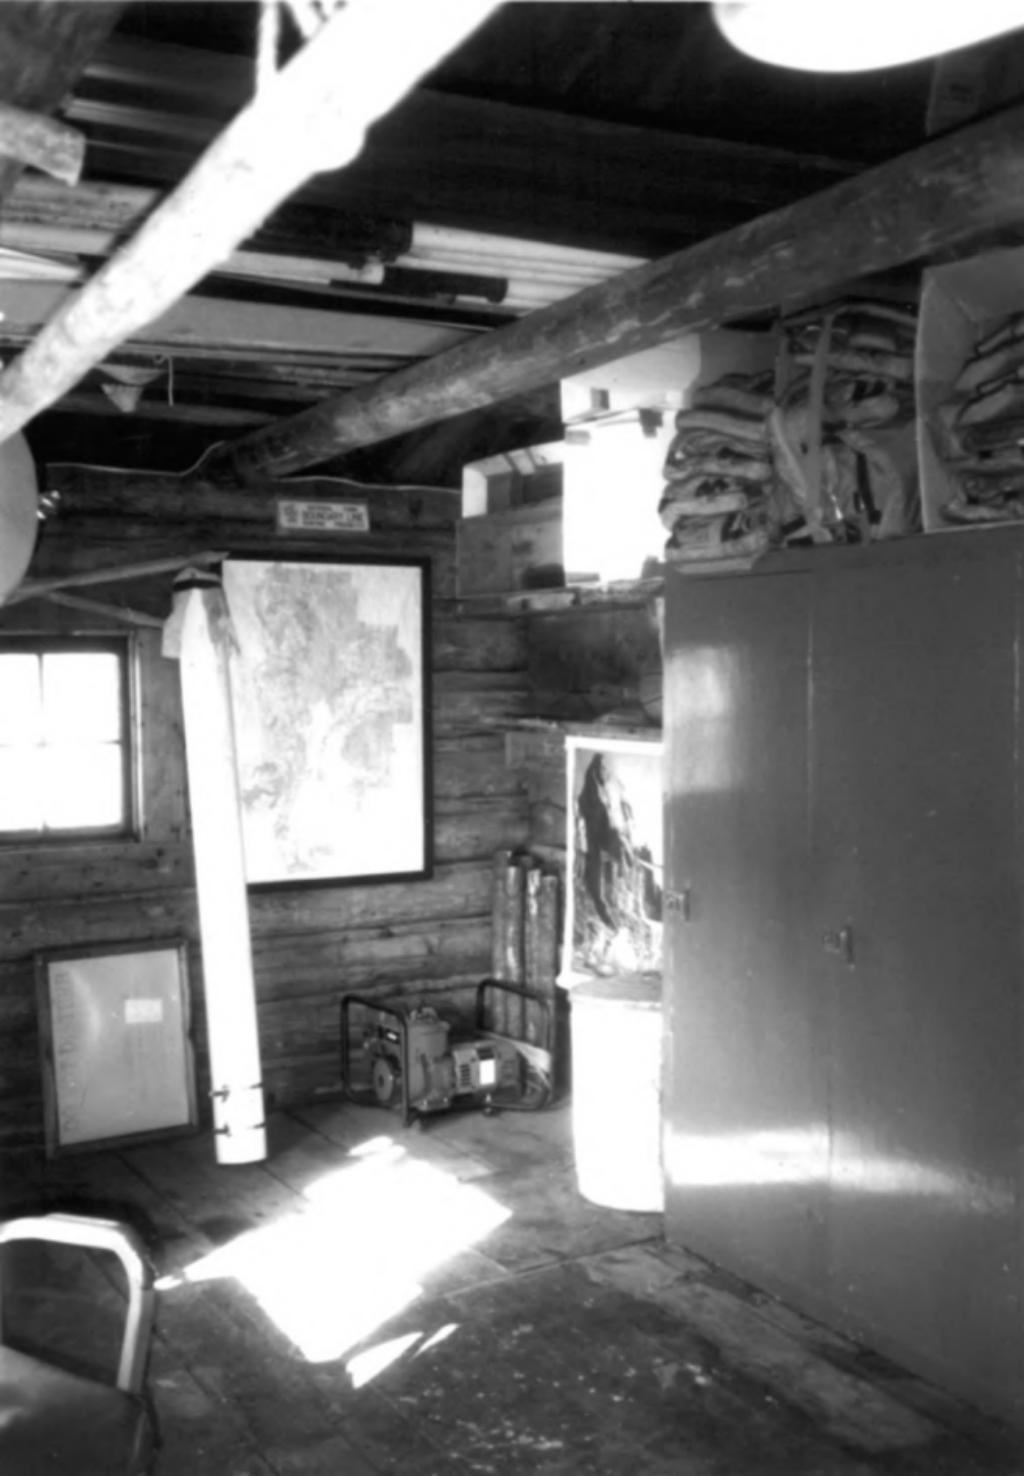
River Cache @sec residence  
GRTE/122

View to SE

The historic garage, currently used as a river cache, is a one-story log building with a long rectangular footprint constructed on a concrete-wall foundation. Wall logs (stained dark brown) are square notched and daubed with concrete that is held in place with lath stops. Enamored metal panels, placed over rolled roofing, cover the side-gable roof. All doors and windows are wood frame, and are trimmed with painted 5" boards.
