National Park Service
Cultural Landscapes Inventory
2004

Memorial Avenue corridor
George Washington Memorial Parkway - Memorial
Avenue

Inventory Summary

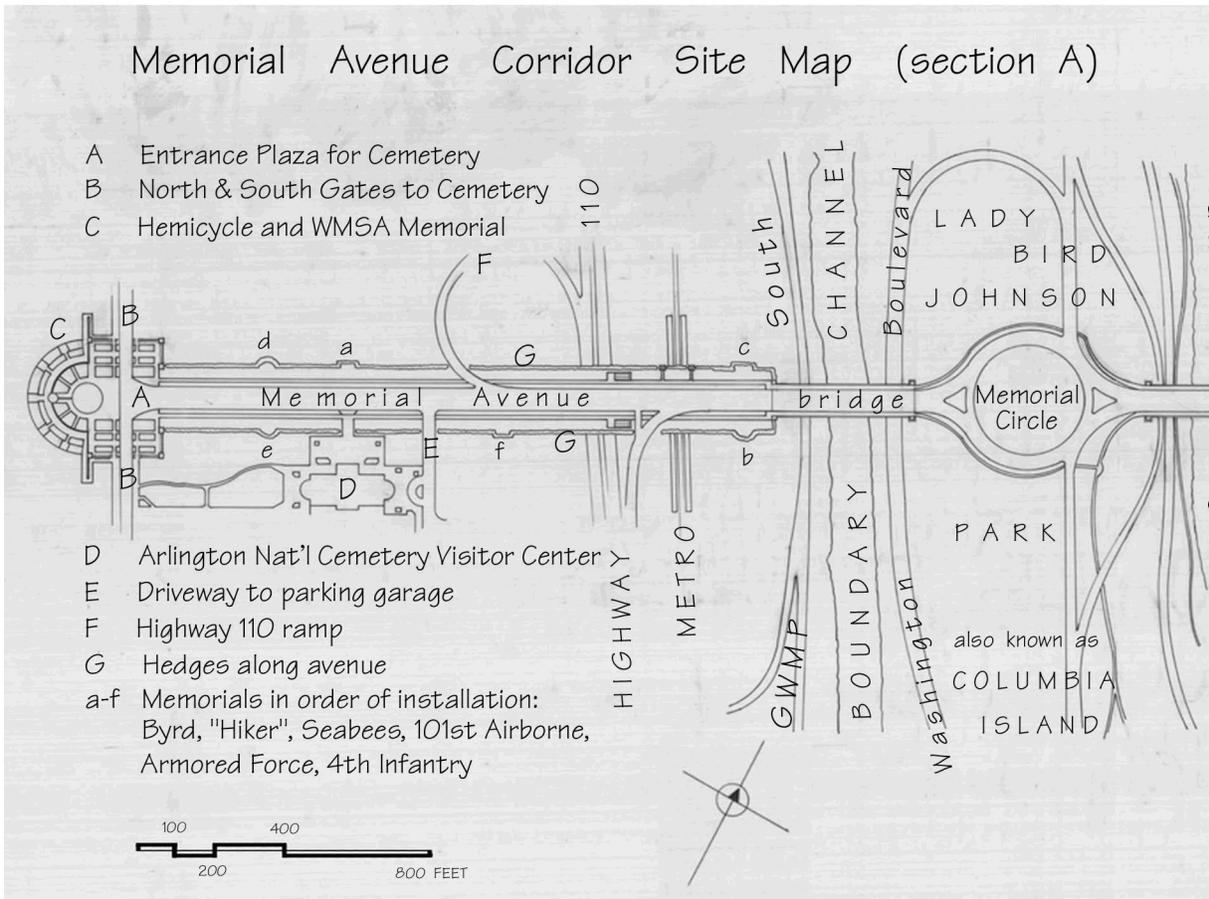
Section A of the site plan shows the western end of the corridor. Parts of the composition are either named or marked with a letter and identified in the legend. (Drawing by D. Guenther.)

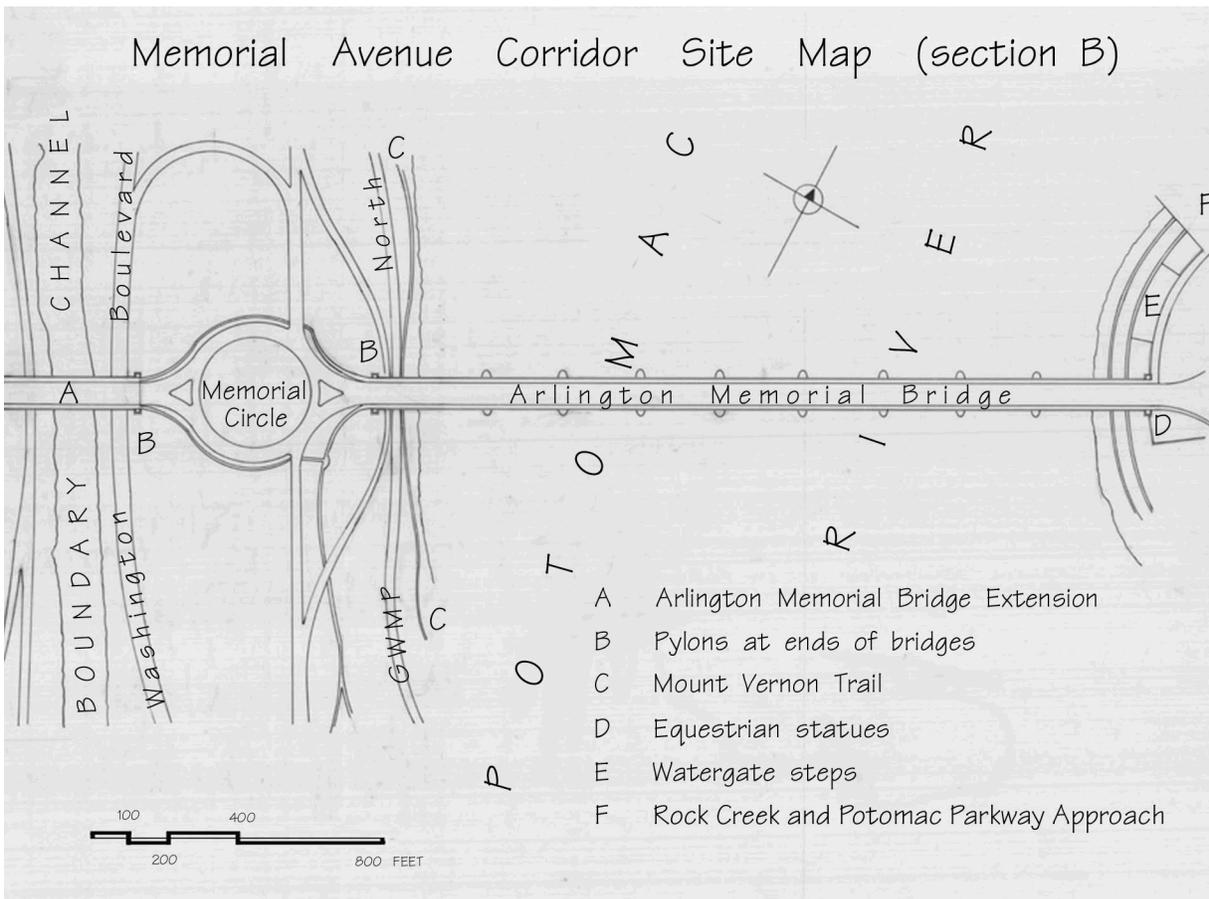
Section B of the site plan shows the eastern half of the composition. Features are either named or described in the legend. (Drawing by D. Guenther)

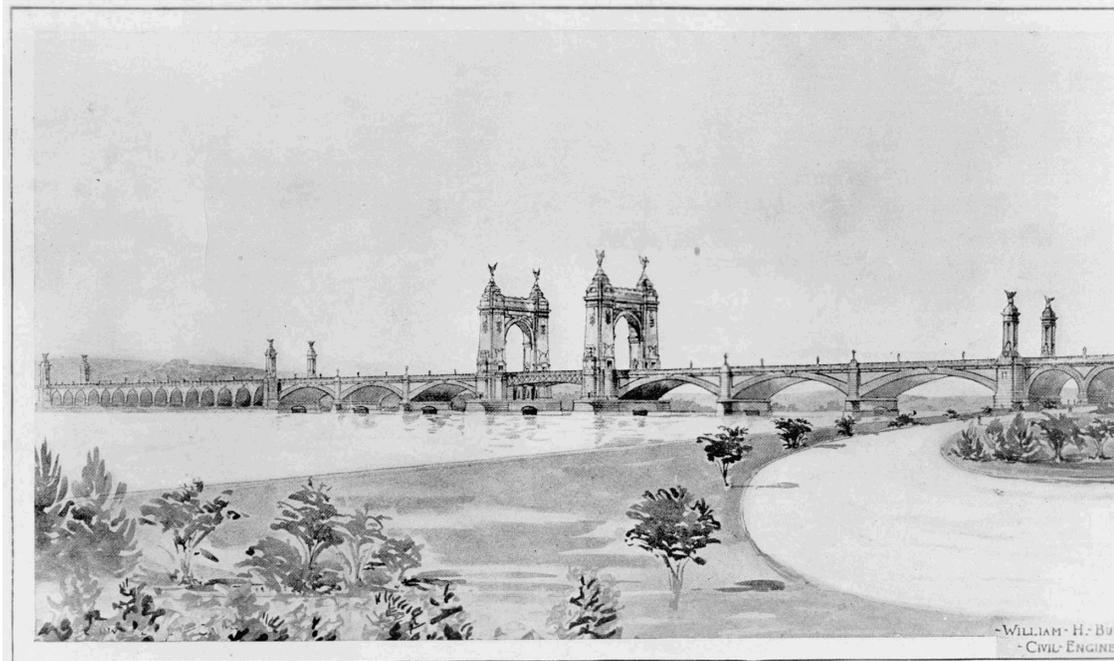
Drawing of the Burr-Casey design for a bridge that was the accepted design for more than 20 years. The McMillan Commission plan prevailed and Arlington Memorial Bridge was built instead. ((NPS/NCR)

Critics of the Burr-Casey bridge design stated that it lacked the appropriate simplicity and dignity (KressCox, 59). Persuaded by these arguments, James McMillan of Michigan, chairman of the Senate Committee on the District of Columbia, reopened the question of the bridge at hearings in January 1901, where the monumental towers of the design were especially criticized. Later that year, the Senate Committee engaged four of the nation's most distinguished designers to study and recommend improvements to Washington's park system including the federal grounds at the heart of the city (KressCox, 60-71). Forming the Senate Park Commission (also known as the McMillan Commission) were the architects Daniel H. Burnham and Charles F. McKim, landscape architect Frederick Law Olmsted, Jr., and sculptor Augustus Saint-Gaudens. All of these men had collaborated on the Columbian Exposition, except Olmsted, whose father had. Charles Moore, clerk of the Senate District Committee and instrumental in many of these developments, served as commission secretary.

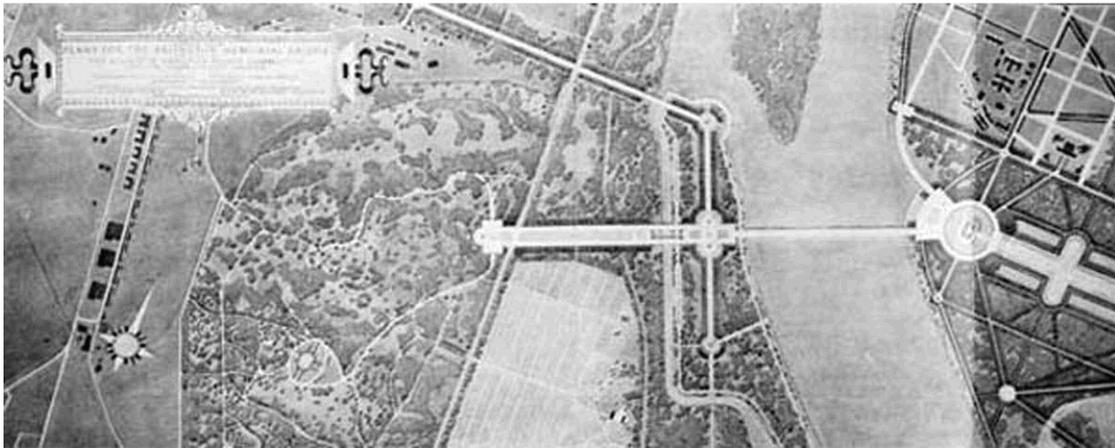
General Plan for Arlington Memorial Bridge prepared for the Arlington Memorial Bridge Commission by McKim, Mead and White and published in the Commission's 1924 report. (AMB Commission Report)

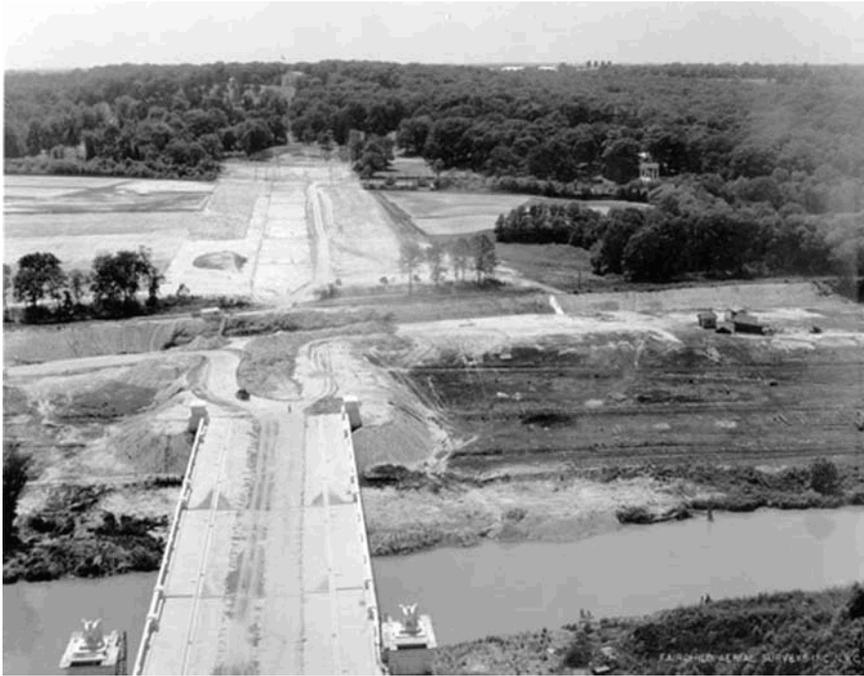
Cemetery entrance and avenue under construction, June 13, 1931. Boundary Channel Bridge nearly completed. Line of trees in middle range mark former railroad/canal. (NPS/NCR: Fairchild Aerial, 17665)

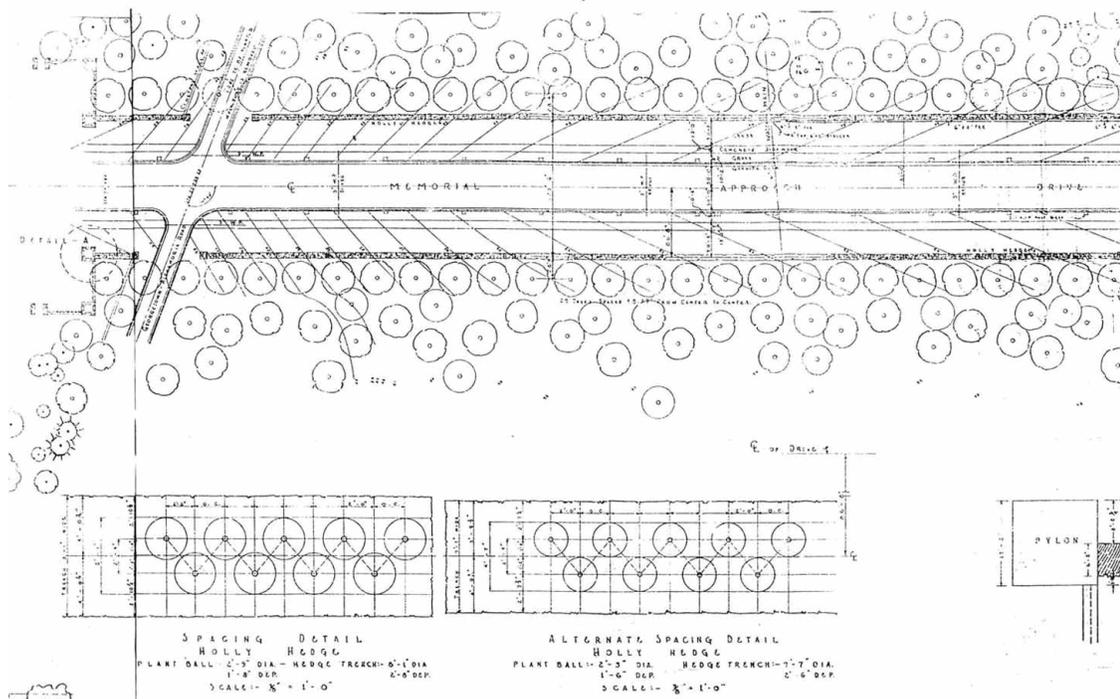
Planting plan for Memorial Approach Drive dated May 21, 1935, shows first trees on each side of avenue evenly spaced and more random beyond. Graphic at bottom shows way to plant holly hedge. (NPS-TIC: 8-135)

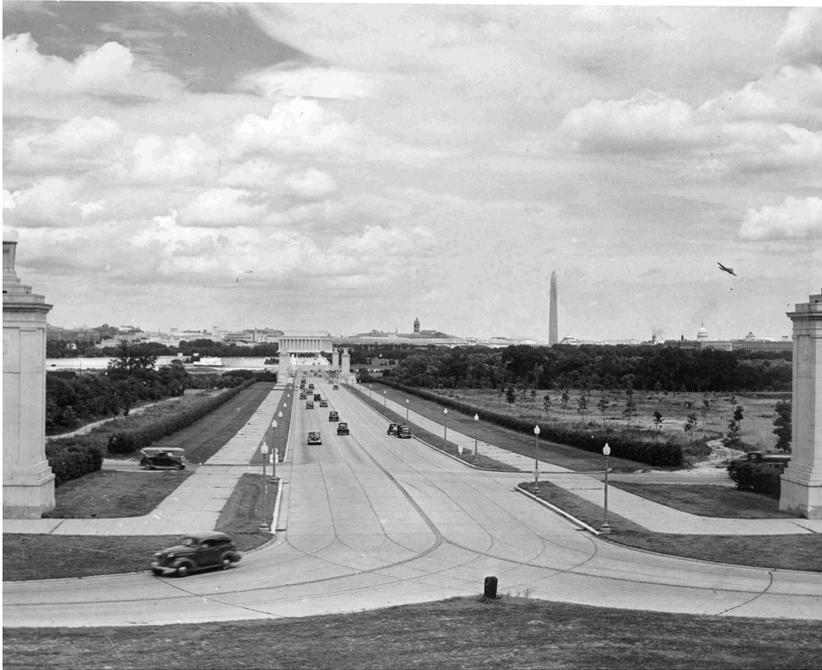
Memorial Avenue c. 1938. Hedge has begun to be shaped, trees are young, and lampposts are in place. Note Arlington Ridge Road crossing and light-colored pavement. (NPS/NCR: National Capital Region, 2.12-42/41)

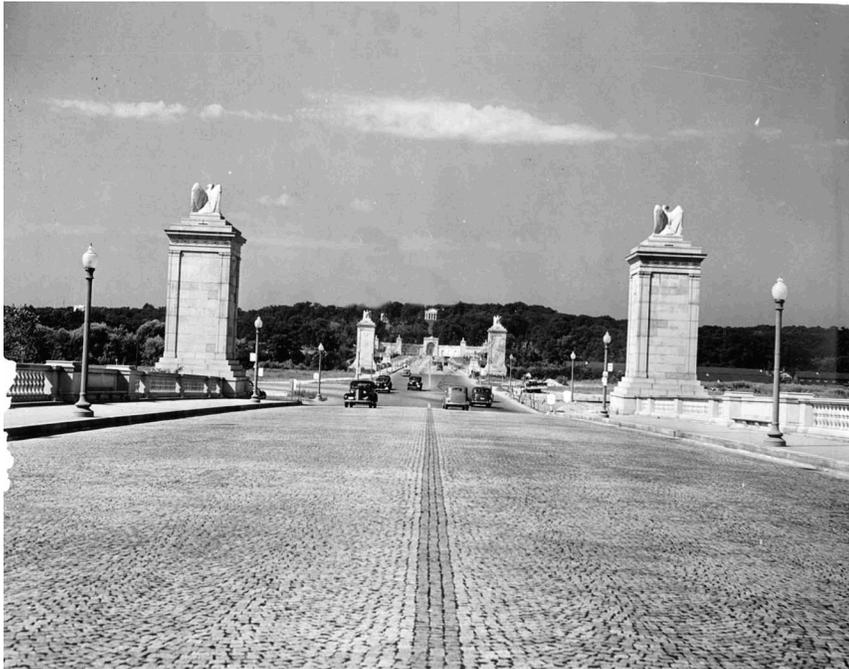
West end of Memorial Bridge c. 1938-39, with Durax roadway. Memorial Circle not yet constructed. Washington standards line temporary roadway on Columbia Island. (NPS/NCR: National Capital Parks, 2.12-42/11)

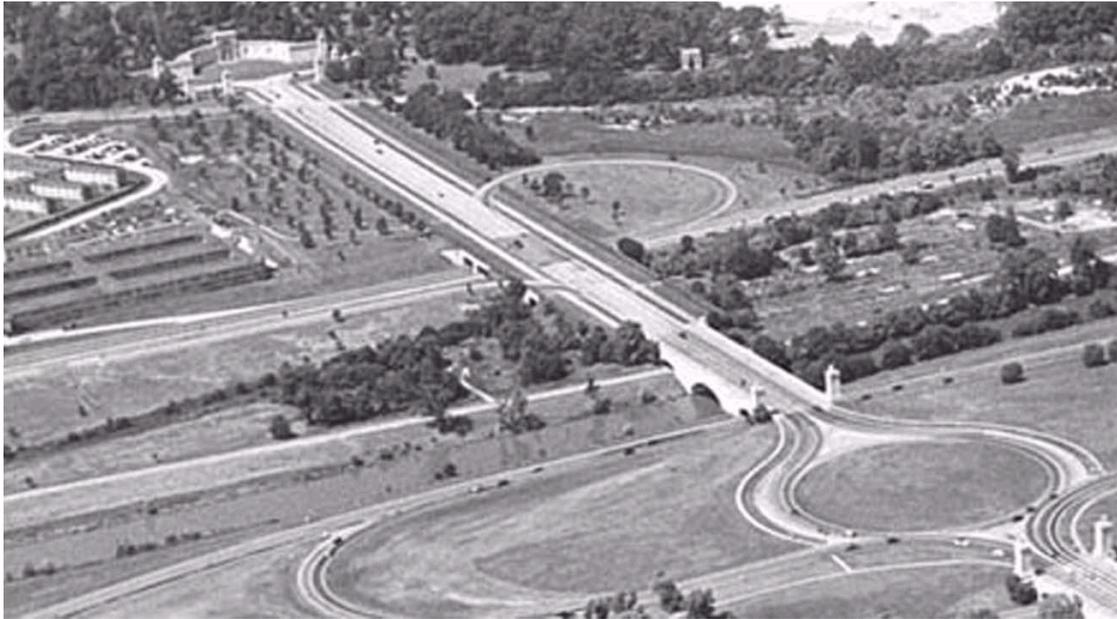
Air view dated Aug. 14, 1950 shows single row of trees with others scattered on Avenue's south side, and a single row and swath of trees along drainage ditch on north. (MRCE: Columbia Island folder 1, Abbie Rowe, 1325-G)

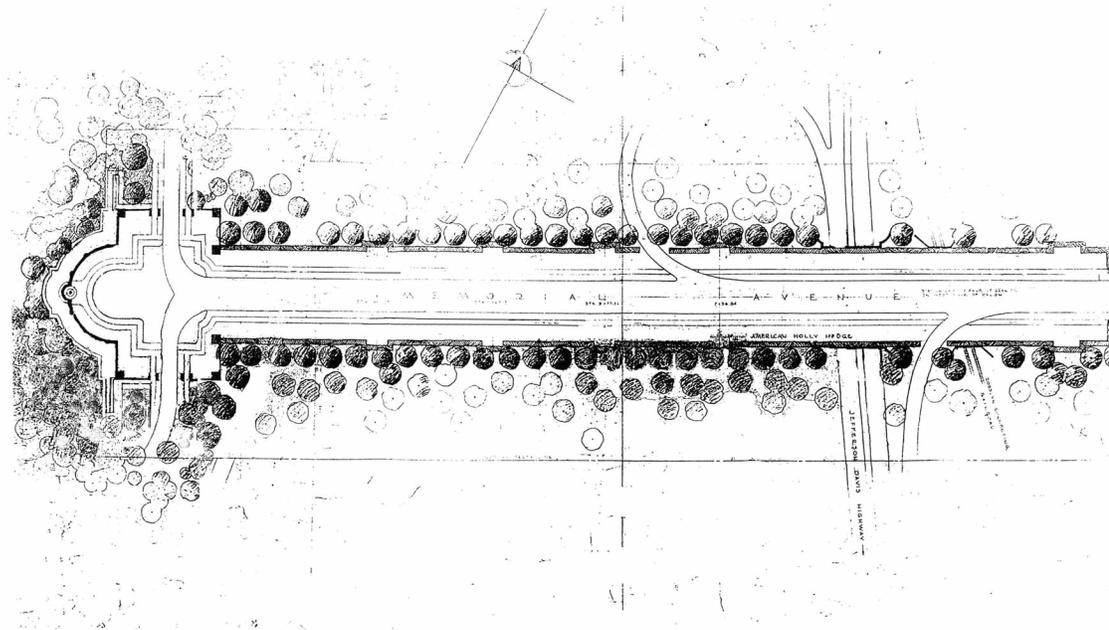
Memorial Avenue Planting Plan from June 3, 1960 shows niches. Also shows trees in generally same places as the 1935 plan except around Highway 110. Change in elevation near new highway not hinted at. (NPS 855/81100A)

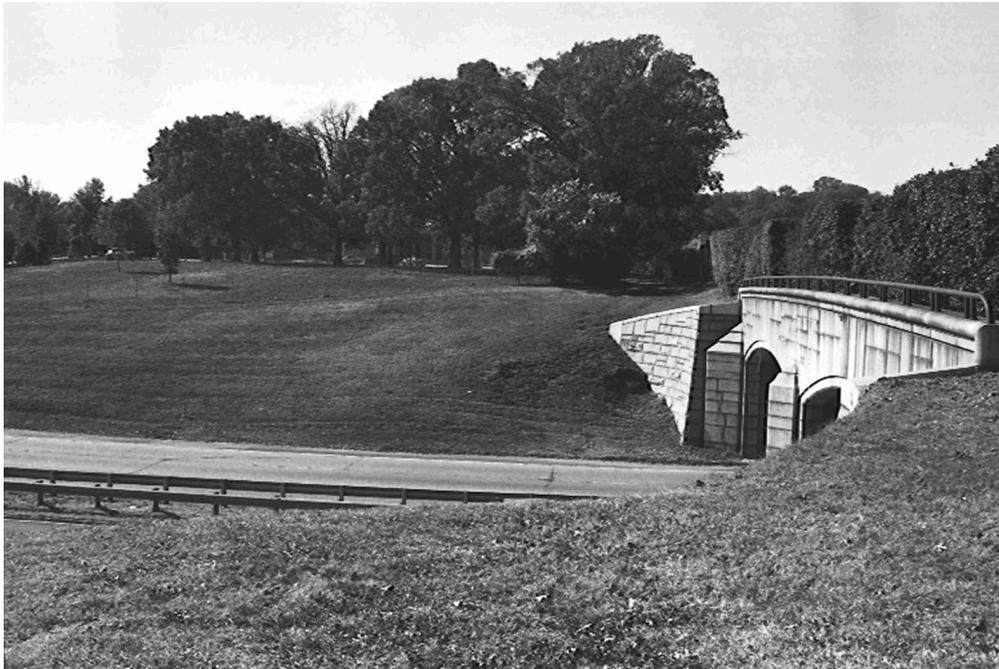
Highway 110, which passes below the avenue, interrupts the Walls' of the avenue provided by white oak trees. View from behind hedge on the south side of the avenue looking west. (CLI team, fall 2000)

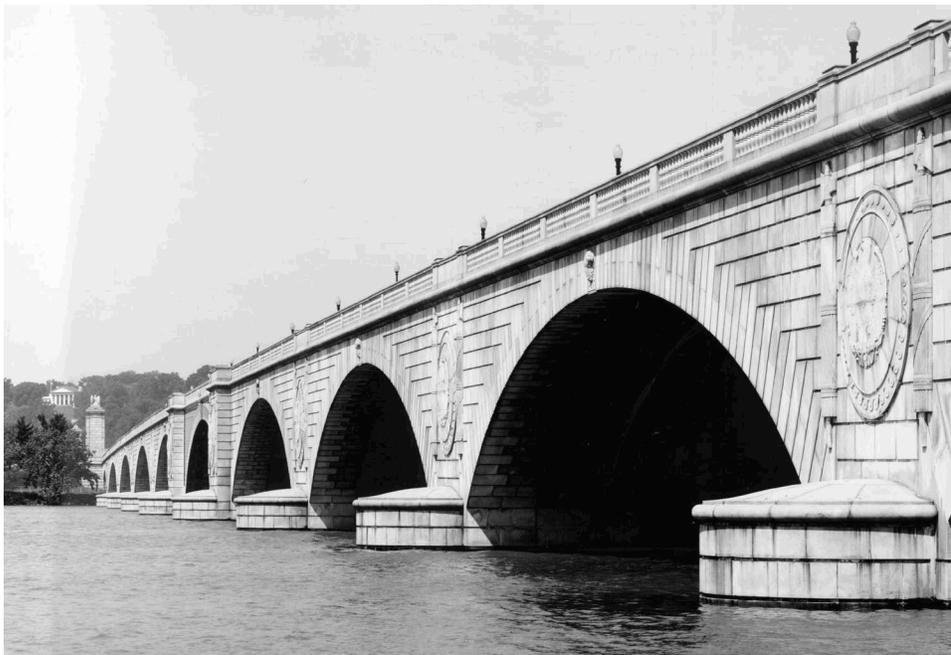
Arlington Memorial Bridge south elevation, looking west. (HAER DC 7-6, December 1988)

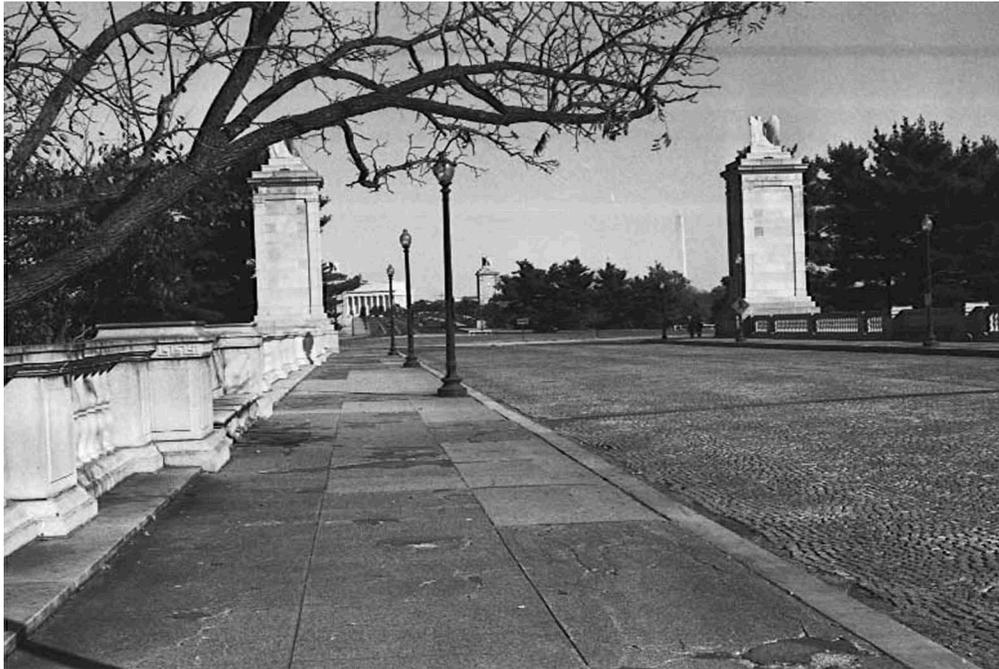
Memorial Avenue Bridge (Boundary Channel Bridge) looking east past Memorial Circle to Lincoln Memorial. Granite block surface of bridge is visible. Sidewalk condition is before recent repair. (CLI team, winter 2001)

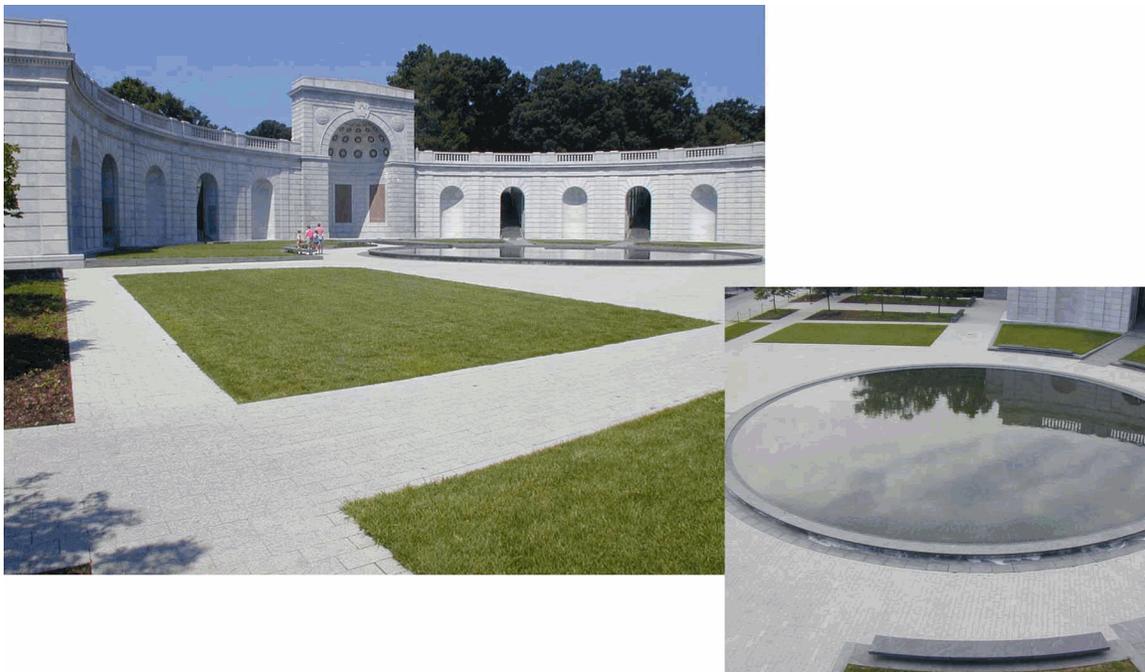
Hemicycle at Arlington National Cemetery Great Entrance. Plaza has been redesigned as part of the Women in Military Service Memorial. Large pool at center of plaza is part of the new design. (LCS team, summer 2001)

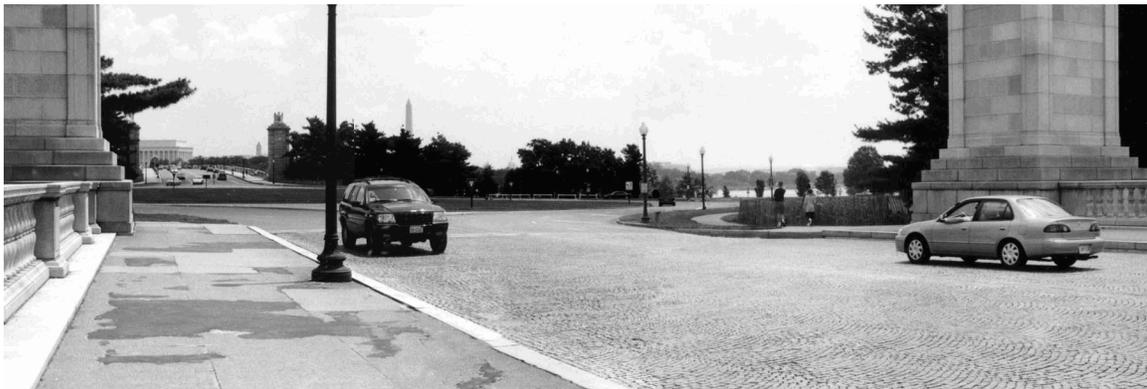
Memorial Avenue Bridge leading to Memorial Circle. Arlington Memorial Bridge and Lincoln Memorial in distance. New sidewalk was laid after this photo. (CLI team, winter 2001)

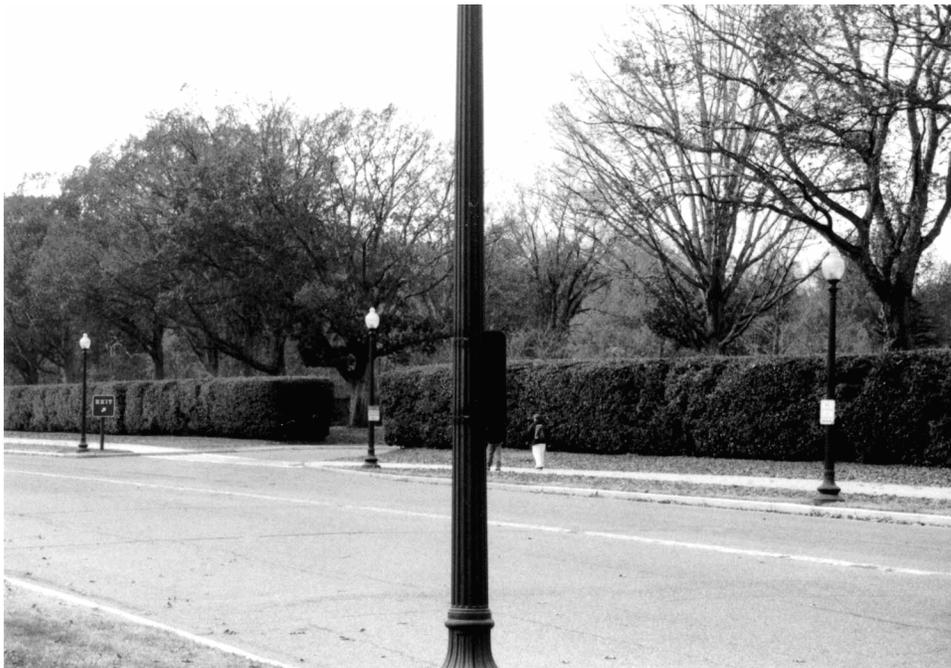
Lampposts known as Washington standards, with single globe, line Memorial Avenue, both bridges and surround the circle. Roadway asphalt is cracked along scoring in underlying bituminous concrete. (CLI team, winter 2001)

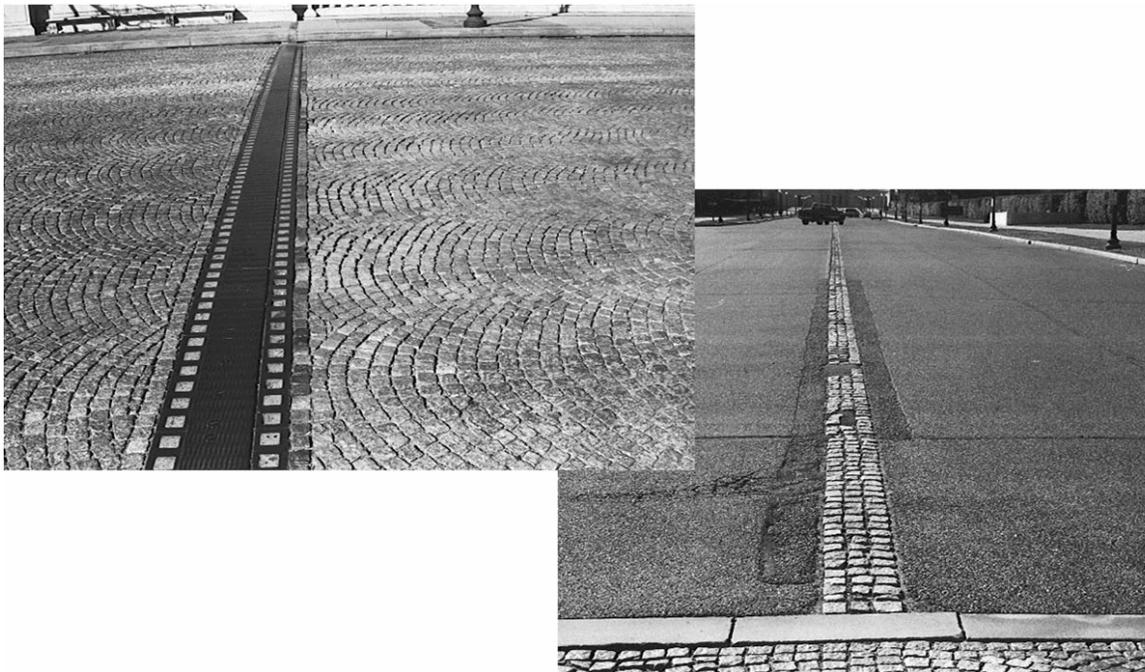
Durax'roadway of Memorial Avenue Bridge with metal expansion joint, left photo. Photo on right shows granite headers at west end of bridge with Durax'centerline of Memorial Avenue. (CLI team, winter, 2001)

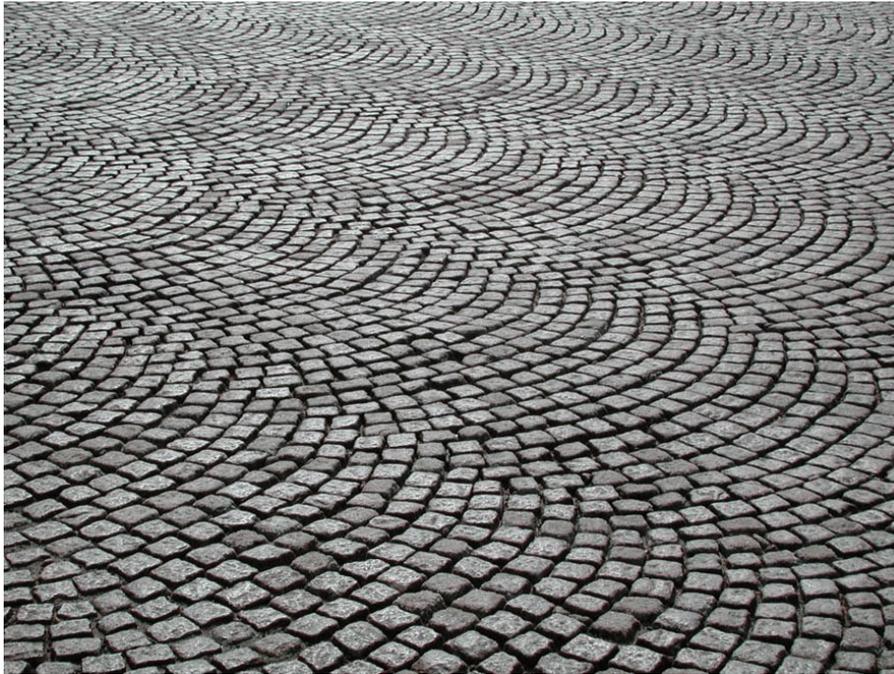
Intricacy of fishscale pattern is readily apparent in this photo taken before bridge repair. Now mortar completely fills spaces between granite blocks. (CLI team, summer 2000)

AD 1990	Built	American Armored Forces Memorial added.
	Restored	Eight lampposts (Washington standards) replaced modern highway-type lampposts around Memorial Circle, which had probably been installed c. 1960.
AD 1996 - 1998	Built	Women in Military Service for America Memorial constructed at hemicycle.
AD 1998	Planted	Little leaf linden and other plantings installed in hemicycle plaza in connection with WMSA memorial.
AD 2000	Built	4th Infantry Division Memorial added.
	Planted	About two dozen white oaks added to avenue's borders.
AD 2001 - 2002	Preserved	Memorial Avenue Bridge (crossing Boundary Channel) repaired in order to alleviate drainage problems.
	Altered	In the relaying of the granite block roadway on Memorial Avenue Bridge as part of bridge repair, the pattern of the blocks has been obscured by excess mortar.

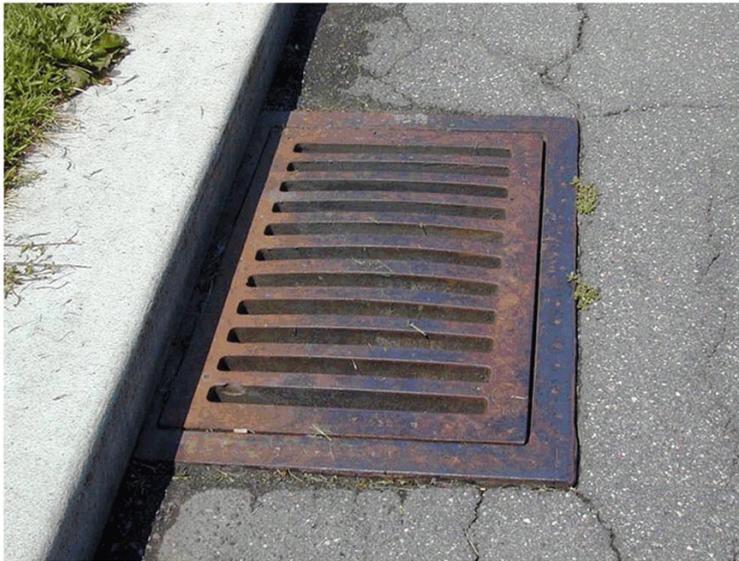
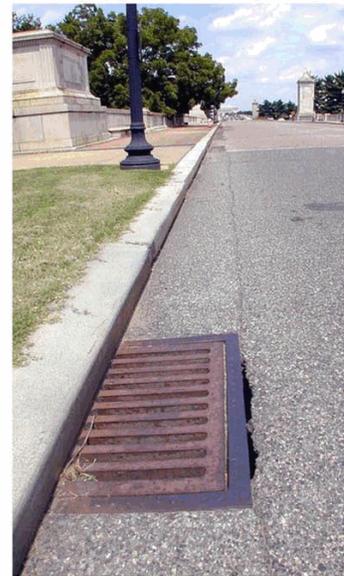
Catch basins along Memorial Avenue. Convex shape of grate to left is evidence that it is the original designed by McKim, Mead and White. (LCS team, summer 2001)

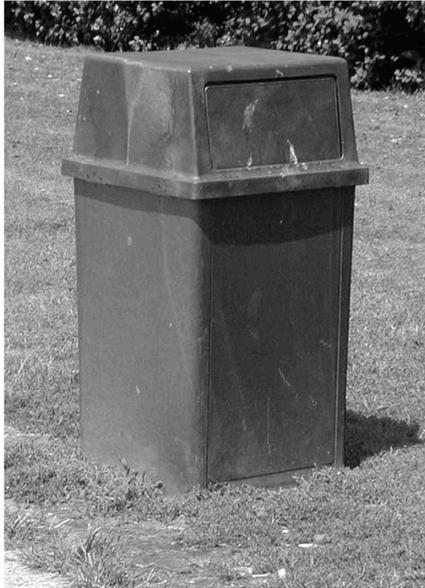
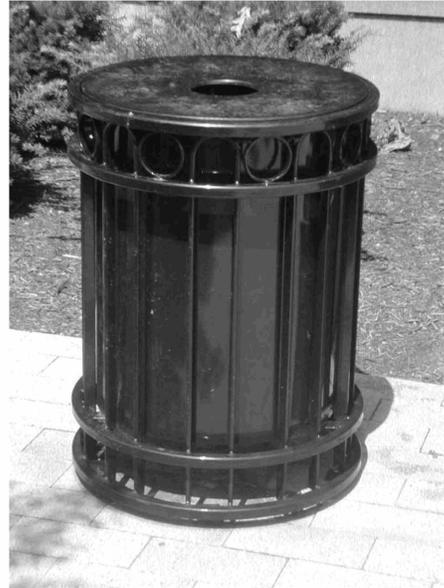
Trash can at left is found on Memorial Avenue near Metro escalator. Similar cans are found at entrance to cemetery visitor center. Trash can on right is at plaza of hemicycle. (LCS team, summer 2001)

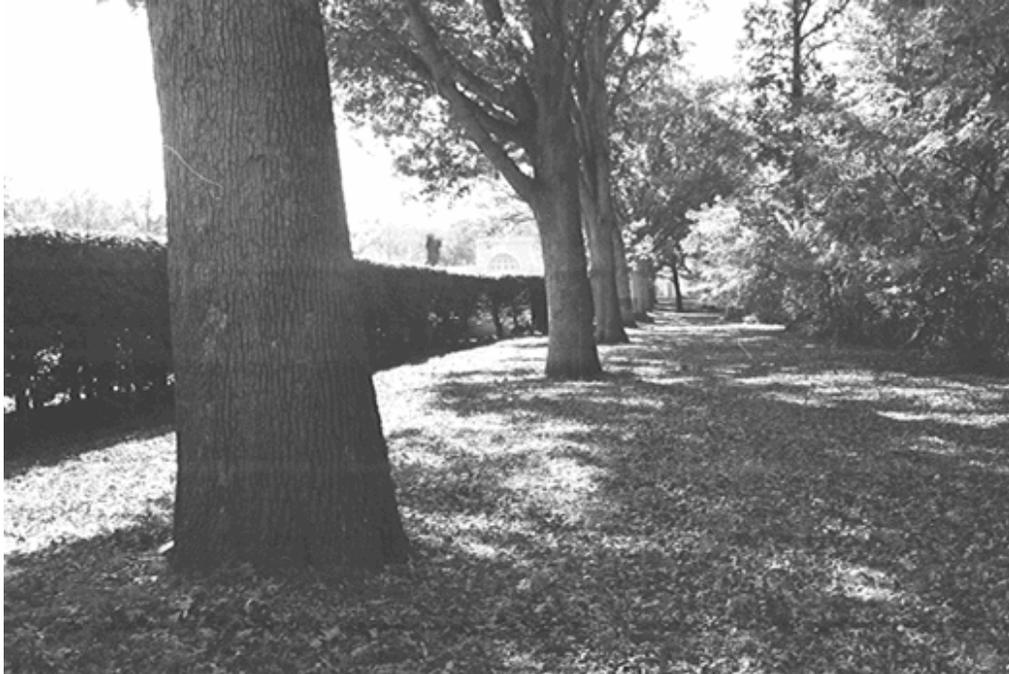
Line of white oaks on north side of avenue as seen from behind the hedge. Vegetation on right is part of thicket that lines a drainage ditch. Hemicycle is faintly visible in distance. (CLI team, fall 2000)

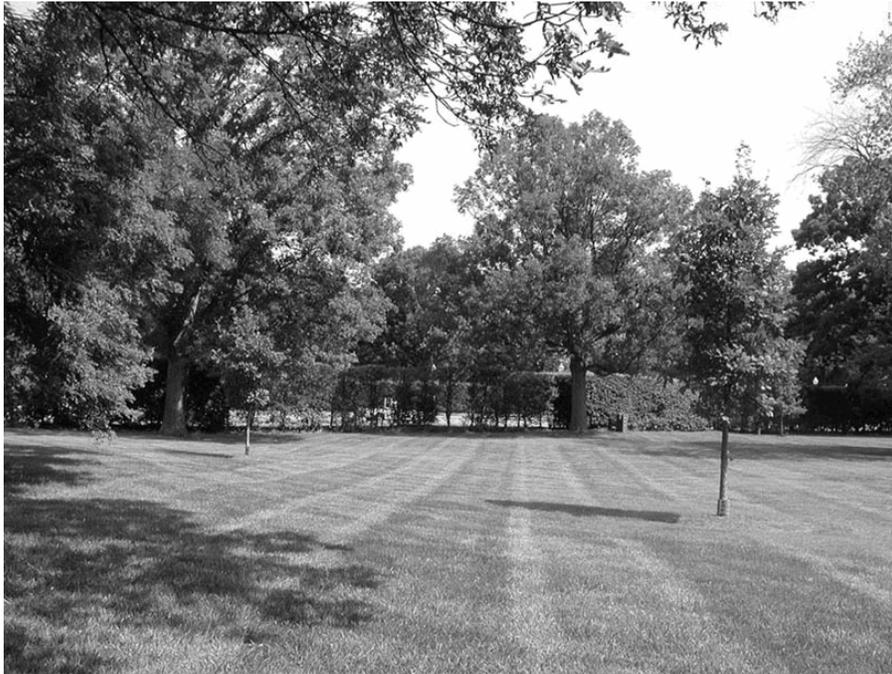
Two newly-planted white oaks in lawn west of visitor center, looking north. Thin section of hedge toward center of image is where Arlington Ridge Road formerly crossed. (CLI team, summer 2000)

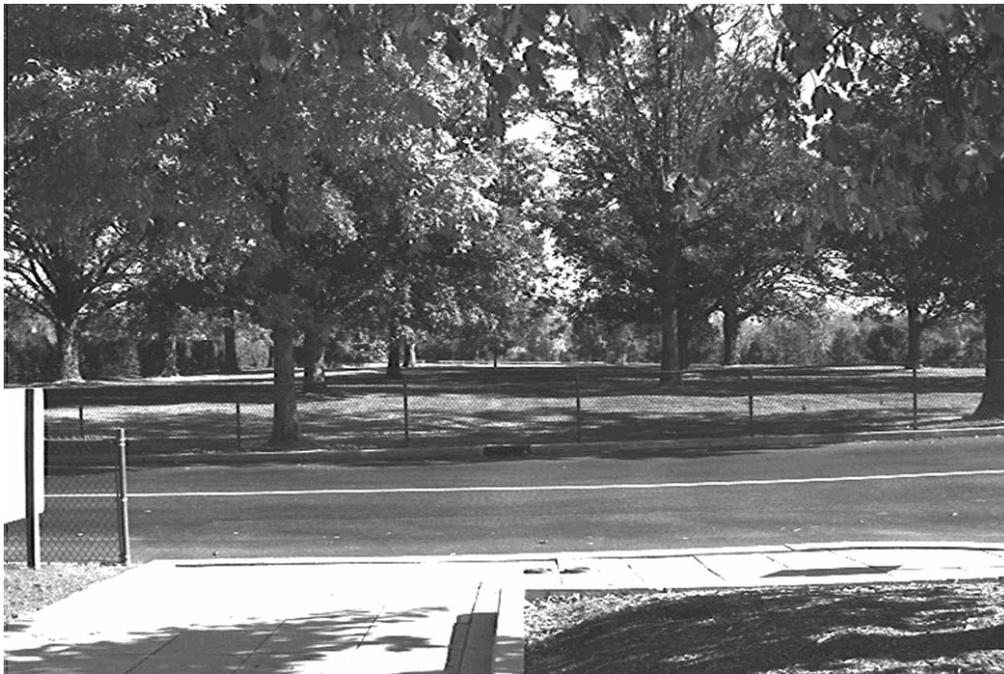
Full planting of white oaks, much like what was planned in mid-1930s, is found east of driveway to visitor center parking and continues for about 400 feet to the Highway 110 slope. (CLI team, fall 2000)

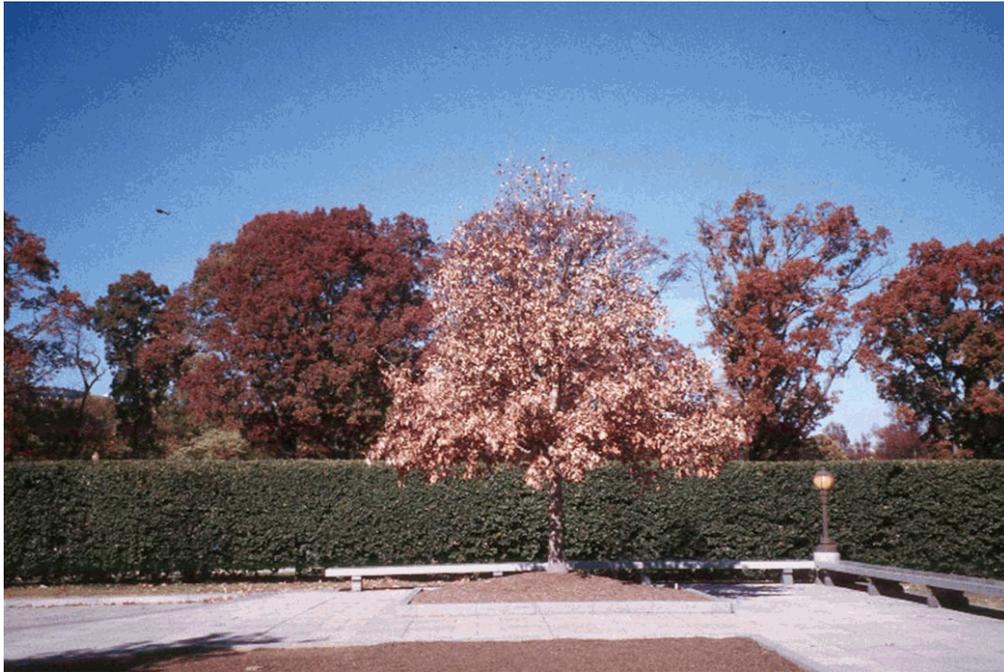
Oaks in fall color from plaza of Arlington National Cemetery visitor center. Swamp white oak in foreground has tan leaves rather than bluish red of white oaks. Spaces are visible in the white oak canopy. (CLI team, fall 2000)

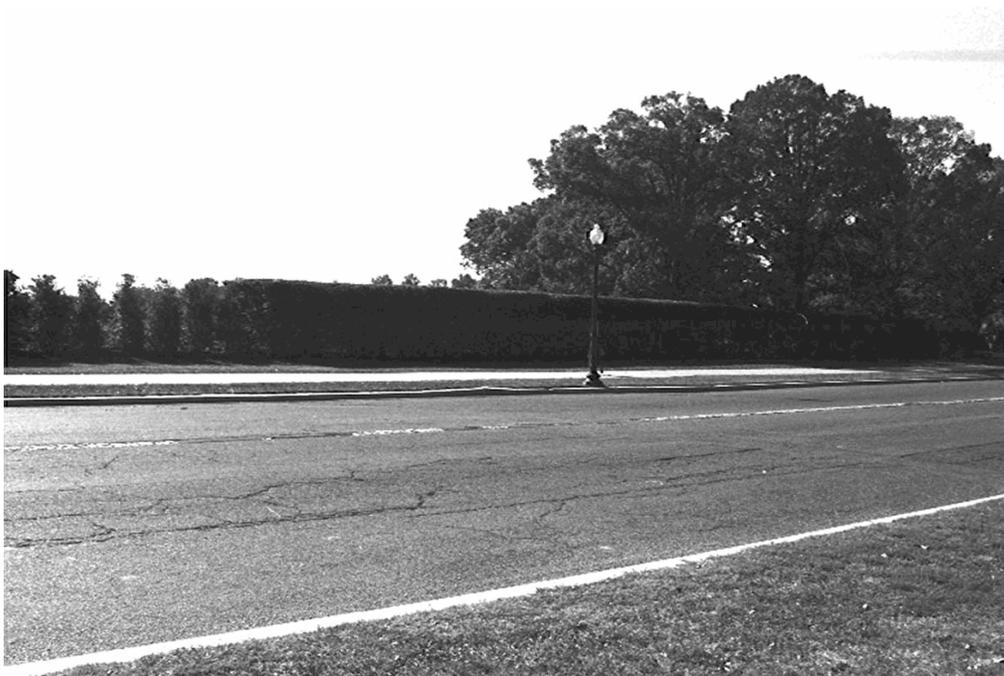
View of gap in Wall of white oaks along Memorial Avenue, looking south. Ground behind hedge where trees are absent slopes down to Highway 110. (CLI team, fall 2000)

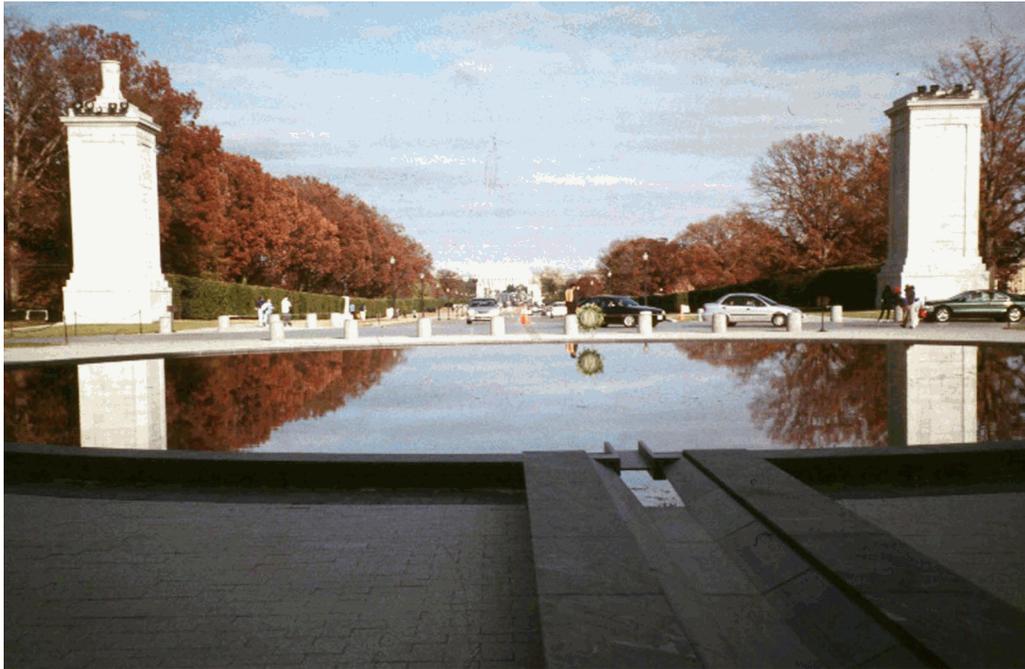
View of Memorial Avenue from hemicycle plaza east to Lincoln Memorial. Pool of redesigned hemicycle plaza is in foreground. Pylon on south side is missing tripod vase. (CLI team, fall 2000)

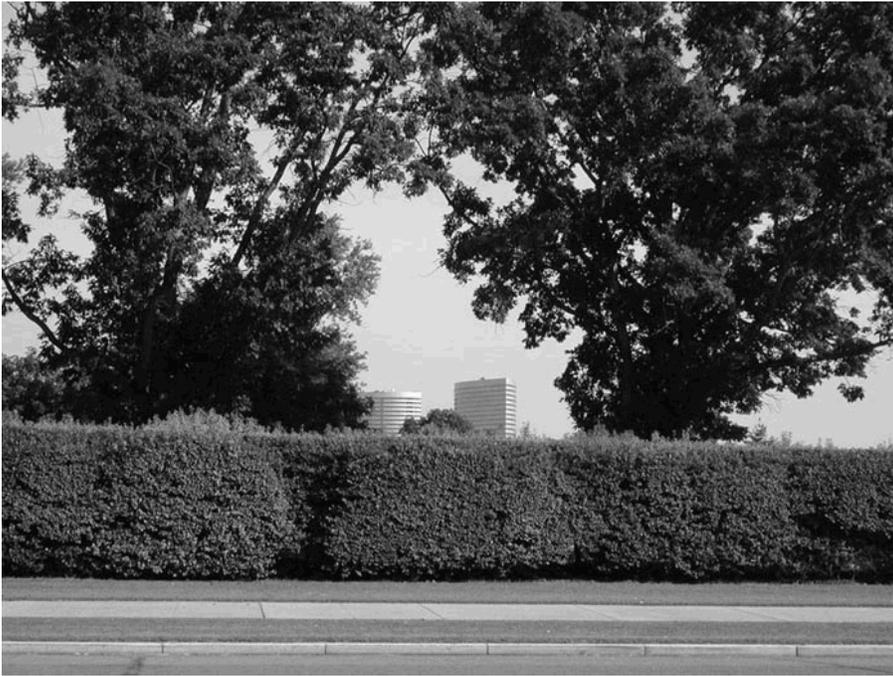
Another view of Rosslyn from approximate midpoint of avenue, where missing trees in second and third rows result in openings in the wall of trees. (CLI team, summer 2000)
