ASSESSMENT OF COASTAL WATER RESOURCES AND WATERSHED CONDITIONS AT KLONDIKE GOLD RUSH NATIONAL HISTORICAL PARK, ALASKA

**Assessment of Coastal Water Resources and Watershed Conditions at
Klondike Gold Rush National Historical Park, Alaska**

Technical Report NPS/NRWRD/NRTR-2006/349

March 2006

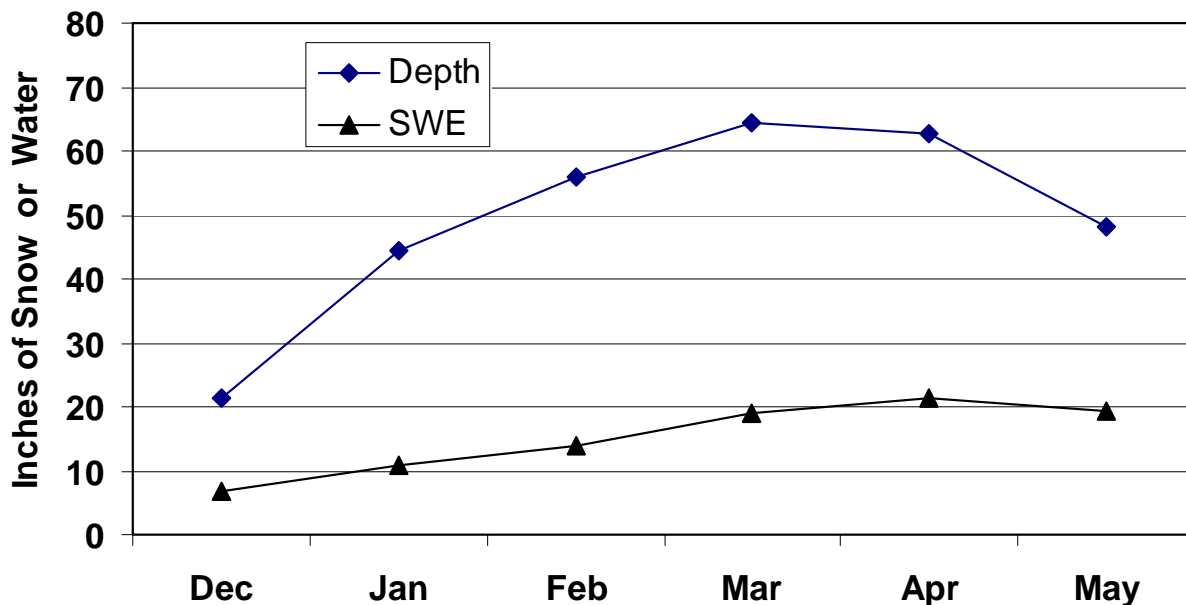
Figure 9. Beginning of month snow depth (inches of snow) and snow water equivalent (SWE; inches of water) at the NRCS Moore Creek snow survey site in the Skagway River watershed. Data are averages for the period 1989-2005 and are available in the NRCS snow course database for Alaska (http://ambcs.org/pub/sc_sum_ak/MOORECREEKBRIDGE.HTM).

River enters Taiya Inlet at the Skagway townsite. Discharge on the Skagway River was measured by the US Geological Survey from 1964-1986 and mean streamflow for this period was 560 cfs (Montgomery Watson 1997). Mean monthly discharge in the Skagway River ranges from <50 cfs in winter to 1500-2000 cfs in summer when discharge is dominated by melt from snowfields and glaciers (Figure 8). The estimated 20 year flood for the Skagway River is 15,300 cfs, while the 100-year flood event is estimated at 38,000 cfs. (TIWC 2005). Peak flows of greater than 30,000 cfs have been recorded three times in the last century (City of Skagway 2005), with a high of approximately 35,000 cfs in October 1901 and October 1943. KLG0 staff maintains a National Resources Conservation Service snow survey station at Moore Creek in the Skagway watershed. This site provides a relatively long-term (1989-present) dataset on snow accumulation in the Skagway watershed. Snow depth and snow water equivalent (SWE) at the site typically peak in March and April (Figure 9).

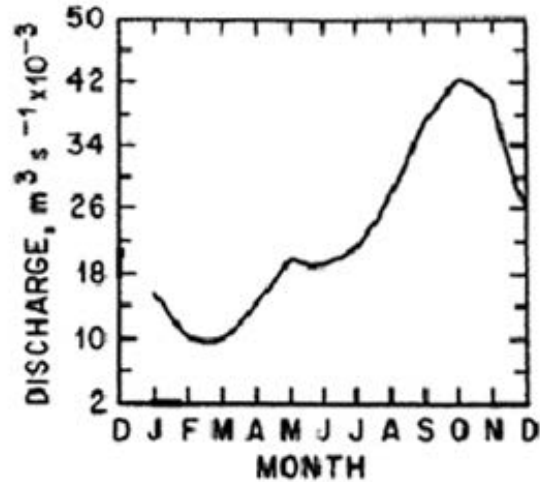
Figure 12. Model-generated values of freshwater discharge in Southeast Alaska based on precipitation, air temperature, and the drainage area of the region, from Royer (1982).

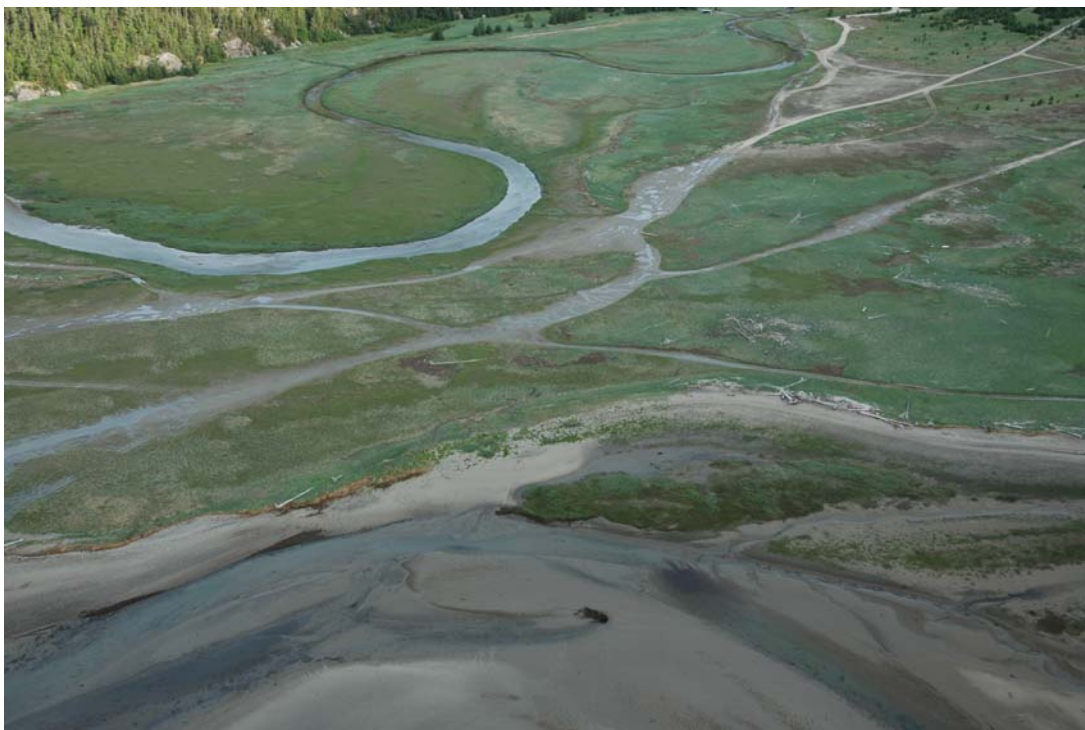
Figure 13. Taiya estuary area. (ShoreZone 2004 (<http://mapping.fakr.noaa.gov/Website/ShoreZone/>))

ShoreZone is a project sponsored by multiple agencies and organizations that conducted aerial surveys of intertidal regions of KLG0 in 2004. This project aerially surveyed intertidal and shallow subtidal areas to identify shoreline morphology, substrate, wave exposure, and biota of intertidal and nearshore habitats. This coastal habitat mapping effort produced an online database with interactive GIS layers, digital maps, aerial images and video of Lynn Canal with plans to map other areas of Southeast Alaska (<http://mapping.fakr.noaa.gov/Website/ShoreZone/>). In the uppermost areas of the upper Taiya Inlet, the substrate is soft sediment and the biological cover is continuous marsh grasses, herbs, sedges and continuous or patchy dune grass; wave exposure is very protected; and the oil residency index is months to years (Figure 13). In rocky areas in the upper Taiya Inlet (predominantly along the sides of the inlet), cover is continuous barnacles, mussels and Fucus; wave exposure is semi-protected; and the oil residency index is weeks to months or months to years (Figure 14).

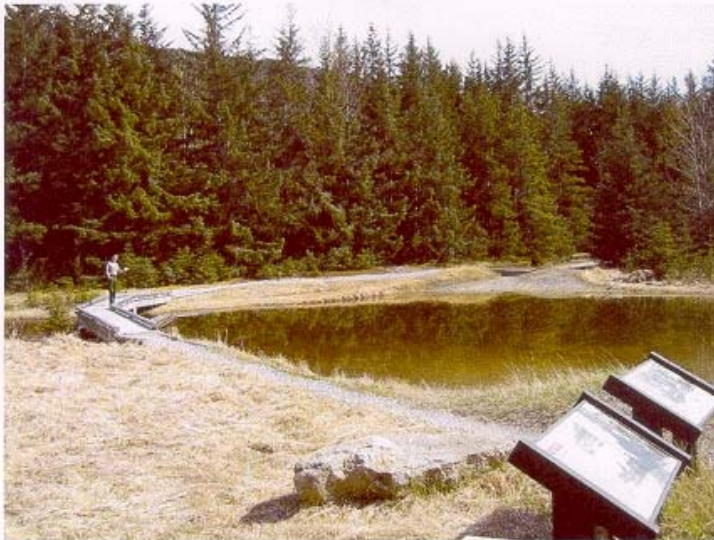
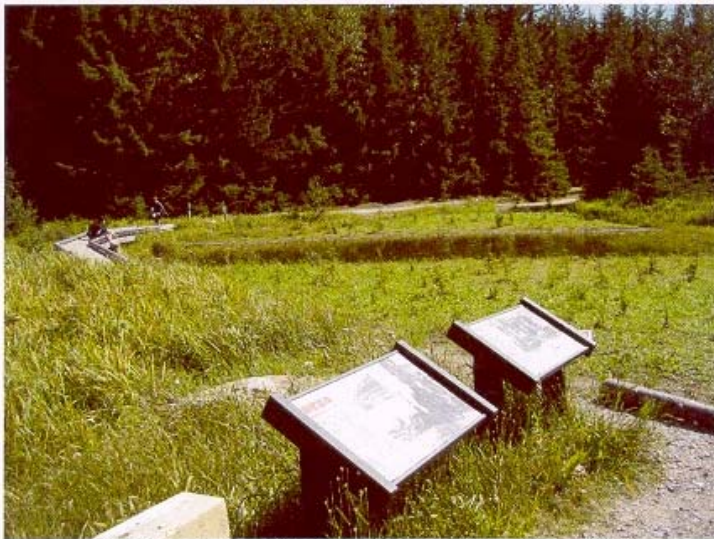
**Nelson Slough Restoration
Fish Habitat Permit FH04-I-0022**

Nelson Slough prior to restoration - 11 May 2004

Nelson Slough post restoration and revegetation - 8 August 2004

Figure 15. Photos of Nelson Slough restoration project. Natural bank structure and aquatic vegetation were restored in this one acre tidal wetland. Photos from Klondike Gold Rush NHP (2004).
