EXCAVATION AND REPAIR
OF SUN TEMPLE
MESA VERDE NATIONAL PARK

DEPARTMENT OF THE INTERIOR
OFFICE OF THE SECRETARY
1916

EXCAVATION AND REPAIR OF SUN TEMPLE.

By J. WALTER FEWKES, *Bureau of American Ethnology.*

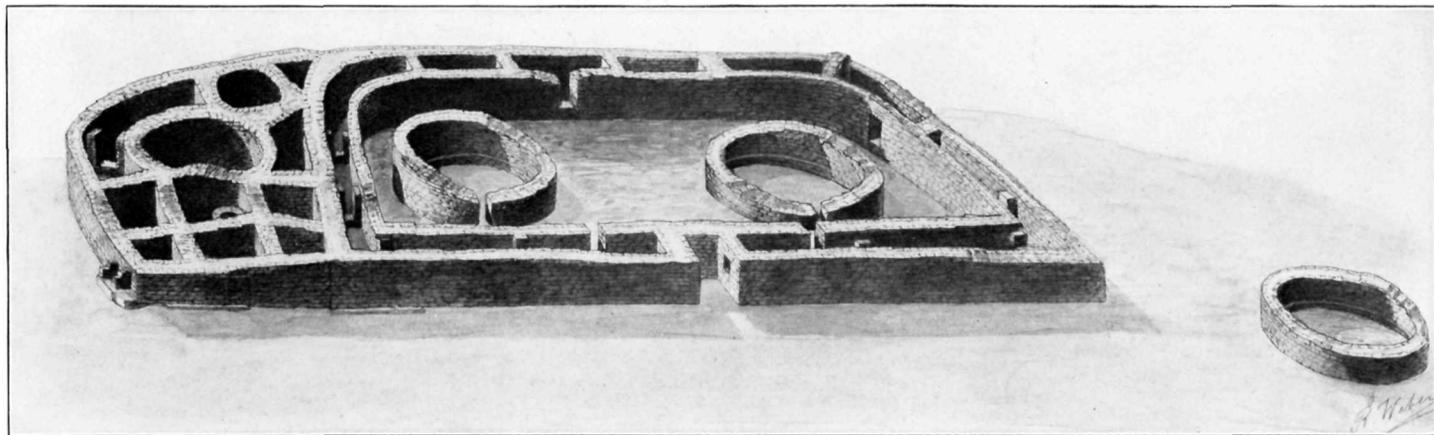
FIG. 1.—BIRDSEYE VIEW OF SUN TEMPLE, LOOKING NORTHEAST.

(Scale, $24\frac{1}{2}$ feet to 1 inch.)

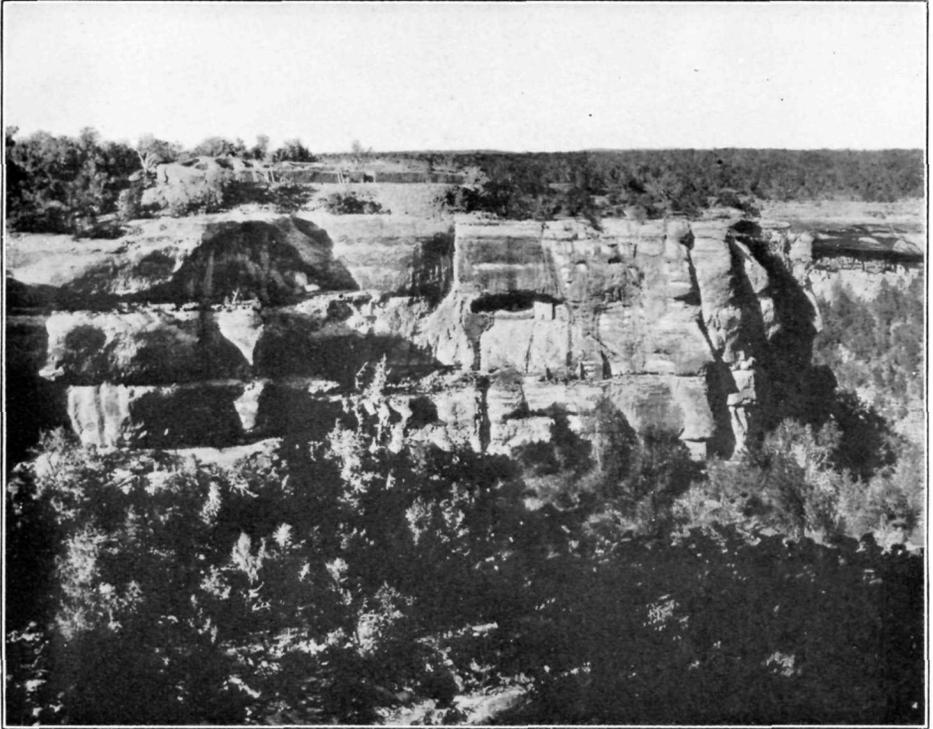
FIG. 2.—VIEW OF SUN TEMPLE AND CLIFF PALACE.

The ruin was purposely constructed in a commanding situation (fig. 2) in the neighborhood of large inhabited cliff houses. It sets somewhat back from the edge of the canyon, but near enough to

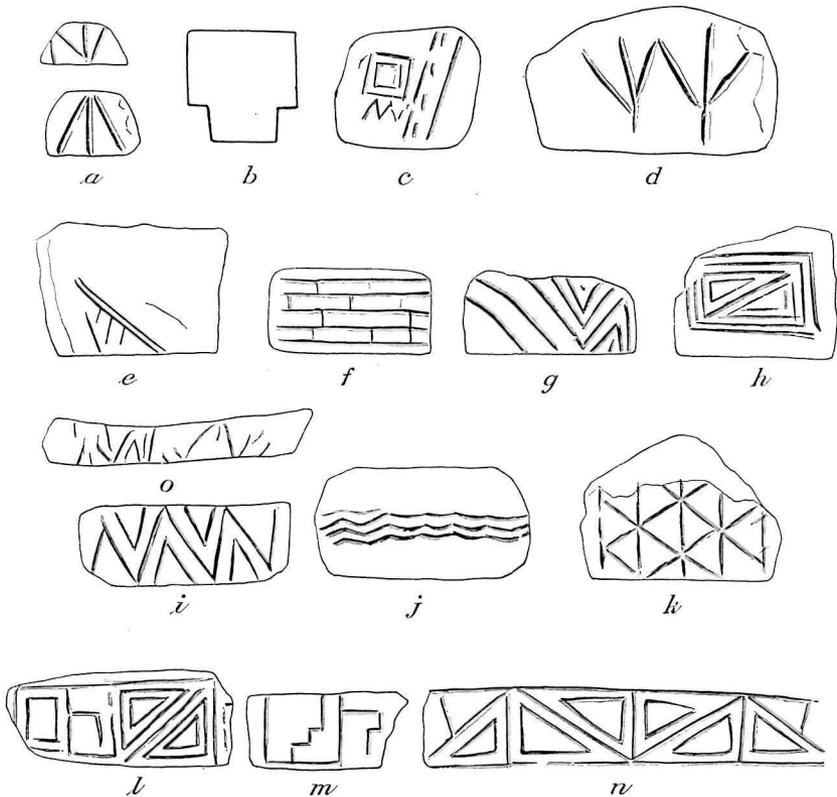
FIG. 4.—TYPICAL DESIGNS ON STONES FROM THE WALLS.

A figure (fig. 4*c*) representing a ladder leaning against a wall is incised on the left-hand side of the entrance to room *o*. On one side, near it, is an outline of a T-shaped door (fig. 4*b*), above which

is a cross, not very deeply cut in the rock. Near the top of the inner wall of room *g*, on the west side, there is an incised figure (fig. 4*h*), commonly found on pottery and on the inner wall of the southwest corner of the plaza another pattern is obscurely indicated.

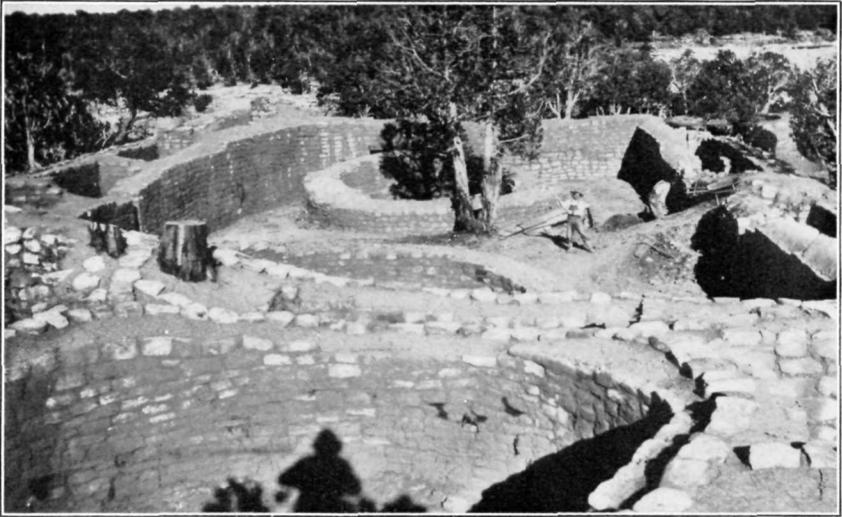
FIG. 5.—INTERIOR OF RUIN, LOOKING EAST, SHOWING CEDAR STUMP.

The surfaces of the walls of many rooms (fig. 5) have been rubbed smooth, the marks of pecking on individual stones not being as well

shown as on the facing of the outer walls. Roots of trees formerly growing on the ruin have made their way between the courses of stone and can still be seen in the walls.

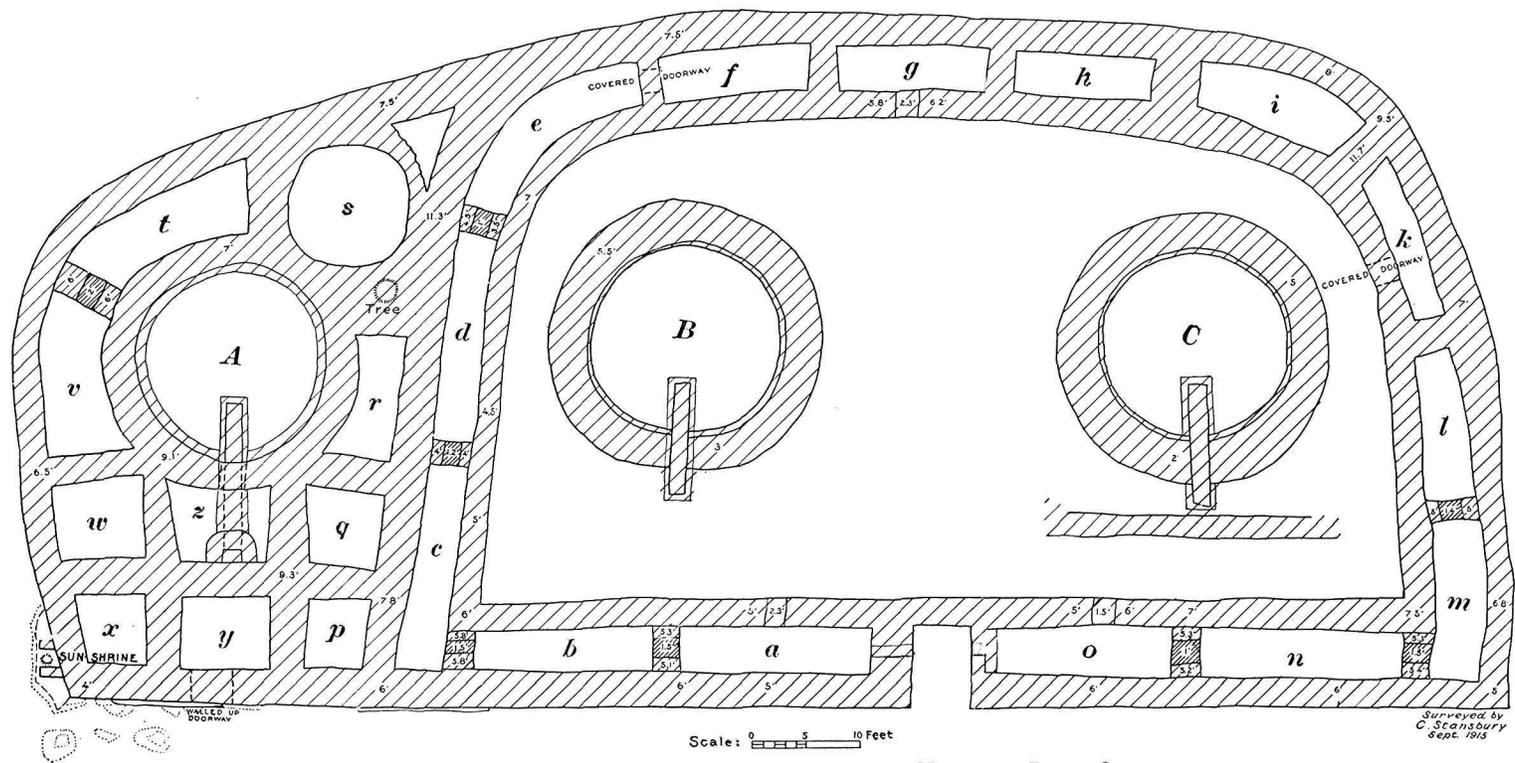
FIG. 7.—GROUND PLAN OF SUN TEMPLE, MESA VERDE NATIONAL PARK, COLORADO.

The ground plan, shown in figure 7, has been well compared to the letter D. The building is formed of two sections, the larger of which taken separately is also D-shaped and may be called the original building, while the smaller, forming the west end, is of later (?) construction and may be known as the Annex. The south wall, which is straight, is common to both original building and Annex and extends from the southeast corner of the ruin directly east-west 121.7 feet. The portion of this wall from the recess to the east corner has exactly the same length as that to the junction of the original building with the Annex. The western end of the original building, on the south

The width of the ruin at its widest portion is 64 feet. The walls average 4 feet in thickness, and are composed of a central core made of rubble and adobe, with two facings made of well-dressed rock, which, however, were not tied into the core and present a serious architectural defect.

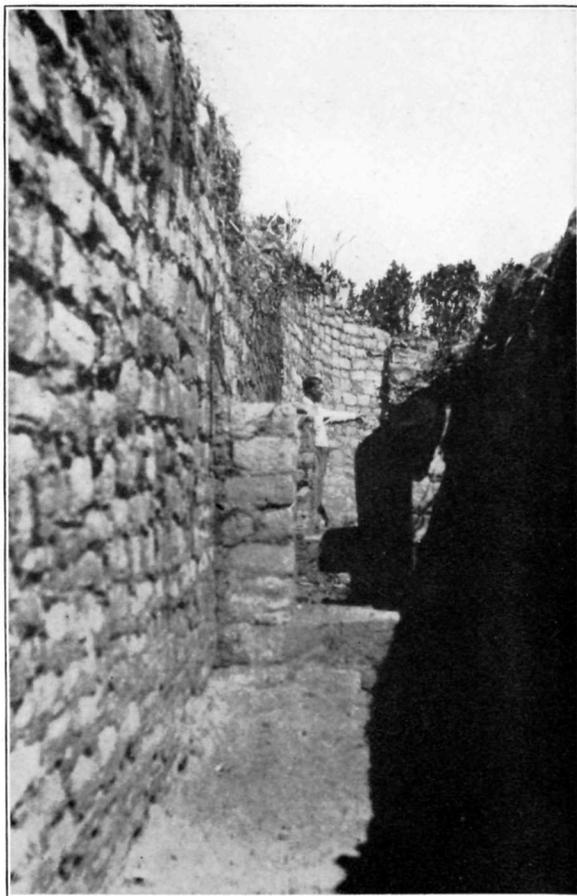
FIG. 8.—WEST WALL OF ROOMS *d* AND *e*, SHOWING DOORWAY.

t-v. The lintels which remained were much decayed and sagged under the weight of the wall above them, so much so that a brace of modern construction was introduced to support them. The lintel that held up the covered doorway of room *r* and that which supported the floor of room *z* above the trench leading into kiva A, were partially intact, but most of the lintels had to be replaced by modern beams, the originals being much decayed (fig. 8).

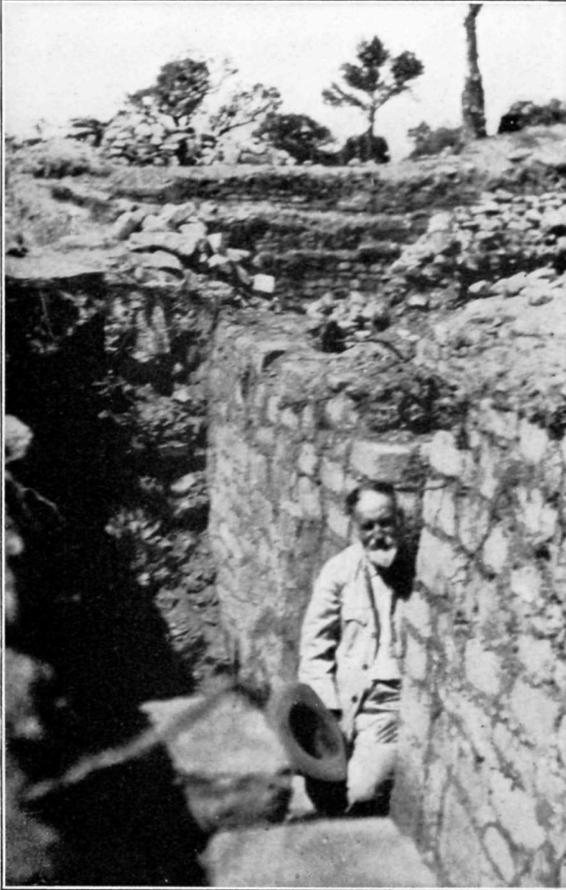
FIG. 9.—WEST END OF ROOM *o*, PARTLY EXCAVATED.

Four of the rooms surrounding the plaza were entered directly by doorways; one of these led into room *a*, others into rooms *g*, *k*, and *o*. The thresholds of the doorways are commonly constructed of large, flat, well-trimmed stones. On each side of the doorway are pilasters (fig. 9) the walls of which are upright and the corners made of good masonry (fig. 9). Evidently all the doorways once had wooden lintels

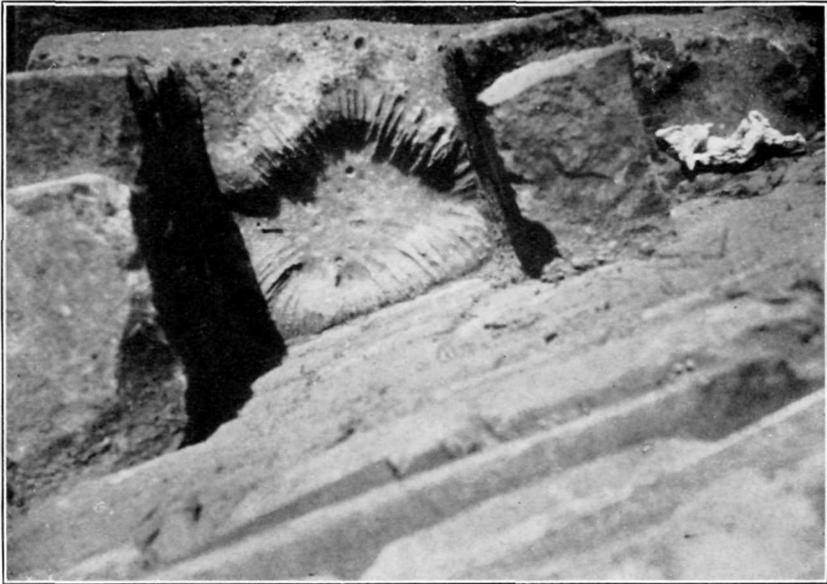
FIG. 10.—SUN SHRINE FROM ABOVE.

One of the most remarkable structures built on the outside walls of the building is near the southwest corner of the Annex. This corner stands on a solid rock that projects about $1\frac{1}{2}$ or 2 feet above the otherwise level foundation of the wall. This cornerstone or foundation of the corner wall protrudes 2 feet beyond the building, and on its upper surface is a fossil with central depressed zone with sharp radiating ridges. The figure (fig. 10) is not artificial,¹ but is possibly helped out by artificial means. A natural object with these charac-

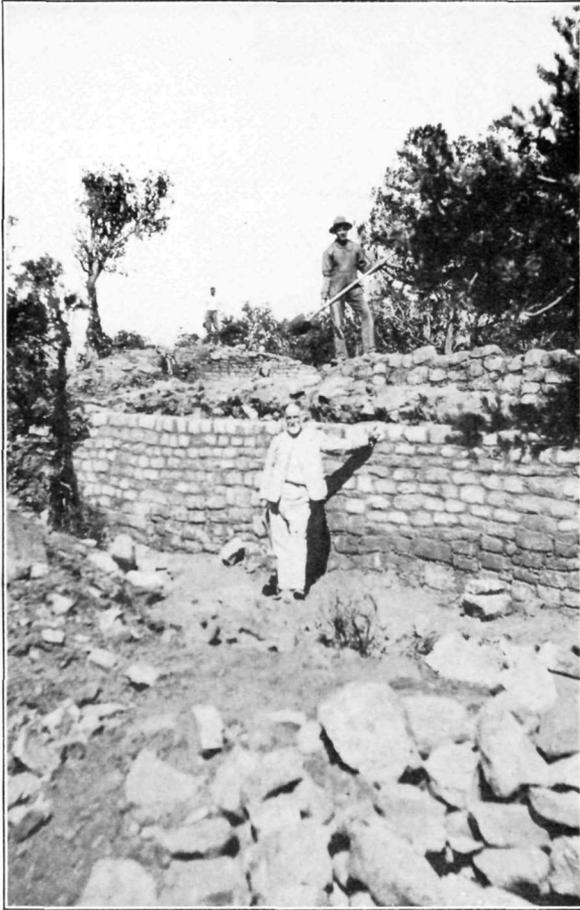
FIG. 11.—PART OF SOUTH WALL, PARTLY EXCAVATED.

The unnecessarily large quantity of adobe in the joints is a weakness, for it allowed water, whether rain or melting snow, to penetrate between the courses of stones or between the facing and the core. When the water froze the walls were broken apart. This is especially

The main causes of destruction of this ruin were not vandals, as at Cliff Palace, but the elements, especially water. After it was abandoned the tops of the walls were exposed to the sky and unprotected either from snow or rain which sometimes falls in torrents. The snow was particularly damaging, for the water from the melting snow percolated between the facings and the core of the wall, and subsequently froze, forcing the facing of the wall away from the central core until it fell. That this was the main cause of deterioration is shown by the fact that as a rule the outer facing of the surrounding wall was more nearly obliterated to a lower level than the inner, and as a rule the core projected often a foot above faces of the wall. The deleterious cause which early led to the overtopping and destruction of walls would be even more potent when they were excavated. Some means had to be devised to prevent a continuation of their destruction (fig. 11).

Although the walls of the building were so massive that they remained intact to the height of the top of the mound, they were partially held up by an accumulated débris. The removal of earth and fallen rocks weakened them so much that some provision had to be made to counteract this loss of support. In order to prevent the

water from melting snow from penetrating the walls, or the rain from percolating between the core of the wall and its facing, I placed a cap of cement on the tops of all the walls. The inner facing of the outer walls, as a rule, stood a few courses of stone higher than the outer, and it was necessary to add masonry to bring the outer wall to the level of the core and inner facing. Having leveled the top of

the wall, I covered it with small, angular fragments of stone, placing these fragments highest in the middle or over the core. Over this roof-like covering was spread a thick layer of adobe. The top of the wall was thus made in a way to shed water. Over this roof of adobe was spread a layer of Portland cement, 2 inches thick, mixed in proportion of 1 to 5, care being taken to use this cement freely in point-

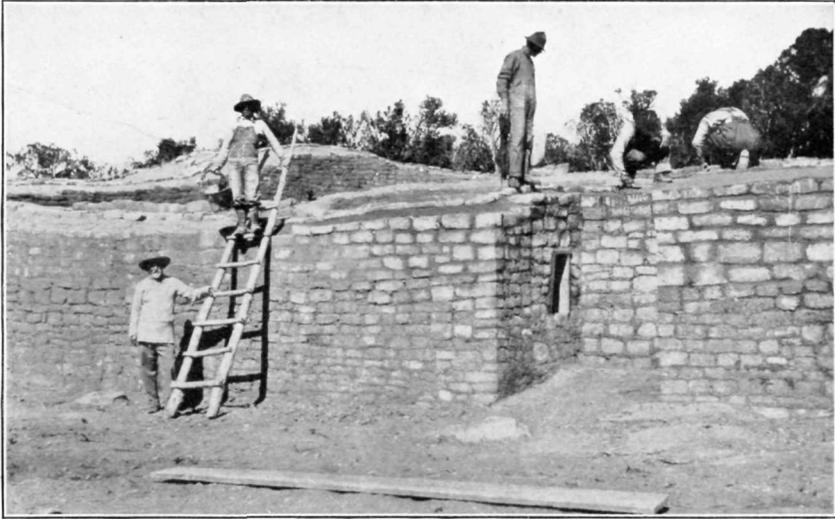
FIG. 12.—CEMENTING WALL OF RECESS IN SOUTH WALL.

ing the joints in the facing of the wall in order to prevent the entrance of water in the cracks (fig. 12). The roof shape of this covering or the fact that it is highest in the middle will shed the water and throw it away from the wall without harm. The layer of cement protects the adobe used in pointing the walls and prevents it from being washed from between the stones. Direct action of rain beating on the surface or outside of the wall could not be prevented in this way.

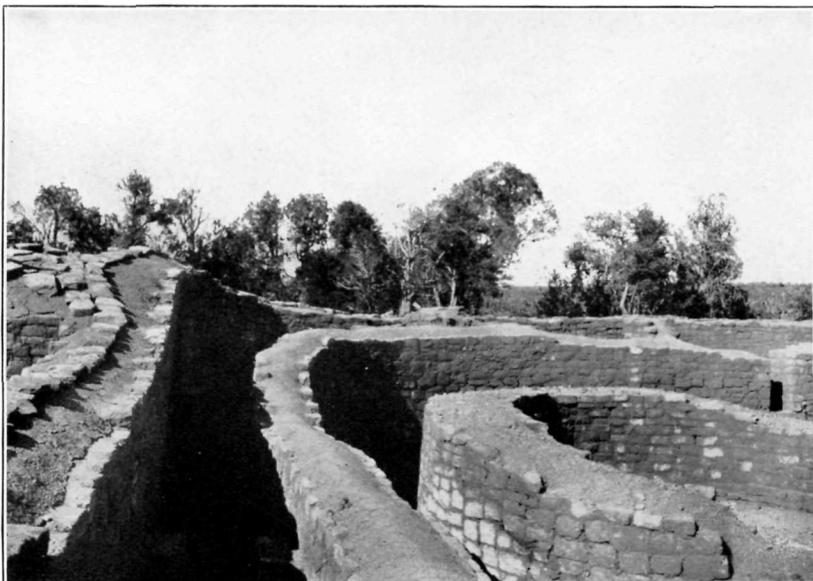
FIG. 13.—WEST ROOMS OF ORIGINAL BUILDING.

wearing away of the cement by anyone who desired to walk on top of the walls, a row of stepping stones (fig. 13) firmly set in place was provided.

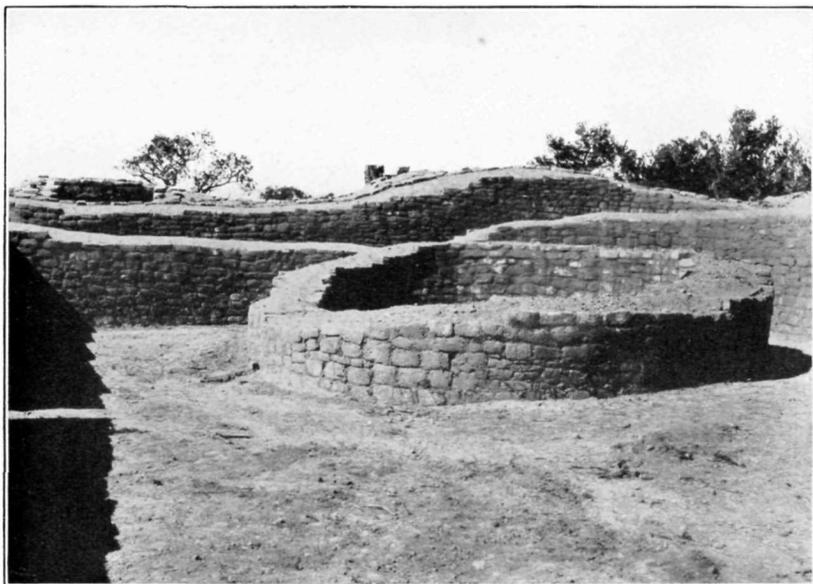
FIG. 14.—WEST END OF PLAZA, SHOWING KIVA B AND STUMP OF OLD CEDAR.

mound. No one can tell the length of this interval in years. We have, however, knowledge of the lapse of time since the mound had accumulated enough soil on its surface to support growth of large trees. In the Annex, between rooms *r* and *s*, near the summit of the highest wall, which is 11 feet 3 inches high, there grew a juniper or red cedar of great antiquity, alive and vigorous when I began work. This tree undoubtedly sprouted after the desertion of the building, and grew after a mound had developed from fallen walls. Its roots penetrated into the adjacent rooms and derived nourishment from the soil filling them. Necessarily when these roots were cut off, thereby killing the tree, I was obliged to fell it, but the stump remains, cut off about a foot above the ground (fig. 14). Three hundred and

sixty annual rings were counted on a section of this tree by Mr. Gordon Parker, supervisor of Montezuma National Forest. Its heart is decayed, but its size suggests other rings and that a few more years can be added to its age. It is not improbable that this tree began to grow on the top of the Sun Temple mound shortly after the year 1540 when Coronado first entered New Mexico, but how great an interval elapsed during which the walls fell to form the mound in which it grew, and how much earlier the foundations of the ruined walls were laid no one can tell. A conservative guess of 250 years is allowable for the interval between construction and the time the cedar began
