Gobbler's Knob Fire Lookout

13. DESCRIPTION AND BACKGROUND HISTORY INCLUDING CONSTRUCTION DATE(S), PHYSICAL DIMENSIONS, MATERIALS, MAJOR ALTERATIONS, EXTANT EQUIPMENT, AND IMPORTANT BUILDERS, ARCHITECTS, ENGINEERS, ETC.

PROPERTY NAME: Gobbler's Knob Fire Lookout

MULTIPLE NAME: Mt. Rainier National Park MPS

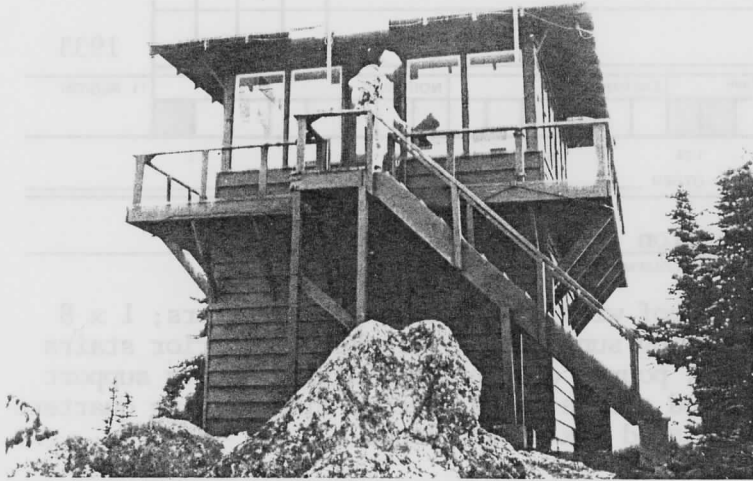
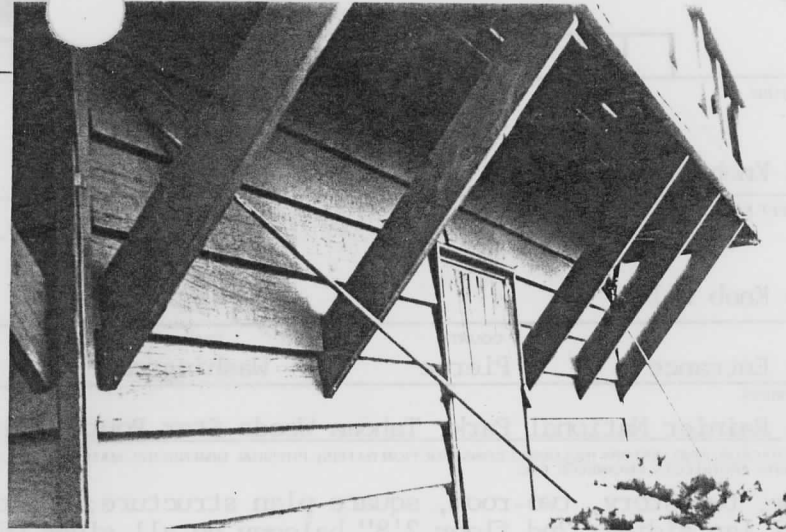
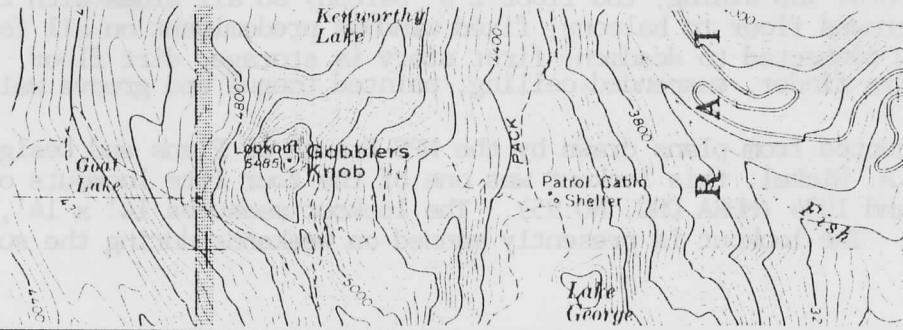
17. PHOTOS AND SKETCH MAP OF LOCATION

Wood frame, two-story, two-room, square plan structure; hip cedar shake roof with wide overhang and rafters; 1 x 8 horizontal lap siding; 2nd floor 2'8" balcony on all sides with 2 x 4 decking supported by brackets; exterior stairs from ground floor to balcony; fixed windows predominant on all four sides; poured concrete foundation; heavy support cables connected to deadmen; first story is storage, dirt floor, tongue and groove walls; second floor living quarters and fire finder, suspended ceiling, painted tongue and groove walls; varnished 1 x 2 oak floors.

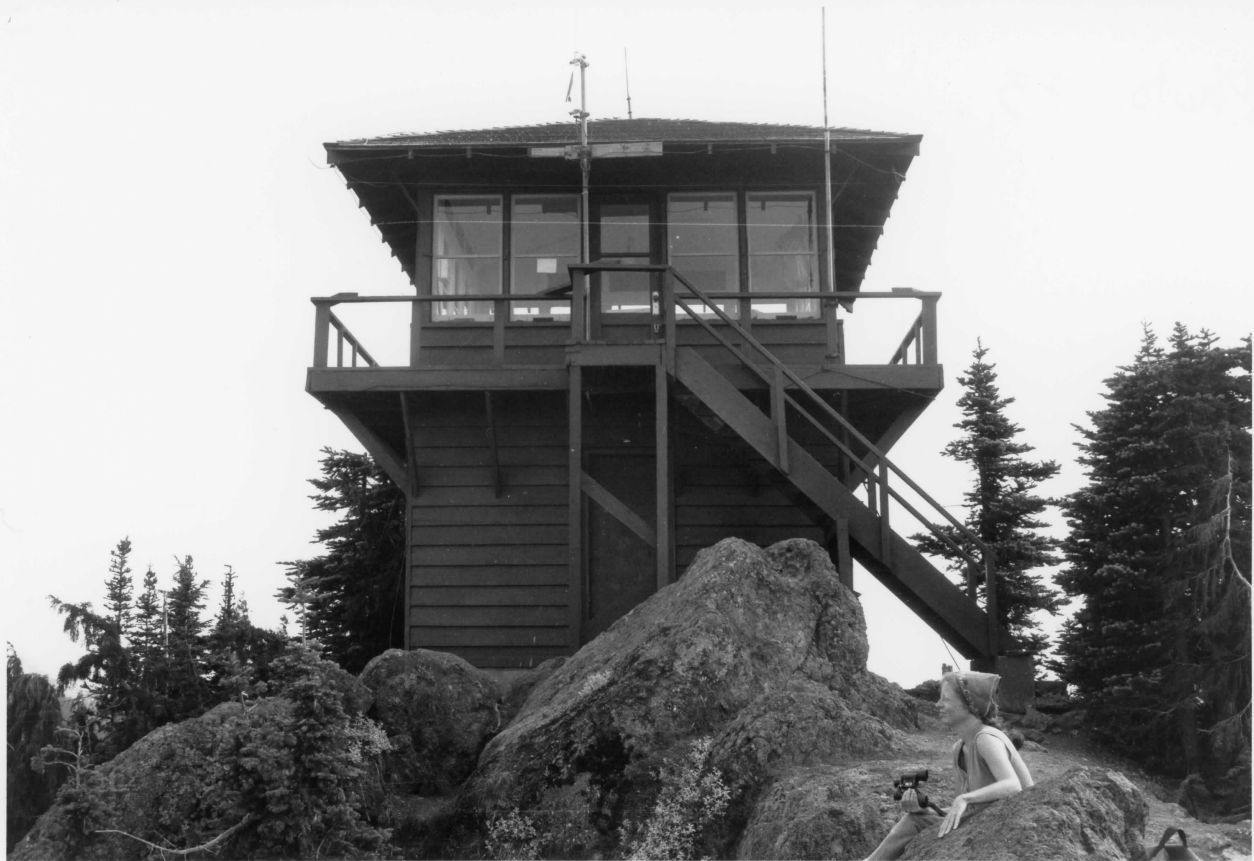
Photo 73

Gobbler's Knob Five Lookout
