Sunset Park Trail Shelter

13. DESCRIPTION AND BACKGROUND HISTORY INCLUDING CONSTRUCTION DATE(S), PHYSICAL DIMENSIONS, MATERIALS, MAJOR ALTERATIONS, EXTANT EQUIPMENT, AND IMPORTANT BUILDERS, ARCHITECTS, ENGINEERS, ETC.

National Register of Historic Places
Continuation Sheet

PROPERTY NAME: Sunset Park Trail Shelter

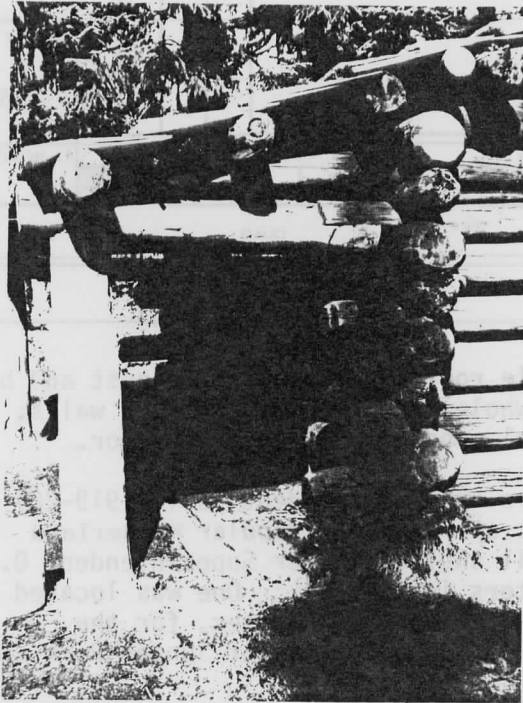
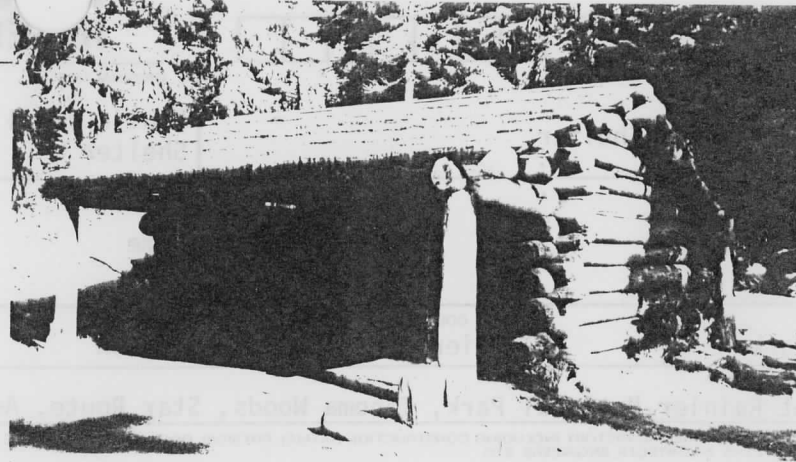
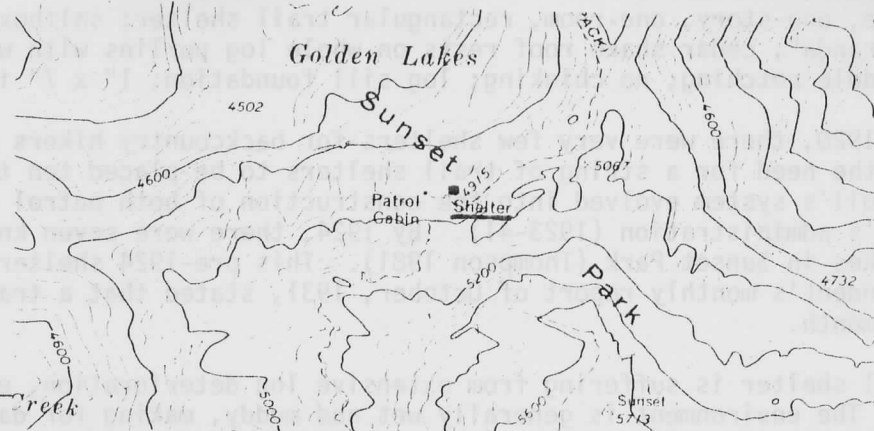
17. PHOTOS AND SKETCH MAP OF LOCATION

Wood frame, one-story, one-room, rectangular trail shelter; saltbox (lean-to) gable roof extends over log post and beam front "veranda"; cedar shake roof rests on whole log purlins with whittled ends; whole log exterior-interior walls; corner saddle notching; no chinking; log sill foundation; 1" x 7" interior vertical wood platform; earth floor.

This trail shelter is suffering from extensive log deterioration, especially on the lower base logs and at the corner notches. The environment is generally wet and muddy, making for damp conditions in and around the shelter most of the year. The deteriorating log sills have sunk below the ground level.

The structure measures 17'6" x 20'4" (16'6" without porch). The front facade opening is 6' x 6.5'. The height of the front "veranda" is 5'8". A 4'4" x 17'6" interior wood platform spans the entire width of the shelter.
