National Register of Historic Places  
Registration Form

historic name Singer's Lake Crescent Tavern

other name/site number Lake Crescent Lodge; Lake Crescent Tavern, Lake Crescent Lodge Historic District

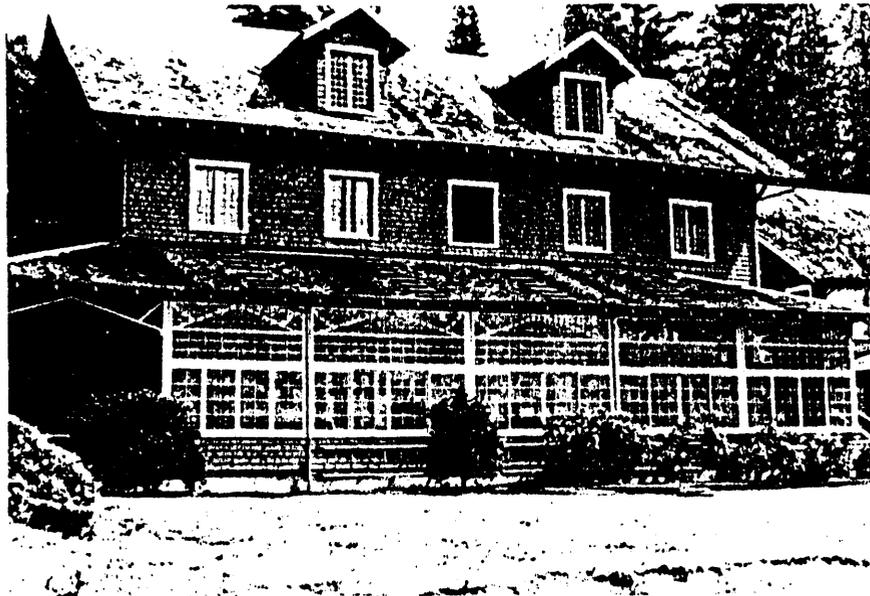
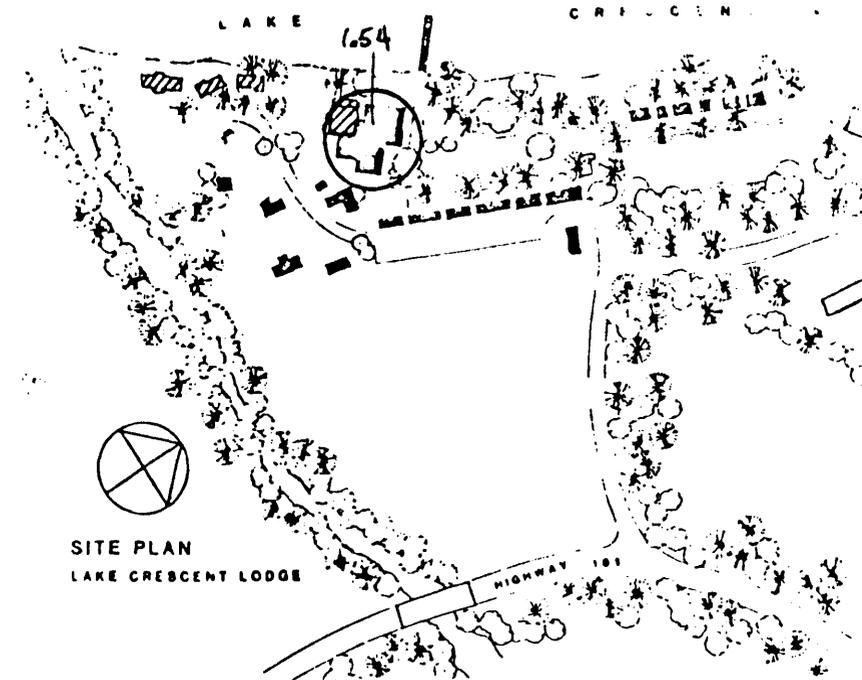
NEG. 2:1A

Irregular in shape; measures 57' x 36' with 11'6" x 56' glass-enclosed porch on north elevation; porch on east elevation measures 12' x 48'; rebuilt kitchen wing measures 40' x 33'. Other than 1 story dining room wing, the overall lodge is 2 1/2 stories; wall construction is wood-frame; siding is wood shingles (painted); multi-gabled roof with wood shingles; hip roof on wrap around porch; post and pier foundation; multi-light casement windows; multi-light main entrance door; wrap around veranda with north elevation portion enclosed with multi-light windows; 4 gable roof dormers with casement windows; large field stone chimney on N.W. elevation. Alterations: addition of a

This building contributes to the integrity of design, workmanship, setting, and sense of time and place of Singer's Tavern Group.

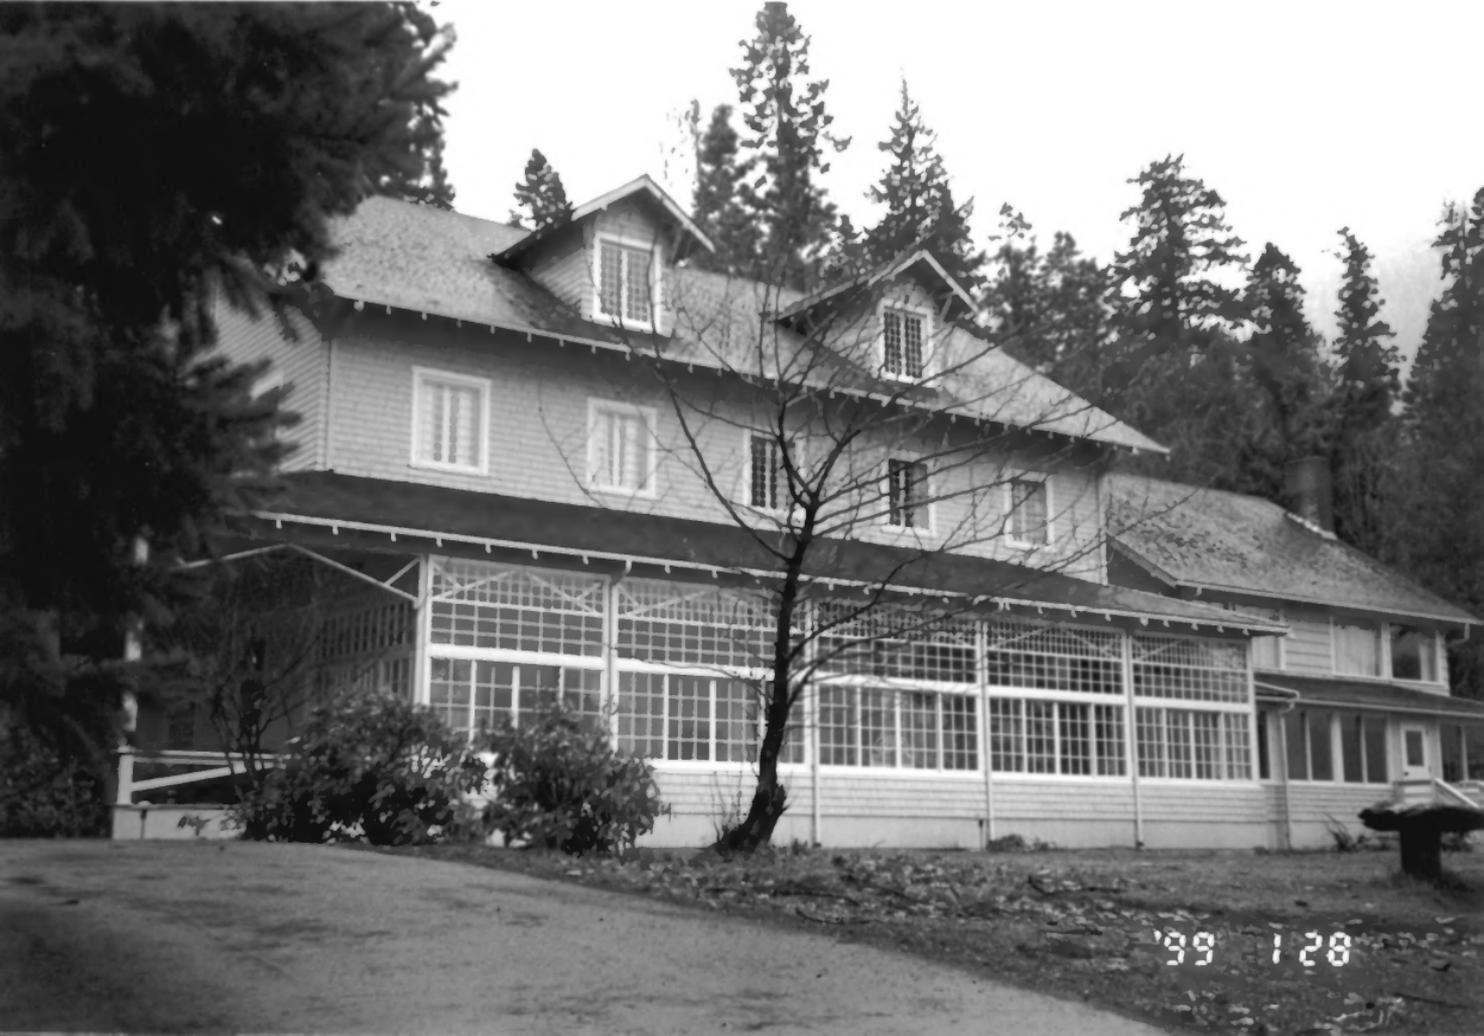
1 of 4

SINGER'S LAKE CRESCENT TAVERN HISTORIC DISTRICT  
LODGE
