NATIONAL REGISTER OF HISTORIC PLACES REGISTRATION FORM

historic name Bates Well Ranch
other names/site number Bates Well, Growler Well, Gray Ranch, El Veit

2. Location Organ Pipe Cactus National Monument

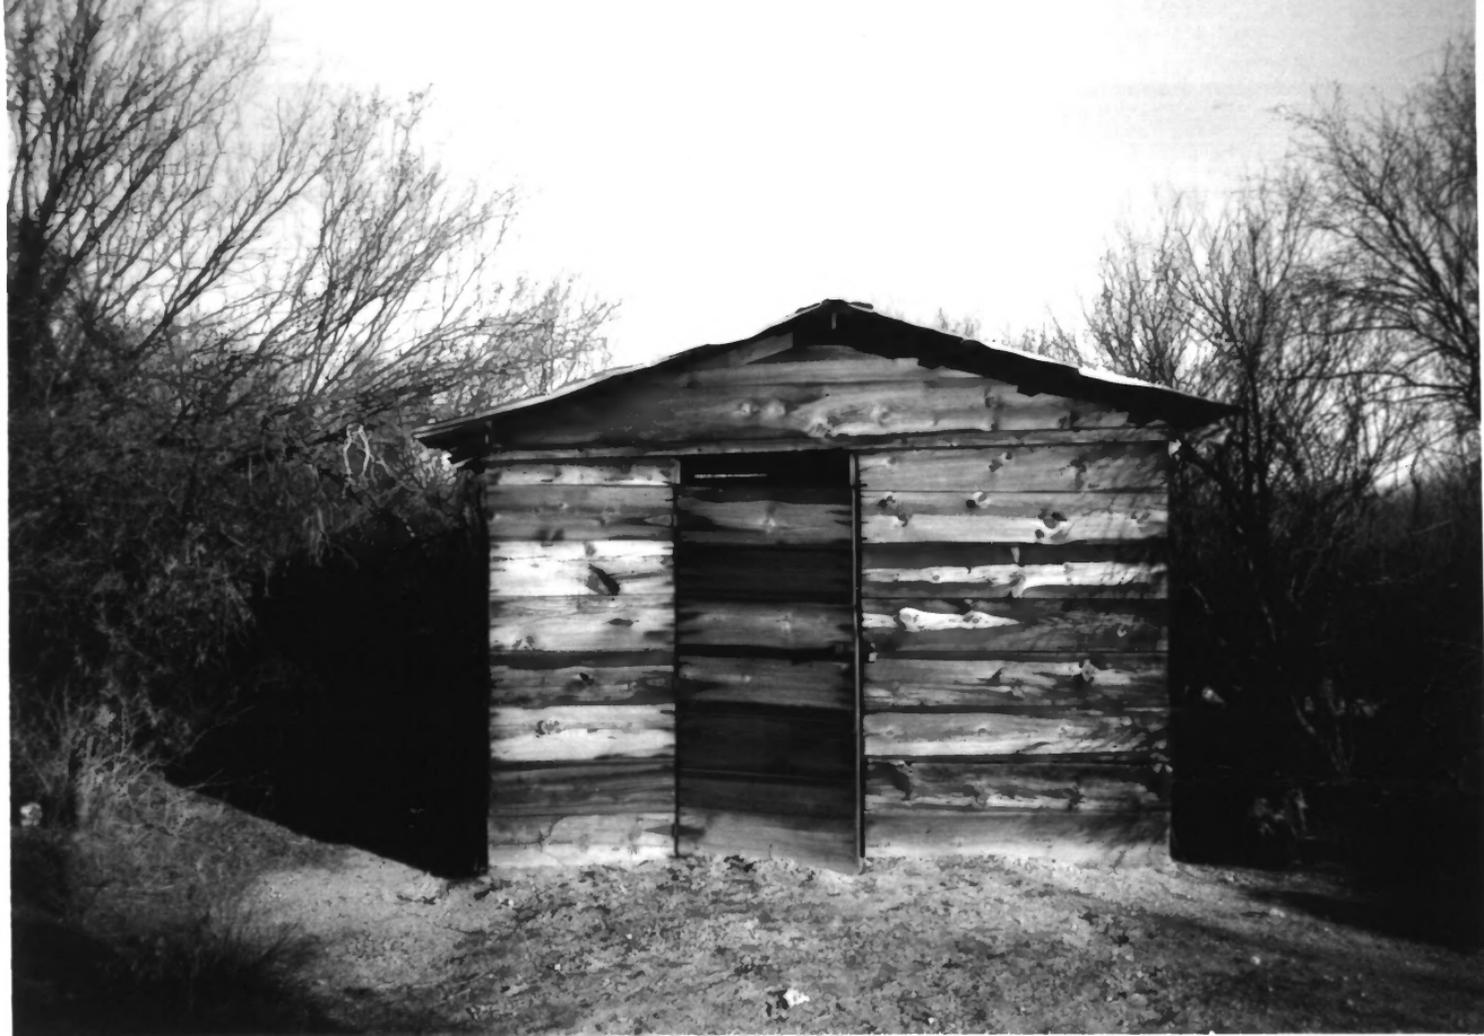
1. Tack House, Bates Well, Organ Pipe Cactus National Monument
2. Pima County, Arizona
3. Lawrence F. Van Horn
4. January 30, 1989
5. Branch of Planning, Western Team, Denver Service Center,
National Park Service
6. looking north
7. Photograph No. 8

Directly across from the bunkhouse above lies the tack house, built circa 1935 and unpainted and of frame and plank construction. It is situated on a north-south axis, and the lumber has a relatively new appearance.

Current conditions are reflected.
LJVH September 22, 1992

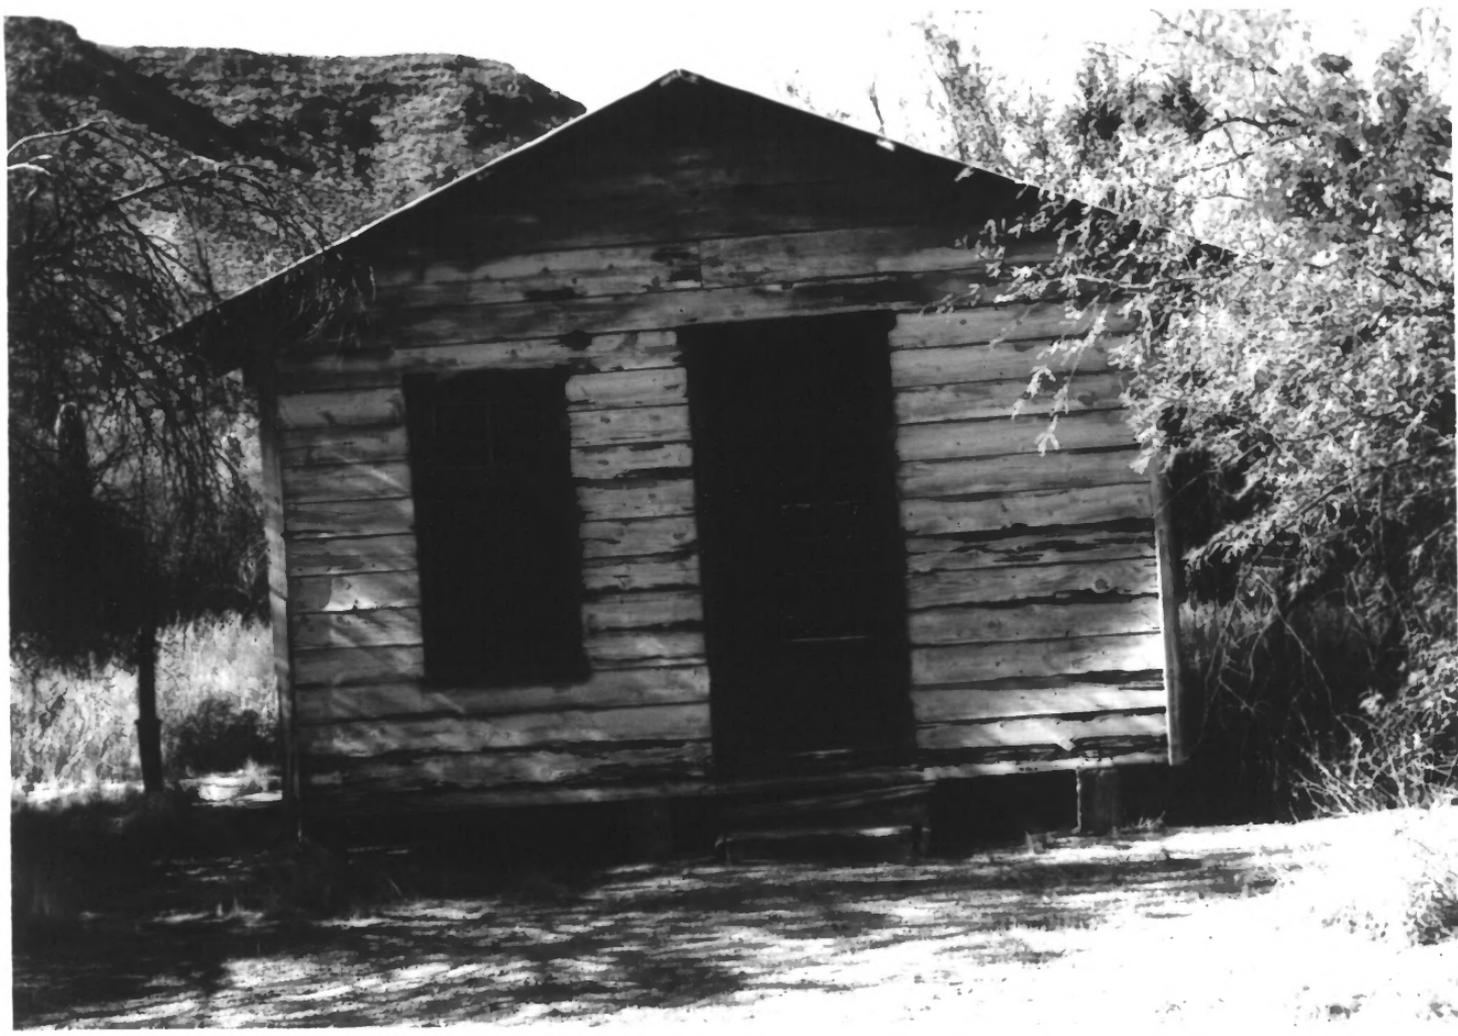
1. Bunkhouse by Arrastra/Bunkhouse No. 1, Bates Well, Organ Pipe
Cactus National Monument
2. Pima County, Arizona
3. Lawrence F. Van Horn
4. July 16, 1992
5. Branch of Planning, Western Team, Denver Service Center,
National Park Service
6. looking south
7. Photograph No. 9

Just west of the windmill and water tank near the eastern corral, Bunkhouse Number 1 (Conner 1989-1991) is of frame construction, covered with tongue and groove boards, and oriented along a north-south axis. Its paint is peeling. This building was constructed circa 1935 according to the 1967 analysis of William Brown and Wilton Hoy.

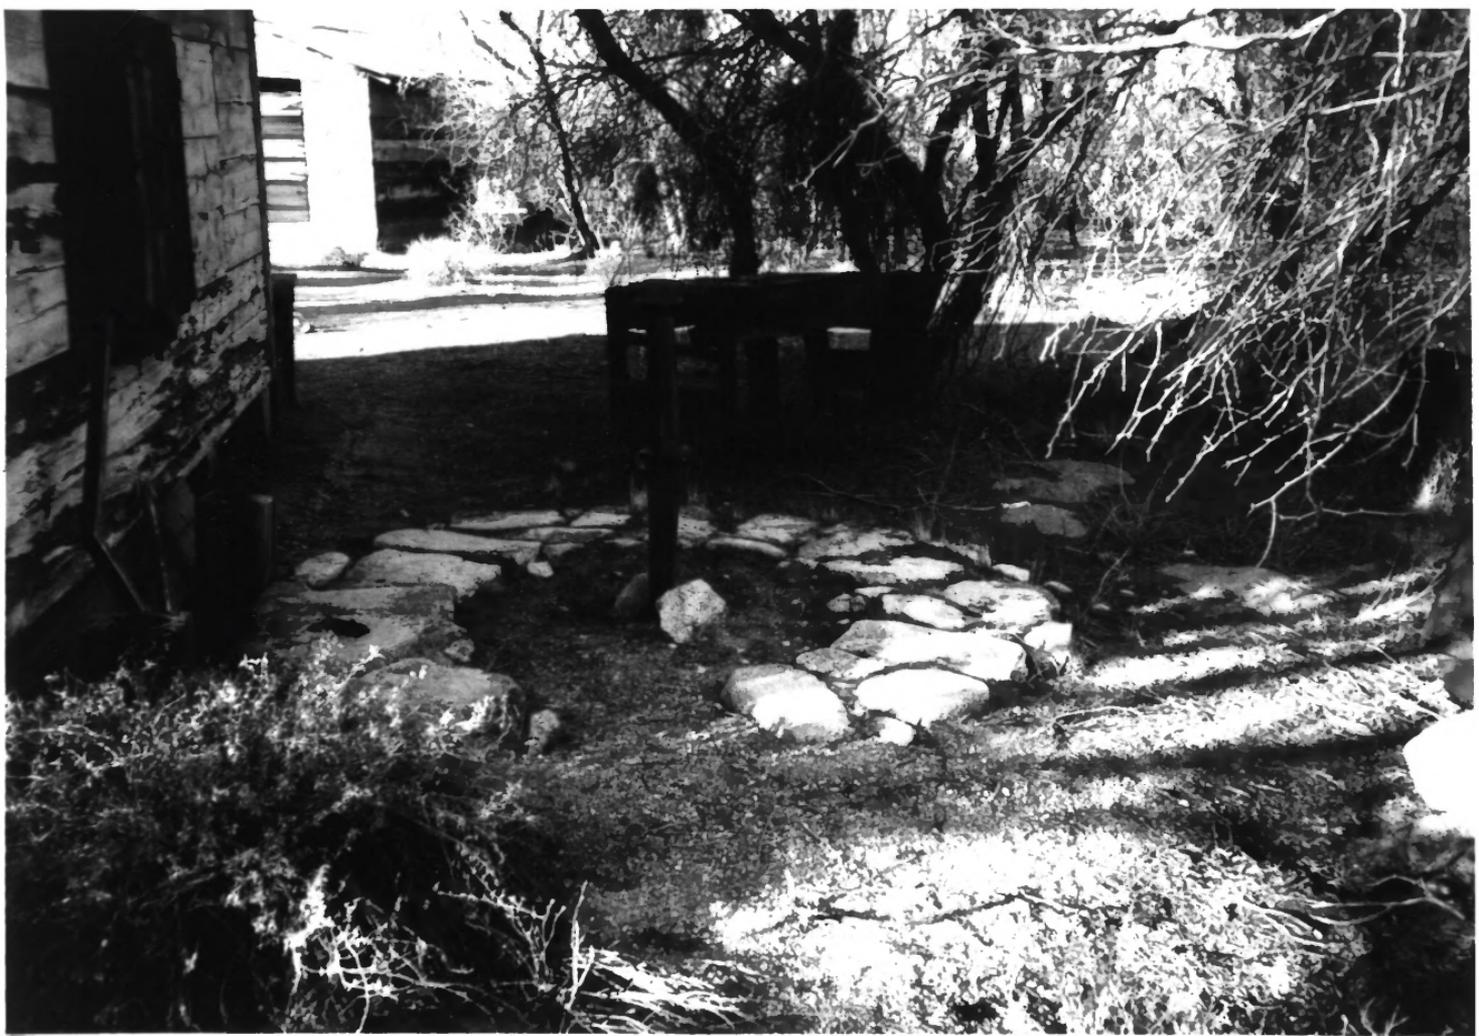
1. Arrastra, Bates Well, Organ Pipe Cactus National Monument
2. Pima County, Arizona
3. Lawrence F. Van Horn
4. January 30, 1989
5. Branch of Planning, Western Team, Denver Service Center,
National Park Service
6. looking north
7. Photograph No. 10

An arrastra, 7 feet in diameter, is located on the eastern side of the bunkhouse between it and the water tank near the eastern corral. Most but not all of the arrastra's stones are in place; a few are missing on the southern edge forming a gap in the embedded stonework. No evidence survives of any wheels or drag stones. About three feet two inches in height, a vertical metal axle, spindle, or round center post is in place. The arrastra may date to 1909 or before. The term arrastra comes from the Spanish and is defined as "a primitive grinding mill for crushing ore; powered by mule, oxen or water power" (Keane and Rogge 1992:103).

Current conditions are reflected.
LHVH September 22, 1992

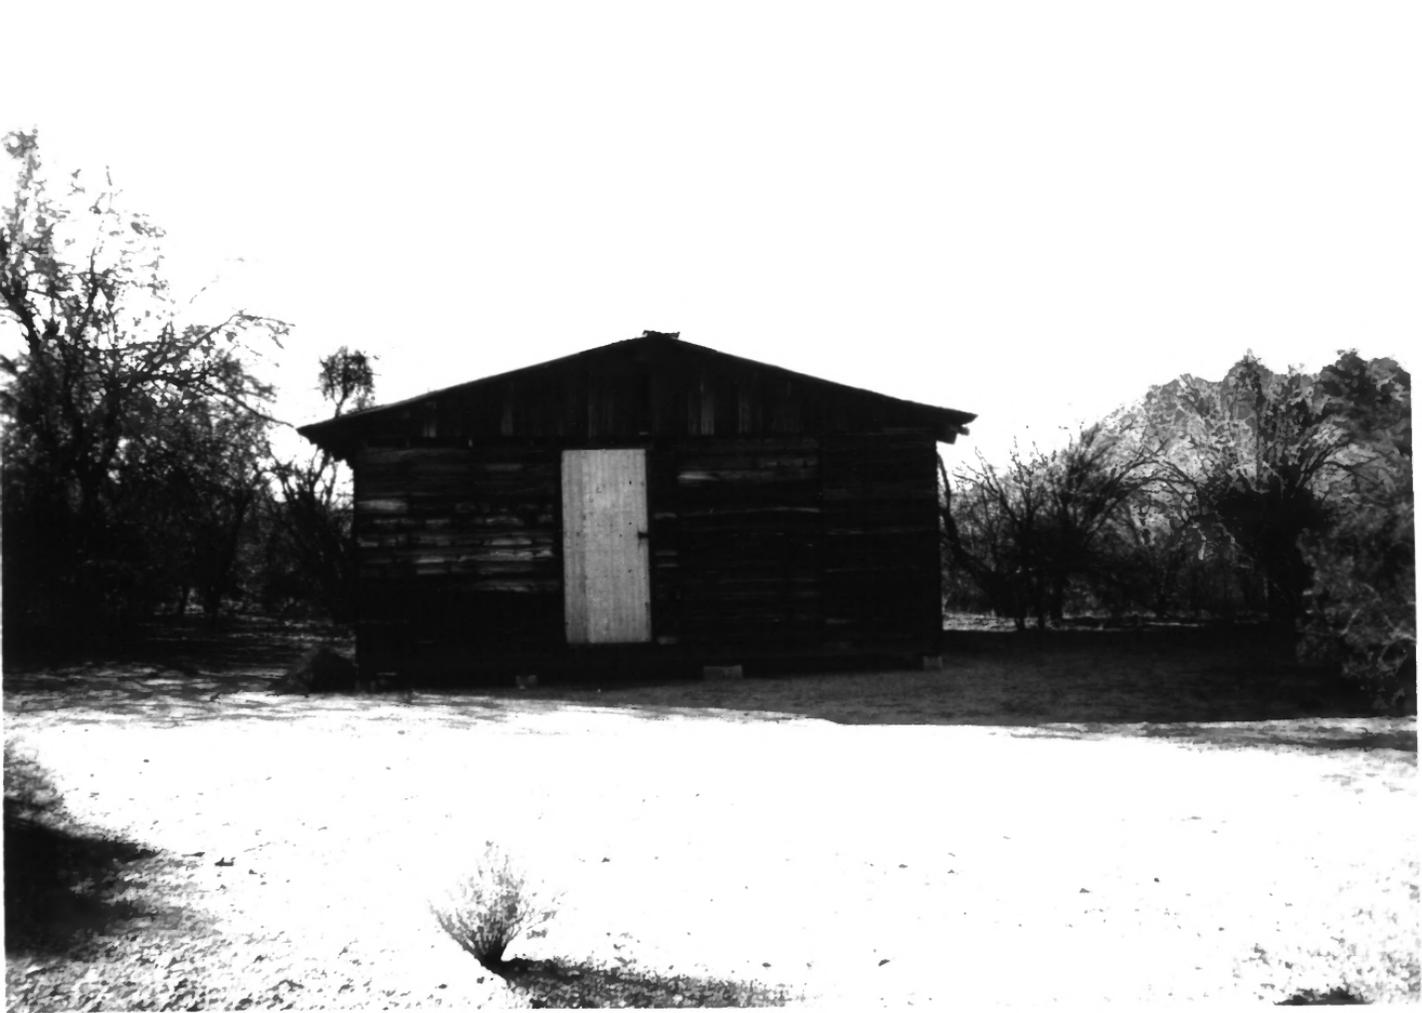
1. Hay Barn/Bunkhouse No. 2, Bates Well, Organ Pipe Cactus
National Monument
2. Pima County, Arizona
3. Lawrence F. Van Horn
4. February 3, 1989
5. Branch of Planning, Western Team, Denver Service Center
National Park Service
6. looking west
7. Photograph No. 11

The hay barn (Bunkhouse Number 2), built circa 1935, is oriented along an east-west axis and located just north of the eastern corral, which is about 600 feet due east of the main house. It is wood frame and unpainted plank construction with much lumber that appears old. Some planks are noticeably newer, indicating replacement. The roof is corrugated metal. Some staffers of the monument refer to this building as Bunkhouse Number 2 (Conner 1989-1991), although historians working in the monument have generally referred to it as a "barn-like shed" (Holland 1972:2) or "hay barn" (Greene 1977b), hence the name Hay Barn.

Current conditions are reflected, except for some loss of the
metal roof. See photo 12. LJVH September 22, 1992

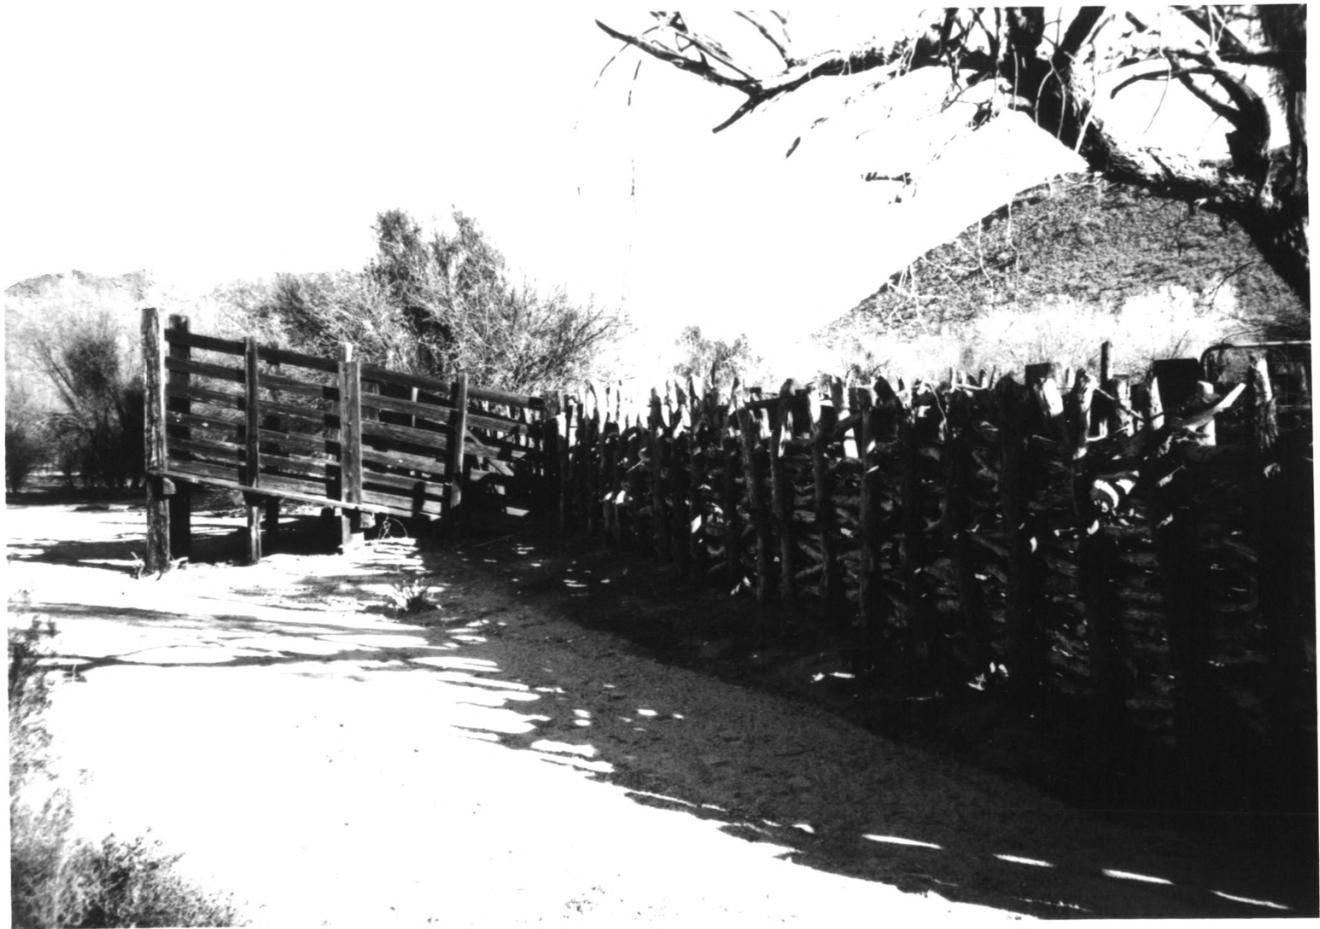
1. Eastern Corral, Bates Well, Organ Pipe Cactus National Monument
2. Pima County, Arizona
3. Lawrence F. Van Horn
4. February 3, 1989
5. Branch of Planning, Western Team, Denver Service Center,
National Park Service
6. looking east
7. Photograph No. 13.

Two corrals are extant on the property, one to the east of the main house and the other to the south. These are attributed to the circa-1935, early Henry Gray period. The eastern corral is about 600 feet from the main house. It is large, irregularly shaped and built partly of railroad ties, partly of mesquite poles and barbed wire, and partly of laid-up mesquite limbs. It has a ramp and a V-shaped loading chute. The corrals are attributed to the circa-1935, early Henry Gray period.

Current conditions are reflected.

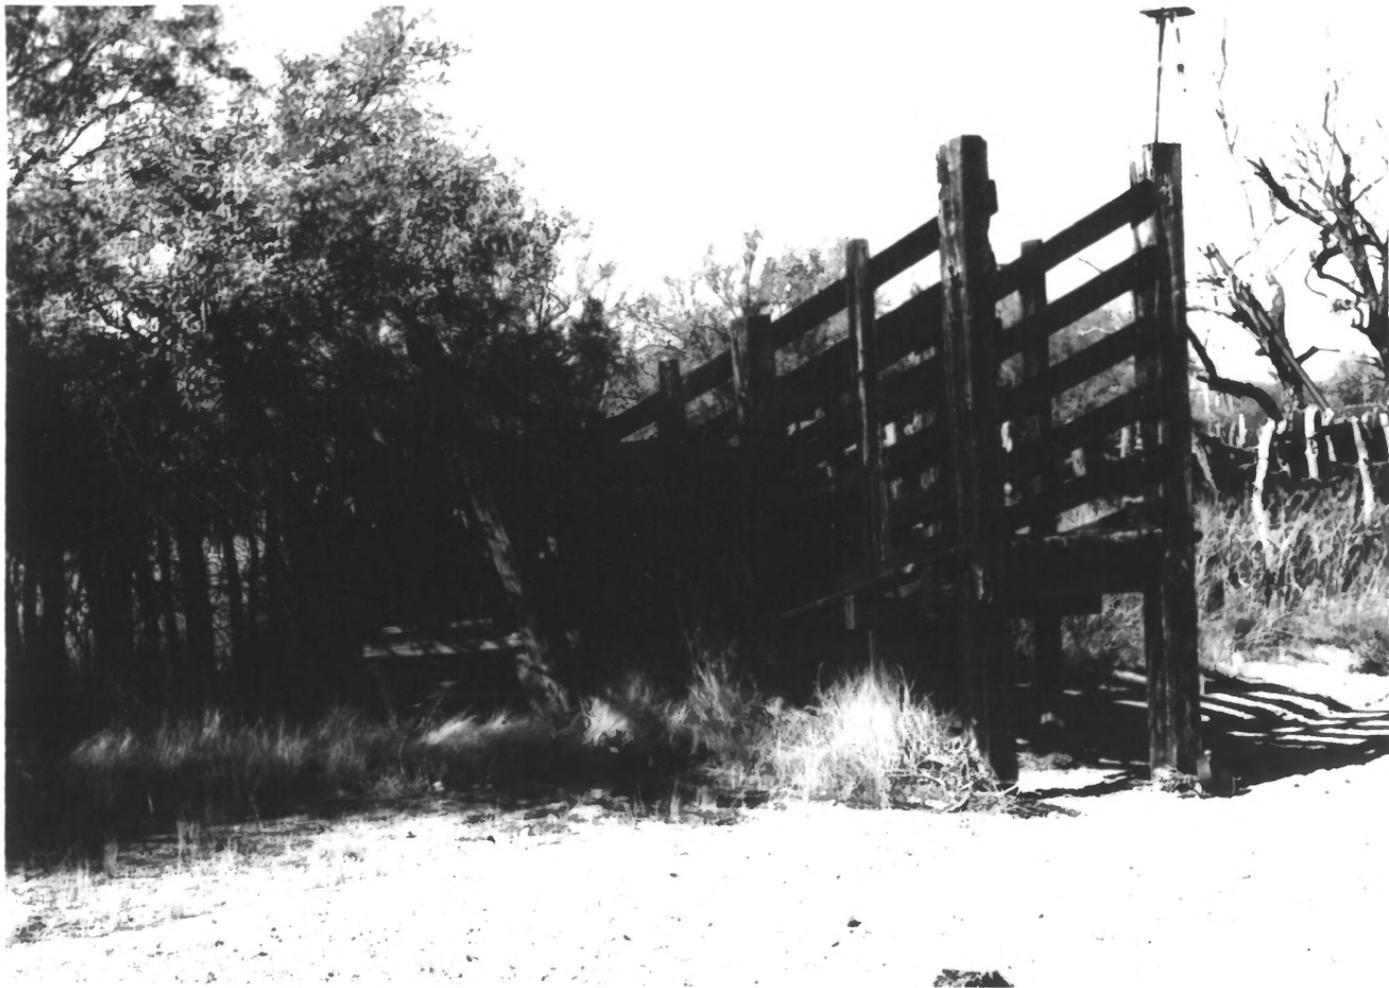
1. V-shaped Chute, Eastern Corral, Bates Well, Organ Pipe Cactus National Monument
2. Pima County, Arizona
3. Lawrence F. Van Horn
4. July 16, 1992
5. Branch of Planning, Western Team, Denver Service Center, National Park Service
6. looking southwest
7. Photograph No. 14

This V-shaped, double chute is a distinctive feature of the property.

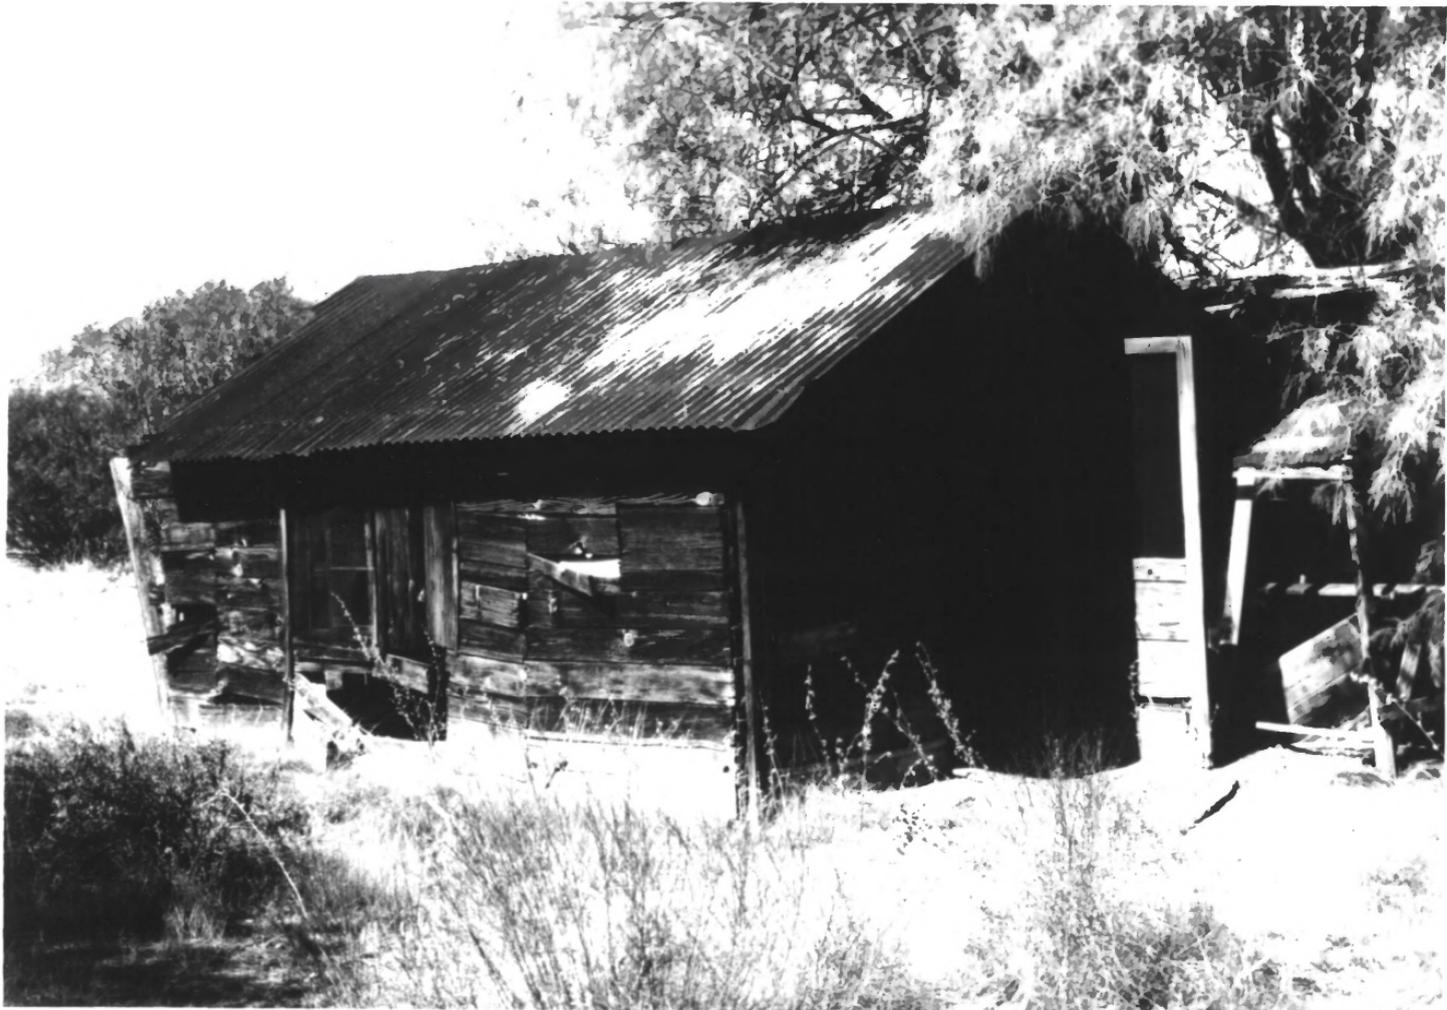
1. Small Residence/Shack No. 2, Bates Well, Organ Pipe Cactus National Monument
2. Pima County, Arizona
3. Lawrence F. Van Horn
4. July 16, 1992
5. Branch of Planning, Western Team, Denver Service Center, National Park Service
6. looking southwest
7. Photograph No. 16

The small residence is on the eastern side of the work shed known as the blacksmith shop, adjacent to it. About the house are examples of devices used in the desert to make life more pleasant such as a desert cooler and a screened box to help protect and preserve food. The condition is fair. The small residence is located about 450 feet south of the main house and was apparently built circa 1935. In 1972, this building was being "used by an Indian who works on the ranch" (Holland 1972:2).

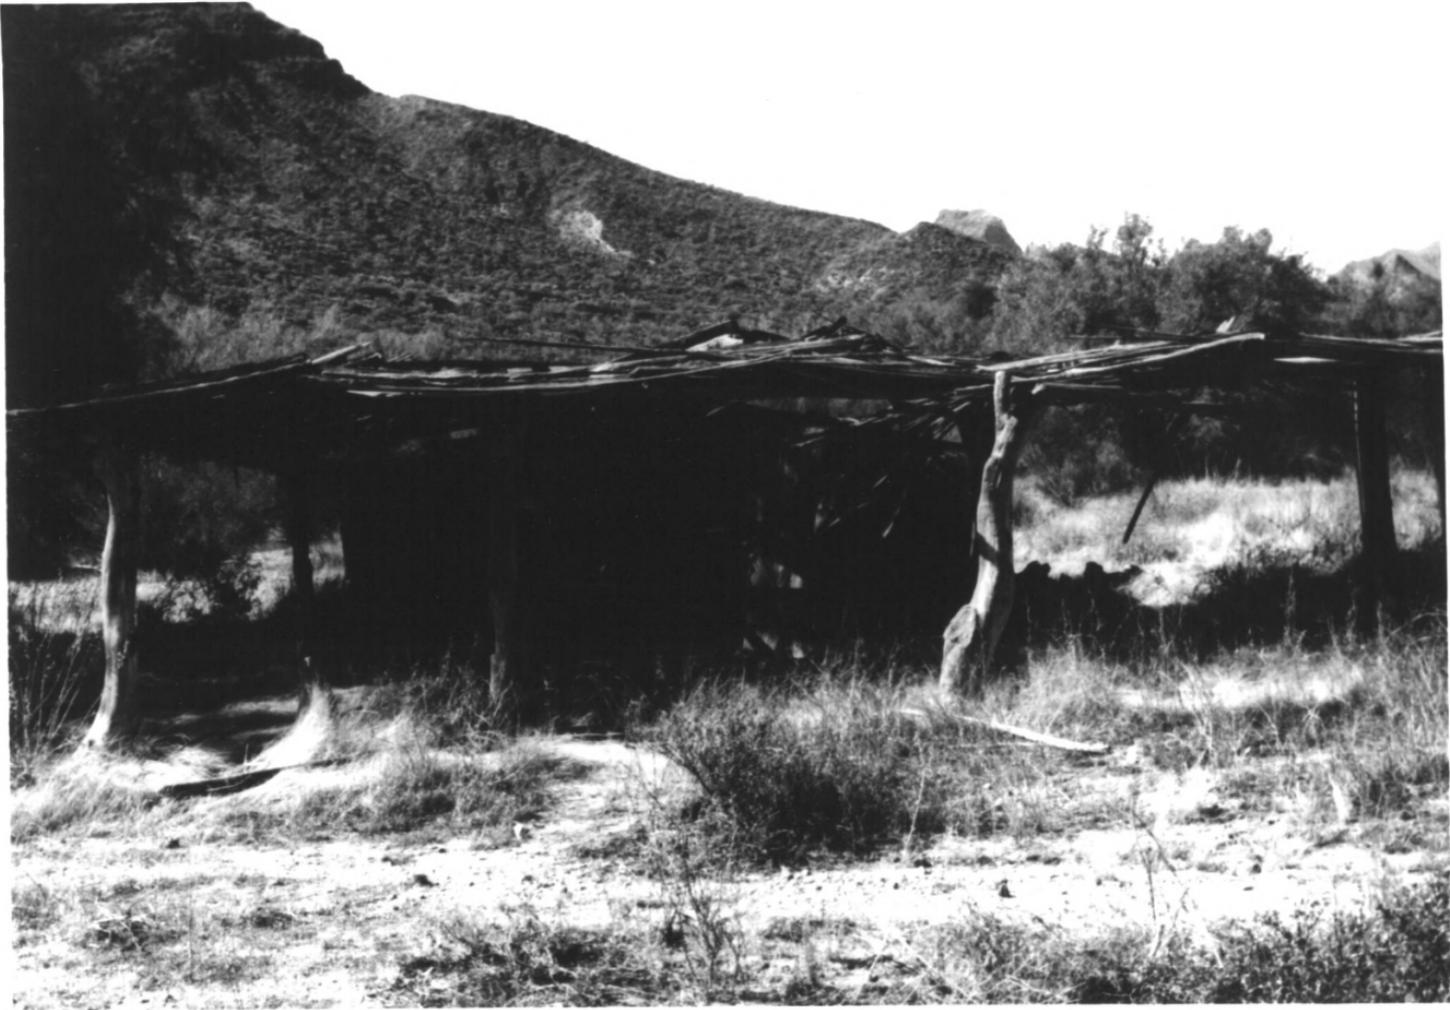
1. Blacksmith's Shop/Shack No. 1, Bates Well, Organ Pipe
Cactus National Monument
2. Pima County, Arizona
3. Lawrence F. Van Horn
4. July 16, 1992
5. Branch of Planning, Western Team, Denver Service
Center, National Park Service
6. looking south
7. Photograph No. 17

The blacksmith's shop, again apparently built circa 1935, is in poor condition and has a corrugated metal roof and a ramada. The walls are a combination of unpainted vertical wooden planks and corrugated metal.

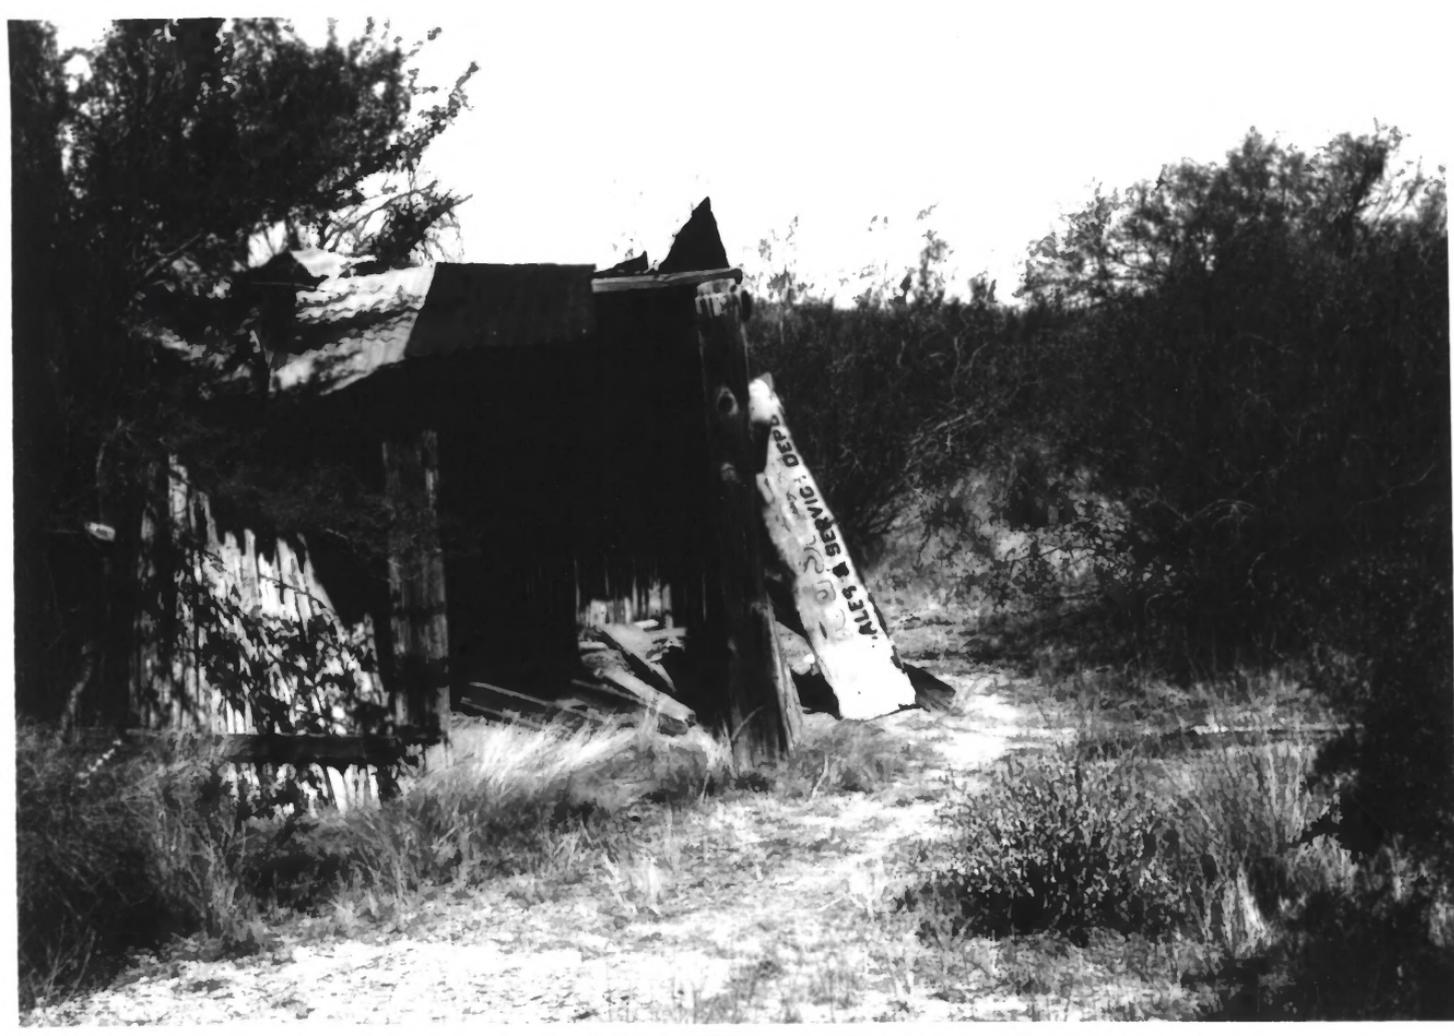
1. Ocotillo Shed/Shack No.3, Bates Well, Organ Pipe Cactus National Monument
2. Pima County, Arizona
3. Lawrence F. Van Horn
4. July 16, 1992
5. Branch of Planning, Western Team, Denver Service Center, National Park Service
6. looking west
7. Photograph No. 18

The small shed of ocotillo walls is in poor condition. It lies east of the blacksmith shop, directly across a dirt road that connects with the southern corral and the main house. The roof is corrugated metal. Like the other buildings above, the date of construction would appear to be about 1935 when Henry Gray went to Bates Well as noted below in the section on historic appearance.

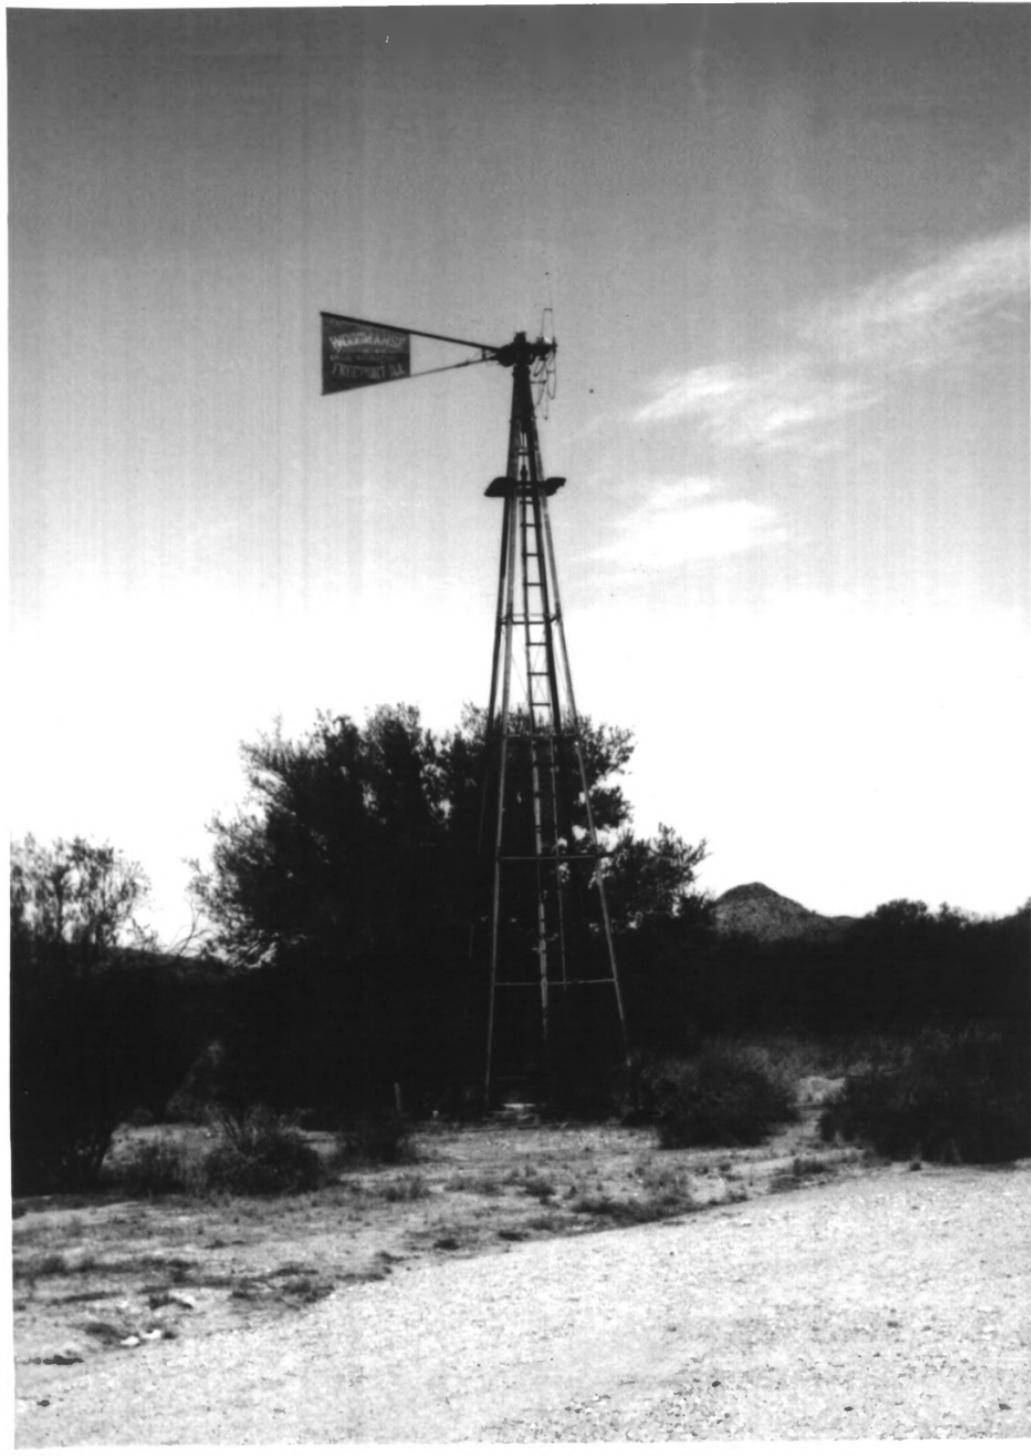
1. Henry Gray's 1953 Windmill-Well/Windmill No. 1, Bates Well,
Organ Pipe Cactus National Monument

Windmill Number 1, the structure and site of Henry Gray's 1953 windmill/well, has its steel tower intact and in place plus the wind wheel and vane. The sails of the wind wheel are missing. The vane has "WOODMANSE Air Master FREEPORT ILL" stencilled on it. See photograph number 5 for a silhouette view of the tower, vane, and wind wheel without sails.

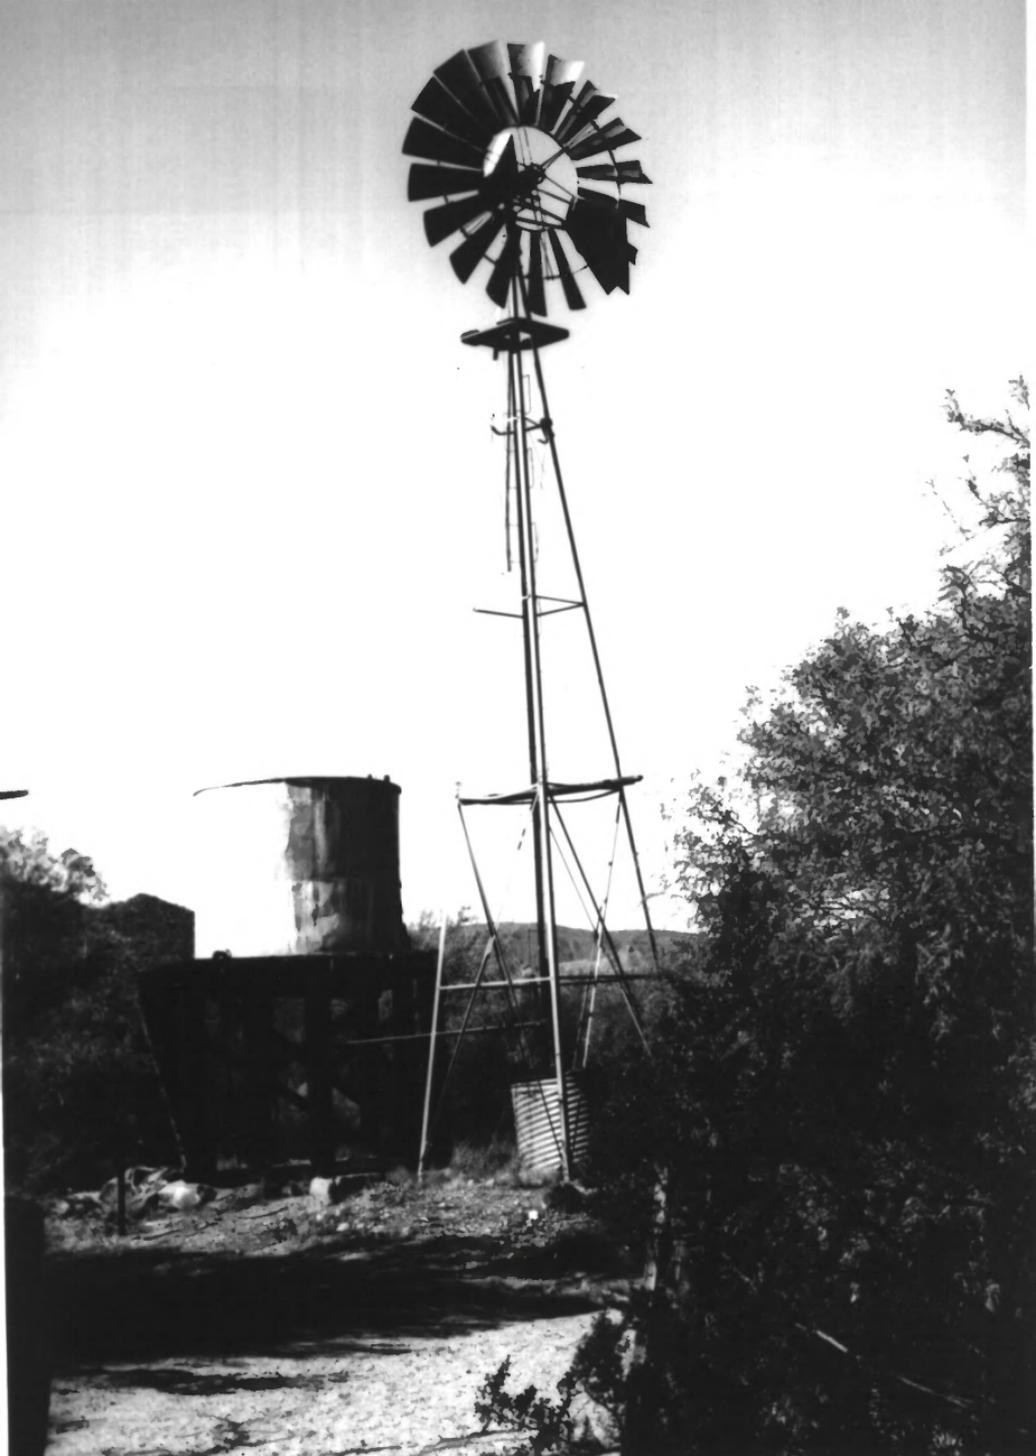
1. Early Gray Period Water Tank Windmill-Well/
Windmill No. 2, Bates Well, Organ Pipe
Cactus National Monument
2. Pima County, Arizona
3. Lawrence F. Van Horn
4. July 16, 1992
5. Branch of Planning, Western Team,
Denver Service Center, National Park Service
6. looking southwest
7. Photograph No. 6

Circa 1935, the water tank that is part of the complex of Windmill Number 2, described below, consists of a galvanized metal cylinder situated on a raised wooden platform. It is in good condition. The cylindrical tank is about 6 feet 6 inches in diameter and 6 feet in height; the platform is about 8 feet 6 inches wide and 7 feet tall for an overall height of 13 feet for the water tank structure.

Windmill Number 2 is situated just west of the eastern corral. The steel tower of the windmill is intact and in place along with the wind wheel, its sails, and the vane. A galvanized metal water tank on a raised wooden platform is immediately adjacent on the corral side of the tower. Stencilled on the vane is the name "MOMSEN-DUNNEGAN-RYAN Co. EL PASO TEXAS." See photograph number 6 for a frontal view of the wind wheel with sails, vane, tower, and water tank.

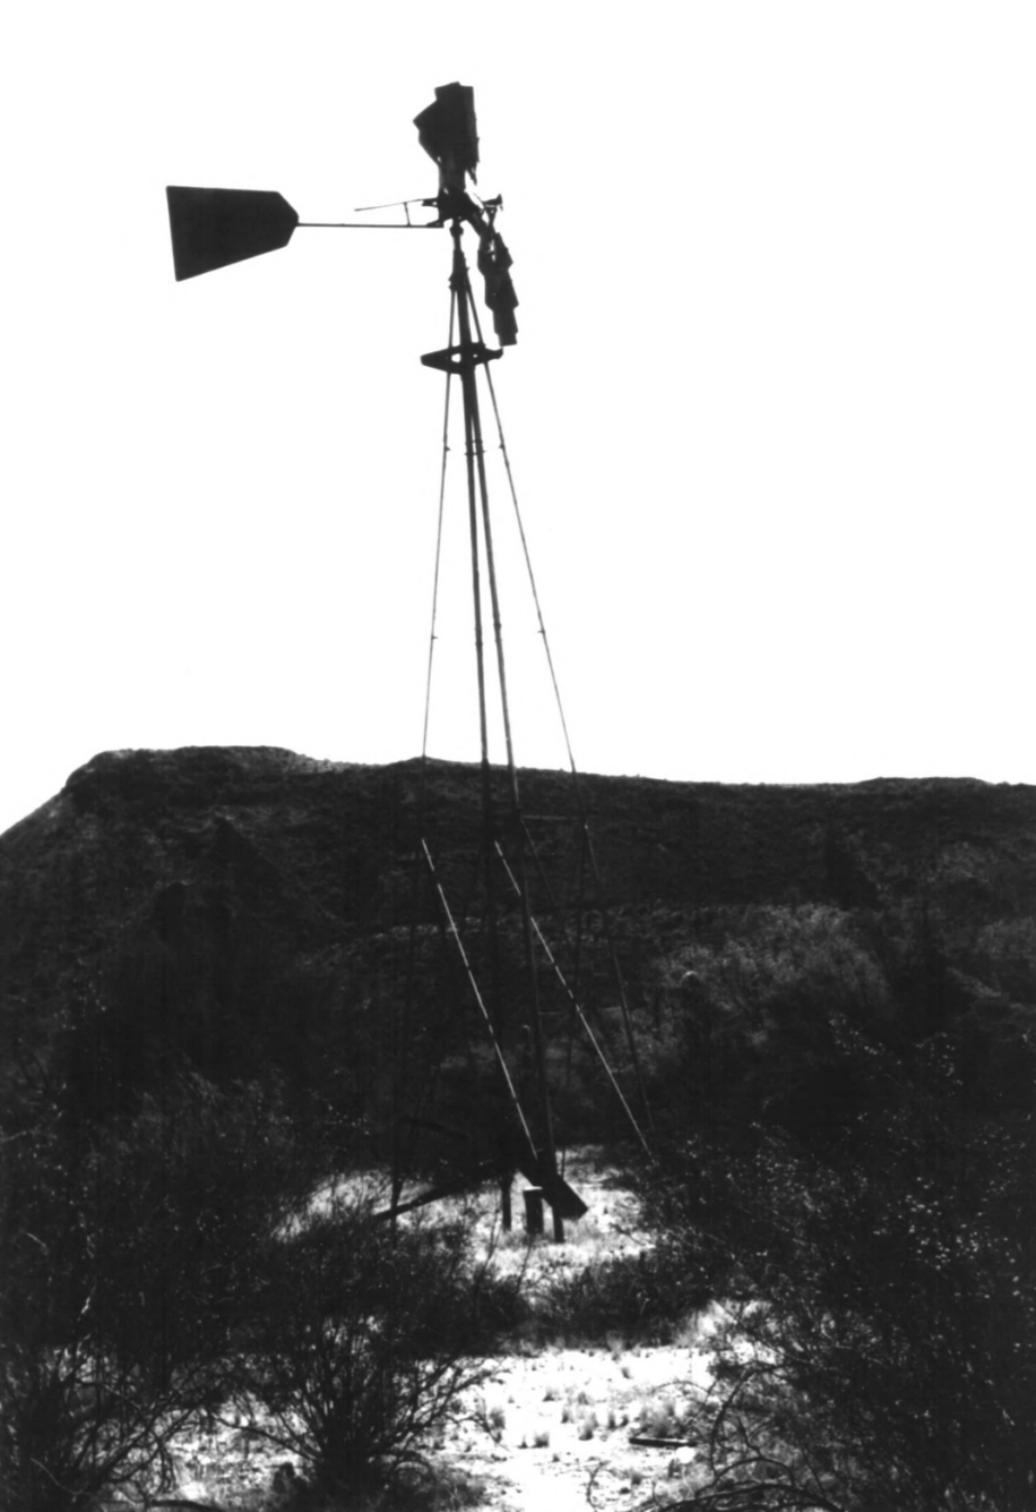
1. Early Gray Period Northernmost Windmill-Well/
Windmill No. 3, Bates Well, Organ Pipe Cactus
National Monument

Windmill Number 3 is the northernmost windmill/well at Bates Well. The well reflects the early Gray period circa 1935. The steel tower of the windmill is intact and in place as well as the wind wheel, its sails, and the vane. The vane has "AERMOTOR" stencilled on it. See photograph number 7 for a silhouette view of the wind wheel with sails, vane, and tower.
