NATIONAL REGISTER OF HISTORIC PLACES REGISTRATION FORM

historic name Bates Well Ranch
other names/site number Bates Well, Growler Well, Gray Ranch, El Veit

2. Location Organ Pipe Cactus National Monument

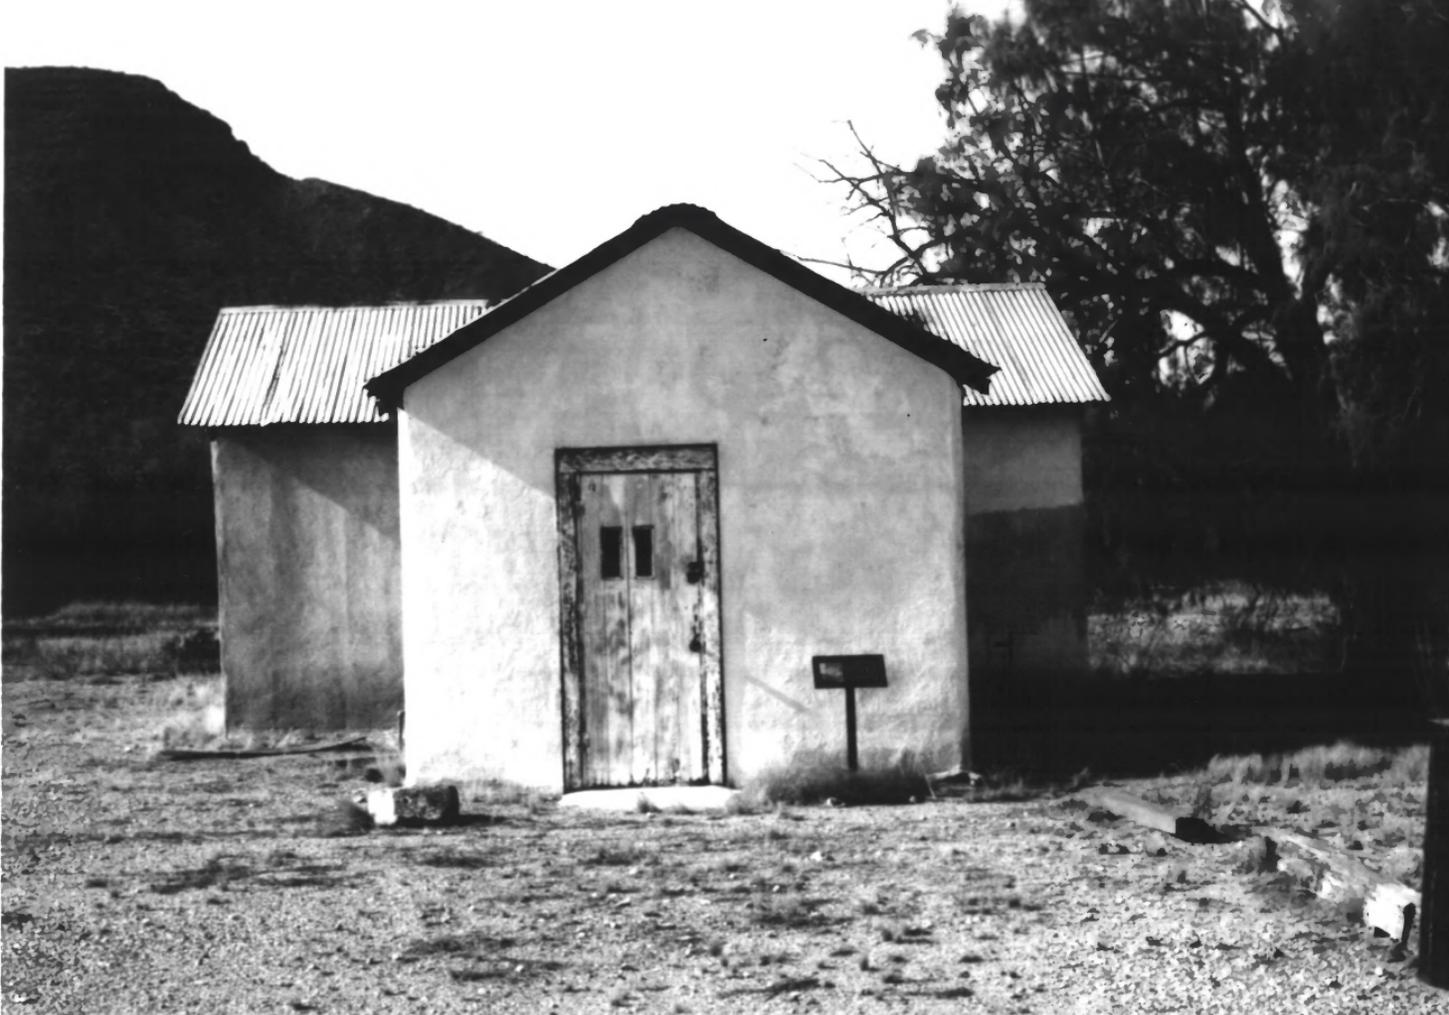
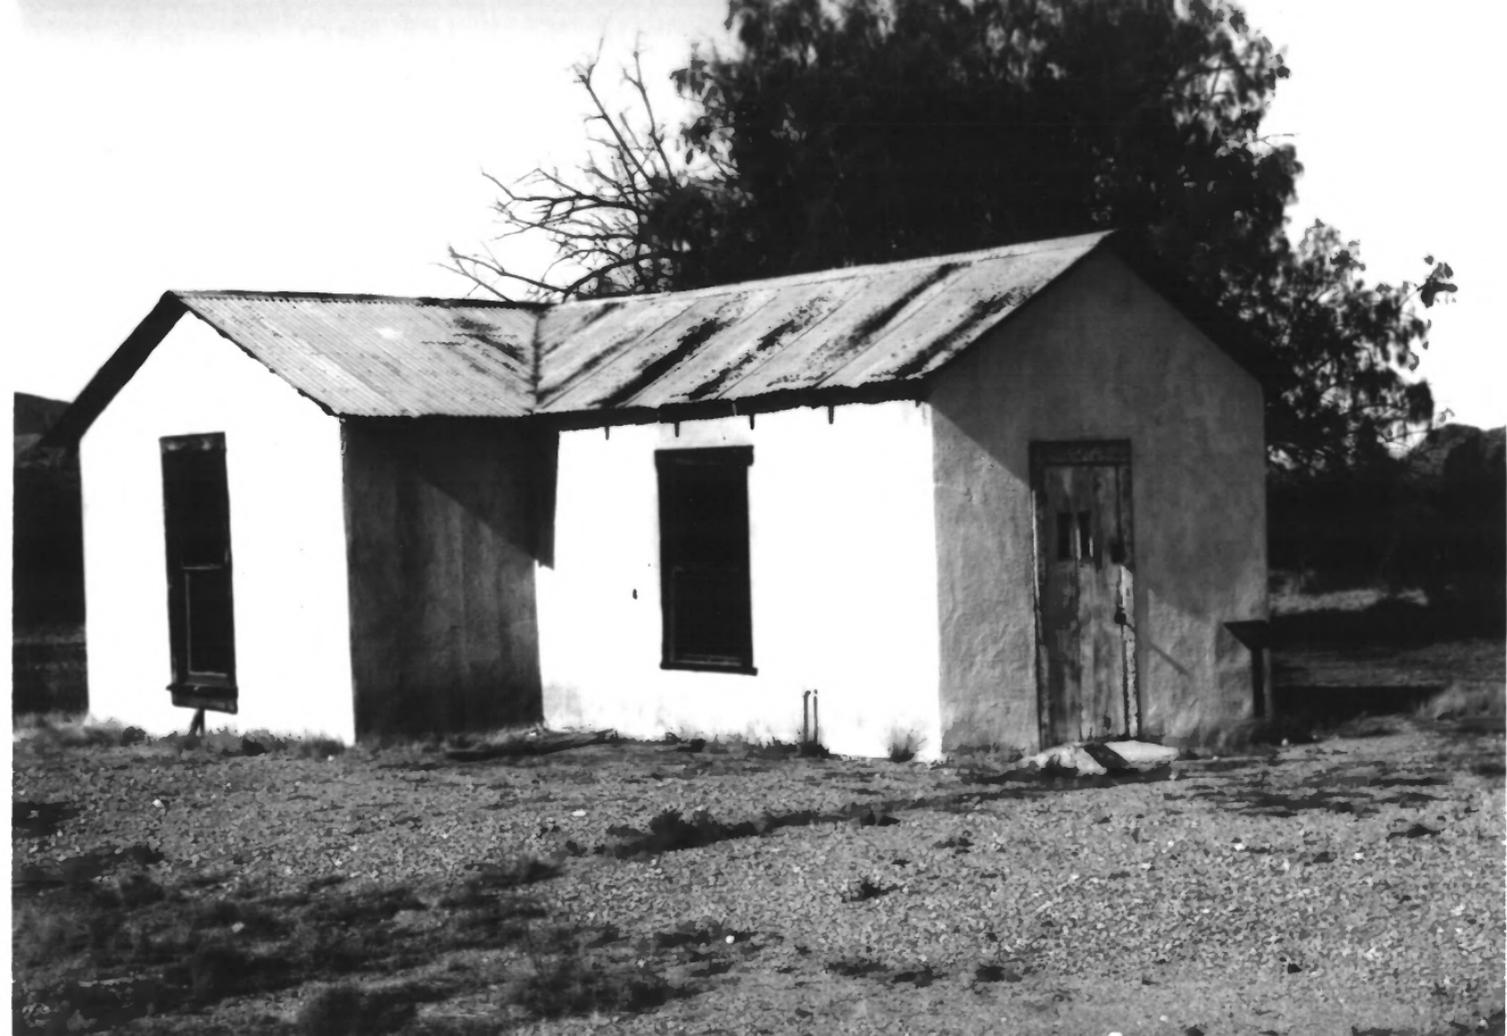
The main ranch house is a simply constructed, T-shaped, one-story frame building with intersecting gable roofs of corrugated tin and an exterior of wooden boards covered with plastered stucco. The house has two rooms -- a kitchen and a large bedroom. The bedroom has especially tall windows relative to the height of the building, which was built in 1936 according to historian F. Ross Holland's interview with Henry Gray, April 19, 1972, at Bates Well. Originally used at Growler Mine to the west,

The main house of the ranch may have been a miner's cabin originally (southern exposure) with a later add-on (northern exposure) (Garrison 1992). The building has been stabilized and is maintained that way as a discovery site for visitors. That is, visitors who want to learn about cattle ranching in what is now Organ Pipe Cactus National Monument may reach the somewhat remote property by four-wheel-drive vehicle and explore it on their own. The other buildings and structures at Bates Well range from good to poor condition.

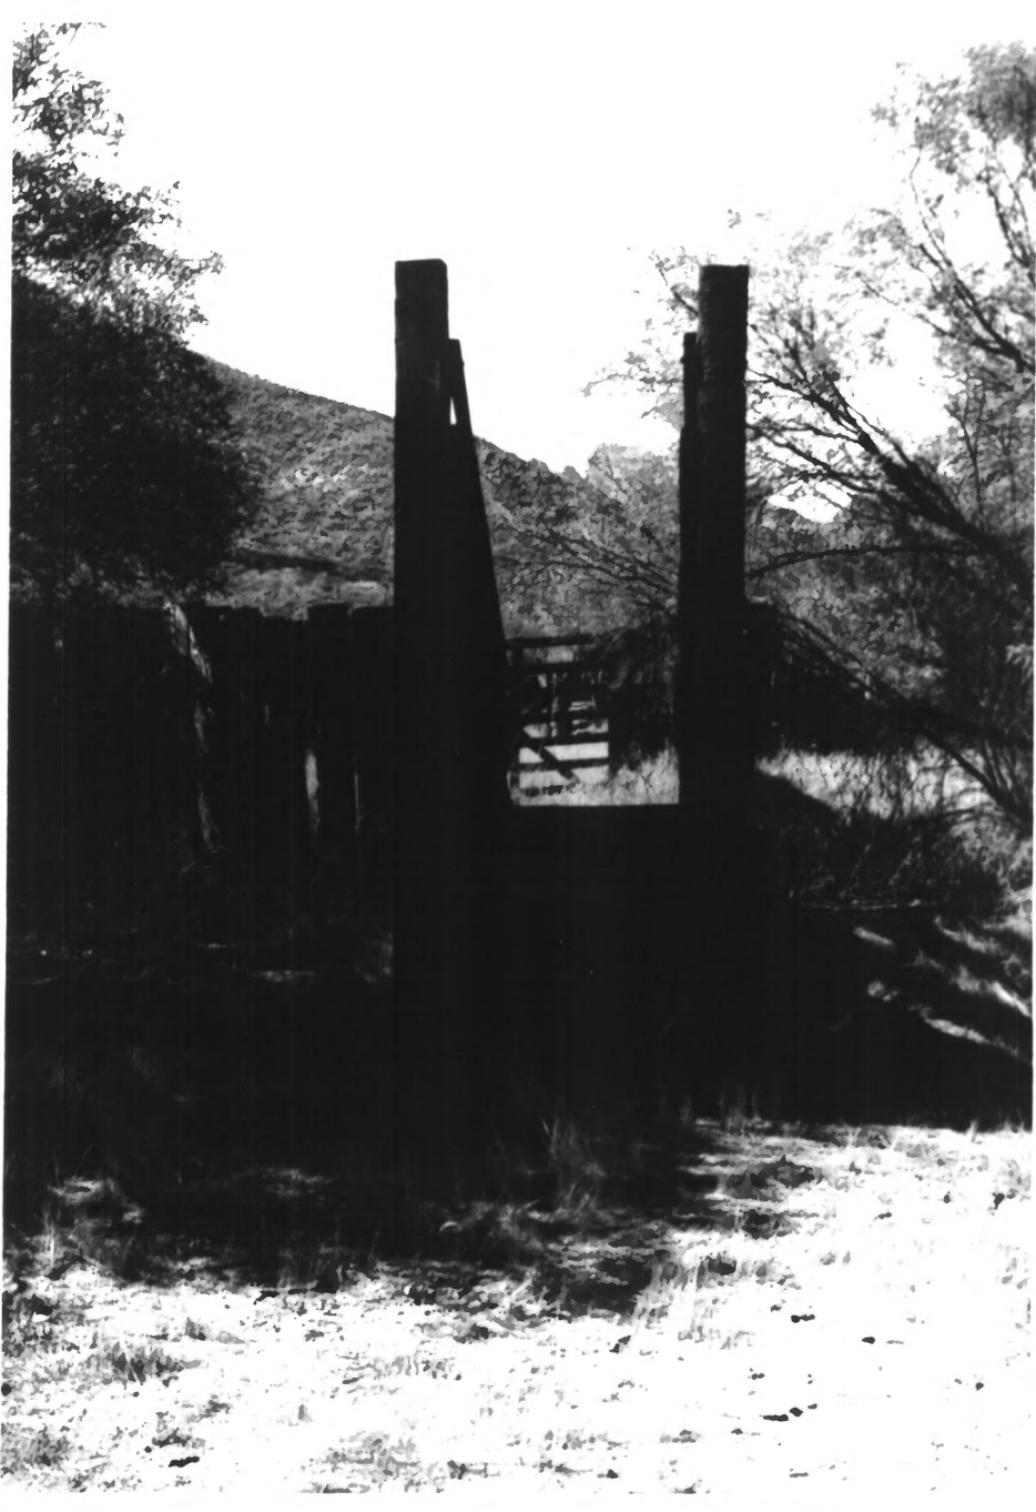
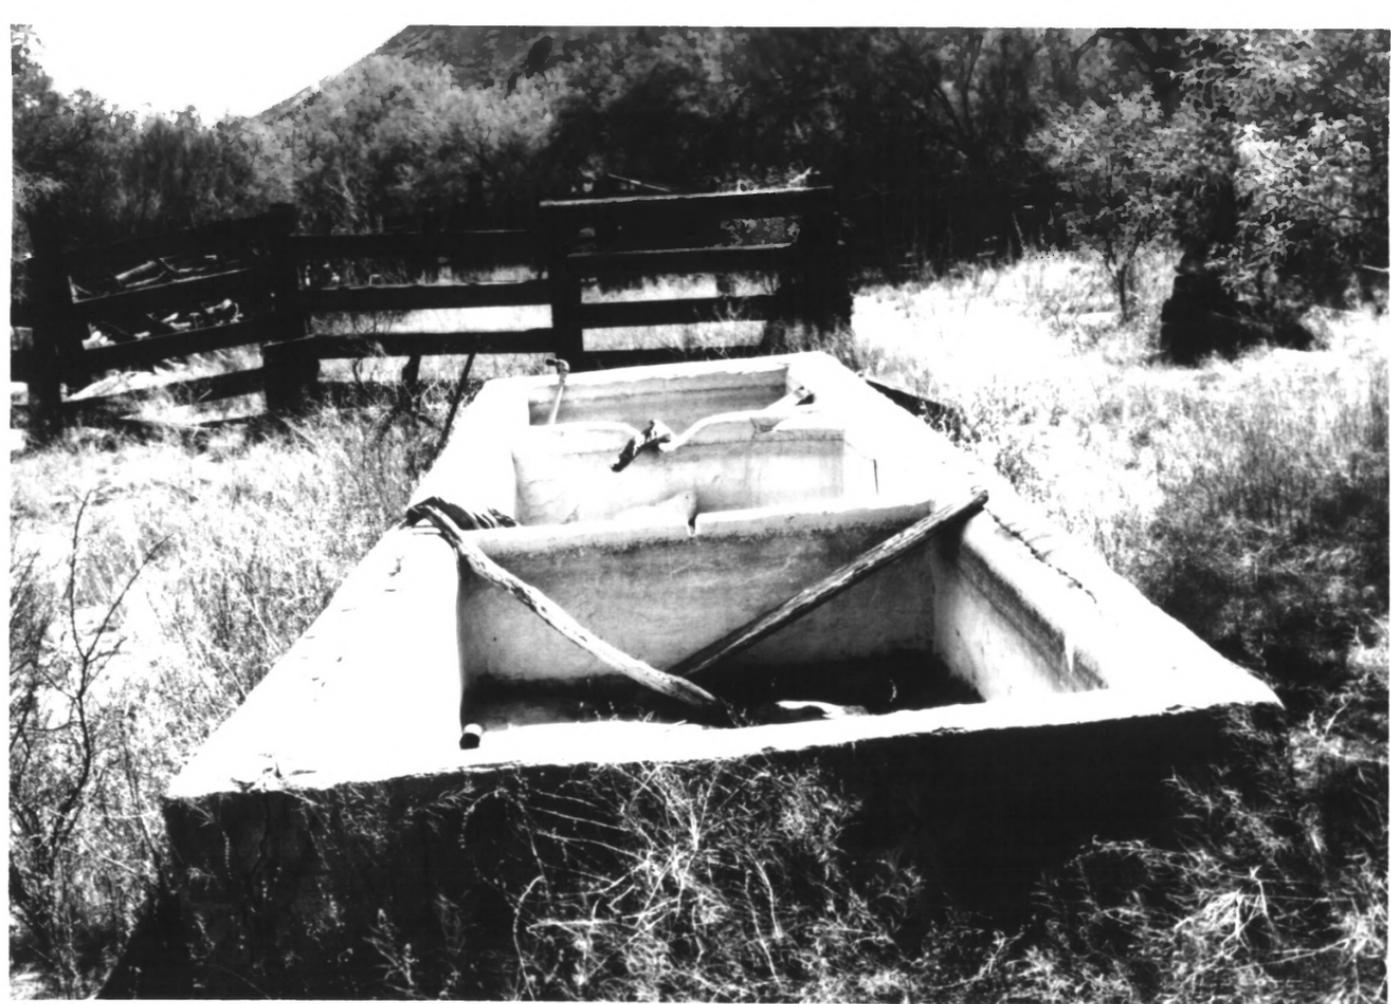
The southern corral is located about 1,050 feet from the main house and constructed partly of mesquite and partly of railroad ties. One section contains a large concrete watering trough; two sections are holding pens; and a fourth section has a chute and loading ramp. As with the other corral, it is shaped irregularly.

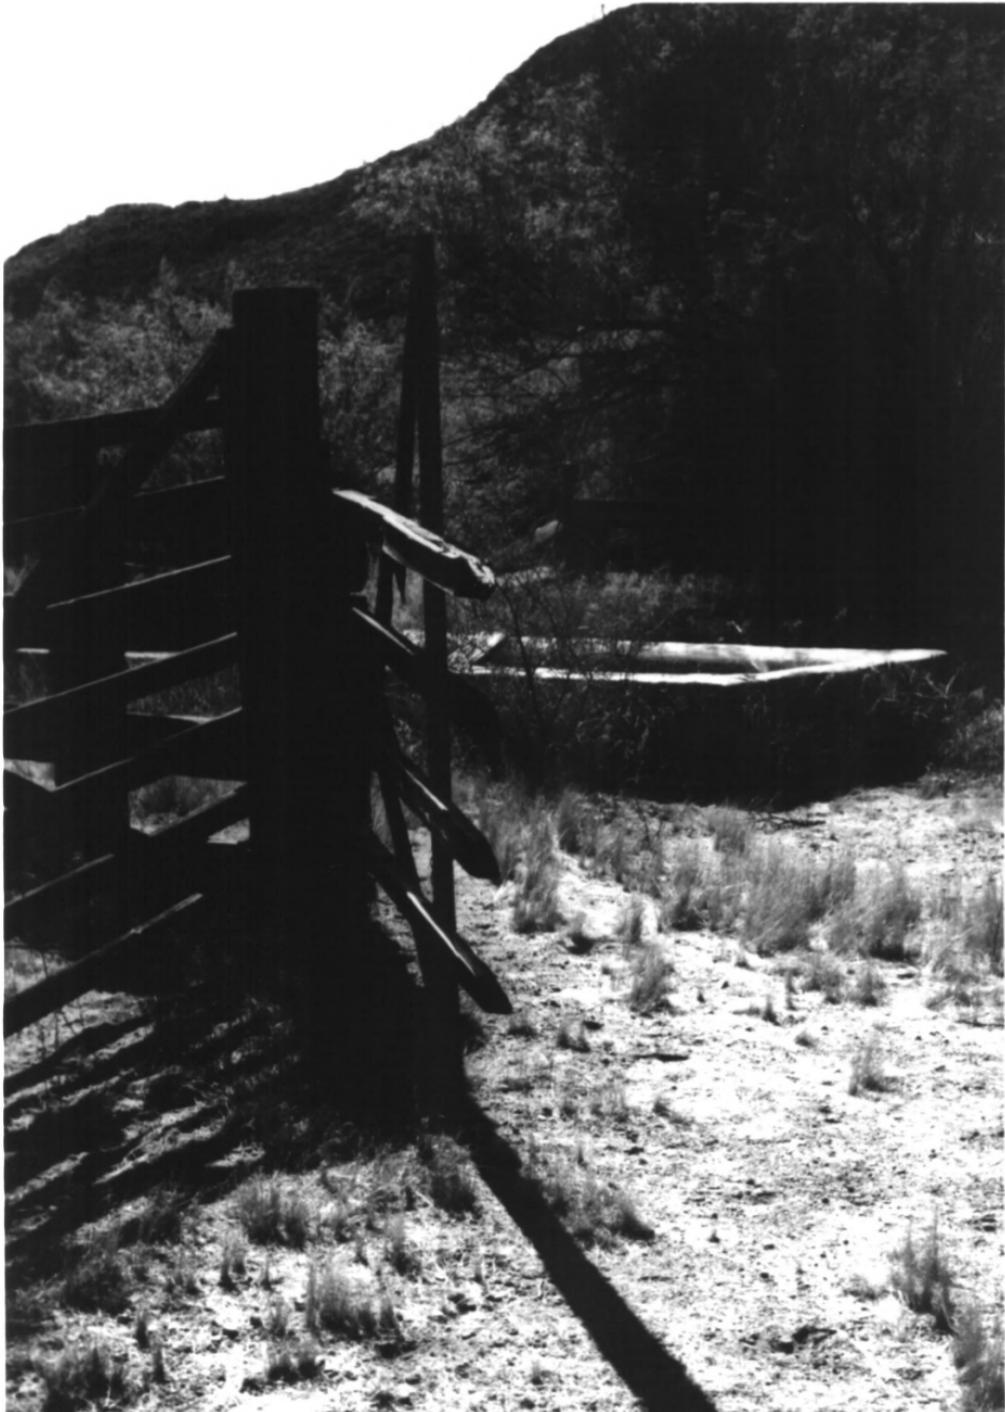
1. Trigger Gate, Southern Corral, Bates Well,
Organ Pipe Cactus National Monument

The frontier-border style of the Grays was noted for its use of miscellaneous building materials at hand and for a series of ranches and line camps about a day's ride apart with wells, corrals, and trigger gates, which were used to roundup the cattle when they came in for water from the open range. According to Wilton Hoy in his 1976 compilation Organ Pipe Cactus Historical Research, "roundups...were...made by trapping the cattle at given water holes surrounded by a corral and a gate through which they could enter but not leave" (page 227). The trigger gate was clever and representative of the Grays' distinctive pattern of cattle raising in the Sonoran Desert. Caroline Wilson, the head of interpretation at the monument, in her 1987 brochure on Puerto Blanco Drive, emphasizes the uniqueness of the trigger gate as a very distinctive feature of Sonoran Desert ranching. "Rather than riding the range to round up cattle in the traditional manner of the American West, ranchers of Northwestern Papaguera, including the Gray family, selected the hot, drought season when natural [watering] holes dried up. They ran water inside the corrals and closed them with trigger gates. So when cattle entered the corral through the V-shaped gates that pointed into the corral, barely allowing passage in, they could not exit the gates" (Hoy 1976:169). See photograph 20, southern corral, Bates Well.

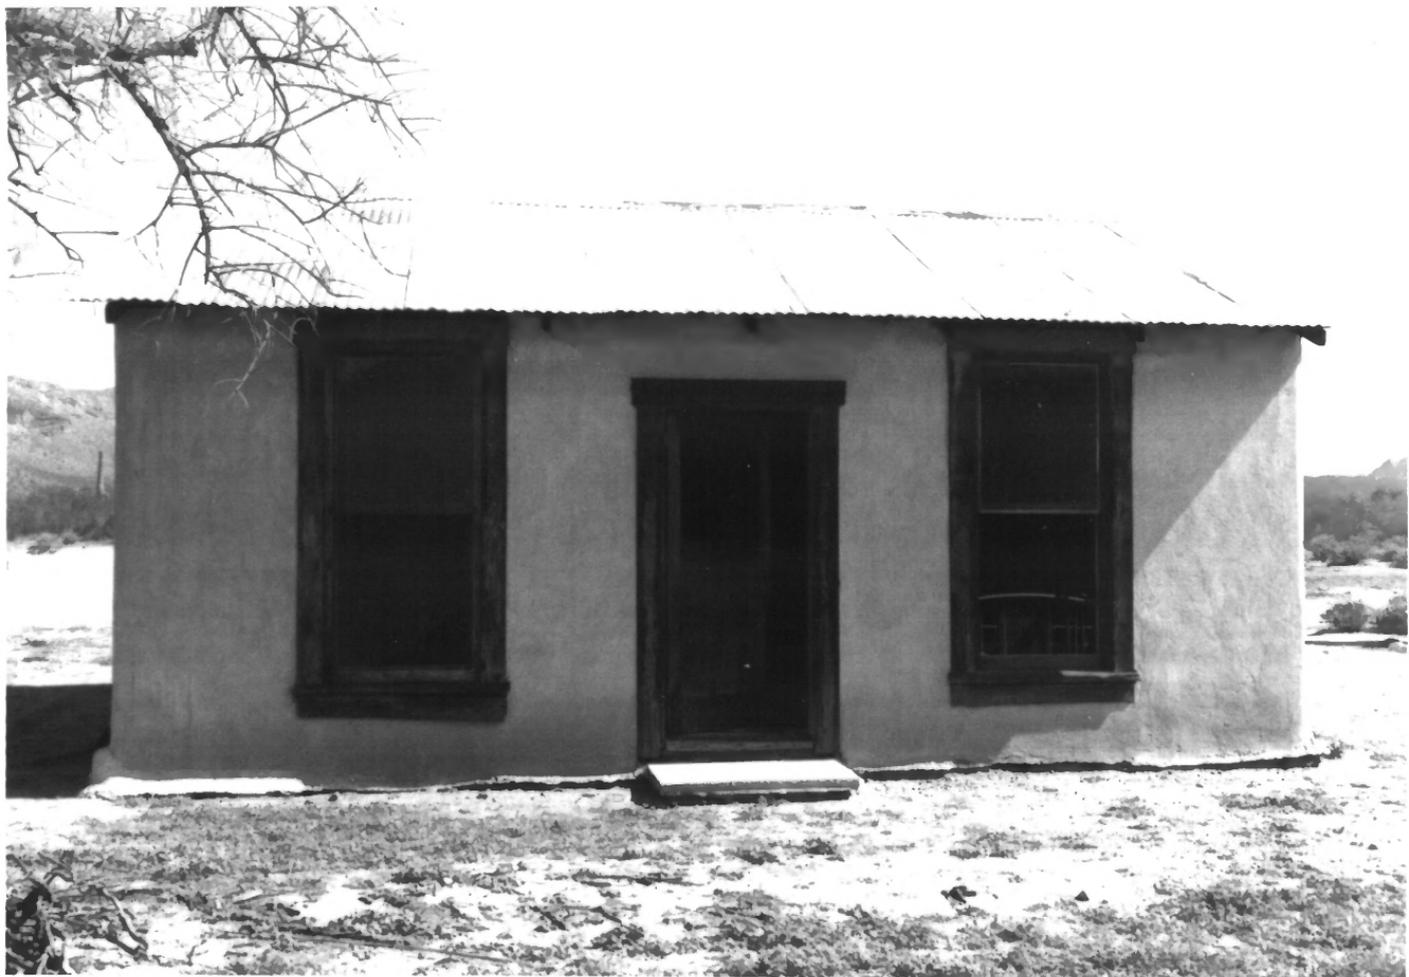
1. Main Ranch House/Henry Gray's House, Bates Well, Organ Pipe Cactus National Monument
2. Pima County, Arizona
3. Charles Conner
4. July 22, 1990
5. Organ Pipe Cactus National Monument
6. looking north
7. Photograph No. 1

Conditions are essentially the same today.
LGH September 22, 1992
