TECHNICAL REPORT NO. 26

A History of the Quitobaquito Resource  
Management Area, Organ Pipe Cactus  
National Monument, Arizona

October 1989

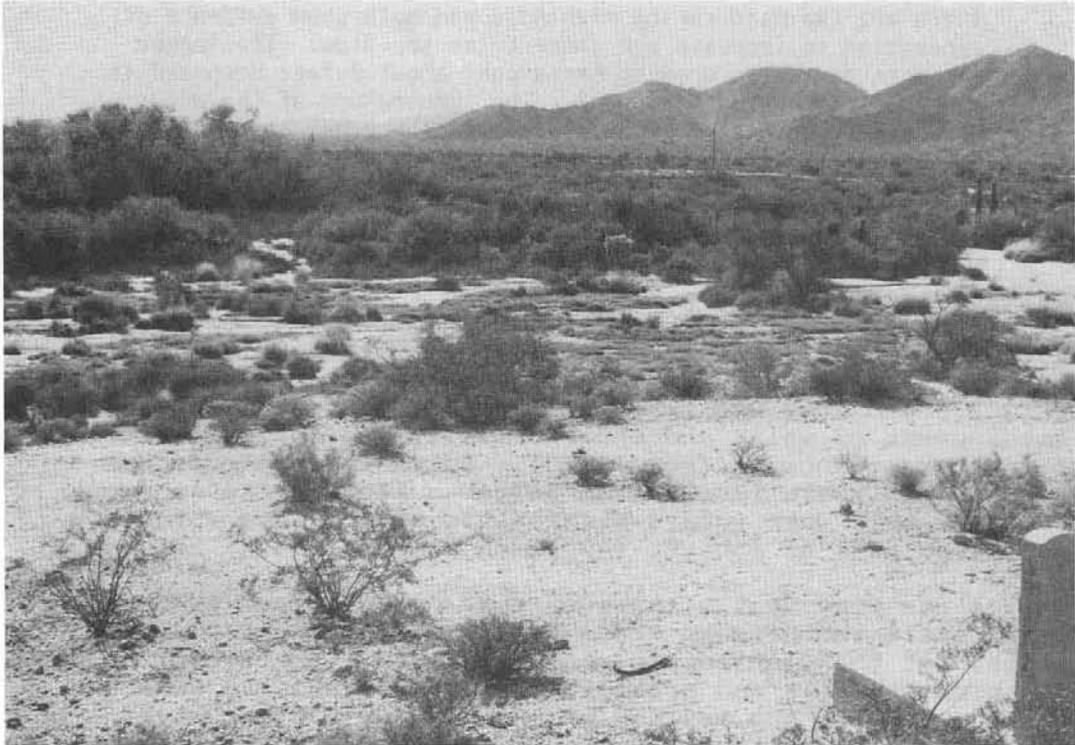
Figure 3b. Photograph of Quitobaquito, looking southeast from Sestier's grave, taken December 11, 1988. All of the buildings, including the foundations of Mikul Levy's store were razed in 1961. The entire area was scraped clean with a bulldozer. This scraped area is populated by a dense stand of Seep-weed (*Suaeda moquinii* Felger in preparation). This species often indicates areas of intense disturbance. Supernaugh's wash (made visible by the line of mesquites must be the one referred to by Lumholtz as connecting to the Rio Sonoyta. If so, the old springs (now dry) must have been flowing heavily. The springs above the pond that are now active do not lie in a drainage nor does the pond. It is difficult to see how these springs could be the ones referred to. The foreground soil now shows fewer cobbles than in 1950. This effect is likely due to recovery from trampling following removal of cattle and the consequent reduction in sheet type soil erosion. The shrubs just beyond are seep-weed with some mesquite, bursage (*Ambrosia deltoidea*), and saltbush (*Atriplex polycarpa*). This stand shows the effects of release from grazing disturbance but has failed to form a dense stand. This contrasts to the vegetation response where removal of the old buildings caused profound disturbance. [Photo by W. Bubul-Bennett]

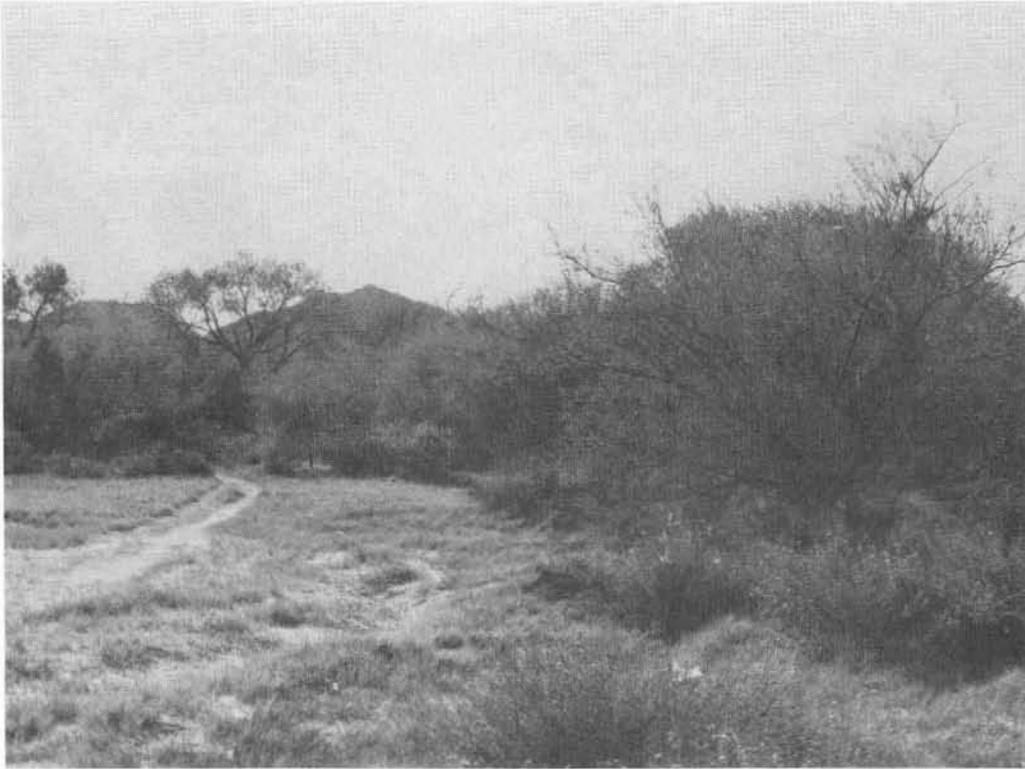
Figure 5b. Photograph of Quitobaquito Pond taken in December 1988. Released from centuries of heavy grazing, the vegetation has become exuberantly reestablished as dense stands arranged in a coarse mosaic. The low ground cover is predominantly saltgrass (*Distichlis spicata*). The low shrubs are tarweed and the taller plants are mesquites (*Prosopis velutina* and *P. pubescens*). Although the mammalian fauna is depauperate, there are 65 species of birds seen regularly and 15 species that nest at Quitobaquito (Johnson, Brown, & Goldwasser 1983). [Photo W. Bubul-Bennett].

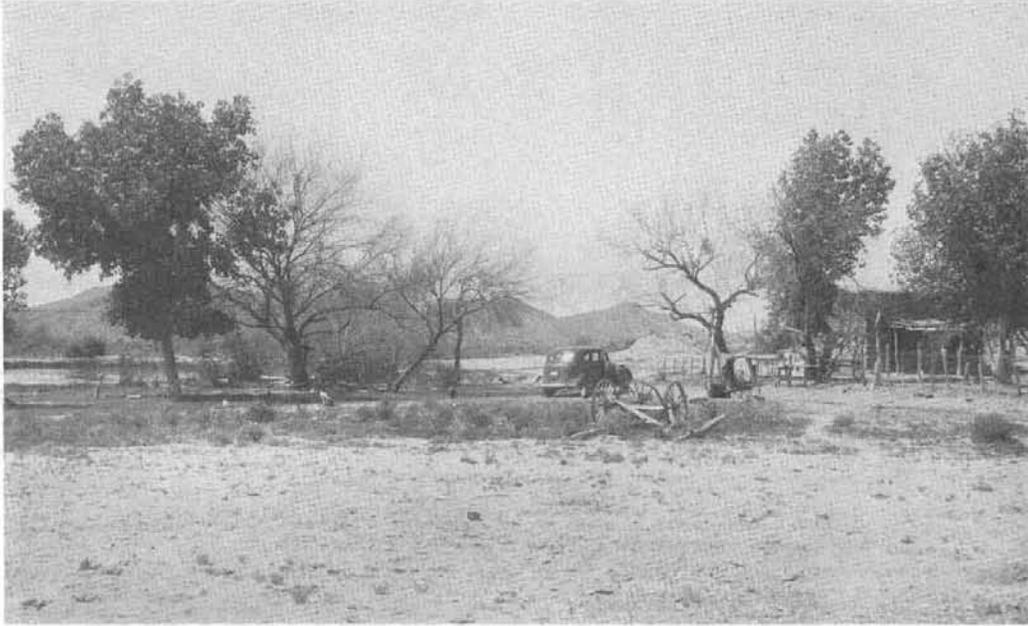
Figure 6a. This is the westernmost of two overlapping views of Quitobaquito Pond looking toward the south. (See also Figures 5a and 5b). Photograph taken May 1939. Jose Juan Orosco's home appears at the extreme right in the lower photograph. After Jose Juan's death in 1946, the house was abandoned. The automobile bears U.S. Government license plates, the Oroscos relied on the buckboard, parked beneath the large mesquite tree to the left of the car, for transportation. A ditch carrying water from the nearby springs flows from left to right concealed in a depression in front of the car. Livestock grazing has kept the pond and ditch free of Alkali Bullrush. Saltgrass is entirely absent. The low vegetation is tarweed, graythorn, *Atriplex* spp., and seep-weed. The present day pupfish observation pool lies approximately beneath the buckboard. The large mesquite near the buckboard is now dead but the small one to the right is still living (1988). The cottonwood growing on the dam at the far side of the pond is the same shown in figures 11, 12, 13, 14, 16, etc. These trees make good markers of orienting other views. [Photo F. Pinkley, J. Miller, N. Dodge, Monument files 2644].

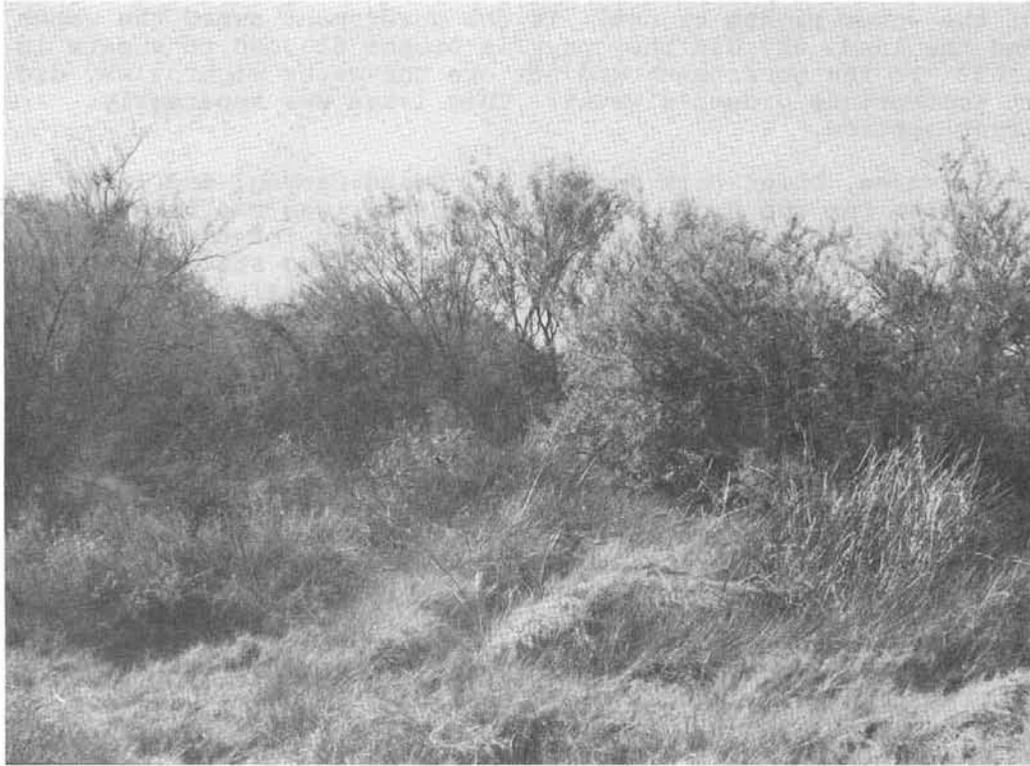
Figure 6b. Photograph of Quitobaquito Pond taken December 11, 1988. The old ditch between the springs and pond runs diagonally from right to left in this view but it is completely obscured by the mesquite and graythorn plants. The ditch function has been replaced by a buried plastic pipe since 1974. However, enough water bypasses the pipe head or seeps underground to support luxuriant hydrophilic vegetation. Ground cover is saltgrass, Alkali Bullrush, and *Elyocharis rostellata*. The shrubs are all tarweed. All of the vegetation visible in the photograph has grown from seed since the Orosco cattle were removed in 1956. [Photo W. Bubul-Bennett].

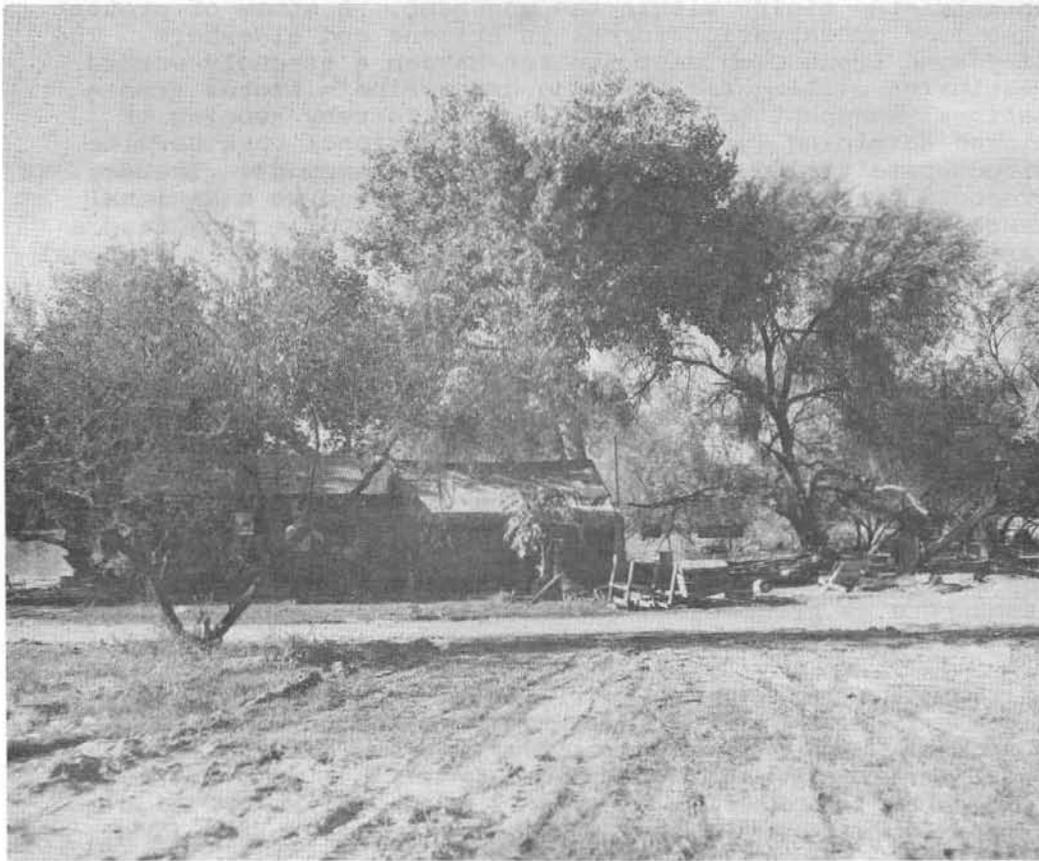
Figure 7a. View to the southwest looking toward Quitobaquito Pond. Photograph taken November, 1957, shows the U.S. Bureau of Animal Industry station established at Quitobaquito in 1949. The government built a low concrete dam at the nearby springs (see figure 9a and 9b) to form a pool so that water could be piped to the new station. This development was undertaken over Jim Orosco's objections. Jim Orosco apparently moved into this building after it was abandoned by the government. Note the two distinctively shaped mesquite trees to the right of the buildings for orientation (compare Figure 6a). The pond lies behind the station. A fig tree has been planted in front of the building (a tent frame) to the right. The foreground has been scraped bare as part of the "clean-up" effort. The National Park Service, in an ill advised effort to beautify Quitobaquito, razed these buildings in 1962 without undertaking any archeological work. [Photo James M. Eden, 11-4-57, monument files 334B].

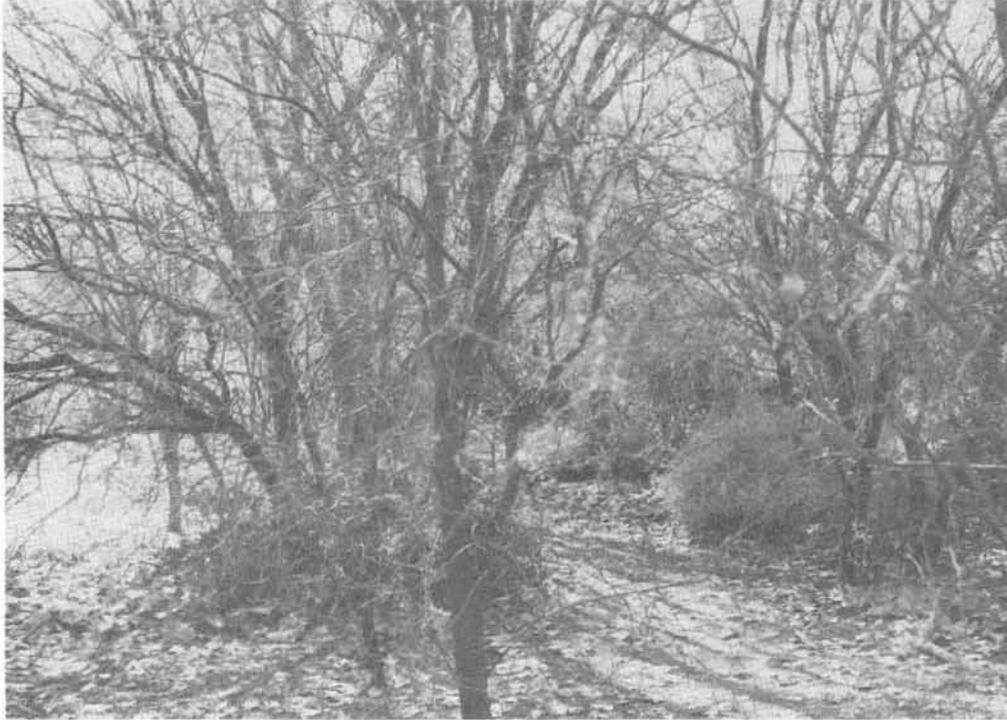
Figure 7b. A view identical to Figure 7a, taken December, 1988, shows the dense mesquite bosque that grew from seed following removal of the Orosco cattle. The mesquites are crowding out the remaining graythorn and Parish Wolfberry (*Lycium parishii*) shrubs remaining from some time before when the ground was less shaded. There is no herbaceous cover; the ground is littered with cottonwood leaves. [Photo P. Bennett].

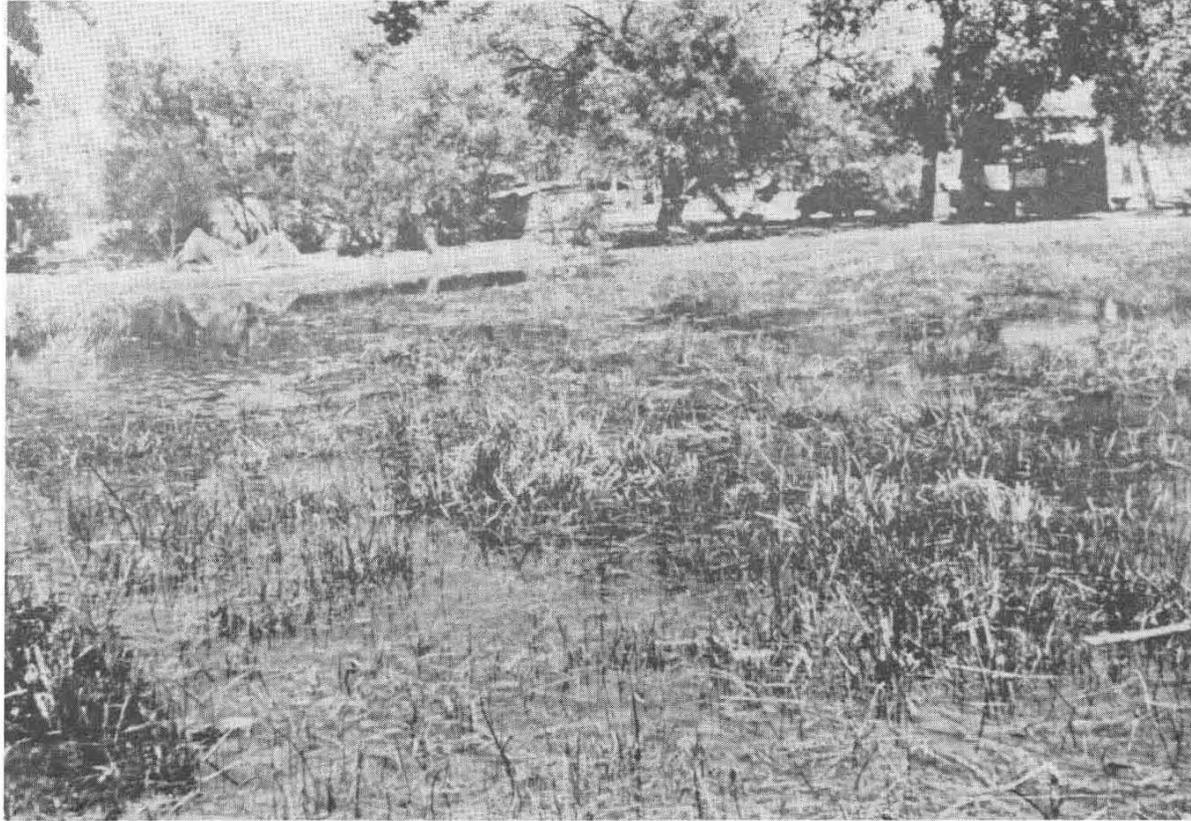
Figure 8: This photograph of Quitobaquito Pond was made by Robert Miller in 1953 when he first visited for the purpose of studying the Desert Pupfish (*Cyprinodon macularius eremus*). The view is to the north and was taken from dam. The Animal Industry buildings appear on the far shore. Open water and channels have been maintained in the Alkali Bullrush by livestock trampling and grazing. At this time the water was a foot or two deep. [Photo R. Miller].

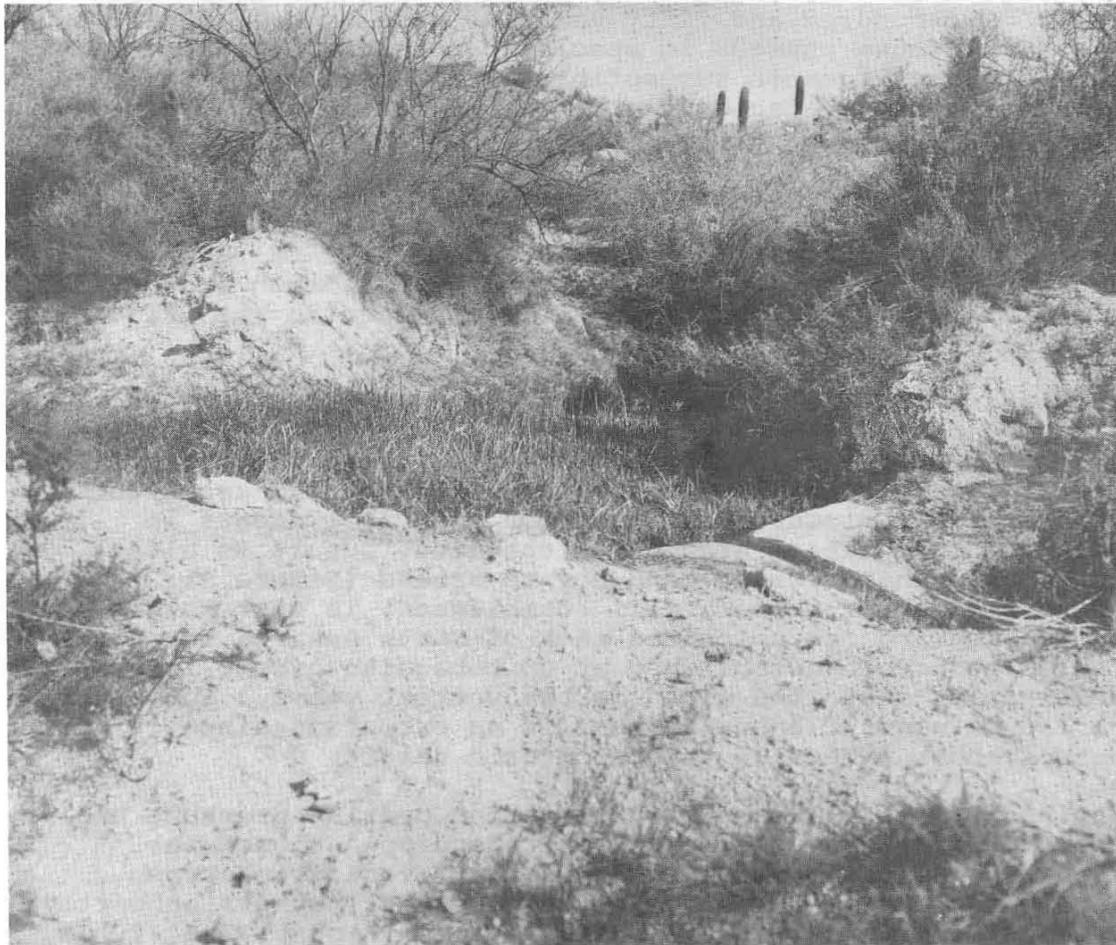
Figure 9a. Photograph shows the southeast spring condition on February 23, 1961, when all of the Orosco cattle had been removed for five years but the Gray brothers cattle were still grazing in the spring head, keeping the Alkali Bullrush in control. The low concrete dam (right center) was installed in 1949 by the government to create a pool so that water could be piped to its installations near the pond. Quitobaquito Spring in reality has multiple seeps lying along the base of the Quitobaquito Hills. At present only two spring heads have sufficient water to warrant collection for piping to the pond. The southeast spring is the one with the most flow and is the one shown in these photographs. View is toward the northwest. [Photo Budge, monument files W-25].

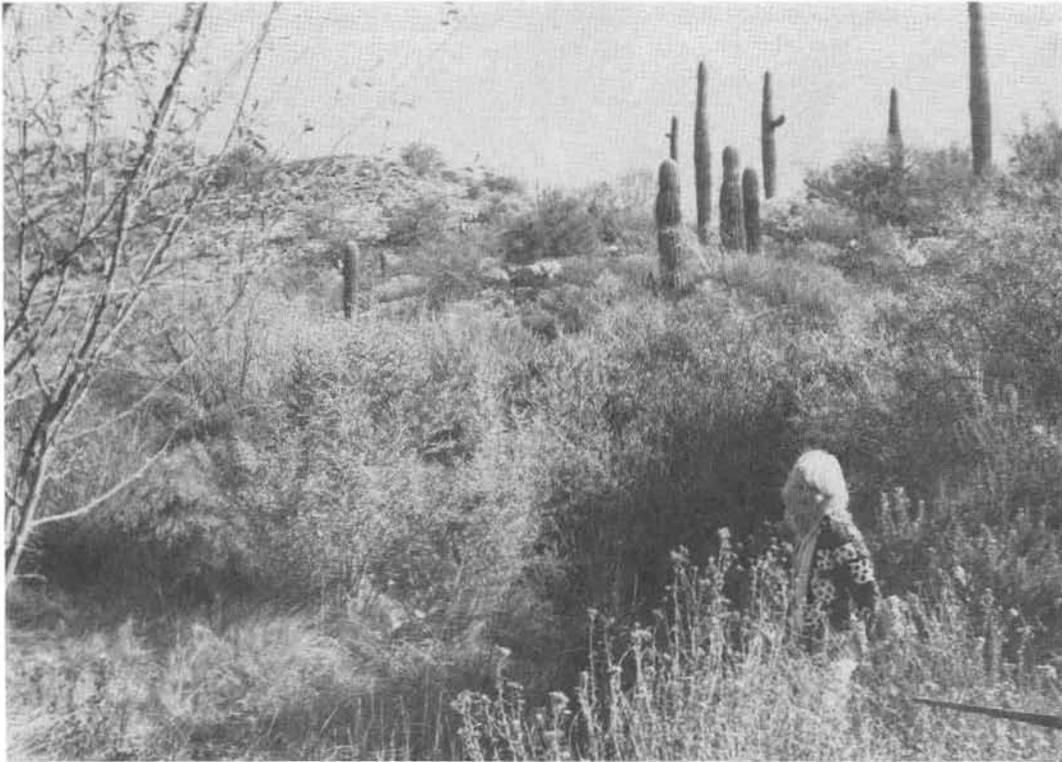
Figure 9b. Photograph of southeast spring taken December 11, 1988. The girl is standing on top of the government dam. Alkali Bullrush must be grubbed out of the spring and ditch periodically. If it is allowed to grow unchecked, water flow may be reduced by as much as 70%. Vegetation composition has changed little in the 28 years since the upper photograph was made. Some of the mesquites to the left of the spring are gone and a seep-willow (*Baccharis salicifolia*) has replaced the graythorn at the back. Note the growth of the saguaros. [Photo P. Bennett].

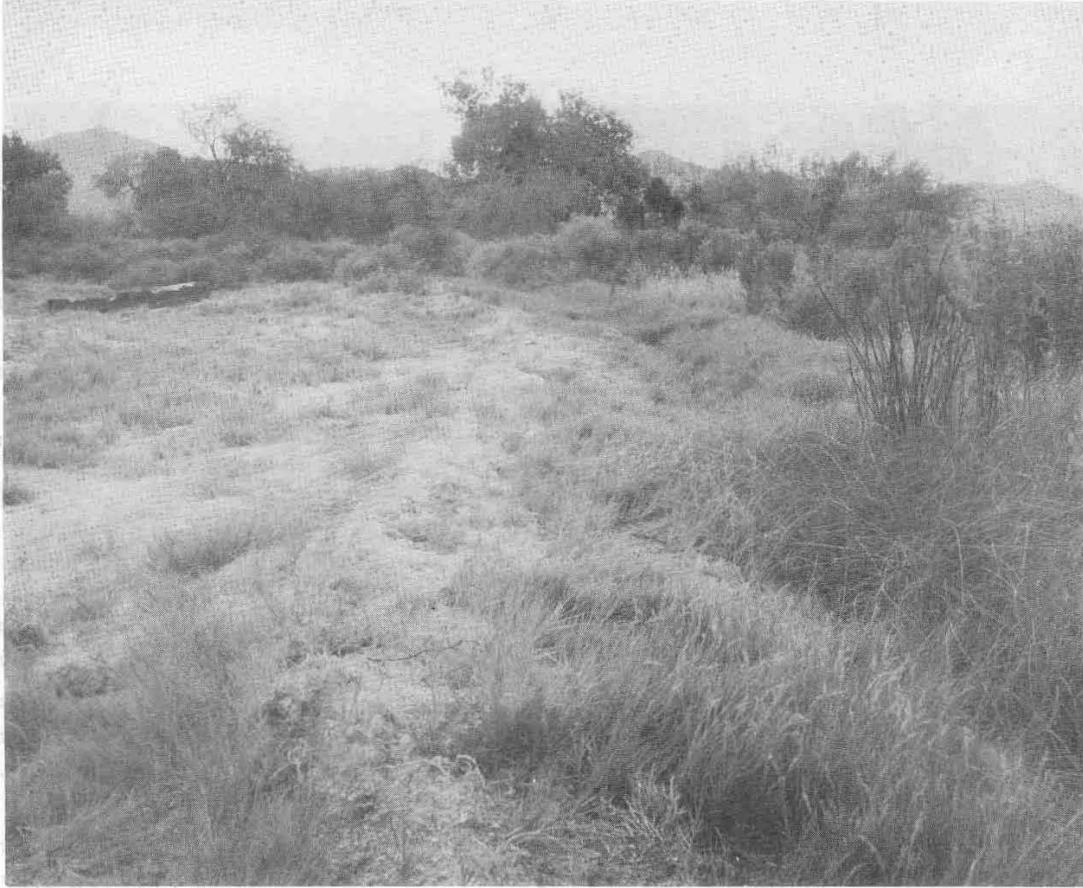
Figure 10a. View looking southwest from the southeast spring. Quitobaquito pond lies beyond the cottonwood trees in the center of the photograph. Photograph, taken on August 23, 1963, shows the outflow from the spring shown in figures 9a and 9b. Grazing has apparently been eliminated. The spring ditch has been dig out with a road grader, probably to eliminate the Alkali Bullrush and increase water flow. [Photo H.T. Coss, monument files W-37].

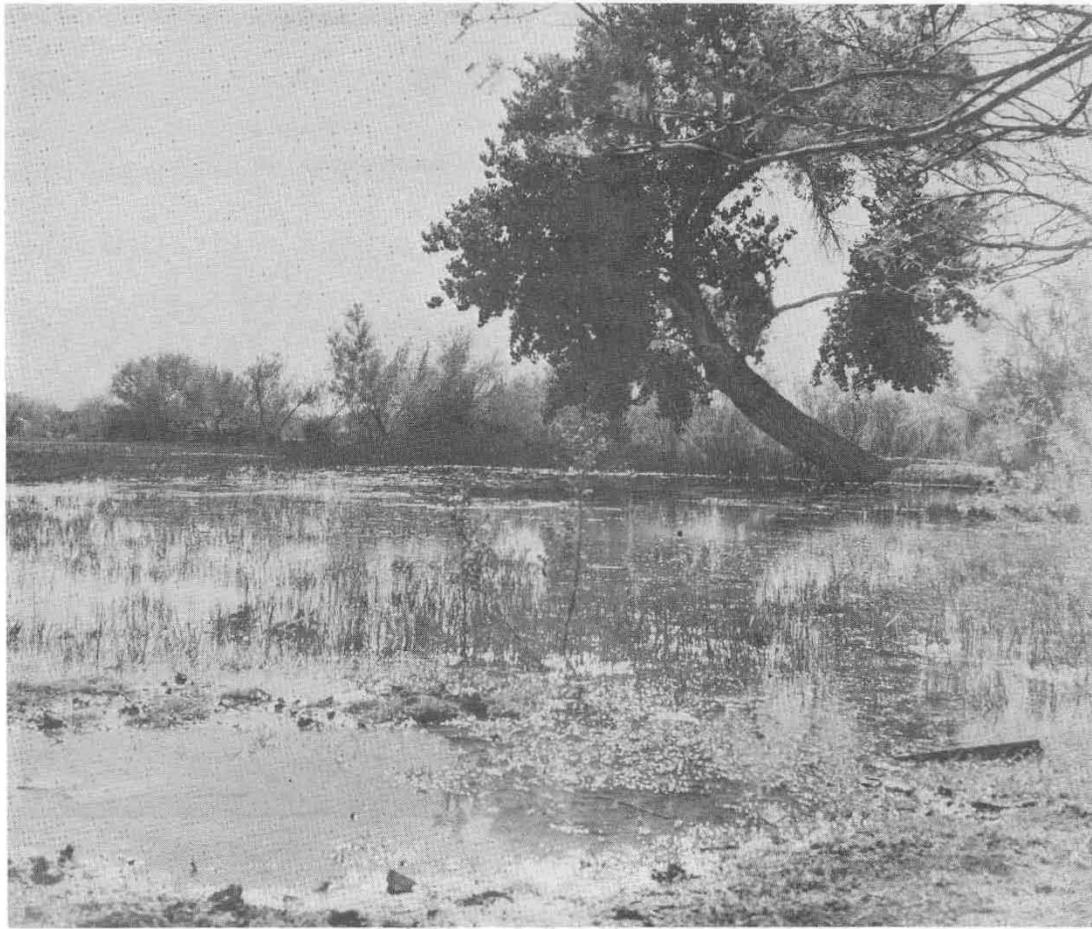
Figure 11a. View of the pond vegetation from the north shore of Quitobaquito Pond. The large cottonwood tree growing on the dam also appears in Figures 11, 12, 13, 14, 16, etc. Photograph was taken on December 9, 1950. Considerable open water is visible between the Alkali Bullrush plants. Shore vegetation is relatively open. The pond and surrounding vegetation is being grazed. [Photo Wm. Supernaugh, V. Dunn, Barton, monument files W-10].

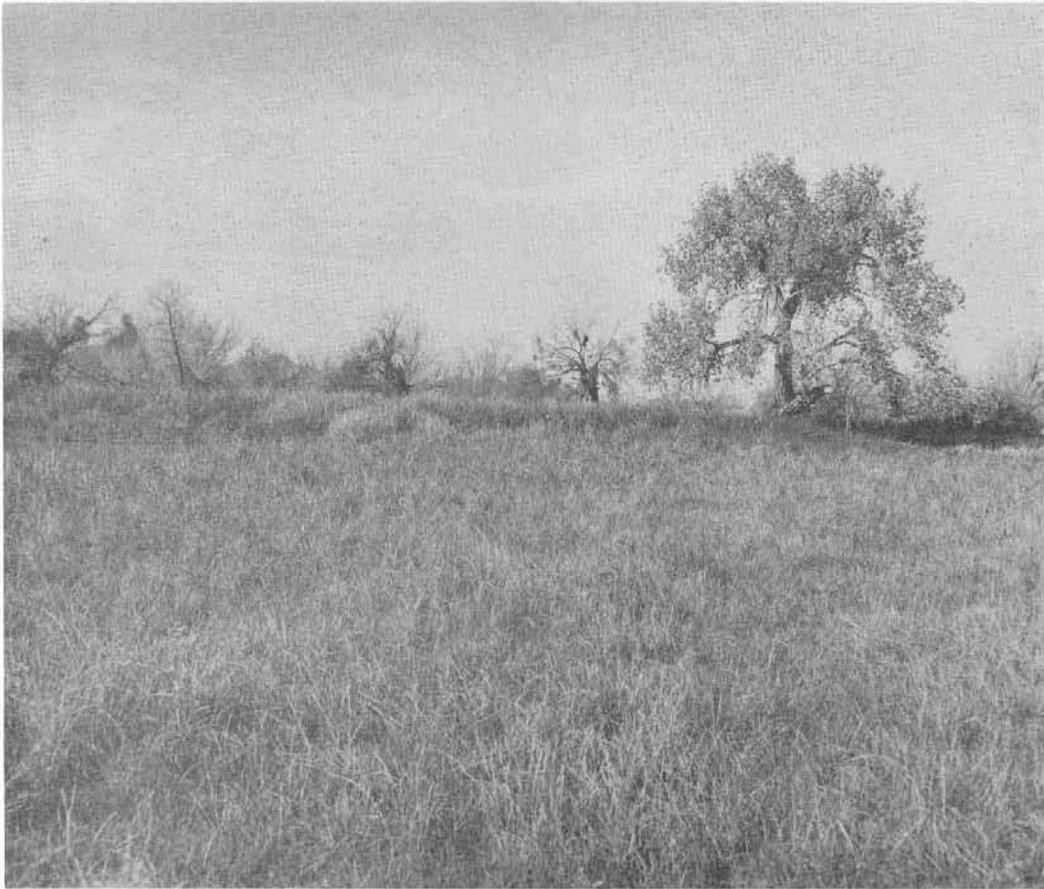
Figure 12a. View of Quitobaquito Pond looking toward the southwest. Photograph, taken on February 16, 1957, shows a dramatic increase in the growth of the Alkali Bullrush compared to Figure 11a. There is a narrow strip of open water remaining along the dam. Everywhere else the pond is invaded by a closing stand to Alkali Bullrush. Cattails (*Typha spp.*) formerly present, have been eliminated by competition at Quitobaquito. Views like this prompted Lowe and Gloyd to recommend deepening of the pond. [H. Parent, monument files W-14].

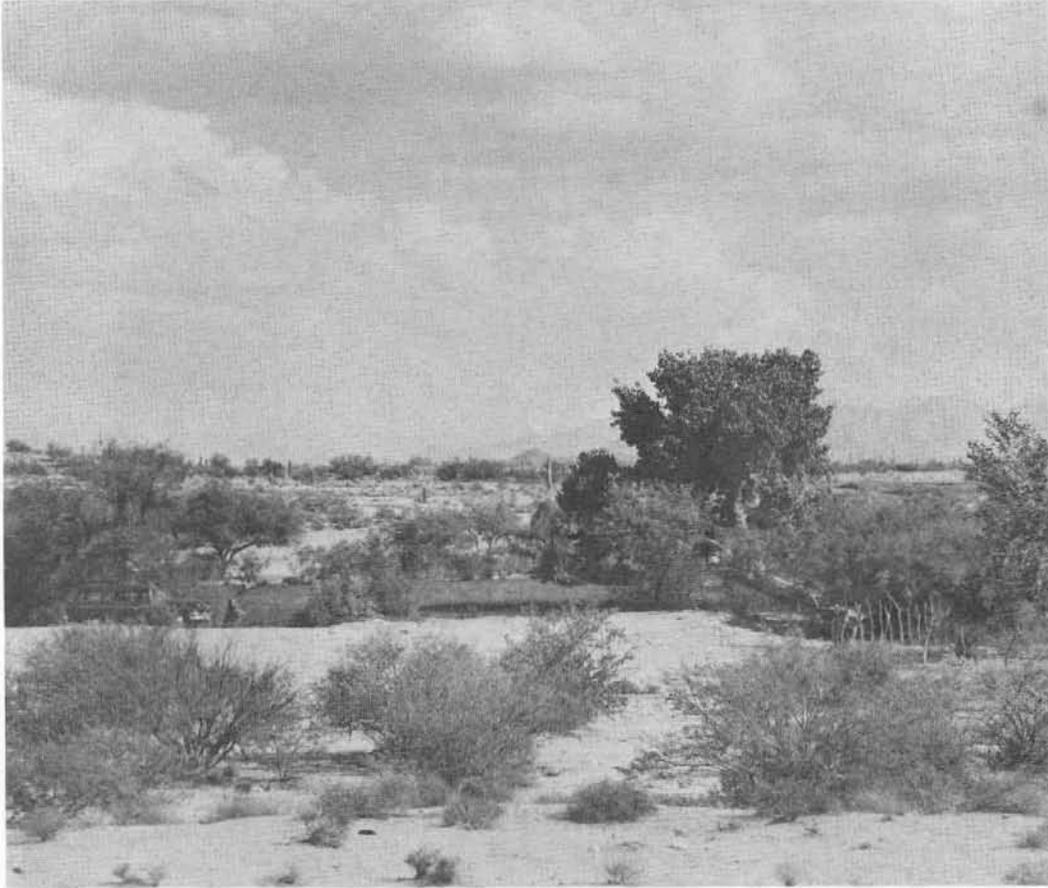
Figure 13a. View of Quitobaquito Pond looking east-southeast. Photograph, taken on February 16, 1957, shows the conditions prevailing immediately after acquisition by the Park Service. The Alkali Bullrush in the pond are quickly forming a closed stand (See Figure 12a). Pondsides vegetation remains quite open; birds and animals may come to water with some concealment but without breaking through brush. Foreground shrubs are mesquite, *Atriplex* spp, Berlandier Wolfberry, and whiteleaf bursage (*Ambrosia dumosa*). [Photo H. Parent, monument files W-15].

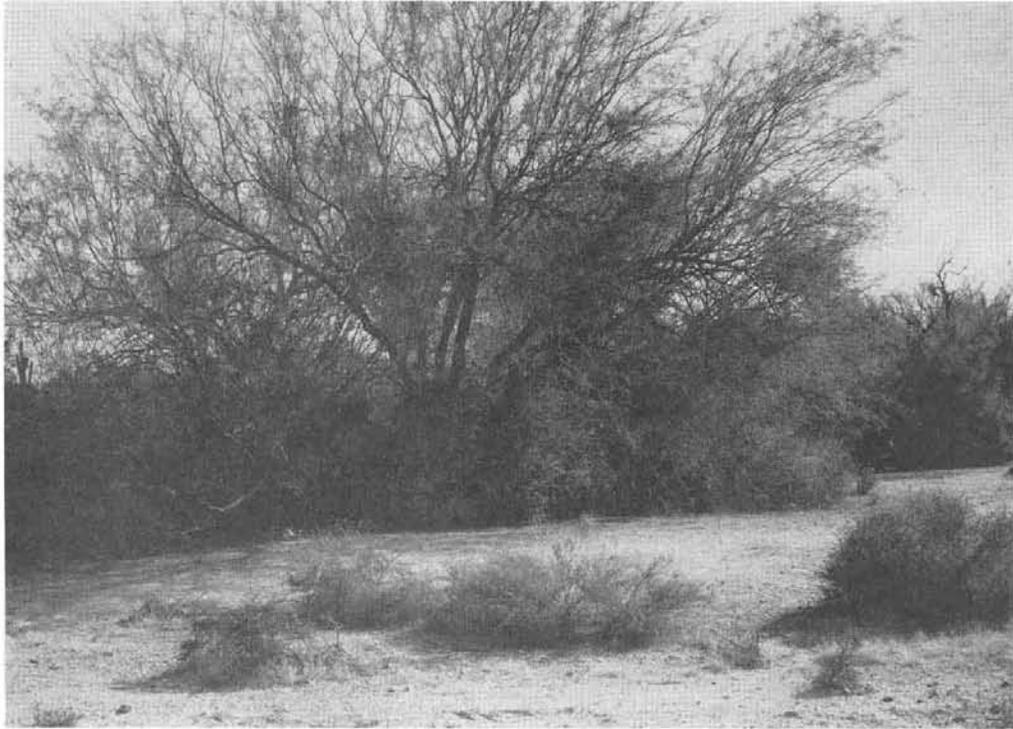
Figure 13b. View of Quitobaquito Pond looking east-southeast. Photograph, taken December 11, 1988 records dramatic vegetation changes. The crown of the southshore cottonwood can just be seen behind the mesquite in the center of the picture. Foreground shrubs are *Atriplex spp.* and Berlandier Wolfberry. The impenetrable thicket, extending 50 feet to the pond is mesquite, Parish Wolfberry, Anderson Wolfberry (*Lycium andersonii*), and graythorn. Cover is so dense that it is little used by large mammals such as deer. Killdeer and other wading birds have been essentially eliminated by the dense cover and vertical pond banks. [Photo P. Bennett].

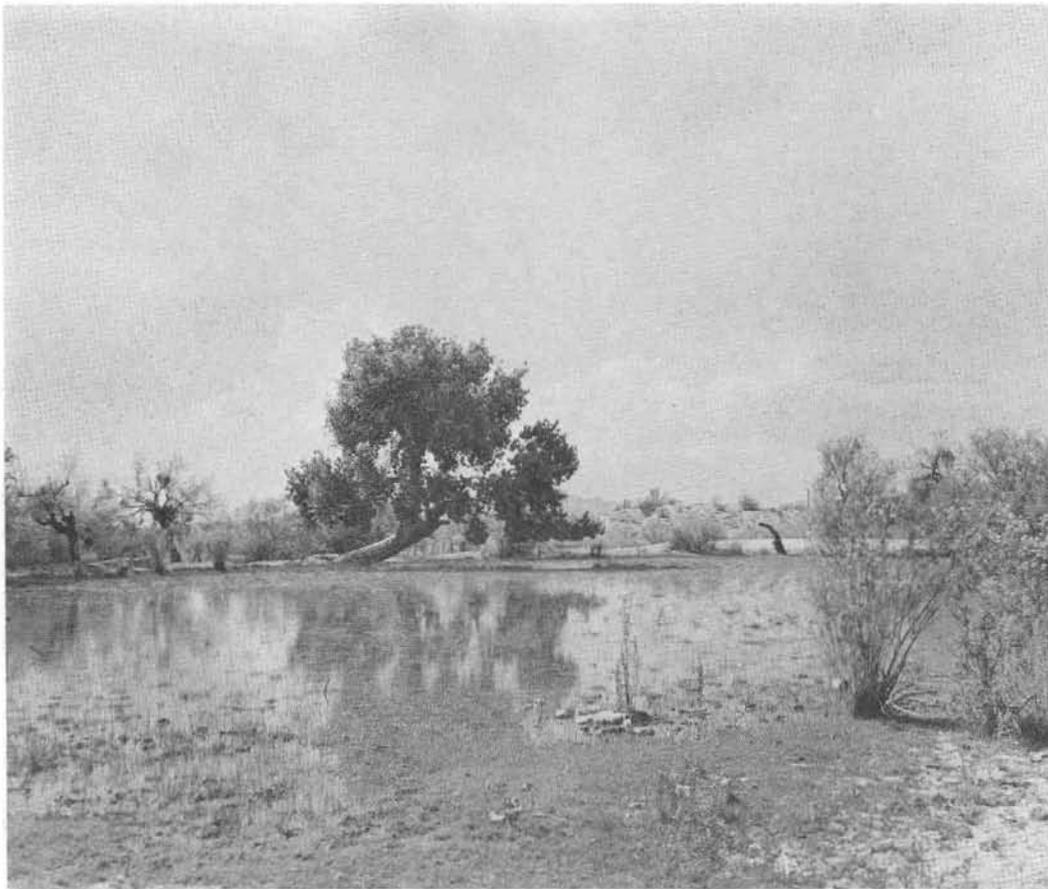
Figure 14a. View of Quitobaquito Pond looking toward the west. Photograph, taken in August, 1957, during the summer rains, shows the pond unusually full. The heavy growth of Alkali Bullrush in the area normally wetted can be seen along the far shore. There was some use being made of the pond for stock watering as evidenced by the tracks in the foreground mud. The east shore is very shallow because sediment is washing into the pond from nearby higher ground. This shallow water would have been made quite warm by the summer sun. This is acceptable habitat for the desert pupfish but not for most other species. Note relatively upright posture of cottonwood on far shore and the relatively open shoreline in the foreground and background. [Photo J.M. Eden, Monum. files W-17a].

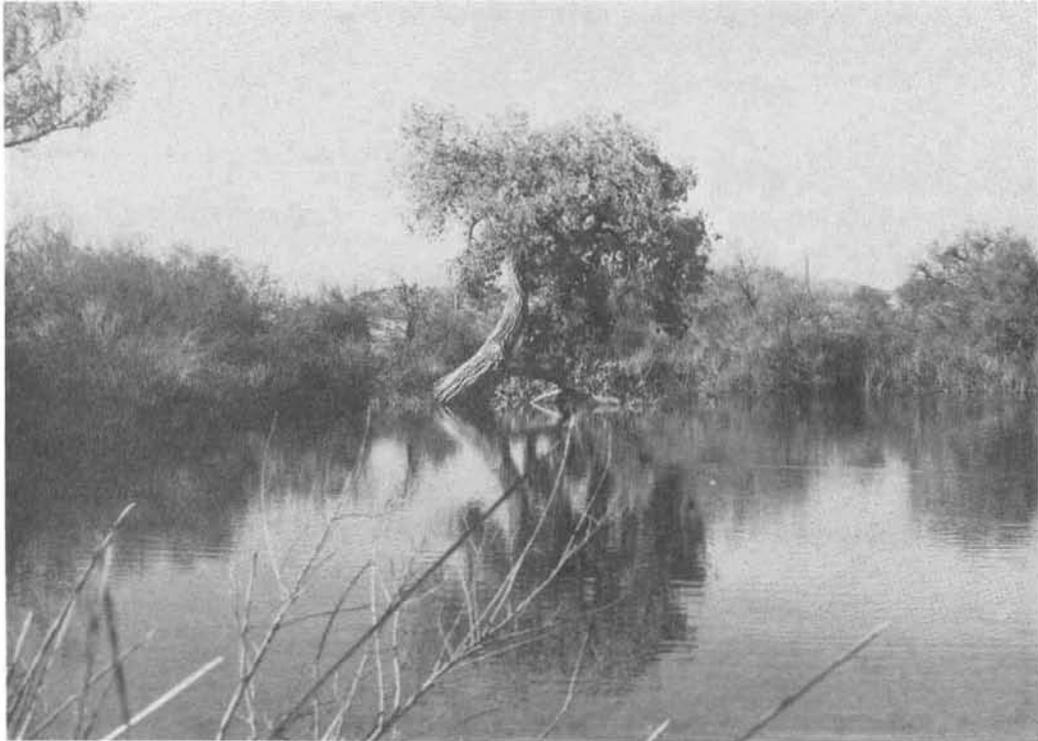
Figure 14b. View of Quitobaquito Pond looking toward the west. Photograph, taken on December 11, 1988, is made from a point 15 feet north of Figure 14a view. Original photo point is now on the new dam and covered by dense growth. Compare with Figure 14a view to see how the pond margin is now closed off by mesquite, other shrubs, and Alkali Bullrush. [Photo W. Bubul-Bennett].

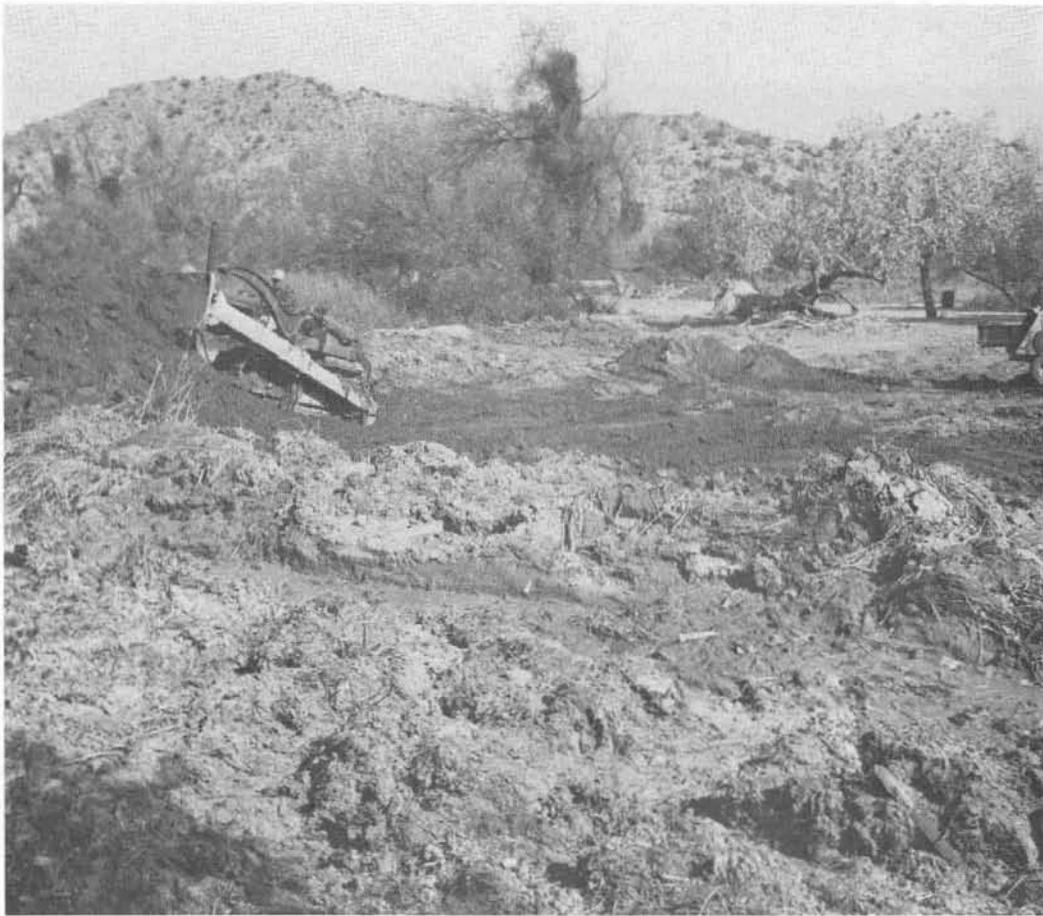
Figure 15a. Photograph shows heavy equipment used to deepen the pond. Heeding the recommendation of Lowe and Gloyd, the Superintendent ordered deepening of Quitobaquito Pond. Late in 1961, the Park Service drained the pond and began excavation. The pond was dug to a depth of 4-6 feet, replacing the warm shallow pond with a relatively cooler lake. A low bench 5 feet wide along a portion of the north shore was the only shallow habitat that remained. Ignoring Steenbergh and Lowe's advice no effort was made to salvage the Sonoran Mudturtles native to the pond. They were left to die. The formerly gently sloping banks were left vertical after excavation, interfering with the ability of any turtles that survived to haul out onto land for nesting purposes. Failure to provide suitable habitat for the pupfish and the turtles would have severe consequence in the future. The soil removed was trucked away or dumped near the north and south edges of the pond. [Photo Steenbergh, 1-62, monument files W 32c].

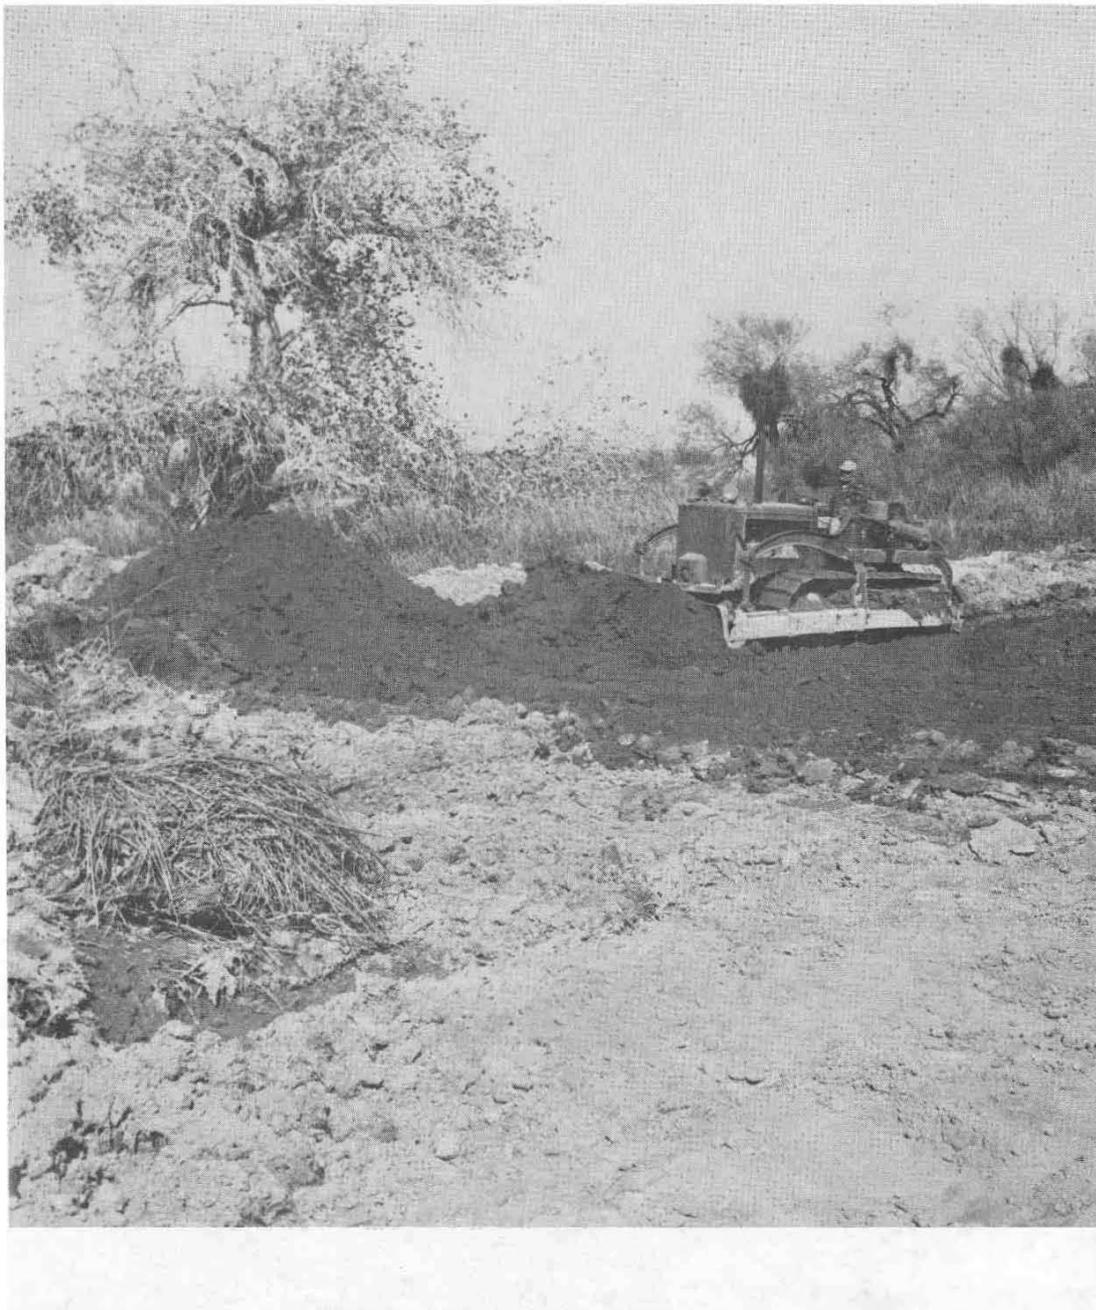
Figure 16a. View of the large cottonwood growing on the Quitobaquito dam. Photograph depicts the excavation operation in the vicinity of the large cottonwood tree on the dam. As the pond bottom was dug down and the earth removed beneath it, the tree on the old dam collapsed and had to be propped up for fear that pulling by the roots would result in dam failure. [Photo Steenbergh, 1-62, monument files W-34a].

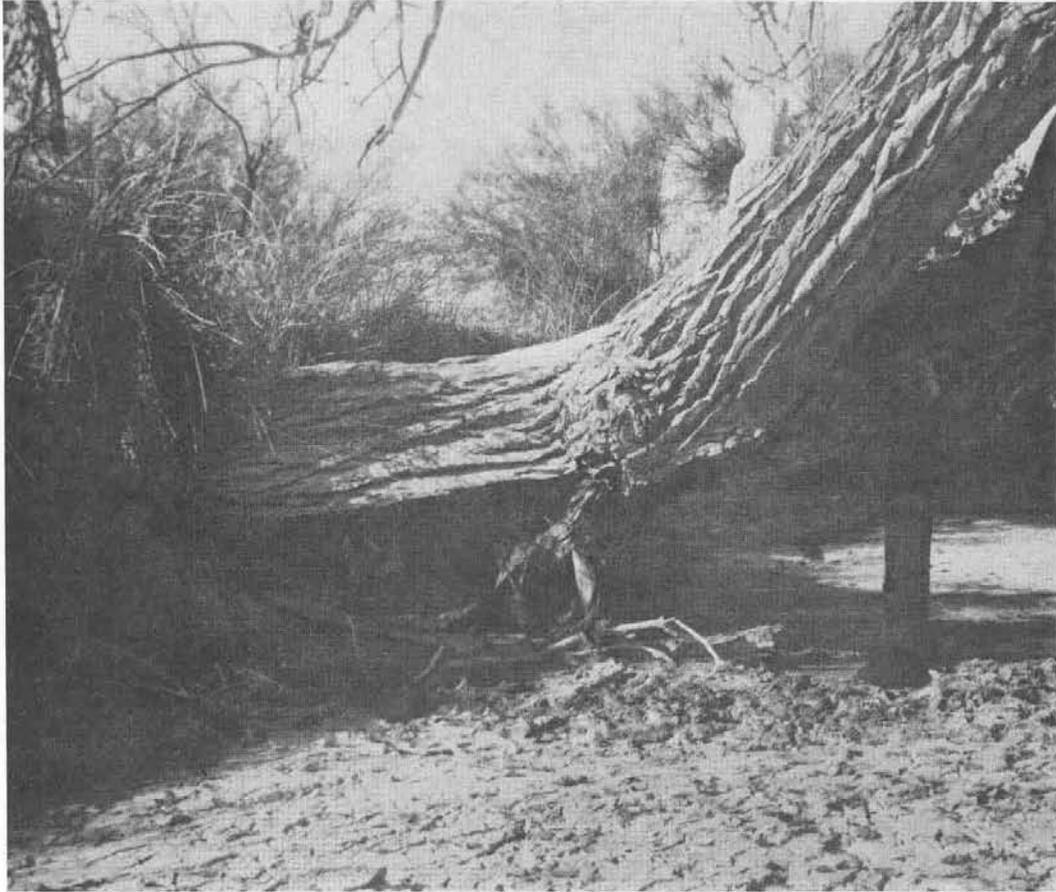
Figure 16b. Photograph, taken in 1969, shows the wooden prop placed beneath the collapsing cottonwood tree during the 1961 excavation. Since the prop was originally placed, the tree has continued to grow and gain weight. How long this prop will last is problematical. Failure of the prop will place the integrity of the dam in jeopardy. [Photo Begeman, monument files Q-23].

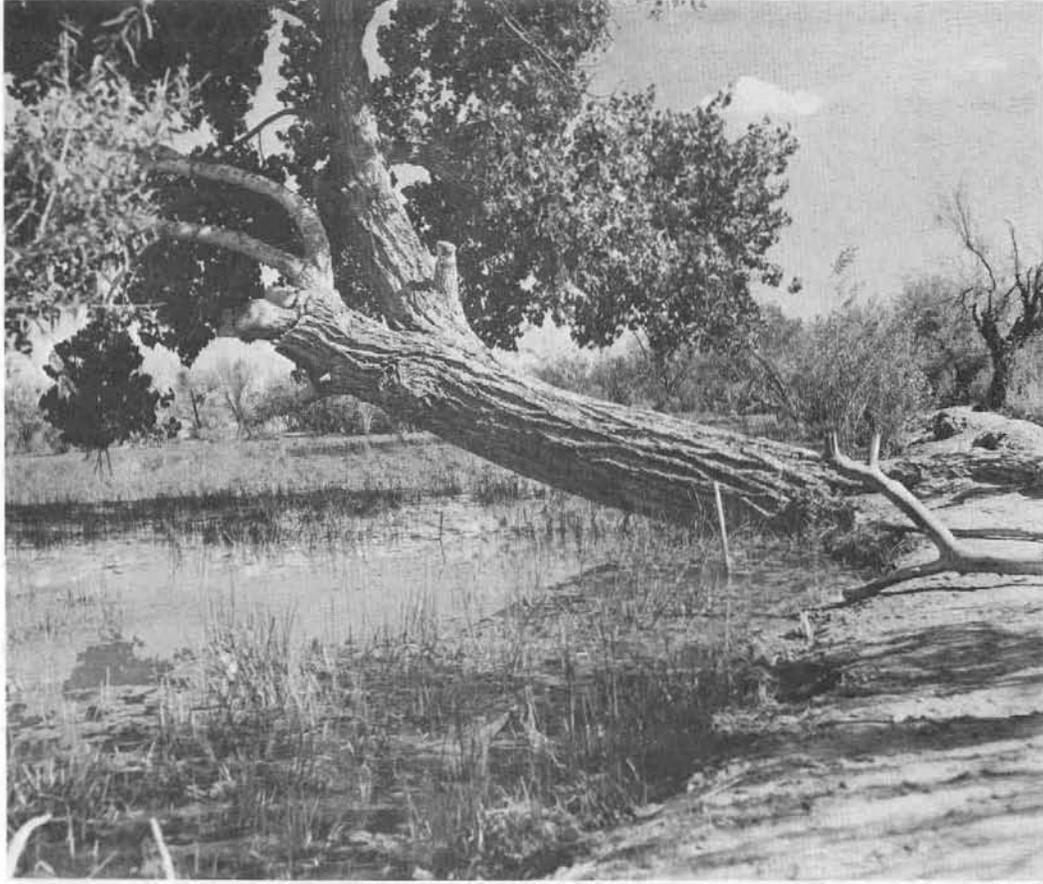
Figure 17a. Photograph shows the old cottonwood tree, growing on the Quitobaquito dam several years prior to the 1961 pond excavation. Note the angle of the trunk in relation to the pond surface. This tree poses a serious threat to the integrity of the dam. [Photo J.M. Eden and F.H. Jacot, 8-21-1957, monument files B-59].

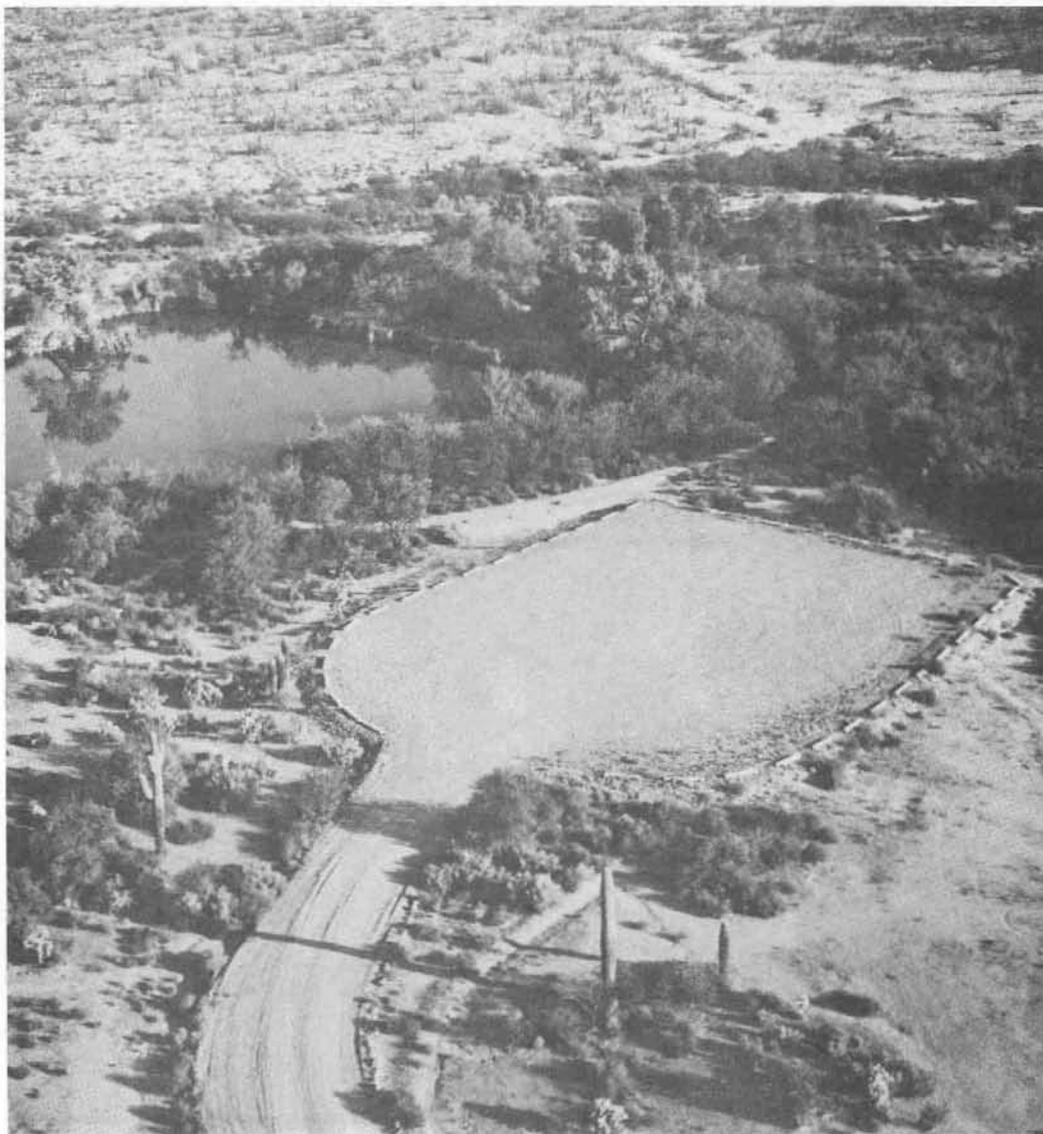
Figure 18a. View of visitor parking lot at Quitobaquito Pond. Photograph taken in April 1968 shows an aerial view of the pond and parking lot. The lot constructed in 1962 was quite close to the pond, allowing drive up access. We believe that this convenient access encouraged visitors to release pet turtles and bait fish such as the Golden Shiner into the pond. Palm trees and domestic ducks have also been found in the area. [Photo Begeman, monument files W-46].
