TECHNICAL REPORT NO. 26

A History of the Quitobaquito Resource  
Management Area, Organ Pipe Cactus  
National Monument, Arizona

October 1989

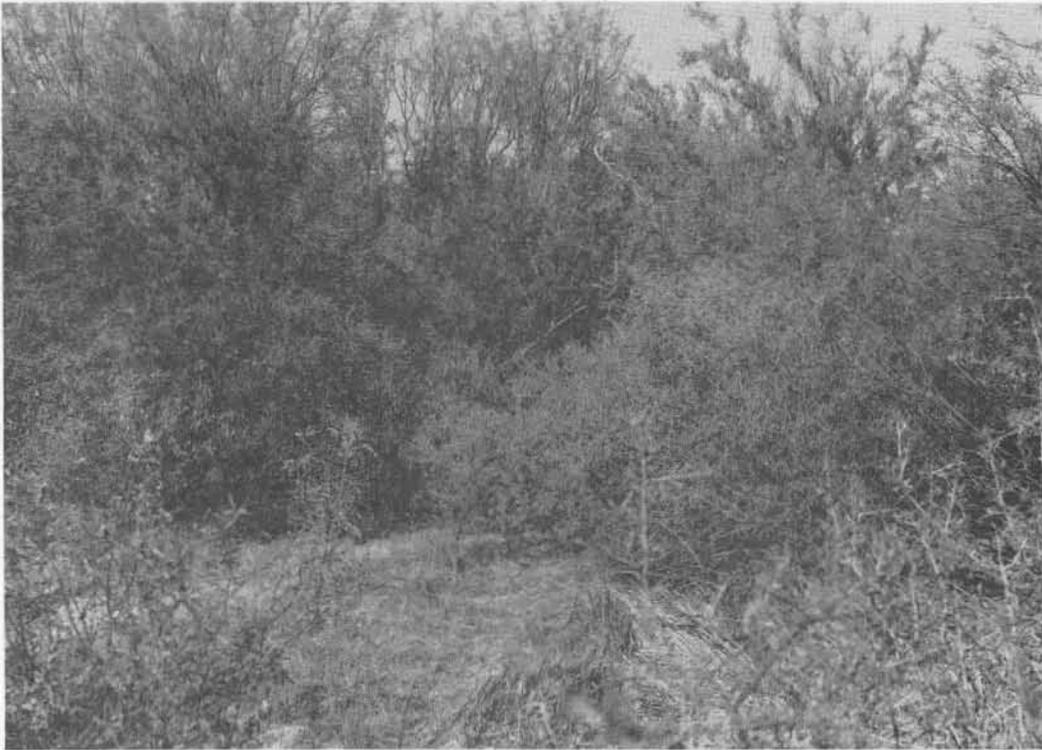
Figure 19b. This is a photograph taken on December 11, 1988 from the same location as Figure 19a. The old ditch can be faintly seen running through the center of the photograph. Since 1969, mesquite, graythorn, Anderson Wolfberry, and Parish Wolfberry have formed a steadily closing impenetrable thicket at the site. In the few openings remaining saltgrass, brickellia, and tarweed lead a precarious existence. In the foreground right, note the remnants of Alkali Bullrush remaining from times before the mesquite bosque out competed other moisture loving vegetation. [Photo P. Bennett].

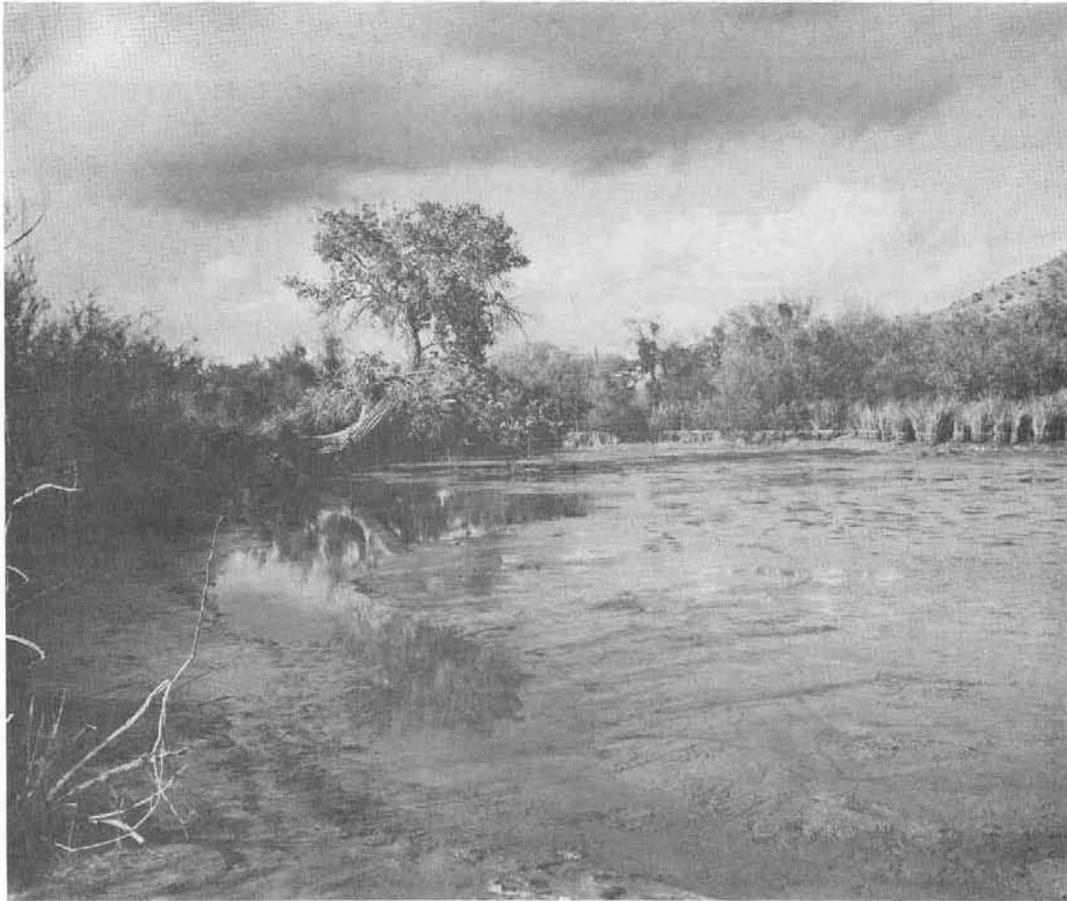
Figure 20b. Photograph was taken on December 9, 1969. Quitobaquito pond has been completely pumped out. Arizona Game and Fish employees are seining out the last of the Desert Pupfish to be salvaged. The pond bottom and banks were sprayed with a strong rotenone solution. Then the pond was allowed to dry out for several weeks before the spring flow was allowed to begin the filling process. None of the Golden Shiners survived this treatment. The Alkali Bullrush have formed an impressive and impenetrable stand along the north shore. The salt crust on the plants marks the pond level. [Begeman, monument files Q-7].

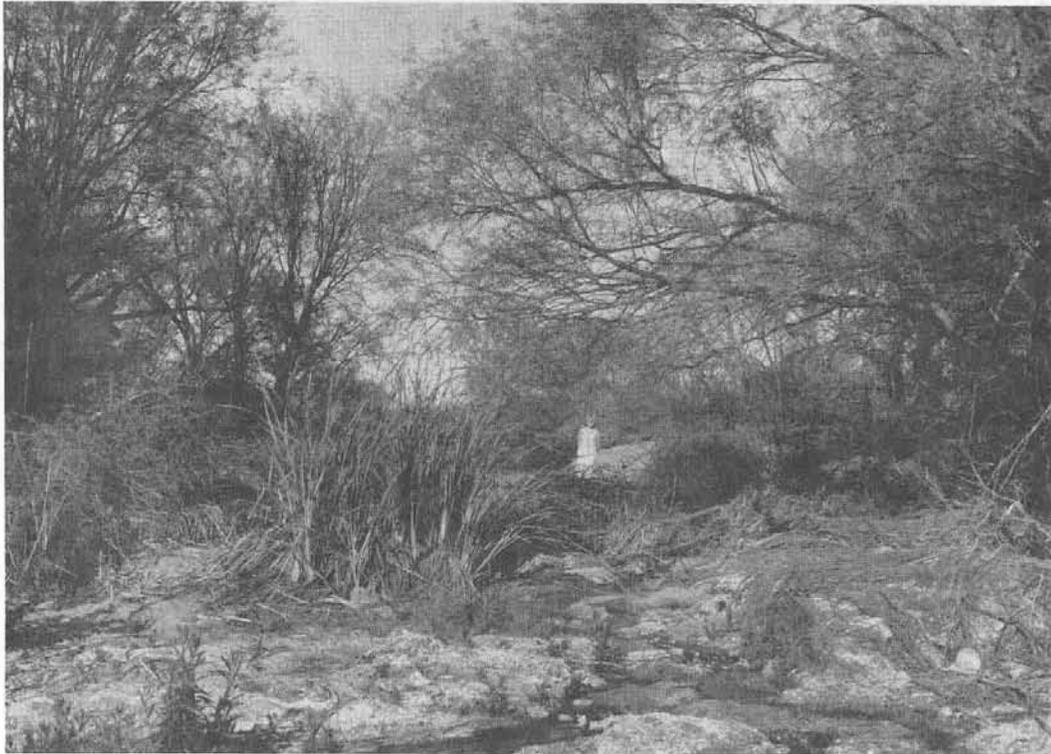
Figure 21b. Photograph of Aquajita Spring taken December 11, 1988. Until heavy summer floods in 1988 scoured the area, this spot was an impenetrable tangle. Note the presence of tamarisk, an exotic species, at the extreme right. Cattails *Typha* spp. were reported from Quitobaquito and Aquajita Spring until 10 years ago. They are still absent or dormant at Quitobaquito, but have become active again at Aquajita following the flood. This species may depend on disturbance and be unable to compete in climax communities at desert waterholes. [Photo P. Bennett].
