Administration Building, Casa Grande National Monument

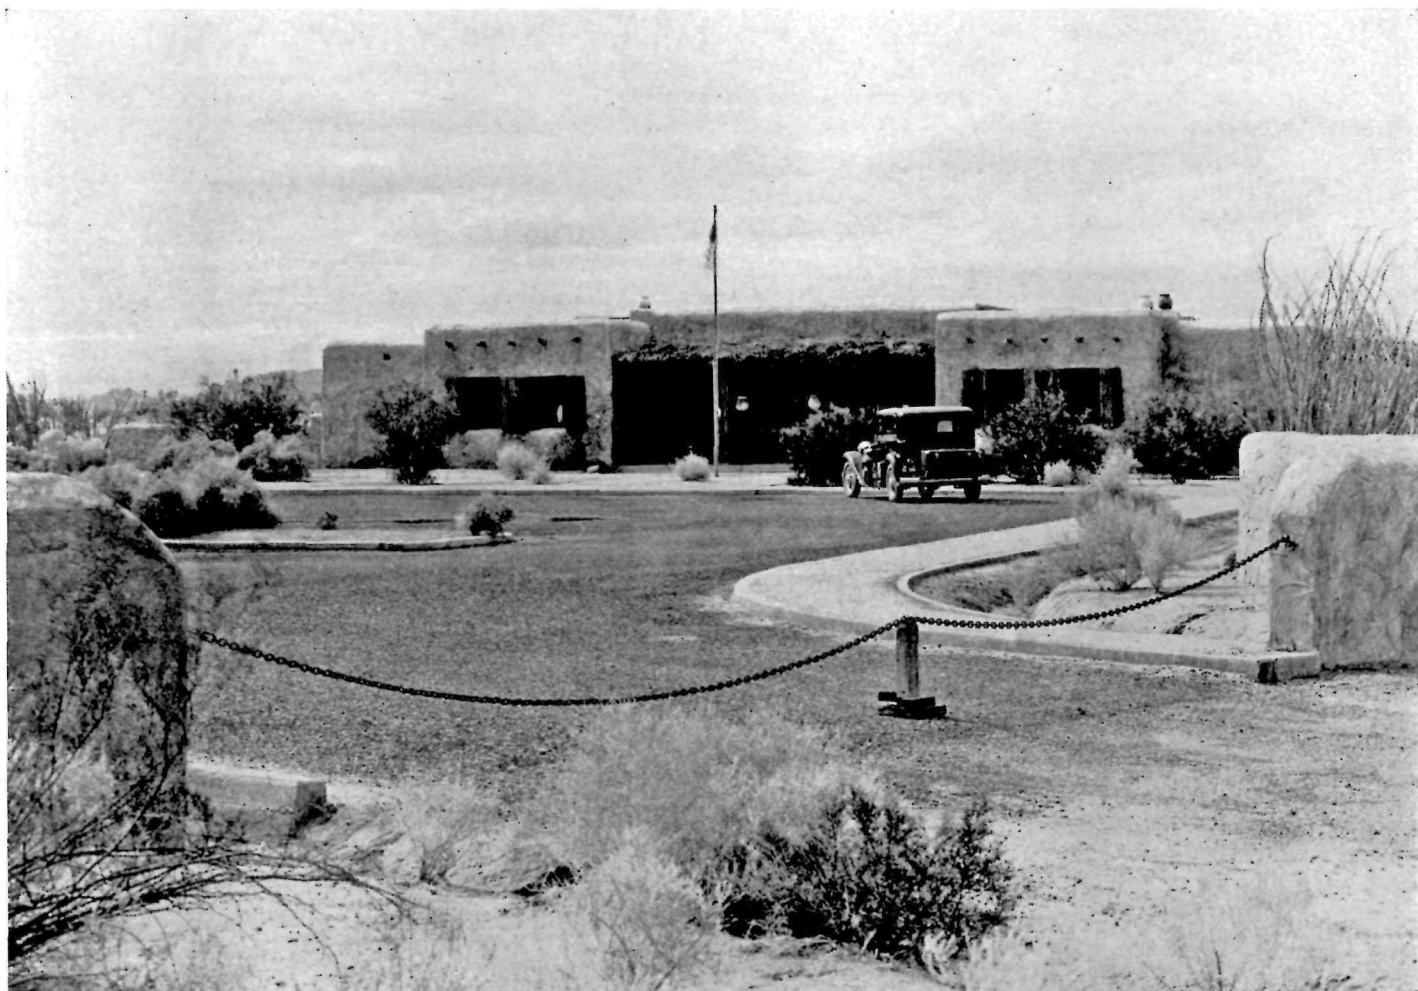
FLOOR PLAN  
Scale 1/2" = 1'-0"

Adobe, in gesture to tradition, and low, in keeping with the surrounding expanse of level terrain, this building is definitely and excellently custom-tailored to the Southwest. It houses various facilities that have legitimate function as phases of park administration and conveys impressively a feeling of organized administrative authority. The architectural style is related to that of the entrance-way and entrance sign of this same park. These subjects are shown elsewhere in this collection.

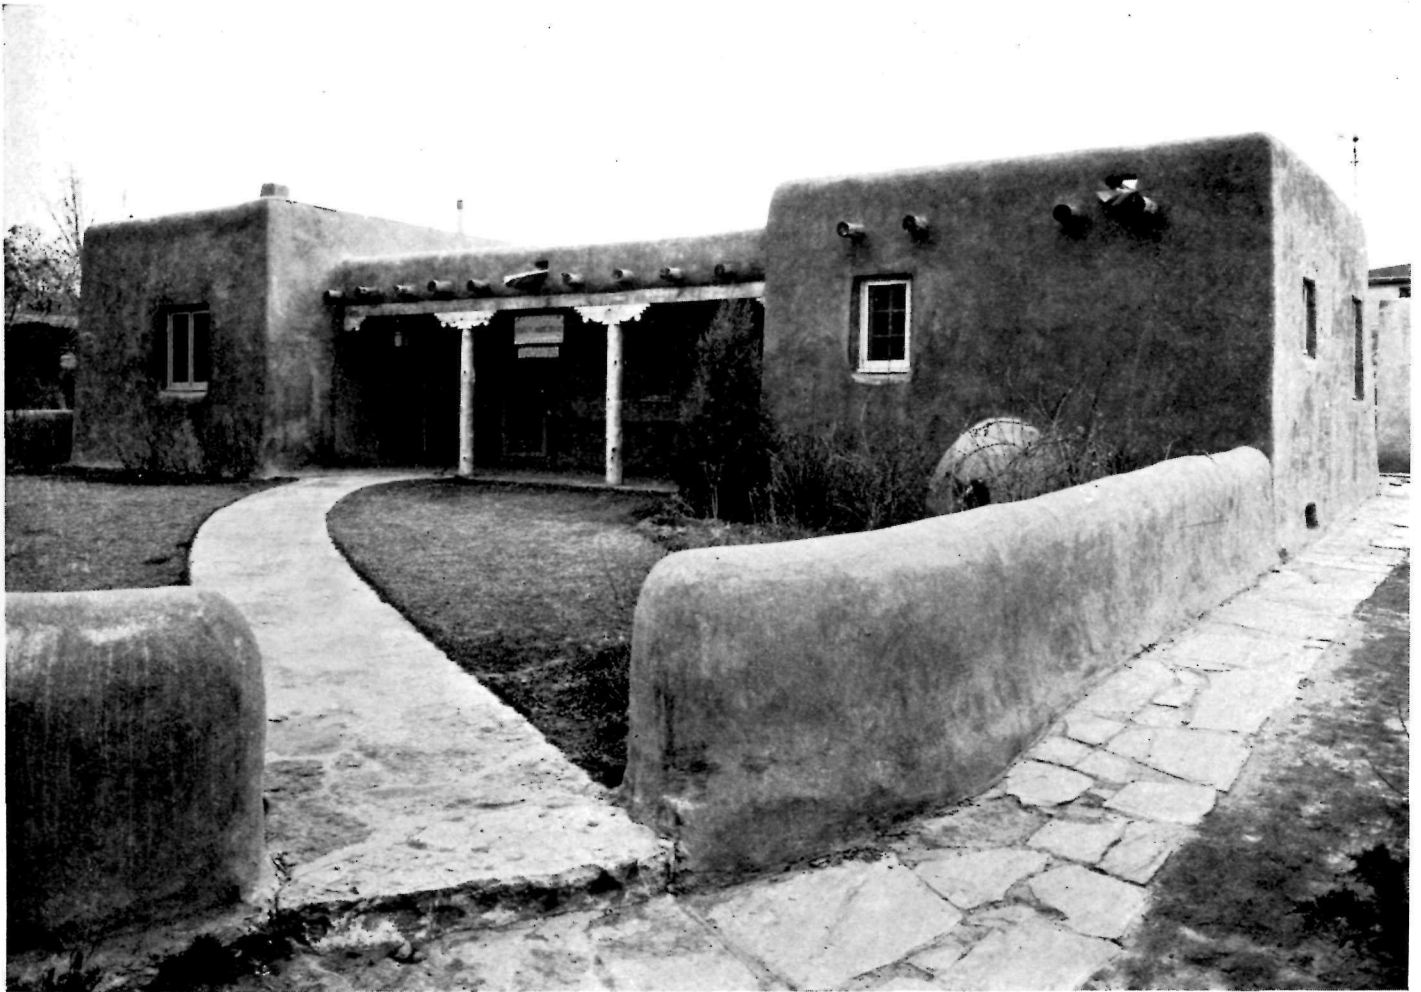
FLOOR PLAN  
Scale  $\frac{1}{16}'' = 1'-0''$

*State Park Administration Building, Santa Fe, New Mexico*

Here are headquarters from which presumably a system of State parks is administered. It carries on the traditions of the adobe architecture of the Southwest in its few and small window openings,

the projecting pole rafters, the rounding of all corners, and the shaped brackets surmounting the log posts of the recessed porch. Its location in a town explains the unfortunately cramped setting.

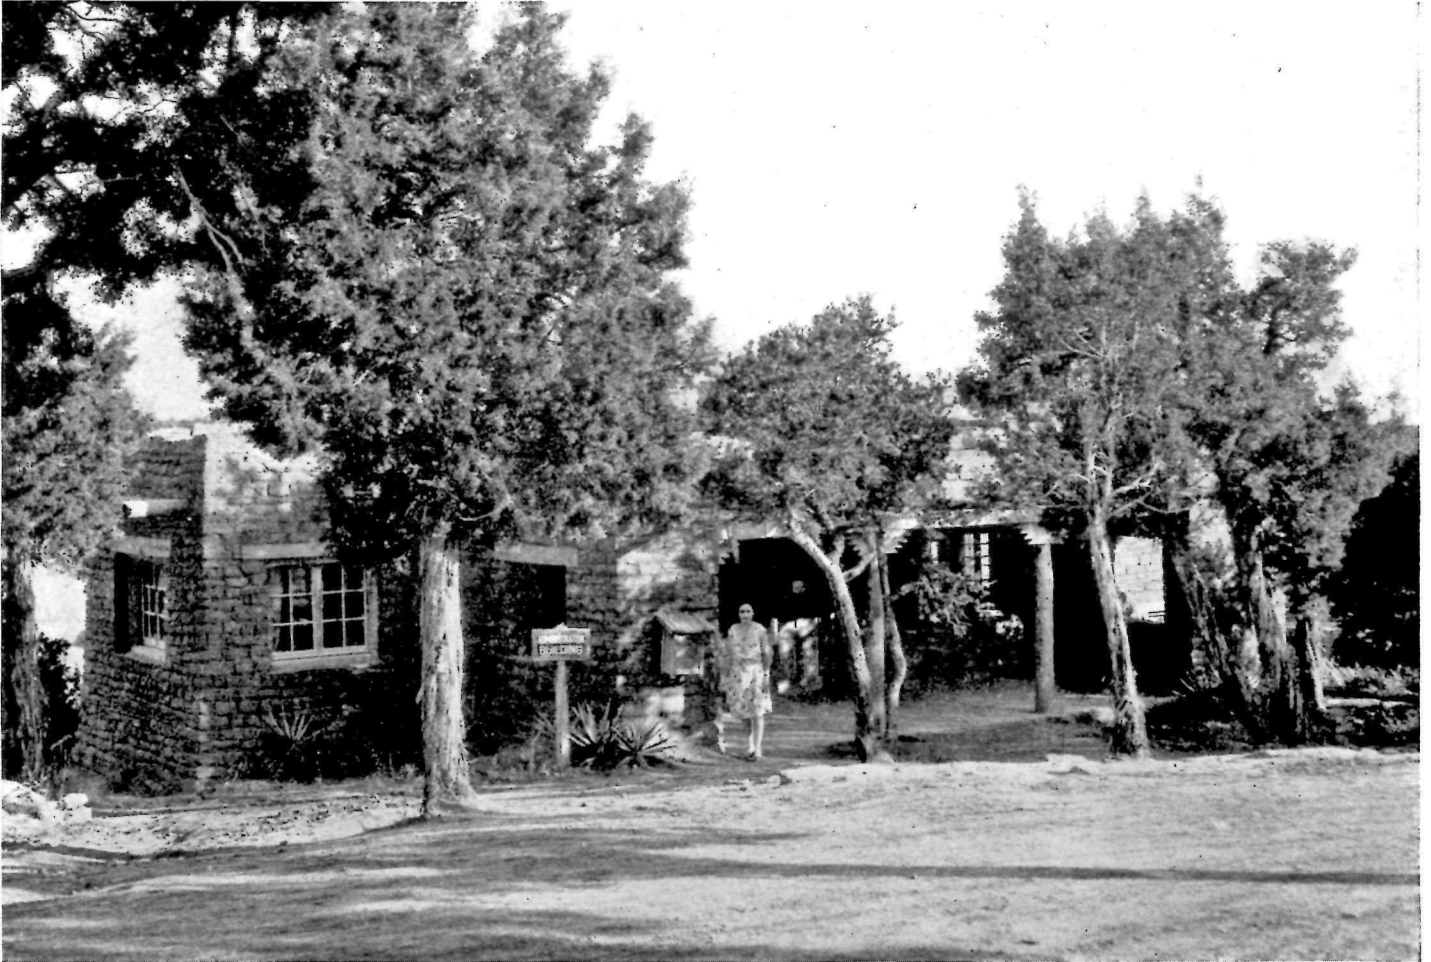
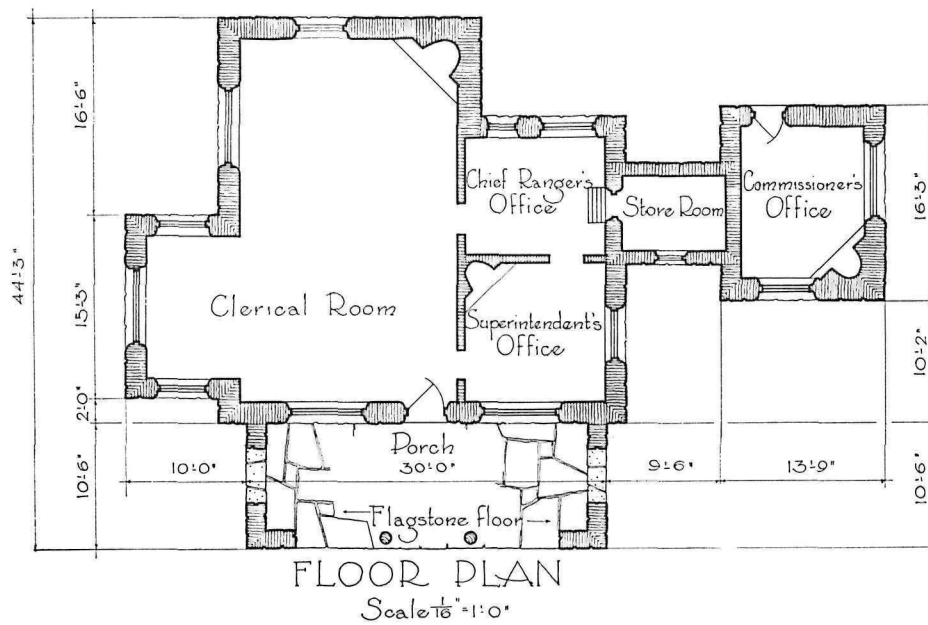
Administration Building, Mesa Verde National Park

Here is exemplified that unusual park structure, an administration building that does not accumulate other functions to gain impressive bulk. Informal

in plan and exterior, it relates well to the other buildings in this national park, several of which are included under other classifications.

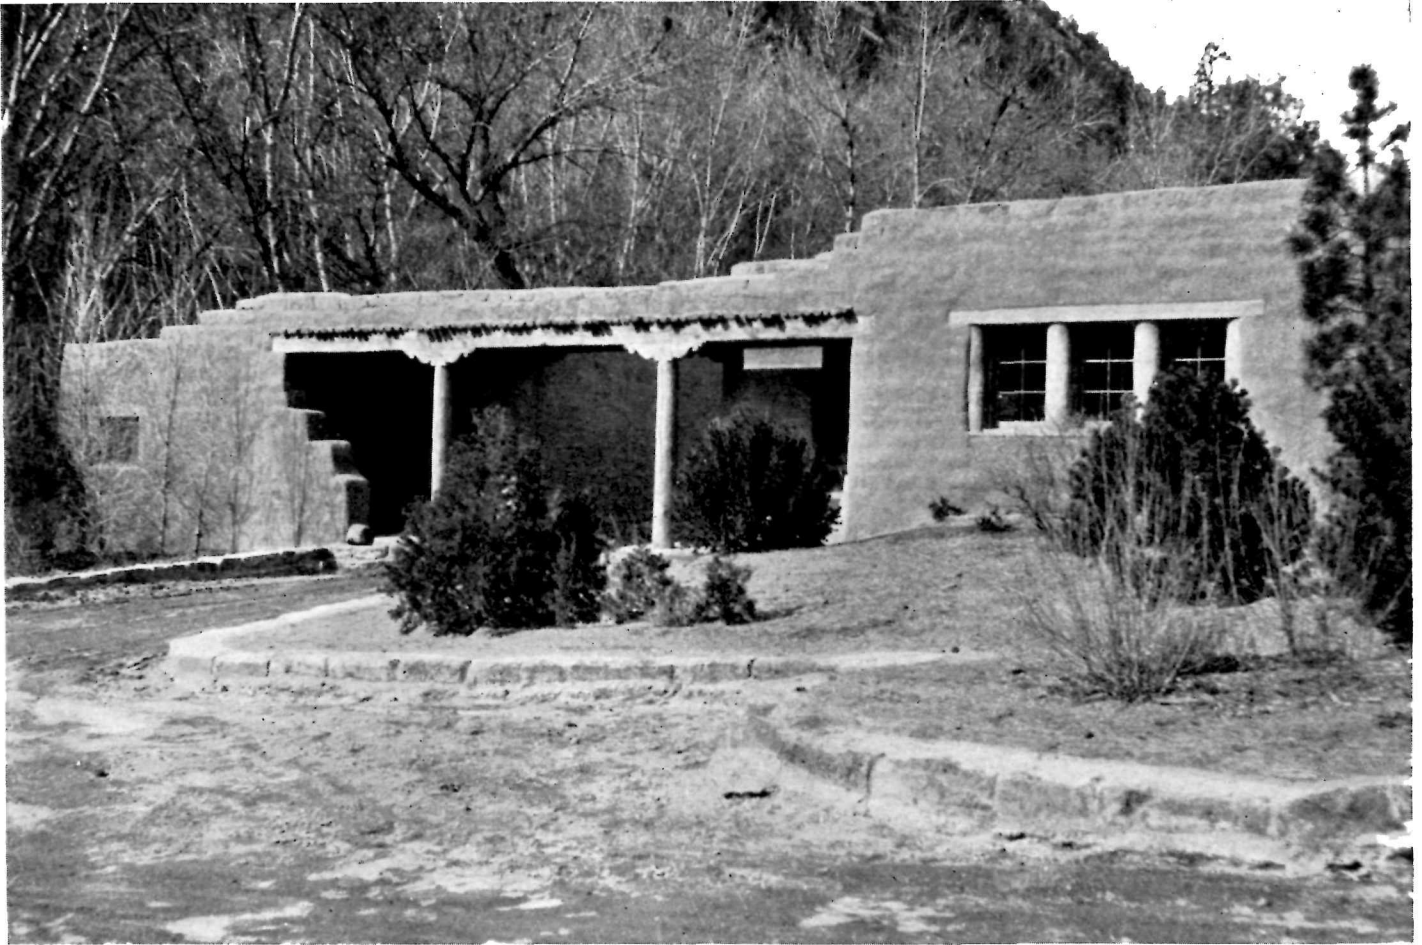
*Administration Building, Bandelier National Monument*

Some buildings win admiration for their very simplicity and modest size, if reinforced with good proportions and textures harmonious with surroundings. Here is one such. It is representative of structure housing administration in minimum terms. For an illustration of the meaning and desirability of singleness of architectural expression or theme in one area, the service group at Bandelier National Monument shown elsewhere should be compared with this plate.

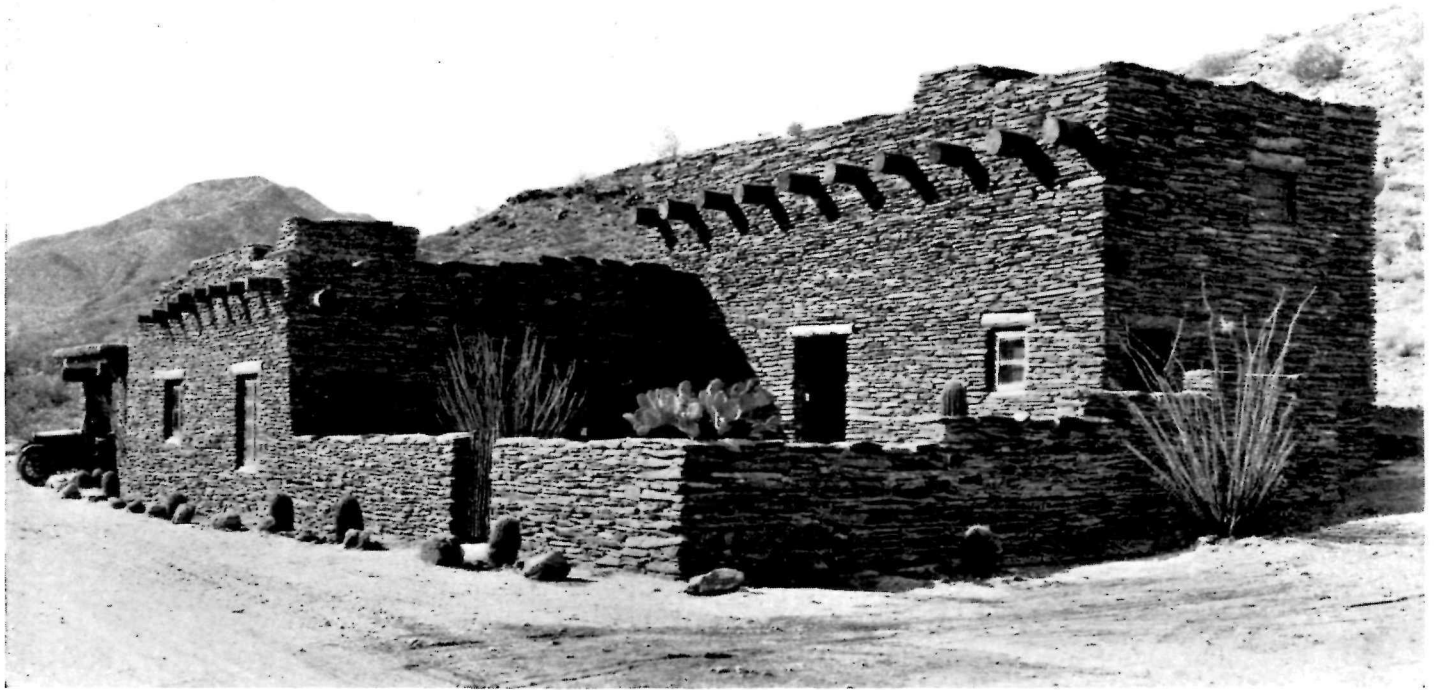
Administration Building, Phoenix South Mountain Metropolitan Park, Arizona

In continuing prehistoric Pueblo structural tradition this building extends the vocabulary of park architecture to include a pleasing and welcome regional expression eminently suited to the Southwest. Interest is caught by the unusual character of the masonry, the several levels of the roof, the haphazard lift and drop of the parapets, and the rhyth-

mic shadows cast by the projecting pole vigas. As is so frequently the case with administration buildings, the plan shown above does not particularly evidence administrative function. The combination of caretaker's quarters, service courtyard, and museum forms more accurately administration "point" than administration building.

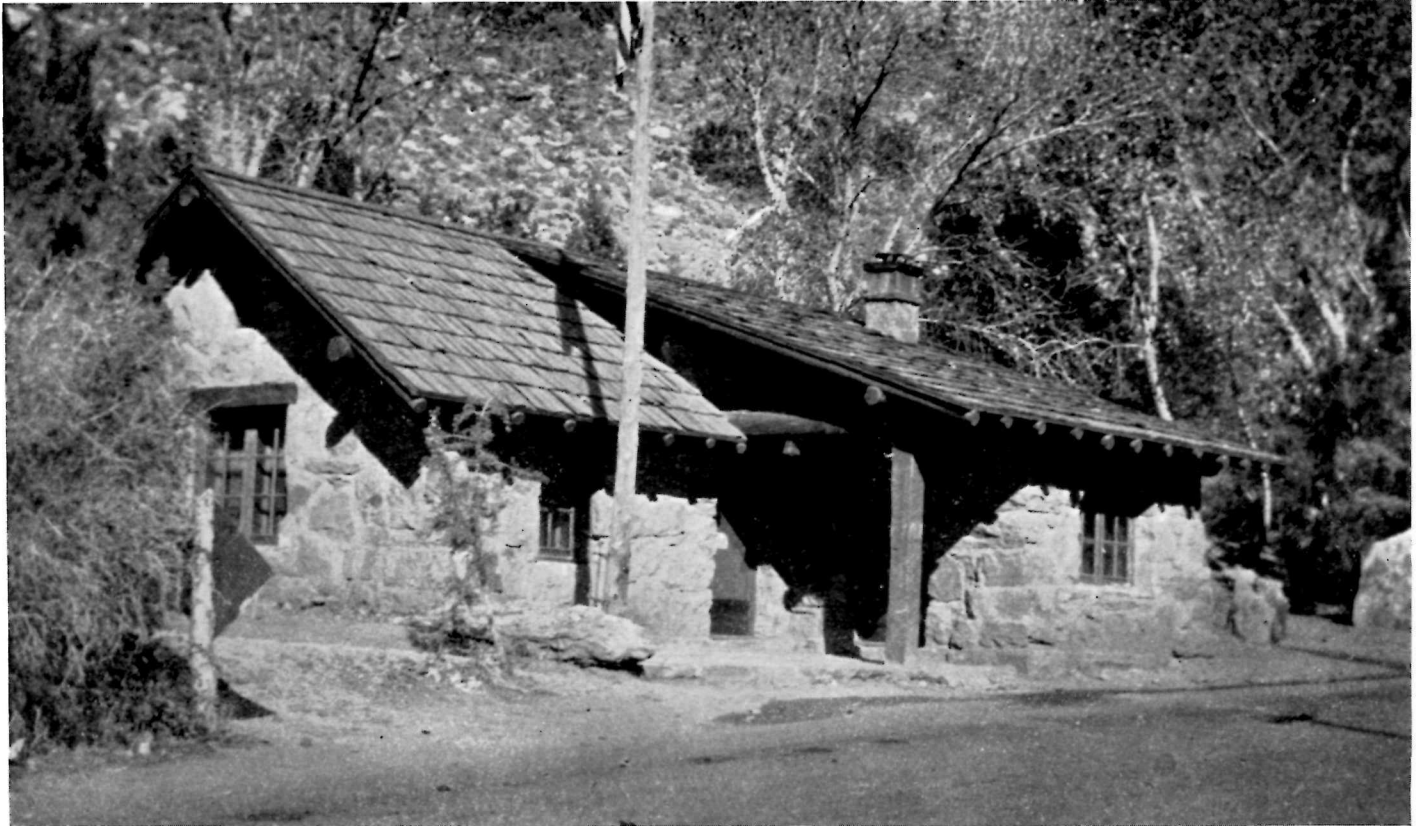
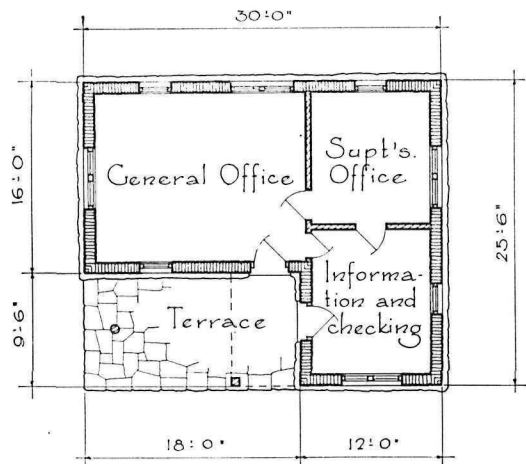
FLOOR PLAN  
Scale 1/8" = 1:0"

*Administration Building, Zion National Park*

The routine functions of administration and contact with the public are here combined in a small building of straightforward plan and the appearance of fitting very well its site at the base of the towering walls of Zion Canyon. Impression is gained that in any future need for expanding administrative facilities the present building will lend itself to alterations and additions with a minimum of disturbance to existing construction.

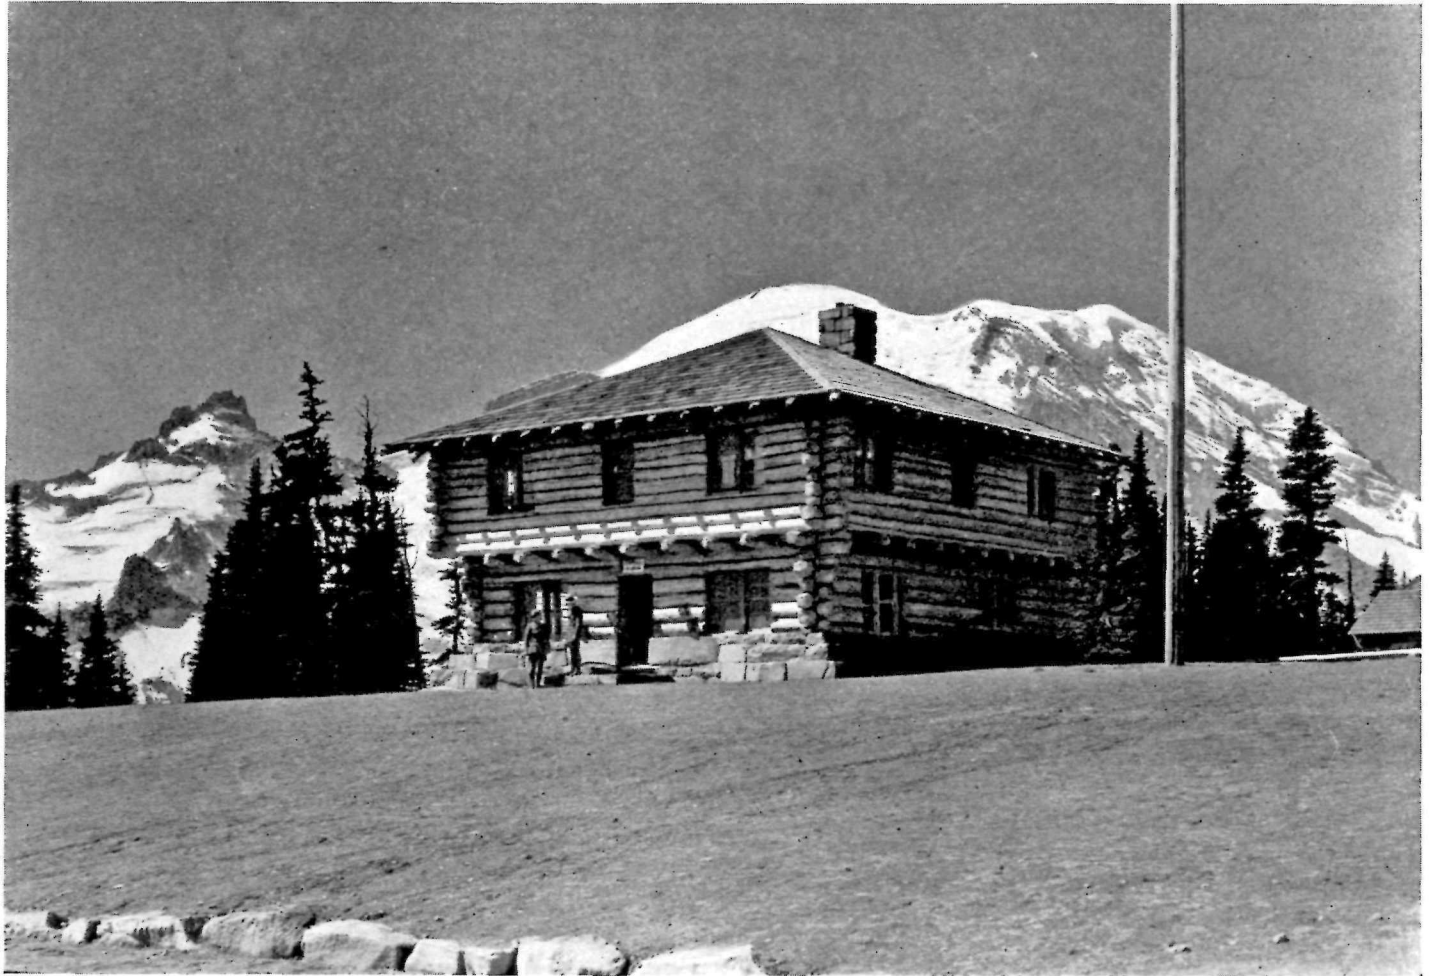
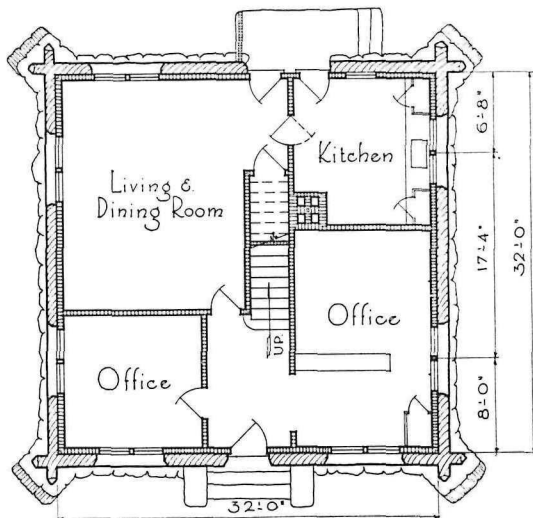
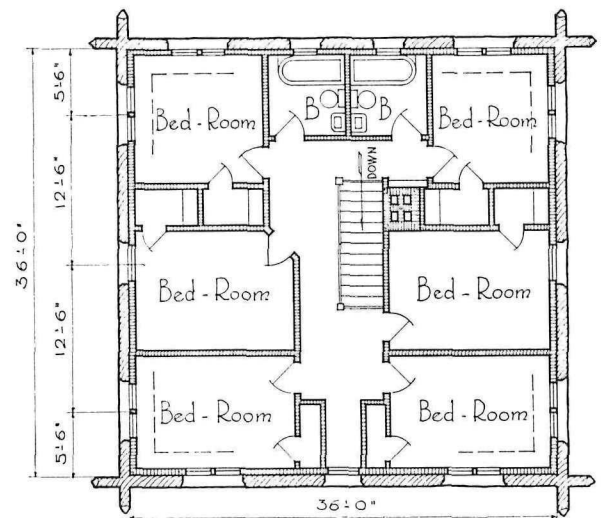
FIRST FLOOR PLAN

*Administration Building, Yakima, Mount Rainier National Park*

Even without benefit of the magnificent background afforded by Mount Rainier this log building would be an outstanding contribution to park architecture. Obviously, but not too self-consciously,

inspired by the early blockhouse, here is a building representative of logical and legitimate adaptation of a traditional form. The log work is neither too precise nor too laboriously rustic.

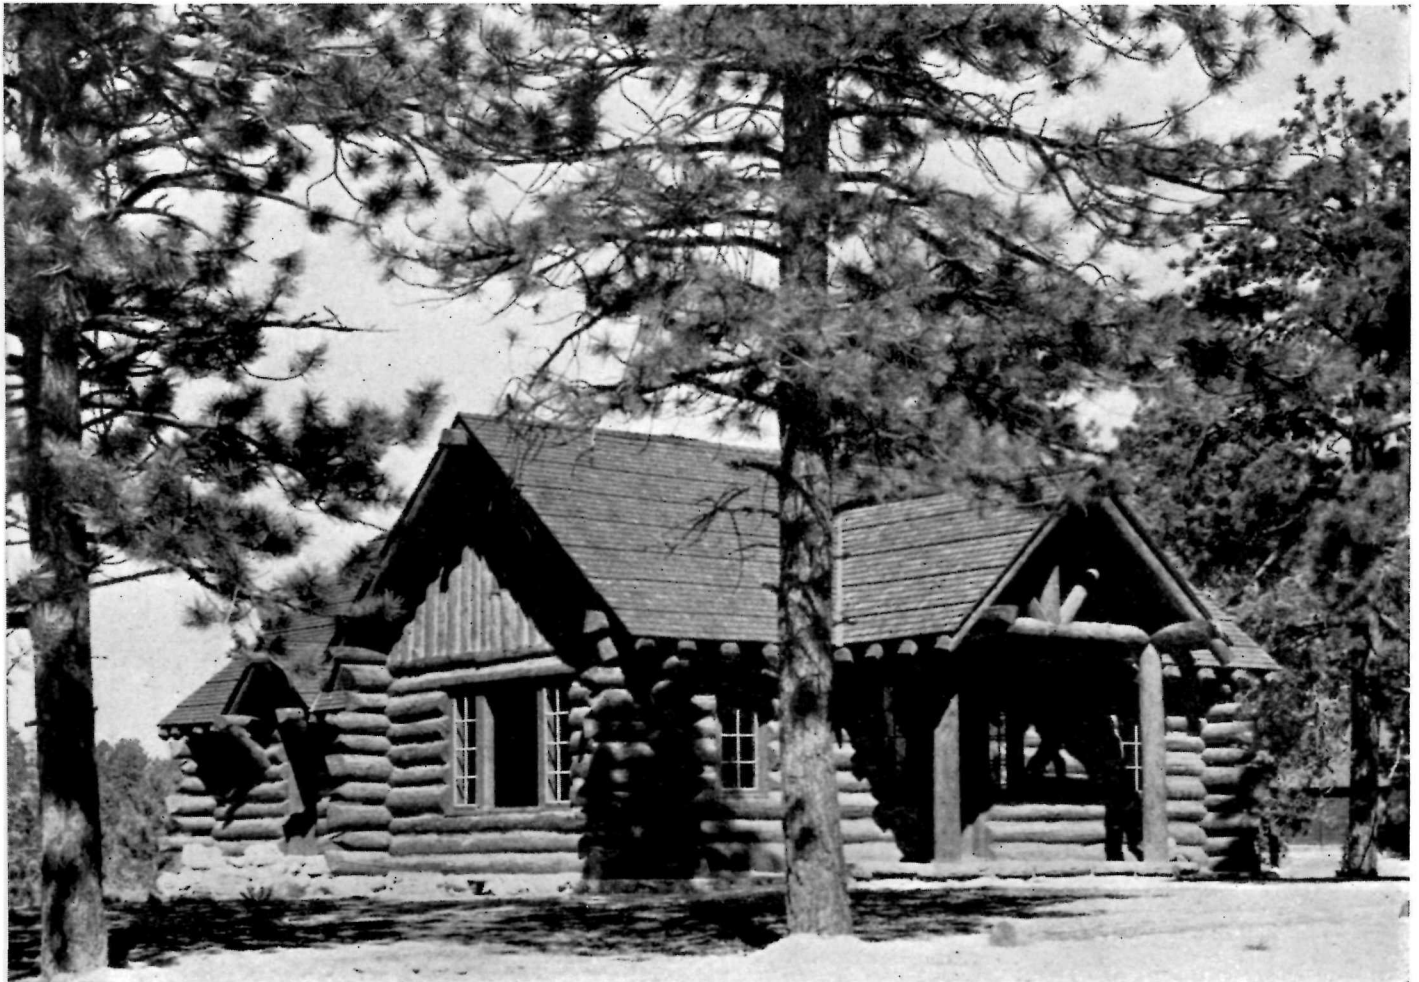
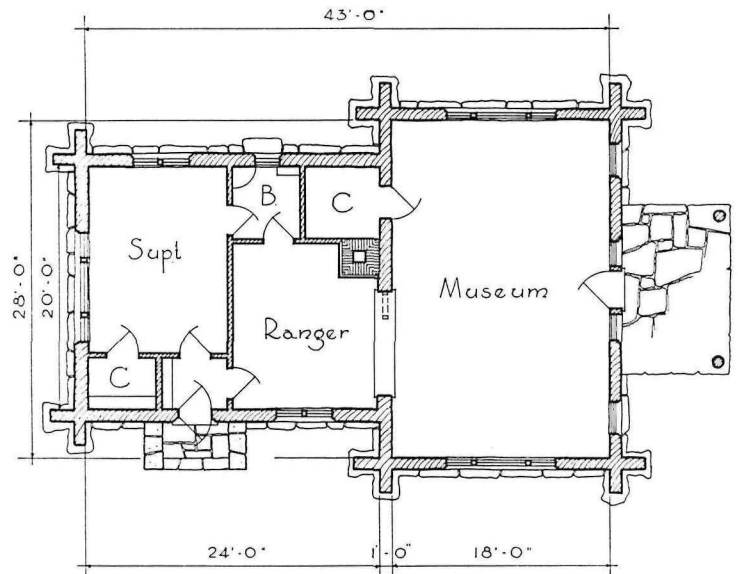
FLOOR PLAN  
Scale 1/8" = 1'-0"

*Administration Building, Bryce Canyon National Park*

In parks not accessible to great hordes of visitors, uncomplicated administration functions and a modest museum display can often be housed in one building to practical advantage. Such is the case here. It permits a limited personnel to do double duty and accumulates into one building of suitable size space that as two buildings could hardly avoid seeming trivial and inappropriate in a park of the magnificent distances offered by Bryce Canyon.

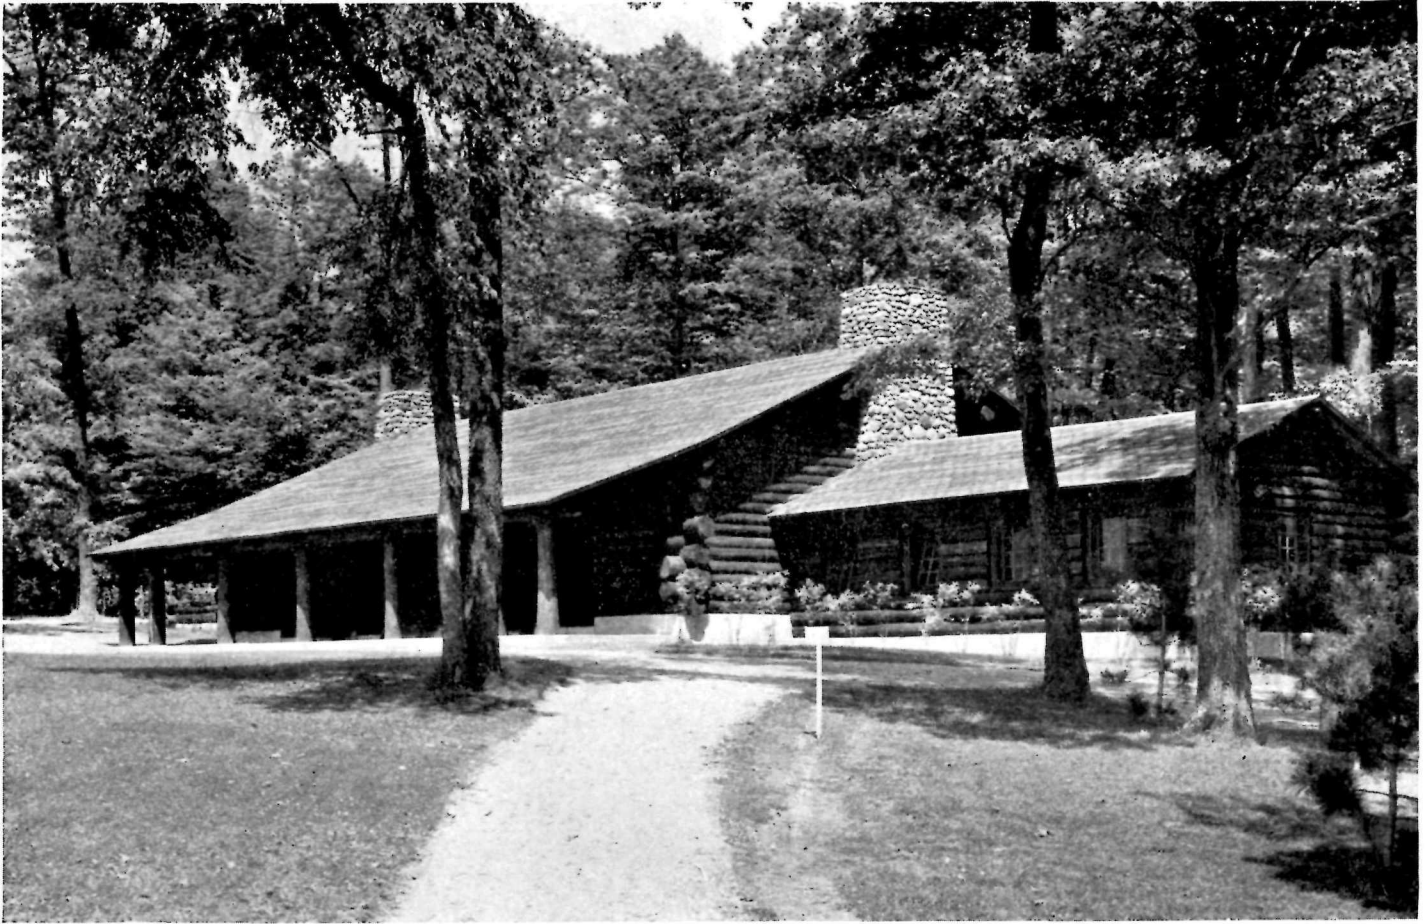
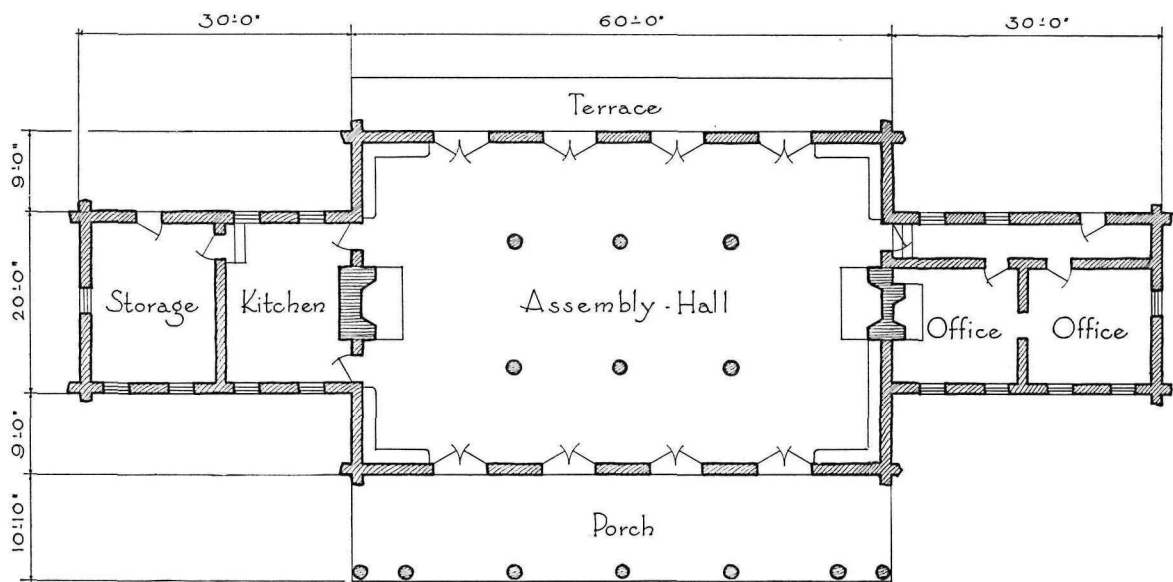
FLOOR-PLAN  
Scale  $\frac{3}{4}'' = 1'-0''$

*Administration Building, Selkirk Shores State Park, New York*

Impressive in extent for a log building and notable for the workmanship of the log construction and the broad sweep of the roof. The severity of the con-

crete base, the trivial boulder masonry of the chimneys, and the thinness of the covering material of the roof are disturbing details.

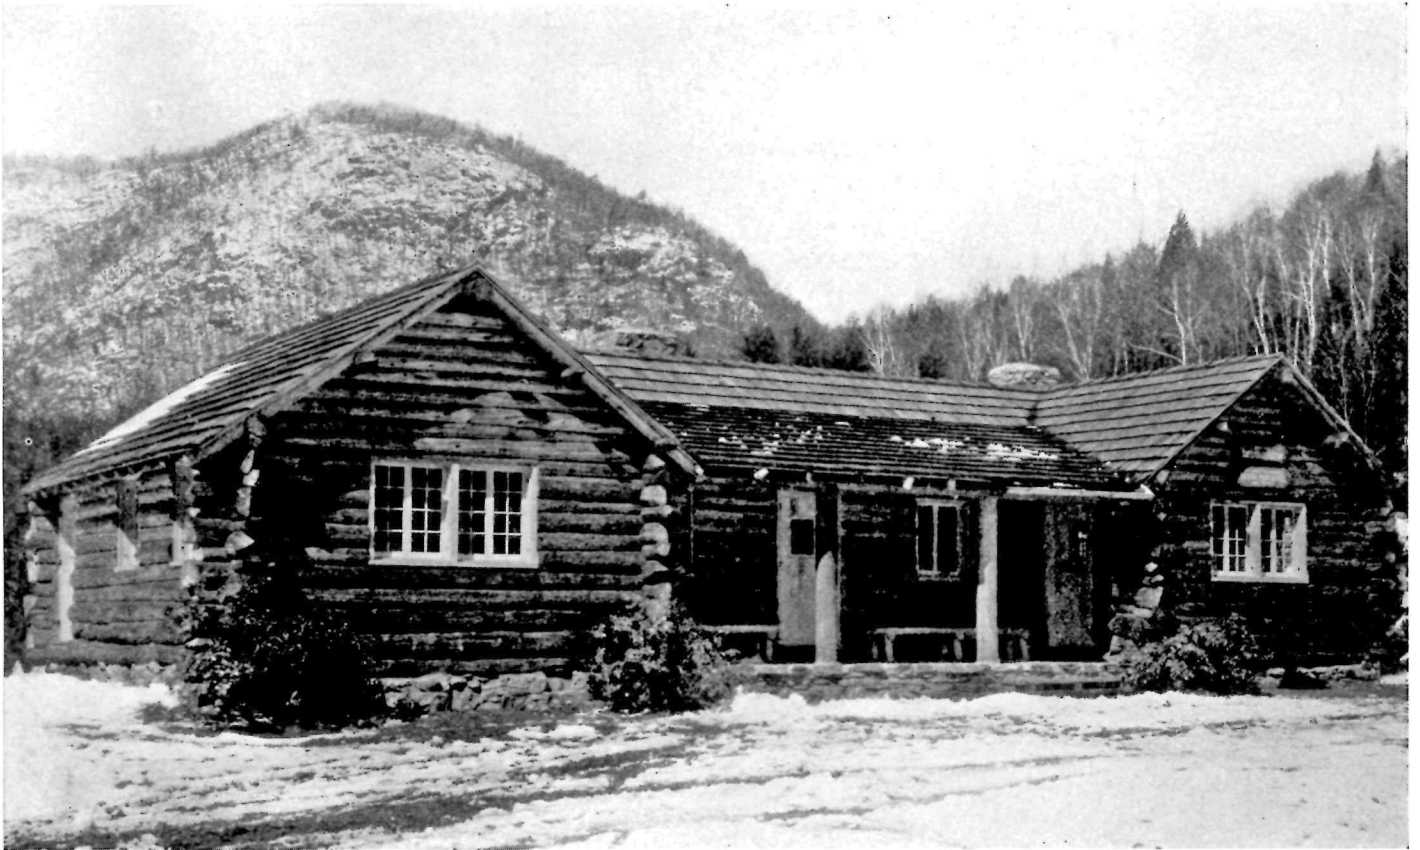
*Administration Building, Mohawk Trail State Forest Park, Massachusetts*

This altogether amiable building is rated a ten-strike in an area where the availability of long, straight logs is far from what it once was. The proportions and details of design and workmanship seem quite beyond reproach. Along with an am-

bitious log bridge at this same park, illustrated under "Bridges", this structure offers convincing testimony that all skilled craftsmanship in log construction did not march westward with the course of empire.

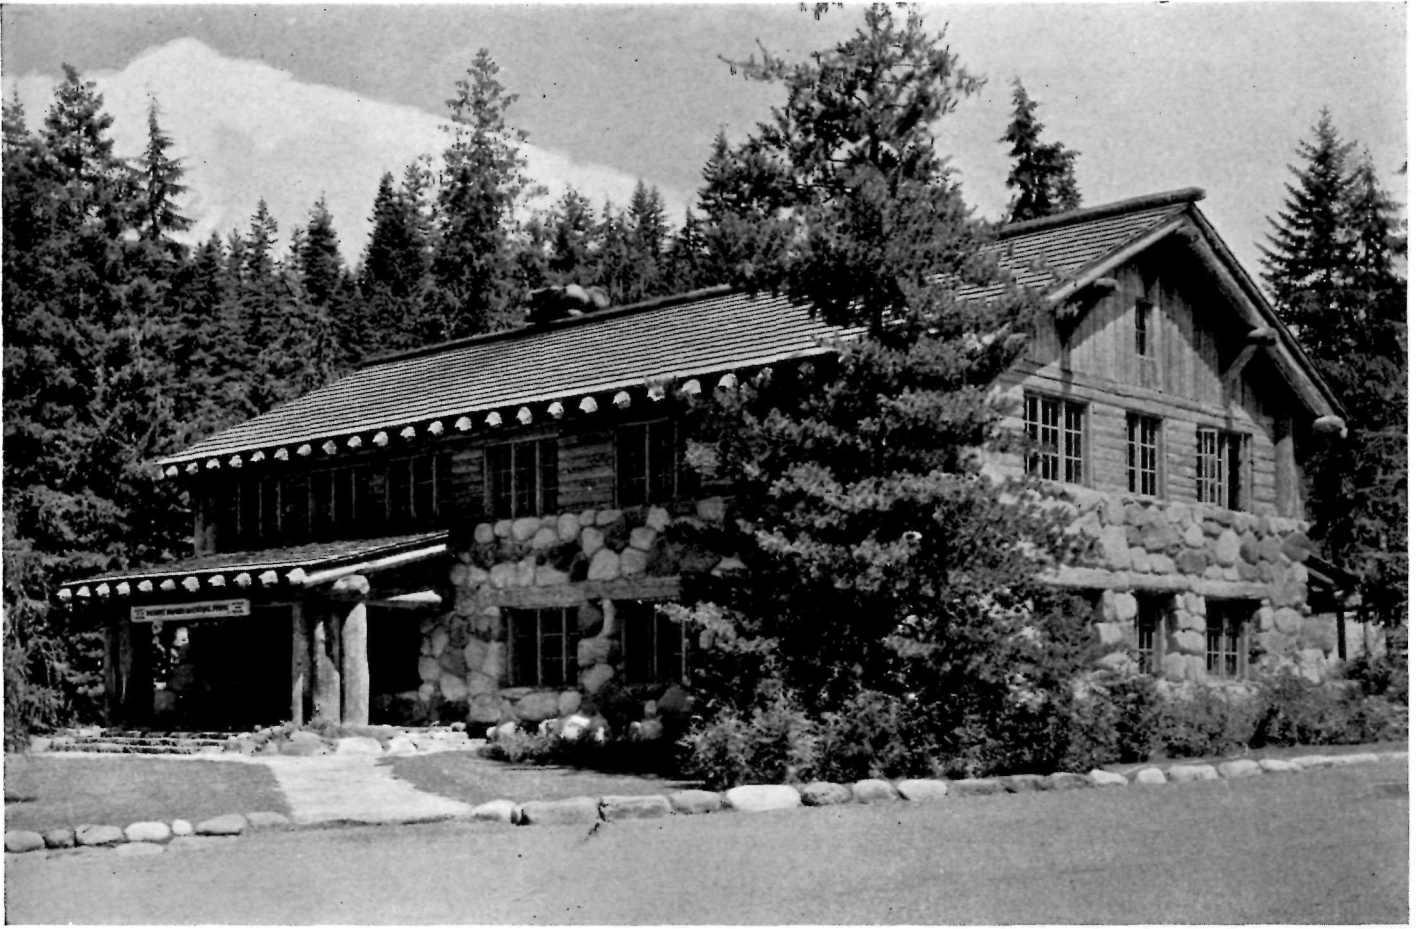
FIRST FLOOR PLAN

*Administration Building, Longmire, Mount Rainier National Park*

The plans on the opposite page exhibit the several functions that may accrue to an administration building in a major park. The employment of boulder masonry as here illustrated is usually dictated and only justified by the absence of more workable rock material within reasonable distance. However well handled, it seems impos-

sible to attain a satisfying appearance of stability. The rafters are appropriately vigorous in scale, and the blunted terminations of them are most agreeable. There is abundant provision of windows to insure a well-lighted interior without sacrifice of wall surfaces to the point where the exterior suffers in appearance.

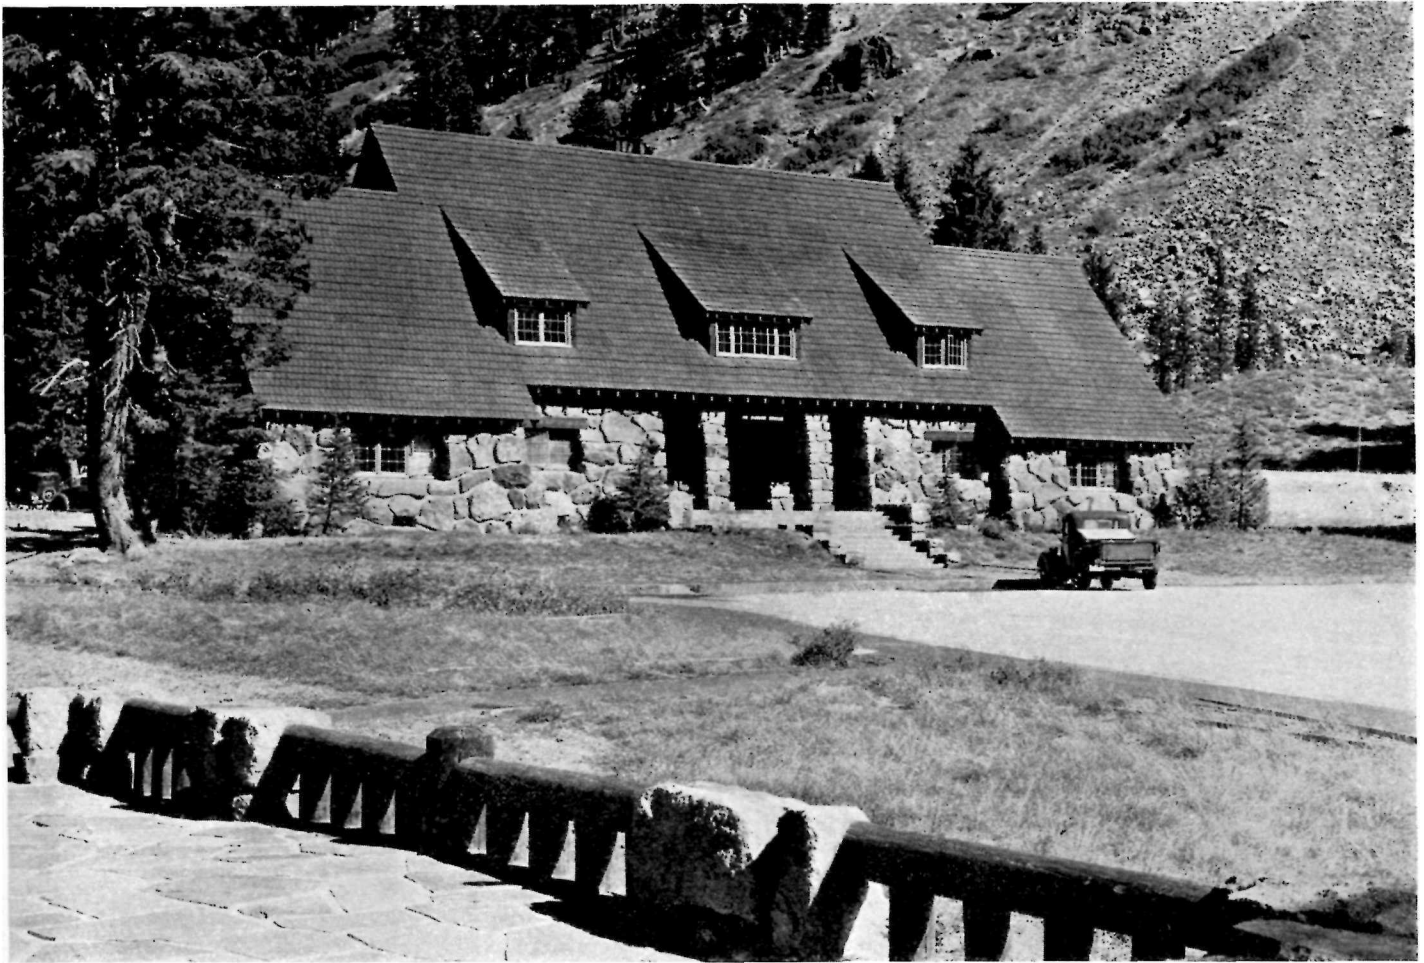
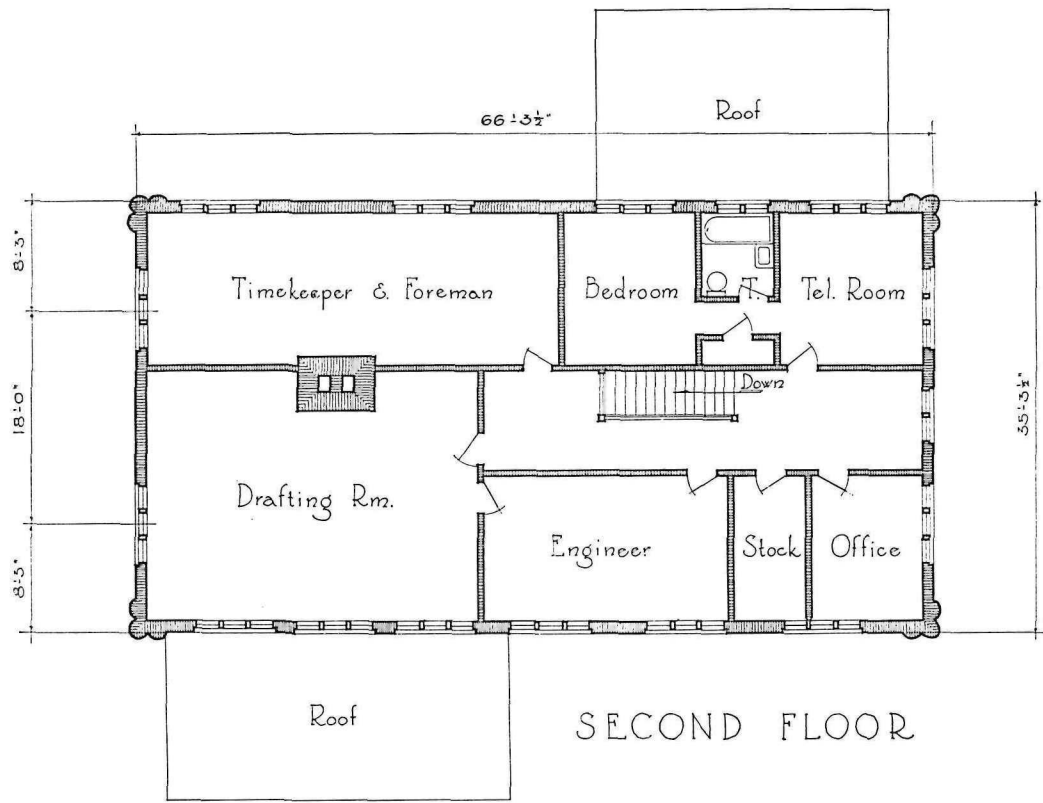
*Administration Building, Crater Lake National Park*

This large administration building and the example at Longmire, Mount Rainier, presented on a previous page, represent typical structural accommodations for the administrative activities and needs of a large park of national importance. First and second floor plans are delineated on the opposite page. The steep roof is dictated by the heavy snows of this area, which often accumulate and drift

to levels above the first story windows. Attention is called to the several structures for housing personnel at Crater Lake, illustrated under "Superintendents' and Staffs' Quarters", for the study of a pervading unity of structural treatment, the usual recommendation for all buildings of a particular area. Massive boulder masonry, stained timbers, steep roofs, and dormer windows are common to all.

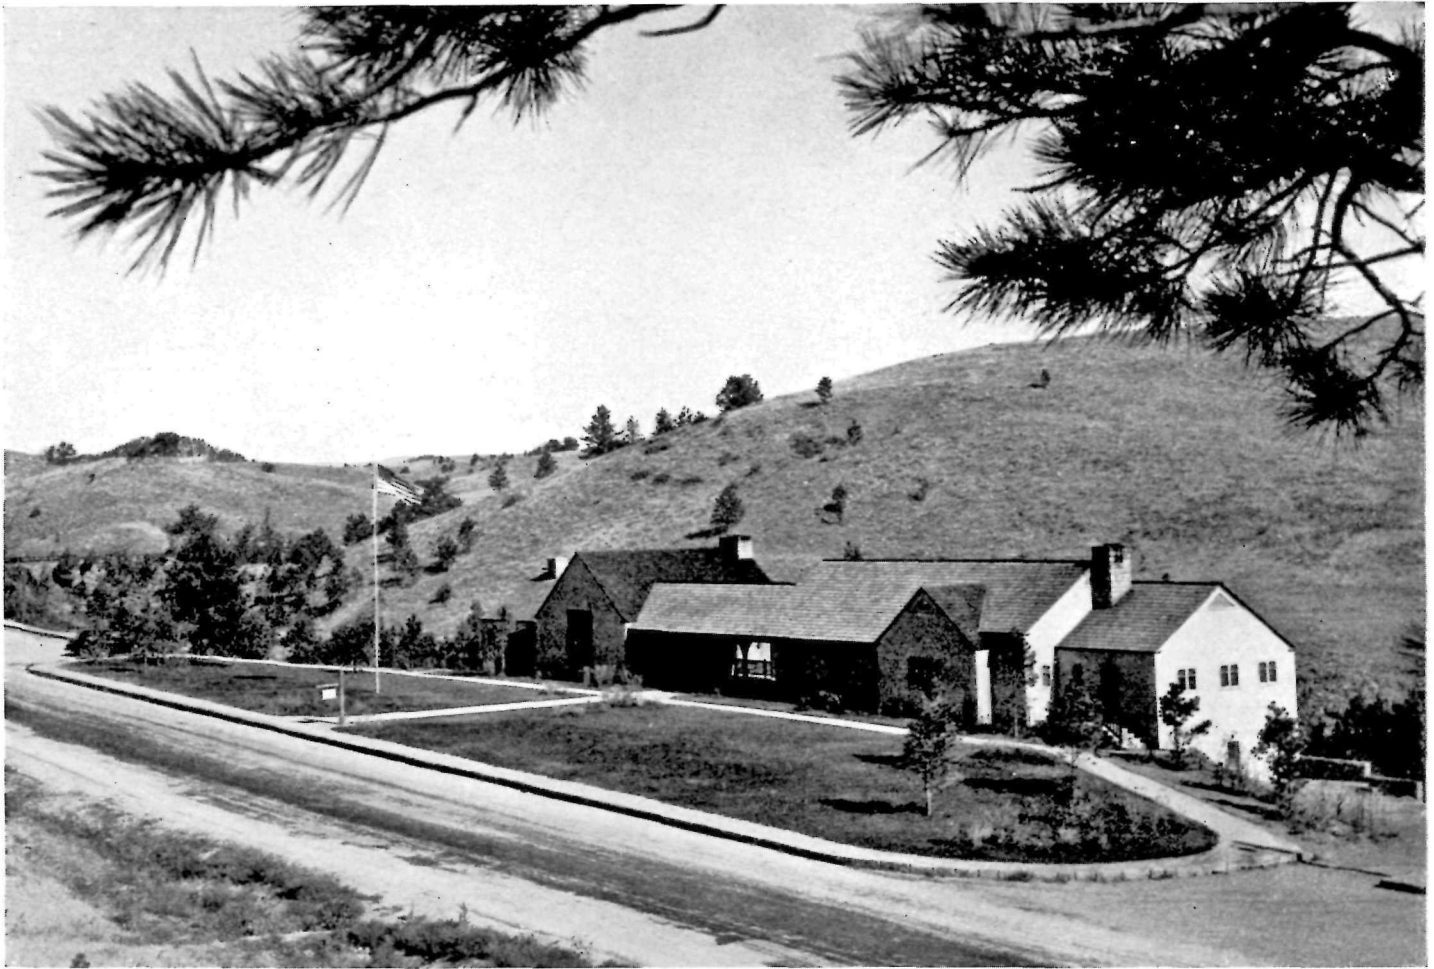
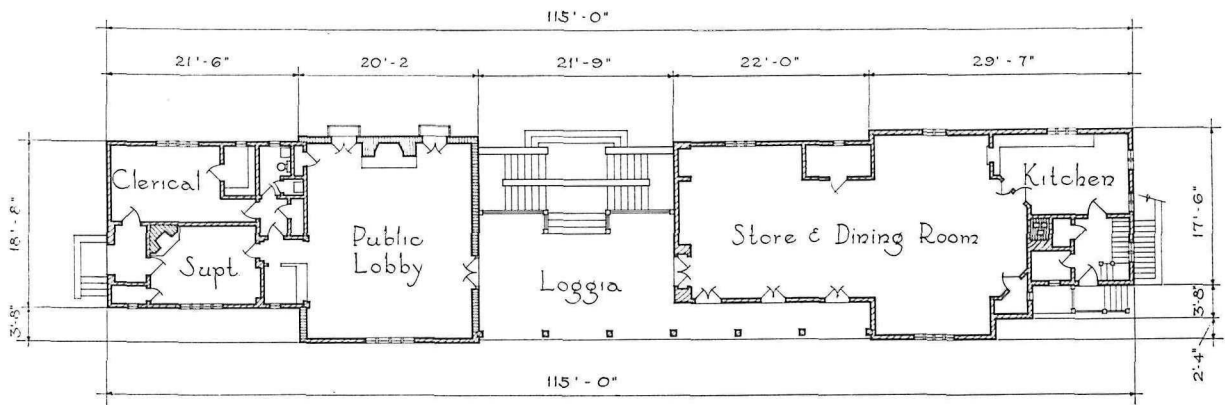
FLOOR PLAN  
Scale  $\frac{1}{8}$ " = 1'-0"

*Administration Building, Wind Cave National Monument*

The architectural expression found here departs in materials and manner of use from what one almost comes to expect in park construction. The widening of vocabulary is welcome, and this particular treatment is well undertaken in surroundings which are comparatively unwooded. The

long-drawn-out, narrow plan produces an exterior which gives the illusion of a building low in height. This also seems a proper effort in the setting pictured. The plan indicates the many related functions that accrue to the administration of a park domain of considerable extent.
