National Register of Historic Places Registration Form

historic name: Pipe Spring National Monument Historic District (Boundary Increase)

other name/site number: Fort Arizona, Pipe Spring(s) Fort, Pipe Spring(s) Ranch, Winsor Castle, Windsor Castle, Winsor Castle Ranch; HS-1-3; Buildings 50-52 (fort/cabins)

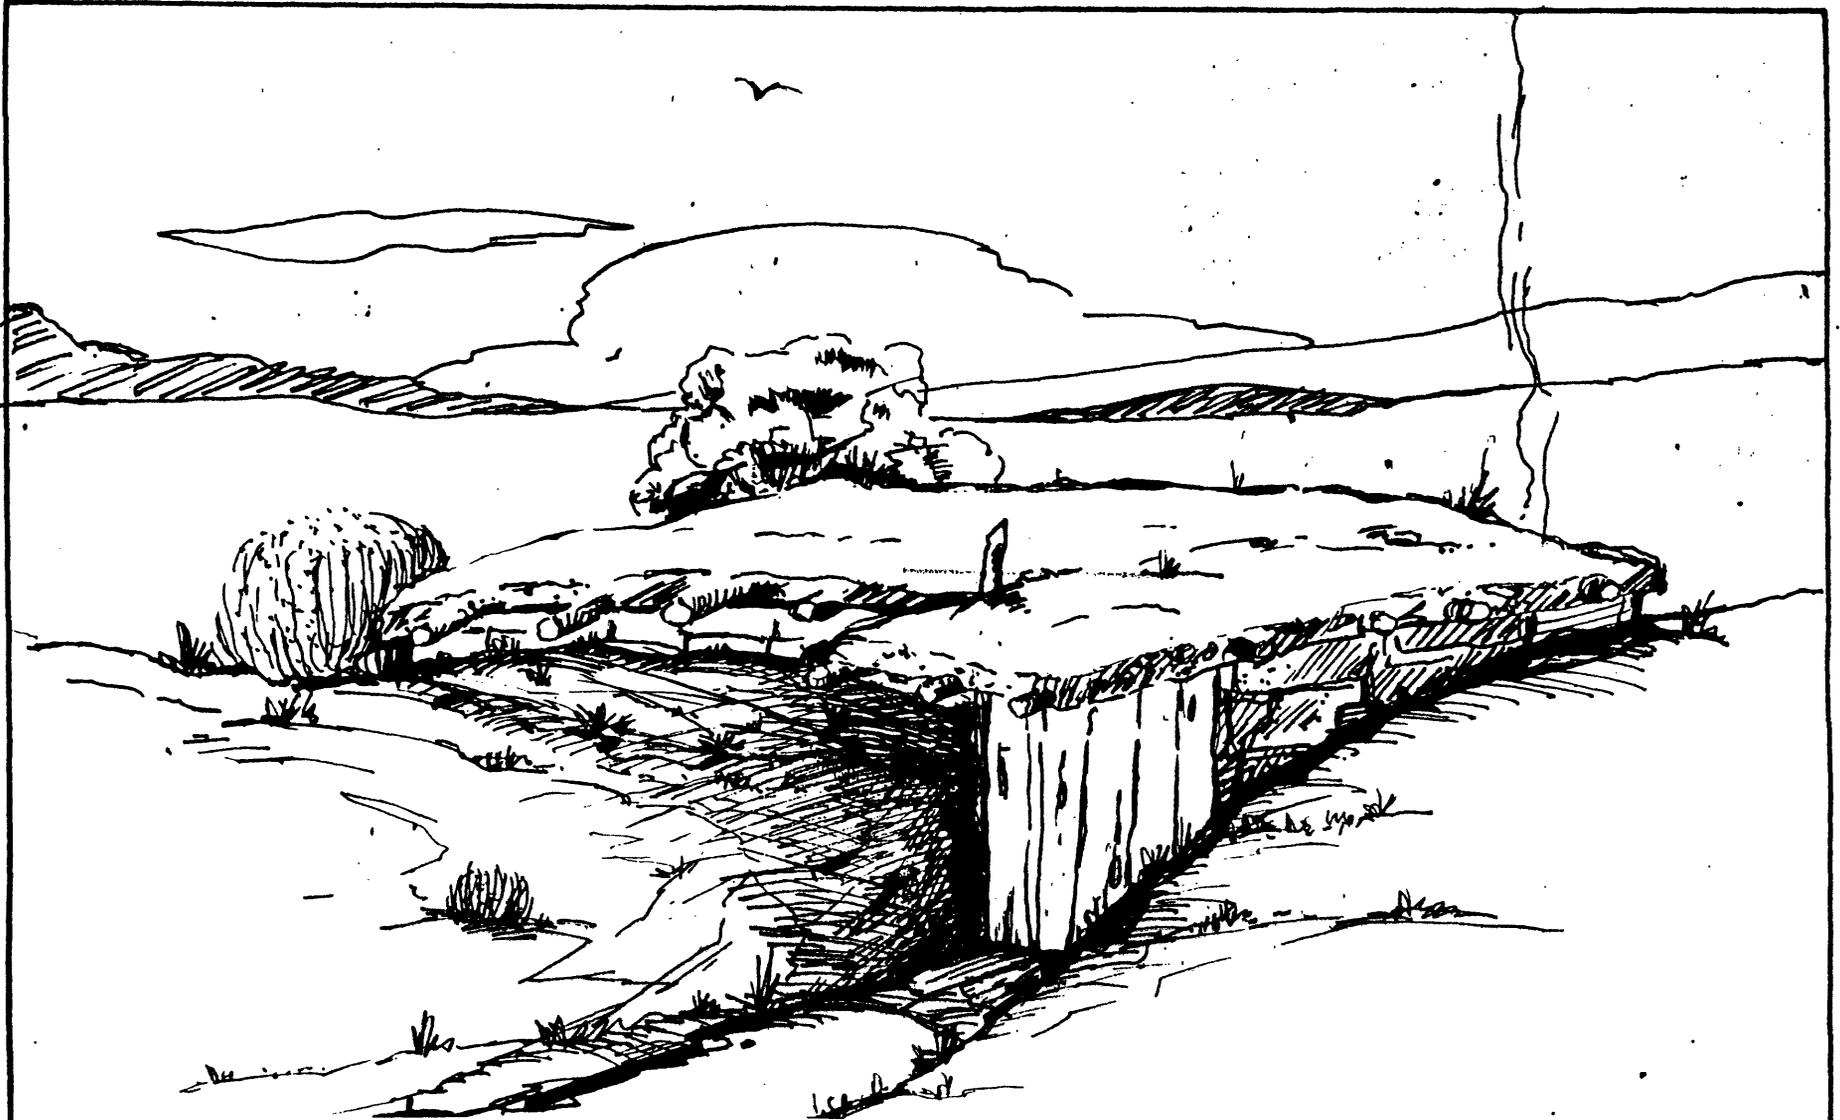
5. Whitmore-McIntyre dugout, as it may have appeared in 1863.

On February 13, 1936, while laying a flagstone walkway from the east cabin to the fort, Custodian Leonard Heaton and a crew of CCC boys uncovered the site of the dugout. The boys continued to excavate under Heaton's supervision the following day until Heaton's suspicions were sufficiently confirmed by finds of broken crockery, animal bones, a mule shoe, burned rock, and other materials. Heaton then stopped work and reported his find to Southwestern Monuments headquarters. He was immediately ordered to cease excavations and to backfill the site. The alignment of the walkway was subsequently rerouted to avoid the archeological site. Its location was then depicted on subsequent monument master plans, shown approximately 30 feet south of the east cabin.

While a number of people wanted the dugout to be reconstructed (some of James Whitmore's descendants and Leonard Heaton, in particular), the decision would soon be made to backfill the site. Heaton made reconstruction of the dugout his first priority for work in 1959. Archeologists Erik Reed, however, recommended backfilling to afford the best protection to the dugout because, he said, "The dirt and clay walls, as well as the remaining crude masonry walls would be almost impossible to maintain."¹¹ The dugout was backfilled in December 1959. In 1969, Supt. Ray Geerdes garnered support from Zion National Park officials in favor of restoring the dugout, but either due to cost or opposition by NPS archeologists, the work was never carried out.
