**NATIONAL REGISTER OF HISTORIC PLACES
INVENTORY -- NOMINATION FORM**

Pierce Ranch

Pierce Ranch; Upper Pierce Point Ranch

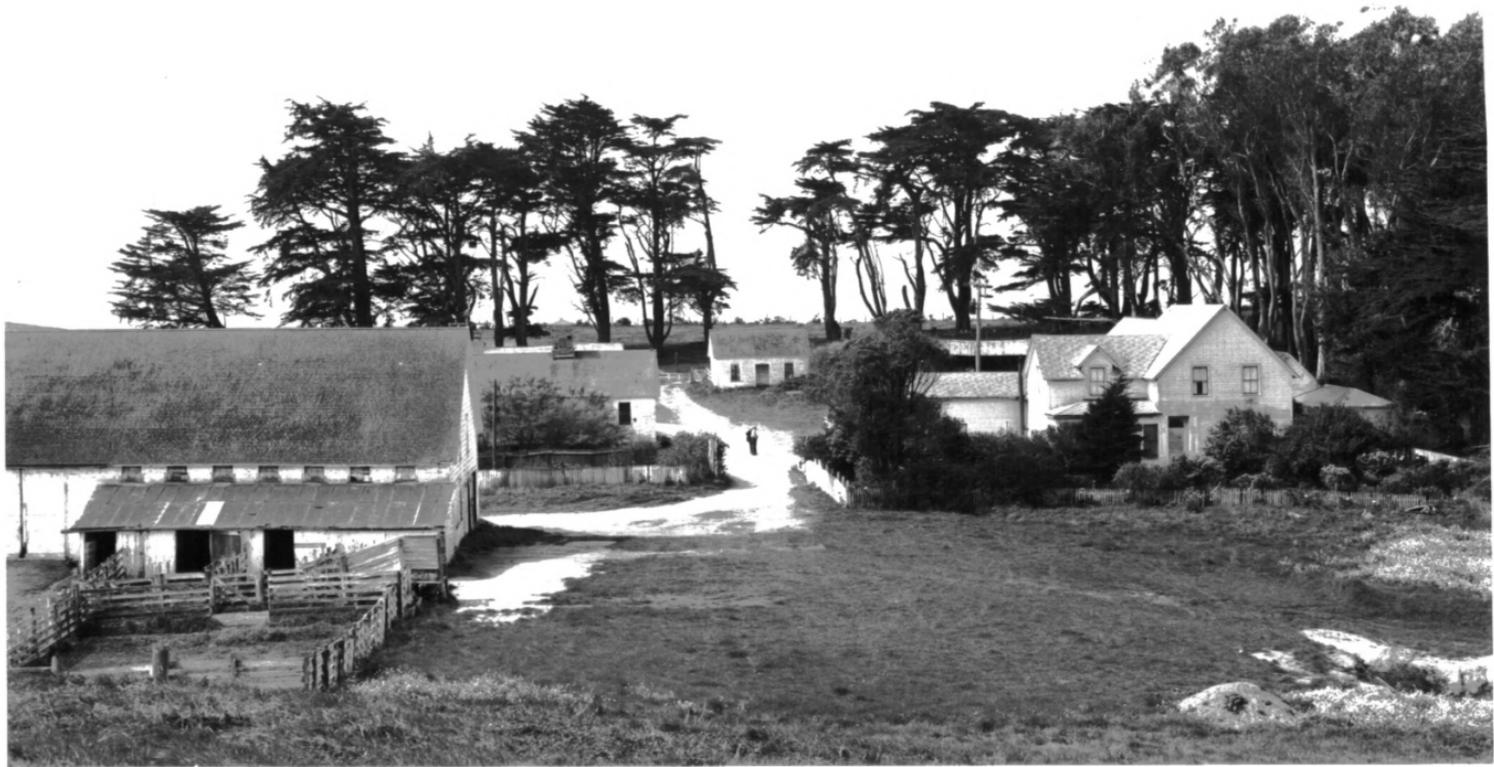
1. PIERCE POINT RANCH (LEFT TO RIGHT: HORSE BARN,
OLD DAIRY, WEST BUNKHOUSE, MAIN HOUSE)
2. POINT REYES NATIONAL SEASHORE, MARIN COUNTY,
CALIFORNIA - VICINITY OF INVERNESS
3. NATIONAL PARK SERVICE PHOTO BY GORDON CHAPPELL
4. APRIL 2, 1980
5. NEGATIVE AT NATIONAL PARK SERVICE, WESTERN
REGIONAL OFFICE
6. VIEW TOWARD WEST FROM CISTERN HILL
7. PHOTO 2 OF 20

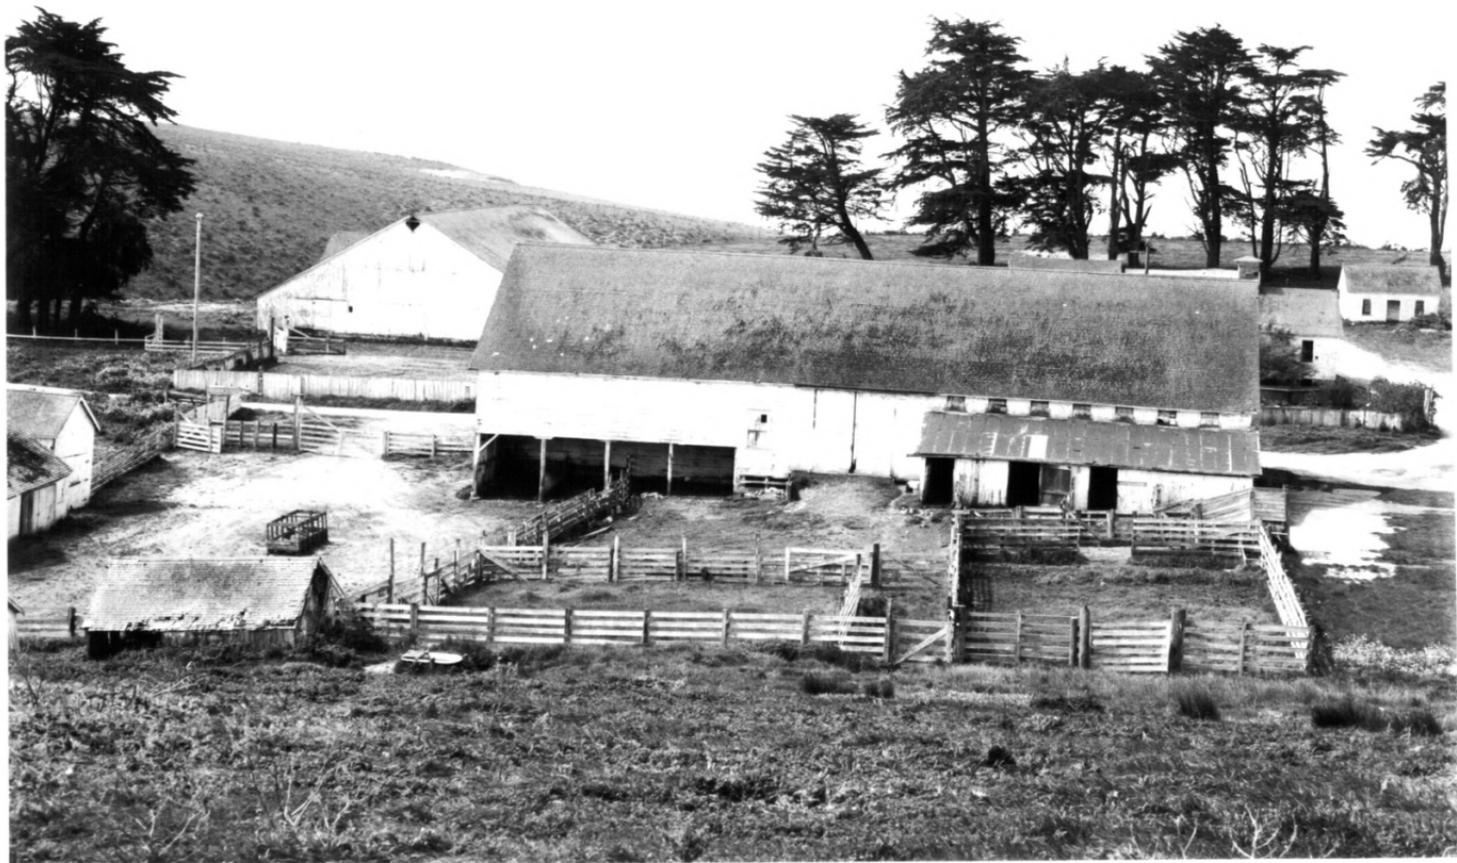
1. PIERCE POINT RANCH (LEFT TO RIGHT: GARAGES,
CHICKEN COOP, HAY BARN IN DISTANCE, HORSE BARN,
FENCES, WEST BUNKHOUSE
2. POINT REYES NATIONAL SEASHORE, MARIN COUNTY,
CALIFORNIA - VICINITY OF INVERNESS
3. NATIONAL PARK SERVICE PHOTO BY GORDON CHAPPELL
4. APRIL 2, 1980
5. NEGATIVE AT NATIONAL PARK SERVICE, WESTERN
REGIONAL OFFICE
6. VIEW TOWARD WEST FROM CISTERN HILL
7. PHOTO 3 OF 20

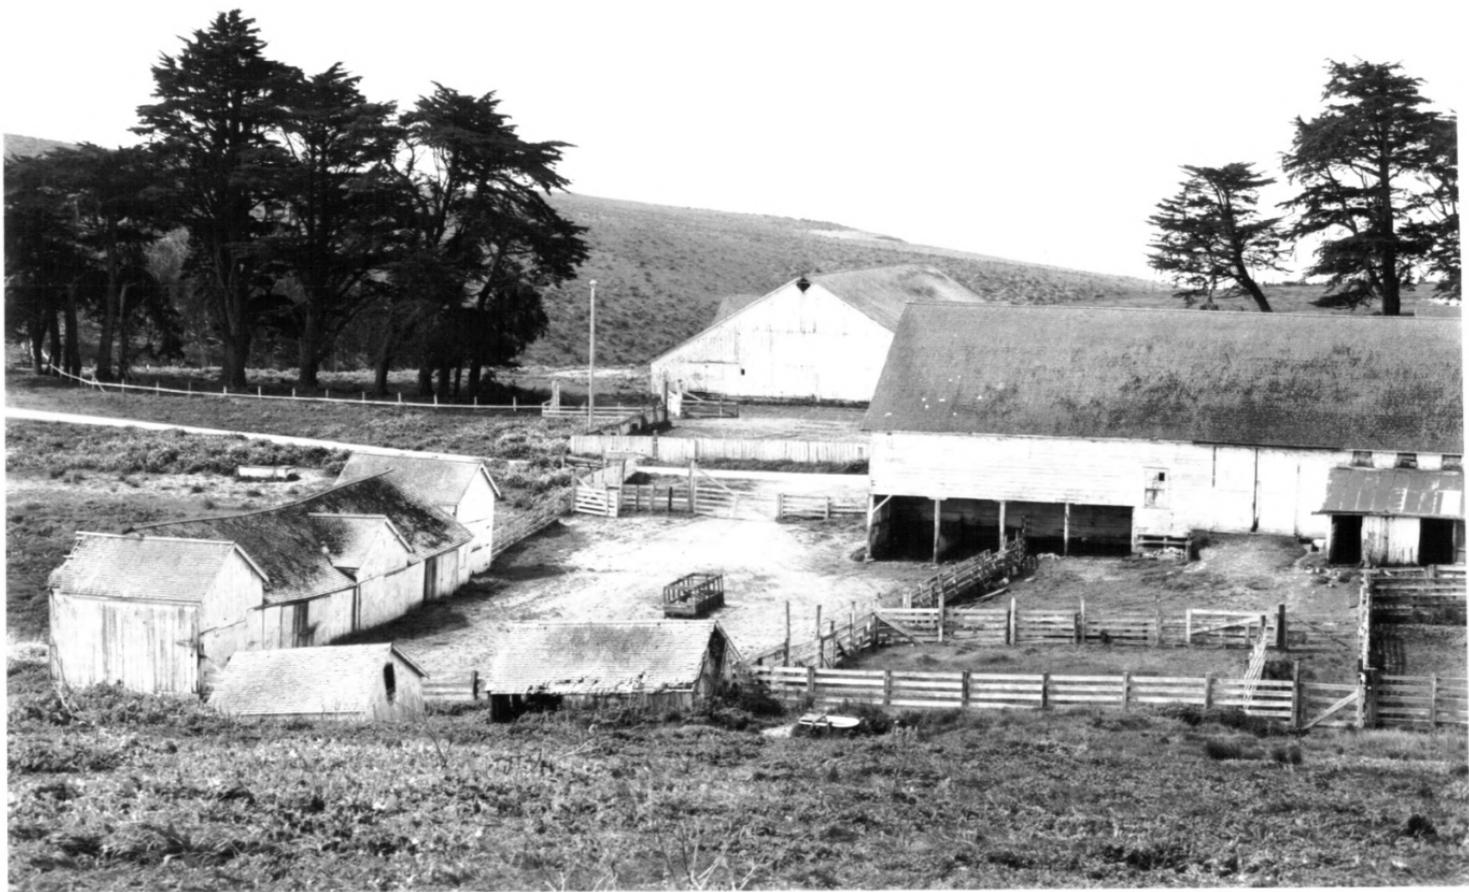
1. PIERCE POINT RANCH (LEFT TO RIGHT: WAGON SHEDS
& GARAGE, TWO CHICKEN HOUSES IN FOREGROUND, HAY
BARN IN DISTANCE, HORSE BARN AND PLANK FENCES AT RIGHT)
2. POINT ROYES NATIONAL SEASHORE, MARIN COUNTY,
CALIFORNIA - VICINITY OF INVERNESS
3. NATIONAL PARK SERVICE PHOTO BY GORDON CHAPPELL
4. APRIL 2, 1980
5. NEGATIVE AT NATIONAL PARK SERVICE, WESTERN
REGIONAL OFFICE
6. VIEW TOWARD WEST FROM CISTERN HILL
7. PHOTO 4 OF 20

Old Wagon Shed - PR 193: East of the Old Garage, its back also forming part of the southern edge of the East Quadrangle, the Old Wagon Shed is a long, nearly rectangular building, actually two structures connected at the roof. Overall, the structures are 24 by 80, the long axis running east/west. The eastern component or structure is 14 by 18 and has a concrete floor and foundations; the remainder of the structure has wood foundation and floor. All walls are vertical 12 inch wide butt boards painted white. All portions are covered with a single gable roof finished with wood shingles. The main facade has a slightly projecting pavilion with its own gable near the center. There is a second front-facing gable at the far end. In the projecting pavilion there is a large pair of hinged upper doors over the several front sliding doors which have been accommodated by cut-out notches in the eave boards.

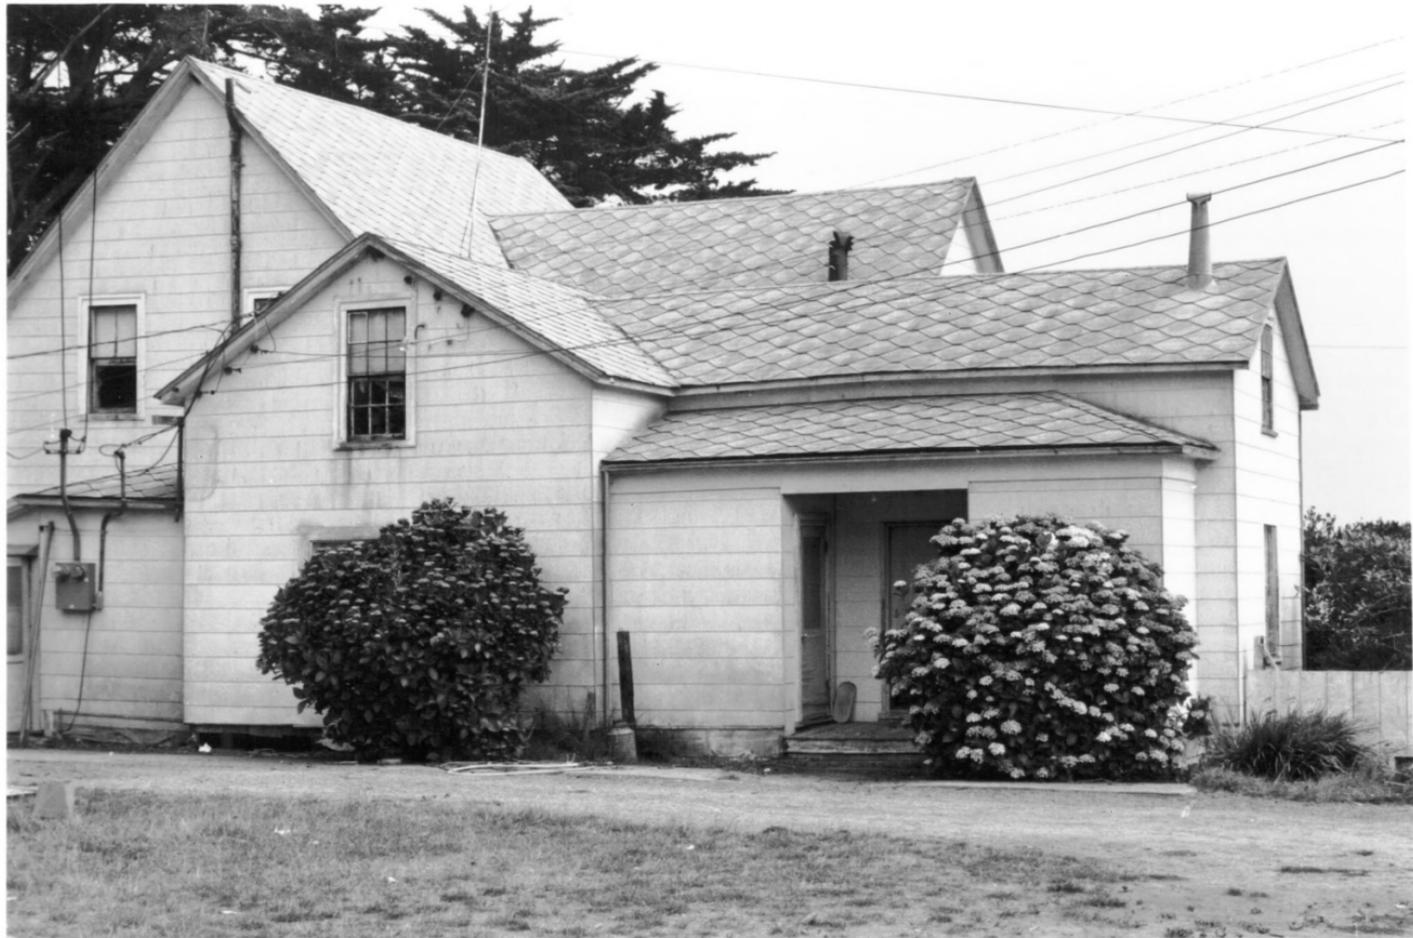
1. PIERCE POINT RANCH - SMALL HOUSE FACING
WEST IN FOREGROUND BELIEVED TO BE 1856
HOUSE
2. POINT REYES NATIONAL SEASHORE, MARIN COUNTY,
CALIFORNIA - VICINITY OF INVERNESS
3. NATIONAL PARK SERVICE PHOTO BY GORDON CHAPPELL
4. JULY 1980
5. NEGATIVE AT NATIONAL PARK SERVICE, WESTERN
REGIONAL OFFICE
6. VIEW TOWARDS EAST-NORTHEAST
7. PHOTO 5 OF 20

However, Mrs. Dorothy McClure, a long time 20th Century resident of the ranch, indicated that the back, or western portion of the house was the older part, a local tradition repeated by the last occupant, Mervin McDonald. A closer look at the house suggests that it is really two houses back to back, the western one a bit further to the south, with the two tied together into what is now a single structure. An 1880 history of Marin County indicated that Abram Pierce built a new house in 1869; this is believed to be the larger, east-facing house. A 1979 article in the Point Reyes Light indicated, on the basis of what historical evidence is not

clear, that the west-facing house was built in 1856 by "Spanish" [e.g. Hispanic] settlers of what in terms of land grants was a part of the Mexican grant of Rancho Punta de los Reyes Sobrante.

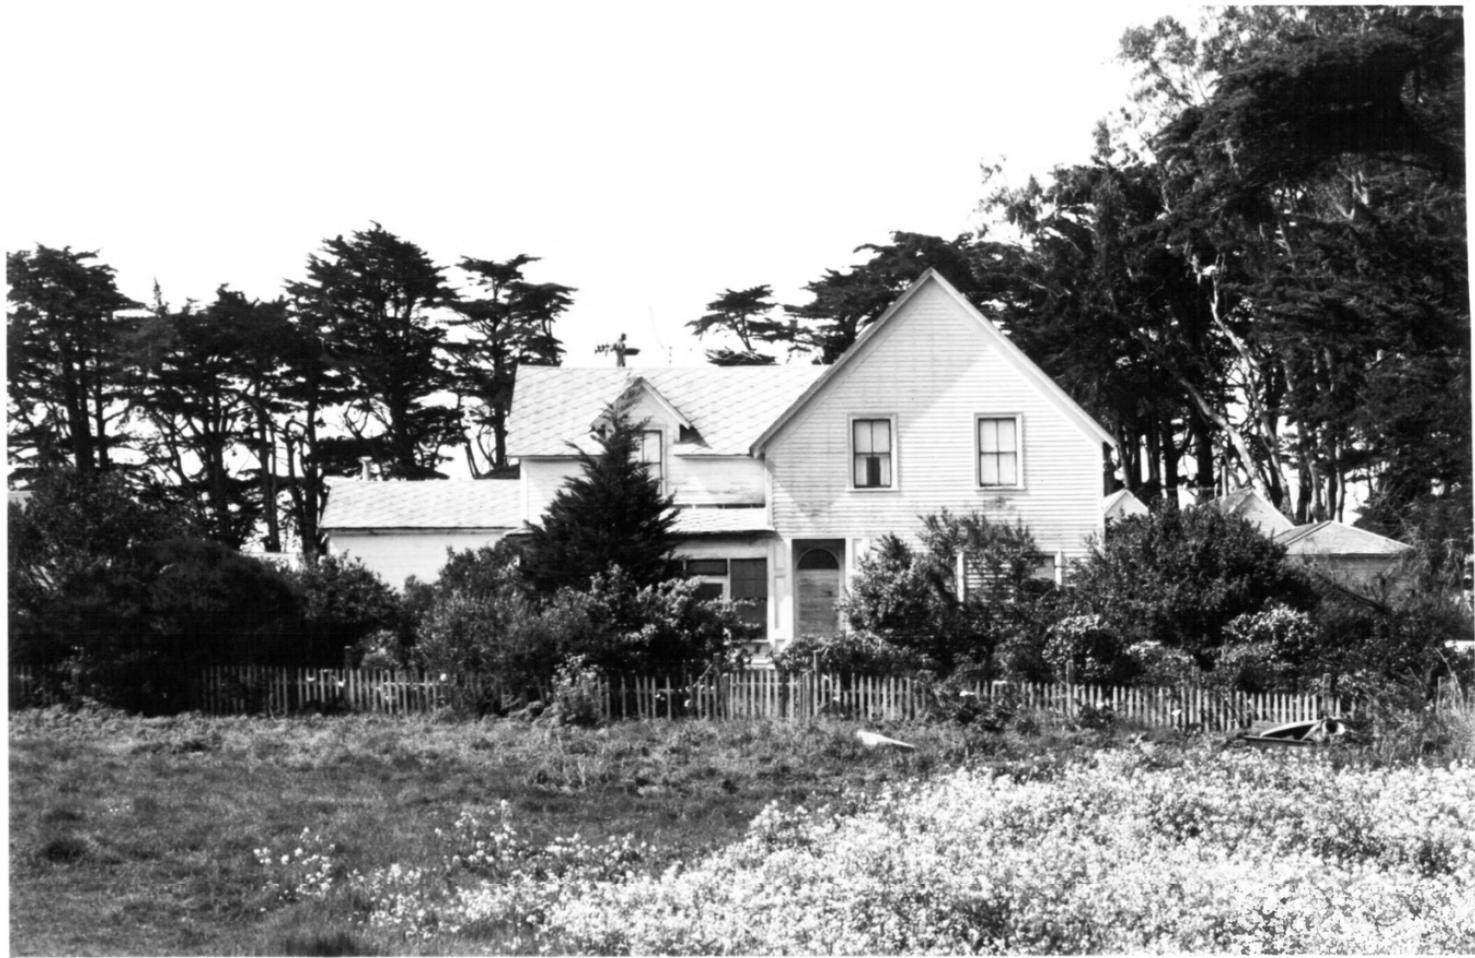
1. PIERCE POINT RANCH (MAIN HOUSE, BUILT 1869,
WITH AN EARLIER 1856 HOUSE VISIBLE AT LEFT)
2. POINT REYES NATIONAL SEASHORE, MARIN COUNTY,
CALIFORNIA
3. NATIONAL PARK SERVICE PHOTO BY GORDON CHAPPELL
4. APRIL 2, 1980
5. NEGATIVE AT NATIONAL PARK SERVICE,
WESTERN REGIONAL OFFICE
6. VIEW TOWARD WEST - SHOWS FRONT (EAST) OF
HOUSE
7. PHOTO 6 OF 20

Main House - PR 180: The main house strikes a visitor at first as being a large, two-story, gable-roofed house facing eastward to Tomales Bay, with a number of what are apparently additions to the rear and southwest.

The main house is thus really two gable-roofed, two-story houses of irregular plan combined into one, with rough overall dimensions of 50 by 60 feet. The combined structure has 16 rooms, not counting closets, entries, and baths. Its major gable roof is finished with faded red composition shingles. Historically the buildings were whitewashed every summer and the wood shingle roofs were treated with graphite and oil which left them black in color, but the main house had been resingled by the McClures in the 1940s and Merv McDonald resingled it with the current shingles still more recently. The original exterior walls were of a narrow horizontal lap siding. This remains exposed on the north and east sides of the 1869 portion. The other sides of that portion and all of the 1856 portion and connections were covered with composition asbestos shingles of a large size in 1959 due to leakage during rainstorms. Beneath the shingles, the walls of the 1856 portion are believed to have been board and batten. Most sash are two over two or six over six double hung, but there are several sliding aluminum replacements on the 1856 portion, and the original window on the downstairs south side of the 1869 portion was replaced and enlarged due to leakage of rain in 1959. The original front porch extended clear across the front, but collapsed during the earthquake of April 1906 and was rebuilt only south of the front hallway. This portion of the porch, originally open, was enclosed with glazing by the McClures some time after 1945. The original front door was, in recent years, boarded up during the 1950s due to leakage of rain around it, but it has recently been reopened. On the back of the front door is a gong-type doorbell with the circular legend cast in the metal: "Taylor's Patent. /Oct 23, 1860." There is a fan lite transom over the front door, filled with a single, fan-shaped piece of glass; originally it may have featured a series of wedge-shaped pieces.

Inside, the staircase railing appears to be original, although not especially ornate. In the northeast downstairs room, the fireplace and mantle appear early, and the fireplace has a cast iron facing which in effect converted it to a stove. Up to the middle part of the 19th Century, fireplaces were common and popular; however, during the latter part of the century, stoves replaced fireplaces in popularity so that many late Victorian homes were built with chimney flues for stoves but no fireplaces. The building of this house with a fireplace, and its possibly later replacement with the cast-iron front, is consistent with this national trend, which incidentally reached the West more slowly than it penetrated the more settled East. Interior features are consistent with the presumed 1869 date

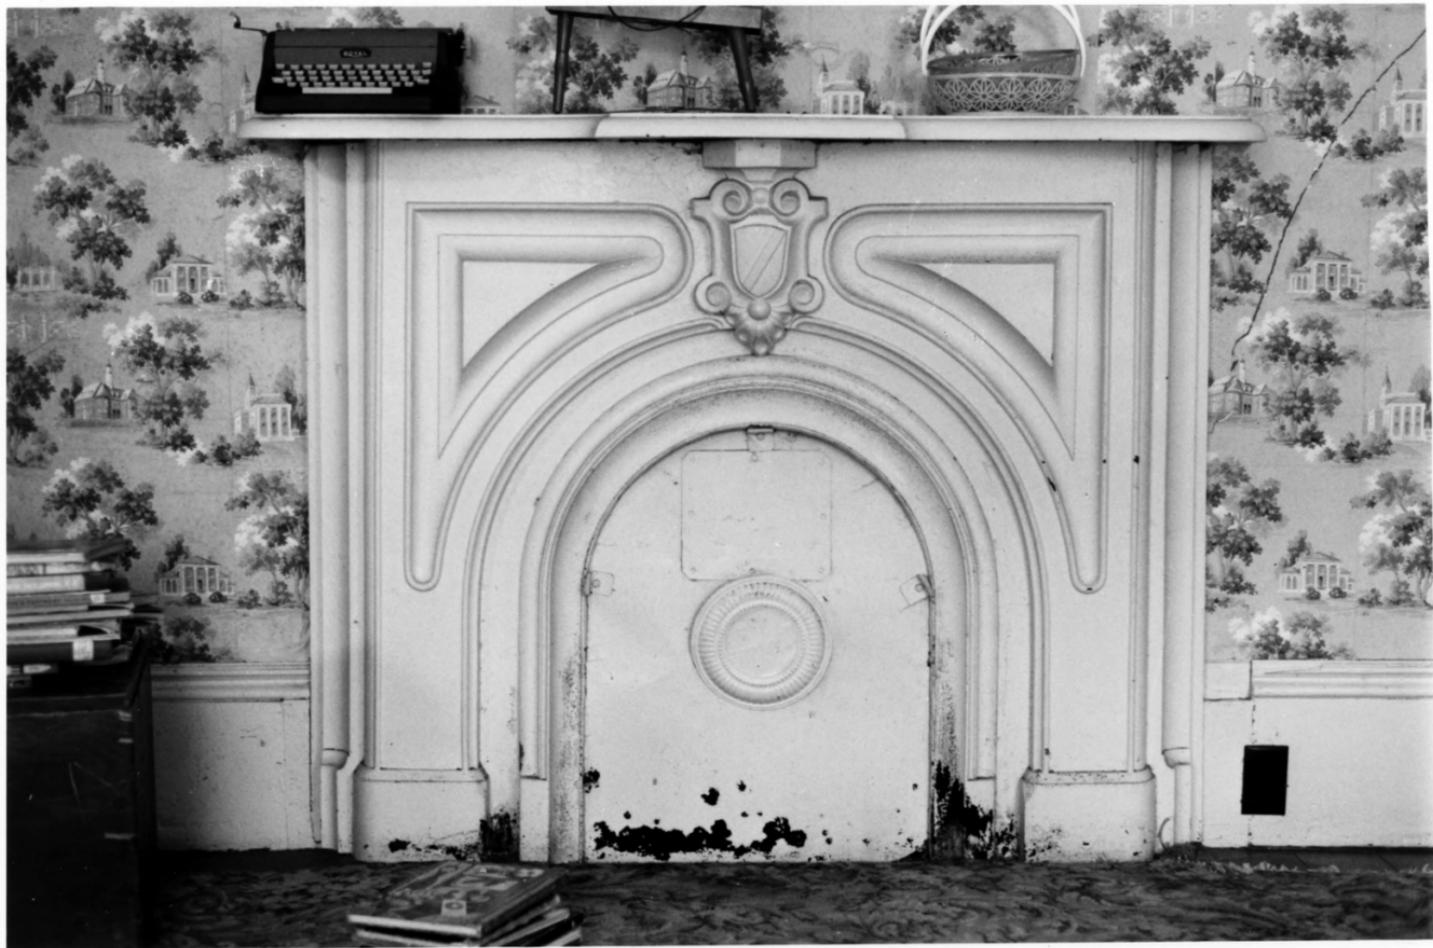
1. PIERCE RANCH (IRON LIVING ROOM FIREPLACE
FACING AND MANTLE IN 1869 HOUSE)
2. POINT REYES NATIONAL SEASHORE, MARIN COUNTY, CALIFORNIA
3. NATIONAL PARK SERVICE PHOTO BY GORDON CHAPPELL
4. APRIL 2, 1980
5. NEGATIVE AT NATIONAL PARK SERVICE, WESTERN REGIONAL
OFFICE
6. VIEW TOWARD WEST - FIREPLACE IS ON WEST WALL
OF LIVING ROOM OR PARLOR
7. PHOTO 7 OF 20

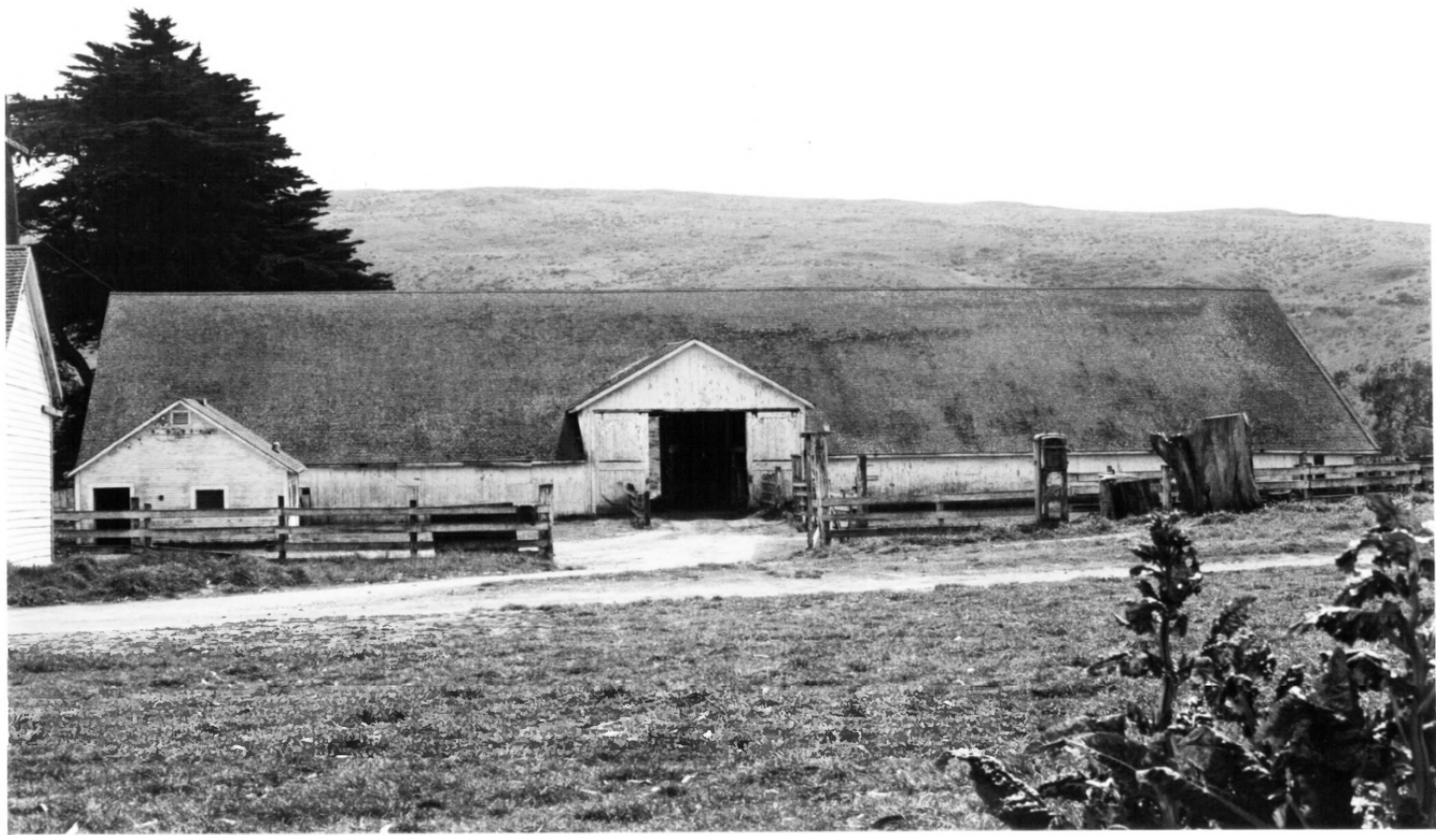
1. PIERCE RANCH , HAY BARN
2. POINT REYES NATIONAL SEASHORE , MARIN COUNTY, CALIFORNIA
3. NATIONAL PARK SERVICE PHOTO BY GORDON CHAPPELL
4. APRIL 2, 1980
5. NEGATIVE AT NATIONAL PARK SERVICE , WESTERN REGIONAL OFFICE
6. VIEW TOWARDS SOUTH
7. PHOTO 8 OF 20

Hay Barn - PR 189: The largest barn and the largest building on the property, this structure forms the southern side of the western quadrangle of buildings. The interior is a single space divided into 5 aisles by the wood structural bay system. It has a foundation of 15 transverse stone masonry walls. It is nearly symmetrical and roughly 65 by 180 feet and has a gable roof with central gabled dormers at each of the main doors, which are in the middle of the north and south sides. The date of this structure is not definitively known, but its graffiti includes the initials "J.M.A." which may correlate with graffiti in another building which spells out "Jose Machado Avila" and is associated with the date 1919. Avila was a lessee of the property when John Rapp owned it or possibly the son of the lessee. It can be presumed likely that the graffiti in the barn was left within a few years of that in the other building, so the barn was very likely present around 1919. At one time this was a dairy barn with 300 stalls in which cows were milked, but it had become a hay barn by 1930.

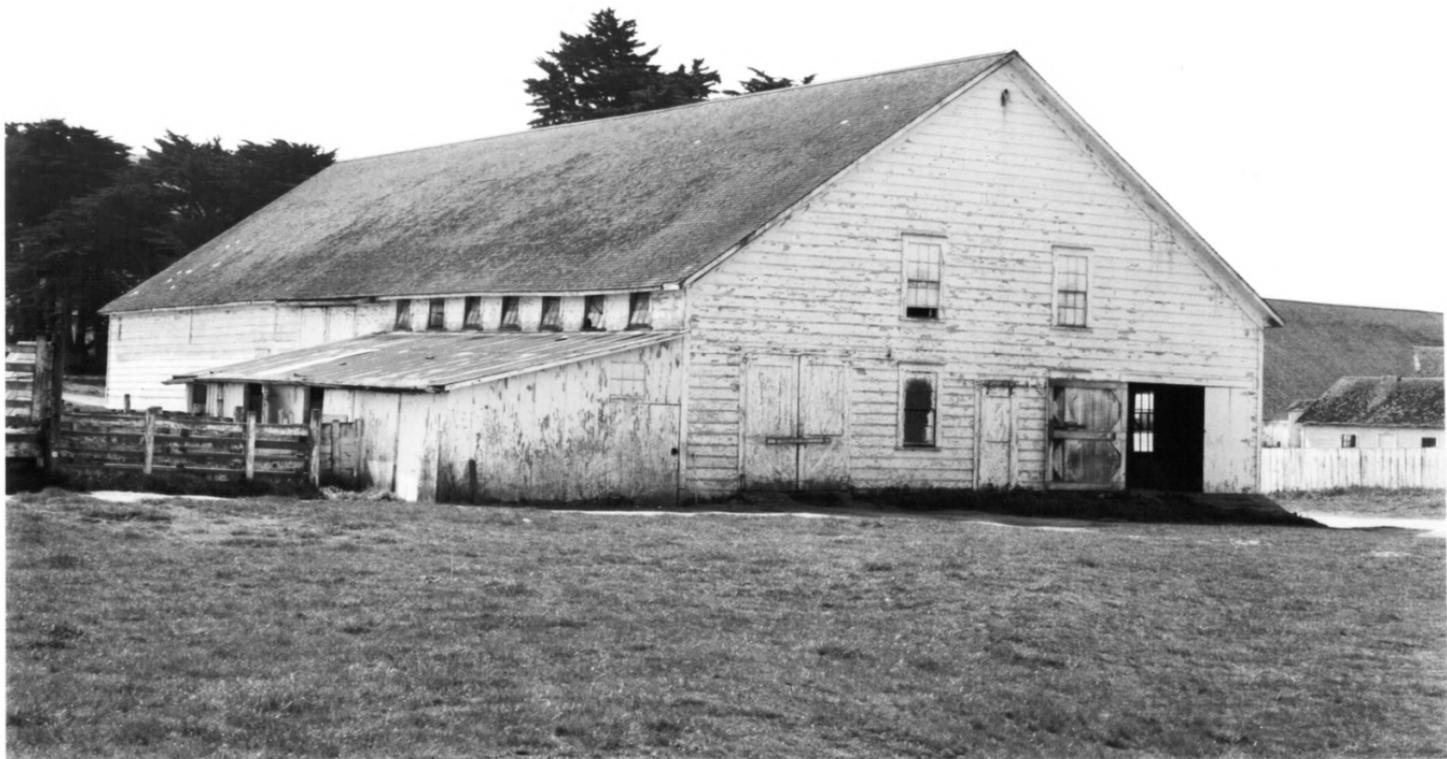
1. PIERCE RANCH , HORSE BARN
2. POINT REYES NATIONAL SEASHORE , MARIN COUNTY,
CALIFORNIA
3. NATIONAL PARK SERVICE PHOTO BY GORDON CHAPPELL
4. APRIL 2, 1980
5. NEGATIVE AT NATIONAL PARK SERVICE , WESTERN
REGIONAL OFFICE
6. VIEW TOWARDS SOUTHWEST
7. PHOTO 9 OF 20

Horse Barn - PR 191: The largest building in the East Quadrangle, and the second largest building at the ranch, the Horse Barn is a rectangular building 50 by 115 feet. It is a "Pennsylvania" type barn with a cantilevered or overhung southeast corner, providing a small protected shelter for stock kept in the adjoining barnyard. The interior space is divided by a central wagon drive, separating stalls, hay mows, milking and work areas into equal halves. It is a wood frame structure with a medium pitch to its gable roof. The long axis of the building runs north/south, and it forms the western edge of the East Quadrangle. The date of this building is not known, but according to Dorothy McClure, an earlier horse barn either burned or was blown down some time prior to 1930. It might be assumed to be an early 20th Century structure except that stairway paneling contains the date in graffiti "December 17, 1884," and elsewhere there is graffiti dating the building to 1890, to an illegible year in the 1890s, and one room has 1906 wallpaper. On the basis of the graffiti, it seems likely that the building dates from no later than 1884 and possibly from much earlier. But one door with an 1890 date definitely was not original to the location where it now serves, and it is possible that the graffiti was on planks salvaged from earlier structures. At the northeast corner on the east side is a shed-roofed extension added by the McClures, 15 by 45 feet, with

the longer axis parallel to the long axis of the barn. The primary exterior finish is horizontal lap siding painted white. One end wall has some board and batten siding which repaired earlier material lost in a storm. The building rests on a slight slope so that at the southwest end it is in fact a two story structure with four open stock stalls cut under the main floor. The interior is divided into multiple spaces and lofts.

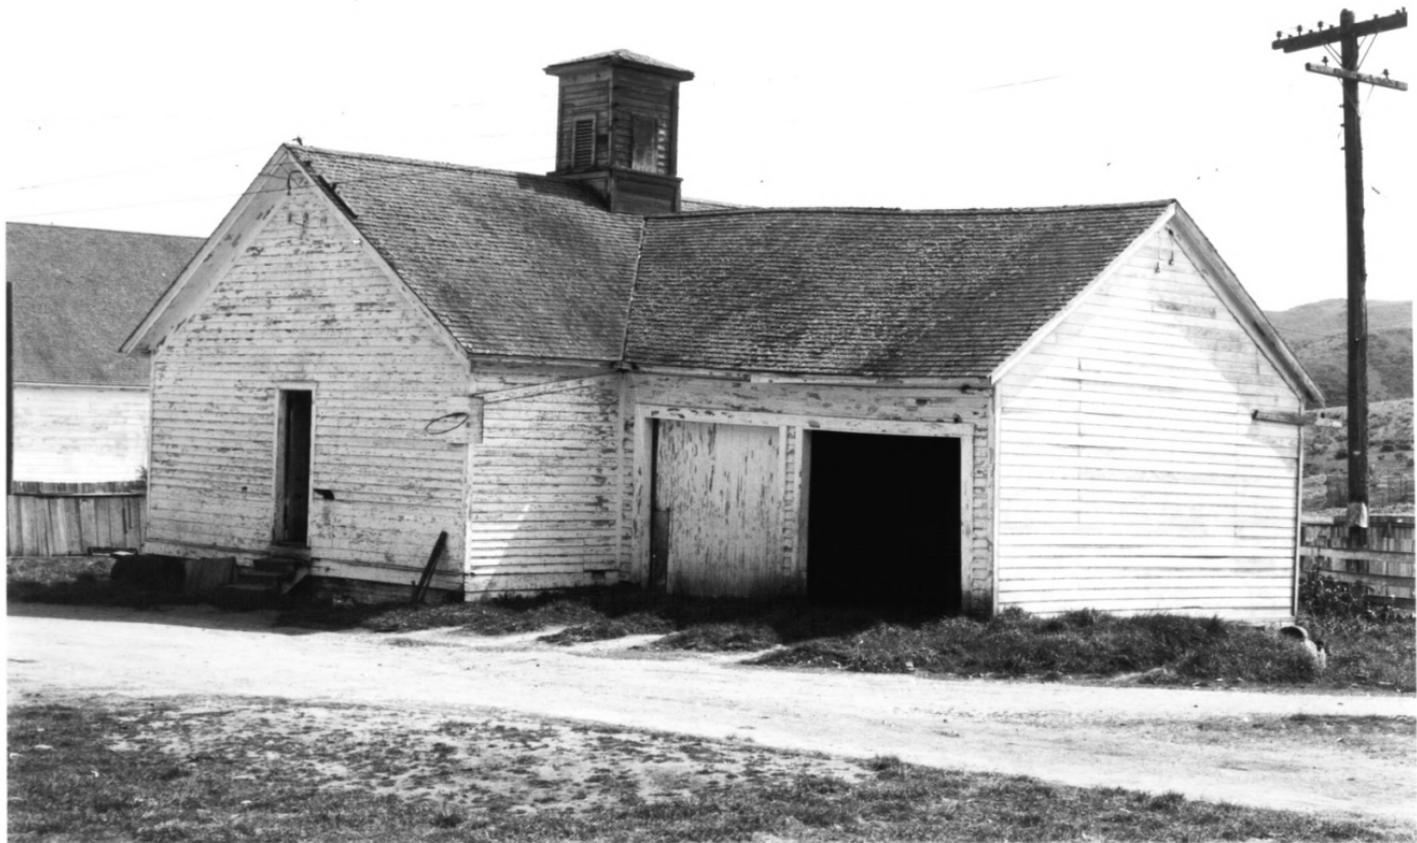
1. PIERCE RANCH , OLD DAIRY
2. POINT REYES. NATIONAL SEASHORE,
MARIN COUNTY, CALIFORNIA
3. NATIONAL PARK SERVICE PHOTO BY
GORDON CHAPPELL
4. APRIL 2, 1980
5. NEGATIVE AT NATIONAL PARK SERVICE,
WESTERN REGIONAL OFFICE
6. VIEW TOWARD SOUTHEAST
7. PHOTO 10 OF 20

Old Dairy House - PR 196: Also known as the "Old Creamery," apparently a predecessor of PR 190, old and outdated by 1933, this rectangular wood frame building is 36 by 25 feet with a smaller 10 by 17 foot addition added to the rear, or south end. Built after 1880, probably early in the 20th Century, possibly in part an alteration or modernization of an earlier structure, it faces north and is near the middle of the western quadrangle of buildings. The main structure has a partial basement with brick walls, once used to store butter, and sits on a brick foundation raised to about two feet above grade. The exterior walls are narrow lap

siding painted white. The gable roof, of a medium pitch, is finished in wood shingles and supports a handsome square cupola which is louvered on all four sides. Sash for the most part are six over six, of wood, and double hung. The building has three rooms, two in the front, each with a concrete floor divided into sections and believed to be precast supported on a wood frame, although one part of the main room has a wooden floor. The interior walls of the main large room are finished with lath and plaster; the added room at the rear has a concrete slab floor on grade and is otherwise unfinished on the interior, as is the small front room where one enters the building.

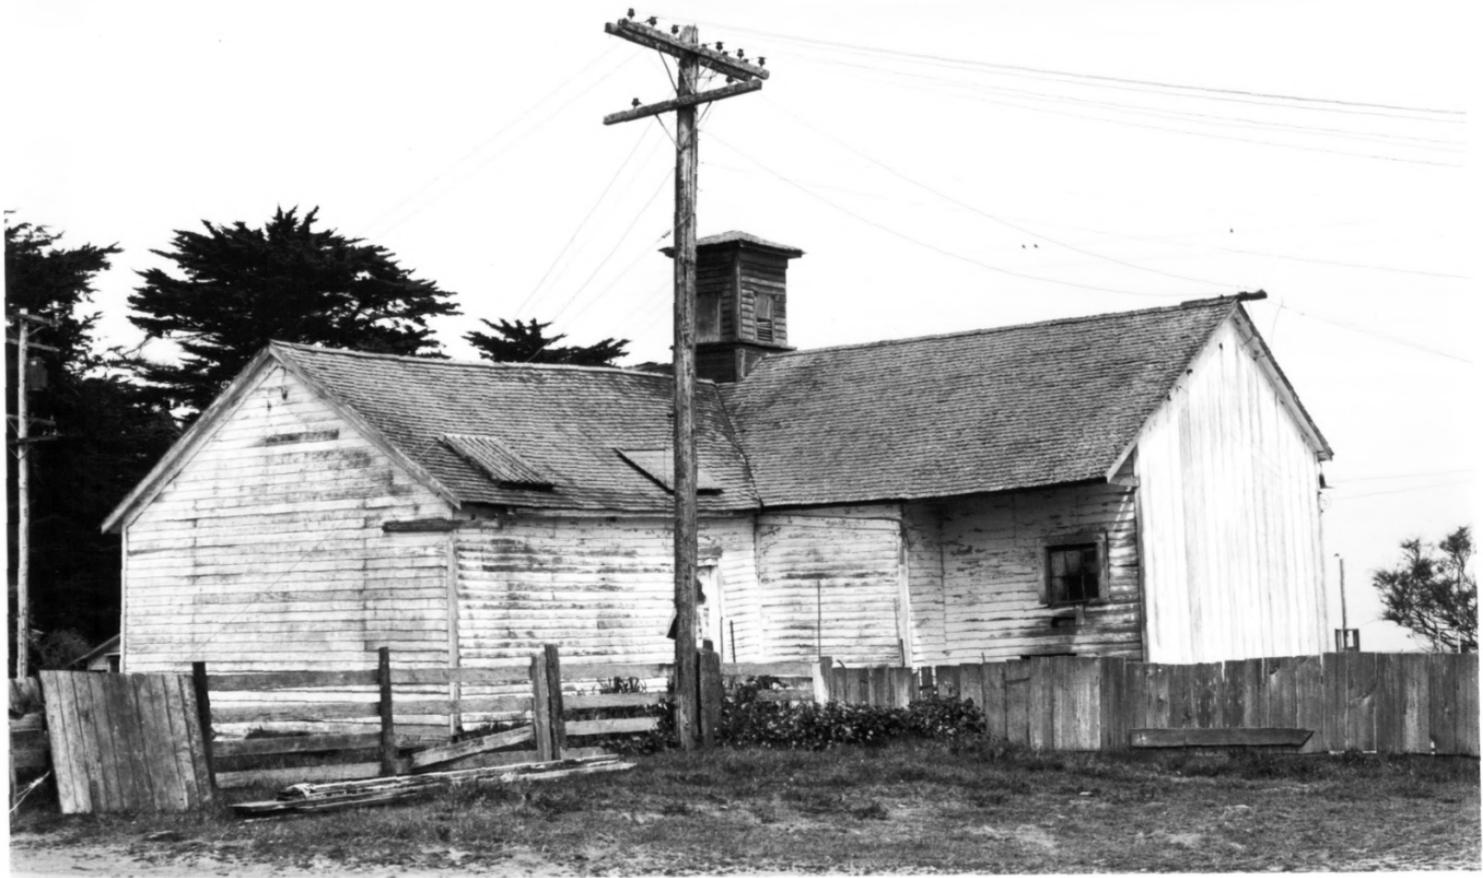
1. PIERCE RANCH ; OLD DAIRY, REAR VIEW
2. POINT REYES NATIONAL SEASHORE , MARIN COUNTY, CALIFORNIA
3. NATIONAL PARK SERVICE PHOTO BY
GORDON CHAPPELL
4. APRIL 2, 1980
5. NEGATIVE AT NATIONAL PARK SERVICE
WESTERN REGIONAL OFFICE
6. VIEW TOWARD NORTHWEST
7. PHOTO 11 OF 20

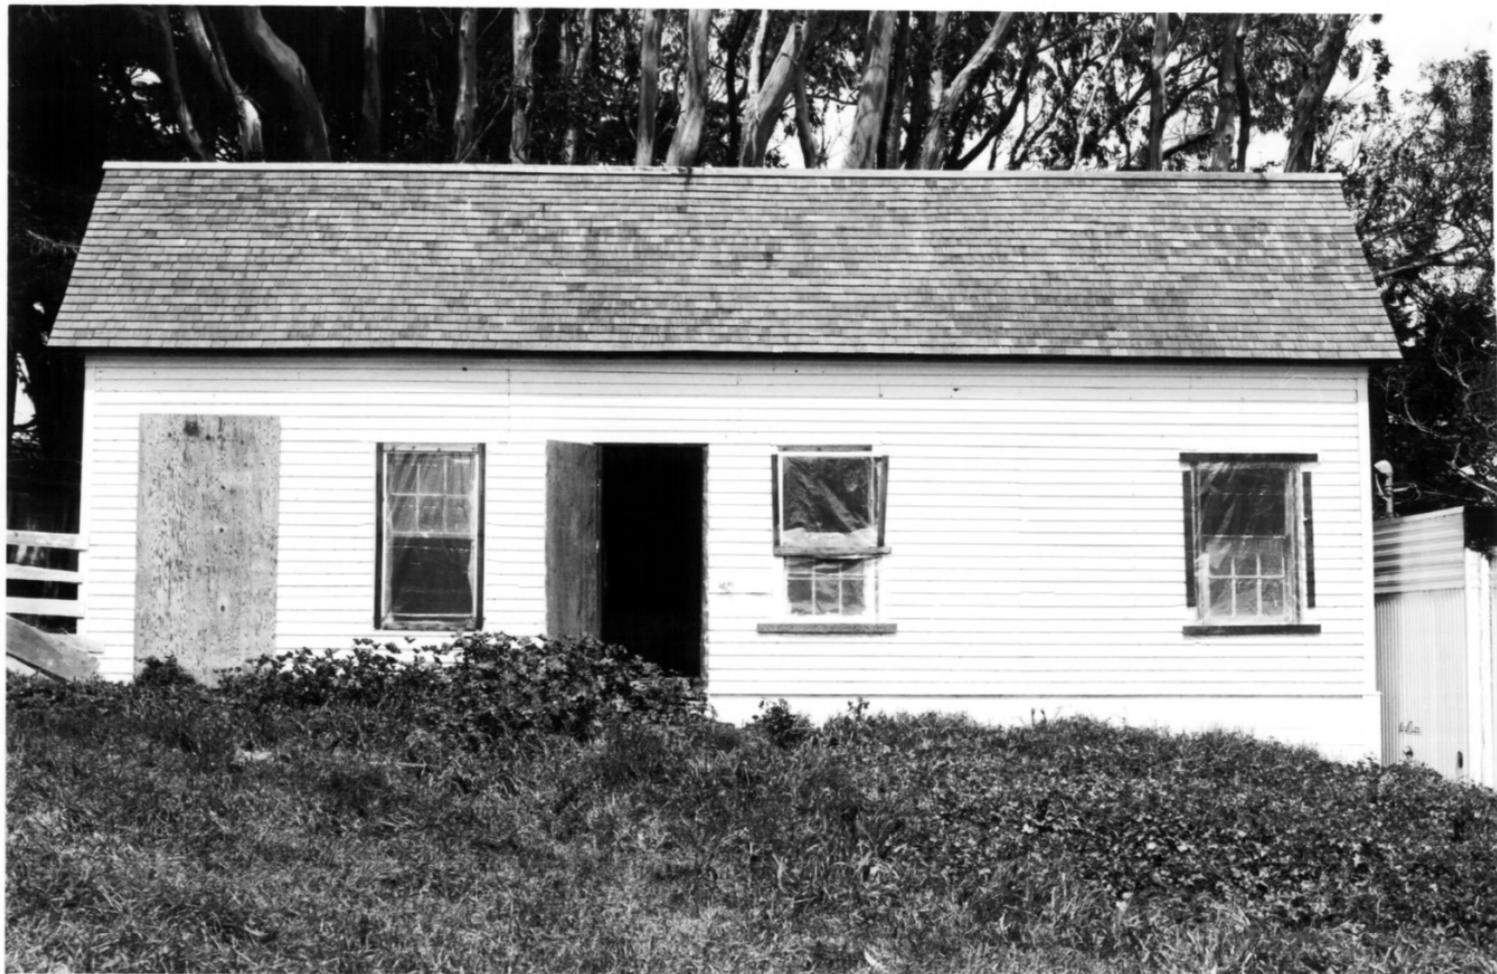
1. PIERCE RANCH; SCHOOLHOUSE
2. POINT REYES NATIONAL SEASHORE, MARIN COUNTY, CALIF.
3. NATIONAL PARK SERVICE PHOTO BY
GORDON CHAPPELL
4. APRIL 2, 1980
5. NEGATIVE AT NATIONAL PARK SERVICE
6. VIEW TOWARD NORTH
7. PHOTO 12 OF 20

School House - PR 183: Supposedly one of the earlier surviving buildings on the ranch, local tradition dates it to the 1860's, but its first documented use as a schoolhouse was in 1878 when the Pierce School District was established. It is a slender rectangular structure, 12 by 36 feet, consisting of two rooms, one for classes, one a cloakroom. Each has an exterior door on the front. The building faces south. The medium pitched gable roof is finished with wood shingles and ridge

boards. The exterior is narrow, horizontal wood siding, painted white. All sash are wood, six over six, double hung. The building was recently restored with new concrete foundation pads and wood foundation posts, and a new horizontal wood skirting to grade, as well as a new wood floor and shingle roofing, applied by the NPS in accord with the Secretary of the Interior's standards for rehabilitation of historic buildings, and with consultation with the SHPO and the ACHP. The building was once used as storage, and for awhile as a chicken house.

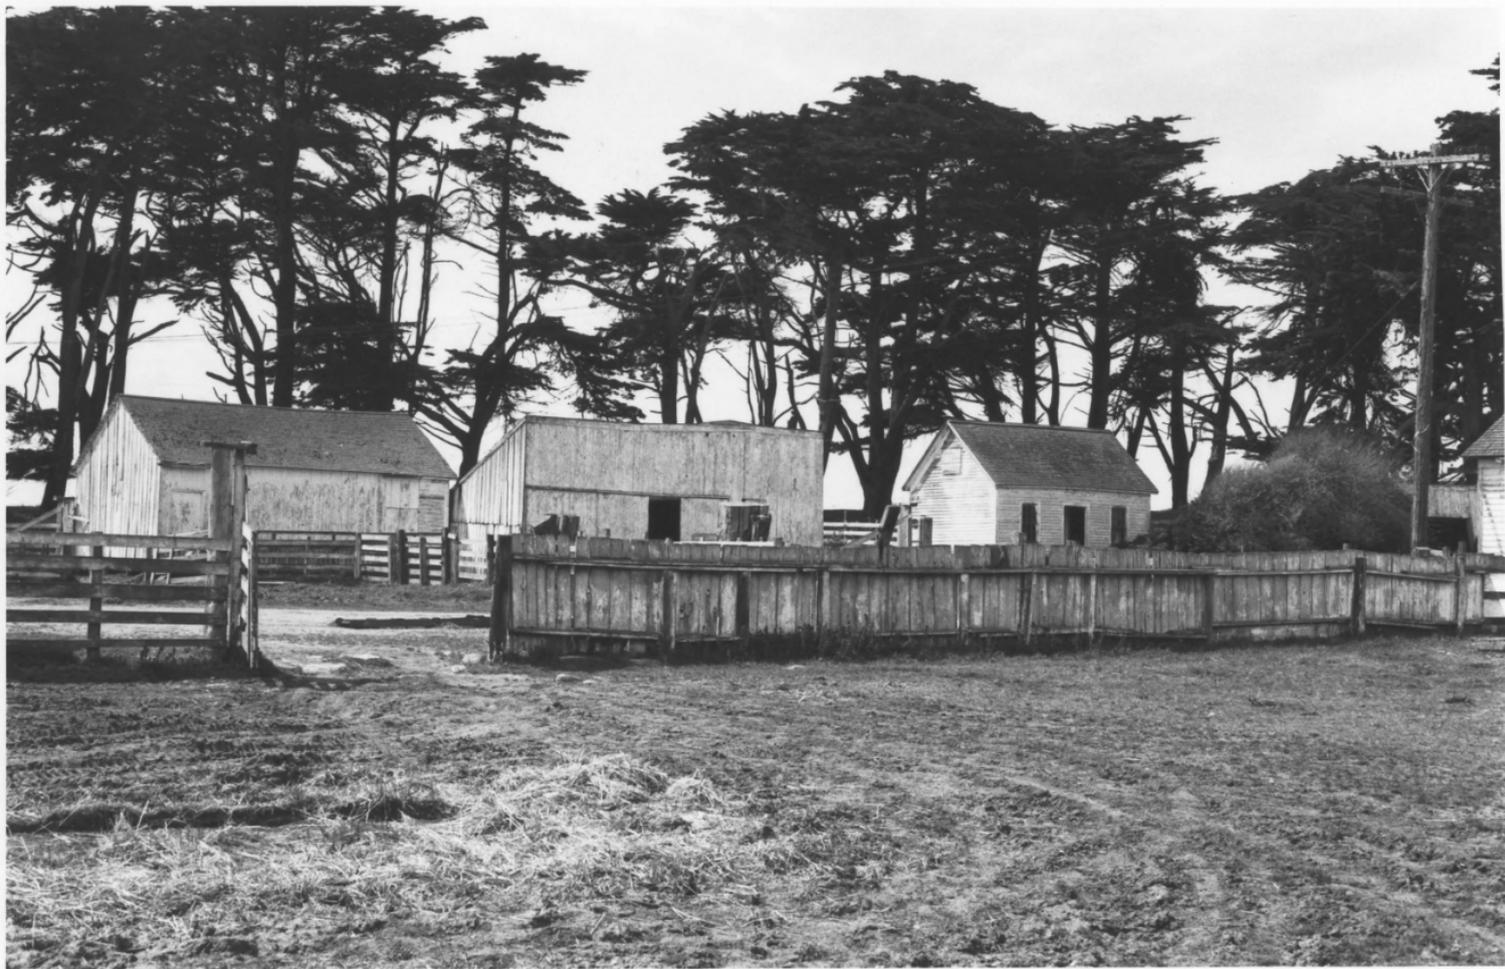
1. PIERCE RANCH ; (L TO R) CALF SHED, WEST GARAGE, WEST
BUNKHOUSE
2. POINT REYES NATIONAL SEASHORE, MARIN COUNTY,
CALIFORNIA
3. NATIONAL PARK SERVICE PHOTO BY
GORDON CHAPPELL
4. APRIL 2, 1980
5. NEGATIVE AT NATIONAL PARK SERVICE
WESTERN REGIONAL OFFICE
6. VIEW TOWARD NORTHWEST
7. PHOTO 13 OF 20

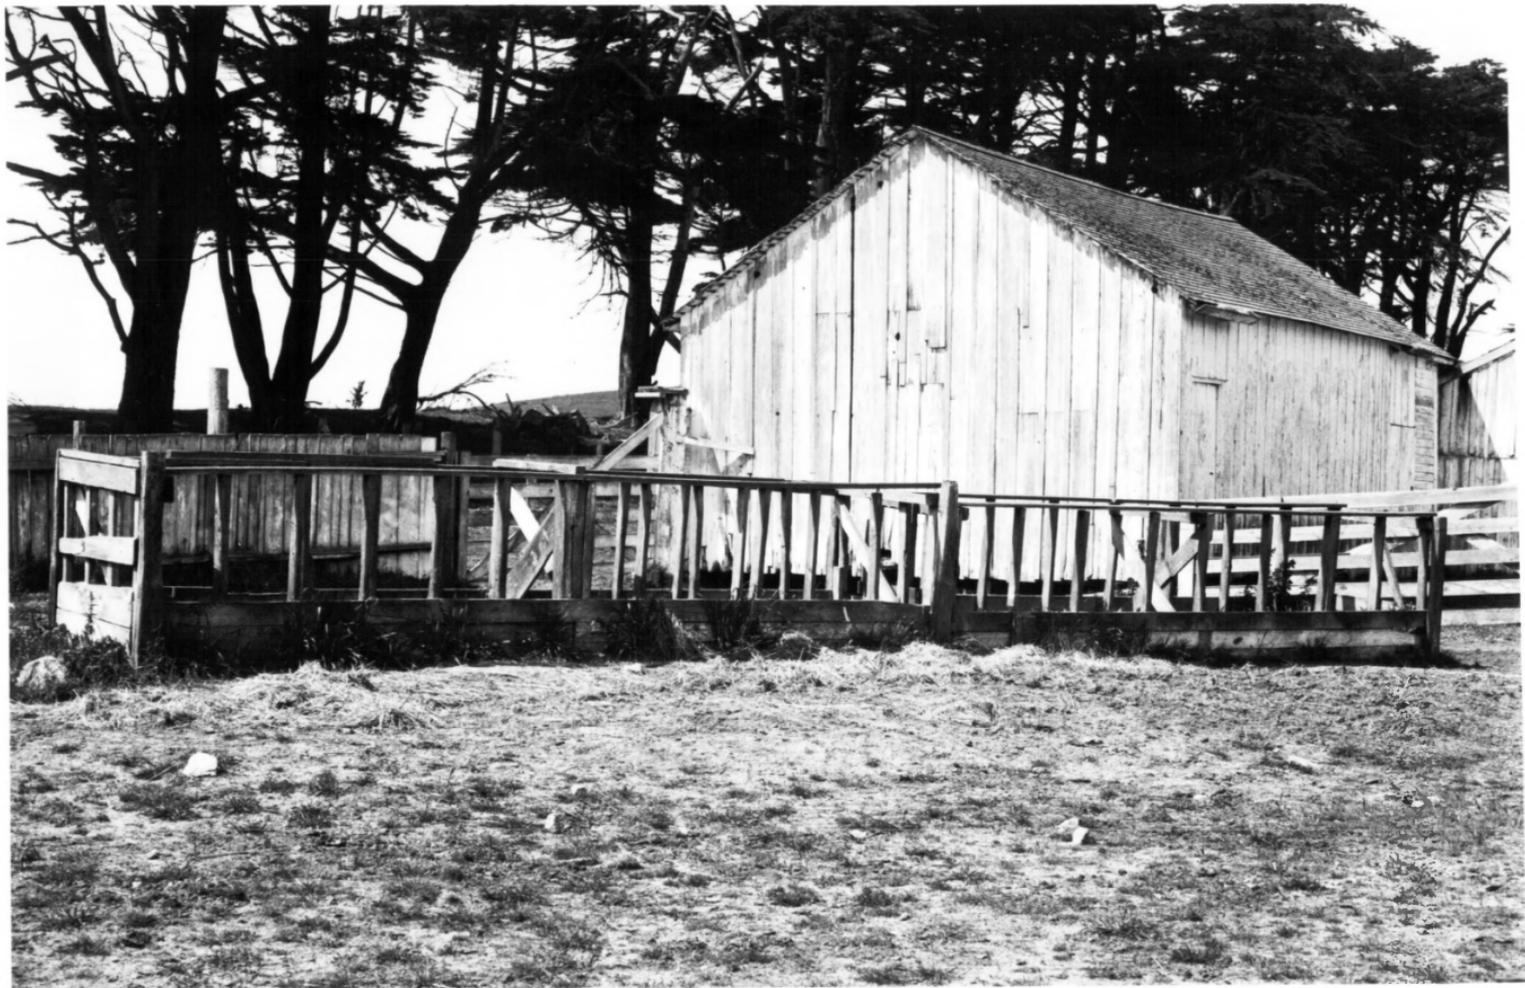
1. PIERCE RANCH ; CALF SHED AND FEEDING TROUGHS
2. POINT REYES NATIONAL SEASHORE , MARIN COUNTY,
CALIFORNIA
3. NATIONAL PARK SERVICE PHOTO BY GORDON CHAPPELL
4. APRIL 2, 1980
5. NEGATIVE AT NATIONAL PARK SERVICE ,
WESTERN REGIONAL OFFICE
6. VIEW TOWARDS NORTHEAST
7. PHOTO 14 OF 20

Calf Shed - PR 188: Facing east, this is a one story, wood frame, gable-roofed building approximately 14 by 30 feet in plan, its walls finished in board and batten, its roof finished with wood shingles. The building was used to protect newborn calves along with their mothers for the first day or two after birth. The building is whitewashed. It was moved to its present site by the McClures, but was used as a calf shed only for a brief period because it was too cold. Its prior location was at the west end of the garage (PR 197).

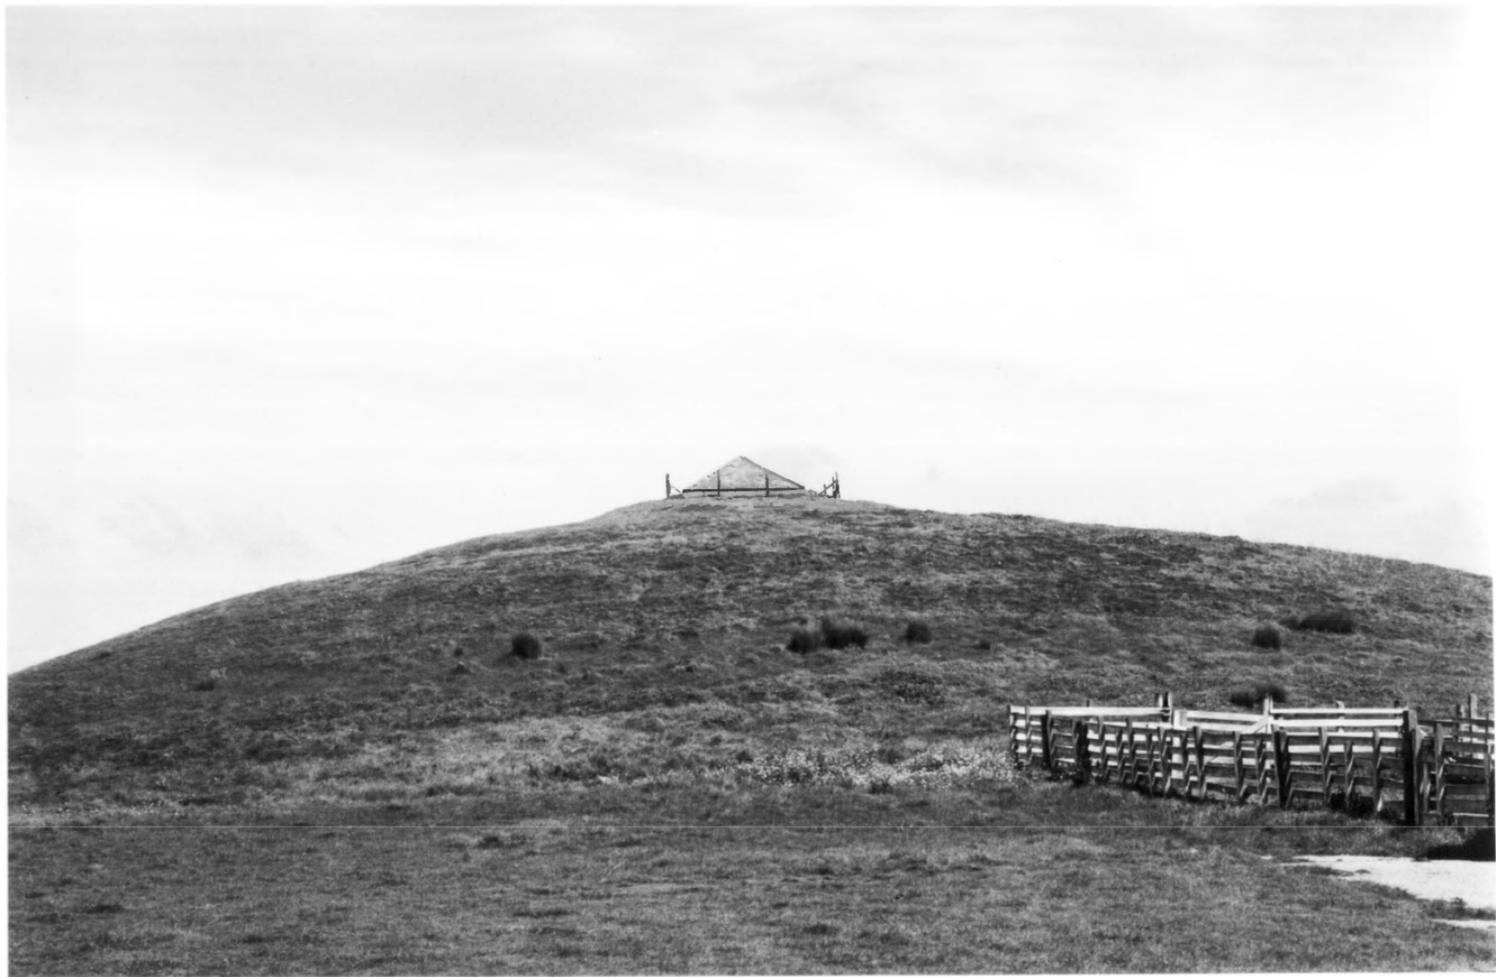
1. PIERCE RANCH ; CISTERN OR TANK AND HOUSING
2. POINT REYES NATIONAL SEASHORE , MARIN COUNTY ,
CALIFORNIA
3. NATIONAL PARK SEASHORE PHOTO BY GORDON CHAPPELL
4. APRIL 2, 1980
5. NEGATIVE AT NATIONAL PARK SERVICE ,
WESTERN REGIONAL OFFICE
6. VIEW TOWARDS EAST
7. PHOTO 15 OF 20

Tank House (Cistern) - PR 199: This structure consists of a cistern buried at the summit of a small hill located east of the Main House and the East quadrangle, surmounted by a wood frame pyramidal roof finished with wood shingles and ridge boards. On the south side of the roof is an access door of wood. The roof rests on the concrete wall which is both the foundation and the cistern wall. This structure was completely rebuilt by Point Reyes National Seashore in 1980.
