**NATIONAL REGISTER OF HISTORIC PLACES
INVENTORY -- NOMINATION FORM**

Pierce Ranch

Pierce Ranch; Upper Pierce Point Ranch

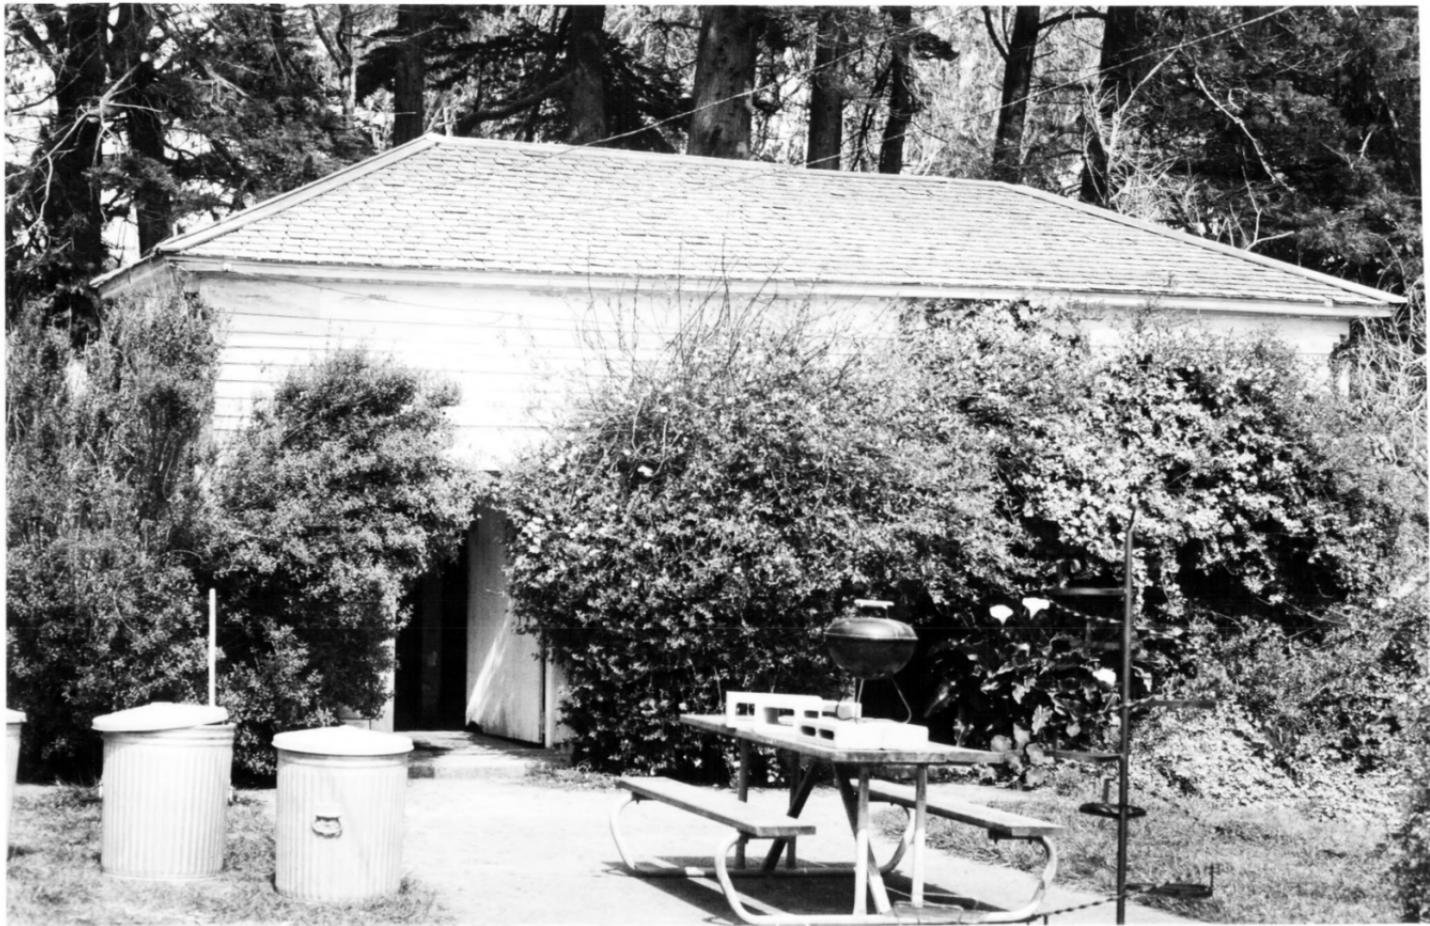
1. PIERCE RANCH; WASH HOUSE (P.R. 181)
2. POINT REYES NATIONAL SEASHORE, MARIN COUNTY, CALIFORNIA
3. NATIONAL PARK SERVICE PHOTO BY GORDON CHAPPELL
4. APRIL 2, 1980
5. NEGATIVE AT NATIONAL PARK SERVICE, WESTERN REGIONAL OFFICE
6. VIEW TOWARDS NORTH
7. PHOTO 20 OF 20

Wash House - PR 181: A small, wood frame, rectangular building roughly 15 by 27 feet, the washroom was originally less than half its present size. The hipped roof, of moderate pitch, is finished with wood shingles. Exterior walls are a narrow horizontal wood siding. Sash in the front are six over six, double hung, of wood. The floor is wood. The building has two rooms, each with its own exterior door. One room has finished wood walls inside, may have insulation, and could have been used at one time for food storage. The east side, according to Dorothy McClure, was used as a wash house, the west side as a storeroom. The west side originally had a belfry and bell on top, but when the large bell there cracked, the McClures removed it and the belfry.
