39 PRESERVATION BRIEFS

Holding the Line: Controlling Unwanted Moisture in Historic Buildings

Sharon C. Park, AIA

U.S. Department of the Interior
National Park Service
Cultural Resources
Heritage Preservation Services

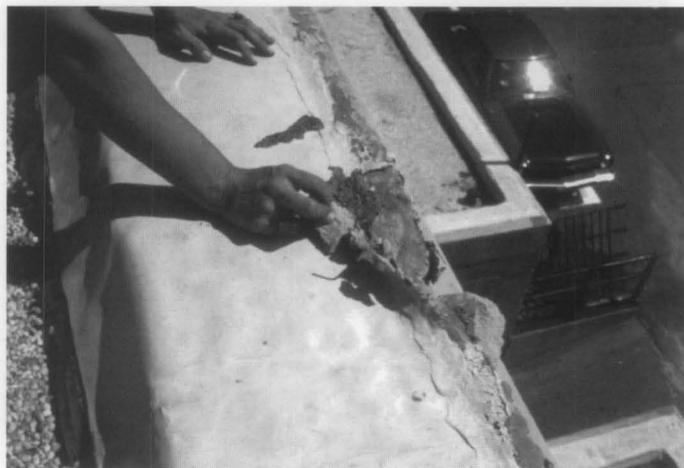
Fig. 1. Moisture problems, if not properly corrected, will increase damage to historic buildings. This waterproof coating trapped moisture from the leaking roof, causing portions of the masonry parapet to fail. Photo: NPS Files.

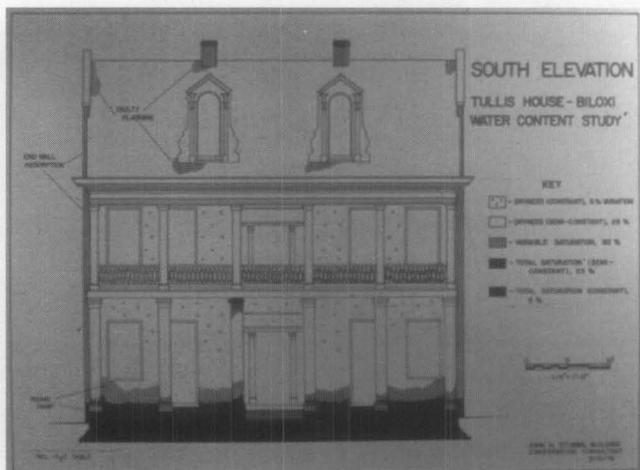
Fig. 2. Historic buildings plagued by dampness problems will benefit from systematic documentation to set a baseline against which moisture changes can be measured. Exterior areas with higher moisture levels may have algae growth or discoloration stains. Drawing: John H. Stubbs.

Identifying the type of moisture damage and discovering its source or sources usually involves the human senses of sight, smell, hearing, touch, and taste combined with intuition. Some of the more common signs of visible as well as hidden moisture damage (see fig. 2, 3) include:

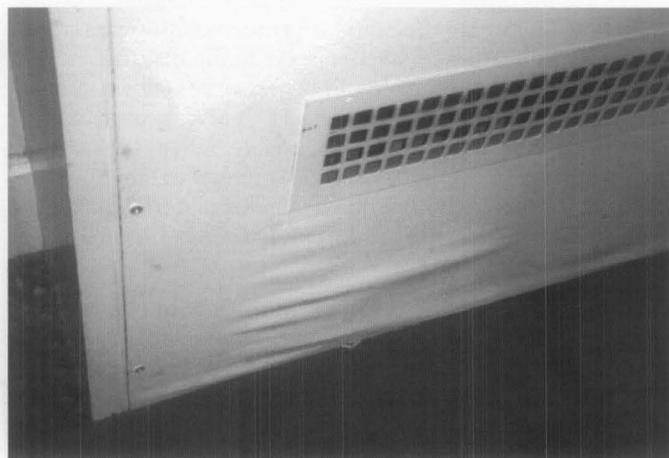
Fig. 3. The deterioration of this wooden cover was a sign that water was leaking from the fan coil unit behind. Photo: author.

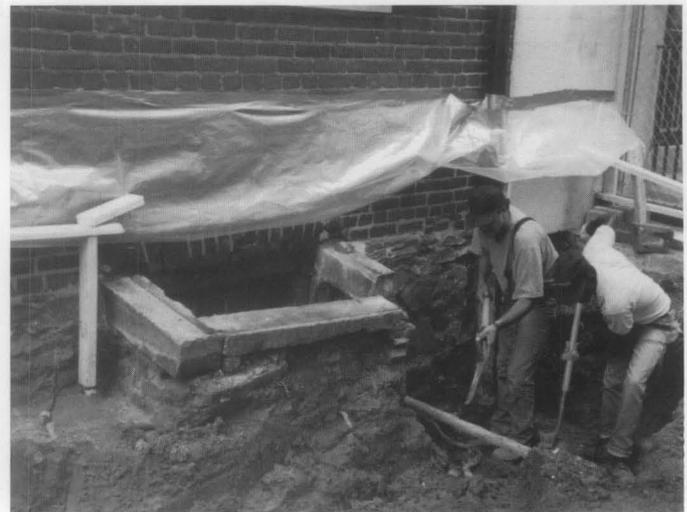
Fig. 5. Excavating this foundation revealed that the downspout pipe had corroded at the “u-trap” and was leaking moisture into the soil. Openings around the horizontal water supply line and cracks in the wall allowed moisture to penetrate the basement in multiple locations. Photo: author.

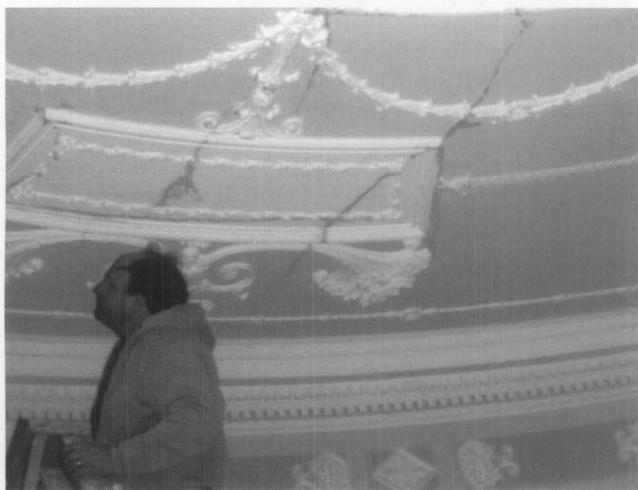
Fig. 6. Uninsulated plumbing pipes close to the exterior wall froze and cracked, wetting this ornamental plaster ceiling before the water supply line could be shut off. As a result, limited portions of the ceiling needed reattaching. Photo: author.

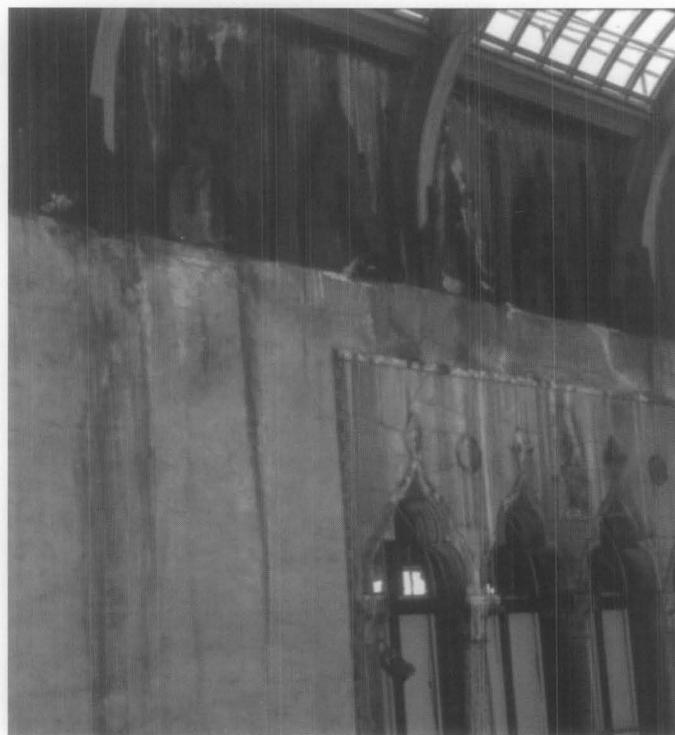
Fig. 7. Condensation dripping from the large overhead courtyard skylight was damaging the masonry in this museum. A new skylight with thermal glazing was installed, replacing the deteriorated single-glazed unit. A new climate control system monitors interior temperature and humidity. Photo: © Isabella Stewart Gardner Museum, Boston.

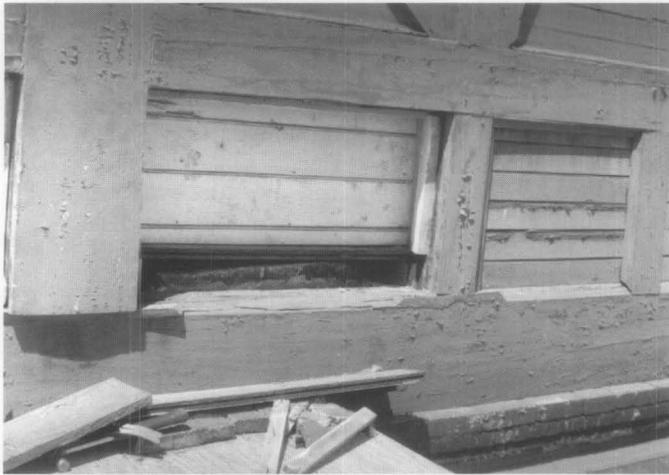
Fig. 8. Damaging moisture conditions can occur during construction. Peeling paint on this newly rehabilitated frame wall was attributed to wall insulation that had become wet during the project and was not discovered. Photo: NPS Files.

plastered interior walls or the construction of new additions attached to historic buildings may hold moisture for months; new plaster, mortar, or concrete should be fully cured before they are painted or finished. The use of materials in projects that have been damaged by moisture prior to installation or have too high a moisture content may cause concealed damage (see fig. 8).

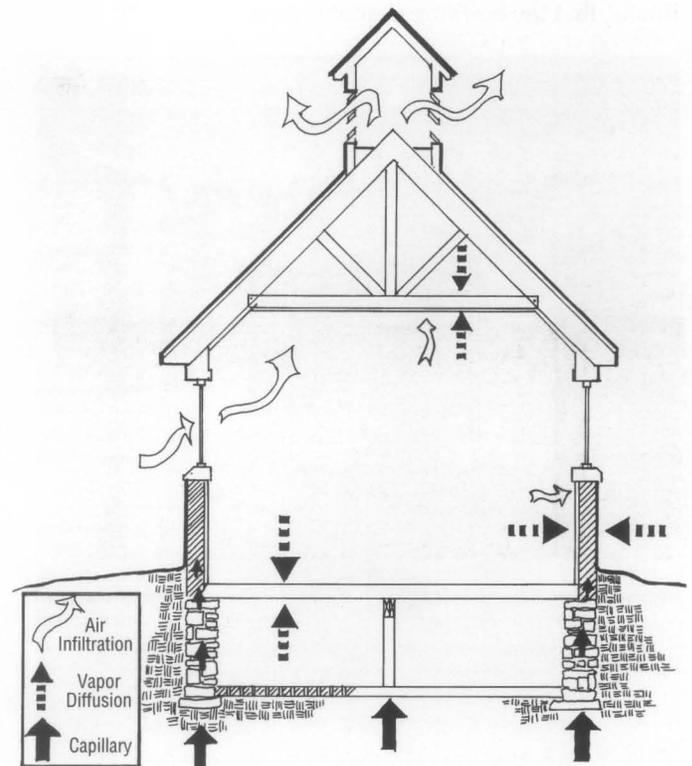
Fig. 9. The dynamic forces that move air and moisture through a building are important to understand particularly when selecting a treatment to correct a moisture problem. Air infiltration, capillary action, and vapor diffusion all affect the wetting and drying of materials. Drawing: NPS Files.

Three forms of moisture transport are particularly important to understand in regards to historic buildings — *infiltration, capillary action, and vapor diffusion* — remembering, at the same time, that the subject is infinitely complex and, thus, one of continuing scientific study (see

fig. 9). Buildings were traditionally designed to deal with the movement of air. For example, cupolas and roof lanterns allowed hot air to rise and provided a natural draft to pull air through buildings. Cavity walls in both frame and masonry buildings were constructed to allow moisture to dissipate in the air space between external and internal walls. Radiators were placed in front of windows to keep cold surfaces warm, thereby reducing condensation on these surfaces. Many of these features, however, have been altered over time in an effort to modernize appearances, improve energy efficiency, or accommodate changes in use. The change in use will also affect moisture movement, particularly in commercial and industrial buildings with modern mechanical systems. Therefore, the way a building handles air and moisture today may be different from that intended by the original builder or architect, and poorly conceived changes may be partially responsible for chronic moisture conditions.

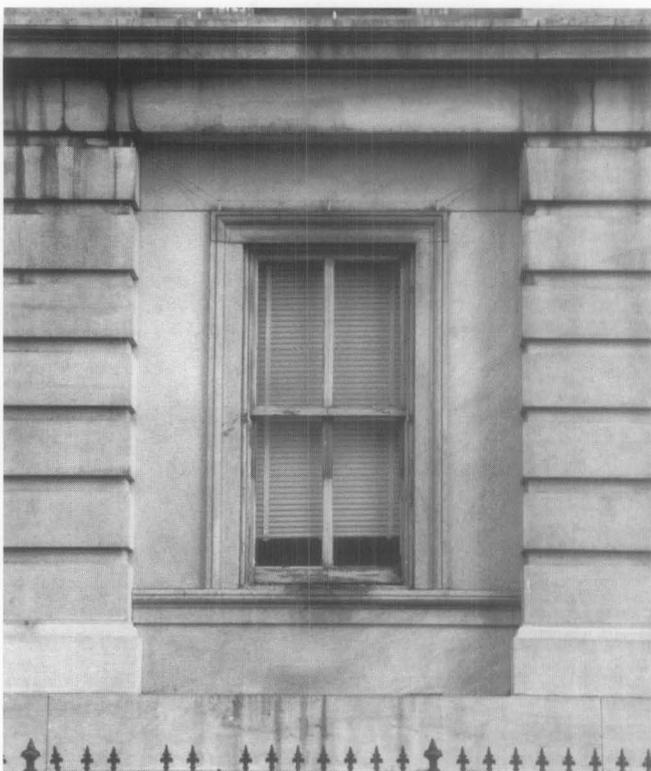
Fig. 10. Infiltration of damp air can occur around loose-fitting or deteriorated window sash and through cracks or open joints in building exteriors. Photo: Ann Brooks Prueher.

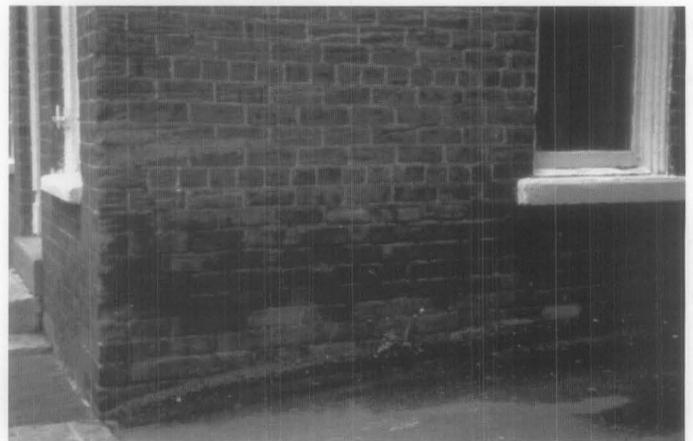
Fig. 11. Capillary rise of moisture in masonry is often accompanied with a horizontal tide-mark line several feet above the grade, as seen here. Removing or redirecting as much ground moisture as possible usually helps reduce moisture within a wall. Photo: NPS Files.

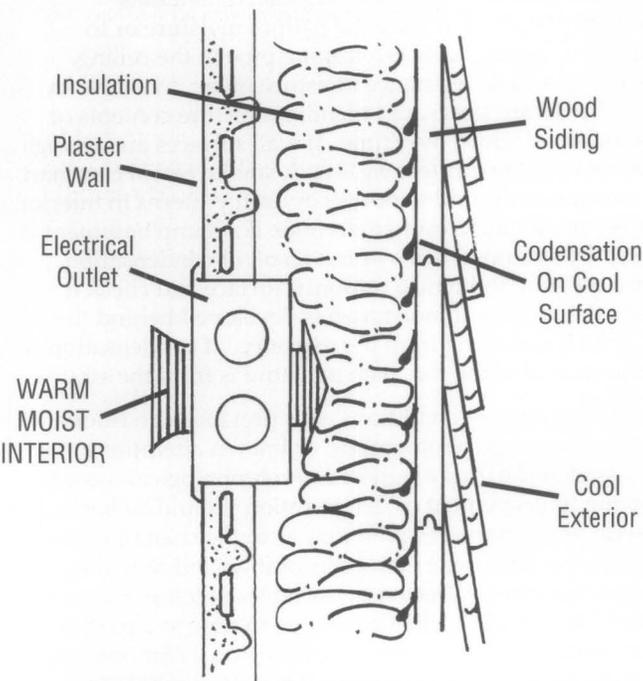
Fig. 12. Vapor diffusion can result in damp air migrating into absorbent materials and condensing on colder surfaces, thereby wetting insulation, damaging electrical conduits, and causing deterioration of the wooden framing. Drawing: NPS Files.

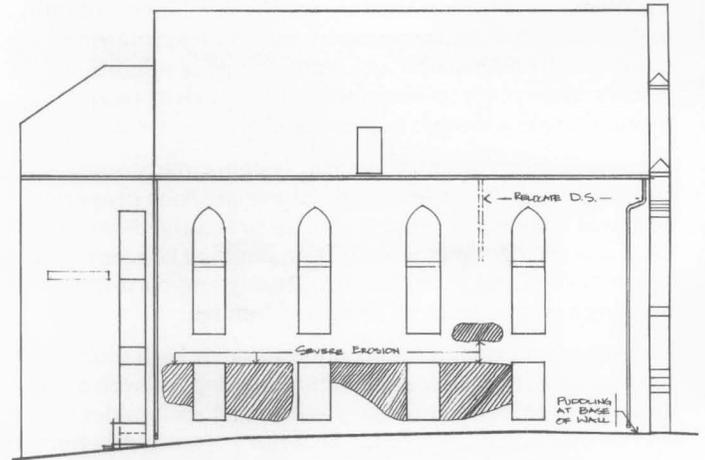
DATE: June 2, 1992	TEMP: 70°	OTHER: Thunderstorm
WEATHER: Fair	TIME: 10:00AM	previous day

Surveying moisture damage must be systematic so that relative changes can be noted. Tools for investigating can be as simple as a notebook, sketch plans, binoculars, camera, aluminum foil, smoke pencil, and flashlight. The systematic approach involves looking at buildings from the top down and from the outside to the inside. Photographs, floor plans, site plan, and exterior elevations — even roughly sketched — should be used to indicate all evidence of damp or damaged materials, with notations for musty or poorly ventilated areas. Information might be needed on the absorption and permeability characteristics of the building materials and soils. Exterior drainage patterns should be noted and these base plans referred to on a regular basis in different seasons and in differing types of weather (see fig. 13).

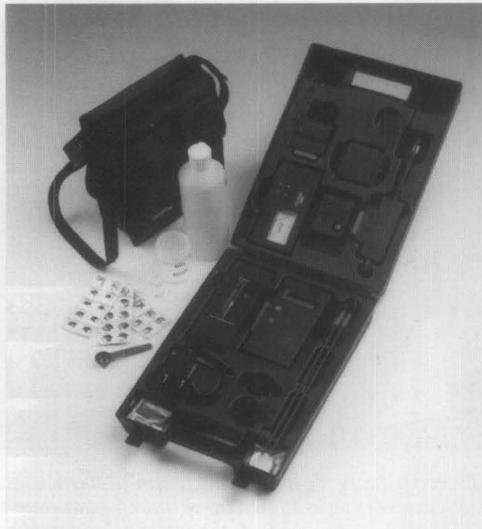
Fig. 14. Using instruments in this damp-check kit can help determine the relative change in wet conditions over time. This involves readings of air temperature, computing dewpoint temperatures, and tracking the moisture content of materials to indicate if they are drying properly. Photo: Dell Corporation.

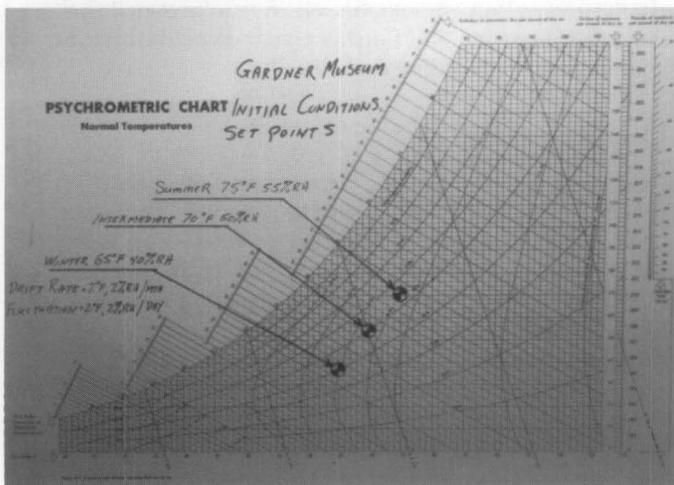
Fig. 15. Psychrometric charts quantify the amount of relative humidity a building can tolerate before dewpoint condensation occurs. This is important when the range of temperature and humidity are critical to both collections management and historic building preservation. Chart: Landmark Facilities Group.

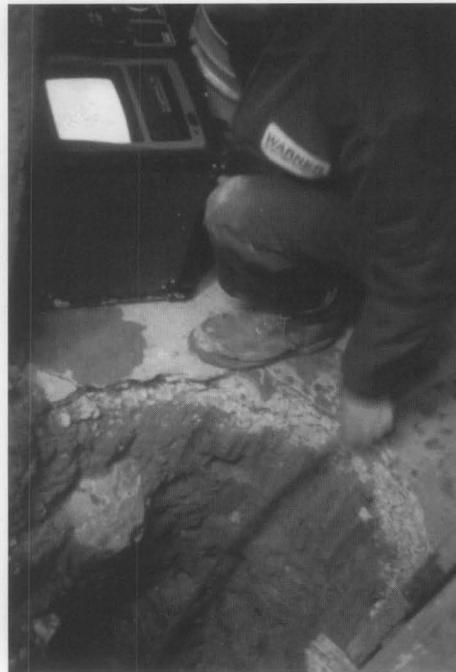
Fig. 16. Contractors specializing in building diagnostics often have video camera or fiber optic equipment that allow the viewing of inaccessible areas. This is particularly helpful in chimney flues or subsurface drains, as shown here. In the past, these areas would need to be excavated for visual inspection. Photo: author.

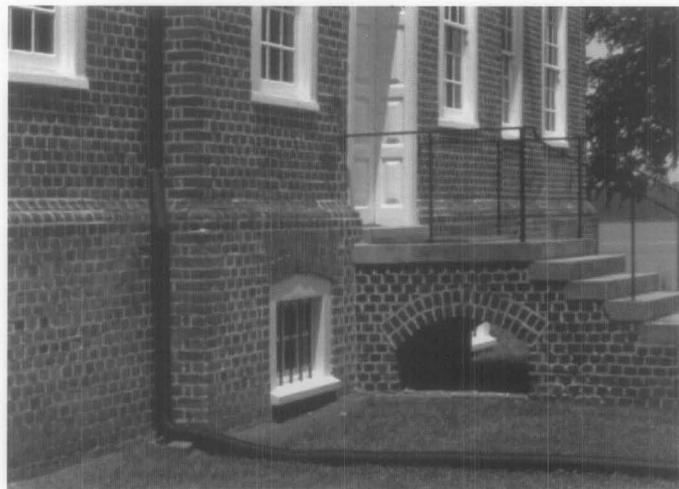
Fig. 17. In testing a theory for the cause of basement wetness, the owner used long black extender pipes to direct roof run-off away from the foundation. This test established that the owner did not need expensive waterproofing of the foundation, but a better drainage system. Photo: Baird M. Smith.

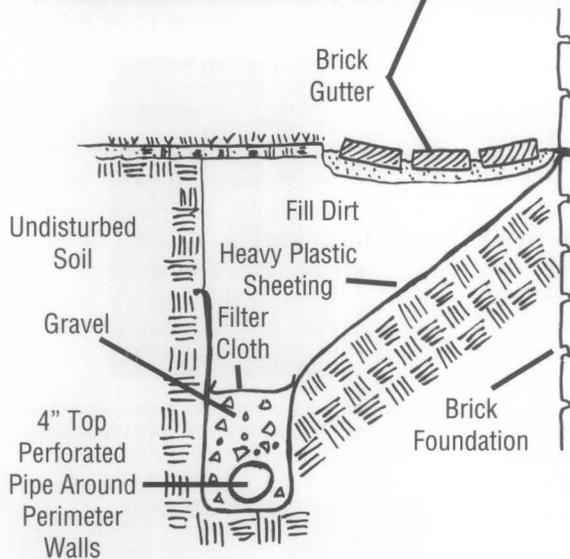
Fig. 18. This detail drawing shows a sub-surface perimeter drain in conjunction with a historic brick ground gutter system to help control roof run-off moisture from entering the historic foundation. Detail: Courtesy, Gunston Hall Plantation. Photo: Elizabeth Sasser.

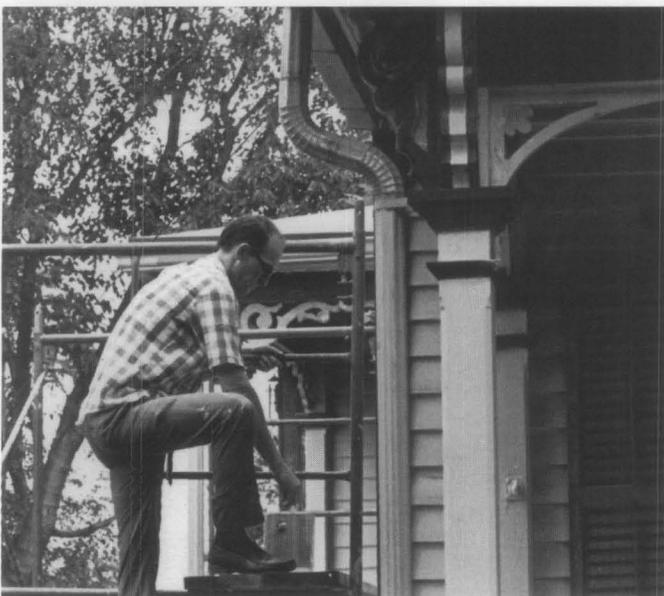
Fig. 19. Maintaining gutters and downspouts in good operable condition, repairing exteriors to keep water out, redirecting damaging moisture away from foundations and controlling interior moisture and condensation are all important when holding the line on moisture deterioration. Photo: Nebraska State Historical Society.

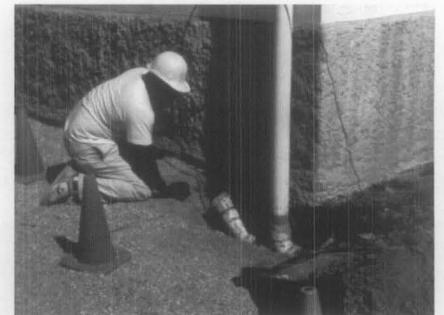
C. Cleaning out gutters and downspouts should be done at least twice a year. Photo: WPTC, NPS.

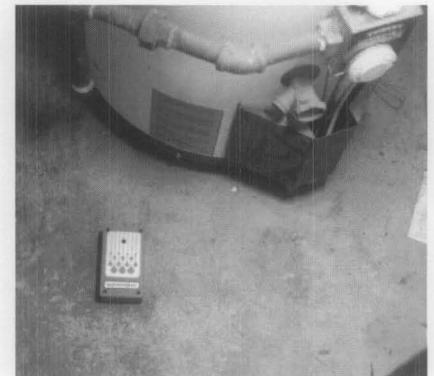
D. Protect the building from damage by maintaining equipment and using alarms, like this floor water sensor. Photo: Dell Corporation.

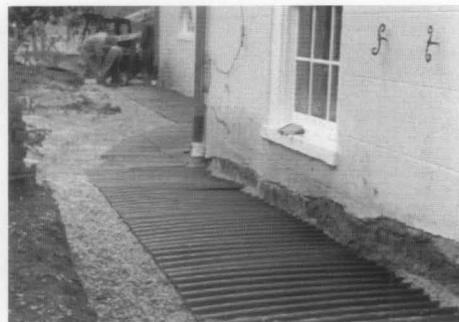
A. Mitigate poor drainage with gravel, filter cloth, or the use of subsurface drainage mats under finished paving. Photo: Larry D. Dermody.

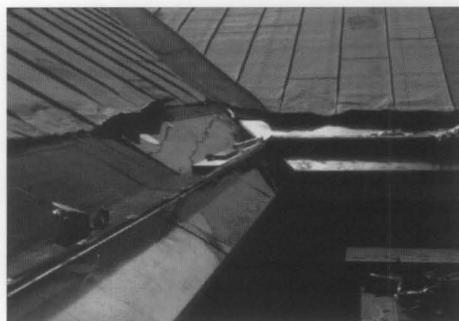
B. Repair roofs and add ice and water shields at eaves and under valleys in cold climates. Photo: Larry D. Dermody.

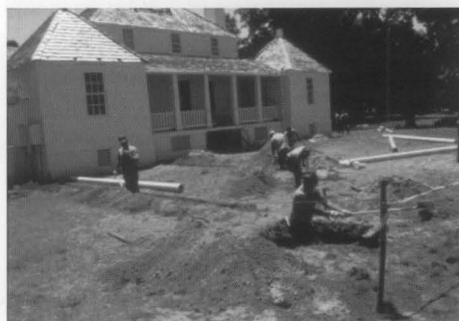
C. Develop new drainage systems for roof run-off that remove moisture from the base of the building. Photo: WPTC, NPS.

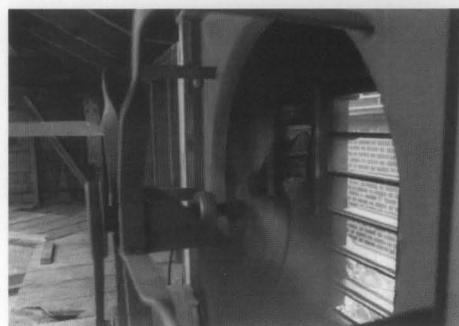
D. Install ventilating fans when additional air circulation will improve damp conditions in buildings or reduce cooling loads. Photo: Ernest A. Conrad, P. E.

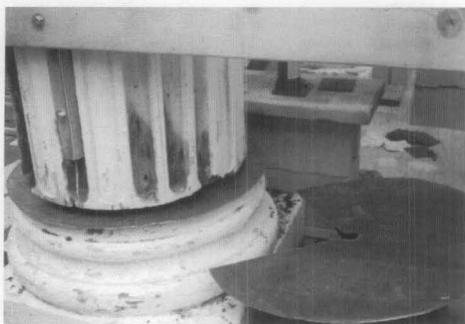
A. This lead sheet was installed at the base of the replacement column to stop rising damp. Photo: Bryan Blundell.

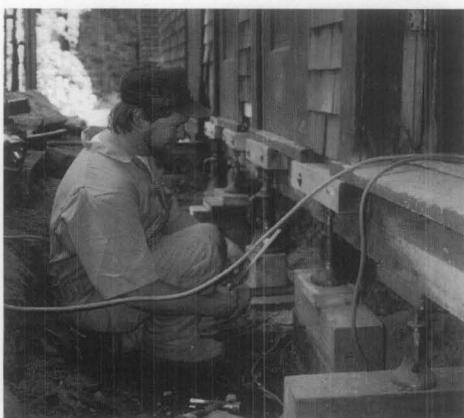
B. Wood sills set on grade were replaced with concrete pier foundation and new wooden sill plates. Changes were not visible on the exterior (see C). Photo: WPTC, NPS.

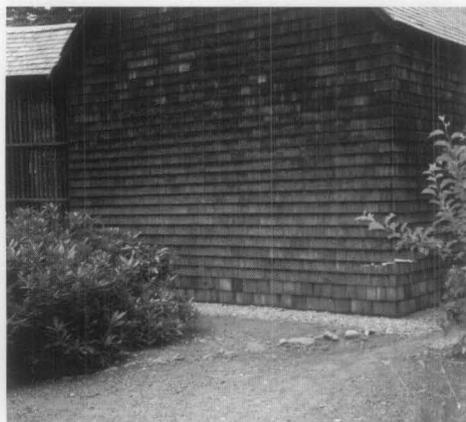
C. The new ground gutter gravel base helps drainage around the concrete foundation (see B above) which is not visible behind the replaced wooden wall shingles. Photo: WPTC, NPS.

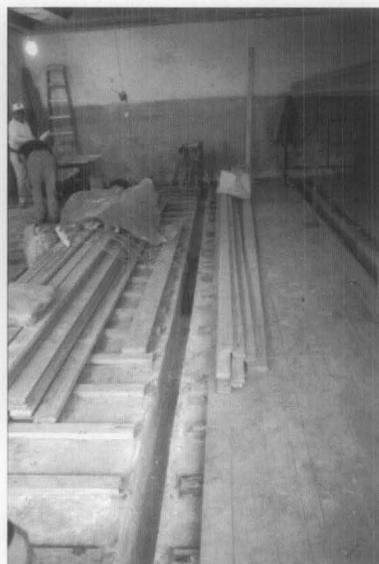
D. In a flood plain, rotted joists were replaced with a concrete slab and sleepers designed to drain water. Spaced flooring allowed drainage and room for damp wood to swell without buckling. Harper's Ferry Center, NPS.

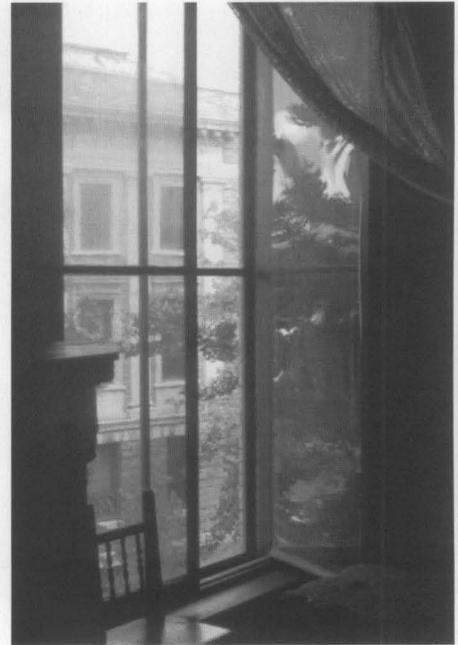
F. Triple glazed windows replaced the originals to control condensation. Photo: © Isabella Stewart Gardner Museum, Boston.

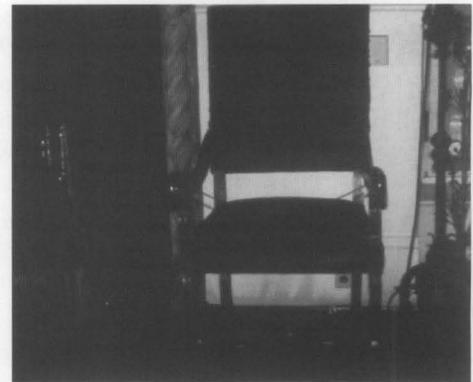
G. New sensors which monitor temperature and relative humidity are located throughout this museum and tied to a computer that controls the climate control system. Photo: © Isabella Stewart Gardner Museum, Boston.

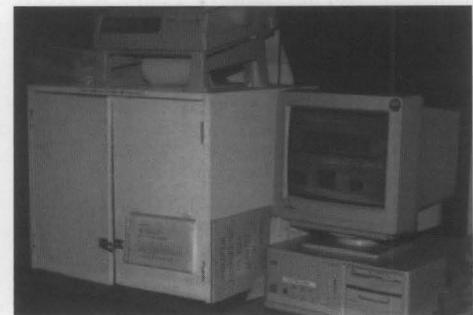
H. New computers tie a variety of monitoring and security features into a comprehensive system which provides warning and backup alerts when any of the system components are not functioning properly. Photo: © Isabella Stewart Gardner Museum, Boston.

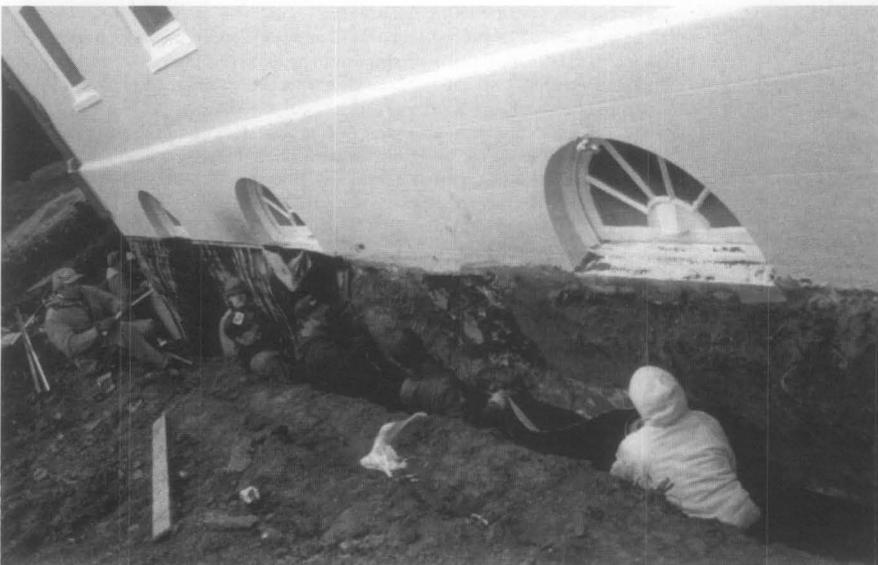
I. Critically damp foundation walls were protected with a layer of bentonite clay to reduce moisture penetration. This work was in combination with new downspouts that were connected to drainage boots that deposited captures roof run-off away from the foundation. Photo: Courtesy, Larry D. Dermody and the National Trust for Historic Preservation.
