46 PRESERVATION BRIEFS

The Preservation and Reuse of Historic Gas Stations

Chad Randl

National Park Service
U.S. Department of the Interior
Heritage Preservation Services

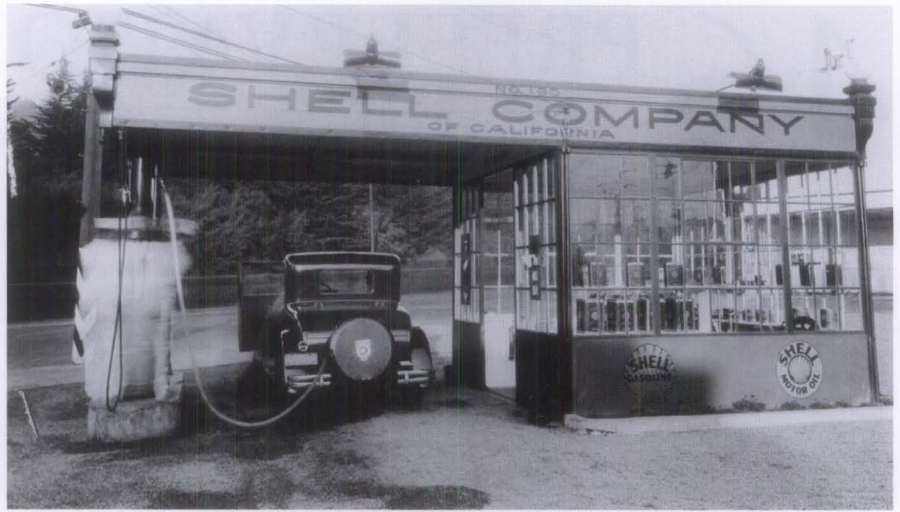
Figure 3. This shed-type station with its prefabricated steel panels, pump island, and canopy prefigured many later gas station designs. Photo: American Petroleum Institute Photograph and Film Collection, Archives Center, National Museum of American History, Smithsonian Institution.

Shed-Type Stations. Detached structures built specifically for the sale of gasoline appeared during the second decade of the twentieth century in an effort to meet the petroleum demand generated by the Ford Model T and other affordable automobiles. In the initial race to expand, companies and independent operators constructed basic sheds to serve as drive-in filling stations. Many were rudimentary frame shacks with wood or corrugated metal exteriors. More substantial designs featured prefabricated metal panels, industrial steel windows, and some limited ornament. In either case, the shed was a utilitarian building used for storage and office space, and to shelter the station attendant. Pumps were placed immediately adjacent to the structure or separated on the lot by a driveway where cars parked to refuel (Fig. 3).

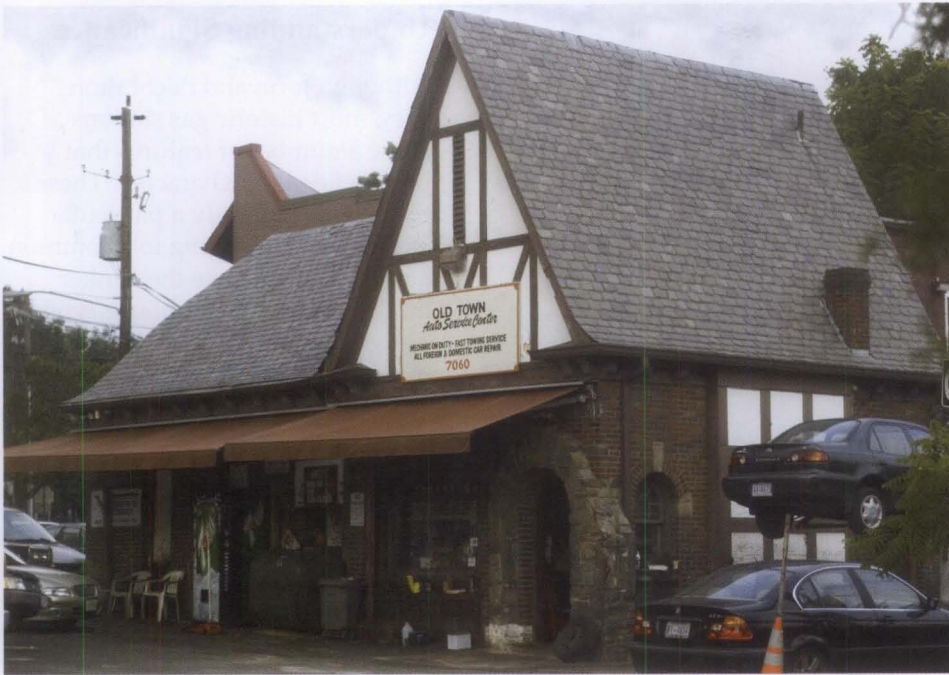
Figure 4. Designs based on popular domestic forms helped stations blend in with residential neighborhoods while imparting a sense of stability and permanence. This Tudor Revival station was converted for use as a repair shop with virtually no change to the structure or site.

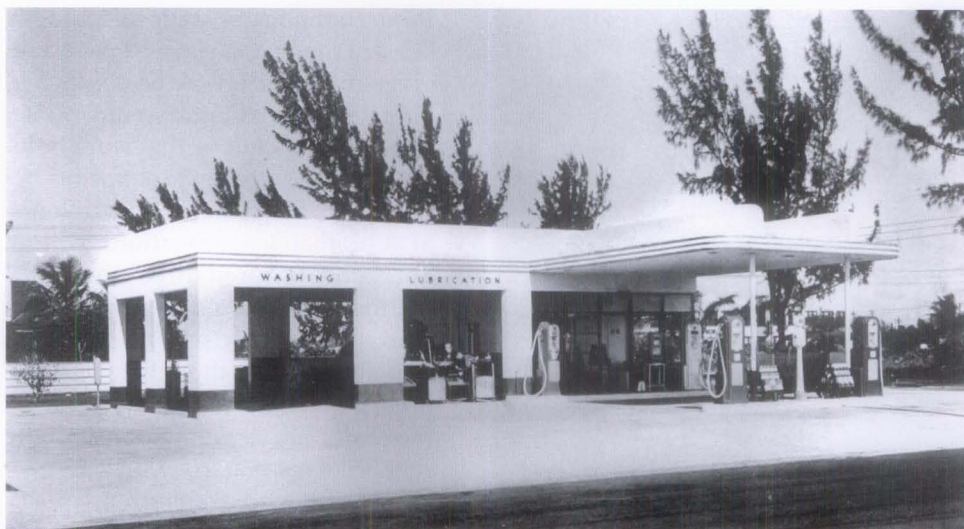
Figure 6. Box-type stations often incorporated Art Moderne forms such as this design's rounded corners, stripes, and large sales windows. Photo: American Petroleum Institute Photograph and Film Collection, Archives Center, National Museum of American History, Smithsonian Institution.

The form and layout of box stations were also influenced by current economic conditions. Pushed during the Great Depression to explore other revenue streams, station owners added service and repair bays (emphasizing the characteristic rectangular footprint of box stations) as well as expanded sales areas to market lucrative car tires, batteries, and accessories. Large display windows and glazed service bay doors highlighted these products and services (Fig. 6).

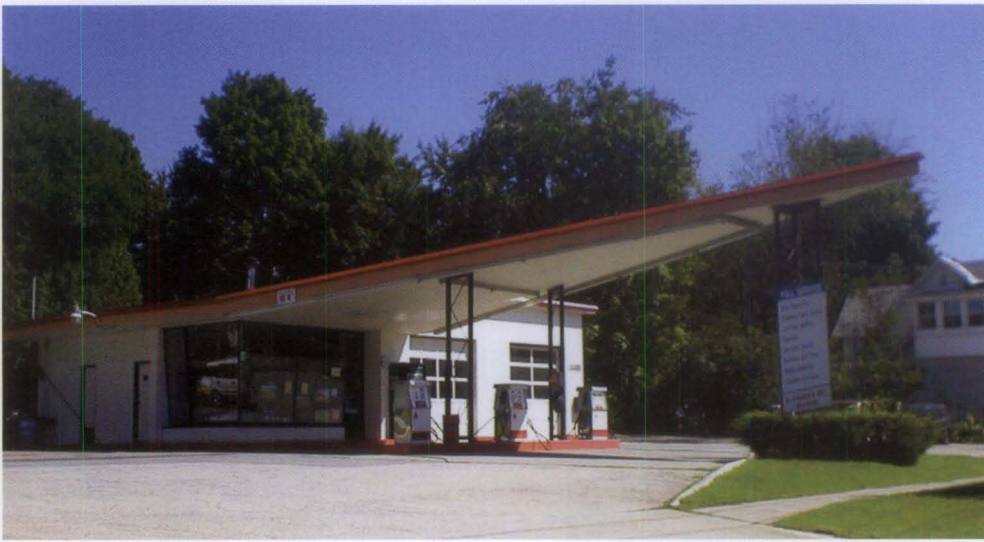
Figure 8. This former Phillips 66 gas station in Burlington, VT, sports a quintessential stylized box design. Its space age canopy is visible from far down the road. Photo: Devin A. Colman.

Although form and decoration vary, most historic gas stations share a number of features that help define their character. These features can identify a particular structure as belonging to a common gas station type, like the clinker bricks used on Tudor house-type designs. Alternately, features may accentuate the uniqueness of a particular structure, such as a custom roof design or circular plan. Some features were highly unusual when first adopted, later became unexceptional, and today are once again rare and distinctive. A prime example is the V-shaped canopy found on postwar Phillips 66 gas stations (Fig. 8).

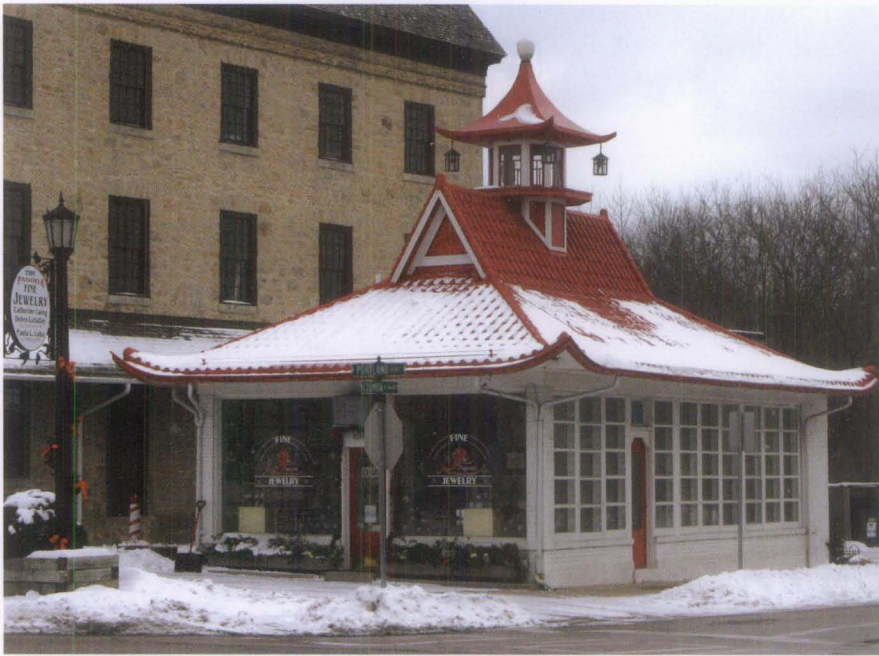
Figure 9. The dominant feature of this former gas station (1929) in Cedarburg, WI, is its pagoda-style metal tile roof (complete with upturned eaves and Japanese lanterns suspended from the cupola). The building currently functions as a jewelry store. Photo: Kenneth M. Itle, Wiss, Janney, Elstner Associates, Inc.

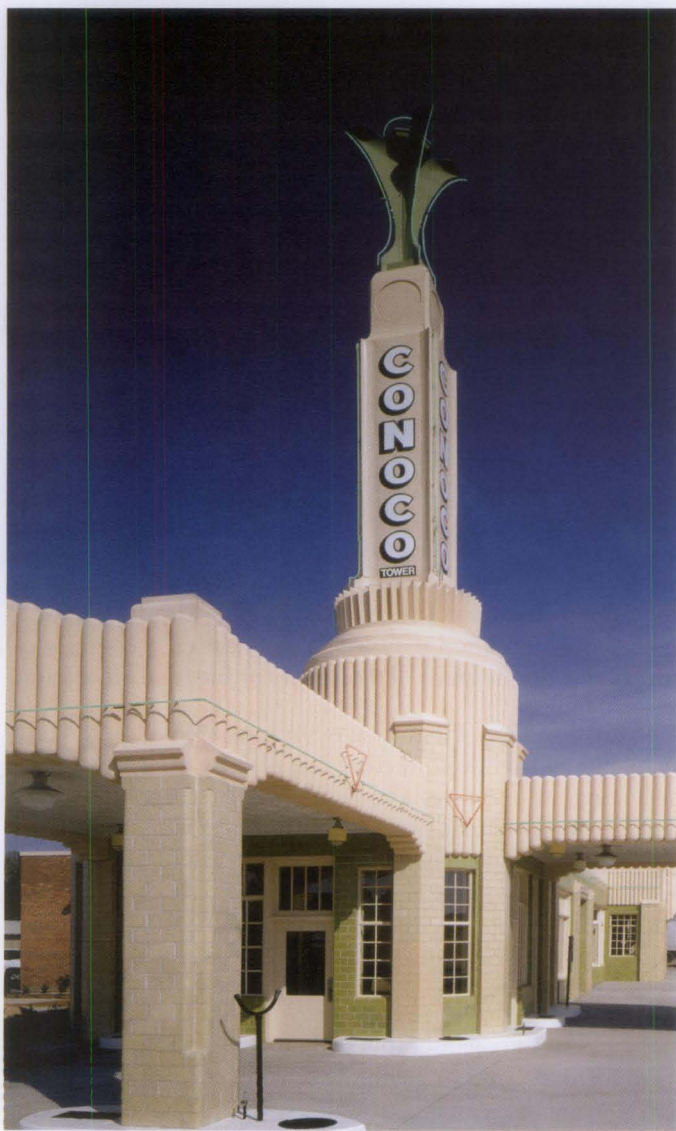
Figure 10. The canopies on this 1936 gas station in Shamrock, Texas, are both functional and integral features of the station's overall design. This building was recently converted for use by the local Chamber of Commerce, partially with FHWA Transportation Enhancements funding assistance. Photo: Mark Trew Photography.

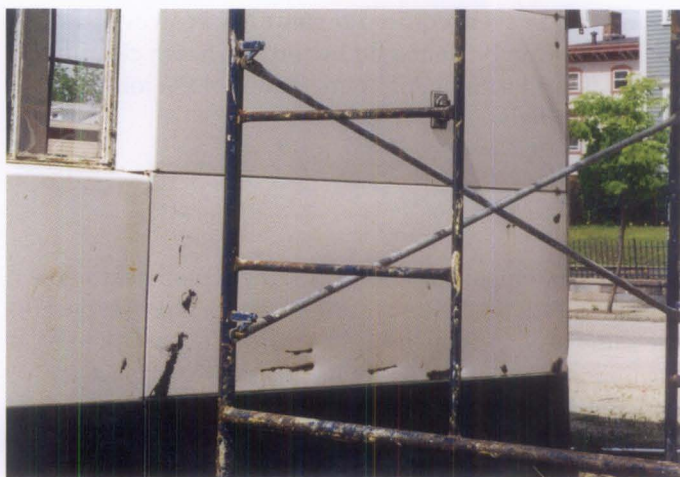
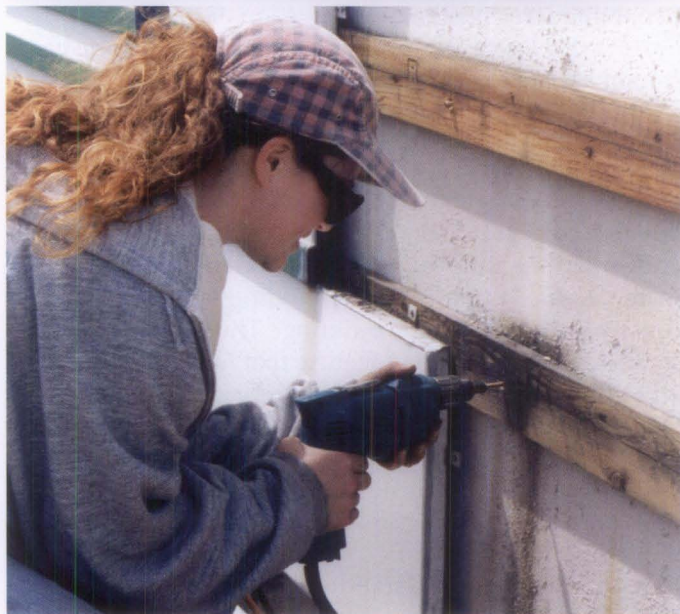
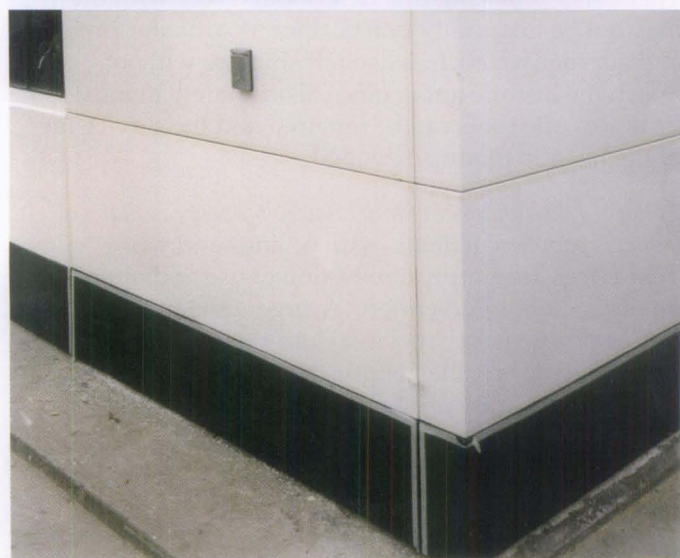
Figure 11. The porcelain enamel facade of this former Texaco station (1960) had numerous dents and scratches that had exposed the steel beneath the enamel to deterioration (top). Rehabilitation work included repairing localized damage to the panels and blending patched areas to match adjacent historic material, replacing sleepers beneath the panels (center), replacing severely damaged panels with like material, and recaulking the joints (bottom). Photos: John Vaughan, Architectural Conservation Services.

Porcelain enamel offers a good example of some of the problems and the level of skill and experience that may be required when repairing historic materials (Fig. 11). Spot repairs of damage (drill holes, impact damage) to these types of manufactured panels are challenging. Because the original glass-like finish was baked on at a high temperature, it is hard to adhere filler and paint to the enamel surface; blending new material with the original surface color is particularly difficult. The preferred, least intrusive, approach is to remove any rust, fill any depressions with a marine epoxy filler, prime, and repaint the surface with a high-quality glossy enamel. This paint coating will likely require a renewed treatment after some years. More severe damage may require replacement with a salvaged or newly fabricated panel. Where panels are loose or select ones need replacement, care should be taken during disassembly as they often are supported by an attachment system that requires a specific sequence of removal and reinstallation.

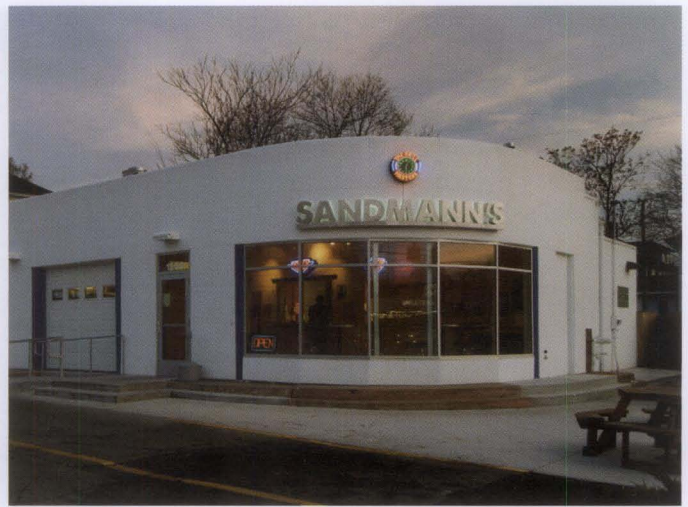
Figure 15. The historic restroom door to the right of the display window was closed off (and entry provided on the inside) when this former gas station in Grand Rapids, MI was converted to a carry-out restaurant. A flush panel was recessed in the opening to identify the historic location of the door. Photo: M Buck Studios.

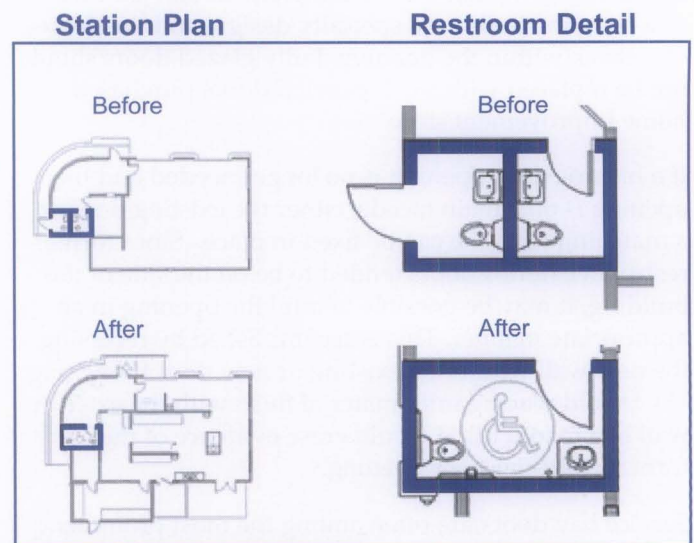
Figure 17. A plan of the same station shown in Figure 15, illustrates how the historic men's and women's rooms were combined to make a single accessible restroom. Drawing: Lott3Metz Architecture.

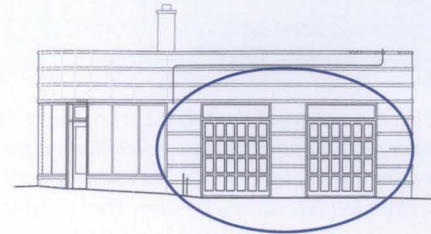
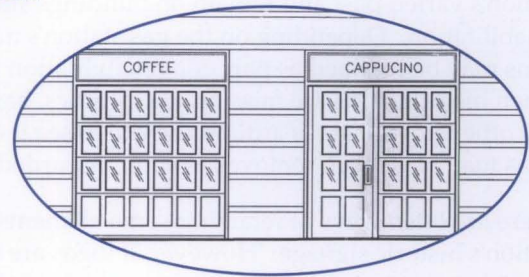
This 1938 concrete block gas station featured a pair of wood multi-light segmental service bay doors (top). When the station was converted to a coffee shop the service bays were reused as a dining area. The doors were fixed in place and a door for customers was introduced in the right opening in a manner that retained the original light configuration (above). To increase the thermal properties of the service bay doors, the single pane glass was removed and replaced with insulating glass (below). The appearance of the door is virtually unchanged and the building retains its historic character. Drawings courtesy Robert Olin, Sherman Perk.

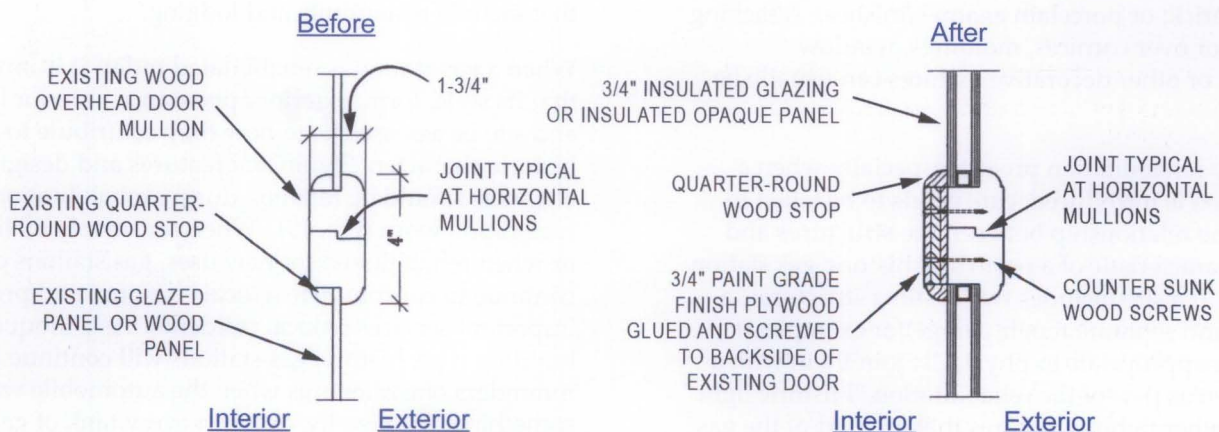
Modifying Overhead Door Mullions

Beginning in the 1930s stations increasingly used segmental overhead doors. Surviving doors can usually be retained and, if need be, upgraded as part of a rehabilitation. It may be possible to replace the existing single-glazed panels with insulated glazing and wood panels with insulated panels while retaining the original door structure. Such treatments may be particularly necessary when the former service bays are used as offices or dining spaces. Fixing a historic door in place is preferable to enclosing the opening with new construction.

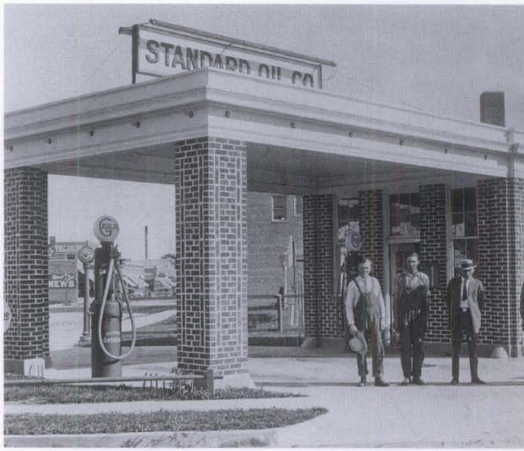
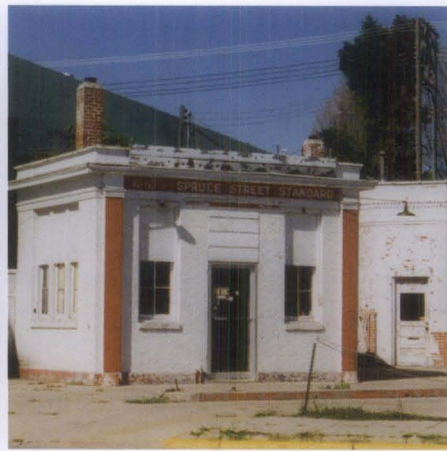
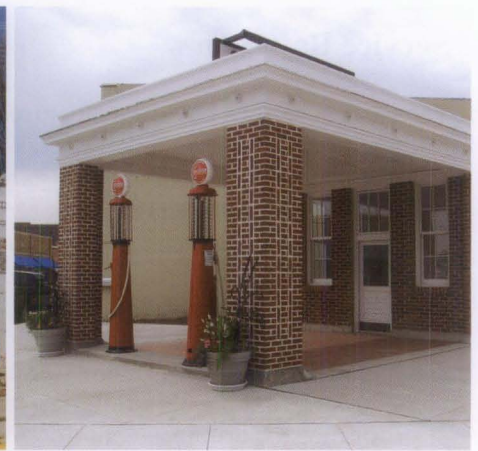
Figures 18. The canopy of the 1920s Spruce Street Station in Ogallala, NE, was an important feature that contributed to the building's character (left). When recently purchased for rehabilitation the canopy had long since disappeared (center). Using photographic and physical evidence, the canopy was reconstructed to match the building's original appearance (right). The station currently functions as a Main Street program office, a visitor center (on Nebraska's Western Trails Historic and Scenic Byway as well as Lincoln Highway Scenic Byway), meeting room, and public restroom facility. Photo: Ogallala Main Street.

and subsequent deterioration can cause the canopies to deflect and damage the main structure. Deteriorated canopies dating from the 1960s that feature custom plastic fascia panels may require replacement pieces molded to match the existing materials. Custom steel trusswork, either in the supporting pier or the canopy itself, if it is deteriorated beyond repair can be replicated with newly-fabricated members matching the existing features. It may be possible to replace missing canopies with new ones based on historic documentation (Fig. 18).

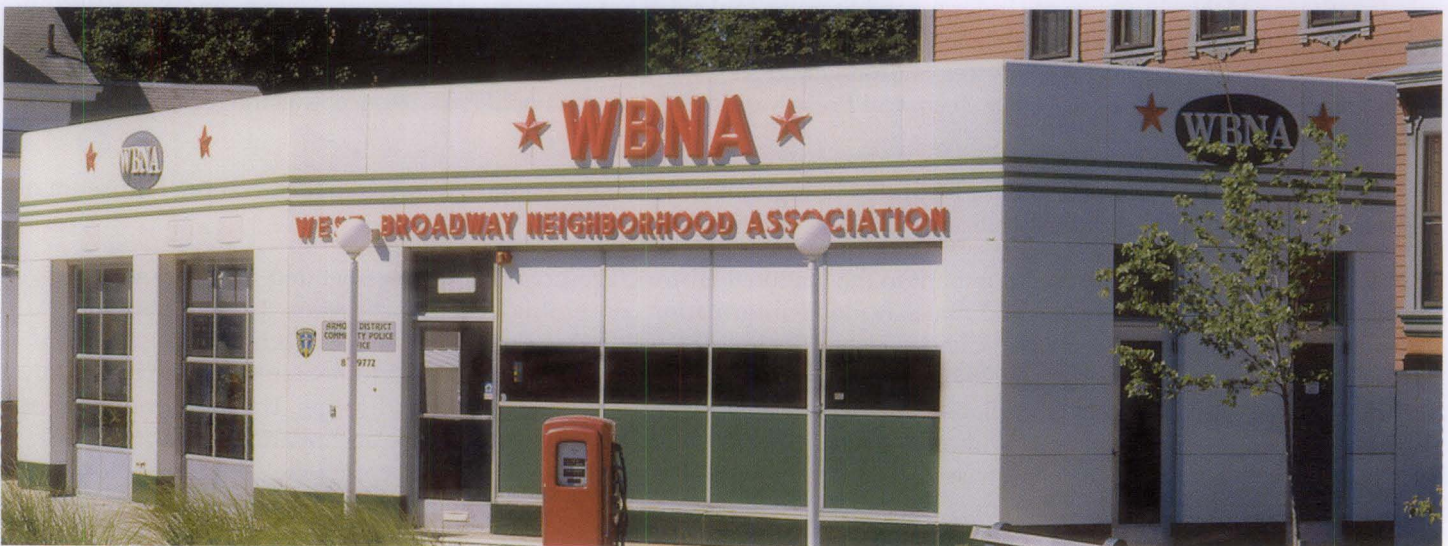
Figure 19. When converted for use as office and meeting space by a local community non-profit, the historic character of this 1960s gas station was retained. Porcelain enamel repairs to this station are illustrated in Figure 11. Photo: Scott Lapham Photography.
