Planning for Exterior Work on the First Parish Church Portland, Maine

*Using Photographs
as Project Documentation*

A Preliminary Survey of the Building

Architect's Specifications for Project Work

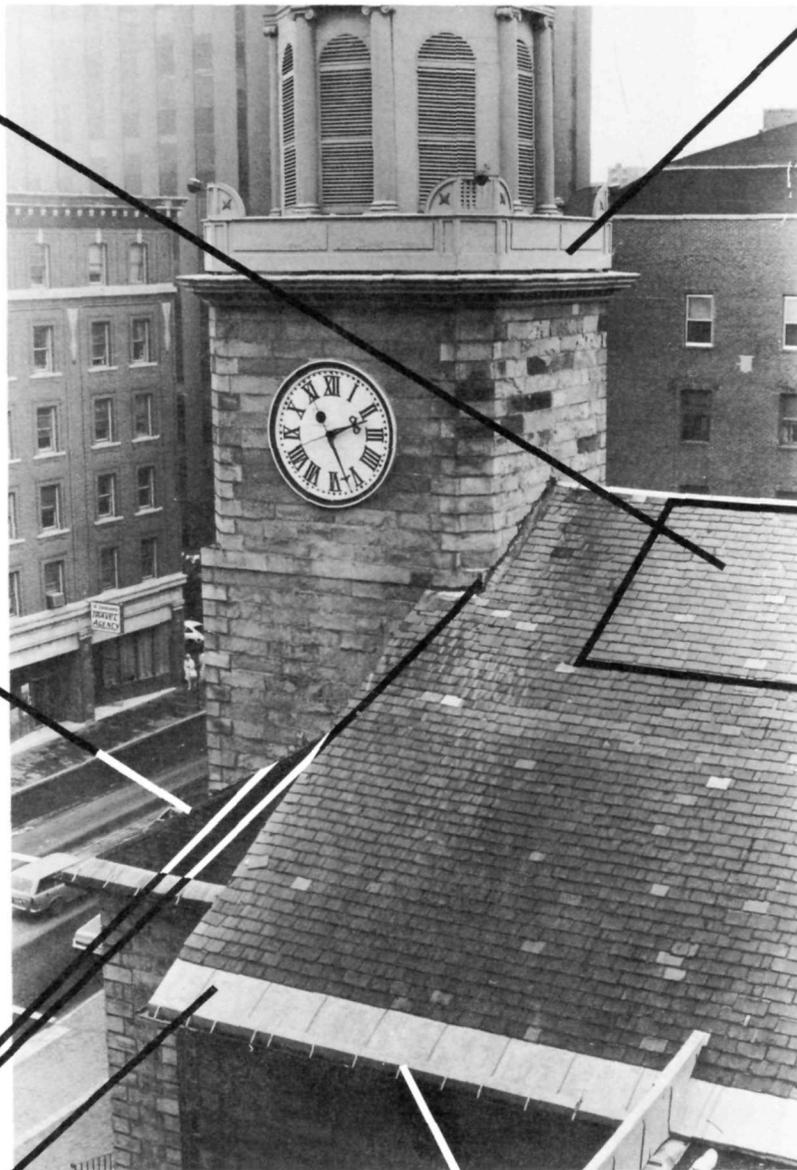
Fig. 1. Deterioration of Roofing and Flashing.

The existing slate roof has undergone numerous repairs over the years and therefore includes several different colors and sizes of slate. Most repairs have been limited to replacement of individual slates, except near the tower where an approximately 15' x 30' section was replaced with green slate (Fig. 1:a) in what was evidently an early, rather sizeable repair job on the main roof (see also Fig. C). Comparison of what we assume is an original slate with other slate samples indicates that the original slate was Welsh purple. We would estimate that only 20–30% of the existing slate can be re-used; the remaining 70–80% will have to be new slate. Obviously, when laying old and new slate side by side, a close color and size match are desirable. New slate will also be required for the two small hipped roof surfaces on either side of the tower, at present covered with black asphalt shingles (Fig. 1:b). Some holes, leaks and previous patching attempts are evident in the roof sheathing when viewed from the attic space. We estimate that 10–15% of the existing roof sheathing will have to be removed and replaced. Other areas of concern are the flashing and counter-flashing. Completely new flashing and counter-flashing will be required at the rear chimney and wherever any roof surface abuts the masonry tower (Fig. 1:c). The existing eave flashing appears to be in good condition (Fig. 1:d). A related flashing item is the re-hanging of several sections of gutter in order to facilitate better drainage (Fig. 1:e). A new metal ridge roll for the main roof and metal hip rolls for the two small hip roofs adjacent to the tower would also be required. Replacement of the existing attic ventilation system at the main roof ridge is also advisable.¹ Inspection of the existing copper roof at the base of the steeple (Fig. 1:f) for any cracks in the seams or joints is recommended. Several water-stained areas were noted in the sheathing beneath this surface which may indicate a leak. Re-soldering of suspect seams should eliminate any current water penetration (see Part 2 specifications, Slate Roofing 06500 and Flashing 07600).

a. APPROXIMATE 15'x30'
PATCH OF INAPPRO-
PRIATE GREEN
SLATE REQUIRING
TOTAL REPLACEMENT.
PATCH IS VISIBLE
IN 1865 PHOTO.

b. HIP ROOF SURFACES
COVERED IN INAP-
PROPRIATE BLACK
ASPHALT SHINGLES
REQUIRING TOTAL
REPLACEMENT

d. EXISTING EAVE FLASHING
IN GOOD CONDITION

e. SECTIONS OF GUTTER
NEED REHANGING

In reference to Fig. 1 (Deterioration of Roofing and Flashing), because no absolute photographic evidence of the 1826 roof ridge detail exists and

in view of the building's early roof repairs, another approach was selected in conjunction with the roofing contractor, Mr. C. Gordon LaRose, Portland Roofing Co., South Portland, Maine: a slate comb roof on the main roof and slate fantail hips on the two small roofs adjacent to the tower (see Part 2 specifications, Slate Roofing 06500).

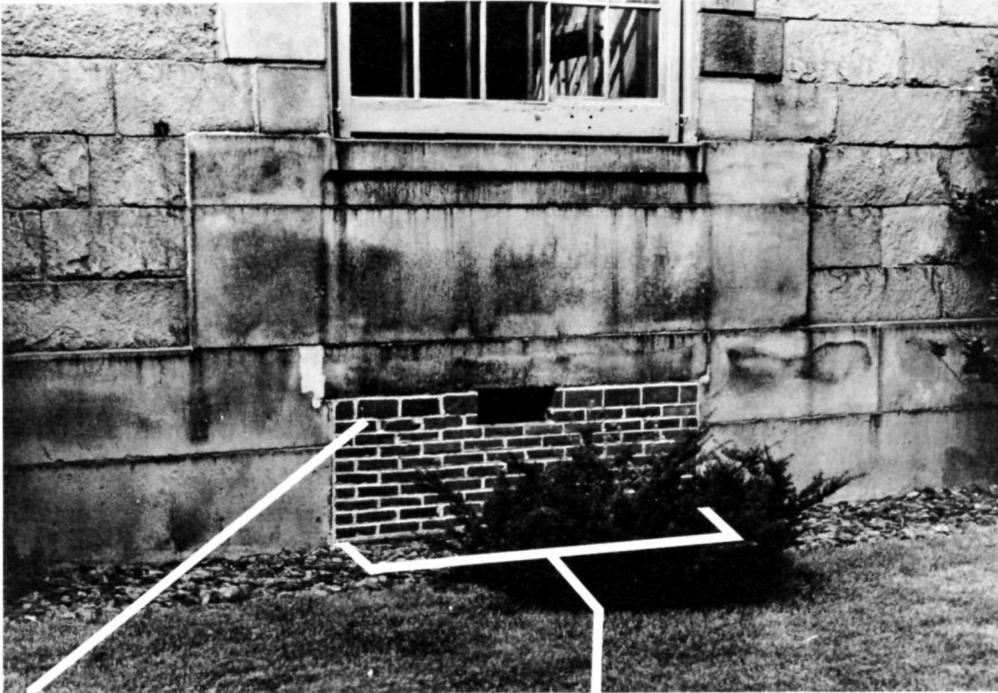
Fig. 2. Below-grade Water Penetration at Basement Window Openings.

The three exterior wall penetrations at basement level were originally doorways to the three storage areas below the church. Within the recent past, each of these openings was closed by the insertion of concrete block and brick masonry, then backfilled with dirt (Fig. 2:a). It would appear, however, that no effort was made to mechanically seal the joints below-grade between the existing stone and the infill material. As a result, sizable amounts of water are penetrating the wall at isolated points below-grade. The water penetration is cause for concern. If the dampness is not removed through ventilation, it may well lead to future deterioration of both wood and masonry materials. We therefore recommend that the immediate area outside of each basement opening be excavated (Fig. 2:b) in order to install proper waterproofing membranes over the below-grade infill material and neighboring existing masonry (see Part 2 specifications, Dampproofing 07150 and related Site Improvements 02700).

a. ORIGINAL BASEMENT
DOOR OPENING FILLED
WITH CONCRETE BLOCK
AND BRICK - THEN
BACKFILLED WITH DIRT

b. BELOW GRADE AREA
TO BE EXCAVATED FOR
WATERPROOFING
TREATMENT

At the foundation on the west wall, existing masonry block walls will be excavated and dampproofed. Existing shrubs will be removed and replanted upon completion of dampproofing and roofing work.

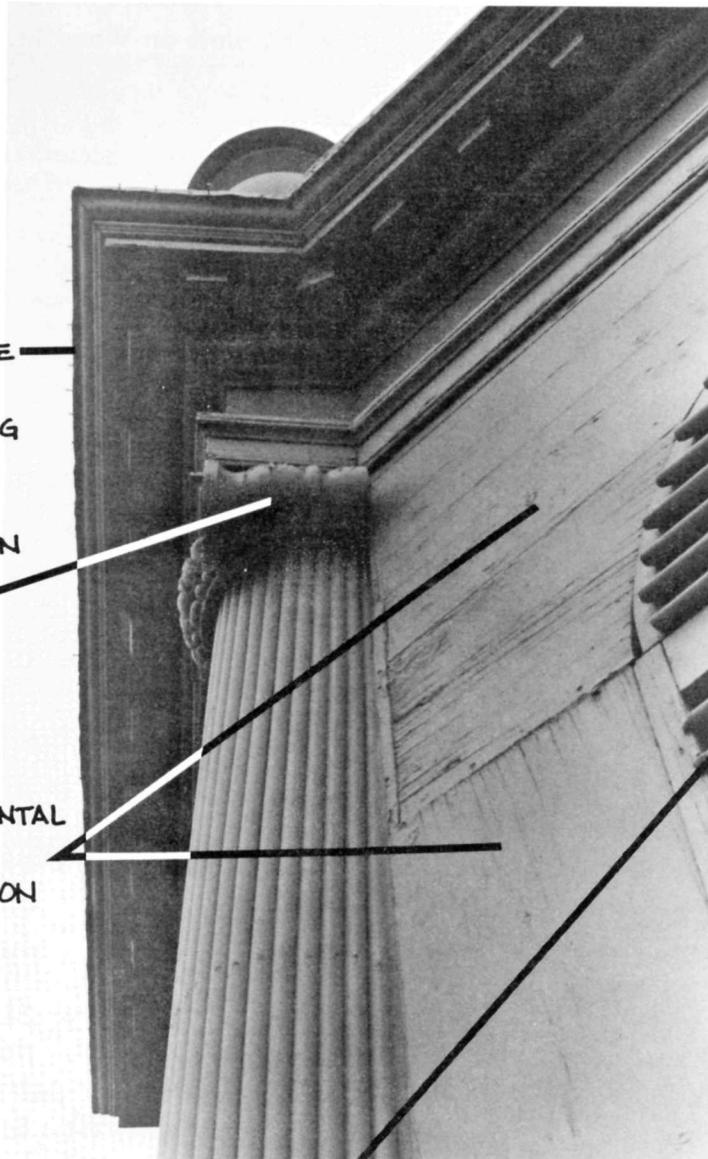
Fig. 3 Cornice Deterioration at the Urn Level of the Steeple.

The cornice flashing, edge-nailed into the crown moulding (Fig. 3:a) is no longer serving its intended function of throwing water away from the cornice below. Instead, the many open nail holes provide an avenue for moisture penetration. Therefore, it is strongly recommended that all existing cornice flashing at this level be replaced and that all new flashing be detailed in such a manner as to avoid edge-nailing. Additional deterioration, including some large holes, is evident at several locations in the cornice soffit and should be repaired. Many of the Ionic column capitals also show weathering and deterioration at their upper surfaces (Fig. 3:b). Where possible, these areas should be consolidated and patched; the worst areas may require piecing-in of new wood. The vertical (Fig. 3:c) and horizontal sheathing (Fig. 3:d) needs a thorough scraping in preparation for painting, in addition to localized patching or caulking of open areas in the wood. The wood louvers (Fig. 3:e) require similar preparation prior to painting (see Part 2 specifications, Rough Carpentry 06100 and Flashing 07600).

3. DETERIORATED CORNICE
FLASHING IN NEED OF
REPAIR - EDGE NAILING
NOT RECOMMENDED

b. DETERIORATED COLUMN
CAPITALS NEEDING
CONSOLIDATION -
POSSIBLY PATCHING

c,d. VERTICAL AND HORIZONTAL
SIDING IN NEED OF
THOROUGH PREPARATION
FOR PAINTING

e. WOOD LOUVERS IN NEED OF
THOROUGH PREPARATION
FOR PAINTING

- J. Continuous around steeple at base of dome below urns; and around steeple bell deck, raise eave flashing and insert underneath a four inch wide copper strip. Isolate from incompatible metal if necessary to prevent electrolysis with 15 pound felt. Renail assembly through sound existing metal into wood backing.
NOTE: This flashing treatment is specified in order to stabilize the existing deteriorated and leaking material. Future corrective measures should involve detailing the flashing to avoid edge-nailing, possibly requiring the replacement of the entire dome roof.

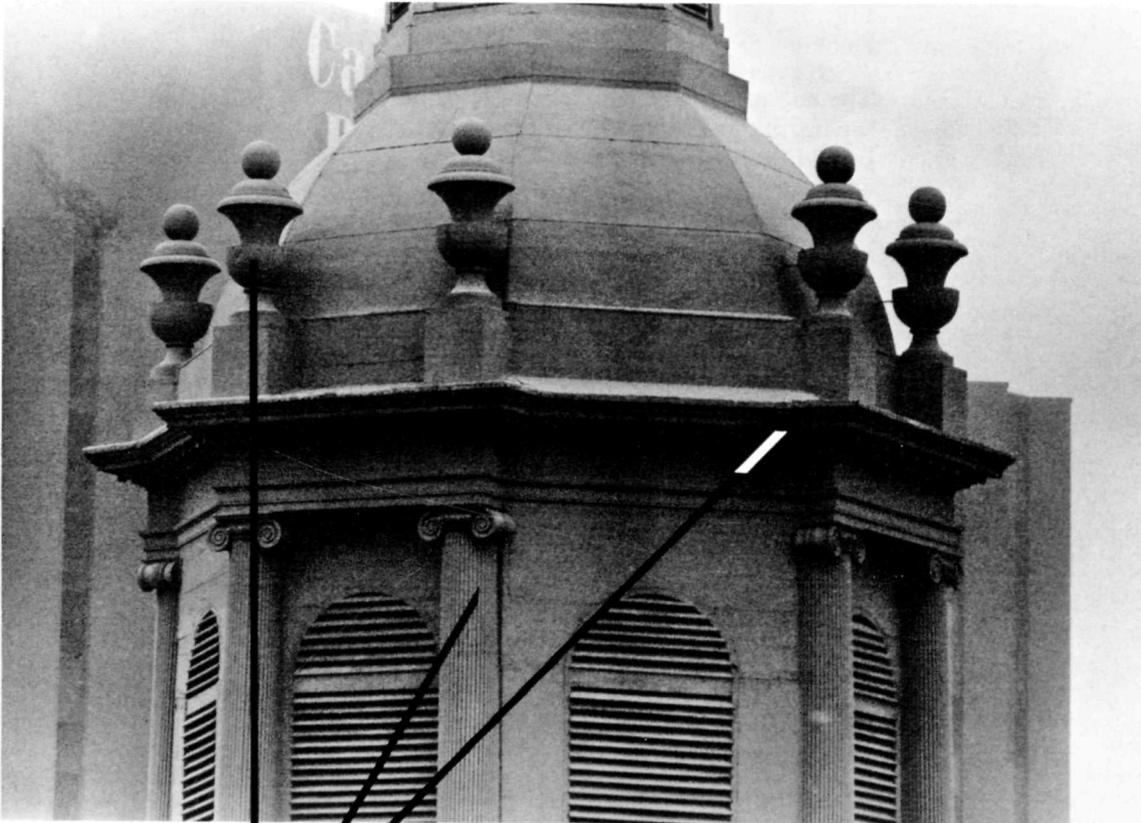
Fig. 4 Paint Failure on Wood Elements of Steeple.

The majority of steeple woodwork² exhibits weathering and loss of paint coverage and adhesion. For the continued life of these elements, we recommend a thorough scraping, sanding, and caulking of all areas of the steeple woodwork followed by the priming of all bare wood and two coats of a premium housepaint (see Part 2 specifications, Painting 09900).

²The space enclosed by the cupola and the curving, metal-covered roof below appears not to be ventilated. Visual inspection from the access hatch above the bell revealed the interior wood surfaces of this space to be quite damp. To prevent any chance of rot developing, we recommend investigating ways of unobtrusively ventilating this space.

GENERAL WEATHERING AND LOSS
OF PAINT ON STEEPLE WOODWORK
REQUIRING THOROUGH PREPARATION
AND REPAINTING

Miscellaneous flashing on the steeple will be repaired and replaced. Parts of the steeple woodwork will be repaired and the entire wood portion of the steeple will be painted.

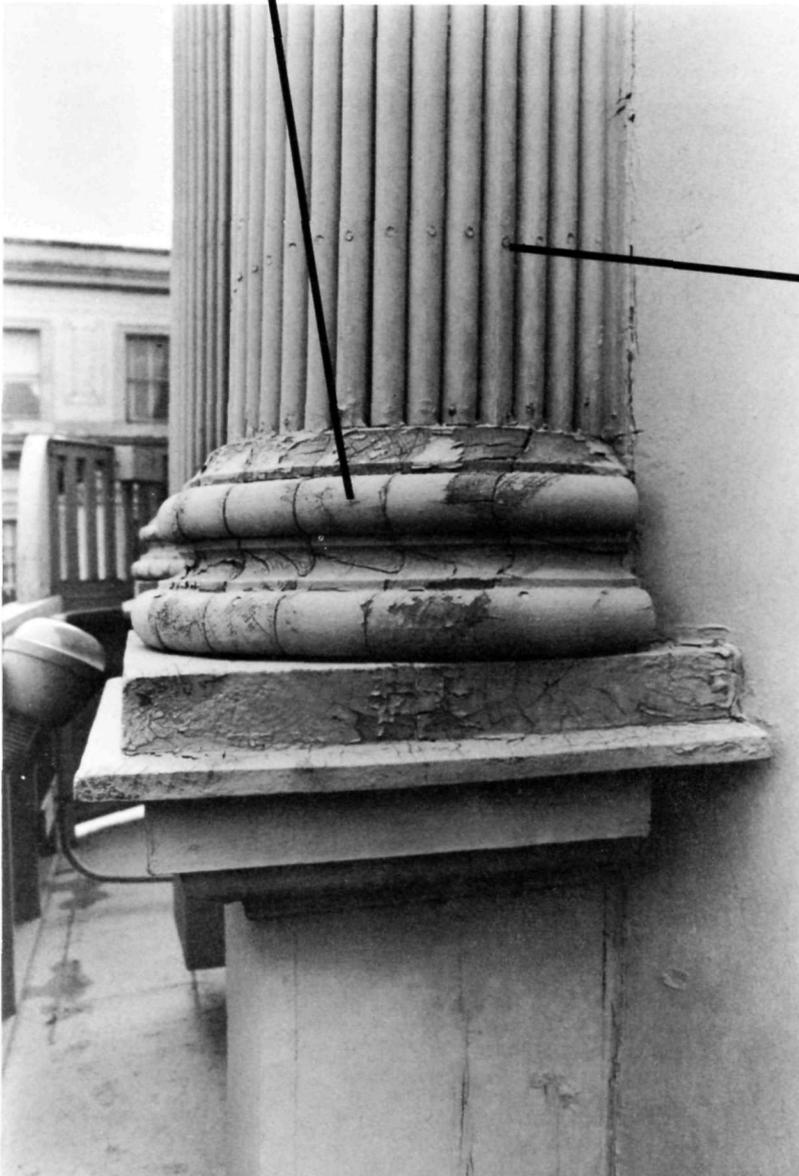
Fig. 5. Delamination of Column Bases at Lower Steeple Roof Deck.

The column bases, which appear to be of recent vintage, are separating at their lamination points (Fig. 6:a). Further inspection should be made to ascertain the probable age of these elements, which would then determine whether the existing bases need expensive regluing and consolidation, or if entirely new bases should be fabricated. The unusual reeding above appears to be fastened with wire nails, indicating 20th century building material (Fig. 6:b); however, close examination of a ca. 1895 photograph of the church (Fig. F) seems to show similar reeding, which would tend to suggest that the existing material was fabricated in a manner approximating that of the earlier material (see Part 2 specifications, Rough Carpentry 06100).

2. SEPARATION OF COLUMN BASES REQUIRING
EITHER REPAIR OR REPLACEMENT

b. COLUMN REEDING
FASTENED WITH
WIRE NAILS

- E. Fabricate new column bases for the above noted locations conforming to profile of existing wood bases. Parts shall each be fabricated from a single piece of thoroughly dry stock as specified and conform to American Woodworkers Institute Standards for custom grade work. Secure in proper position on columns.

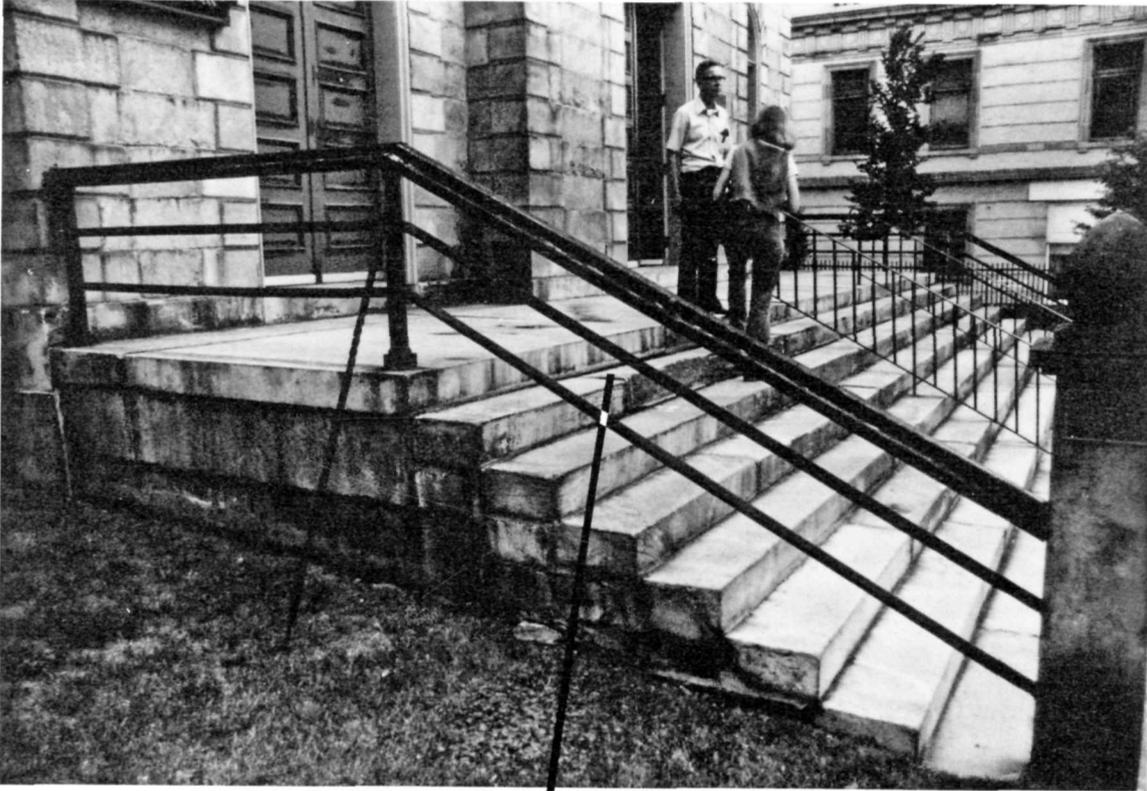
Fig. 6. Uneven Settlement of Main Entry Stairs.

For the most part, the stone stairs appear to be in reasonably good condition. A few slabs have twisted or rotated, opening large gaps between the slabs (Fig. 6:a). These gaps may be allowing water to penetrate under the slabs where it could possibly be leaching mortar away from the supporting spur walls below (Fig. 6:b). We believe that the present condition of the stairs does not warrant immediate attention; however, it should be pointed out that one or two of the slabs could present a problem to an elderly person or to someone who fails to notice the uneven settlement. Repairs to the stair slabs and the supporting walls below could possibly best be effected by removal of the uppermost large stone sections. Once all stone is re-set in position, all joints should be grouted and caulked with a suitable non-staining material to prevent future moisture penetration (see Part 2 specifications, Mortar 04100 and Brick Masonry 04210).

a,b. TWISTED OR ROTATED SLABS CAUSING POSSIBLE WATER PENETRATION AND MORTAR LEACHING - NEEDS FUTURE ATTENTION

The front stone steps of the church will be dismantled for foundation repair and the steps relaid.

- A. Jack up large platform stone at doors. Make front edge continuous with adjacent slabs. Remove unsound mortar and brick from supporting walls. Replace with new brick and/or mortar to provide continuous bearing for stone.

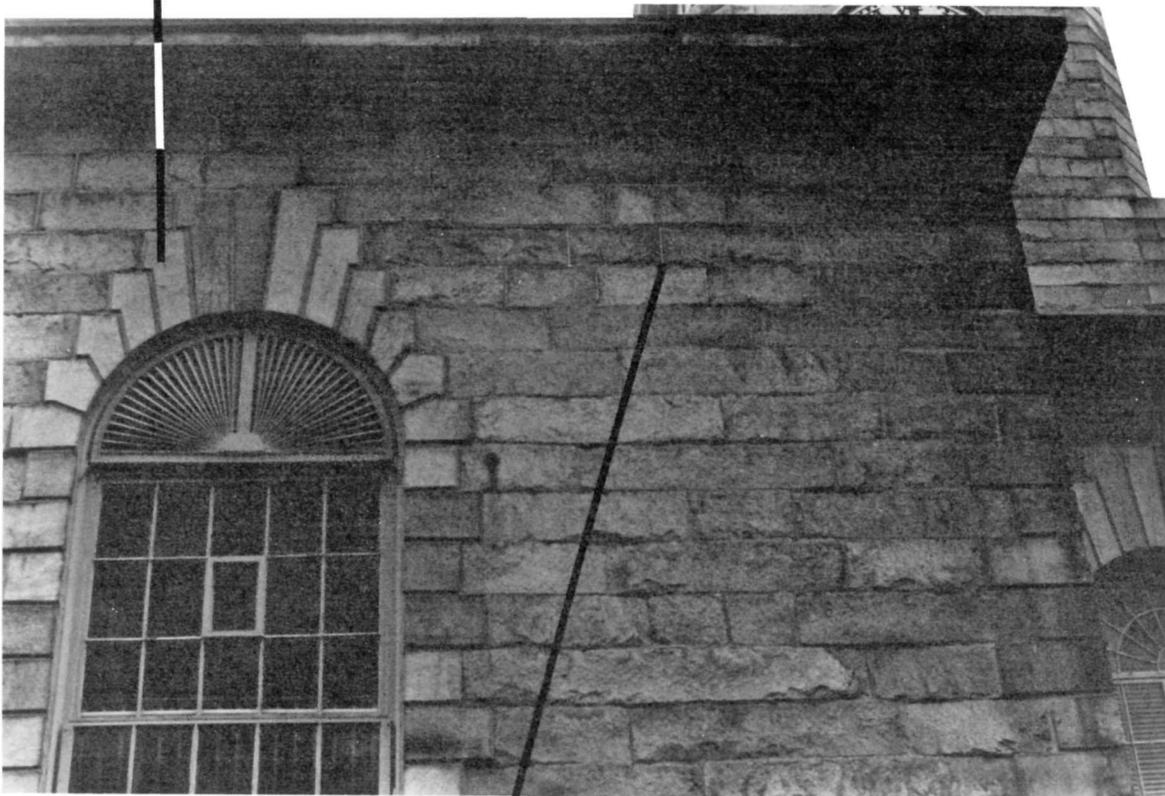
Fig. 7. Uneven Weathering of Mortar Joints.

³We also recommend that an attempt be made to examine the mortar joints of the church which are now covered by the construction of the parish house. It may be possible, by lifting one of the sash on the parish house side of the church (Fig. F), to see undisturbed mortar joints from the original period of construction. The discovery of these joints could possibly be of great assistance in determining future repointing materials and techniques.

a. RAISED MORTAR JOINTS
DIRECTLY UNDER THE EAVES

b. UPPER MORTAR JOINTS OF
LIGHTER COLOR THAN THOSE
BELOW

NOTE: PRIOR TO ANY REPOINTING WORK,
AN ANALYSIS OF EXISTING MORTAR
COMPOSITION AND PROFILE IS
RECOMMENDED

No specifications have been provided for Fig. 7 (Uneven Weathering of Mortar Joints) and Fig. 8 (Exfoliation of Stone at Center Doorway) as per Mr. Hecker's recommendations, because further investigation and/or monitoring of these areas must be conducted prior to the development of additional items of work.

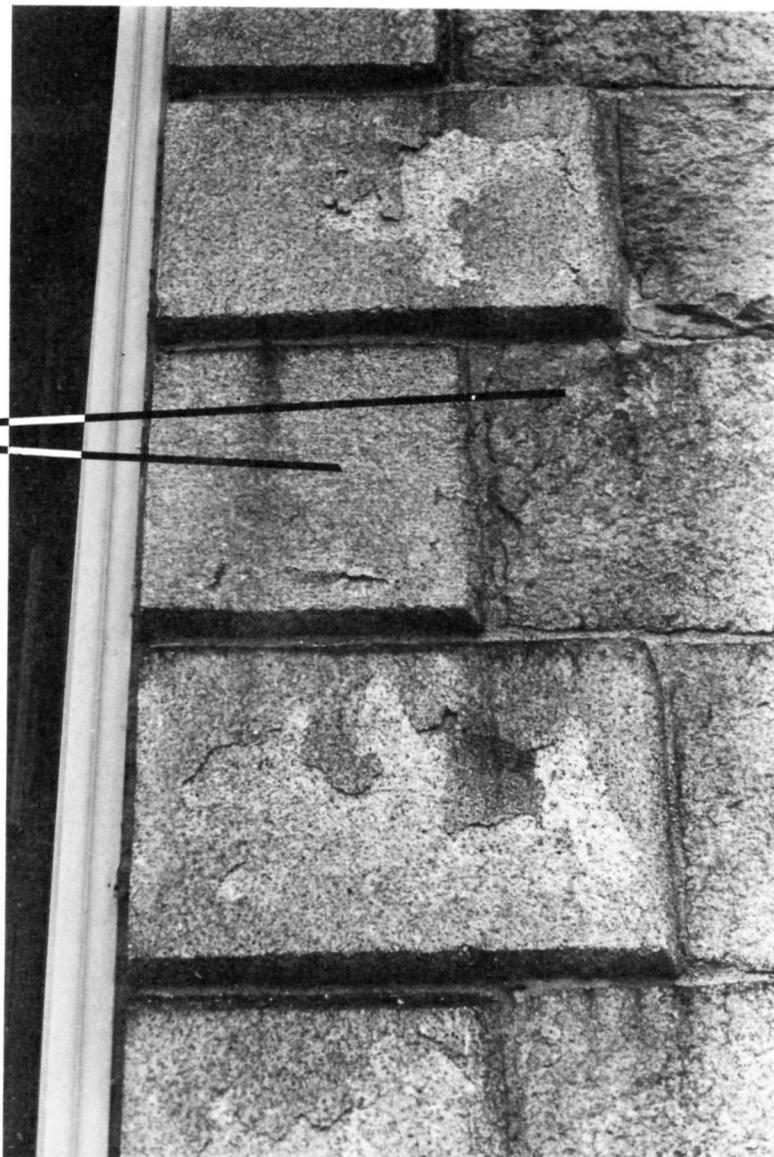
The weathering crust which has formed on the doorway quoins (Fig. 8:a) and adjacent masonry (Fig. 8:b) is exfoliating due to a combination of factors. The Portland urban environment imposes many stresses upon stone which include a higher level of sulfates and carbon dioxide in the atmosphere, frequent freeze-thaw cycles, street salting during the winter, a salt water environment, and winter and summer fog sequences. Unfortunately, little can be done to prevent additional weathering crusts from forming and exfoliating. Even in an ideal climate, most stones exhibit formation of a weathering crust, but at a much slower rate.

a,b WEATHERING CRUST
FORMED ON THE
DOORWAY QUOINS
AND ADJACENT
MASONRY
