Rocky Mountain National Park

Historic Preservation in Rocky: Restoring the McGraw Ranch

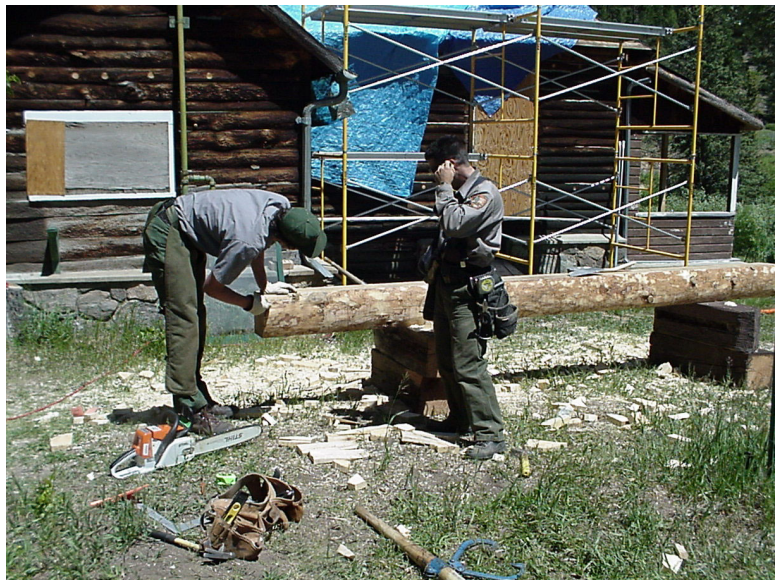
Park staff cut logs to repair a building at McGraw Ranch. (NPS-RMNP photo)
