National Park Service
Cultural Landscapes Inventory
2014

Sagamore Hill
Sagamore Hill National Historic Site

Site Plan

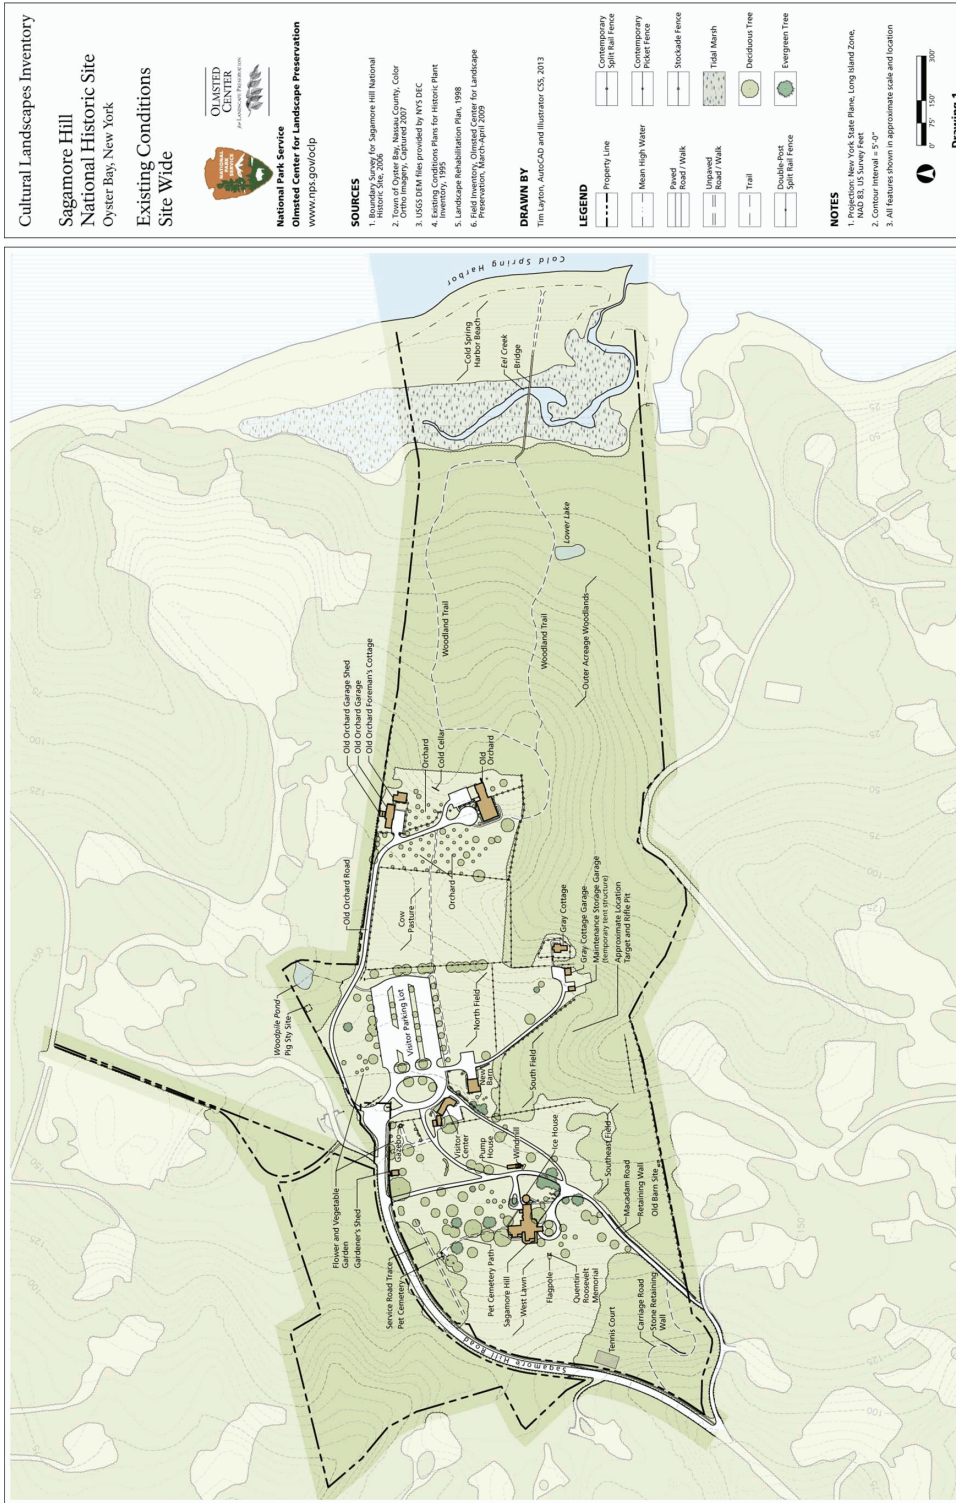
Overall site plan for Sagamore Hill NHS (Olmsted Center for Landscape Preservation--hereafter OCLP--2014).

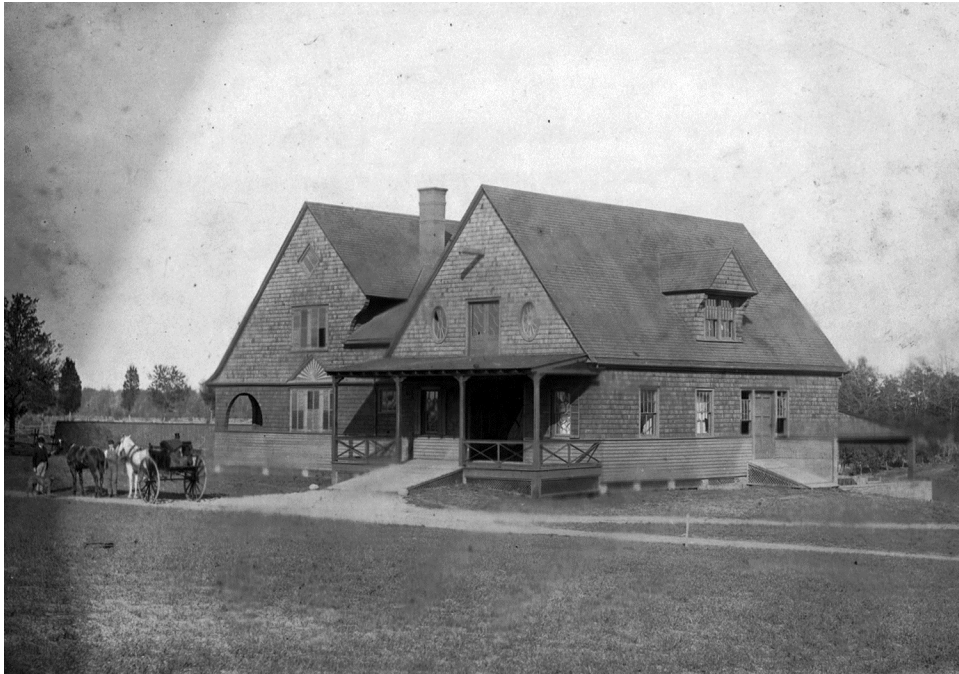
Figure 3. View looking northeast at the west facade of the stable and lodge, 1905. The carriage road/service road provided access to the building (SAHI, #1112, Box 6).

Charles Alonzo Rich, these buildings incorporated elements of both the Victorian Queen Anne-style and the more subtle Shingle-style rustic qualities (Figures 2 and 3). The two-and-one-half story house was located on the top of a hill on the western part of the property, which offered sweeping views to the Long Island Sound and Cold Spring Harbor. The stable and lodge was situated to the northeast of the house and served as a shelter for cows, horses, hay, and grain and as a home for the grounds caretaker until it burned down in 1944. During Roosevelt's absence, carpenters from Wood & Son completed both buildings in 1885. That same year, Wood & Son also constructed an ice house just to the east of the house. The ice house was an octagonal building with brick walls that stored ice cut from nearby ponds and sheltered two large tanks that held the farm's reserve water supply. To provide the primary water for the farm, contractors built a windmill and pump house around a hundred feet northeast of the ice house between 1884 and 1886. As workmen were completing these projects, Theodore made ready to return to his new country home. In 1886, he married his childhood friend and neighbor, Edith Kermit Carow, and the following summer they moved to Sagamore Hill with his daughter Alice. Here, Theodore and Edith Roosevelt would raise a family that included five more children (Bellavia and Curry 1995: 17,34-38,45-47; Naylor 2007: 18,20-21; National Register 2013, Draft, Sec. 7:4, Sec. 8: 21,24).

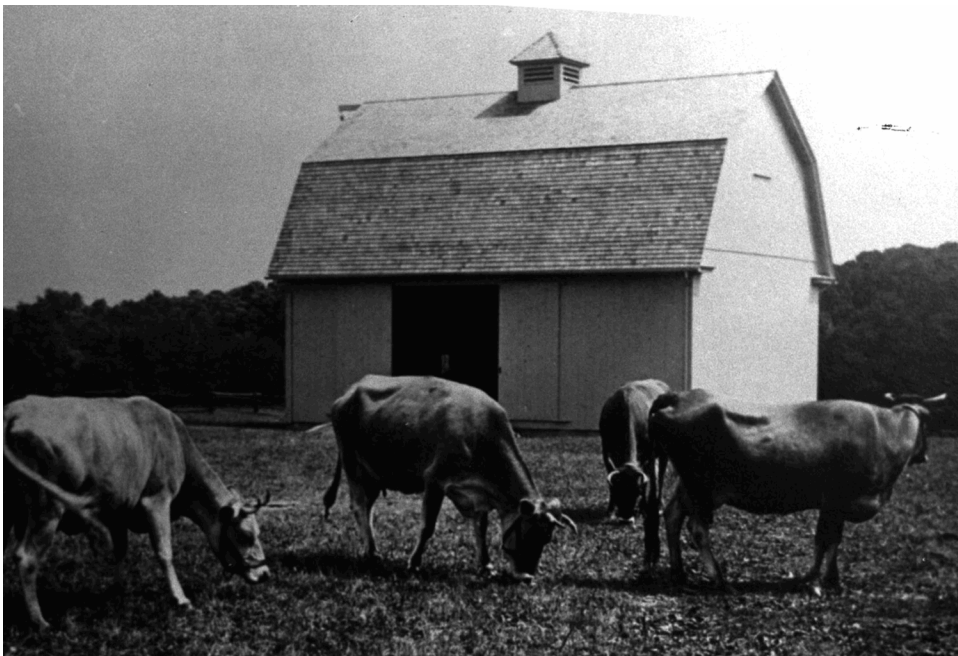
Figure 8. View looking southeast at the New Barn, shortly after its completion in 1907 (SAHI, #1113, Box 6).

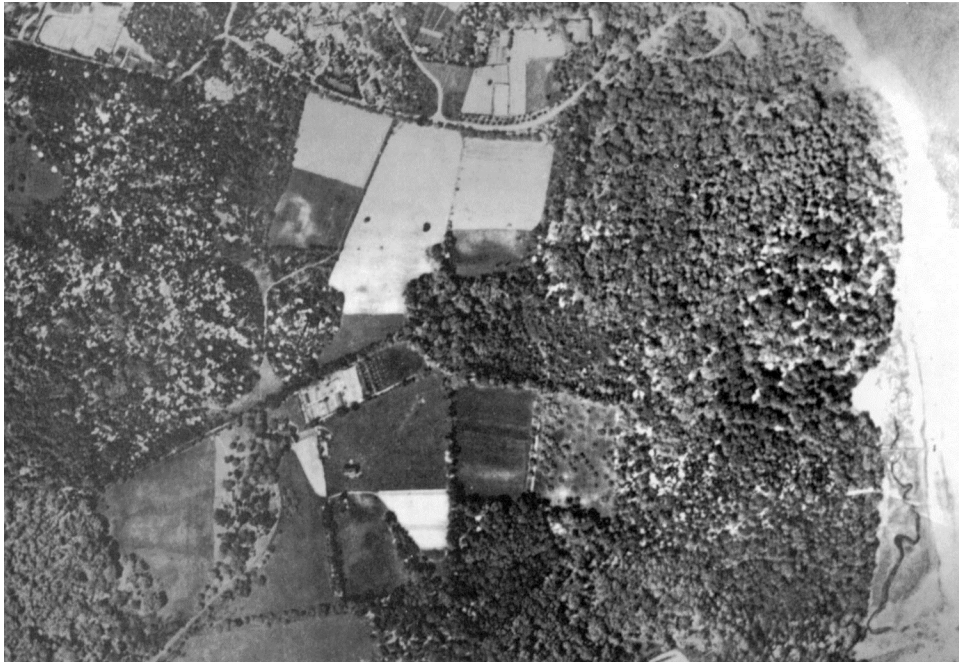
Figure 11. Aerial photograph from 1926 showing the various fields and the original orchard, top right. The house is near the center of the photograph, left of the curved entrance drive (Nassau County DPW-Drainage Section, Mineola, New York).

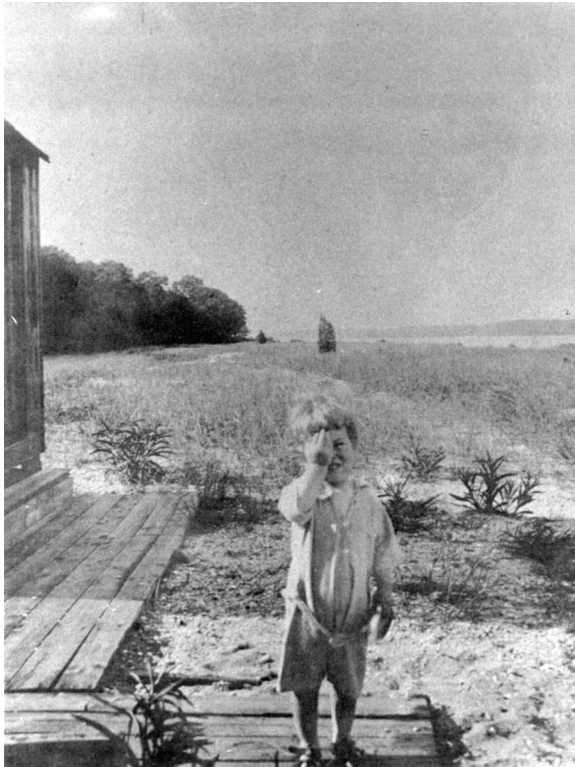
Figure 14. Bathhouse at Cold Spring Harbor beach, circa 1917. Vegetation on the beach and marsh consisted of predominantly low-growing species adapted to the sandy soils (SAHI, Family Photo Album #7644).

The Roosevelts developed their beachfront for recreation as well. Early in their residence at Sagamore Hill, the family constructed a bridge over Eel Creek to access the beach, where as early as 1888, they constructed bathhouse (Figures 13 and 14). The family's frequent picnics often started with a long walk or row. Most famous perhaps were the point-to-point excursions, which found the Roosevelts crossing the landscape from point to point by any means possible, without regard for obstacles. Theodore intended the exercise to cultivate hardiness and athleticism in his children (Bellavia and Curry 1995: 20,28,55; National Register 2013, Draft, Sec. 8: 24-25).

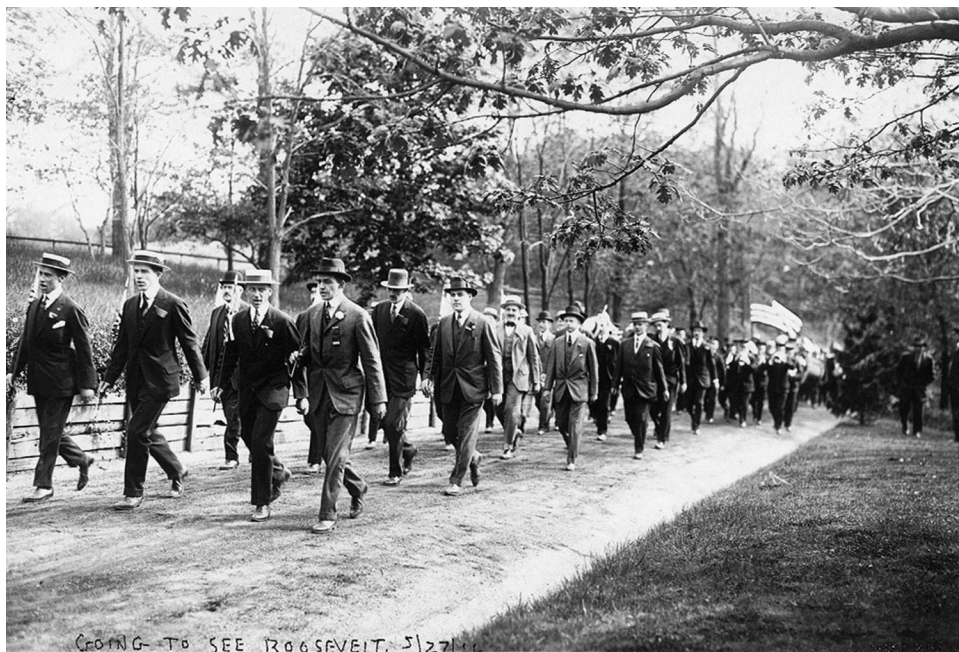
Figure 16. "Going to See Roosevelt," May 27, 1916. The wood retaining walls along the entrance drive would later be replaced by dry-laid stone walls (SAHI, #13712).

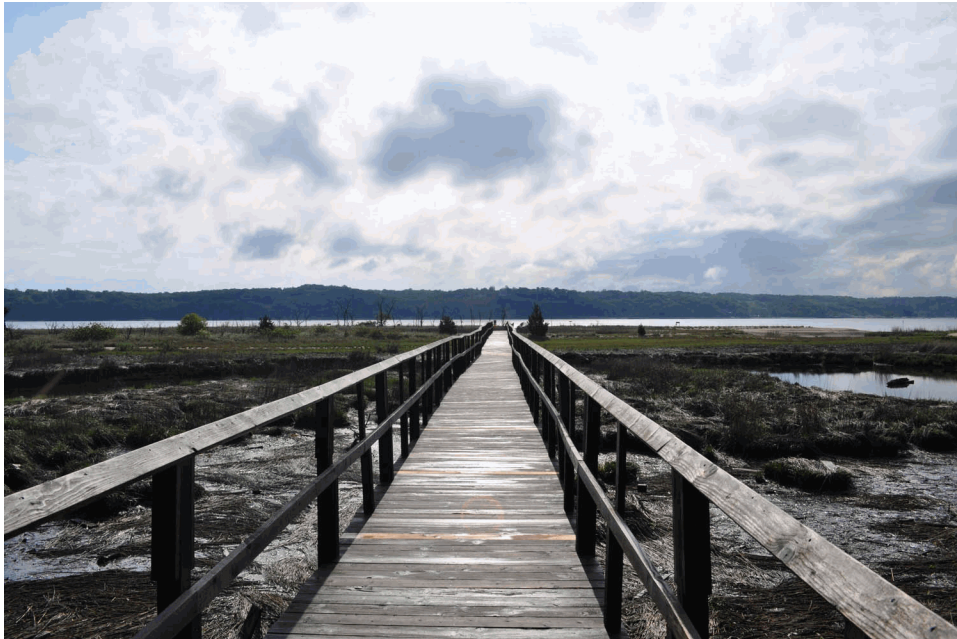
Figure 18. View looking east at the reconstructed boardwalk 275 feet south of the historic bridge location. This photograph was taken prior to severe damage from Hurricane Sandy in October 2012 (OCLP, DSC_0260, 2012).

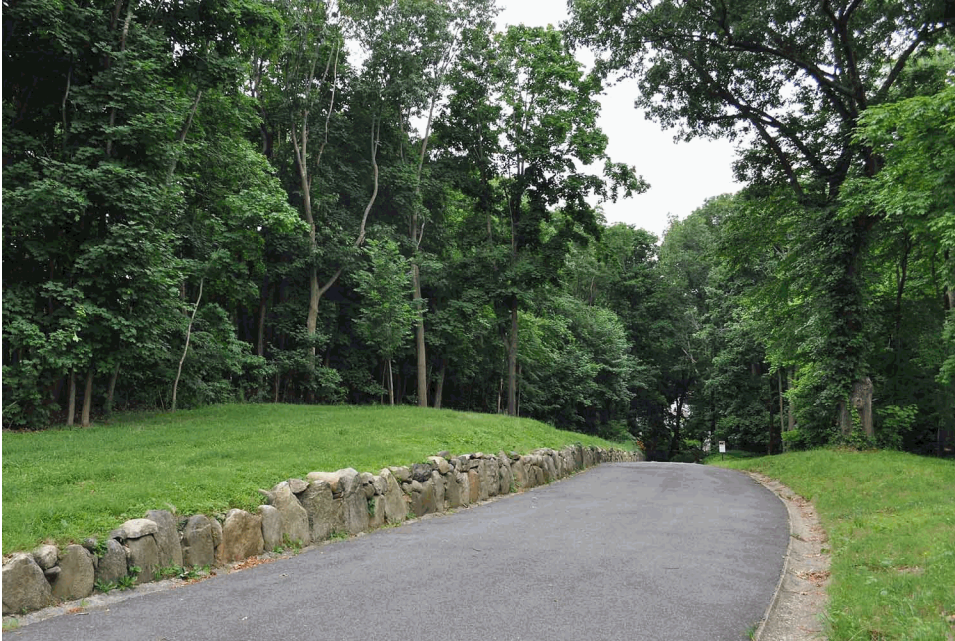
Figure 21. View looking southwest at the Macadam Road and its gutters and stone retaining wall (OCLP, 2013).

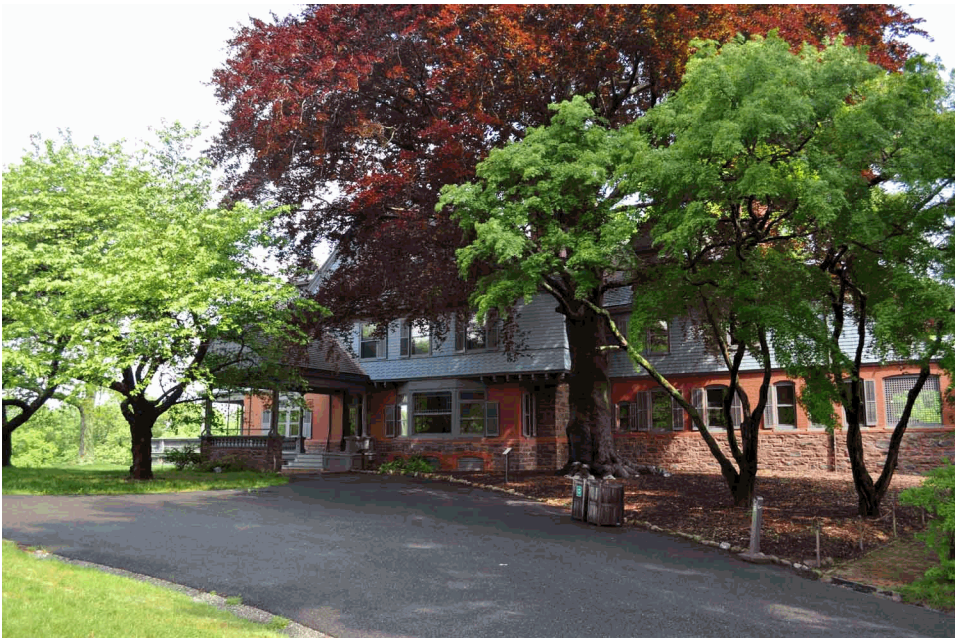
Figure 22. View looking northwest at the circular drive and the house's porte cochere (OCLP, DSC_0430, 2012).

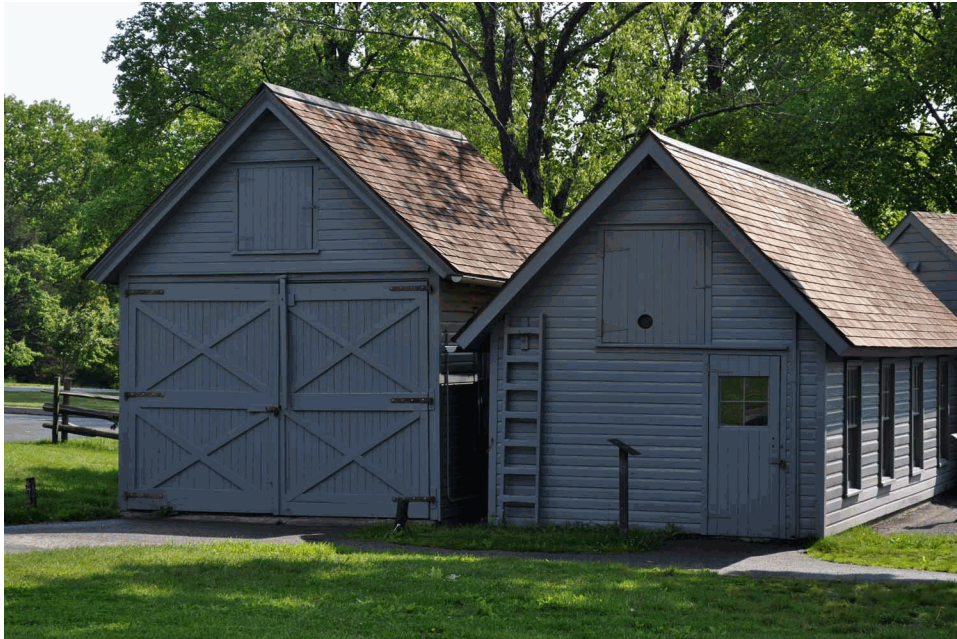
Figure 24. View looking east at the chicken house and farm shed (OCLP, DSC_0369, 2012).

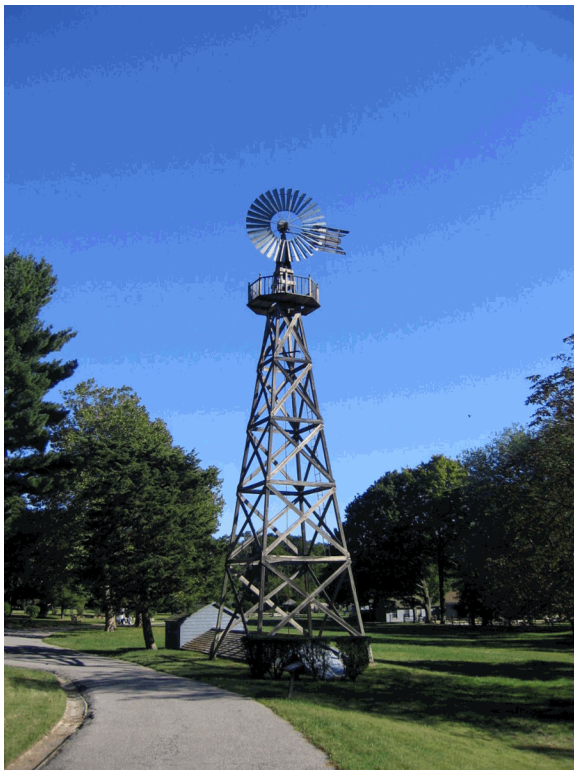
Figure 27. View looking north at the windmill and pump house (OCLP, 9-22-05 142, 2005).

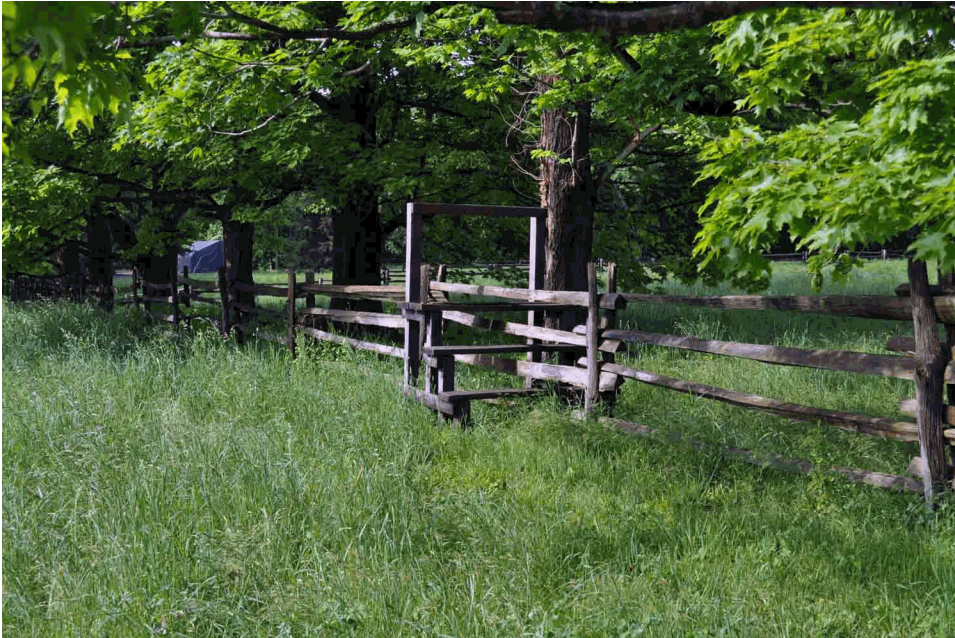
Figure 29. View looking southwest at historic fence and a stile at the pasture (OCLP, DSC_0317, 2012).
