# CULTURAL LANDSCAPE REPORT FOR THE SAN CRISTÓBAL OUTWORKS

SAN JUAN NATIONAL HISTORIC SITE

SITE HISTORY, EXISTING CONDITIONS, ANALYSIS & EVALUATION, AND  
TREATMENT

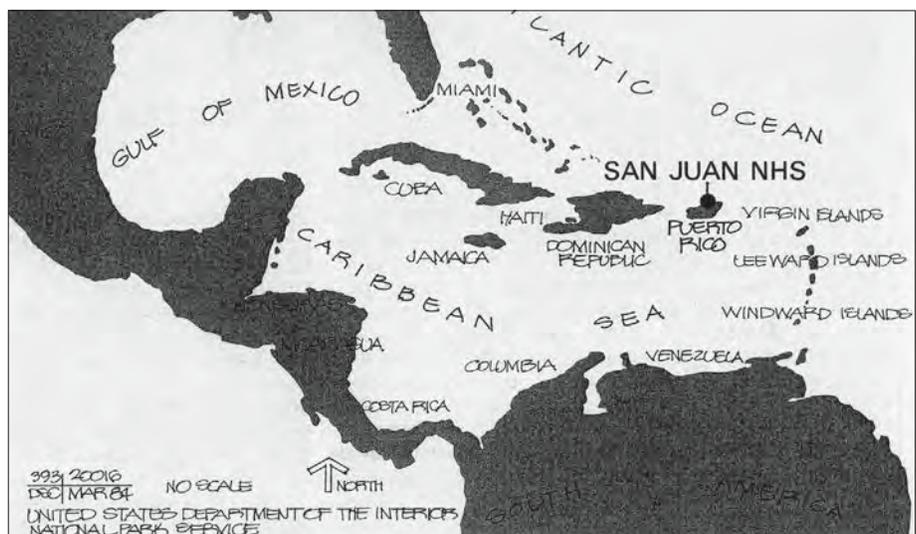
**Figure 1.1:** Regional Context, from 1984 General Management Plan for San Juan National Historic Site, (Denver Service Center, Drawing 393/20061).

For nearly thirty years, park planners and managers have perennially posed the question, “what is to be done with the Castillo San Cristóbal’s Outworks?” The purpose of this report is to answer specific questions and offer a range of appropriate choices that park administration and resource managers need to consider in order to fulfill park plans to open the San Cristóbal Outworks to visitors and to offer expanded interpretive opportunities connected to the globally significant Spanish fortifications at San Juan, Puerto Rico (Figure 1.1)

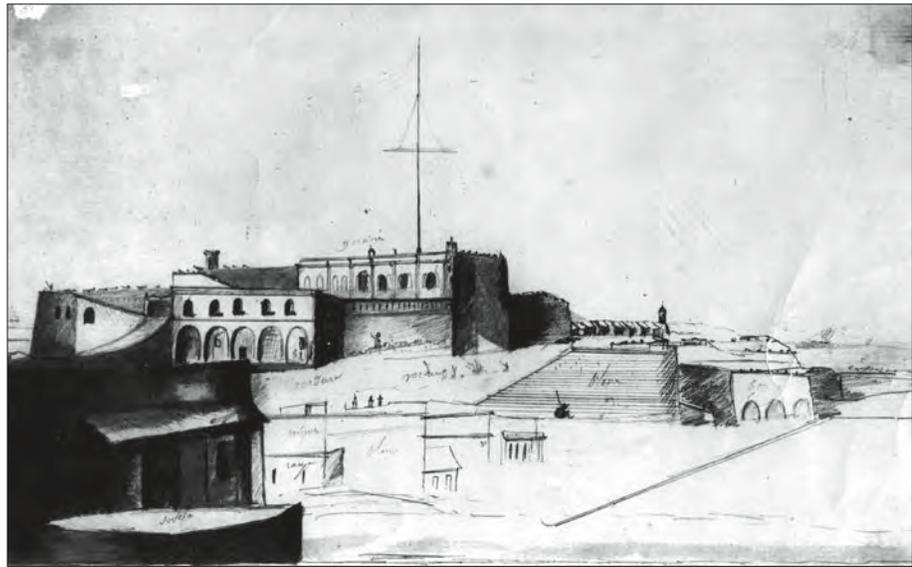
**Figure 1.2:** Drawing of Castillo San Cristóbal, c. 1821-1823 by French naturalist Auguste Plée. View is oriented toward the north. The San Cristóbal Outworks can be seen at image right, (Los dibujos puertorriqueños del naturalista francés Augusto Plée (1821-1823), Revista del Instituto de Cultura Puertorriqueña, Número 68/ JULIO-SEPTIEMBRE 1975, San Juan NHS Collection).

Juan's historic fortresses (Figure 1.2). San Cristóbal's purpose was to defend the approach from the land to the east, and was tested in 1797 when the British unsuccessfully attacked the city. One-hundred years later, Spanish troops fired on U.S. warships from one of San Cristóbal's north-facing gun batteries.

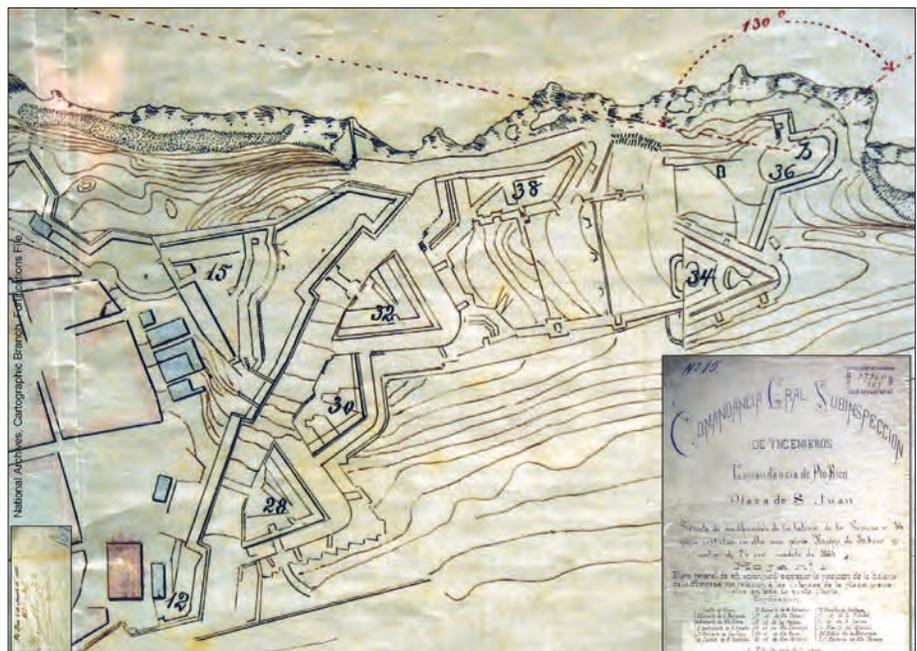
**Figure 1.3:** Detail, Spanish plan for modernizing armaments, c. 1897. “15,” marks the central Castillo of San Cristóbal; “28” marks the Santiago Bastion and Gate (demolished in 1897); “30” marks the La Trinidad Counterguard (partially demolished in 1897); “32” marks the San Carlos Ravelin; “38” marks the Santa Teresa battery; “36” marks the La Princesa battery, and “34” marks the El Abanico Fort. Two slender lines bisecting the Outworks parcel are the Spanish 1st and 2nd Retirada, or retreat lines, (National Archives II, Cartographic Branch, Fortification File).

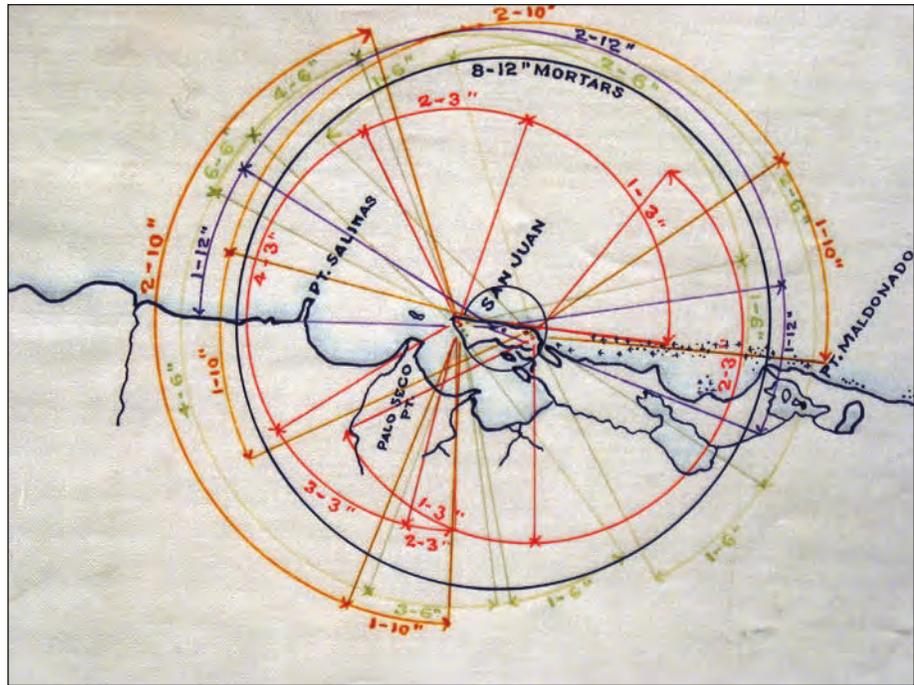
**Figure 2.3:** Field of fire diagram for ambitious 1899 plan of defenses prepared by Captain H. F. Hodges. Soon after the United States acquired Puerto Rico, a \$1,000,000 program of defenses was planned for San Juan as the new territory's principal harbor. Appropriations for the program were never granted, (National Archives II, Cartographic Branch, Fortifications File, Dr.107, Sht. 3-36).

program (\$27.6M in 2015 dollars) for new artillery and submarine mine defenses (Figure 2.3). Arranging for such a sum of money through a Congressional appropriation is a lengthy and involved process, and before such generous funding could be secured, Hodges' highest priority for quick improvements to the defensive system centered on mounting a battery of light rapid-fire guns - to cover the

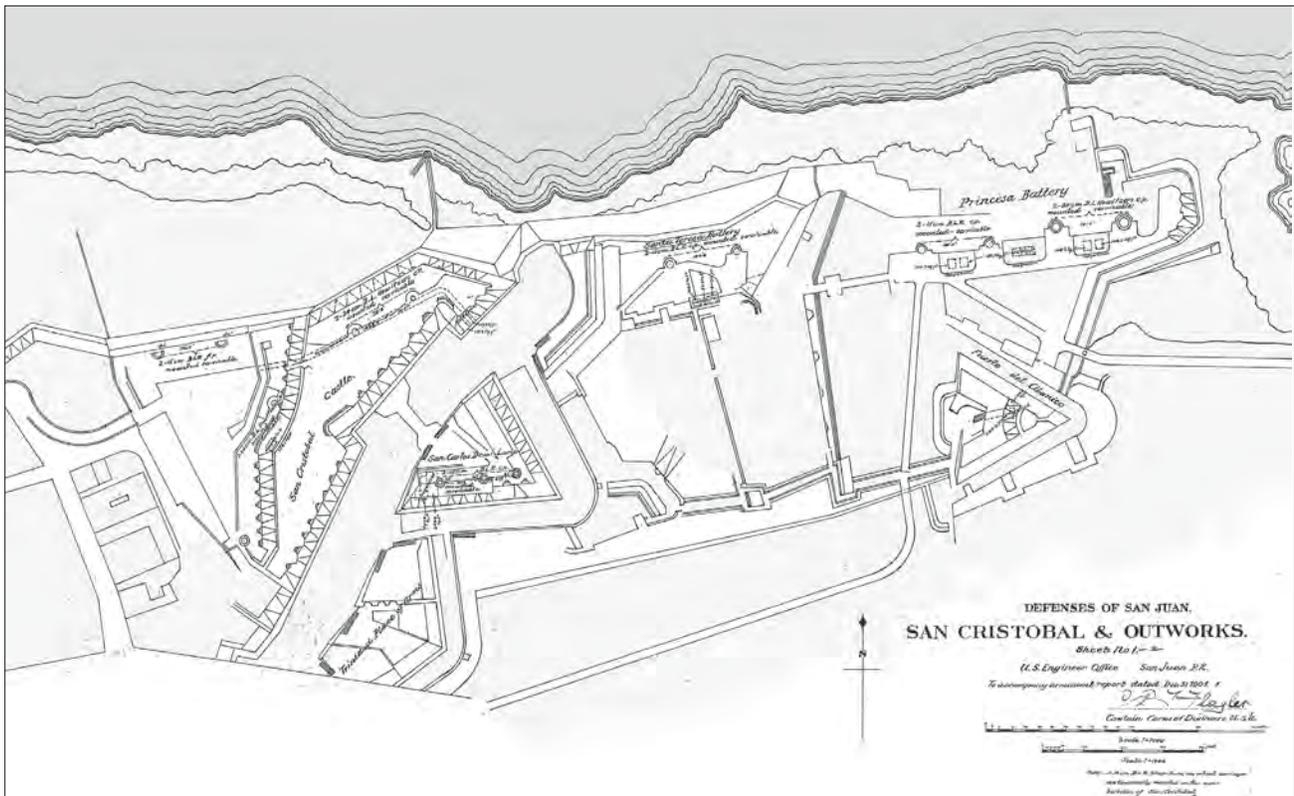
**Figure 2.4:** Detail of the 1901 Flagler Plan for San Cristóbal & Outworks, (National Archives II, Cartographic Branch, Fortifications File).

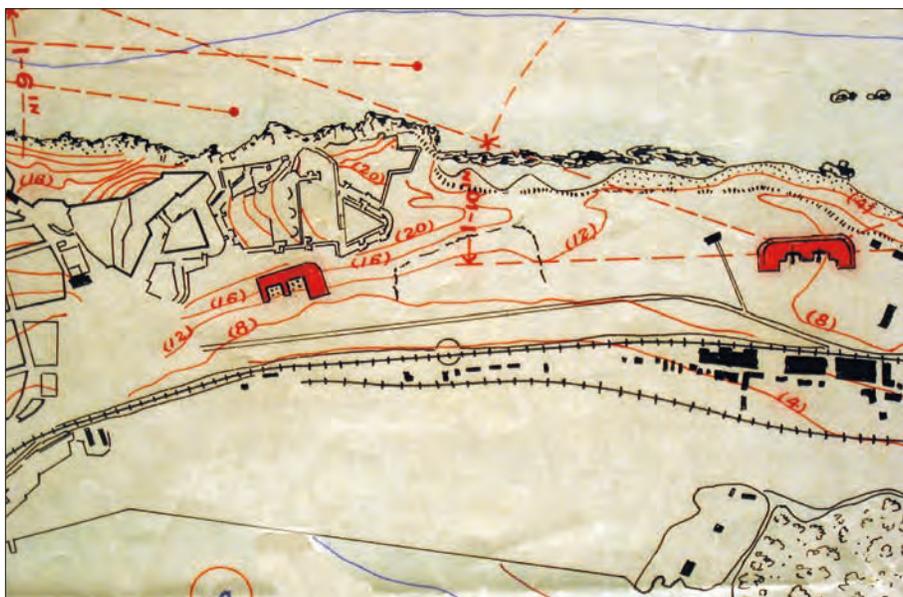
**Figure 2.5:** Detail of 1899 Hodges Plan for San Juan Defense Project. This plan proposed to locate a mortar battery emplacing eight mortars east of the San Carlos Ravelin. Doing so would use the existing masonry fortifications of San Cristóbal and the topography of its outworks as defensive cover for the new battery which would lob projectiles in a high vertical arc, (National Archives II, Cartographic Branch, Fortification File, Dr. 107) .

From one particular drawing accompanying Captain Hodges' missing report, it is understood that the plan with reference to the San Cristóbal Outworks was to construct a mortar battery immediately east of the San Carlos Ravelin on government owned land (Figure 2.5). Such placement would allow the battery to lob projectiles in a high vertical arc, using rising topography and existing Spanish fortifications immediately to the north as cover. Further to the east, between the advanced glacis of El Abanico and the first line of defenses at El Escambrón, Hodges proposed a new battery of coastal artillery featuring emplacements for two breech-loading seacoast rifles on disappearing carriages. Judging by further endorsements on the wrapper bearing Hodges plan, the proposal was still being actively pursued with revisions, as late as 1902. However, following the initial draft of the 1899 plan, the Foraker Act was passed in April of 1900, establishing civilian government in Puerto Rico. With the military ceding a measure of control to civilian authorities, Captain Hodges' plan for an expanded system of fortifications soon came up against as yet unrealized 1897 plans to expand the city beyond its ancient walls.

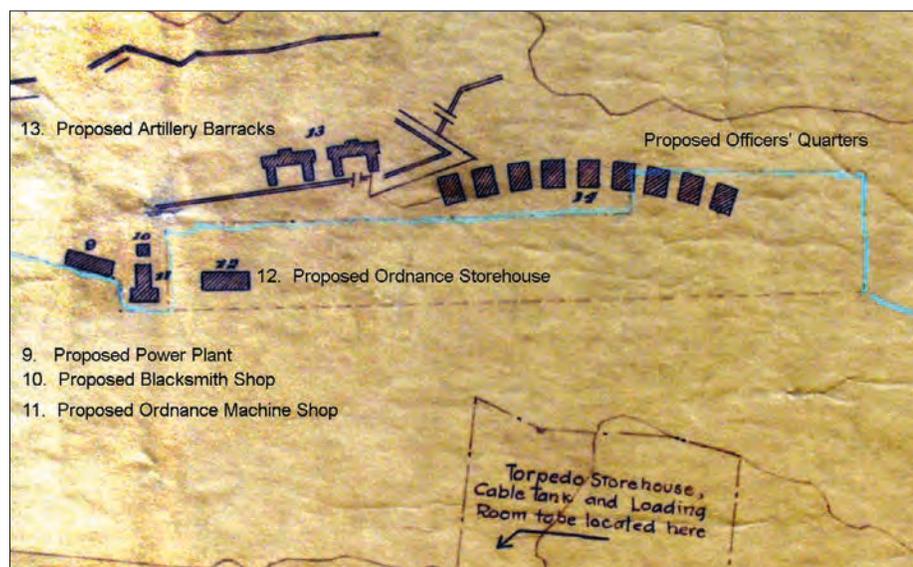
**Figure 2.6:** Detail of 1903 proposal for two artillery barracks immediately west of El Abanico, and an "officers' row" of nine dwellings on the El Abanico advanced glacis. This proposal required the purchase of lands from the Insular Government that had only recently been transferred to local control. Detail of blueprint (reversed for legibility) bearing proposal of Judson to Adj. Gen. 1903, (National Archives II, Cartographic Branch, Fortifications File).

purposes, and upon it may be located a central electric plant for illumination, search light and power purposes; an ordnance depot, and perhaps store-houses for other staff corps and departments. Within the outworks of the fort barracks may be constructed for several companies of coast artillery. To the east of the fort, upon the glacis is the most favorable location in San Juan for the construction of officers' quarters<sup>14</sup> (Figure 2.6).

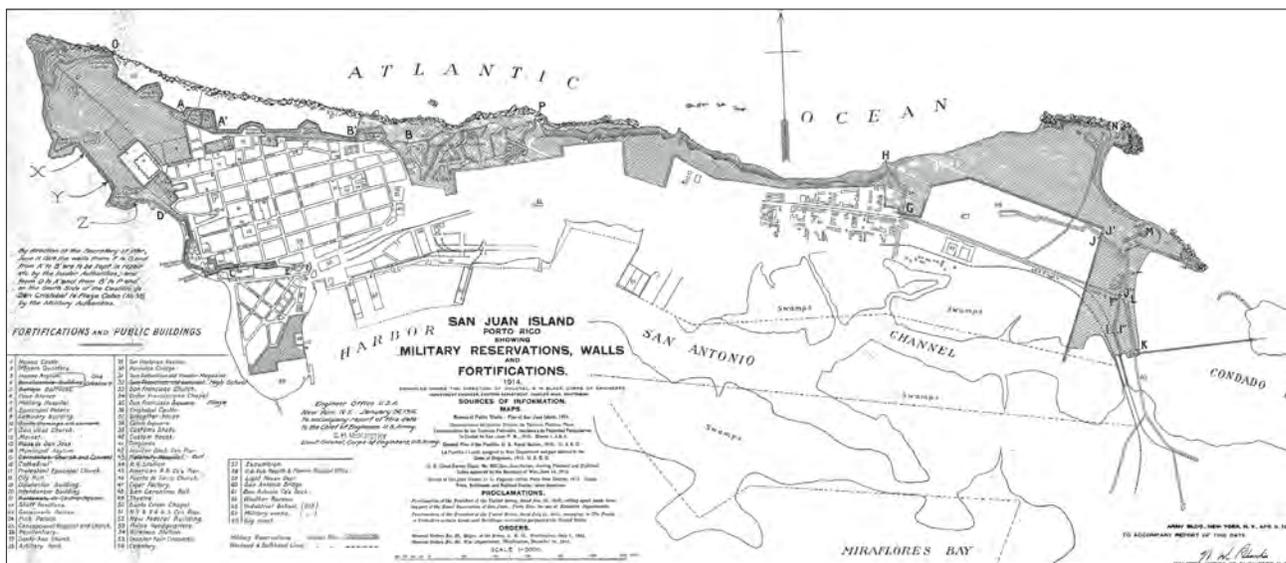
Figure 2.8: Detail of 1914 base map of the San Juan system of fortifications prepared by the Army Corps of Engineers, (National Archives).

A detailed map of San Juan and its walls was prepared to help facilitate an answer to the question of who should care for which walls (Figure 2.8). This map of San Juan’s fortifications was prepared under the direction of Colonel W. M. Black of the Corps of Engineers, who claimed that it had “been prepared from the best data obtainable, although it is probably not entirely correct.”<sup>24</sup> This map would later be reused time and time again, copies of it marked with annotations and notes concerning various repair and preservation projects. Annotations on one of the early copies of this map indicate that the Secretary of War instructed that after June 11th, the city walls beginning at a point marked as “F” of the map at San Justo Bastion, extending to the west and north to the point marked “D” on the map be kept in repair by the Insular Government. The troublesome section of northern seawall, beginning west of San Domingo Bastion at a point marked “A,” and extending to Castillo San Cristóbal to a point marked B’ would also be cared for by the Insular Government.

reflecting true conditions. What is most interesting about the 1914 map regarding the San Cristóbal Outworks is the apparent survival of the Spanish 1st and 2nd retreat lines, or *Retirada*, well into the second decade of the 20th century. Follow up correspondence helps to confirm this, documented the Army’s pursuit of a repair and sanitation program, directing the “filling up of ditches at the east end of the island.”<sup>25</sup> This order explicitly related to the filling of ditches well east of San Cristóbal’s Outworks that were part of the First Line of Defense at El Escambrón near Castillo San Gerónimo, and the Second Line of Defense, near the developed portion of Puerta de Tierra. It is reasonable to surmise that the surviving ditches and declivities remaining as part of the 1st and 2nd *Retirada* bisecting San Cristóbal’s Outworks were filled as part of the same effort. In his report to Colonel Black, Lieut. Colonel C.H. McKinstry noted:

**Figure 2.11:** Enlargement of a portion of Figure 2.8 above. This better shows wood-frame workshops or storehouses next to a Spanish building designed with proportions and roof geometry similar to the El Abanico guardhouse. Also note the earthen berms shielding the gun emplacements at the Santa Teresa battery.

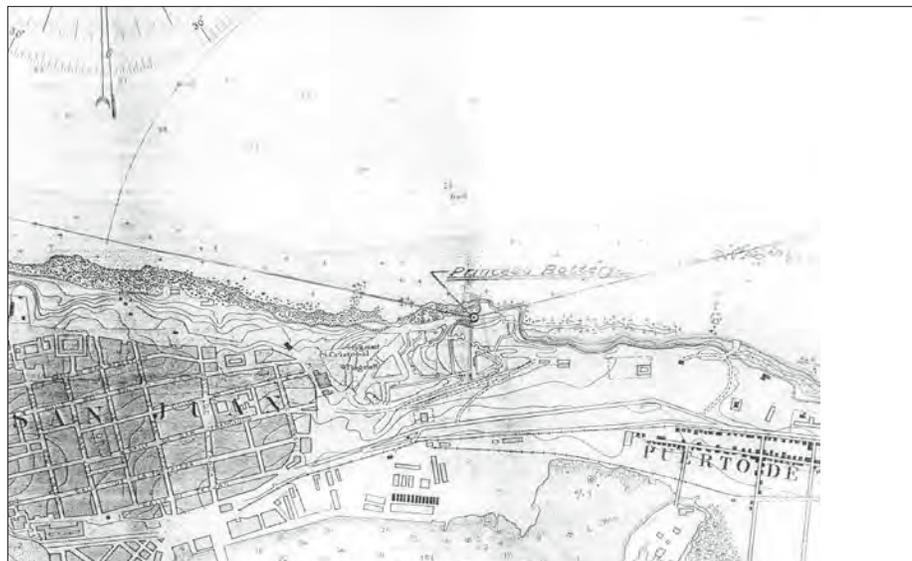
**Figure 2.9:** Detail of U.S. Coast and Geodetic Survey Chart, bearing markings locating two of three 4.7 inch Armstrong Seacoast Guns for emplacement during World War I, 1917, (USGS).

Locations for two of the three Armstrong guns were quickly agreed upon. One gun would be located at the La Princesa Battery in the San Cristóbal Outworks, and a second gun would be located inside the mouth of the harbor at the Santa Elena Bastion (Figure 2.9). There was more discussion offered as to a suitable location for the third gun. Locating the third gun at El Morro was discouraged by the Assistant Engineer in San Juan, who favored installing two guns at La Princesa. El Morro was considered an inferior site because it was seen as "...the most prominent object visible when approaching San Juan by water from any direction

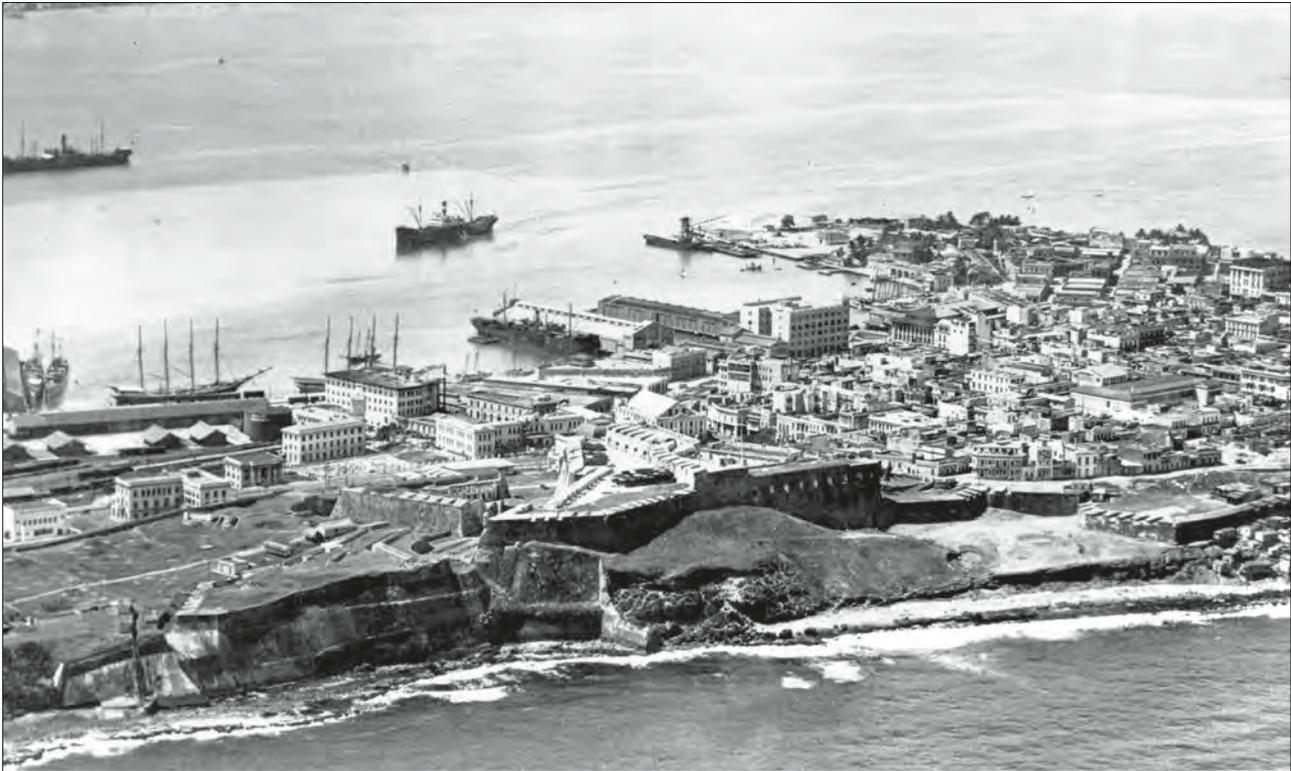
**Figure 2.10:** Oblique aerial photograph of San Cristóbal and Outworks, 29 March 1924. Image indicates survival of the Spanish “Covered Way” following World War I, as well as remnants of the 1st and 2nd Retirada, appearing to have been filled in, or covered with soil in this photograph. This image also shows the geometric markings of there having been a recent encampment in the area, (National Archives, RG126, PG Box 7 of 9, folder 7a).

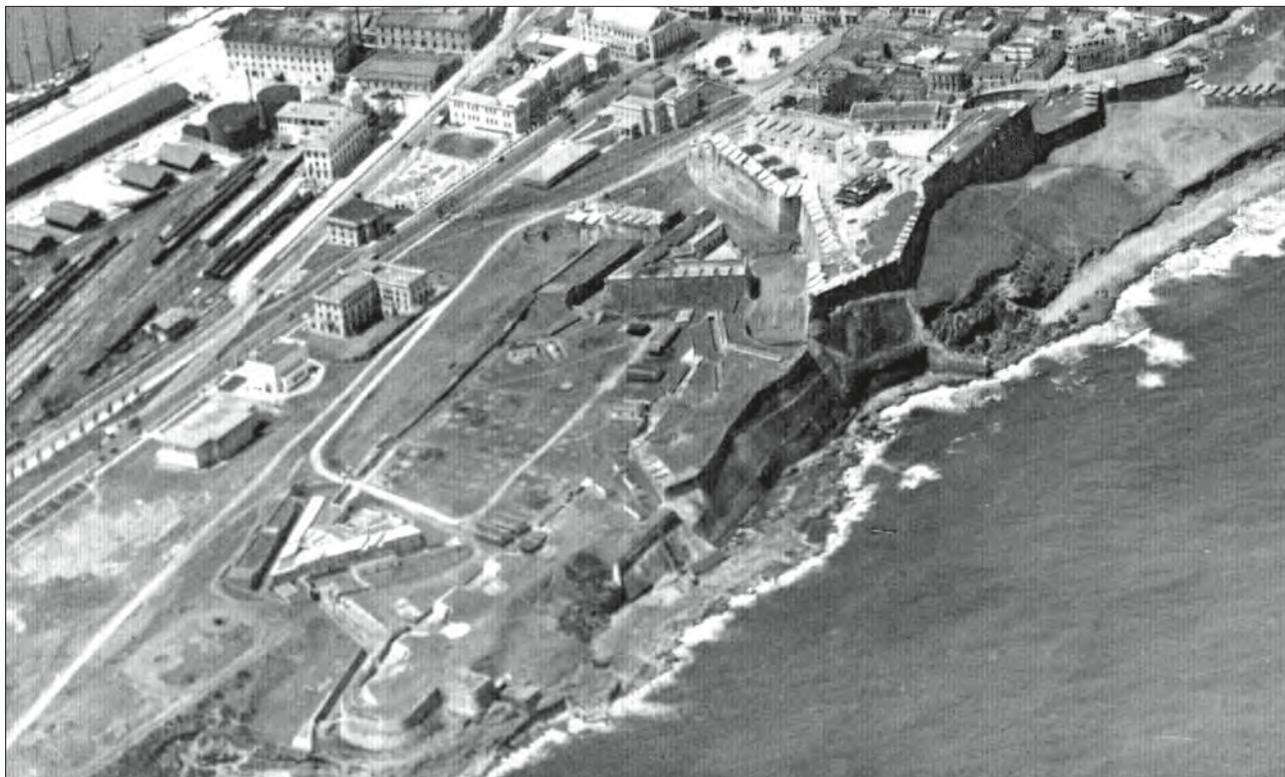
**Figure 2.12:** Oblique aerial photograph of San Cristóbal and Outworks, 29 March 1924. This image documents the presence of a mound of earth immediately east of El Abanico, possibly indicating a storage place for explosives. Also note the extent of the earth shielding covering the Santa Teresa and La Princesa batteries, and the erosion of the oceanfront slope above the so-called “haunted guardhouse,” (National Archives, RG126, PG Box 7 of 9, folder 7a).

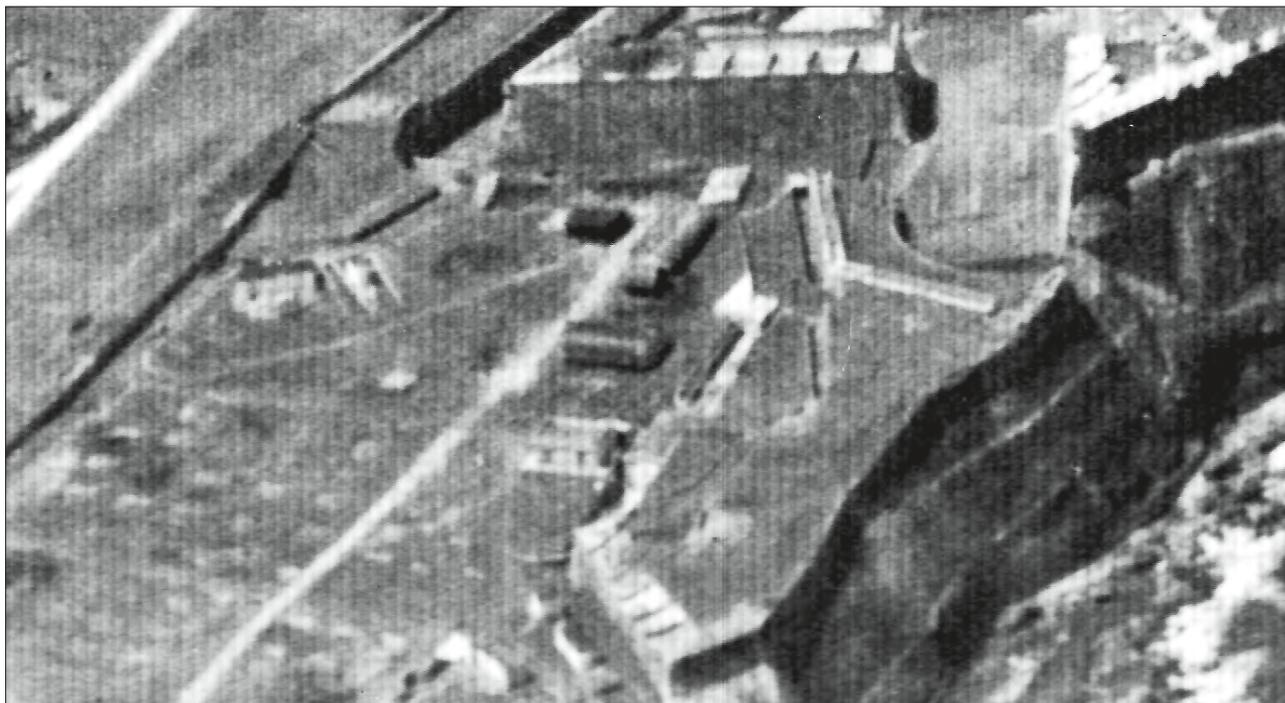
**Figure 2.13:** This image is an enlargement of a portion of the photograph appearing as Figure 2.10 above. This close-up shows the geometric pattern appearing to be evidence indicating a prior encampment, or cantonment, on this site.

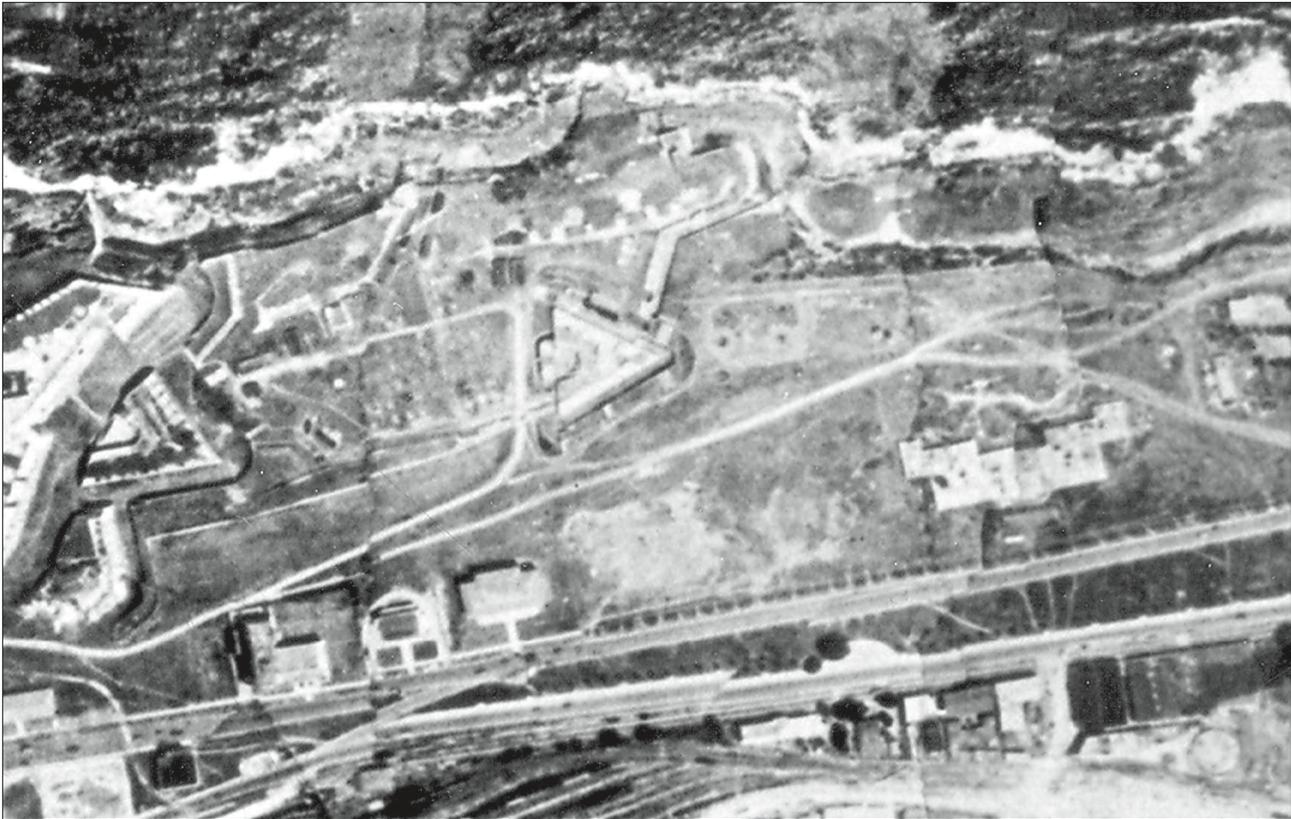
**Figure 2.14:** Aerial photograph, San Cristóbal and Outworks, 29 May 1924. Note the circulation patterns created by unpaved roads and footpaths within the Outworks area, also note the Puerto Rico Capitol building under construction. Taken from the U.S.S. Wright Aircraft Scouting Fleet, from 4,000 feet elevation, (National Archives, RG77, Entry 393, box 227).

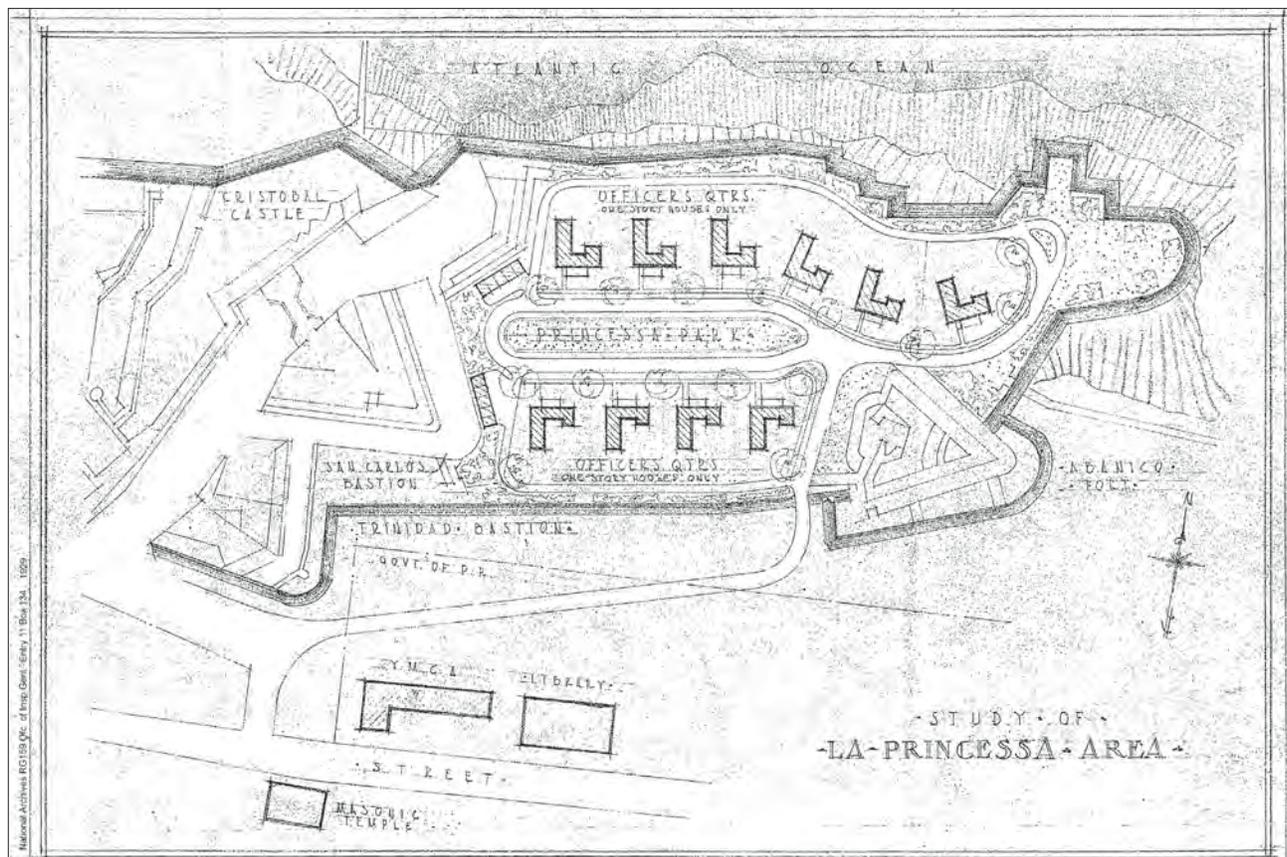
**Figure 2.15:** Detail 1929 Post Development Plan, Study for La Princesa [sic] Area, (National Archives, RG 159, Office of the Inspector General, Entry 11, box 134).

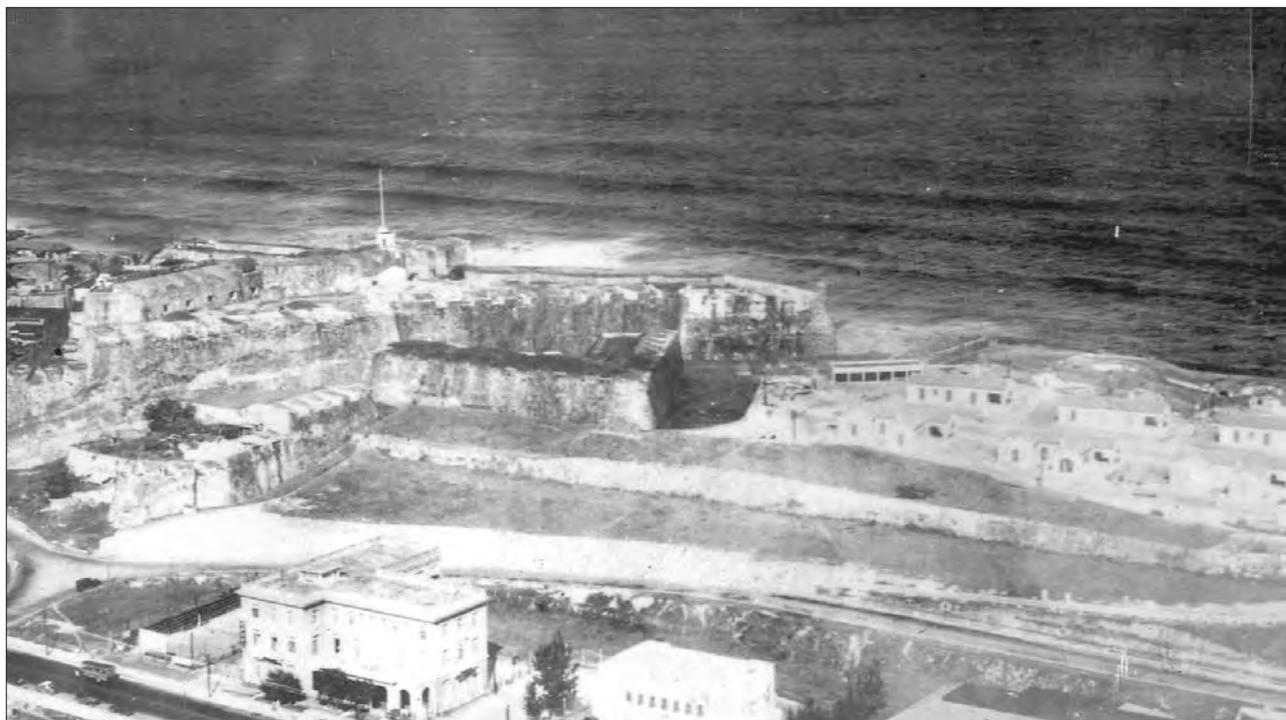
**Figure 2.16:** Oblique aerial photograph c 1930, with La Princesa Housing Area shown under construction, (San Juan NHS Collection, 11960).

buildings themselves were described as “of the one story bungalow type, constructed of reinforced concrete with tile roof and tile floors” (Figures 2.16-2.17). The site plan for the development was completed without materially departing from the preliminary “study” for the project approved by George Ford and the military leadership in the summer of 1929. Perhaps this is because the 1929 study bore the note: “No changes will be made on this plan and no additional buildings constructed without the personal approval of the Secretary of War.” The characteristics of the site plan appear to have been well suited to the needs of military families. The single family dwellings were arranged around a central greenspace identified on the plan as “Princesa Park” and featured street lighting and street trees. Gates and wire mesh fencing provided a measure of security against intruders, and as a safety measure to the north lining the cliffs above the ocean.

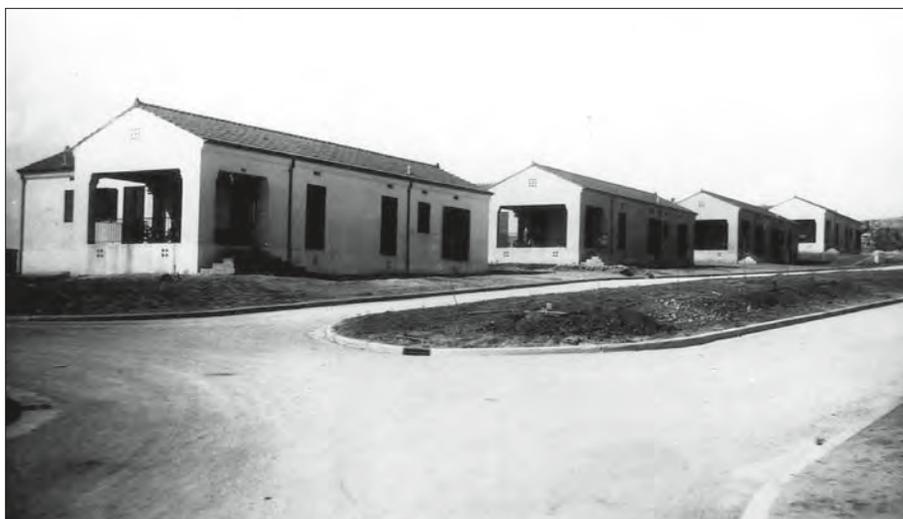
**Figure 2.17:** The Army's "La Princesa Housing Area" was completed in January of 1931 under the supervision of the Quartermaster Corps Construction Services. As part of a worldwide program of post improvements, developments such as this one were designed in consultation with leading architects and planners, (San Juan NHS Collection, 2881).

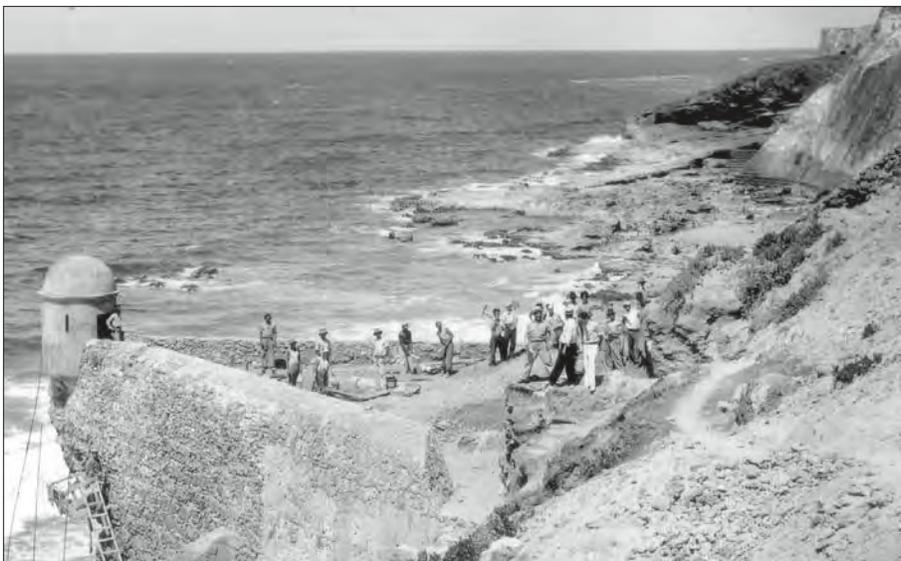
**Figure 2.18:** The Army supervised repair projects funded under the Depression-era WPA program in 1939. This image shows repair work taking place at San Cristóbal's so-called "Haunted Sentry Box" c. 1939, (National Archives II, RG126 PG, box 2 of 8, folder 2F).

Even this half-measure proved too difficult to accomplish as an Army led restoration program, funded with relief funding provided by the Works Progress Administration (WPA) was drafted in October of 1939, only weeks after Germany's invasion of Poland. A comprehensive masonry repair and restoration program directed at the San Juan military reservation for 1939-40 was instead solely administered by the Quartermaster Corps. At Castillo San Cristóbal, this program included removal of loose debris and vegetation from walls and the bases of walls. Walls, firing steps, and embrasures were cleaned, pointed and faced, and storm

drainage systems were repaired and improved. Courtyard patio walking surfaces and sentry boxes were repaired or replaced (Figure 2.18)

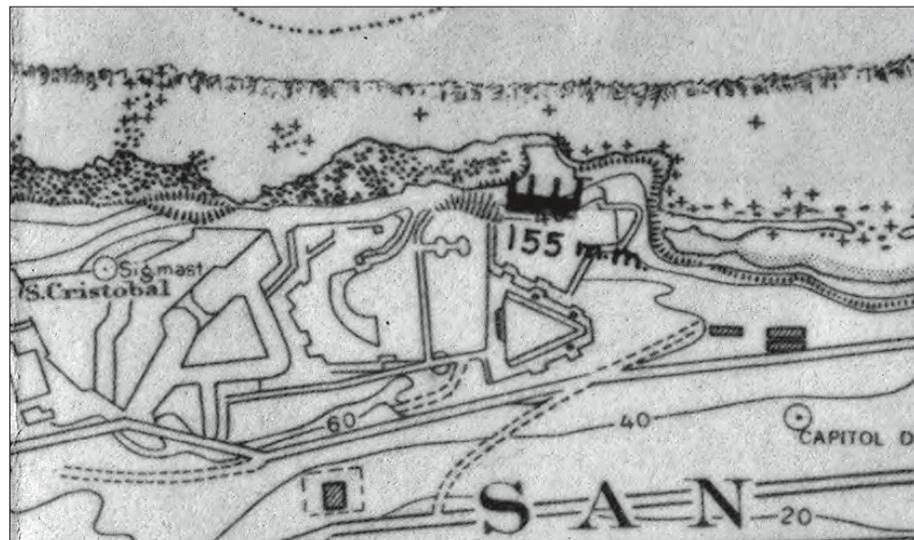
**Figure 2.19:** Detail of U.S. Coast and Geodetic Survey Chart, marked up in 1941 showing location of battery of four 155mm guns emplaced at La Princesa. These guns had the advantage of being quickly emplaced early in the war, (National Archives II, RG 77, Harbor Defense Files, Entry 1007, box 118).

The new gun battery at La Princesa emplaced four M1918 155mm "Grande Puisseance Filloux" guns of French design. These field artillery guns of World War I vintage were adapted for use in coastal defenses by mounting them on circular center-pivot mounts developed by the Army for use in Panama. Each emplacement within the battery of four guns was surrounded with traverses made of piled

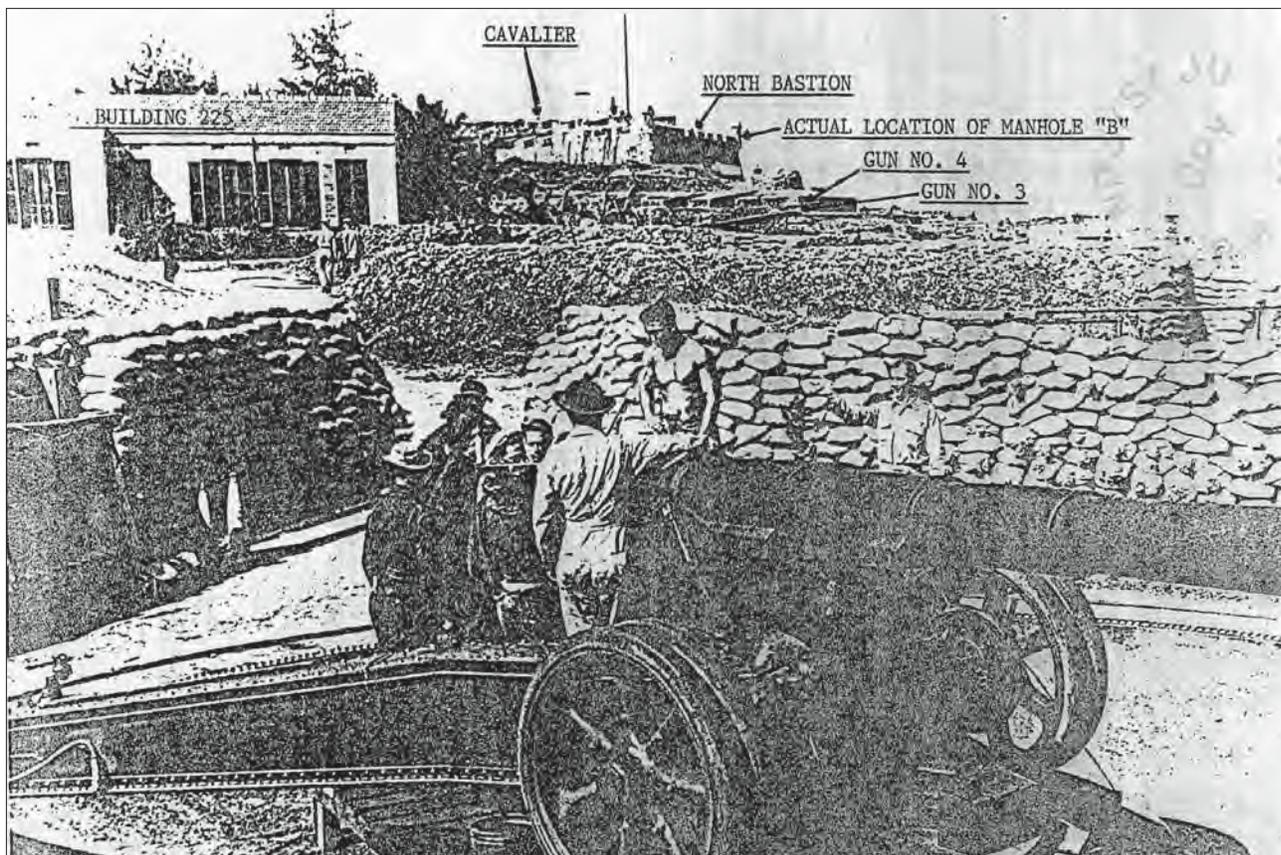
**Figure 2.20:** Photocopy of image showing the 155mm battery at San Cristóbal's La Princesa in operation c. 1943. Note close proximity to officers' housing, (San Juan NHS Collection, Preliminary research report of Hector R. Marin, 1 March 1985, showing "Gun Number 2, Battery Number 3 (La Princesa) 155mm M1918 GPF Gun, 1st Battalion, 51st Coast Artillery).

sandbags for protection in case of an explosion or gun failure (Figures 2.20-2.21). Powder charges and shells were stored in magazines constructed by the Spanish and subsequently refitted. Because of the close proximity of the neighboring officers' housing, only a small quantity of ammunition was stored on site.<sup>60</sup>

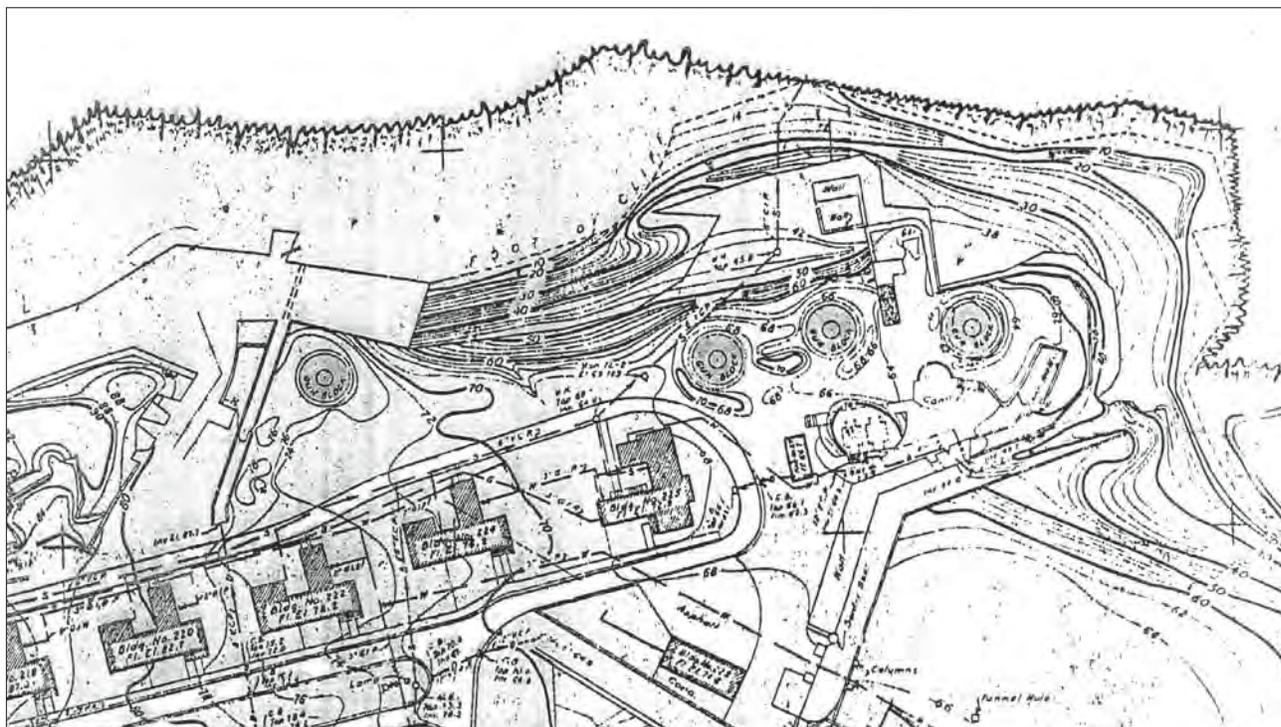
**Figure 2.21:** Detail of Fort Brooke As-Built Plan, c. 1945. Image shows exact placement of the guns making up the 155mm battery, (San Juan NHS Collection, Preliminary research report of Hector R. Marin, 1 March 1985).

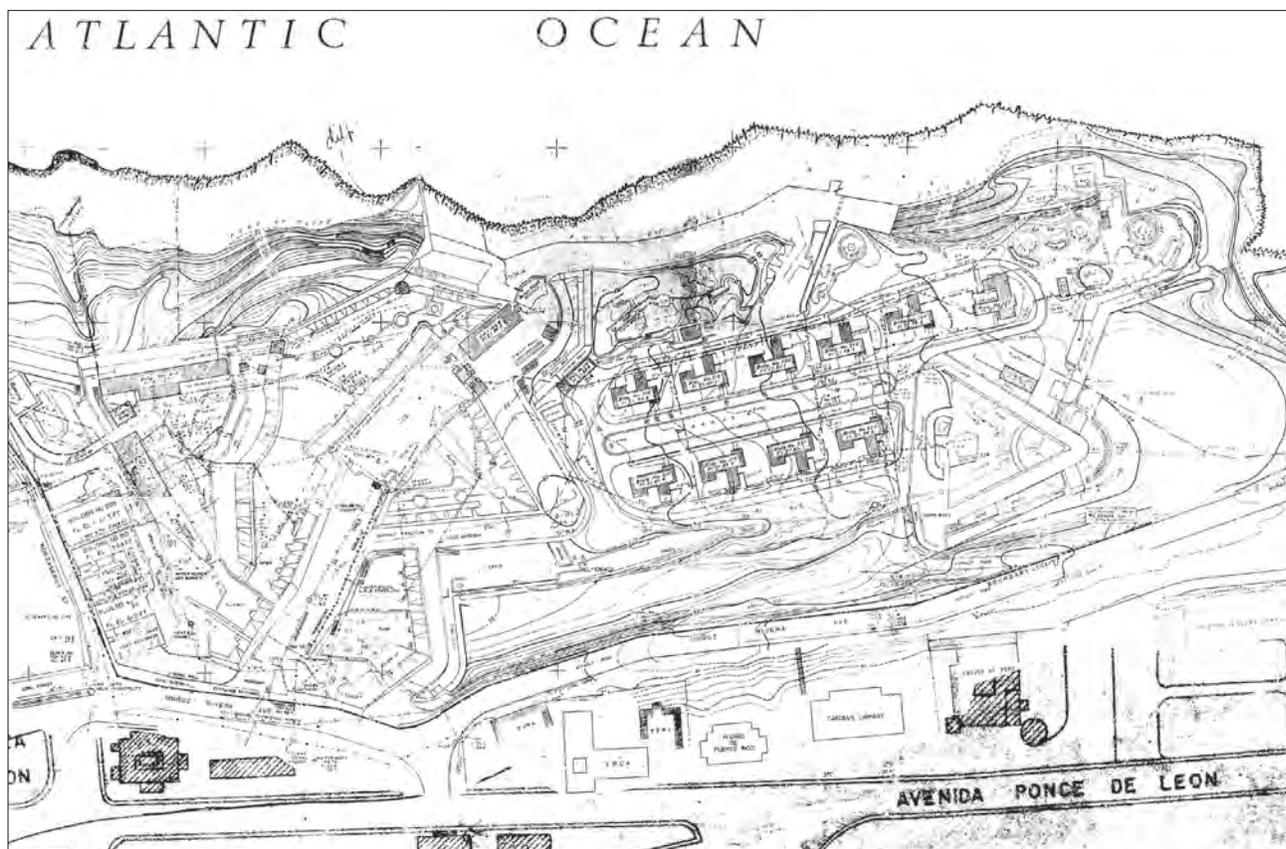
Figure 2.22: Detail of 1949 Fort Brooke As-Built Plan. The preparation of this precise drawing coincided with the formal establishment of San Juan National Historic Site, (San Juan NHS Collection).

Even prior to the war, the undercutting of walls and foundations through the action of the surf had become pronounced. Given war-time budgets, between 1940 and 1946, the deterioration of San Juan’s fortifications accelerated, with the War Department ruling that funds appropriated to the military could not be used for the rehabilitation of historic structures.<sup>64</sup> Designation as a national historic site under the authority of the National Historic Sites Act of 1935, permitted funds to be appropriated and expended for their preservation. However, responsibility for requesting appropriations and expending preservation funding would remain the responsibility of the Army. Designation as such also permitted the involvement of National Park Service expertise in the treatment of historic structures. With the approval of President Truman, the order creating the San Juan National Historic Site was signed by Secretary of the Interior J.A. Krug on February 14, 1949 (Figure 2.22).

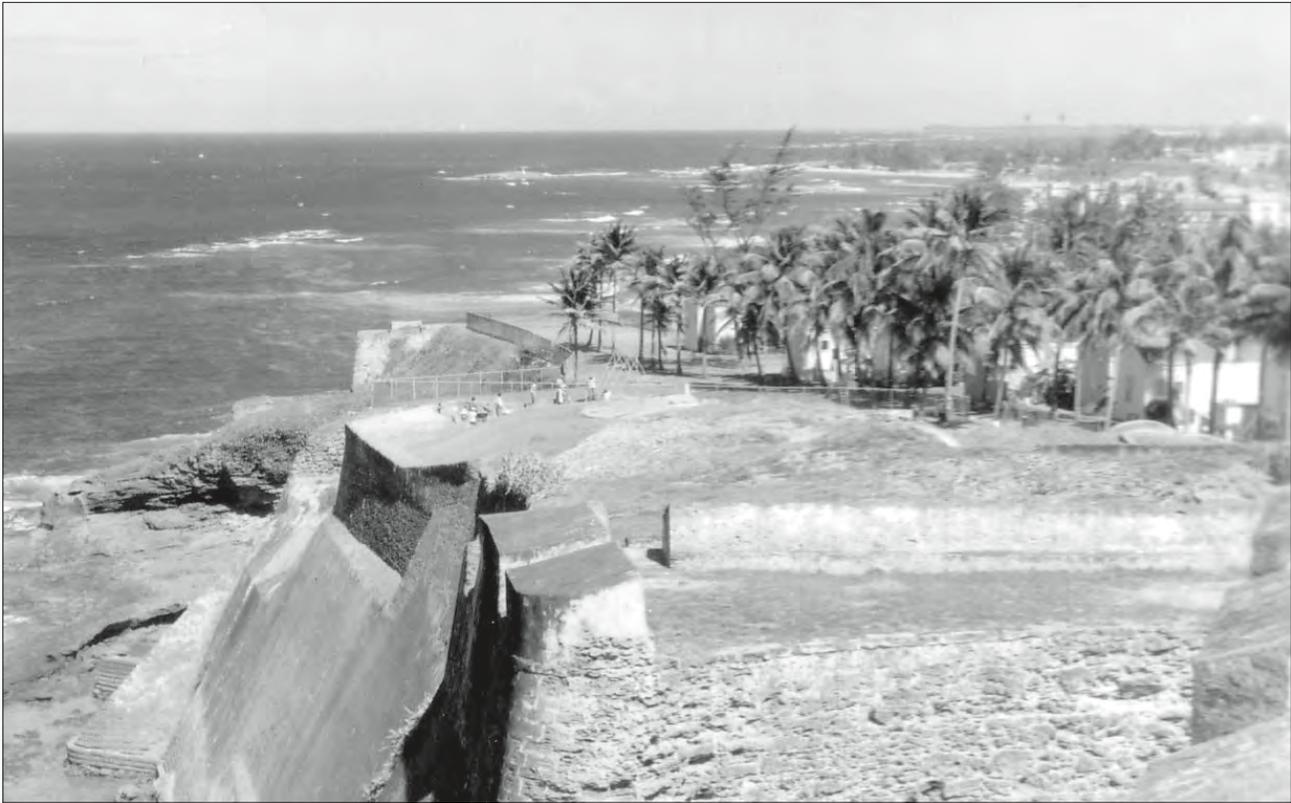
**Figure 2.23:** Earthen berms placed by the Spanish in 1897 to absorb the force of bombardment were removed in 1963 with funding supplied by the Accelerated Public Works program, (San Juan NHS Collection, 4094).

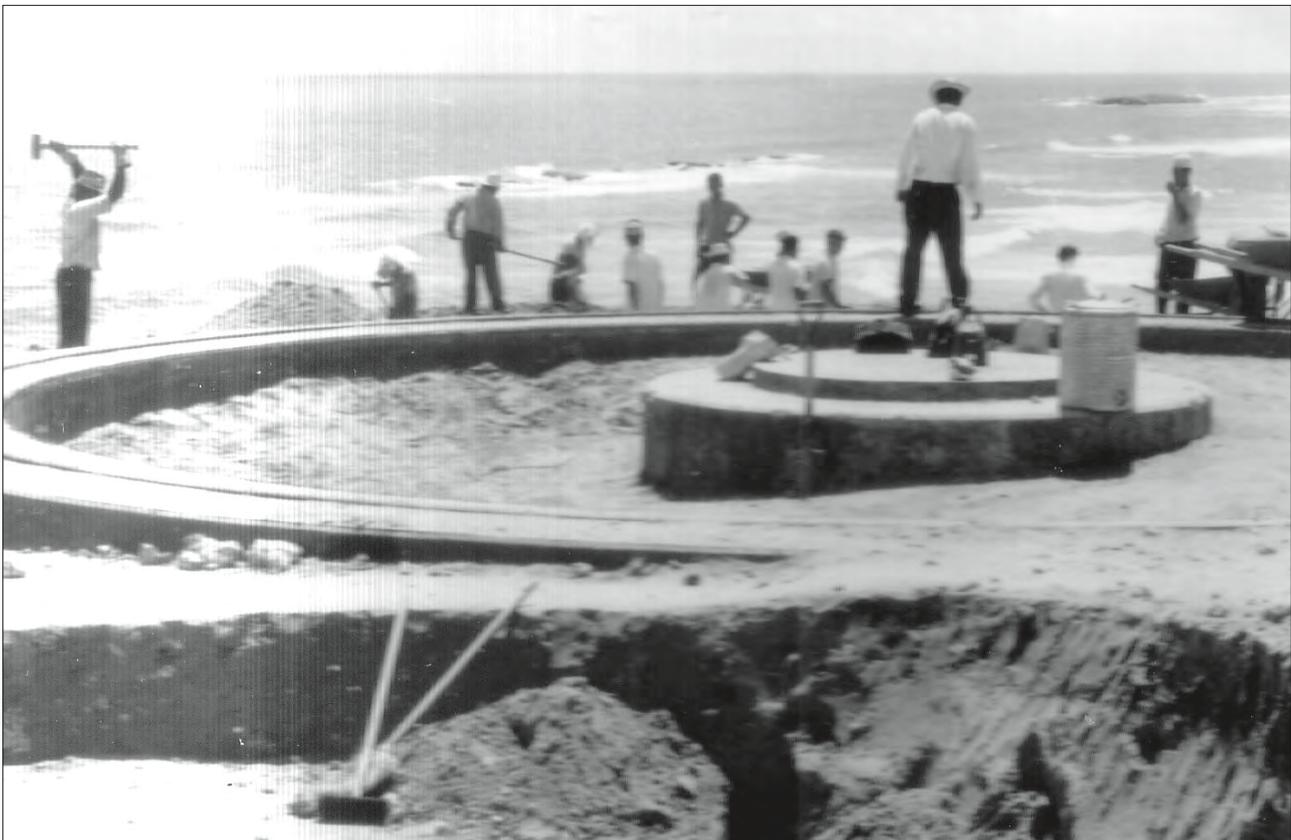
**Figure 2.24:** At the La Princesa battery, the 1963 WPA earthmoving extended beyond removal of the earth sheltering installed by the Spanish, also uncovering one of the four 155mm gun mounts installed by the U.S. Army during World War II, (San Juan NHS Collection, 4100/141).
