# CULTURAL LANDSCAPE REPORT FOR THE SAN CRISTÓBAL OUTWORKS

SAN JUAN NATIONAL HISTORIC SITE

SITE HISTORY, EXISTING CONDITIONS, ANALYSIS & EVALUATION, AND  
TREATMENT

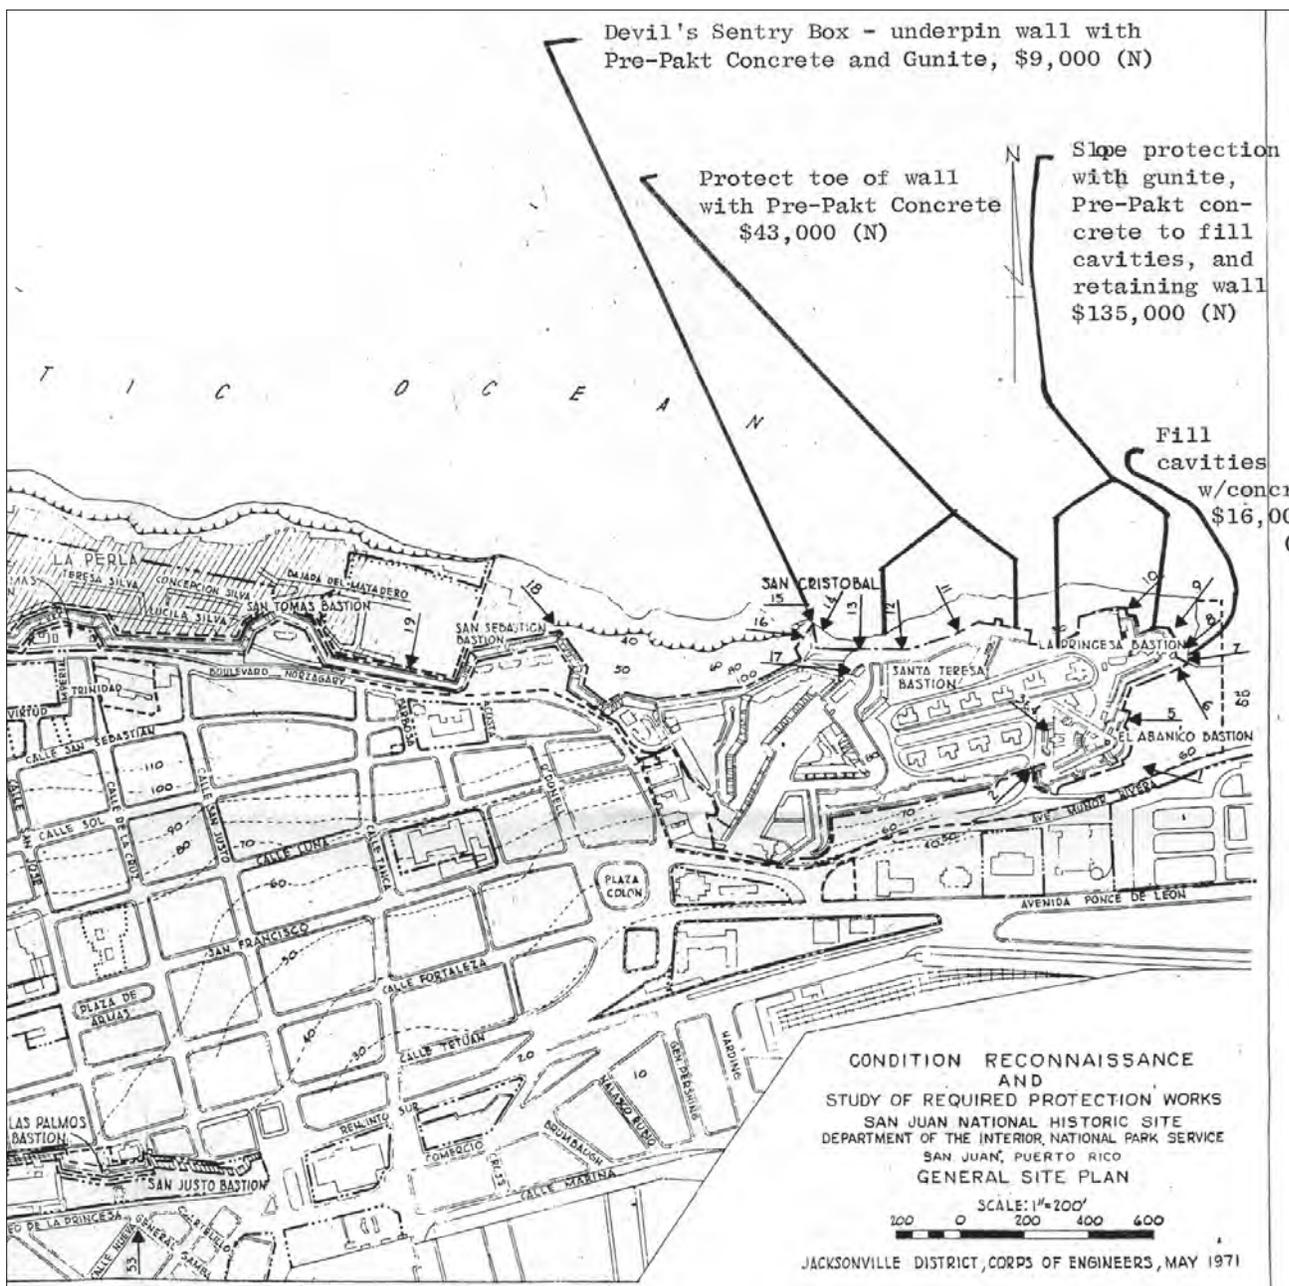
**Figure 2.25:** During the 1970's the National Park Service took measures to protect the foundations of the historic Spanish fortifications that were eroding due to surf action. Detail from, "Conditions Reconnaissance and Study of Required Protection Works," Army Corps of Engineers, May, 1971, (San Juan NHS Collection).

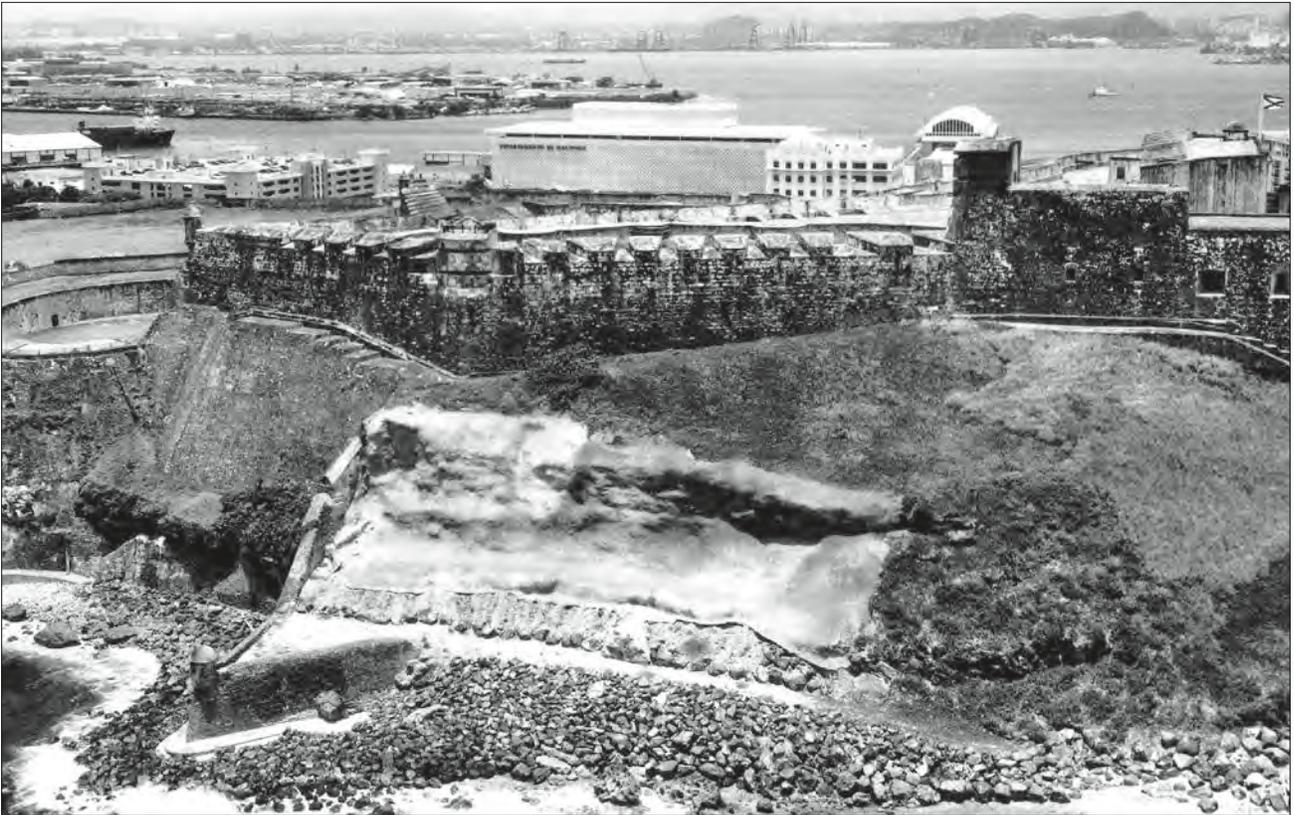
**Figure 2.26:** Photograph showing the characteristics of the repairs made by spraying concrete on the slope at high pressure using the “Guniting” process, c. 1981, (San Juan NHS Collection, HABS PR-47-41).

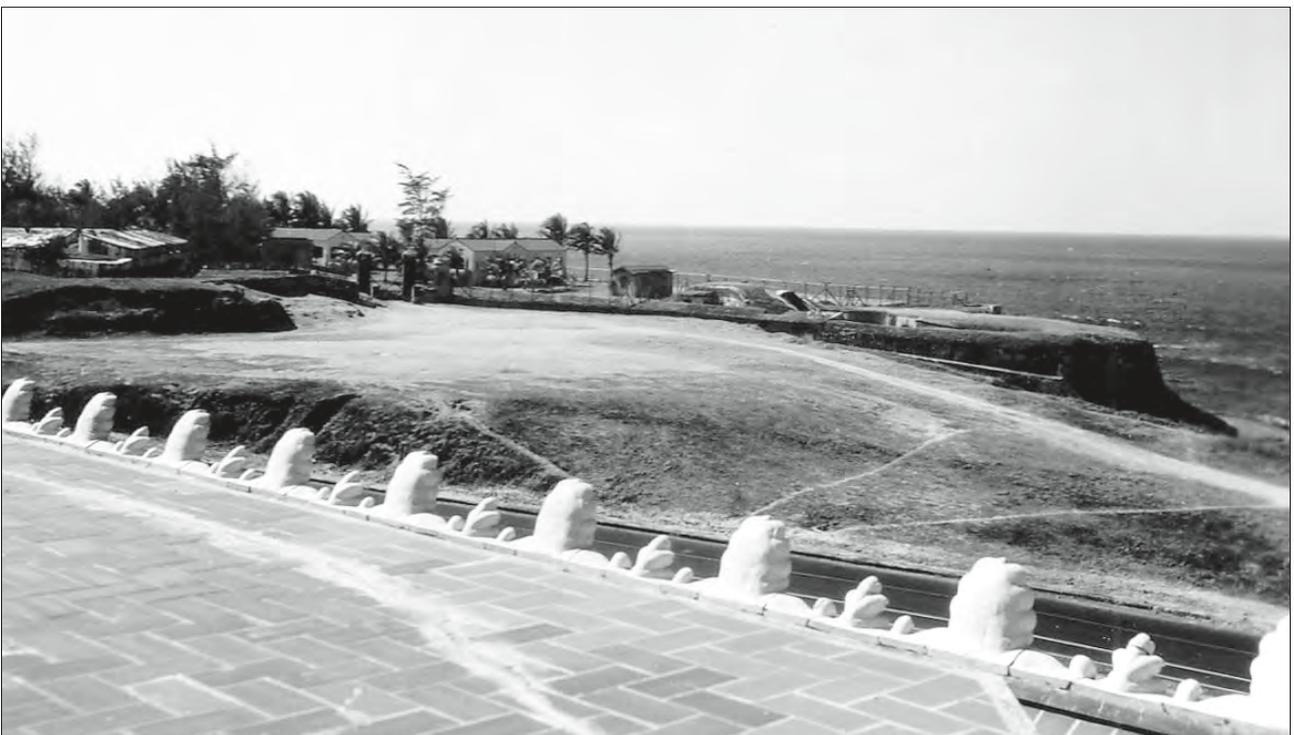
**Figure 2.27:** Image taken c.1950 from the Puerto Rico Capitol building of the Hill of the Three Wisemen, the designed earthform east of El Abanico. This photo shows the soil compaction and erosion caused by the use of this area for informal parking during weekends and special events, (San Juan NHS Collection).

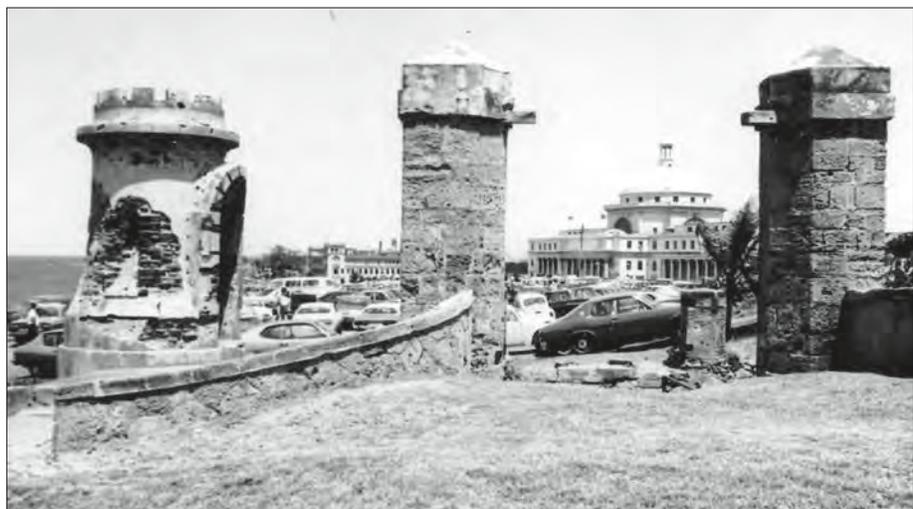
**Figure 2.28:** During the 1970s and early 1980s, the advanced glacis east of El Abanico, locally known as the “Hill of the Three Wisemen” was used as informal parking. This was one of the preservation issues raised in the 1984 General Management Plan for San Juan National Historic Site, (San Juan NHS Collection, 2871).

mally as an unsightly parking lot, causing erosion and potentially damaging subterranean features (Figure 2.28).

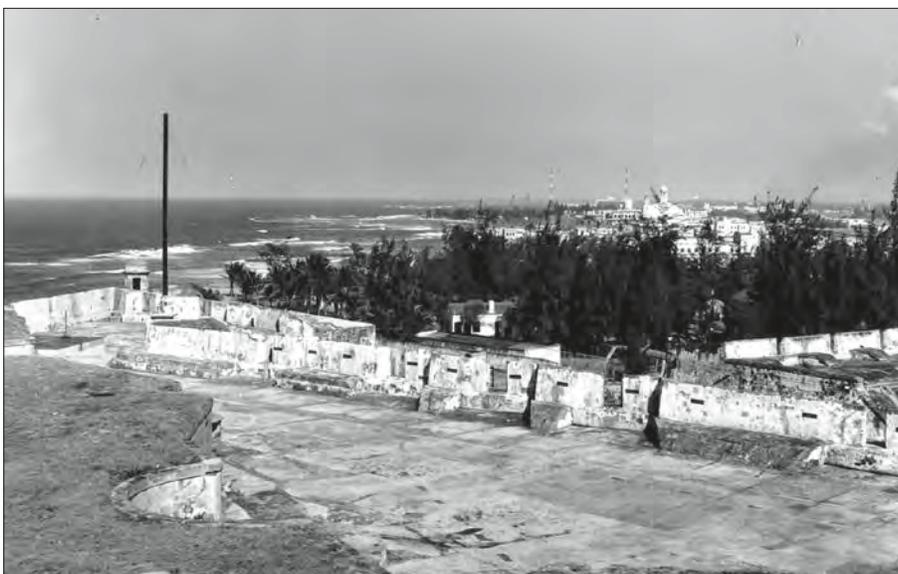
**Figure 2.29:** When the National Park Service finally acquired the five-acre La Princesa [sic] Housing Area from the U.S. Navy in 1973, the vacant buildings became a liability, attracting illegal and unsavory activities. Additionally, the presence of the former military housing, along with its street trees and landscaping, obscured the historic "field-of-fire," oriented toward the land approach to San Juan. The National Park Service demolished the housing in 1980. Compare this image to Figure 2.2, taken c. 1896 from the same vantage point. Image c. 1963, (San Juan NHS Collection, 9508).

proach to San Juan that Castillo San Cristóbal was designed to defend (Figure 2.29). Superintendent Whitt's forecast for the demolition was apparently optimistic. His annual report for 1979 (submitted in 1980), notified the Regional Director that the demolition contract had recently been negotiated with the Small Business Administration for completion of the work during the upcoming year.<sup>84</sup>

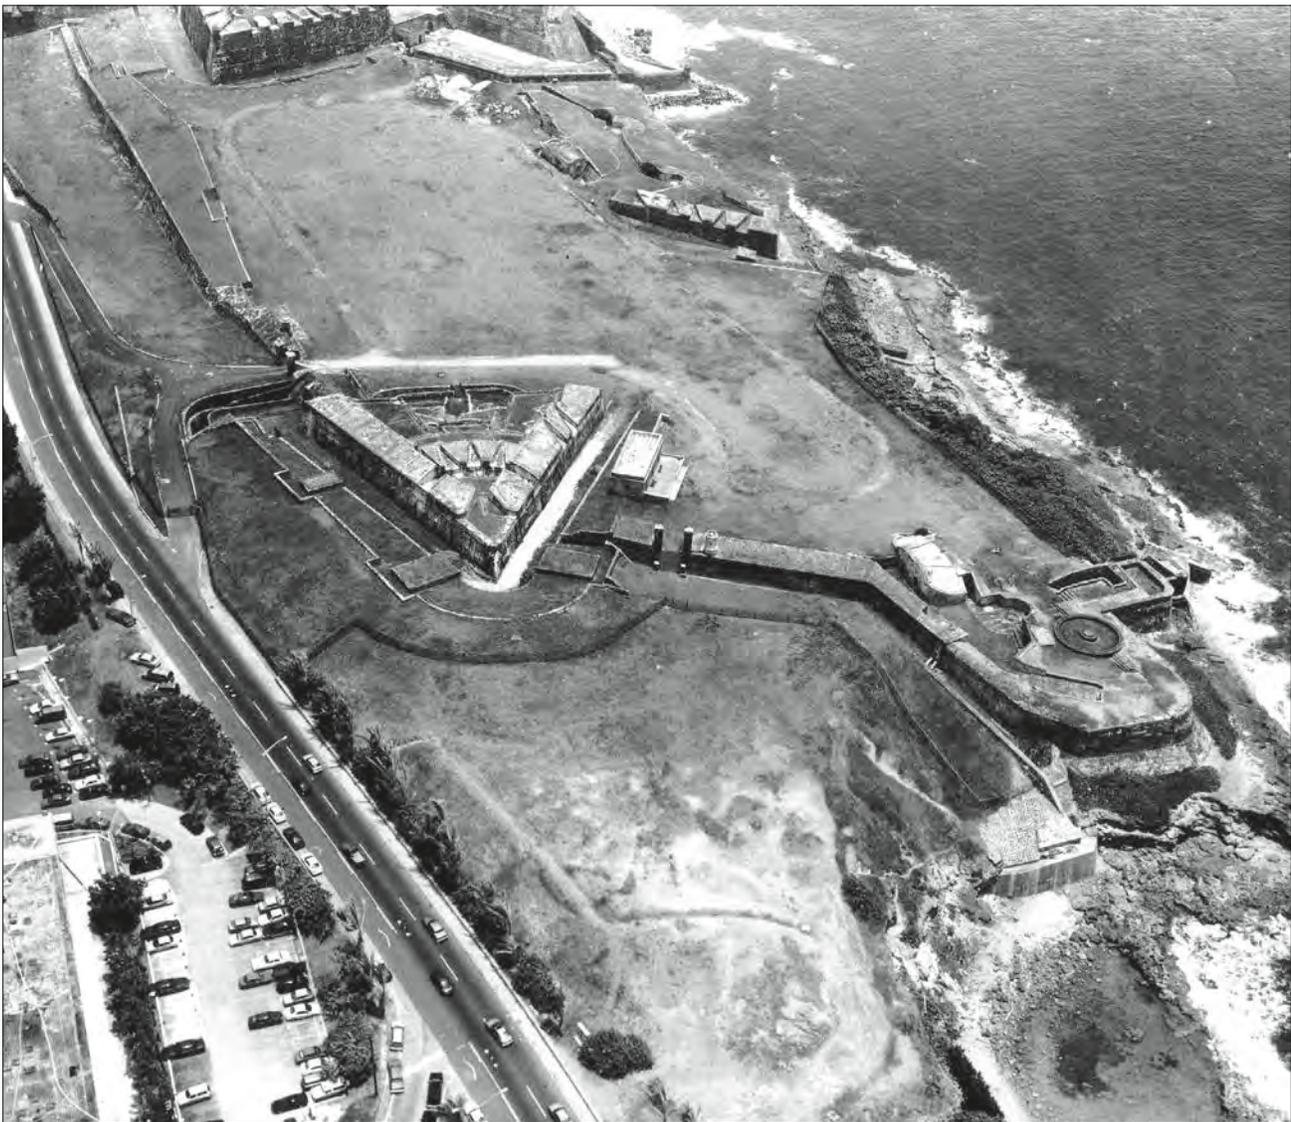
**Figure 2.30:** This c. 1981 image of the San Cristóbal Outworks shows the property soon after the National Park Service removed the housing development constructed by the U.S. Army in 1930-1931. Note location of security fencing surrounding the parcel. Public access to this area has been limited since National Park Service acquisition in 1973, (San Juan NHS Collection, HABS PR-94-7).

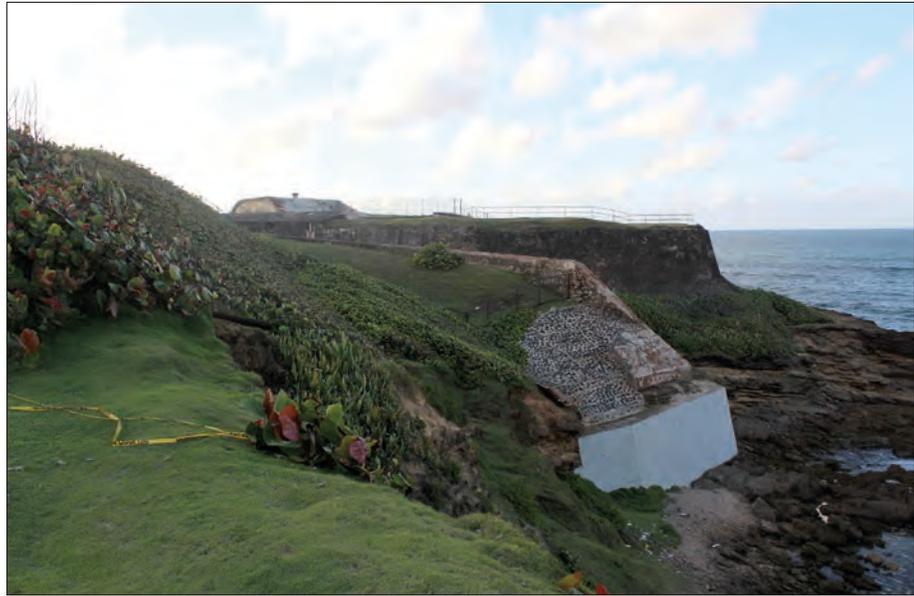
**Figure 3.1:** View northwest to the great wall and La Princesa. Steep cliffs descending to the Atlantic Ocean have been reinforced with a mixture of stone, masonry work, and concrete. Vegetation grows on portions of the sea cliffs, 2012 (SAJU).

Although no longer an active military base, the San Cristóbal Outworks retain the general organization and interrelationships characteristic of the historic period. The outworks themselves and their physical relationship to one another remains primarily unchanged from the historic period. Prior to c.1930 the 1st and 2<sup>nd</sup> Retirada walls bisected the central open area of the outworks north to south. The Retirada walls were removed in preparation for the 1930 construction of officers housing. In 1980, the National Park Service removed the officers housing, accompanying roadways, and residential plantings. The Outwork fortifications remain clustered around a modified open area consisting primarily of turf grass. To the north and east, as during the historic period, a combination of fortification walls and natural cliffs drop steeply to the shores of the Atlantic Ocean (Figure 3.1). The south boundary of the park continues to be

Vegetation within the Outworks, as during the historic period, consists primarily of grass. Grass covers steep designed slopes within the fortifications and the central open area. Volunteer vegetation grows on the eastern sea cliffs (Figure 3.1). Residential plantings, including palm trees planted c.1930, within the interior of the outworks have been removed. Removal of volunteer vegetative growth on fortifications has been executed within the past decade to reduce the impact of vegetation on historic structures.

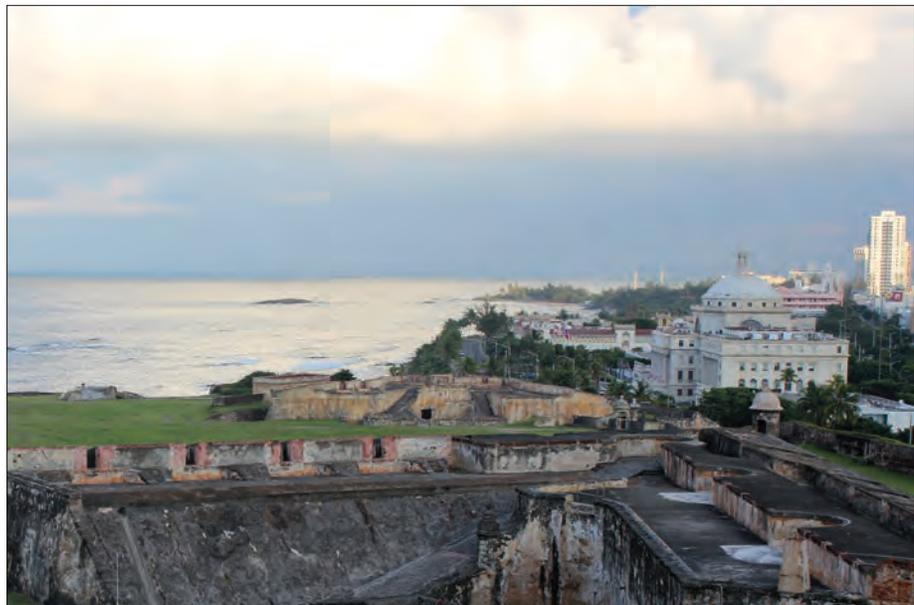
**Figure 3.2:** View east across San Carlos to El Abanico and the Capitol. As during the historic period the land drops quickly to the Atlantic Ocean north of the Outworks while fortification walls form the south boundary (image right) The modern city of San Juan is visible beyond the park boundary, 2012 (SAJU).

defined by topographic change and fortification walls. Contemporary security fencing lines much of the perimeter. South of the park is the modern city of San Juan. San Cristóbal continues to define the western edge of the San Cristóbal Outworks (Figure 3.2).

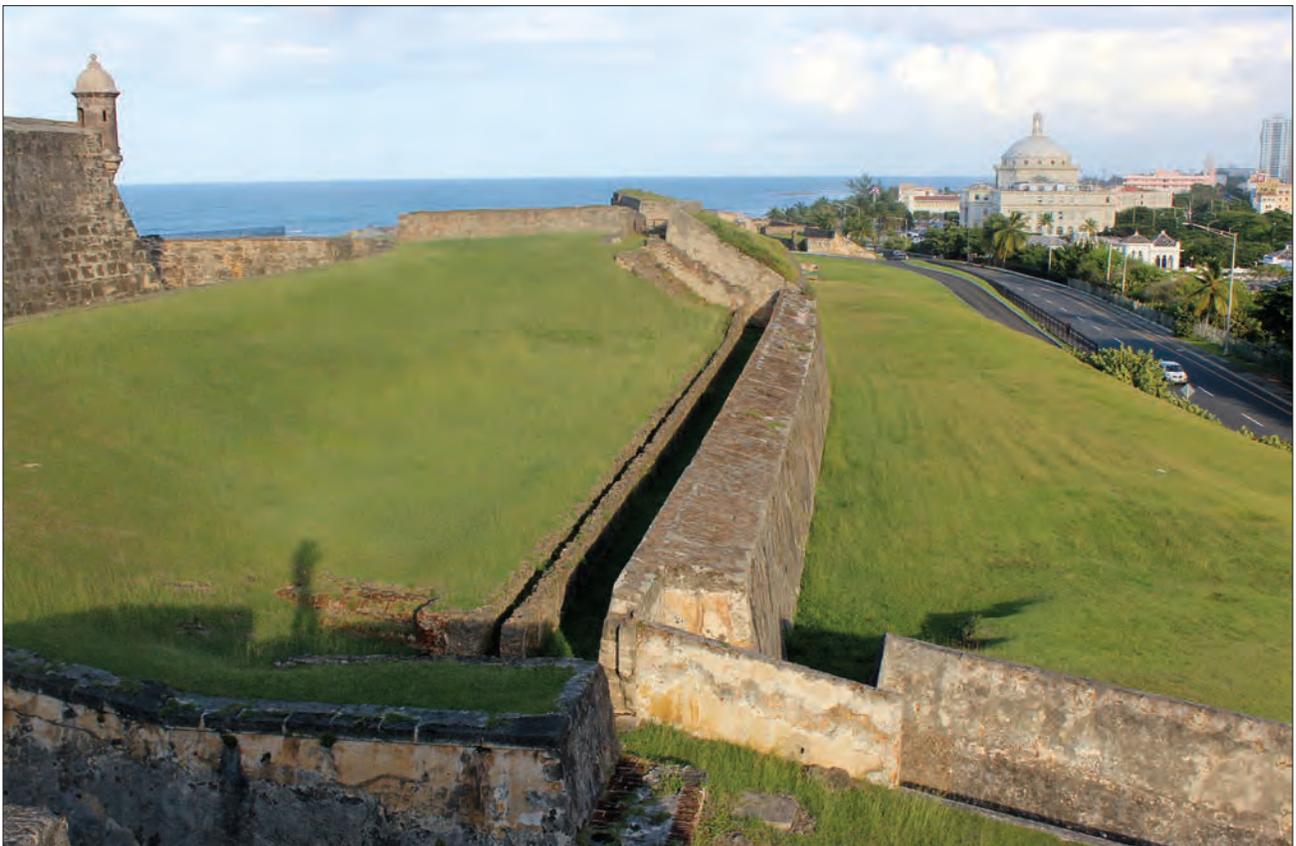
Figure 3.3: View northeast from La Trinidad. Substantial fortification walls line the south boundary of the Outworks. Site topography drops in a series of steep steps from the central portion of the Outworks to the south boundary and Avenida Muñoz Rivera. Portions of the south entry drive and Avenida Muñoz Rivera are visible at image right, 2012 (SAJU).

advantage. Within the Outworks, topography has been carefully designed and engineered to work in conjunction with the fortifications. Constructed as a land defense from the east, the site retains unobstructed views to the east. The site's natural topography complemented by additional height offered by the defenses provides a sweeping view to the east. Contemporary development within San Juan has altered the view to the east, however the historic wide-spread view remains (Figure 3.3).

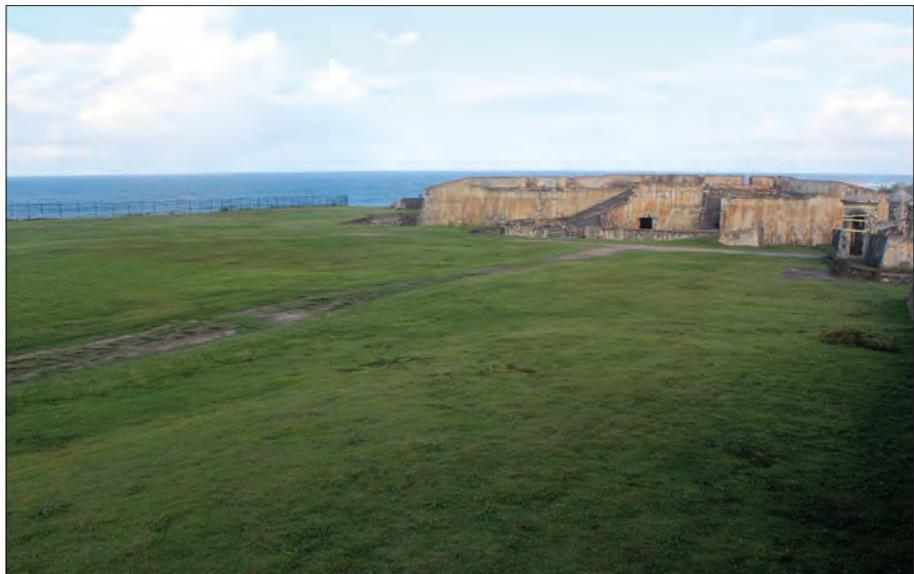
**Figure 3.6:** View northeast across the open central portion of the Outworks to El Abanico. A trace of a residential vehicular circulation route installed c. 1930 is visible in the middleground. The South Gate sentry box is visible at image right, 2012 (SAJU).

Circulation systems at San Juan National Historic Site include both historic and contemporary pedestrian and vehicular routes. During the historic period a network of tunnels allowed below-ground pedestrian movement between fortifications. Many of these tunnels remain today, although the entrances to some tunnels have been sealed. During the historic period the Outworks were accessed via the south and east entry drive. The south entry drive was expanded in conjunction with the development of the officers housing in the 1930s, to include a 'y' at the entrance from Avenida Muñoz Rivera. The south entry drive is presently surfaced crumbling and cracking bituminous asphalt concrete (Figure 3.4). Although no longer extant, the entrance of the east entry drive to the fortifications is marked by the Northeast Bridge (Figure 3.5). Evidence of the northeast drive itself has been removed. An internal vehicular circulation system consisting of several loops surrounding a residential boulevard served the officers housing development constructed in the 1930s. Both the officers housing and the roadway system were removed by the National Park Service in 1980. Today a faint trace of the internal residential circulation system is still visible today (Figure 3.6).

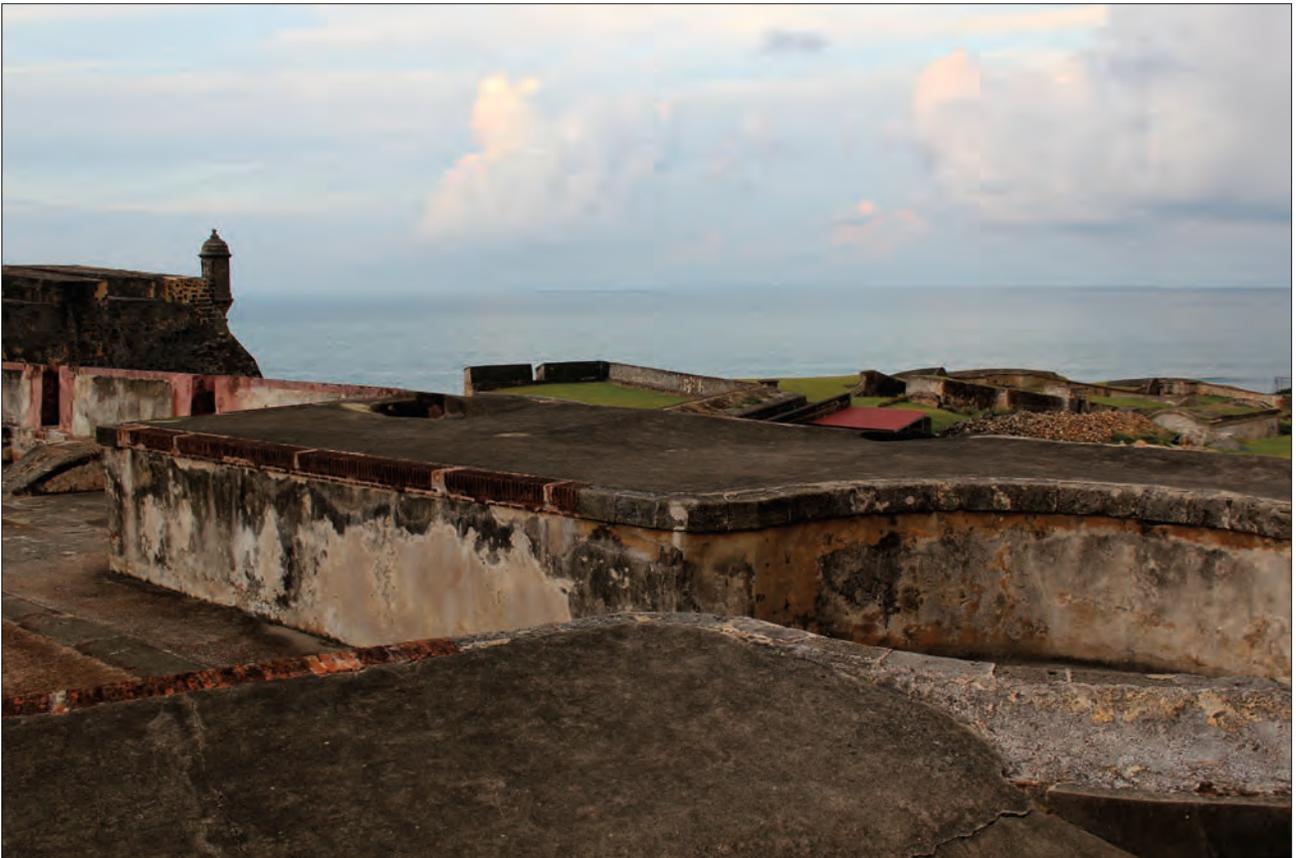
Figure 4.3: View north from San Carlos to Santa Teresa and the Atlantic Ocean beyond. Note the various layers of patches and repairs on the fortification walls, 2012 (SAJU).

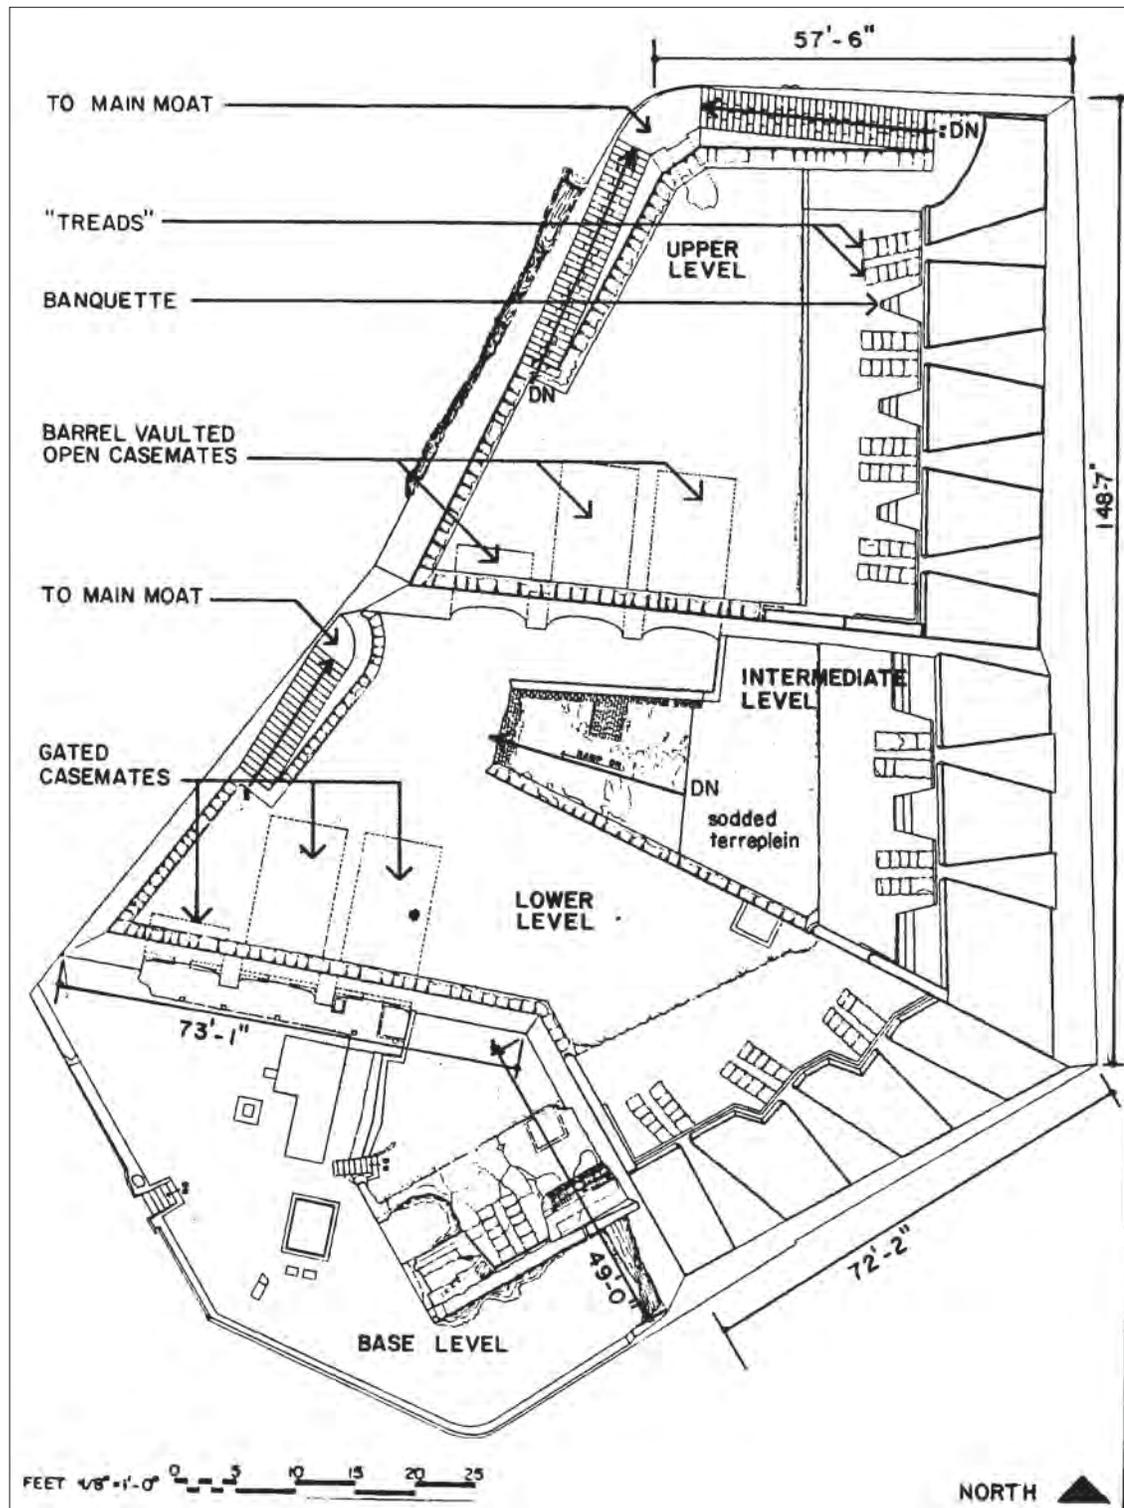
Figure 4.7: La Trinidad Counterguard with levels and elements labeled. HABS drawing (1984) annotated by Jana Gross (1989), (HSR Volume II, 364).

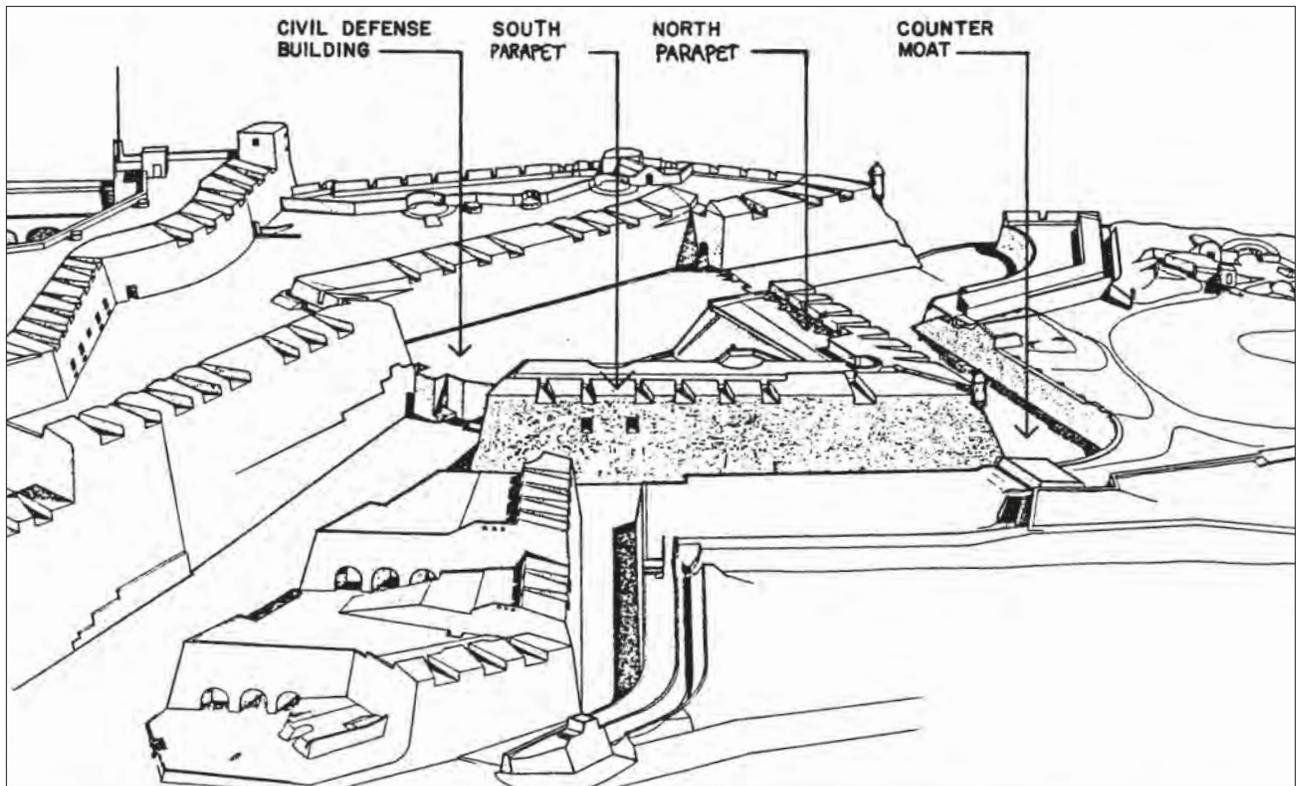
Figure 4.8: Aerial perspective of San Carlos Ravelin with features labeled. Based on a HABS site plan (1985), annotated by Jana Gross (1989), (HSR Volume II, 335).

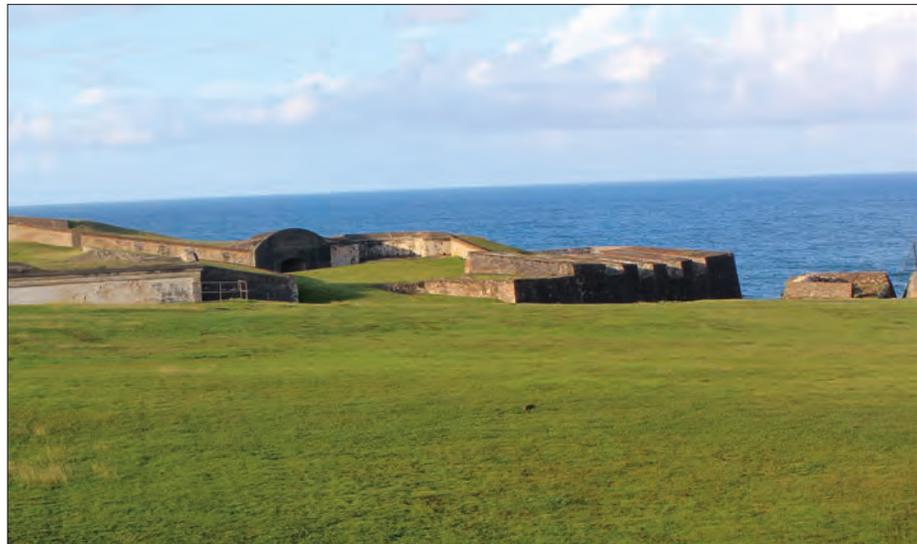
Figure 4.9: View north to Santa Teresa Battery. North of Santa Teresa the land drops sharply to the Atlantic Ocean. The open area in the foreground was the site of the 1st and 2nd Retirada walls between c.1898 and 1930, and the officers housing development between 1930 and 1980, 2012 (SAJU).

century covered way, latrine, vaulted bunker, 1897 rifle mounts, concrete surfaced “pad”, magazine, ditch, counter forts, banquettes, moat, and counter mining gallery (HSR, Volume II, 301). The battery is in good condition, Impacted by moderate structural deterioration. The structure received extensive preservation treatment concluding in 2005 (LCS)(Figure 4.9 and Figure 4.10).

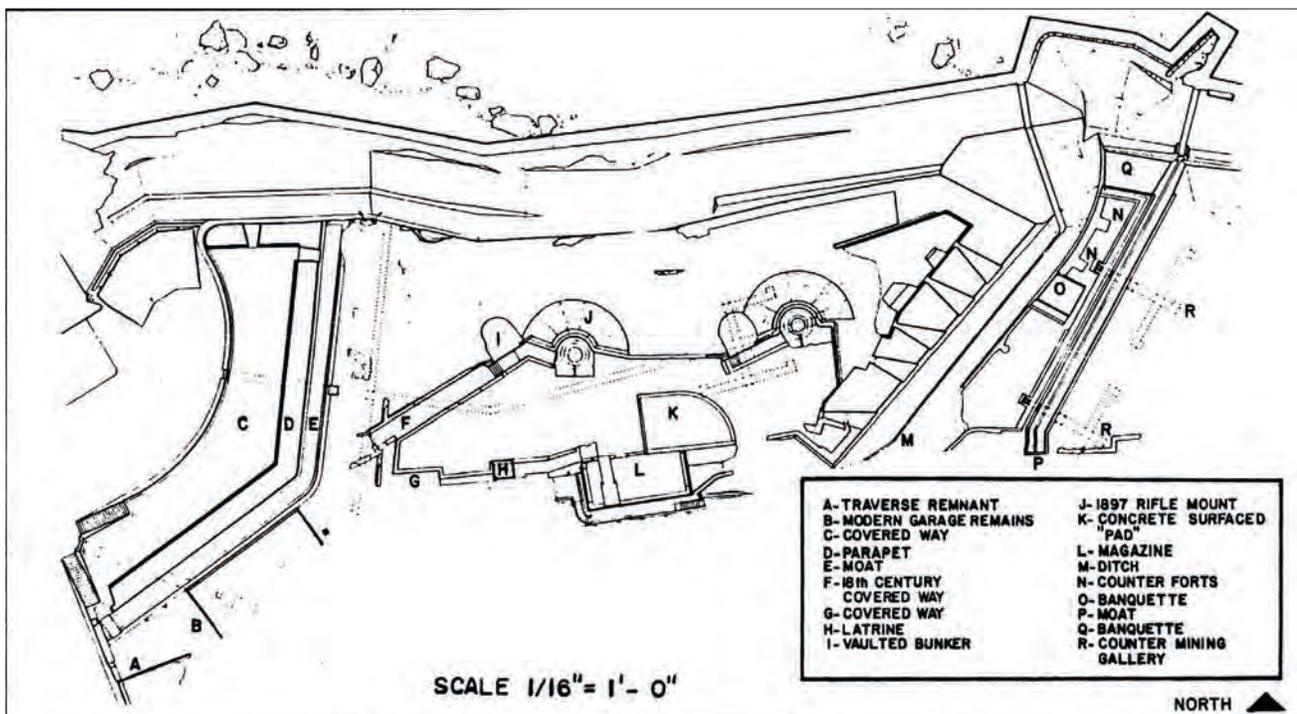
Figure 4.10: Plan of Santa Teresa Battery with individual features labeled. HABS drawing (1986) annotated by Jana Gross (1989). (HSR Volume II, 301).

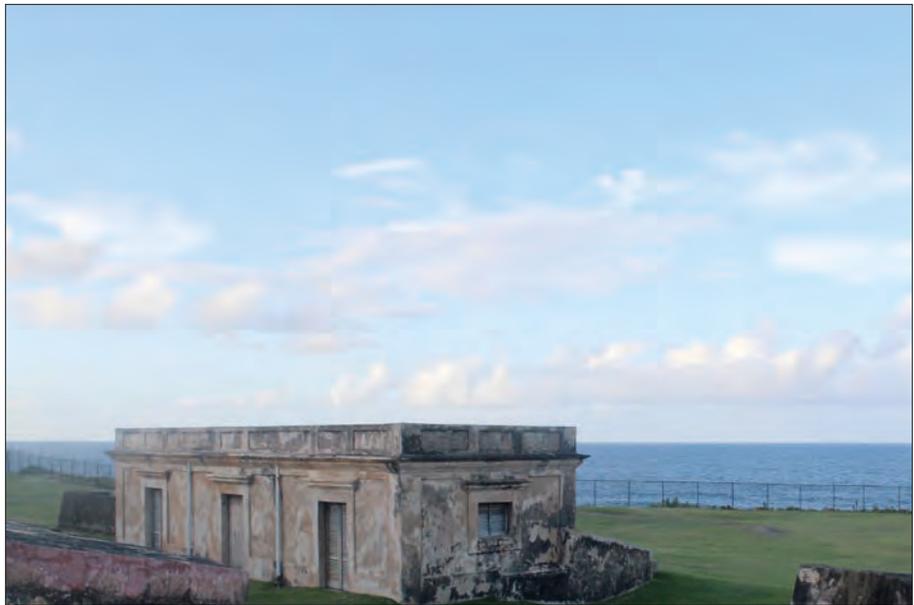
Figure 4.11: View northwest to the El Abanico Guardhouse from El Abanico, 2012 (SAJU).

The north façade was altered in 1930 when the United States Army converted the building to a four-car garage. The structure was converted to a visitor restroom c. 1980 by the National Park Service. Two masonry retaining walls lay adjacent to the structure (HSR, v2, 447-450). The guardhouse is in fair condition, being moderately impacted by inappropriate or inadequate preservation/ rehabilitation efforts that utilized Portland cement exterior finishes, structural deterioration, and vandalism (LCS)(Figure 4.11 and 4.12).

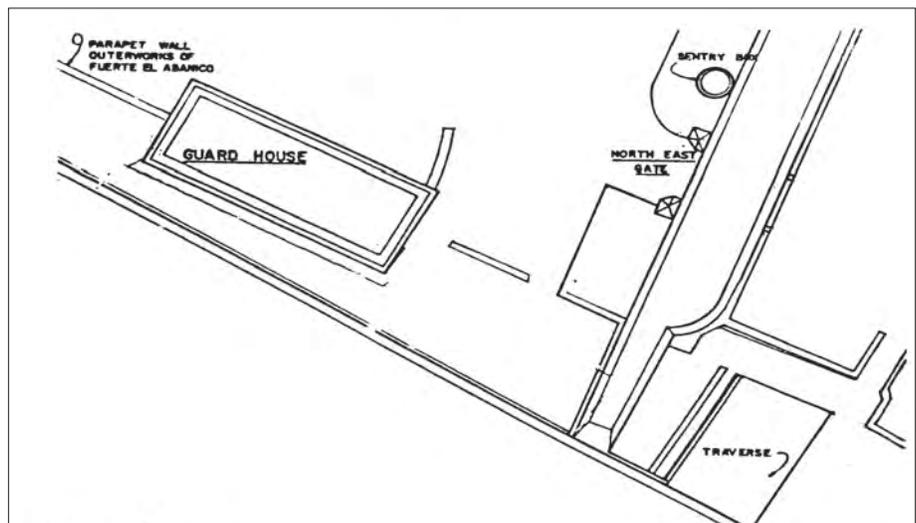
Figure 4.12: HABS site plan showing location of Gaurdhouse at El Abanico, 1963, (HSR Volume II, 448).

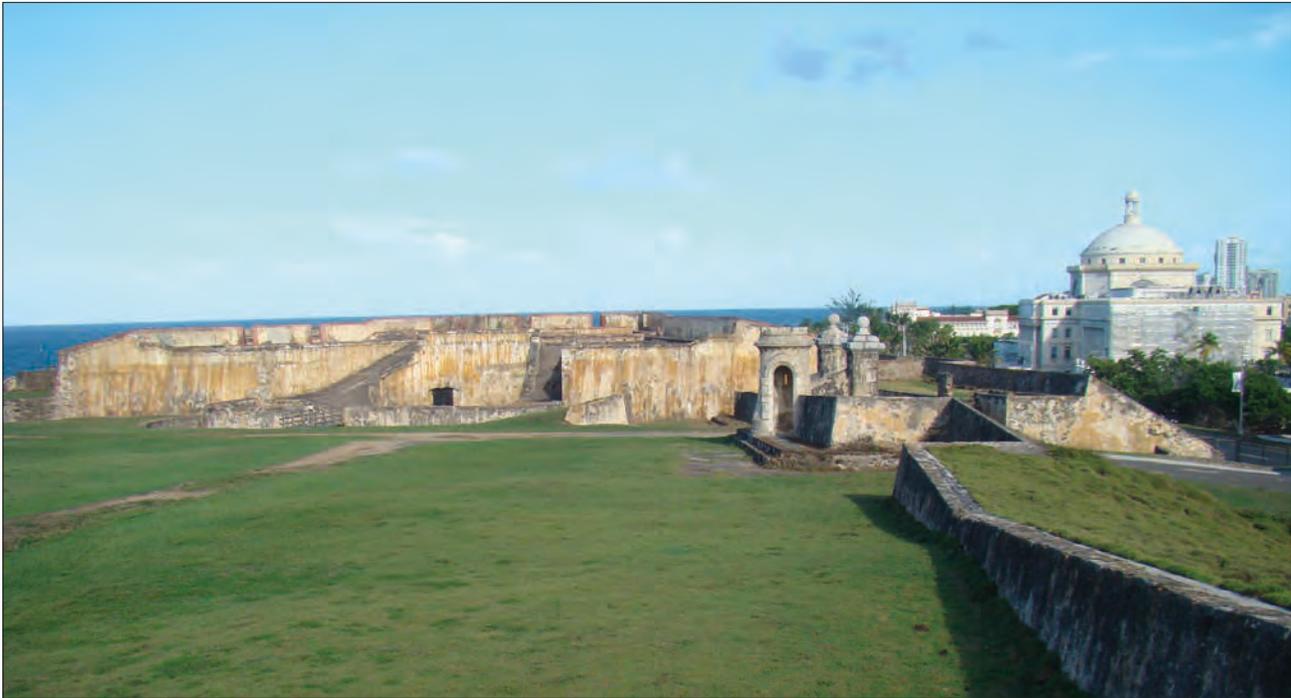
Figure 4.13: View east from the central open area within the Outworks. The South Gate sentry box is visible to the right of El Abanico. The Capitol building is at image right, 2015 (SAJU).

hill overlooking the north coast and San Juan's Puerta de Tierra district which is the primary land approach into Old San Juan (HSR, Volume II, 416-430). Features include a covered way at the entrance, the gorge (entrance area with moat), the north and south ramps, the 'fan battery', north and south terrapleins, the main moat, dry moat, moat's covered way, and the forward glacis. Altered by the Spanish between 1896-1897 and by the United States Army between 1901-1902, the National Park Service again altered the structure in 1960, further stabilizing the structure in 2001 (LCS). The structure is in fair condition, facing moderate impacts from structural deterioration, previous improper preservation efforts using Portland cement finishes, the growth of volunteer vegetation (Figure 4.13 and Figure 4.14).

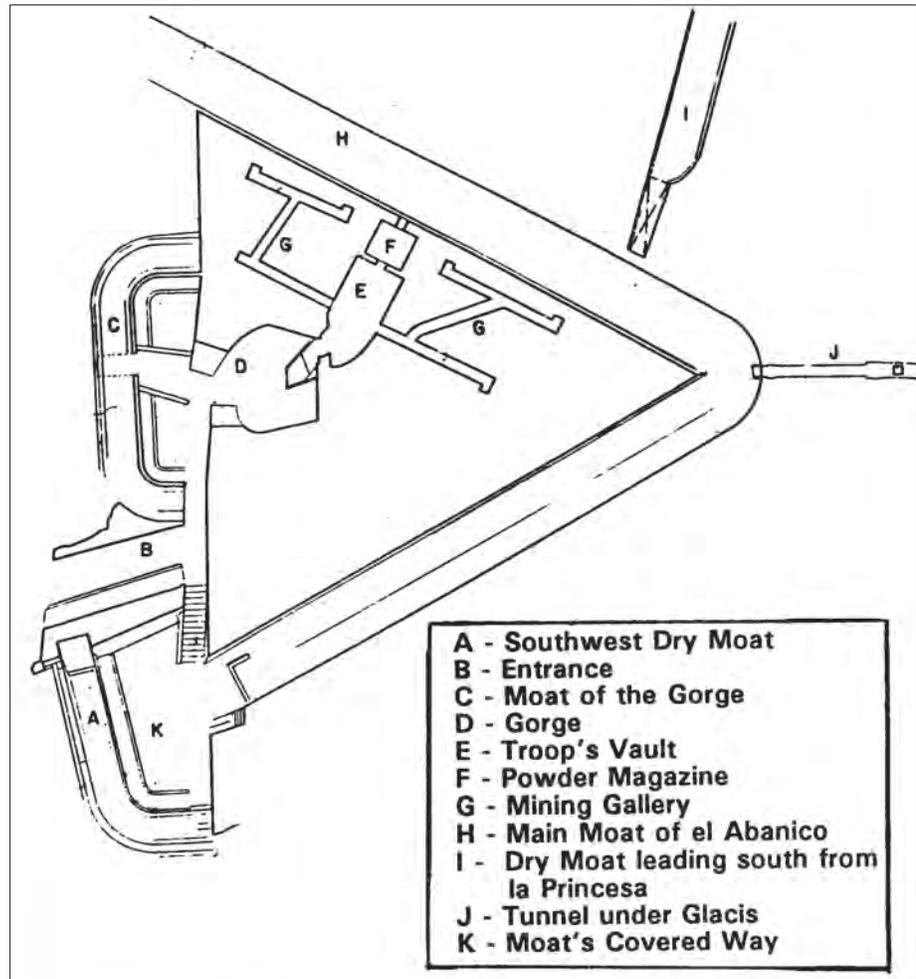
Figure 4.14: Plan of El Abanico with selected elements labeled. Detail of HABS plan (1963) as annotated by Jana Gross (1989), (HSR Volume II, 419).

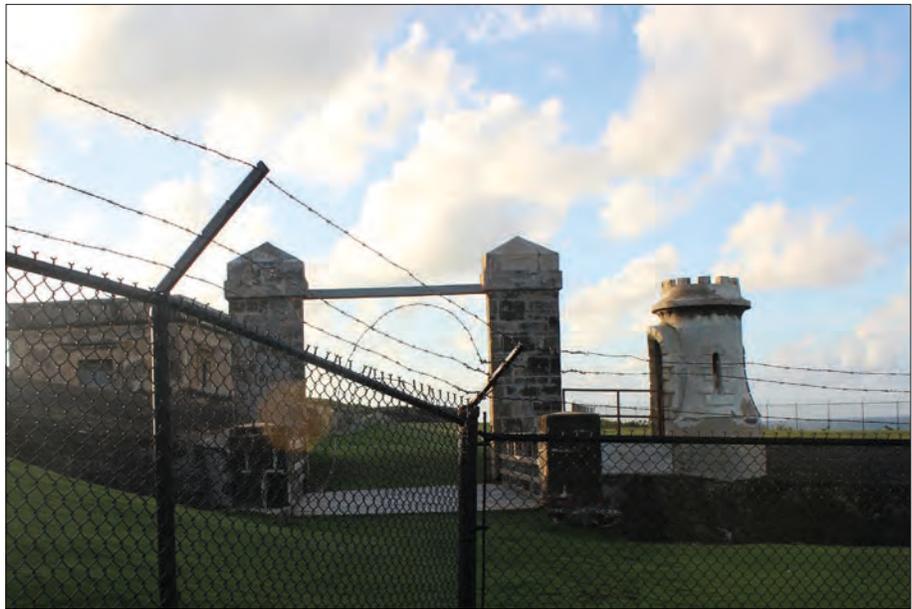
Figure 4.16: East elevation of the Northeast Gate, HABS drawing, 1963 (HSR Volume II, 469).

Cristóbal and to La Princesa. The Northeast Gate provided access for construction materials for a large scale modification project to La Princesa. The Northeast Gate and the South Gate are similar. The structure is in good condition (LCS) (Figure 4.15 and Figure 4.16).

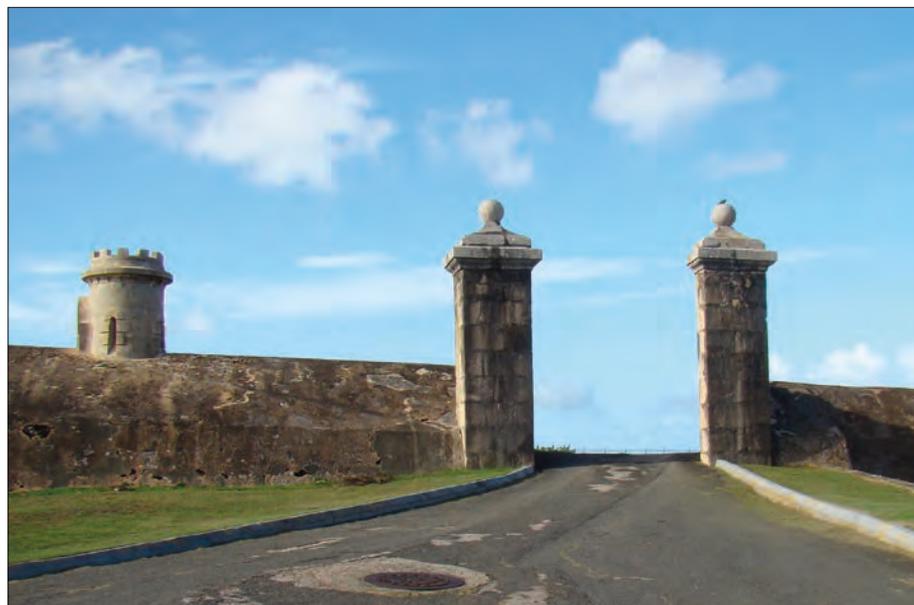
Figure 4.17: View north to the South Gate, including posts and sentry box. The historic wooden gate has been removed, 2015 (SAJU).

sandstone in an ashlar pattern. Both gates and hardware are missing. Portland cement patches indicate where brackets once extended to support the gates. The sentry box is located west of the gateposts and is approximately eleven-feet tall. The sentry box of the South Gate and the Northeast Gate are similar. The wooden gate itself was removed prior to 1963, although at that time the iron eyelet remained. (HSR, v2, 480) The South Gate is in fair condition. The South Gate sentry box is in need of stabilization and repairs. No evidence of protective stucco remains on the posts. The gate is occasionally used to access the outworks area (LCS) (Figure 4.17 and 4.18).

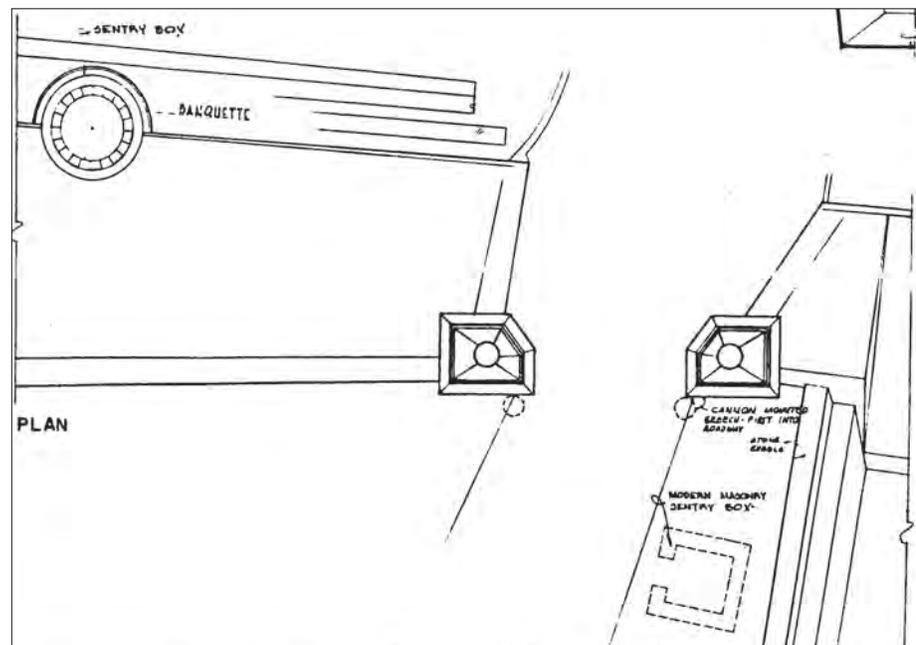
Figure 4.18: Plan view of the South Gate of El Abanico, drawn by HABS, 1963. (HSR Volume II, 481).
