# CULTURAL LANDSCAPE REPORT FOR THE SAN CRISTÓBAL OUTWORKS

SAN JUAN NATIONAL HISTORIC SITE

SITE HISTORY, EXISTING CONDITIONS, ANALYSIS & EVALUATION, AND  
TREATMENT

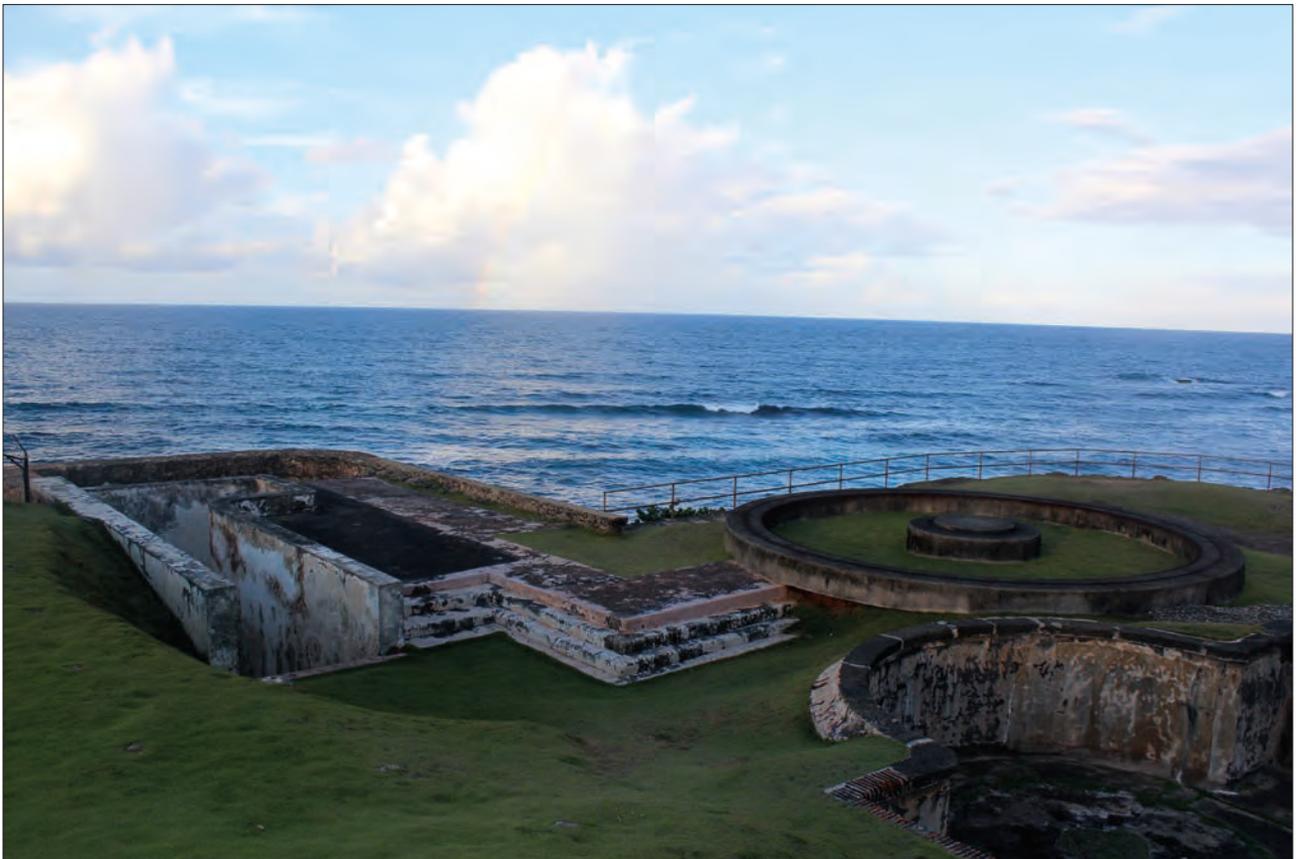
Figure 4.19: View northeast across La Princesa. The north wall of the fortification drops steeply to the Atlantic Ocean below, 2012 (SAJU).

gun-block indicate the re-orientation of La Princesa weaponry toward the sea. By the late nineteenth century and into the twentieth century, La Princesa was a focal point in San Juan's coastal defenses. The battery embodies three centuries of military technology (HSR, Volume II, 380). Recent preservation efforts have improved the condition of the structure. The structure is in fair condition, being moderately impacted by structural deterioration, vandalism, and natural factors such as exposure to extreme weather (LCS) (Figure 4.19 and Figure 4.20).

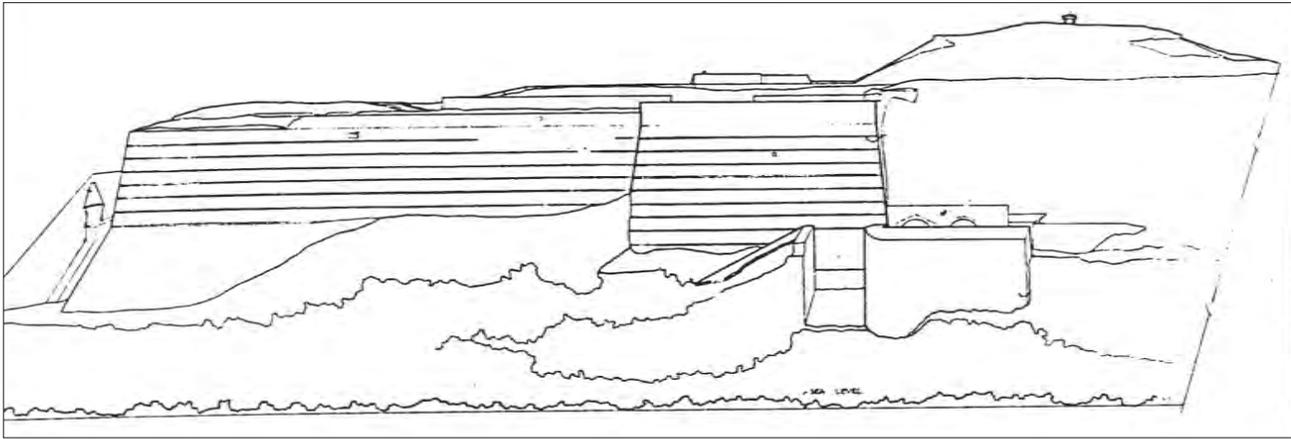
Figure 4.20: North elevation of La Princesa. Drawing by HABS, 1963, (HSR Volume II, 385).

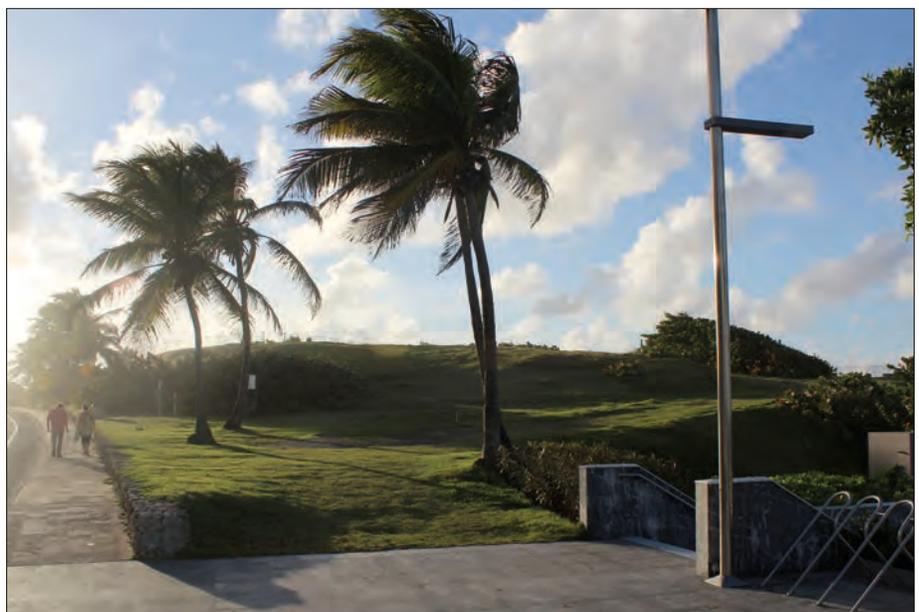
Figure 4.21: View west from the Plaza San Juan Bautista to the Forward Glacis of El Abanico, also known as the 'Hill of the Three Wise Men,' 2012 (SAJU).

Natural topographic features were integrated into the construction of forts, including El Abanico which is located on a natural topographic rise (HSR, Volume II, p. 416). The Forward Glacis of El Abanico, also known as the 'Hill of the Three Wise Men' was used as a parking area during the 1970s. Use of this area as a parking lot caused erosion and potentially damaged subterranean features. In 1988, the National Park Service rejected a proposal from the Commonwealth to construct a landscaped parking lot on the Hill of the Three Wisemen, immediately east of El Abanico. The Forward Glacis of El Abanico is a contributing feature (Figure 4.21).

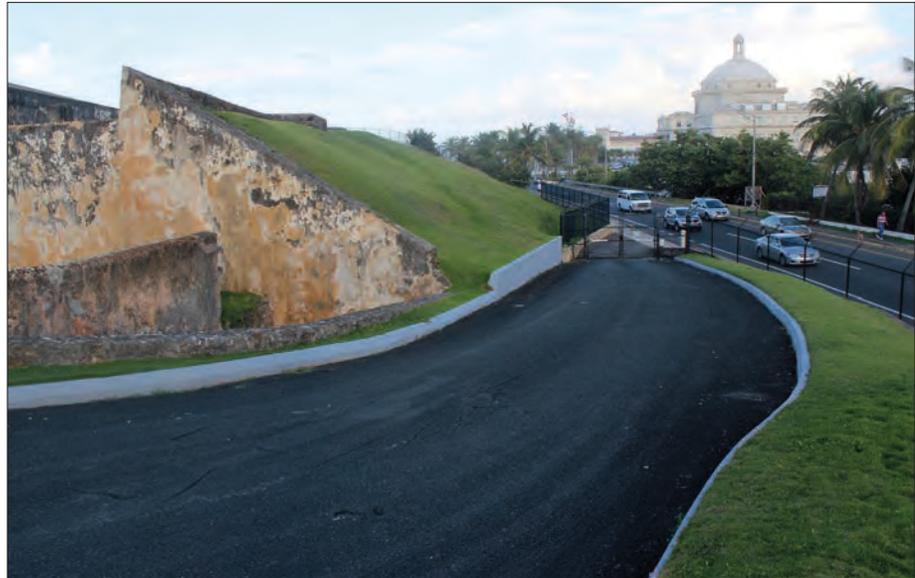
Figure 4.22: View east from the drive to the South Gate along a portion of the outer wall of the San Cristóbal Outworks. Note the steeply-sloped walls covered in grass, 2012 (SAJU).

Cristóbal fortifications rise nearly 150 feet above sea level. The network of walls, moats, ramps, and stairs within the fortifications exist within both natural and designed topography. The topography of San Cristóbal is contributing (Figure 4.22).

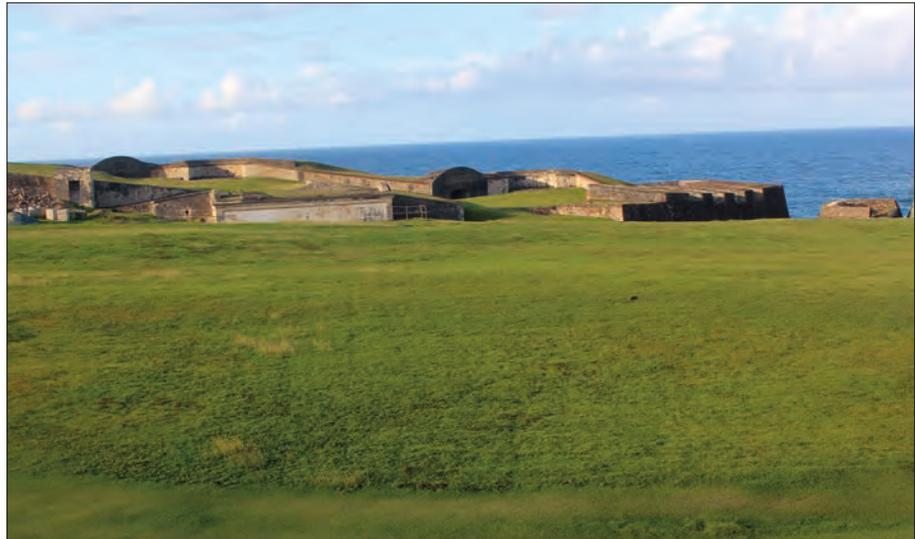
Figure 4.23: View from the south side of the open central area of the Outworks north to Santa Teresa. Note the relatively flat grade, remnant portions of the La Princesa Housing Loop Road are visible, and the predominant turf grass vegetation cover, 2012 (SAJU).

Turf grass was the primary ground cover during the historic period. Turf grass remains the primary ground cover. Volunteer vegetation growing on, within, and surrounding the Outworks is removed by the National Park Service to protect resources and maintain the historic character (Figure 4.23).

Residential plantings consisting of trees and foundation plantings surrounding residences of the La Princesa Housing area were planted c. 1930. Palm trees lined the interior residential streets. Residential landscaping in the Outworks area was removed c. 1980 when the National Park Service removed the housing development (Figure 4.23).

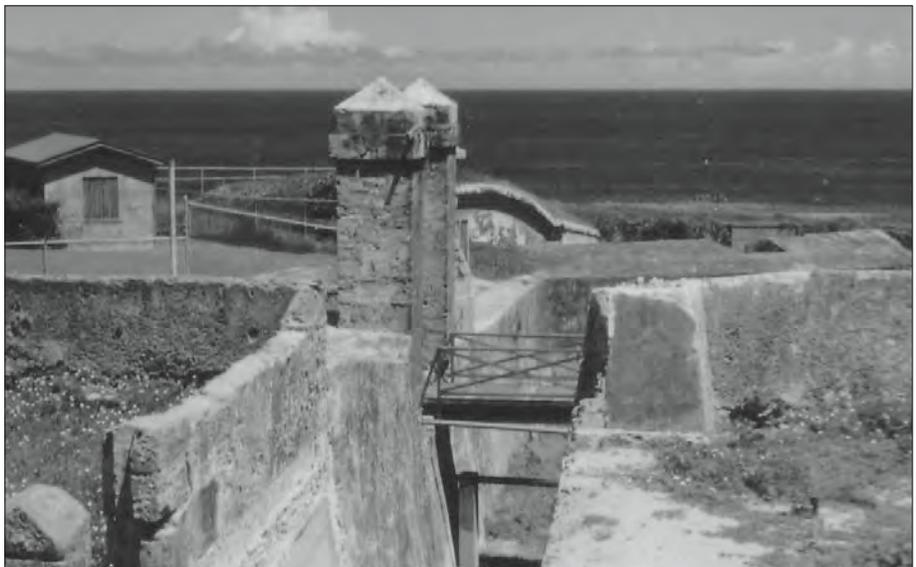
Figure 5.3: View north to the Northeast Gate of the San Cristóbal Outworks from the El Abanico fortification, c. 1957. Note the placement of security fencing within the historic perimeter walls, (SAJU Photograph Collection 10987-46).

Visitor safety, resource protection and effective law enforcement must continue to be a primary management concern. However, the current strict control of public access to the San Cristóbal Outworks parcel is a leftover practice from when this area housed U.S. Army officers and their families. Its continuation currently prevents this area from fully serving residents of San Juan and also visitors from around the world (Figure 5.3).

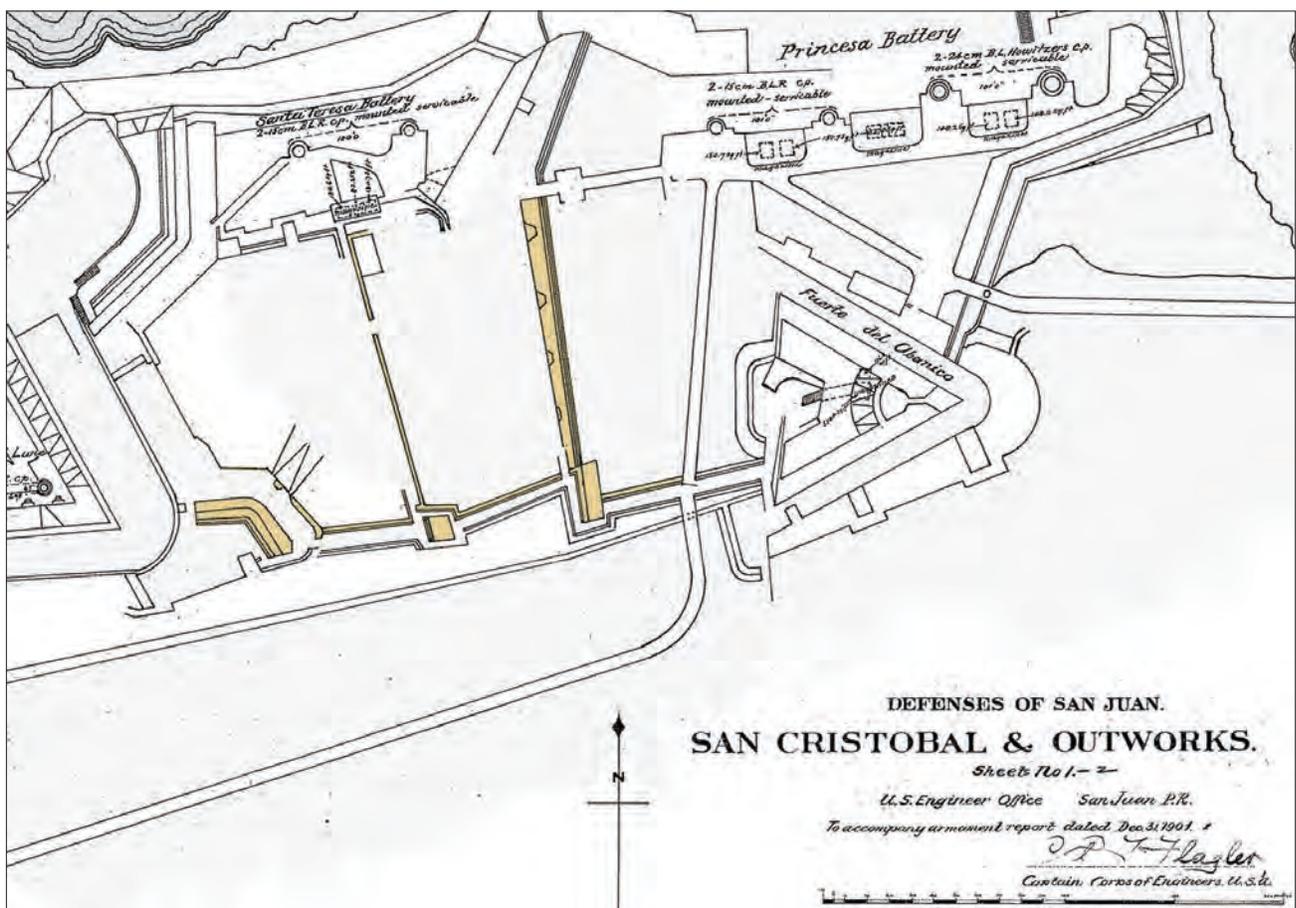
Figure 5.8: Detail of 1901 Flagler Plan, highlighting the locations of missing 1st and 2nd Retirada defensive features. New visitor pathways should highlight these important missing features, (National Archives, Cartographic, Fortification Files).

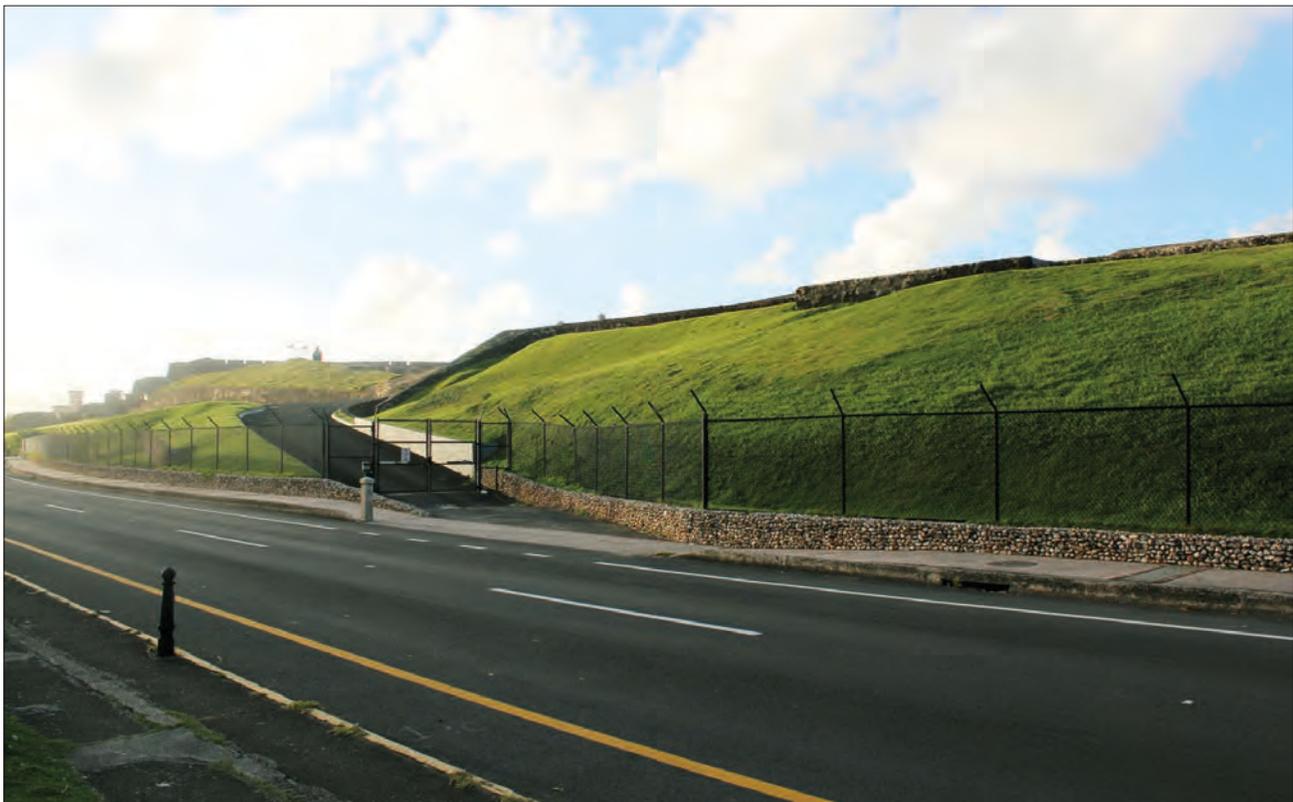
Figure 5.9: View north from Avenida Muñoz Rivera to the entrance of the San Cristóbal Outworks. The existing security fencing surrounding the San Cristóbal Outworks parcel presents an unwelcoming appearance, SAJU, 2012.

The existing safety and security fencing, topped with strands of barbed-wire, provides an unwelcoming first impression to visitors passing the Commonwealth Capitol and entering the old city of San Juan (Figure 5.9). Acknowledging the necessity for safety and security fencing here, a new design for this infrastructure should be implemented that satisfies safety and security requirements, while also creating a more positive impression on San Juan's visitors (Drawing 5.1 and 5.2). Doing so will provide the San Cristóbal Outworks parcel a greater civic presence and role in welcoming visitors to the old city. Prior to 1980, security fencing excluding unauthorized night-time to this area was partially concealed behind surviving defensive walls (Figure 5.10). Existing security fencing paralleling Avenida Muñoz Rivera and east of El Abanico should be replaced with barrier more compatible with the architecture of the historic fortifications (Figures 5.11 and 5.12).

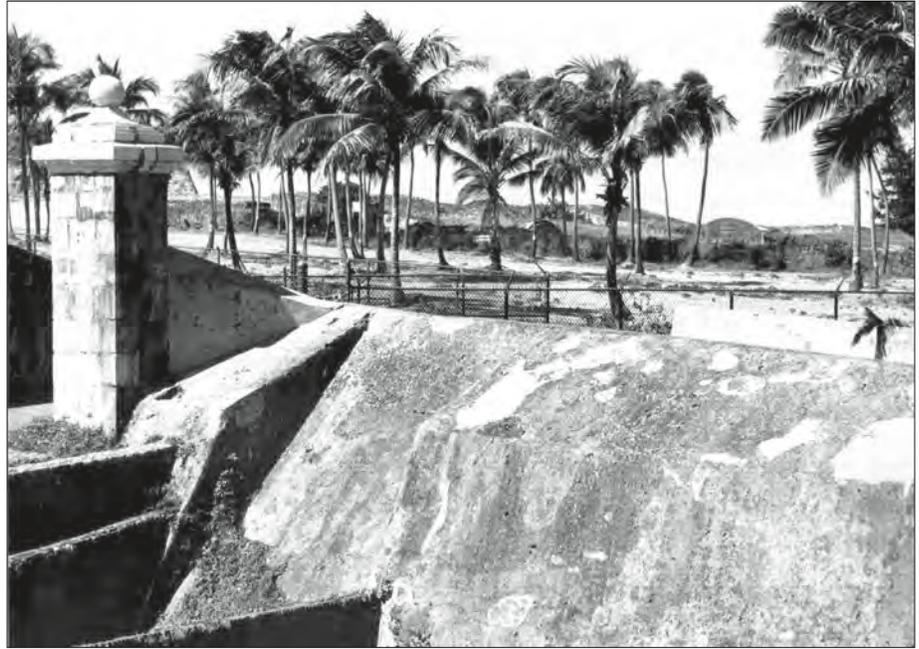
Figure 5.10: Prior to 1980, security fencing serving the former La Princesa housing development was located within the historic masonry walls surrounding the parcel, (SAJU Photograph Collection, c. 1981, 7519).

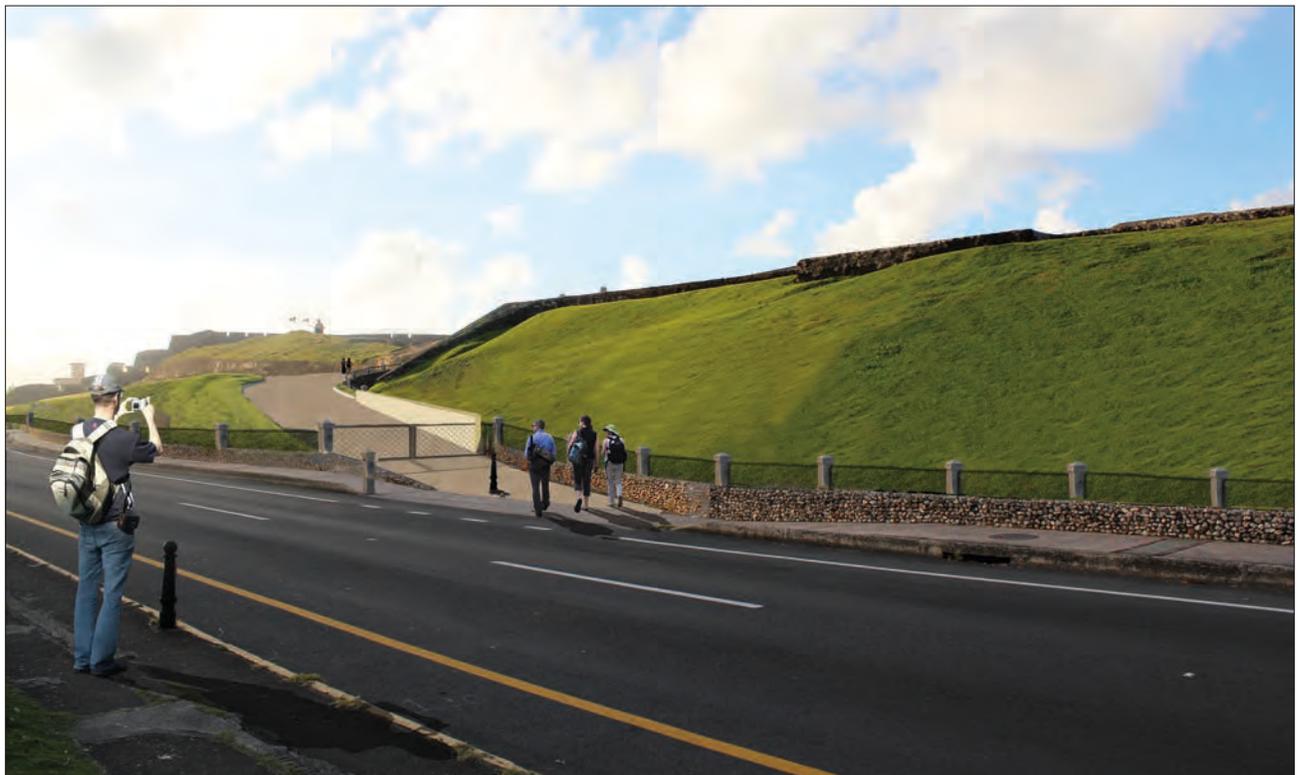
Figure 5.11: This photosimulation image illustrates the relocation of the existing security fencing to create a more welcoming appearance upon entering Old San Juan. The shorter railing shown simulated above is intended as a safety feature, discouraging visitors from climbing the engineered slope of the El Abanico Fort, (OCLP, 2013).

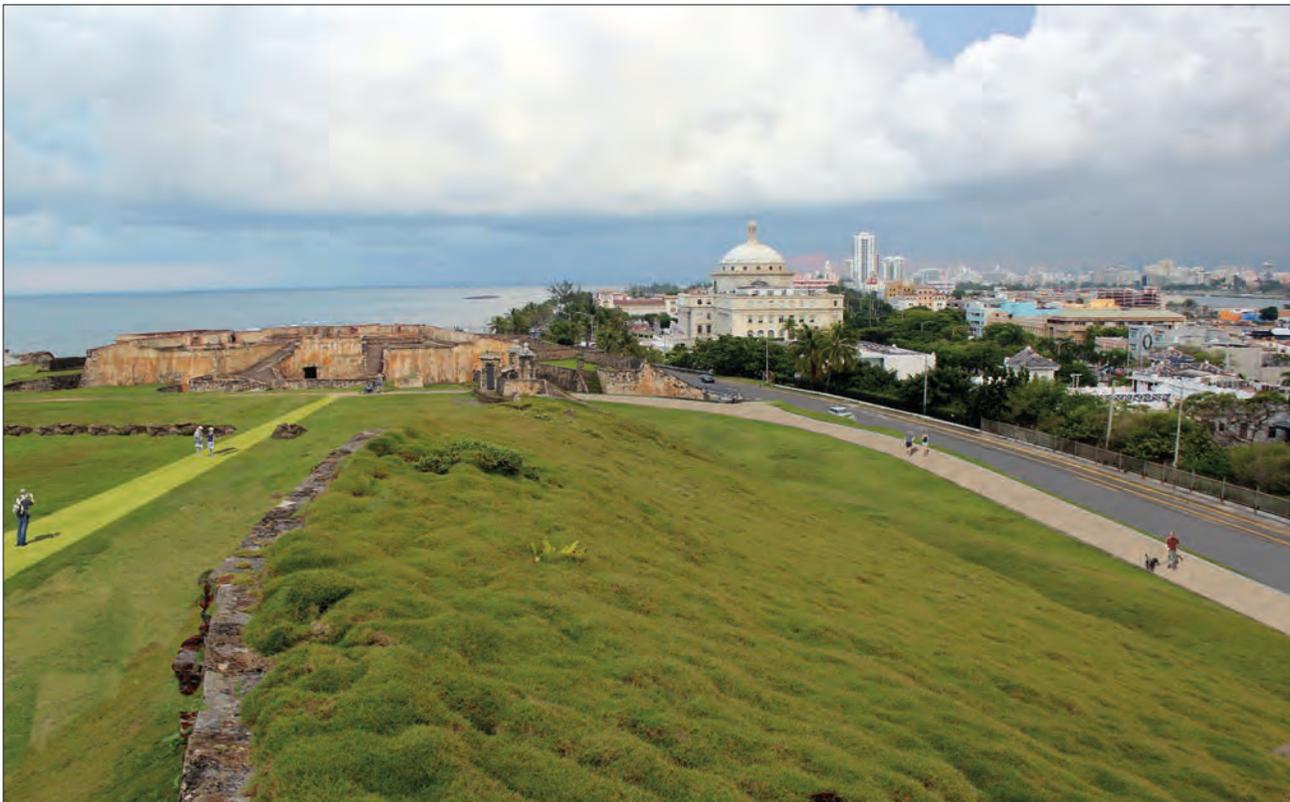
Figure 5.12: This photosimulation image illustrates the relocation of the existing security fencing away from Avenida Muñoz Rivera, creating a more welcoming appearance upon entering Old San Juan. The relocated security fence also marks the approximate location of the former "covered way," a missing defensive feature, (OCLP, 2013).

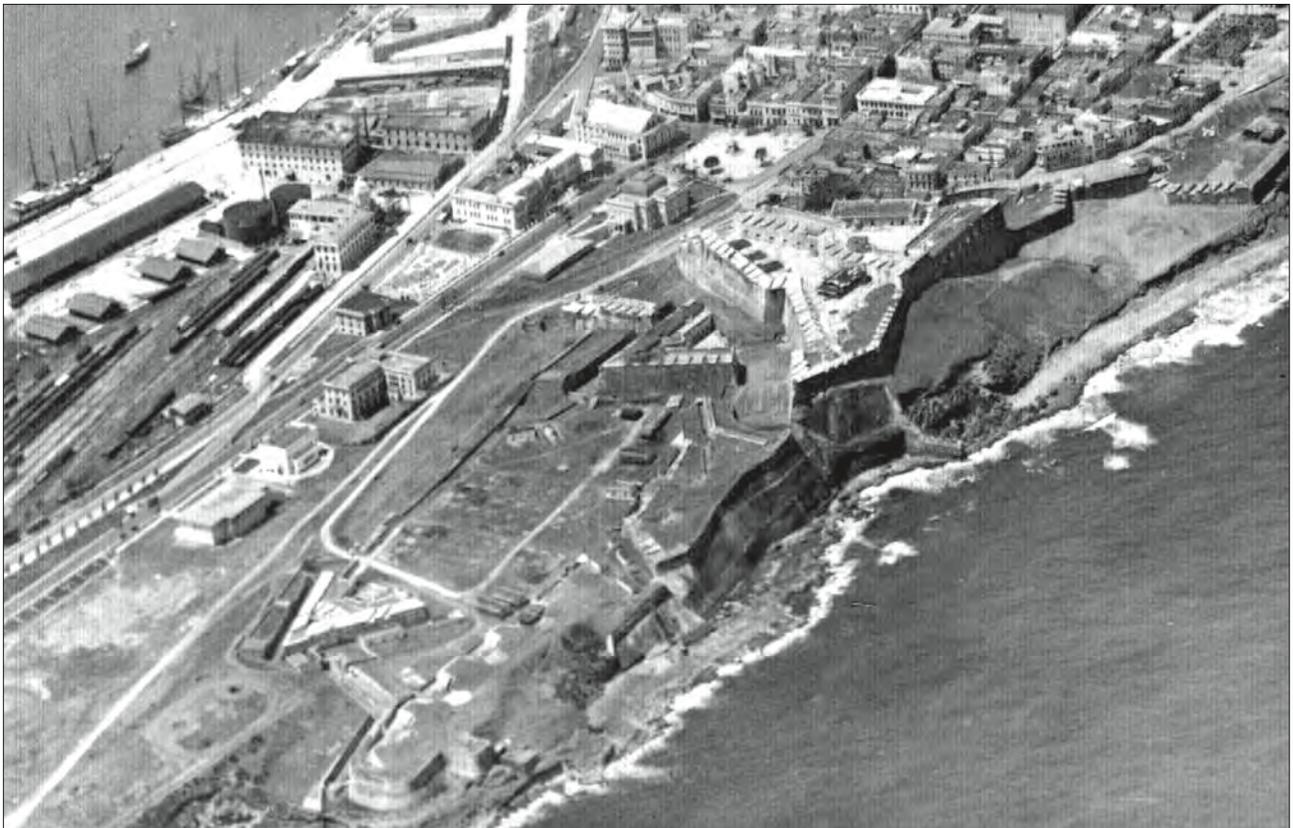
Figure 5.13: Oblique aerial view of San Cristóbal Outworks parcel during March of 1924. This image documents the survival of the 1st and 2nd Retirada features and the covered way well into the 20th century, (National Archives, RG126. PG Box 7 Folder 7a).

Site disturbance from both the 1930s construction and 1980s demolition of the Army’s La Princesa housing complex, has made it difficult to provide effective interpretation of the Outworks defensive system to park visitors (Figure 5.13). Missing defensive features, including the first and second Retiradas, and the missing Covered Way, should be economically marked with materials and methods causing minimal ground disturbance (Drawing 5.1).

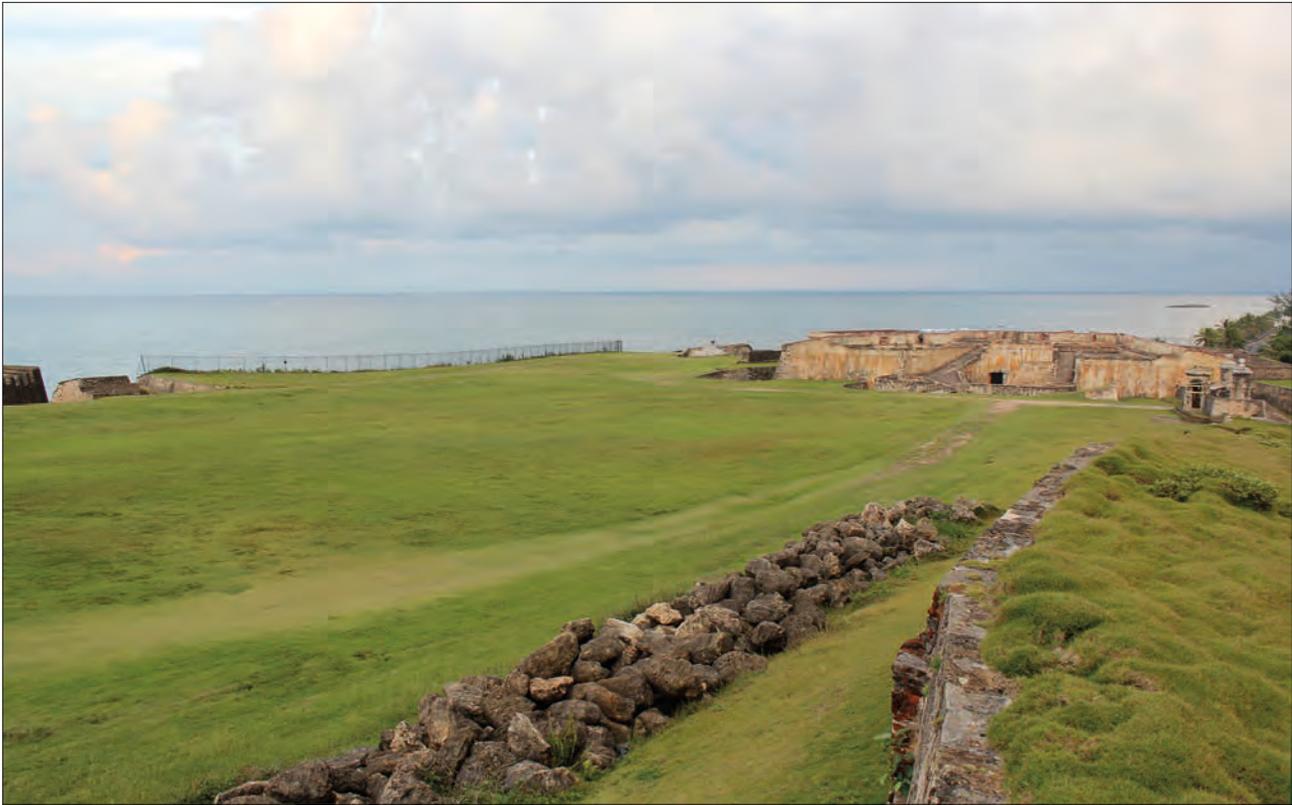
Figure 5.14: View northeast to the La Princesa battery and the El Abanico Fort. Stockpiled masonry materials are shown in the foreground, 2012 (SAJU).

The park masonry preservation program has found the San Cristóbal Outworks parcel a useful location for stockpiling masonry materials needed for the never-ending task of repairing San Juan's historic walls and fortifications (Figure 5.14). The San Cristóbal Outworks parcel may continue to meet this practical requirement of the park maintenance program and also fulfill interpretive objectives if this stockpiled masonry could be relocated and placed so as to mark the location of the first and second Retiradas. Doing so will cause no ground disturbance, and will actually accommodate a greater quantity of stockpiled masonry than is presently stored on site (Figure 5.15).

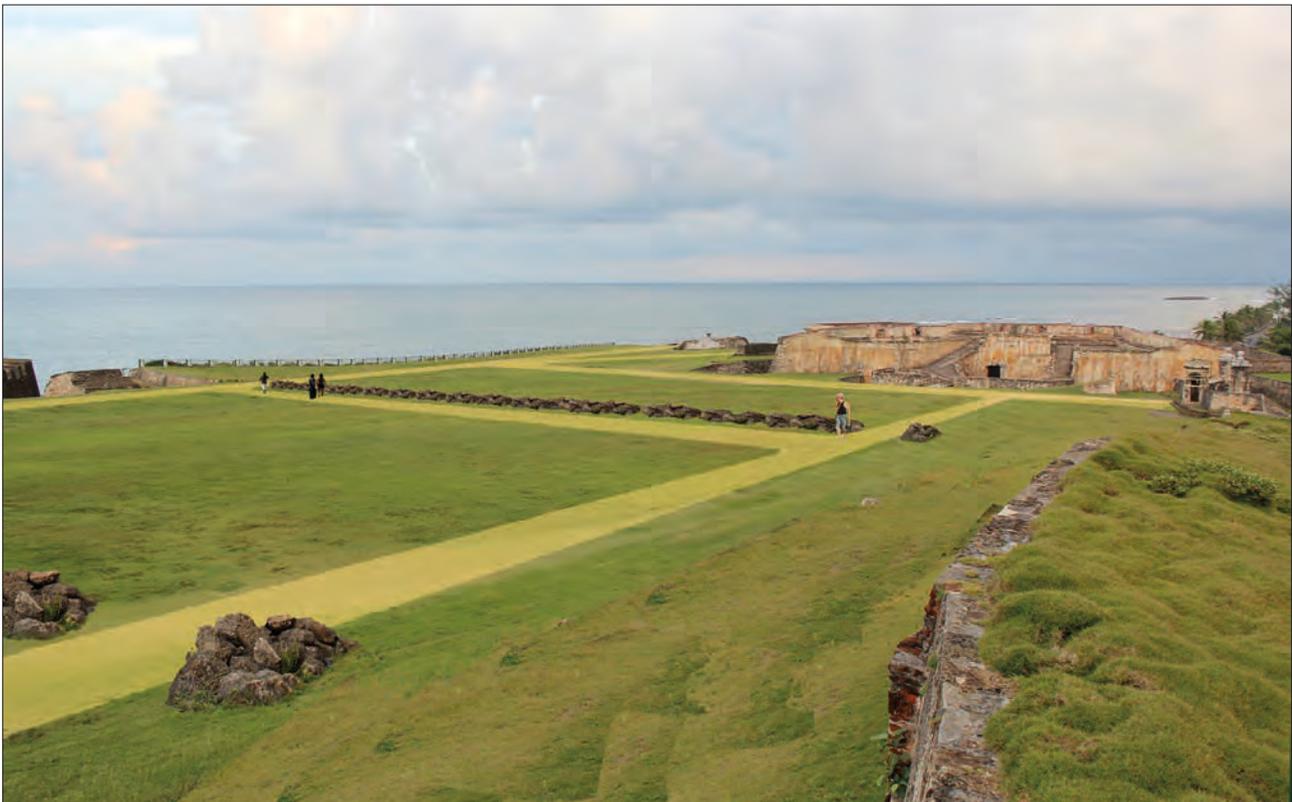
Figure 5.15: Photosimulation based on the prior image, illustrating Treatment Tasks 3 and 5. The portrayed visitor circulation system utilizes the alignment of the circulation system constructed in 1930 to serve the La Princesa housing complex. Missing defense features, including the 1<sup>st</sup> and 2<sup>nd</sup> Retiradas have been marked with relocated stockpiles of masonry, (OCLP, 2013).

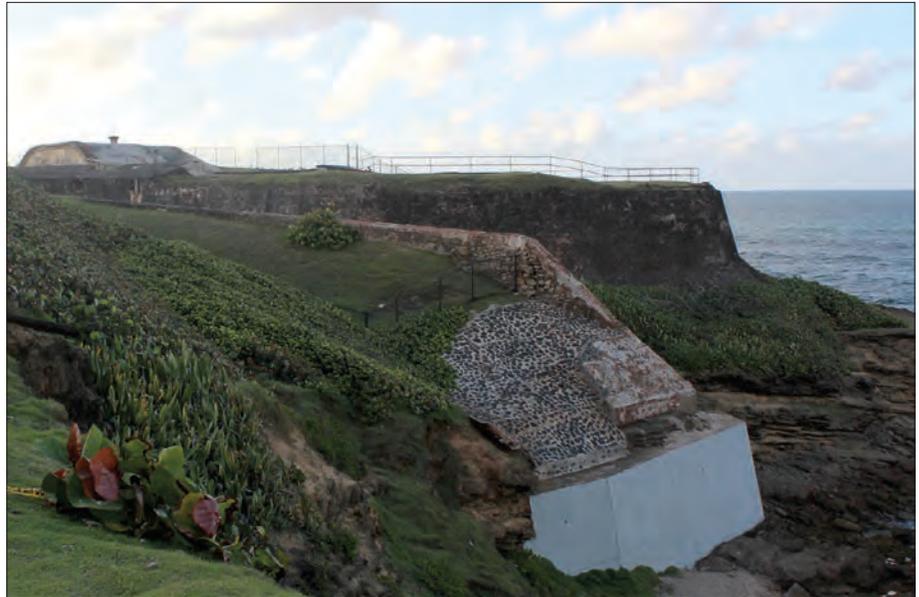
Figure 5.16: View west to the La Princesa battery, showing non-compliant safety railings, 2012 (SAJU).

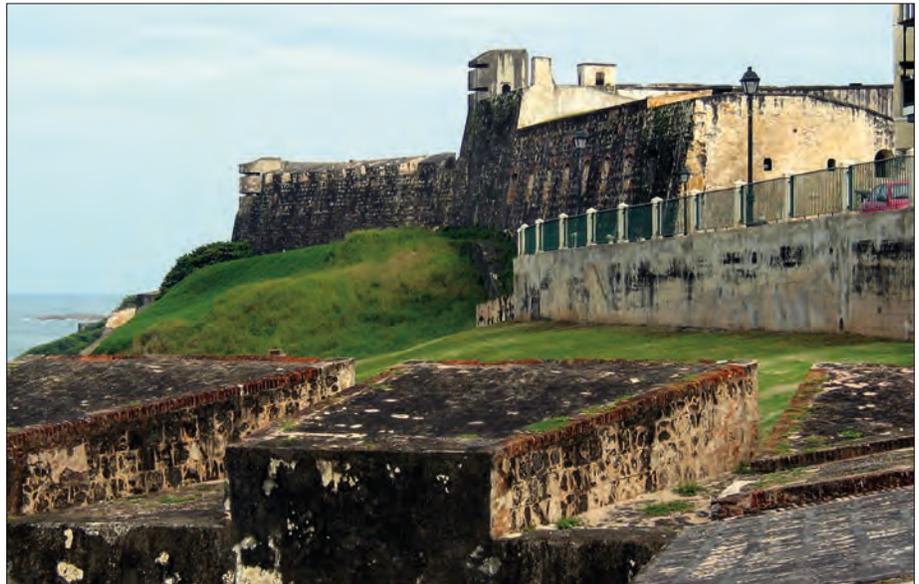
Figure 5.17: View east to the main entrance to the Castillo San Cristóbal showing an example of compliant safety railing infrastructure along Norzagaray Street, 2007 (SAJU).

Immediately west of the main entrance to the Castillo San Cristóbal on Calle Norzagaray, there is an appropriate example of code compliant safety railing that could be considered for adaptation and widespread application (Figure 5.17). In compliance with the spirit of the *Secretary of the Interior's Standards for the Preservation of Historic Properties*, this new infrastructure should not give the false impression as historic fabric. However, this new infrastructure should also show respect and compatibility with similar urban furnishings found nearby (Figure 5.18).

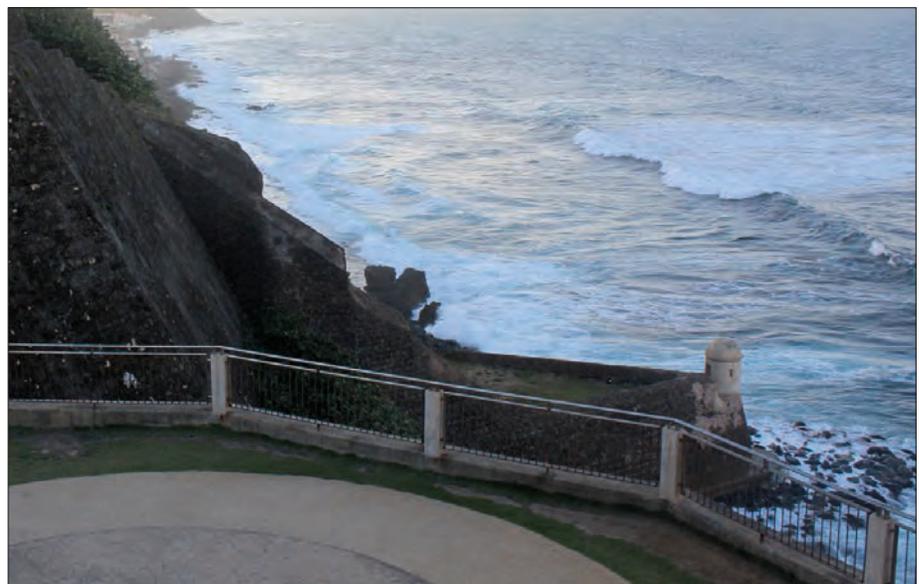
Figure 5.18: View west in San Cristóbal's Dry Moat where the park has recently installed code-compliant safety railing, 2012 (SAJU).

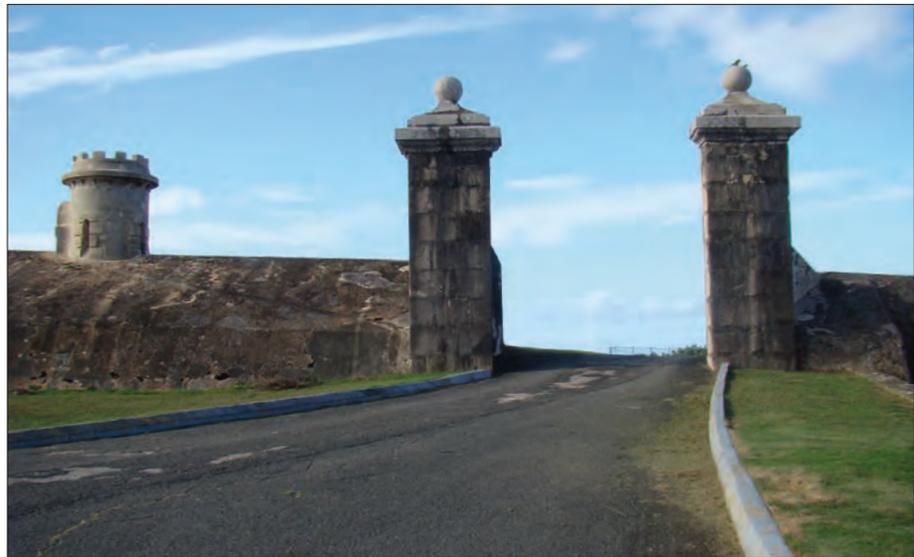
Figure 5.19: View north to the South Gate. Note the missing gate feature and deteriorated asphalt surface, 2015 (SAJU).

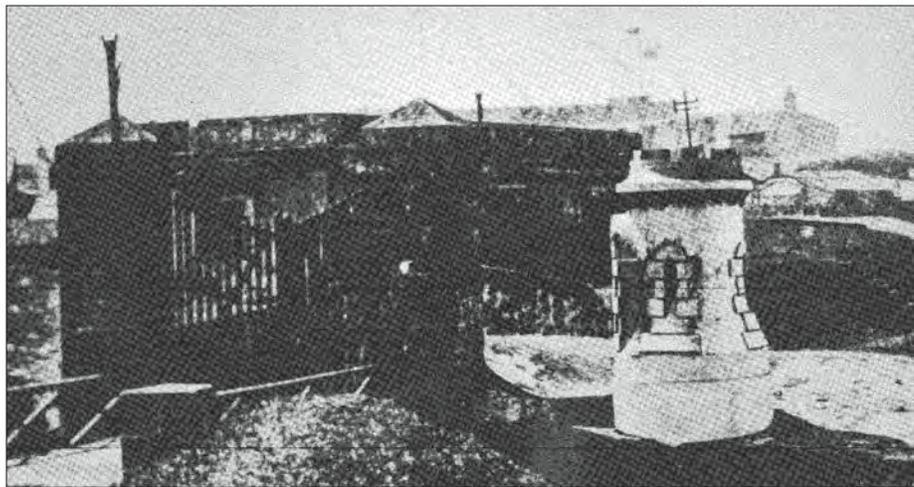
Figure 5.20: Detail of post-1904 photo of Northeast Gate looking west. Note the form of the wooden gate, (HSR Volume II, 474).

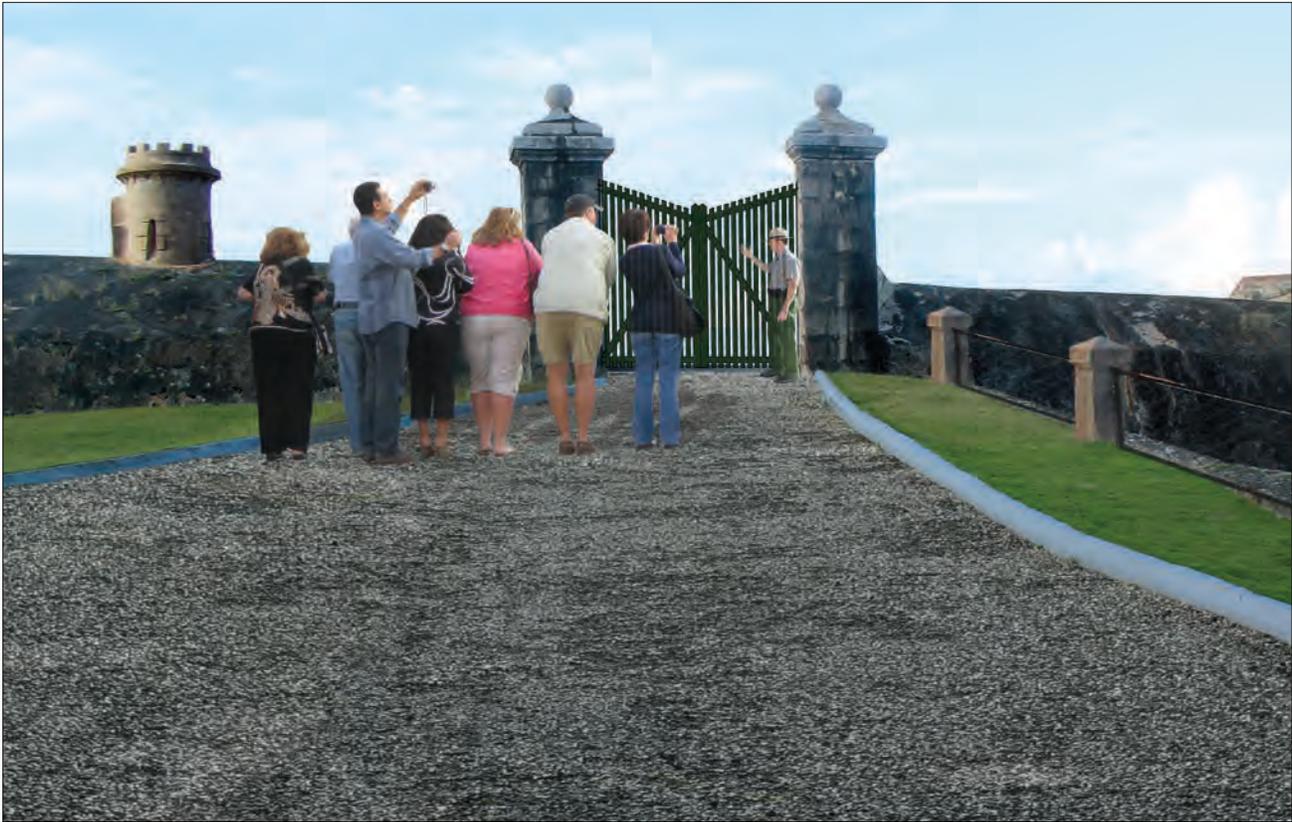
Figure 5.21: Photosimulation looking north toward the South Gate. Note the replacement wooden door within the South Gate, (OCLP 2015).

The details of the historic gates within the south and northeast entrance gate are not fully documented. An early 20<sup>th</sup> century photograph of the Northeast Gate appears in the Historic Structure Report prepared for San Juan's historic fortifications. This poor quality image indicates a wooden picket gate comprised of two leaves, suspended on stone pintels at ground level and leveled with a timber pintel let into the masonry piers (Figure 5.20). Using the historic photograph as an approximate guide, a historic architect and historic carpenter should be consulted to prepare shop drawings, select appropriate materials, and design and plan a

conservative construction methodology. Once the imposing security fencing along Avenida Muñoz Rivera has been replaced with a safety rail, as described in Task 4, the installation of the replacement wooden gates within the South Gate entrance will further enhance the entrance experience for visitors while providing an additional measure of security (Figure 5.21). Visitor safety, resource protection and effective law enforcement must continue to be a primary management concern.

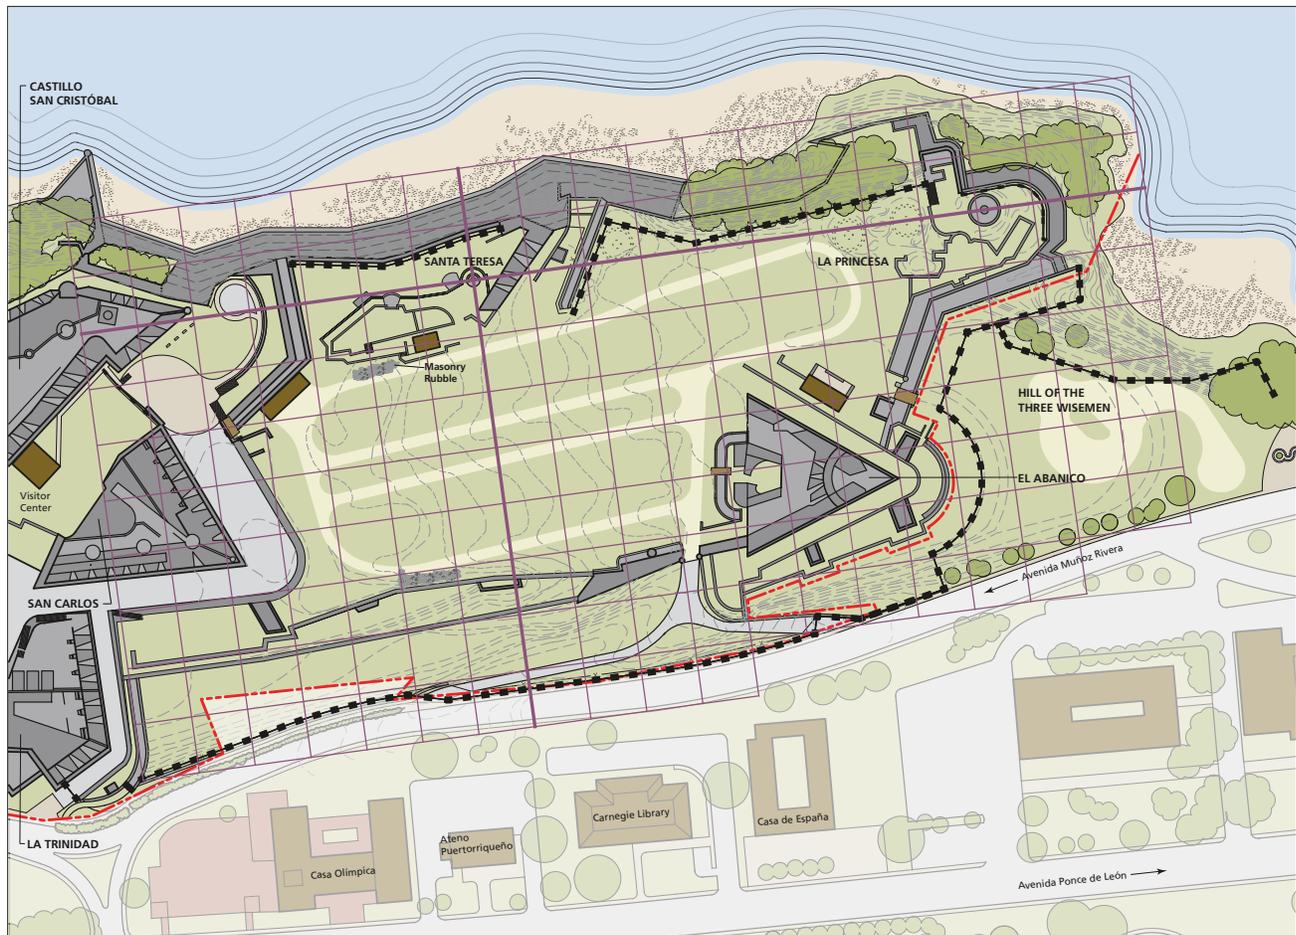
Figure 5.22: Diagram of example geophysics grid laid over existing conditions plan. The baseline of the x-axis is oriented on the center points of the Santa Teresa and La Princesa gun batteries. The y-axis originates at the center point of the Santa Teresa gun battery, (OCLP 2015).
