# Preservation/Restoration of Moton Field

## Phase II

Tuskegee Airmen  
National Historic Site  
Tuskegee, Alabama

*Historic Structure Report*  
*Army Supply Building*

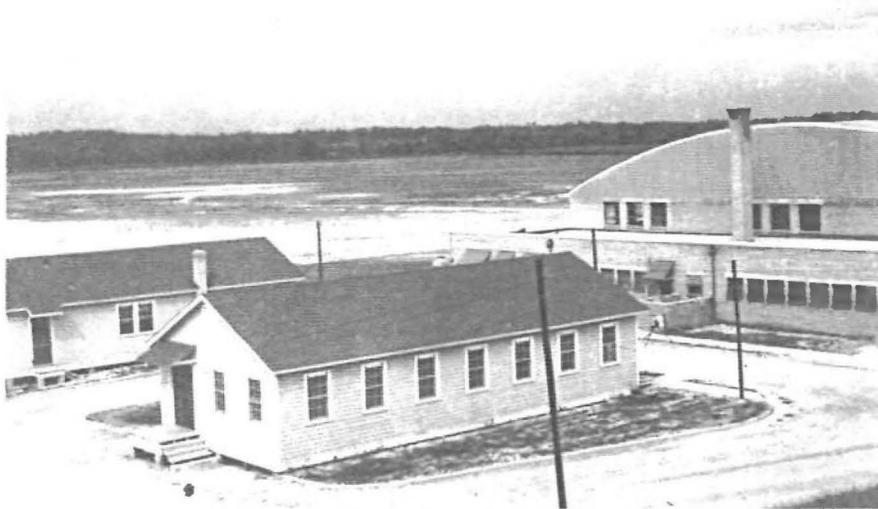
**Figure 2:** Historic photograph of the Army Supply Building (center foreground) behind Hangar Number One. Historic Photograph Collection, Howard University.

Based on historic photographs, the building was a one-story, frame, front-gabled structure set on a pier foundation. (See *Figure 2*.) The building was constructed west of Hangar Number One and adjacent to the similarly designed and constructed Flight Command Office/Cadet Class and Waiting Room. The Army Supply Building was constructed to provide storage space for military supplies needed for operation of the primary flying school. Historic photographs show that the exterior additions to the building proposed in the May

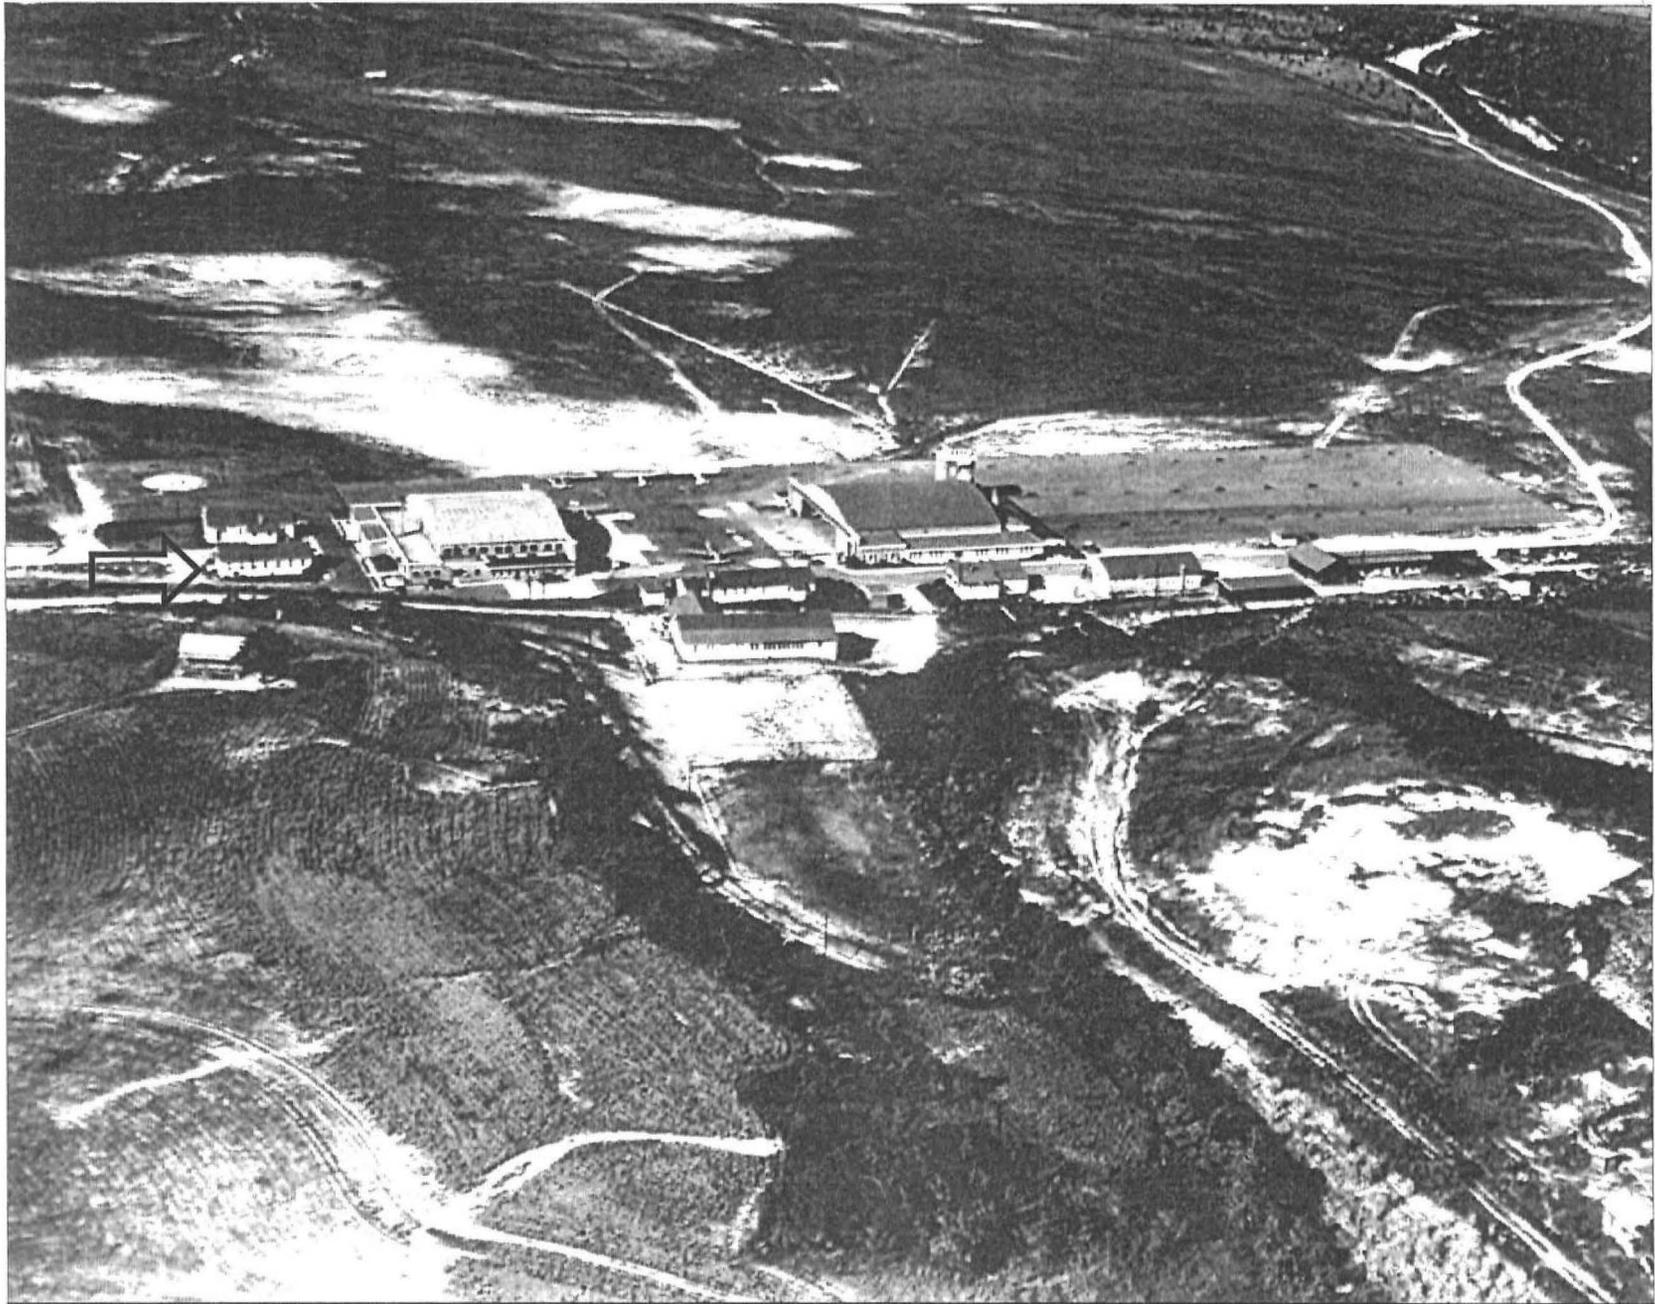
**Figure 3:** Circa 1945 aerial photograph of Moton Field showing the Army Supply Building west of Hangar Number One. Historic Photograph Collection, National Park Service Curatorial Storage Facility, Tuskegee Institute NHS.

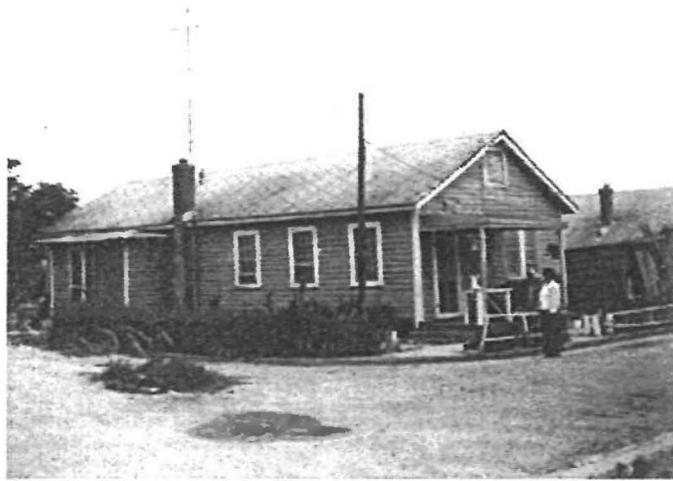
**Figure 4:** 1977 photograph of the east front and south side facades of the Army Supply Building. Booker Conley's Files, Physical Plant, Tuskegee University.

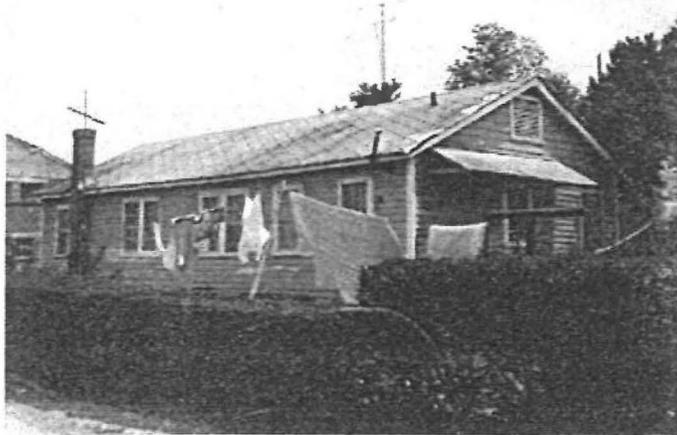
**Figure 5:** 1977 photograph of the west rear and north side facades of the Army Supply Building. Booker Conley's Files, Physical Plant, Tuskegee University.
