**NATIONAL REGISTER OF HISTORIC PLACES
INVENTORY -- NOMINATION FORM**

GREY COLUMNS

399 OLD MONTGOMERY ROAD

TUSKEGEE

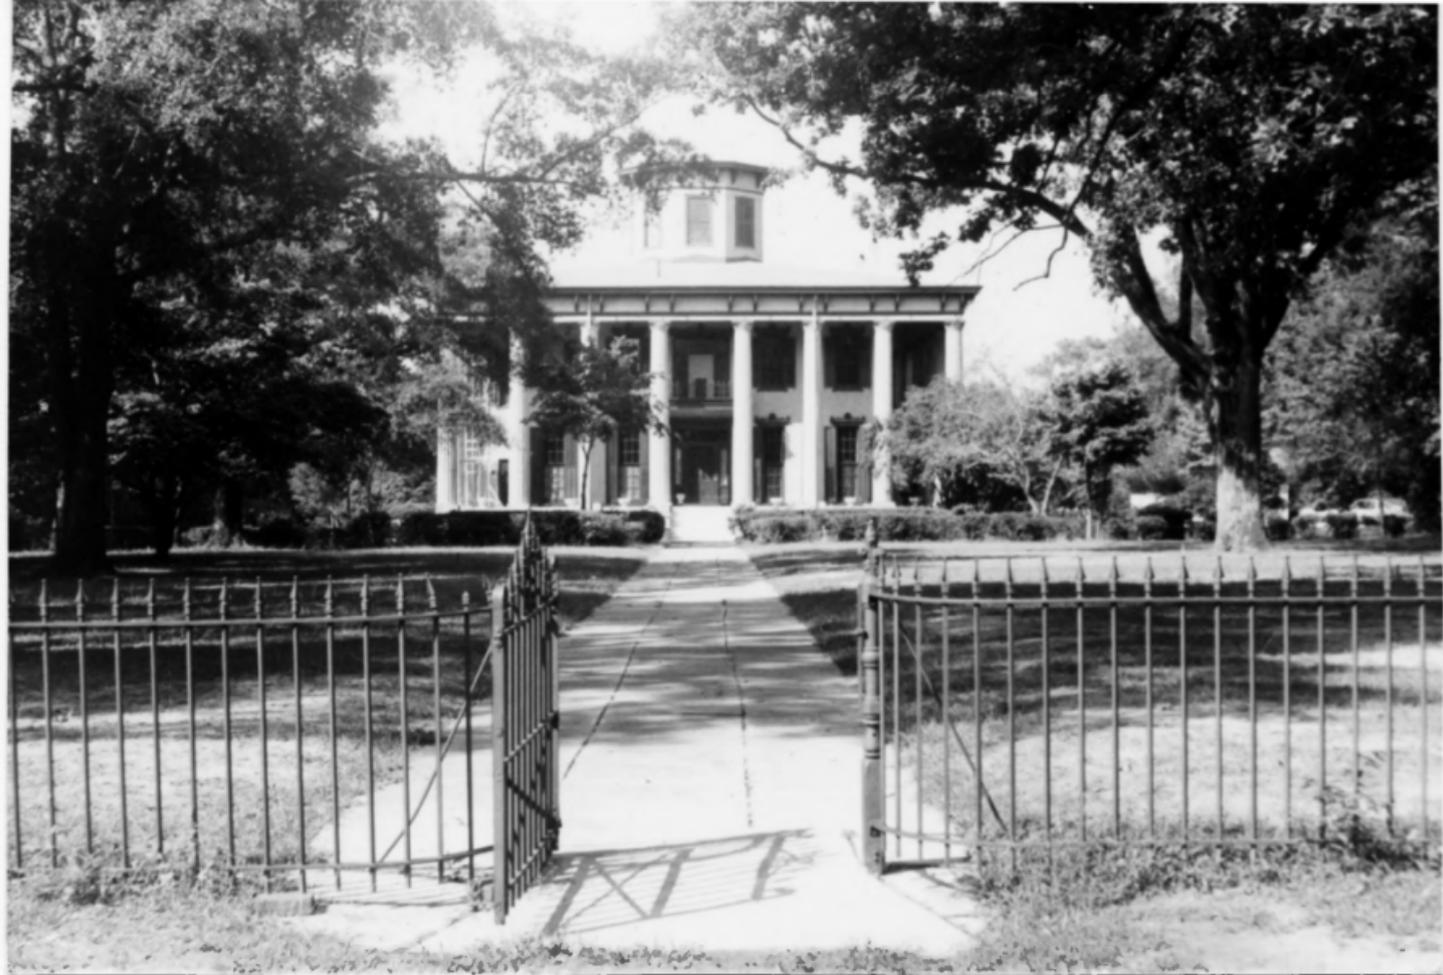
Macon County
Northeast Elevation - Main House
National Park Service, DSC, 1978

The original portion of the house is a two-story T-shaped building with a full Doric colonnade filling out the remaining three sides of the T into a square form. The roof is a shallow hip roof covered with asphalt shingle roofing. The historic roofing was standing seam metal. At the peak of the roof is an octagonal cupola with a hip roof and lightning rod on top of it. The main roof is pierced by six brick chimneys covered with stucco painted a cream color, two plumbing vent pipes, and two square metal ventilators. The chimneys were original unstuccoed and unpainted. The vent pipes were added around 1920 and 1950, respectively. The ventilators were probably installed around 1920. Both the main roof and the cupola roof have wide wood eaves with sawn Italianate-style brackets. There are eight metal downspouts (two on each side) running from the gutter to the ground. The downspouts facing the portico run outside the face of the columns. Two downspouts run down the south and west walls of the cupola.

There are four doorways leading to the main section. The northeast (front) wall has two doorways. The lower doorway is relatively fancy, having sidelights and transom, and is flanked by two wood Corinthian columns painted cream, supporting wood modillions for the balcony. The balcony has a cast iron railing. Opening onto the balcony during the historic period was a door flanked by two sidelights and having a transom. This door was replaced by a stuccoed frame wall flanked by two narrow doors and having a pressed, frosted glass transom when the adjacent room was converted for use as a bathroom, probably around 1920. The remaining two exterior doorways are found at the southwest ends of the side porticos. They are relatively simple, having only four-panel wood doors in masonry openings. Originally, there was also a rear (southwest) doorway having sidelights and transom. The door was replaced and the wooden stoop and steps removed around 1920 when the rear addition was constructed.

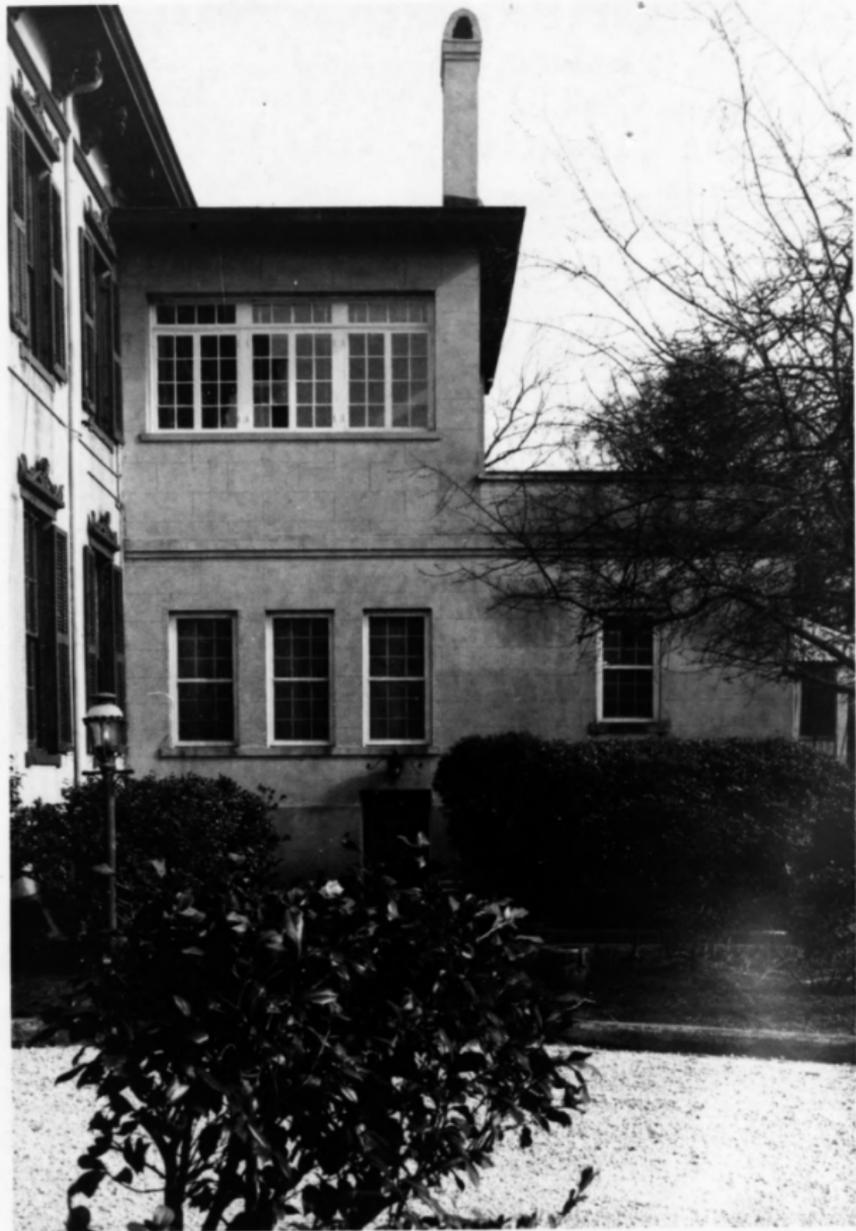
Northwest Elevation - Wing

The rear addition consists of a full first floor above a raised basement. At the second floor level is a smaller, glazed sleeping porch. At the southwest wall there is a small, enclosed porch reached by a flight of concrete steps from the northwest. The roof of the one-story section is a gable form enclosed within a parapet wall. It is covered with asphalt shingles, as is the truncated hip roof of the upper sleeping porch. The sleeping porch roof has wide wood eaves painted dark brown. Two stuccoed brick masonry chimneys rise from the southwest wall of the sleeping porch. The brick masonry walls of the addition are covered with stucco scored to resemble ashlar masonry. The stucco is unpainted in contrast with that of the main portion.

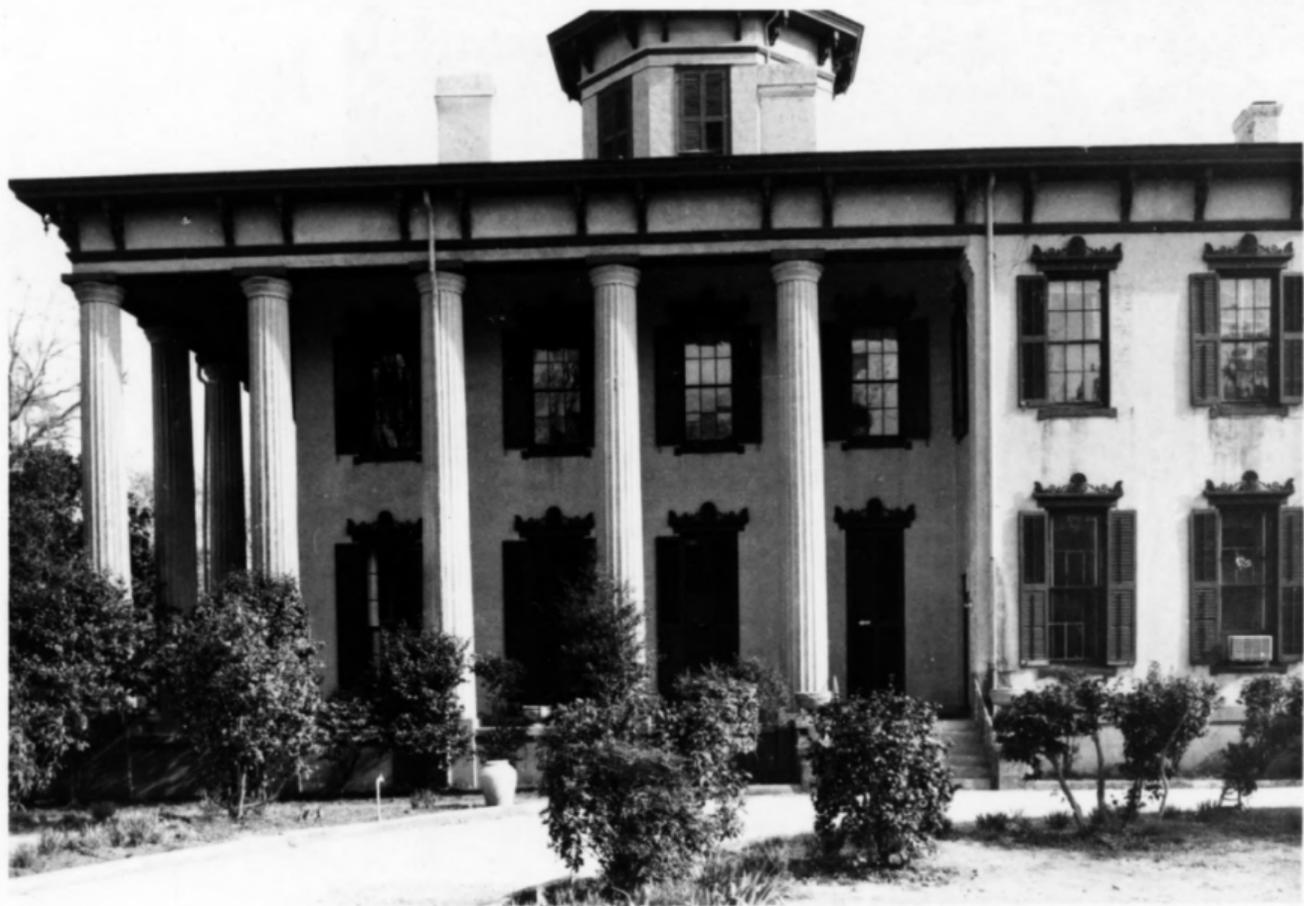
Grey Columns, 399 Old Montgomery Road
Tuskegee Institute National Historic Site
Tuskegee, Alabama
Macon County
Northwest Elevation - Main House
OCT 25 1979

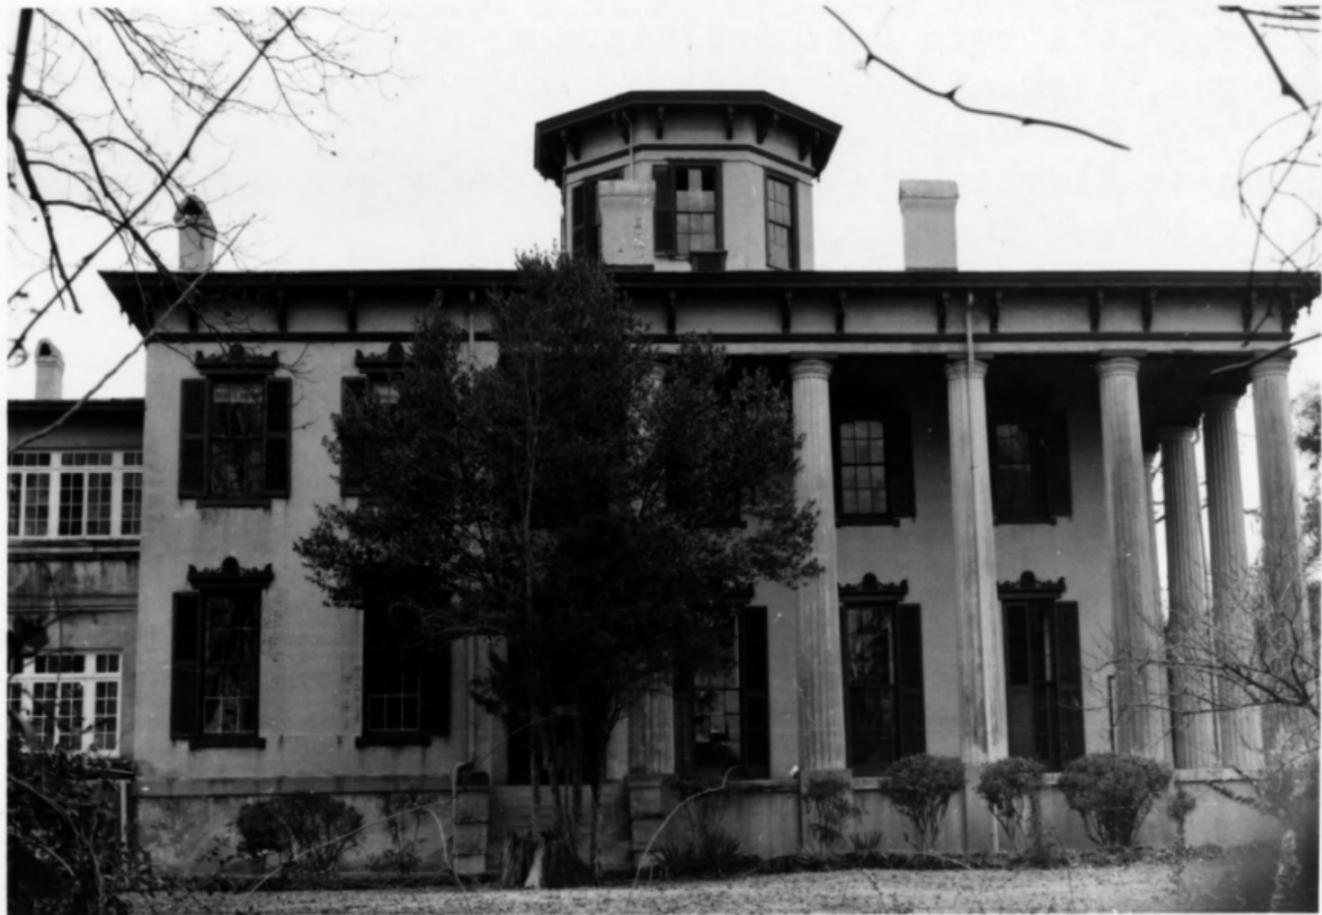
Southeast Elevation - Main House
National Park Service, DSC, 1978

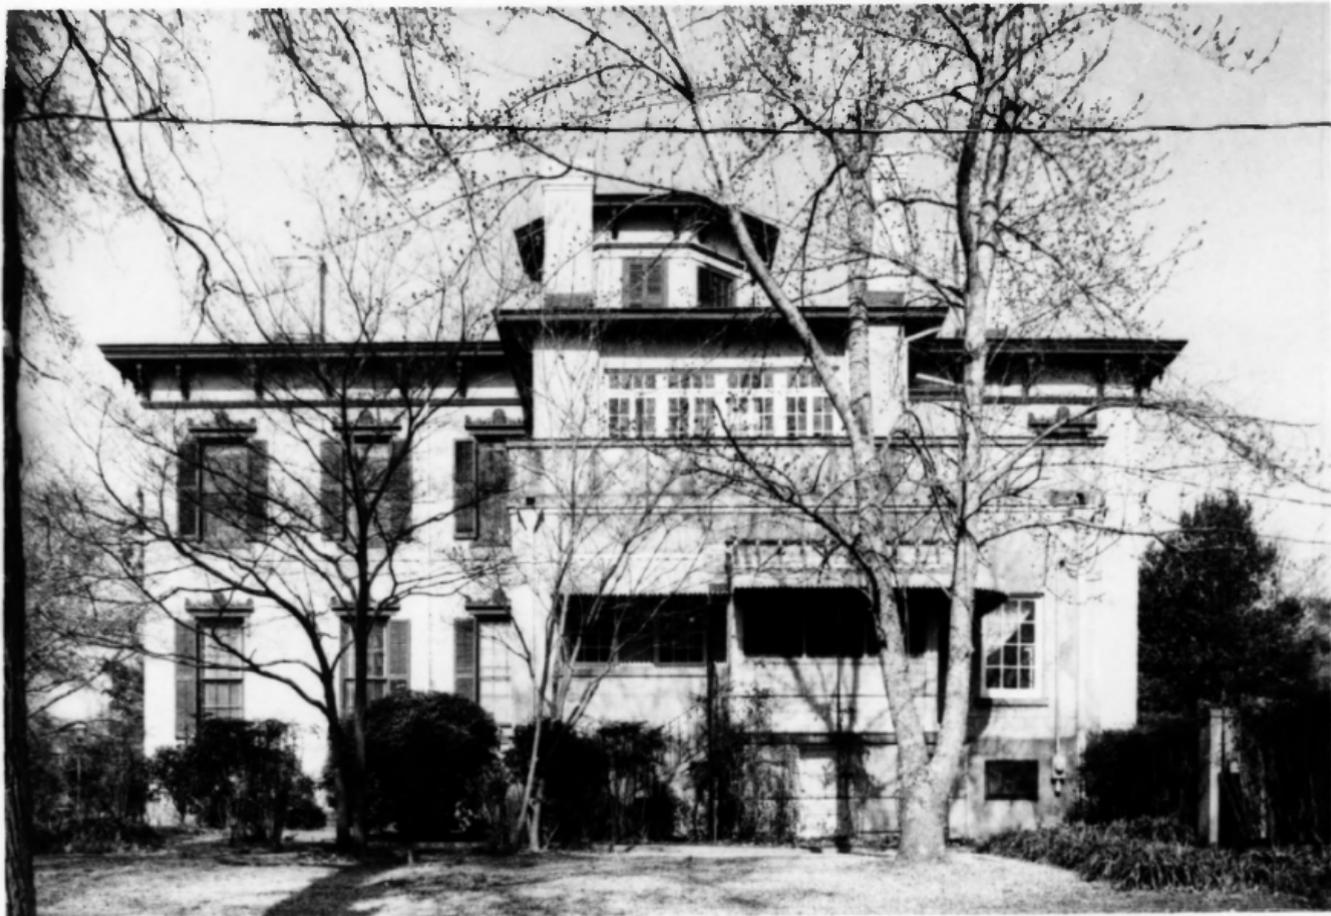
MacCormack OCT 25 1979
Southwest Elevation - Main House and Wing

At the intersection of the southeast addition wall and the southwest wall of the main section is a badly deteriorated greenhouse constructed in the 1950's. It has low, red brick masonry walls, a blue-green corrugated fiberglass gable roof, a french door flanked by two sidelights on its southeast side, and a window wall of two-over-two double-hung sash along its southwest elevation.

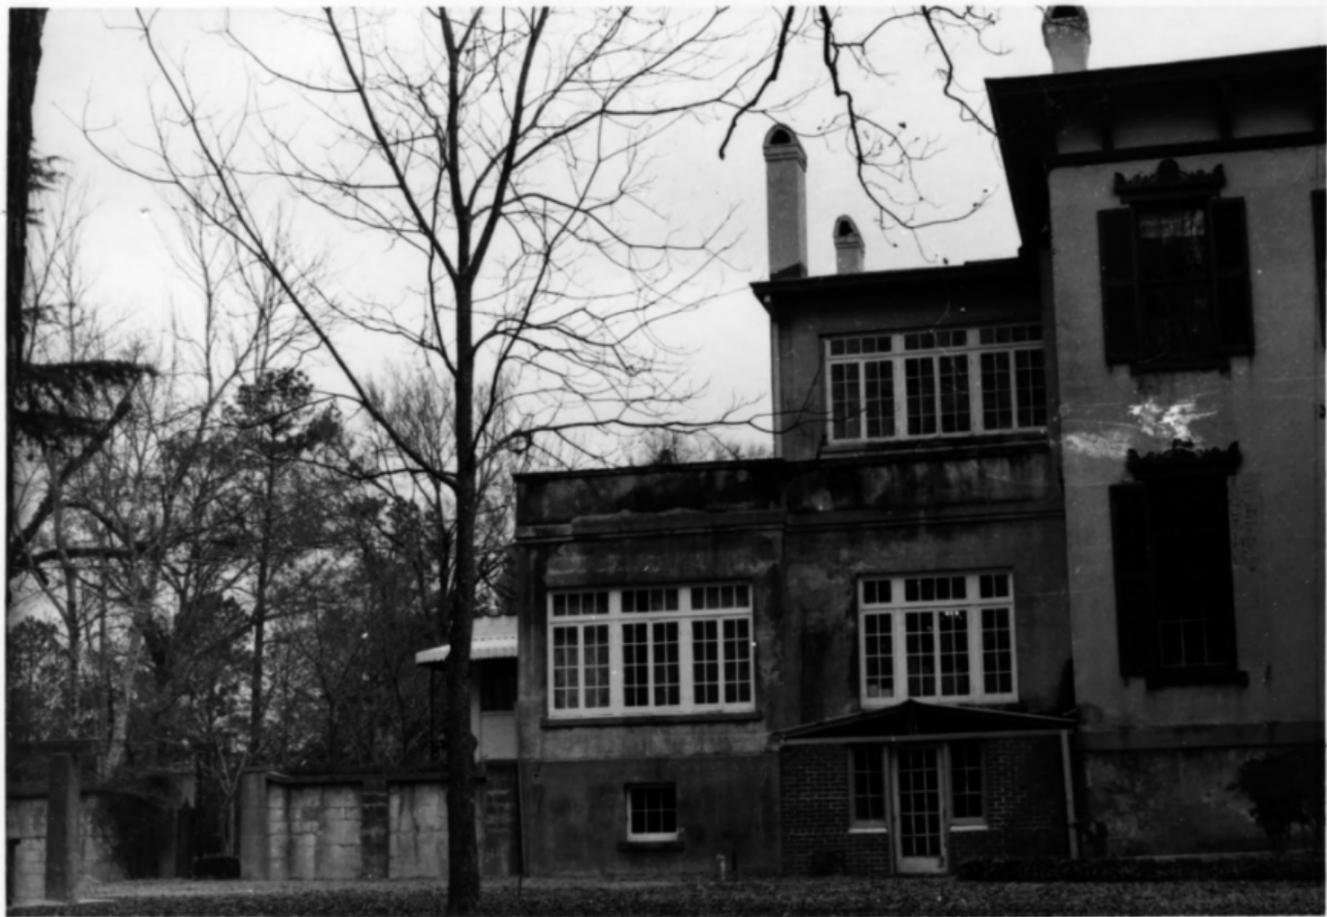
Macon County
Southeast Elevation - Wing **OCT 25 1979**
National Park Service, DSC, 1978

The windows of the addition are of numerous types. The most prominent consist of pairs of eight-light casement sash below four-light transom sash arranged either singly or in groupings. These are on the sleeping porch and the southeast side of the first floor. Nine-over-nine double-hung sash with exterior screens are on the northwest elevation and the northwest end of the southwest elevation of the first floor. There are six-light fixed sash at the southwest ends of the northwest and southeast walls. At the northeast end of the southeast wall is a pair of badly deteriorated cast iron Roman-style fixed sash. There is also a cast iron coal chute painted black at the southeast end of the southwest wall.
