**NATIONAL REGISTER OF HISTORIC PLACES  
INVENTORY -- NOMINATION FORM**

HISTORIC Mission San José de Tumacácori

AND/OR COMMON Tumacácori National Monument, Tumacácori Mission

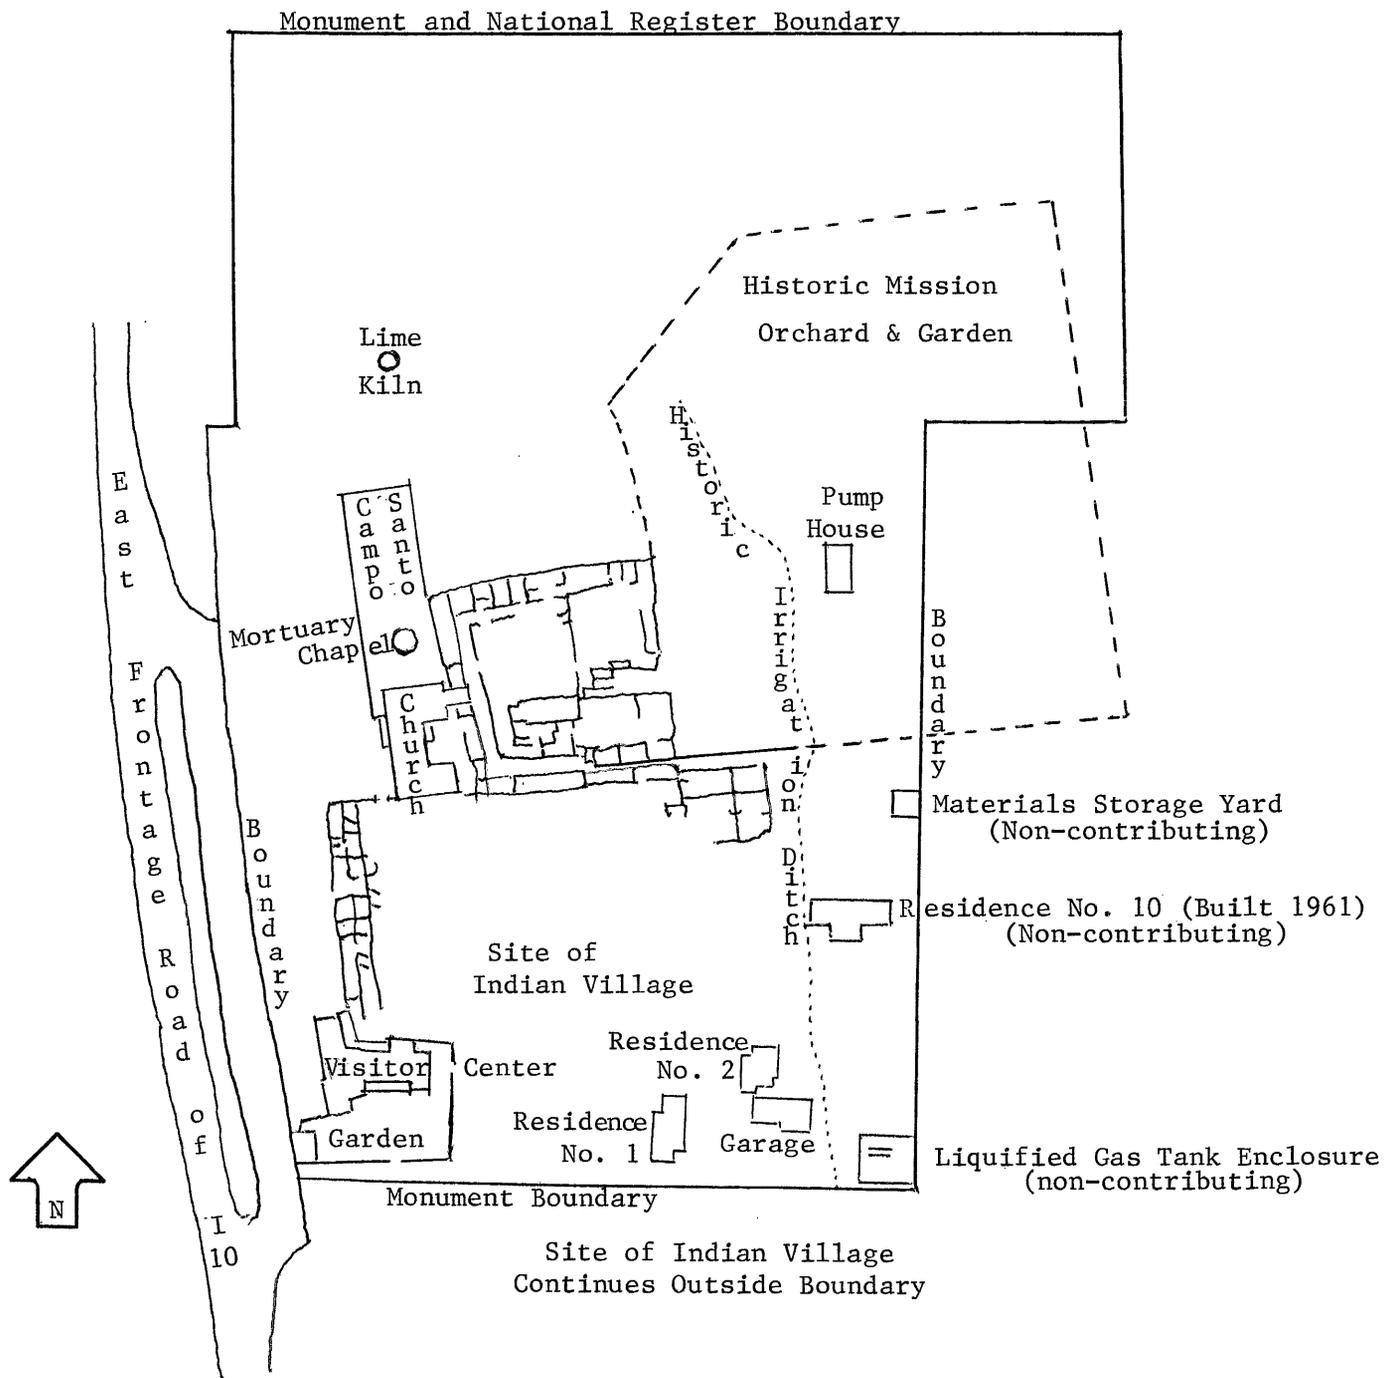
PLAN OF TUMACACORI NATIONAL MONUMENT  
 Tumacacori, Santa Cruz County, Arizona

Revision August 1986 of  
 plan by Ross R. Hopkins  
 August 1983; Revision by  
 Gordon Chappell

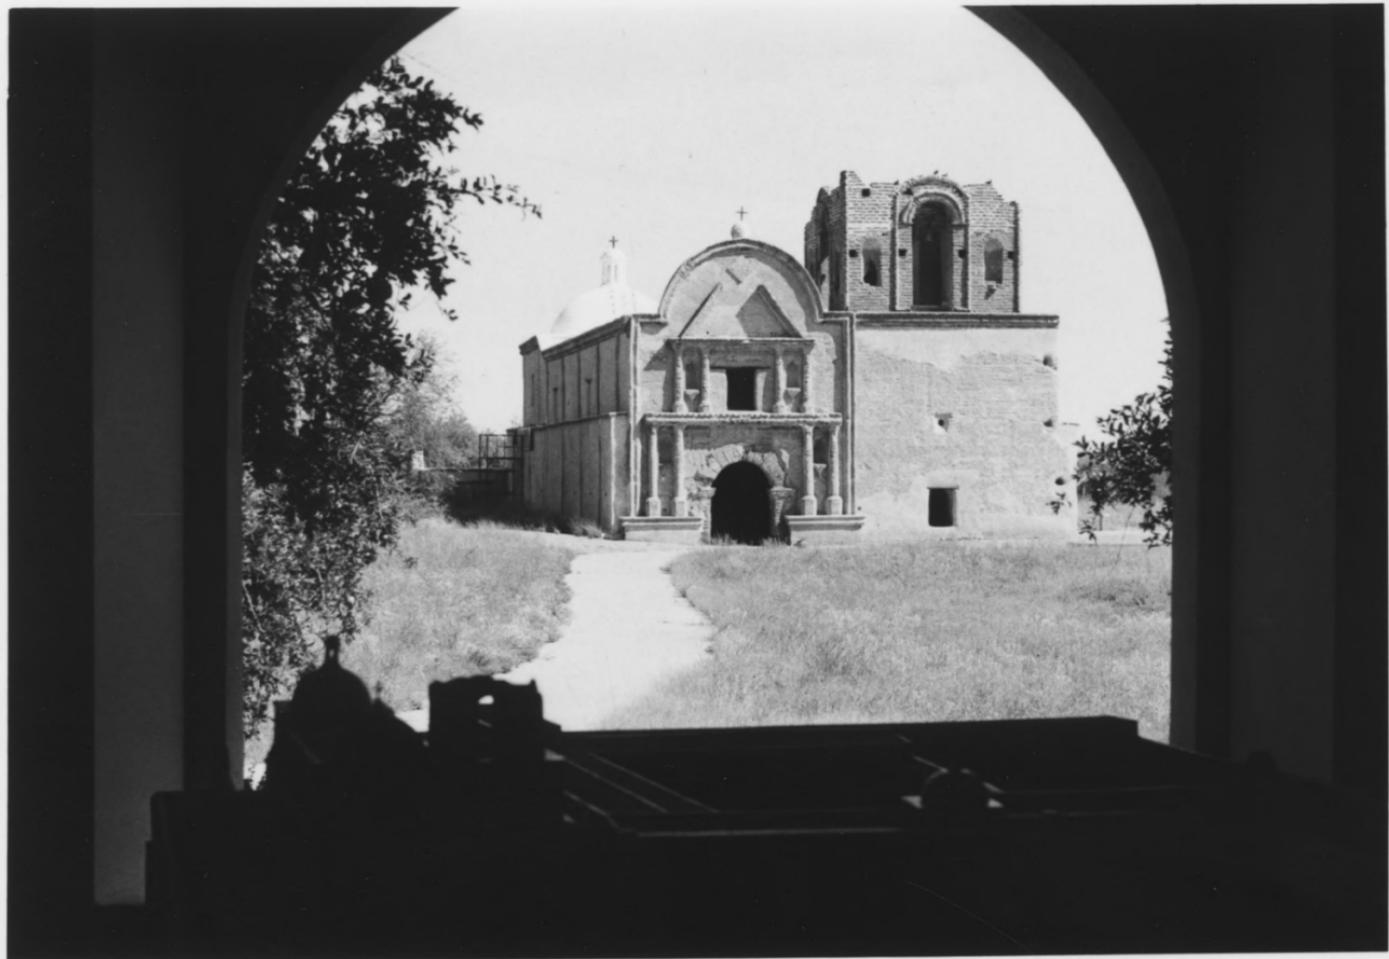
Photo No. 1 of 24

Tumacacori Mission from Visitors  
Center (with model of mission  
in the foreground)

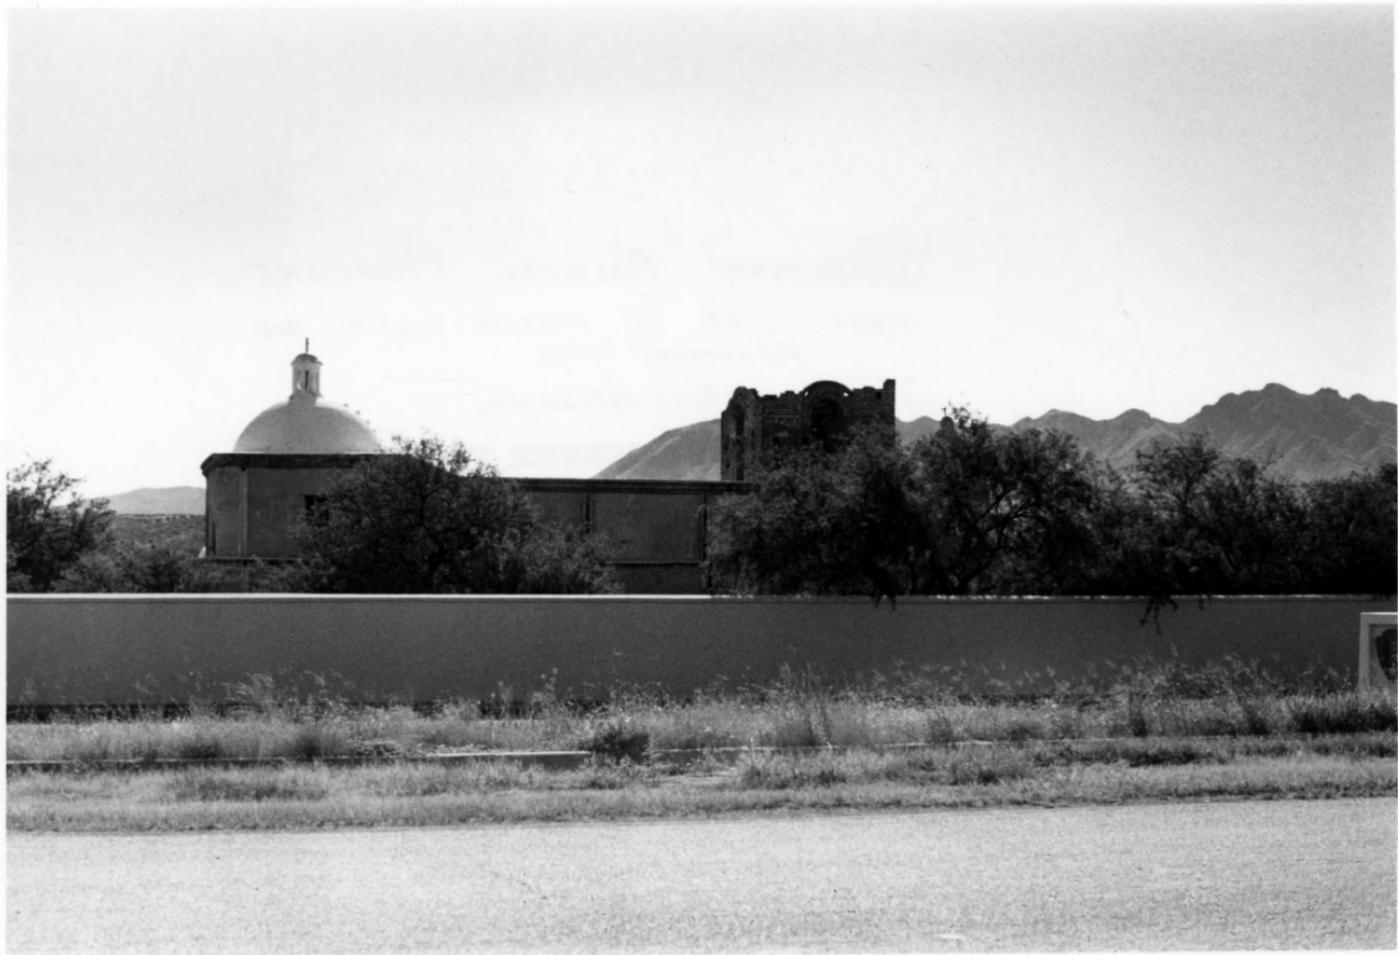
Photo No. 4 of 24

West side of mission church and Monument wall

View toward east

[Franciscan] Mission San José de Tumacácori - The largest, most important, and most imposing historic building in Tumacácori National Monument is the historic Franciscan mission church, construction of which began in 1799 or 1800 and continued intermittently until 1822 under a succession of Franciscan padres, primarily Friars Gutiérrez, Estelric and Liberós. In plan, the mission church is in the form of a large "[" with the long, vertical segment comprising the nave--the main part of the church which housed the congregation--with the altar at the top, or north end, and the sacristy extending to the east under its barrel-vault roof. Near the south end, or bottom, the baptistry, with the bell-tower above it, also extended to the east. The long, rectangular, rather narrow, two-story high nave of the church runs essentially north-south, and is without a transept. At the north end of the nave is the chancel, sheltering the altar, roofed with a dome, and featuring original decoration painted on its interior plaster. The nave itself is roofed with a beam and plank roof reconstructed in 1923 and replaced or renewed in 1947. At the south end of the nave, above the entrance, was a choir loft, supported by a brick arch, which was reached through the same stairway which reached the bell-tower. Today, the choir loft is gone, though traces of it may be seen on the walls. The three-story adobe brick bell-tower was designed to hold four bells, each in an arched opening, but the builders of the mission never finished the bell-tower, originally intended to be capped with a dome. They completed it only to a short distance above the bell arches. The nave has a modern tile floor. The walls of the church are thick and massive, of adobe (sun-fired) brick, and today are finished in a modern lime plaster. The walls were capped with fired brick to protect them from erosion by the elements. In building the walls, the workmen added adobe brick fragments or stones extending outward from the mortar between the adobe bricks to serve as a bonding device to hold the plaster finish coat on both interior and exterior surfaces. Where needed for foundation footings, rock was used. Wood framed door and window openings, except where the builders employed arches, for which they sometimes used fired brick rather than adobe. The facade on the south end of the church is decorated on both the first and second story levels with two pairs each of bas-relief doric columns, and above that an arched, raised parapet to accommodate a decorative broken pediment, which was restored in 1921.

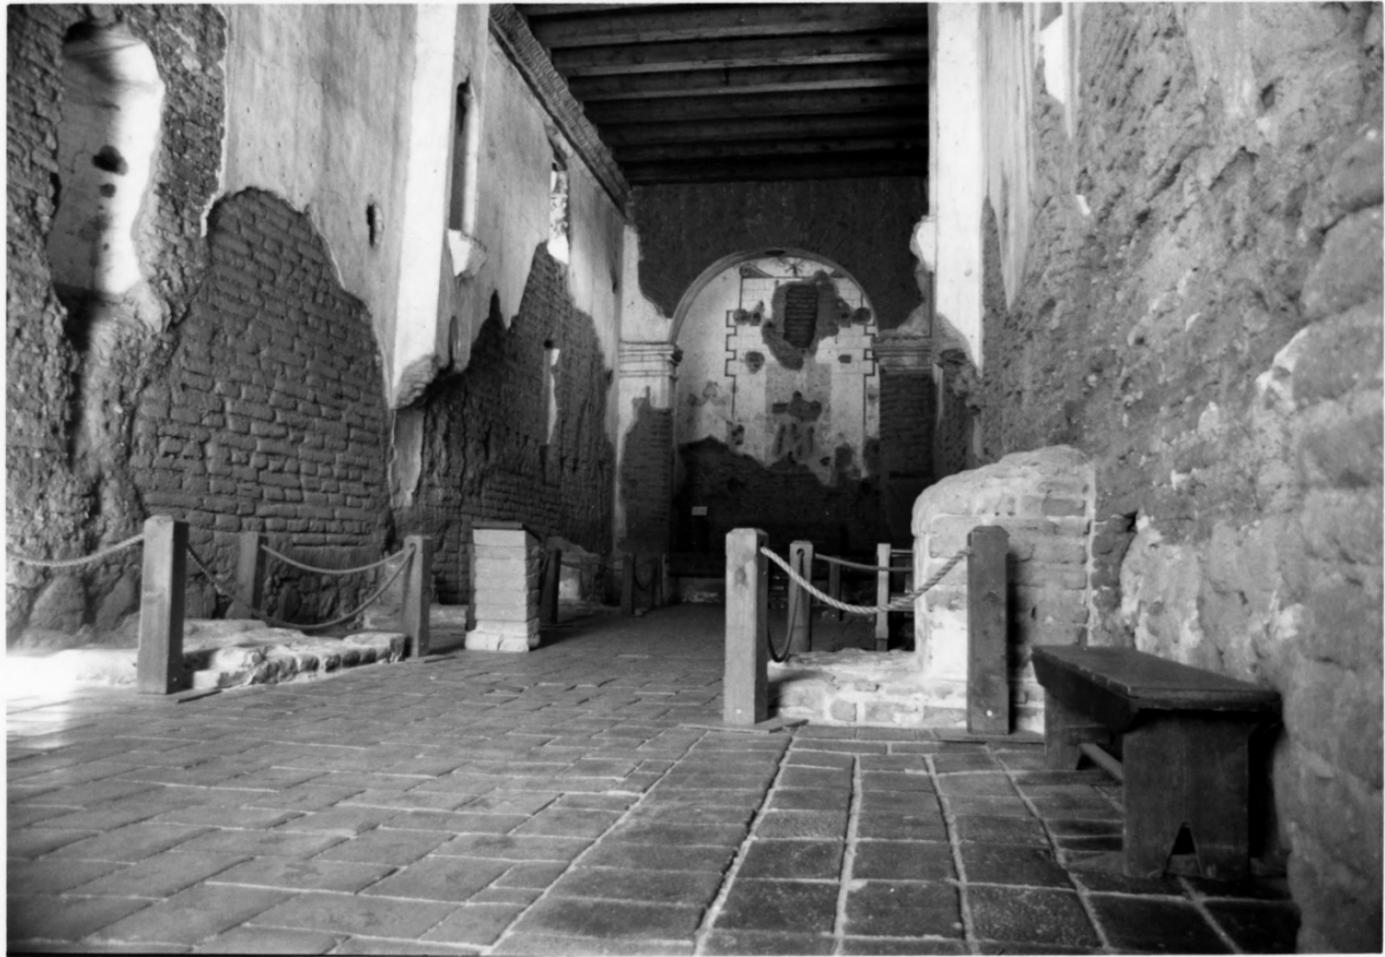
Photo No. 5 of 24

Nave of mission church from near entrance

View northward - note original painted  
decoration above altar

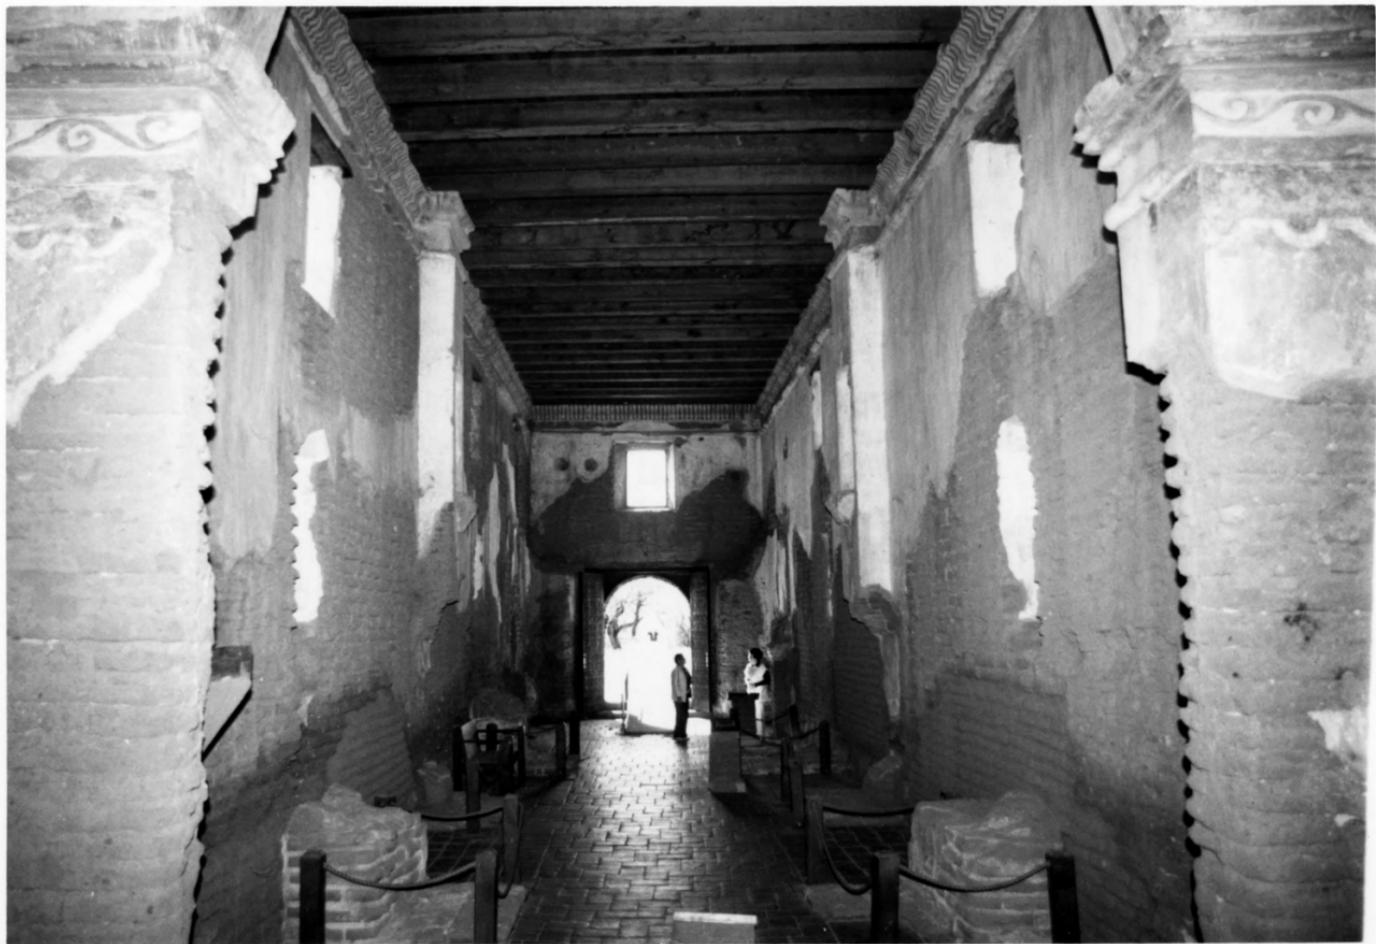
Photo No. 6 of 24

Nave of mission church from chancel

View southward

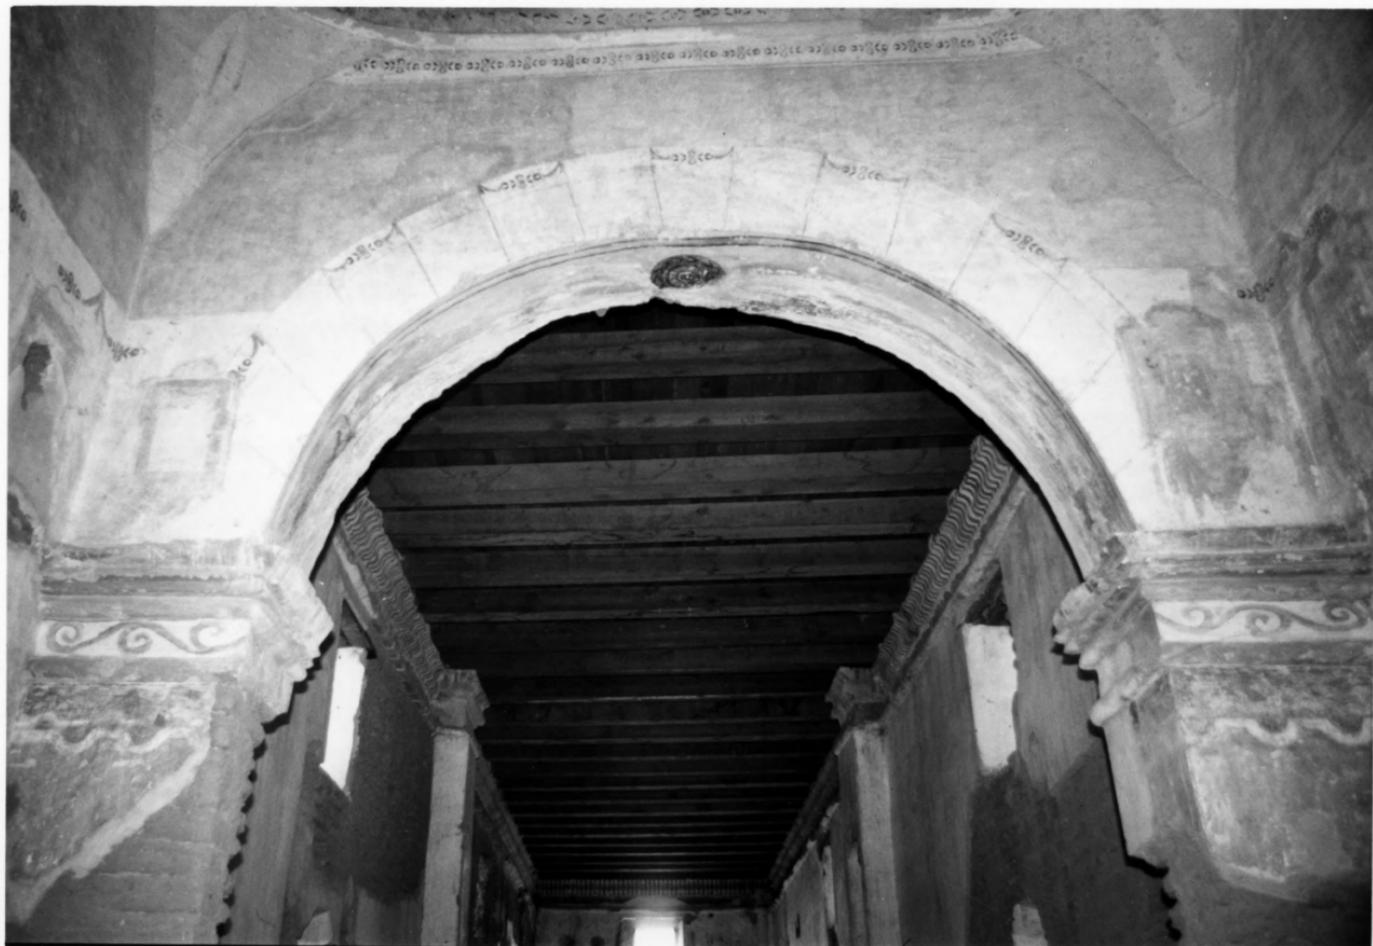
Photo No. 7 of 24

Arch between Chancel and Nave

View southward - note original painted  
decorations on plaster

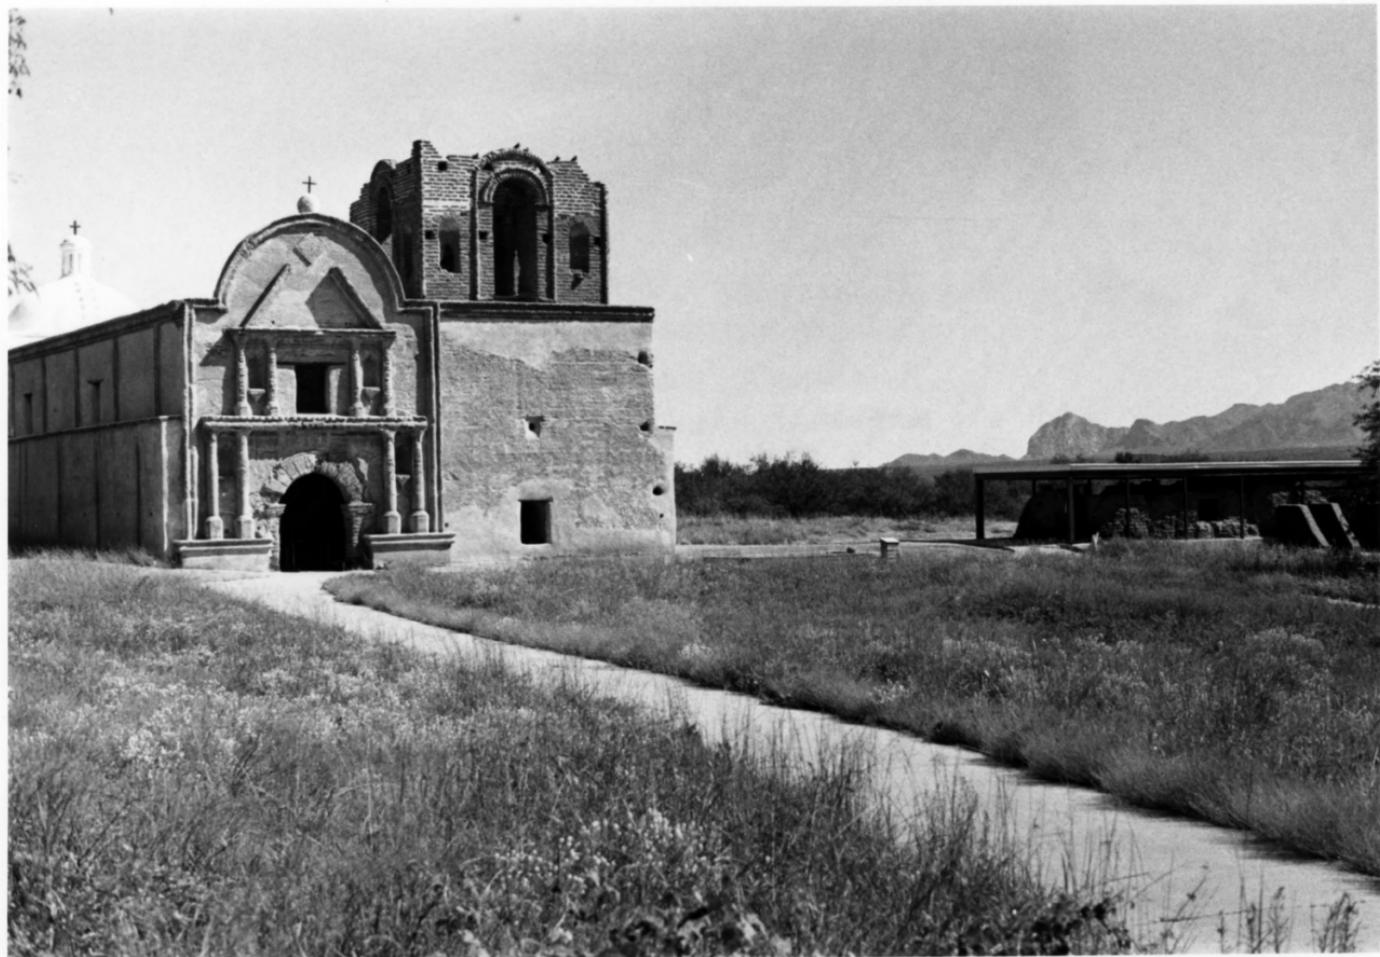
Photo No. 8 of 24

Franciscan Mission Church (left)  
and Convento (right)

View northeast toward the Santa Rita  
Mountains

Convento - The Convento was the residence for mission personnel. Actually, to the east of the mission church once stood a rather large complex of connected adobe structures, the exterior of which, in plan, forms a rather large square, containing a large number of rooms not all of which may have existed at any one time. Built of adobe bricks, all of this has been melted down by the rains into low adobe mounds, except for two segments the walls of which are largely intact. Although these today appear superficially as individual buildings, both once were part of this large connected complex of adobe rooms. East of and in alignment with the front wall of the bell tower of the church, with its axis running east-west, are the ruined walls of two rooms which were part of the residential quarters of mission personnel, the Convento. The surviving portion forms a rectangle whose longer axis is east-west.

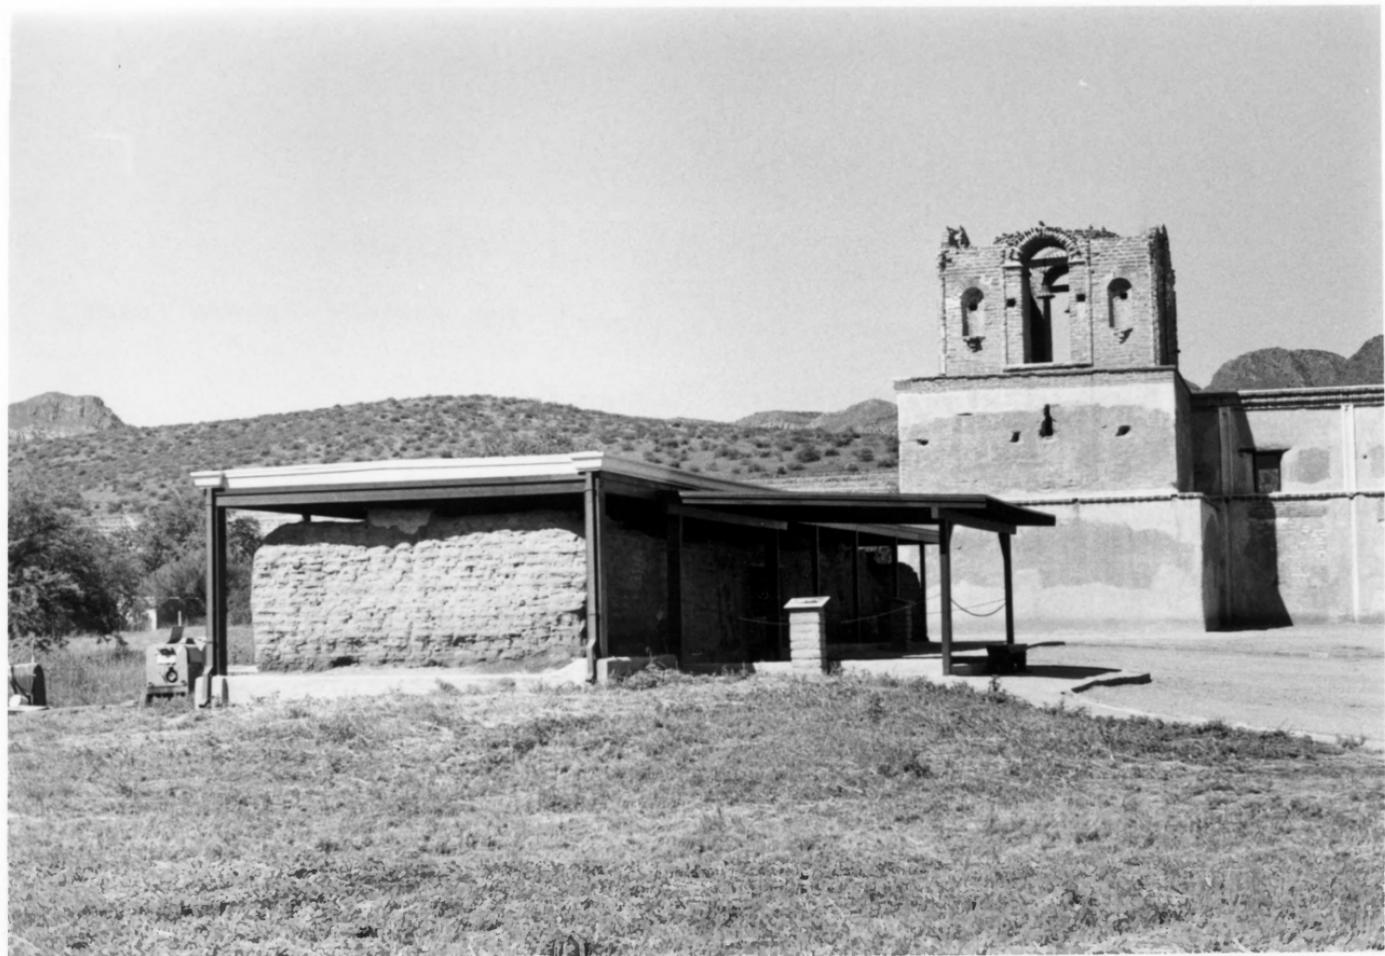
Photo No. 9 of 24

Convento ruins (left) and mission church  
(right)

View westward toward Tumacacori Mountains

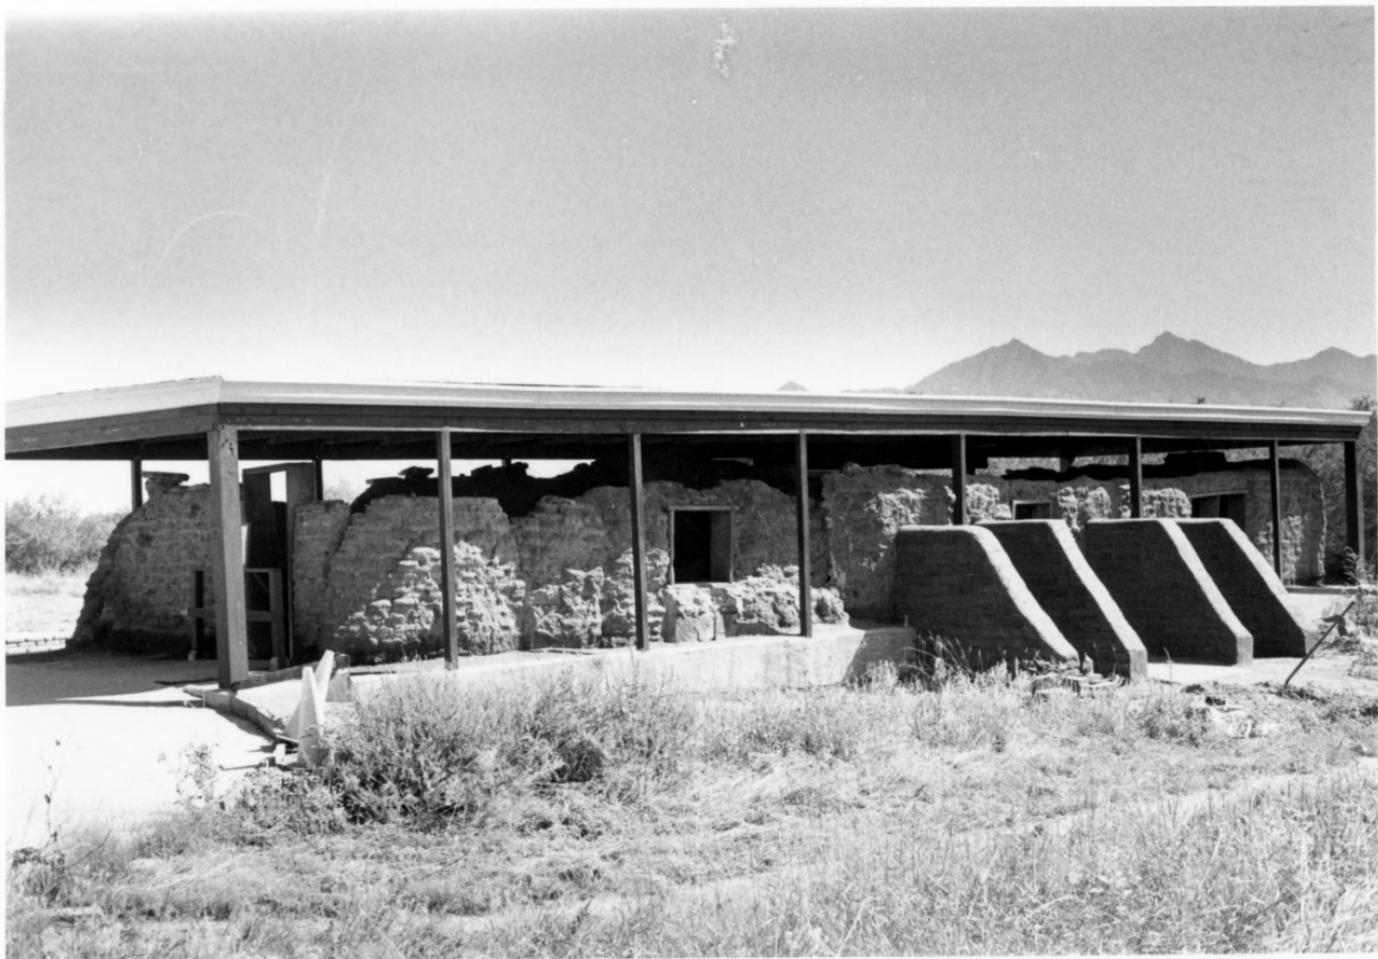
Photo 10 of 24

Ruins of the Convento

View toward the northeast

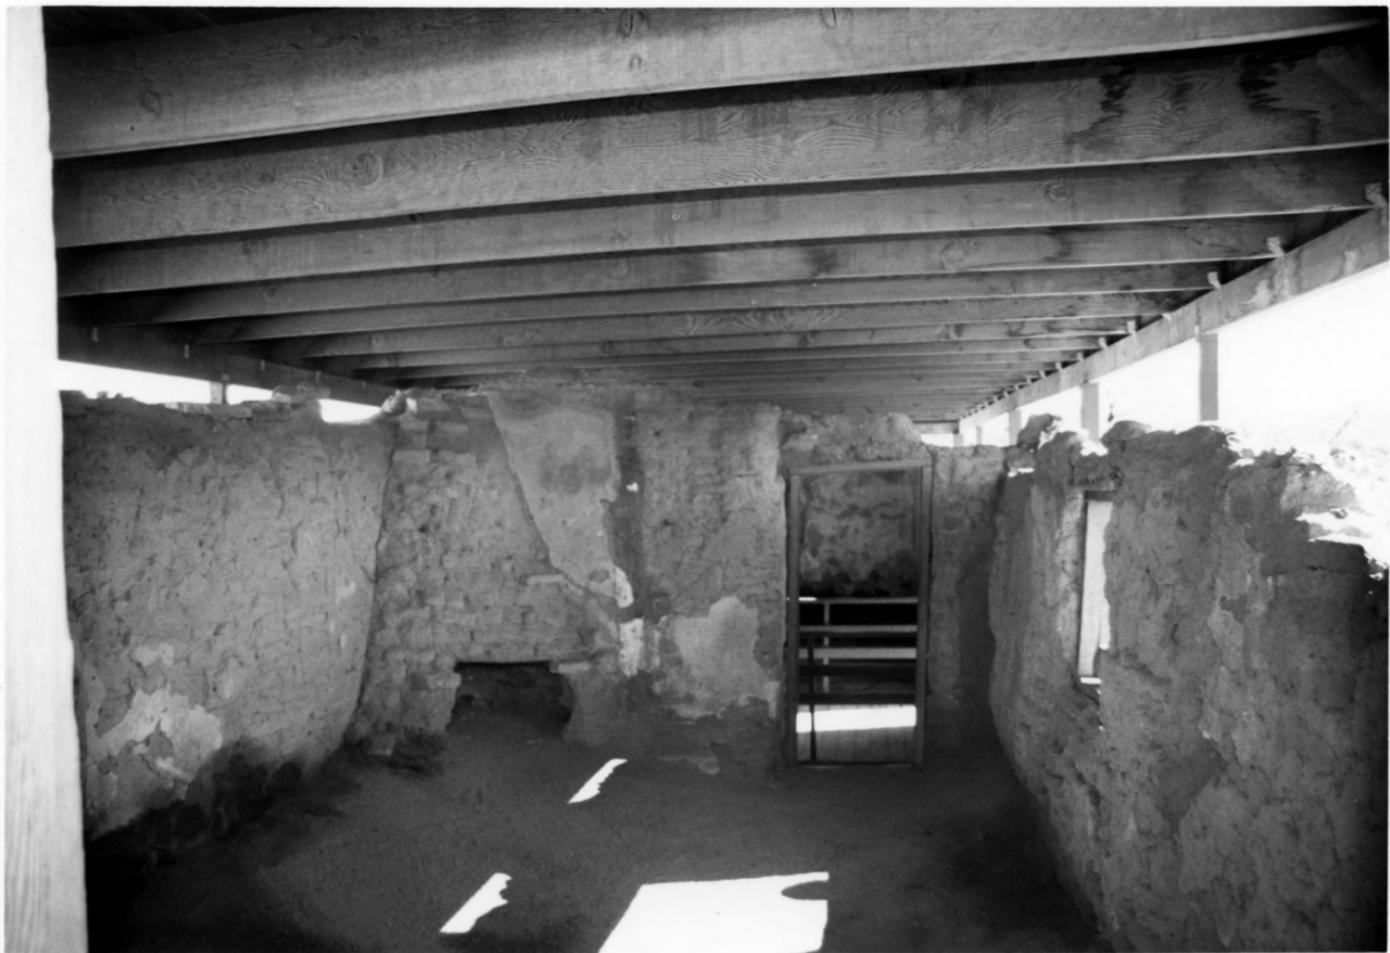
Photo No. 11 of 24

Tumacacori National Monument  
Interior of the ruins of the Convento.  
Tumacacori, Arizona

View eastward

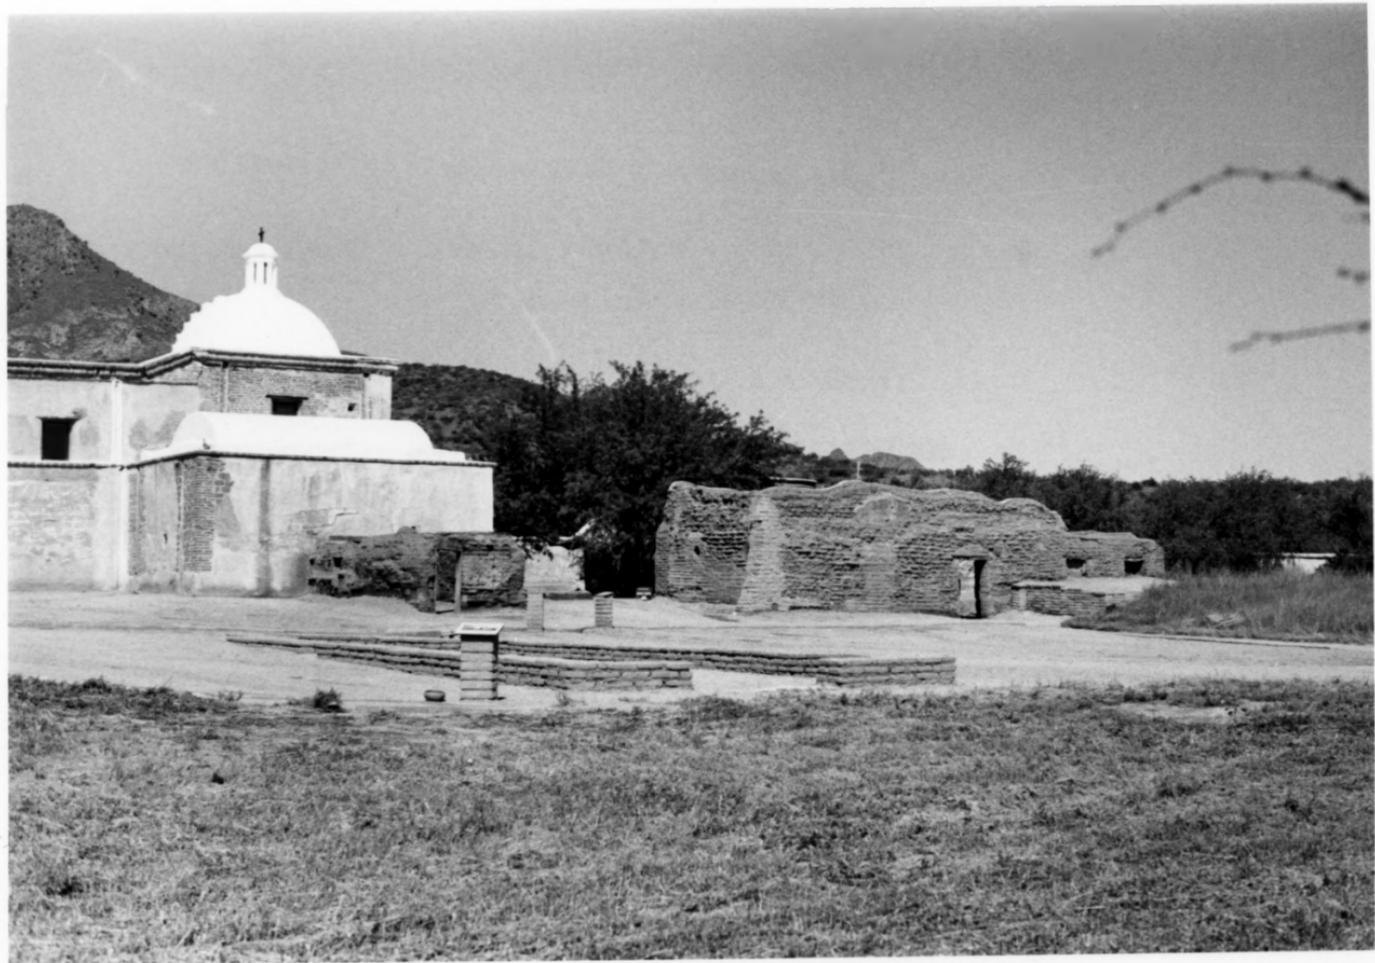
Photo No. 12 of 24

Tumacacori National Monument (Jesuit)  
Site of first (Jesuit) mission church  
(center, foreground)

View northwest with second (Franciscan)  
Mission Church at left, granary at  
right, Campo Santo in center

[Site of Jesuit] Mission San José de Tumacácori - Constructed during the summer of 1757 under the supervision of Padre Francisco Xavier Pauer of the Society of Jesus, today only the foundations of this small, modest mission church survive. Other buildings were constructed as part of the Jesuit mission complex, which after expulsion of the Jesuits in 1767 continued to be used by the Franciscans, but little above-ground evidence remains. These resources today comprise a historical archeological site. Although it has been subjected to the effects of natural deterioration, disturbance incidental to construction of the later Franciscan mission complex, damage by treasure-hunters, and sheer vandalism, much significant knowledge regarding the sequence of construction and other subjects remains in the ground for future archeological investigation.

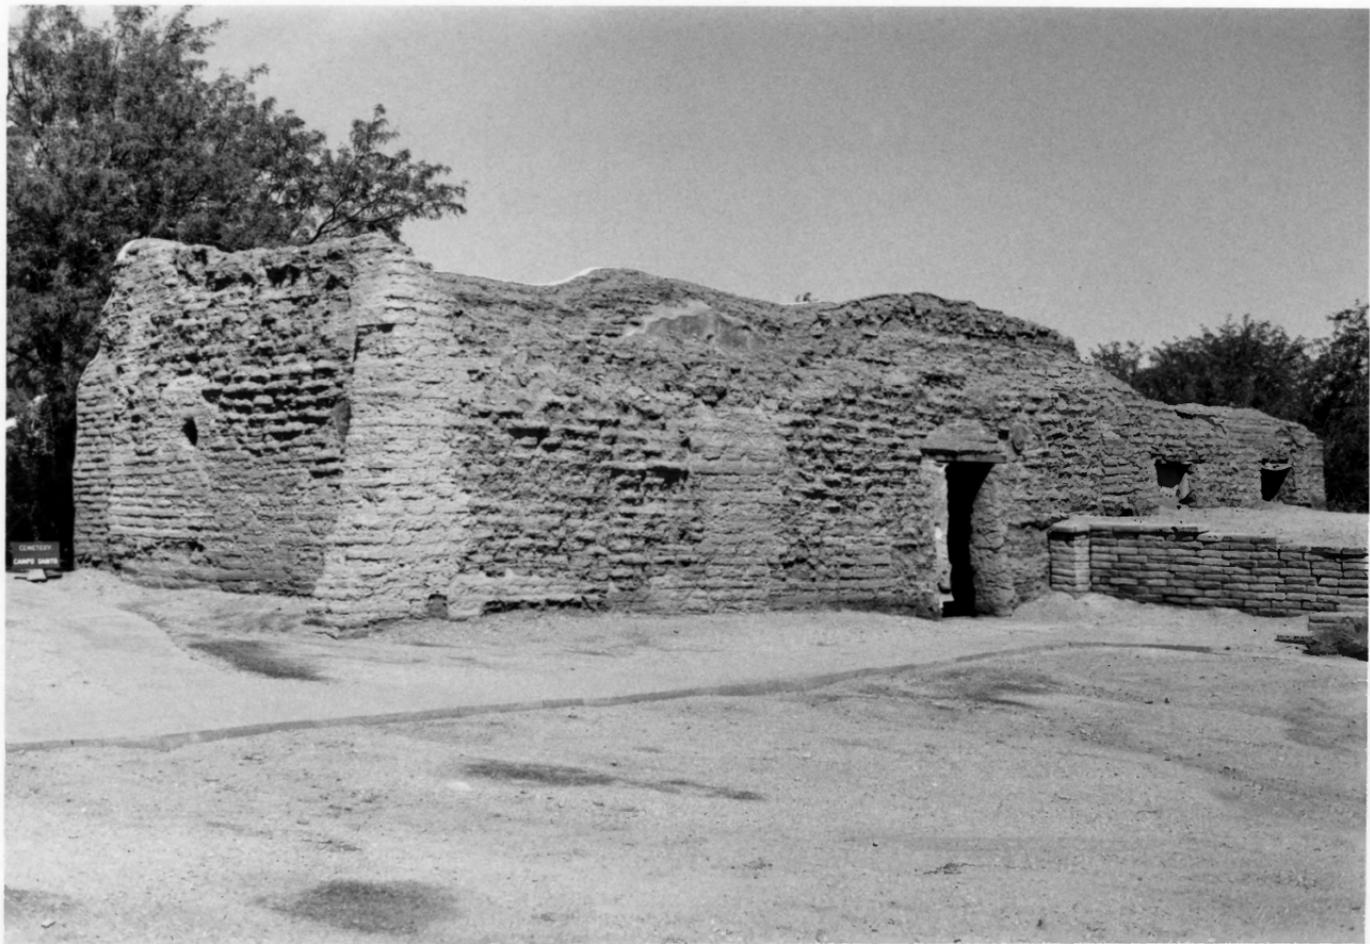
Photo No. 13 of 24

Mission granary (before stabilization)

View northwest

Granary - A second part of the large complex which once stood northeast of the mission church, the Granary is a long, rectangular, single-roomed structure with its longer axis oriented north-south, its west wall forming the east wall of a part of the Campo Santo compound directly east of the Mortuary Chapel. Like the other buildings, it was of adobe, now badly weathered and partly dissolved by the rains.

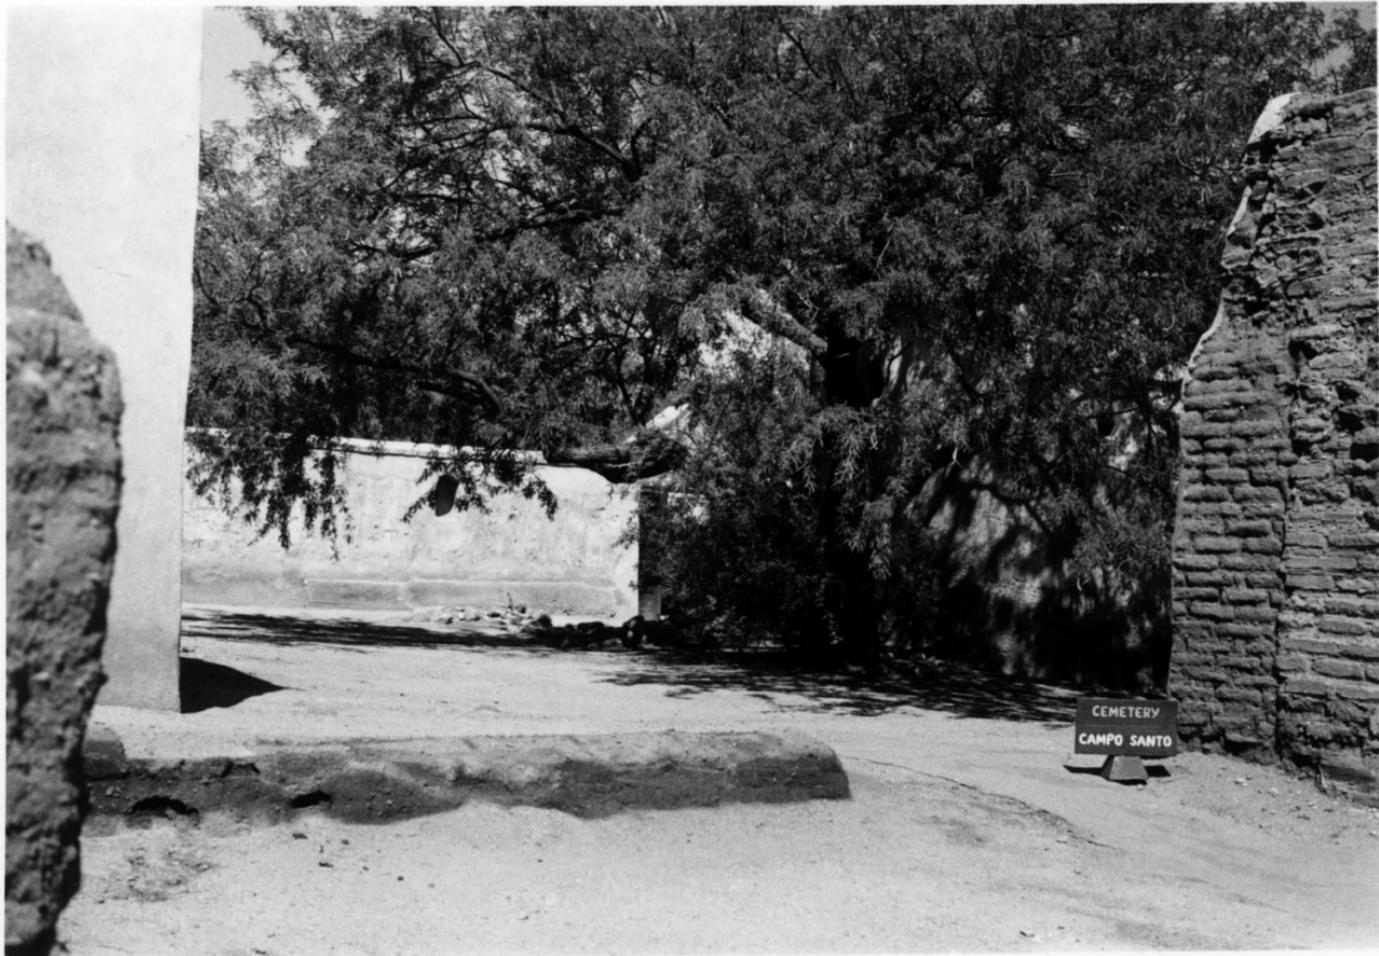
View No. 14 of 24

Portion of the Campo Santo (cemetery)

View toward northwest, church at  
left, granary at right

Campo Santo - North of the church lies the area which was the original mission cemetery. It is enclosed by a historic adobe wall connected to the northwest corner of the church,

the north end of the church forming the south end of the Camp Santo, with the wall enclosing its west, north, and part of its east sides, connecting with the northwest corner of the granary, whose west wall formed a continuation of the east wall of the Campo Santo.

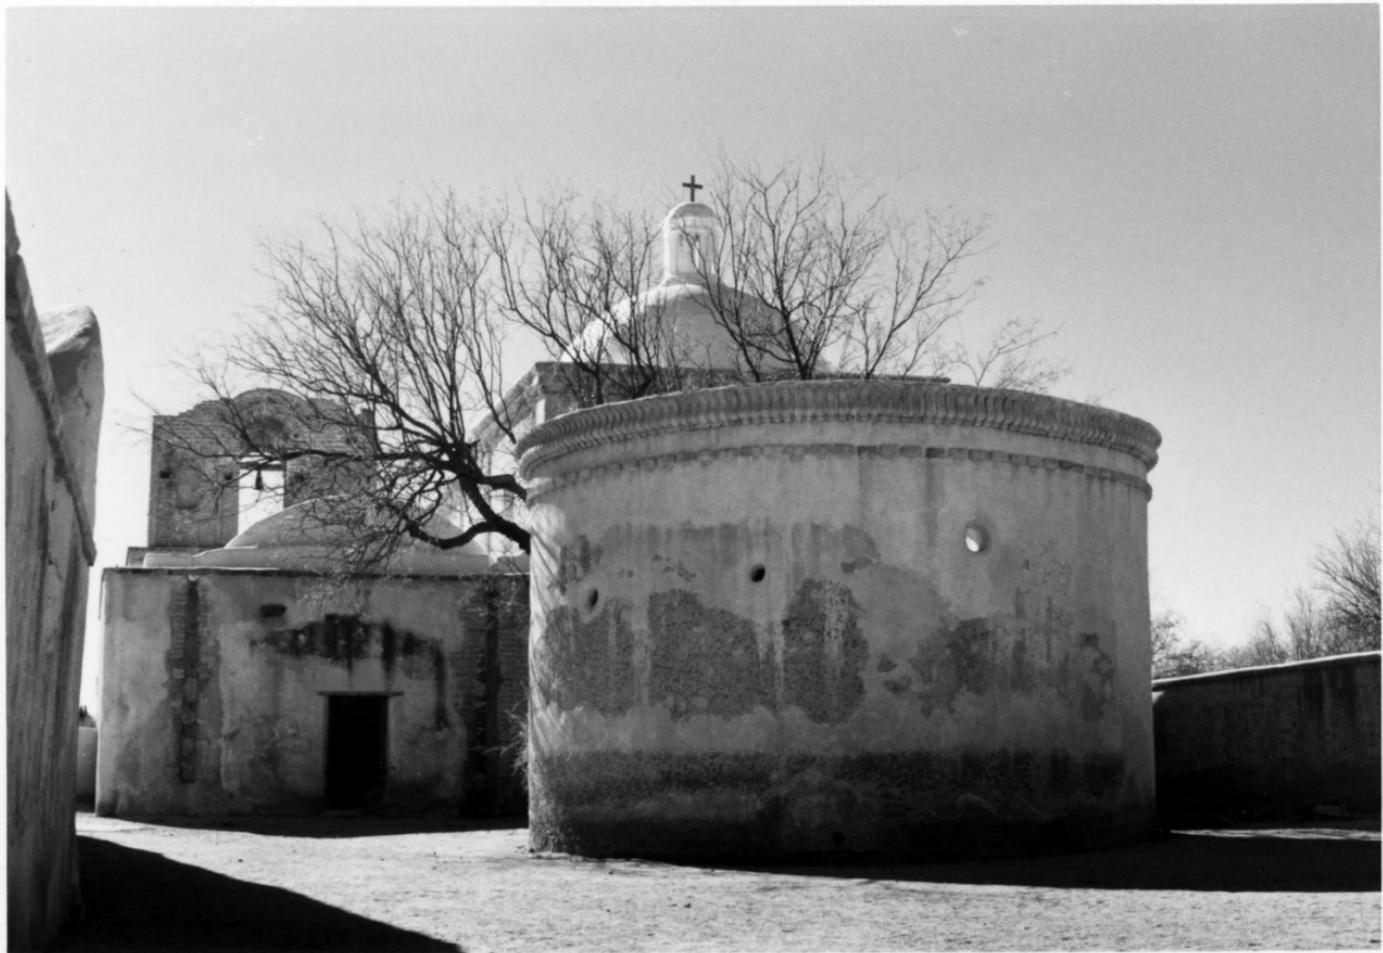
Photo No. 15 of 24

Mortuary Chapel in foreground, rear of mission behind it

View toward south in Campo Santo

Mortuary Chapel - Within the Campo Santo is the mortuary chapel, a small, circular adobe structure with plastered walls capped with the same ornamental fired brick cornice that capped the adobe walls of the church. Originally, this mortuary chapel was supposed to have a domed roof, but construction of that apparently never began, so the resulting incomplete structure is (and apparently always has been) open to the sky. The mortuary chapel is entered by a door on its west side.

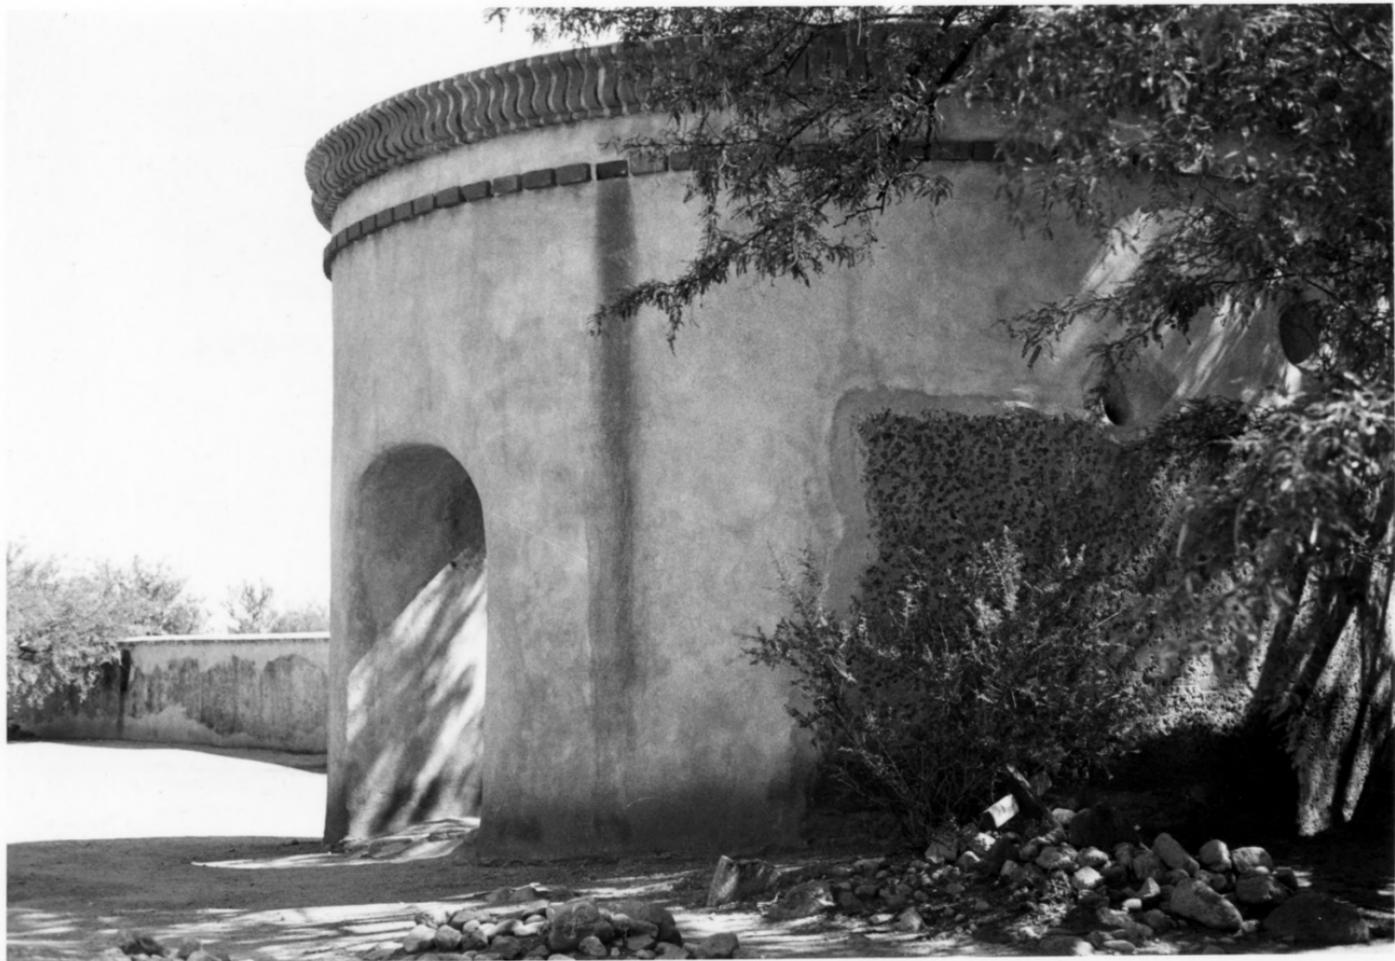
Photo No. 16 of 24

Unfinished Mortuary Chapel

- Chapel doorway on left
