**NATIONAL REGISTER OF HISTORIC PLACES  
INVENTORY -- NOMINATION FORM**

HISTORIC Mission San José de Tumacácori

AND/OR COMMON Tumacácori National Monument, Tumacácori Mission

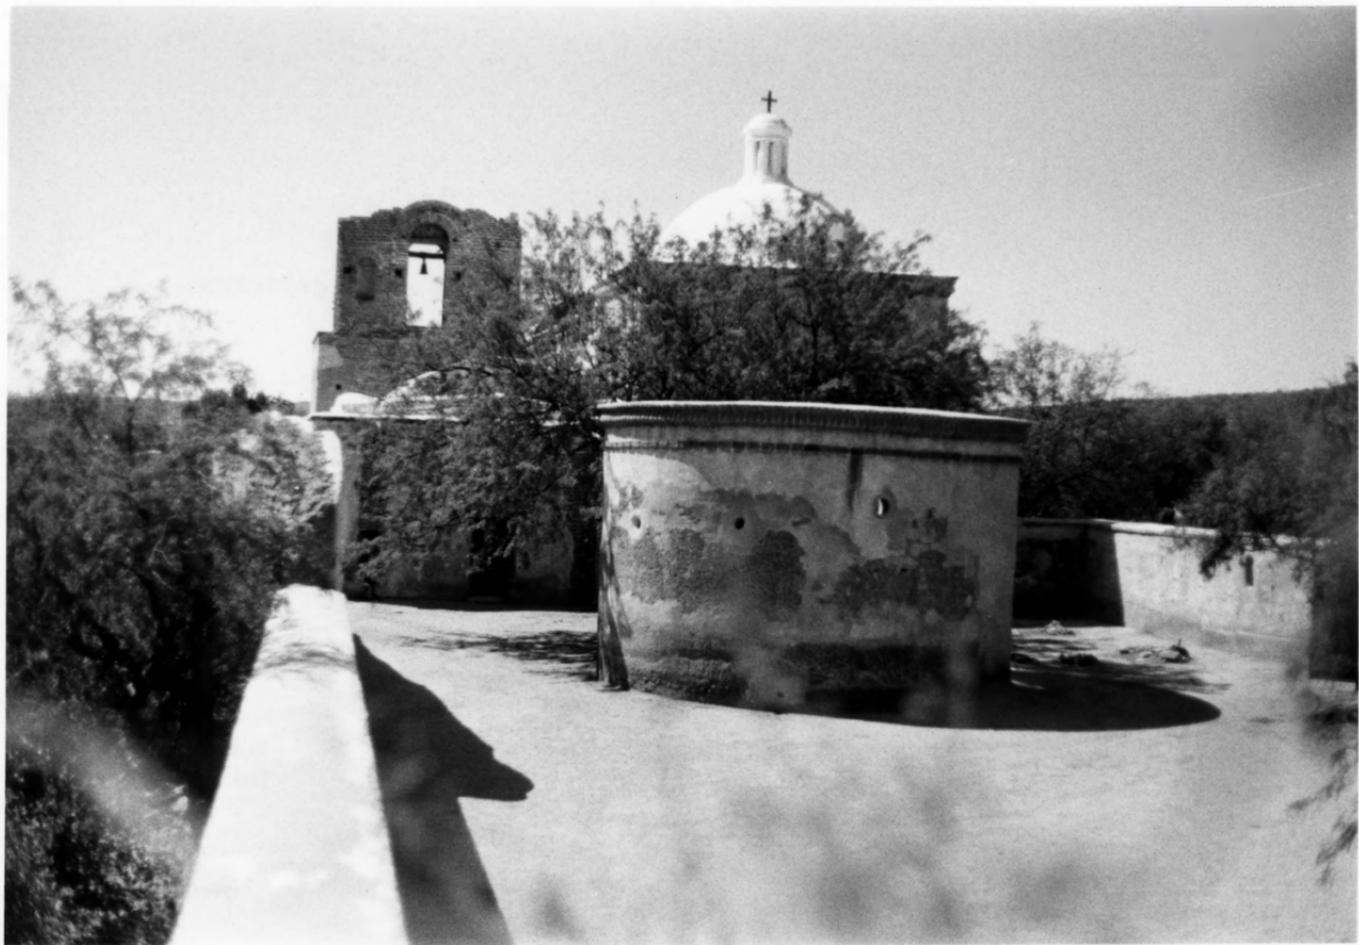
Photo No. 17 of 24

Mortuary Chapel and Mission Cemetery

View south, Mission San Jose de  
Tumacacori in Background

Mortuary Chapel - Within the Campo Santo is the mortuary chapel, a small, circular adobe structure with plastered walls capped with the same ornamental fired brick cornice that capped the adobe walls of the church. Originally, this mortuary chapel was supposed to have a domed roof, but construction of that apparently never began, so the resulting incomplete structure is (and apparently always has been) open to the sky. The mortuary chapel is entered by a door on its west side.

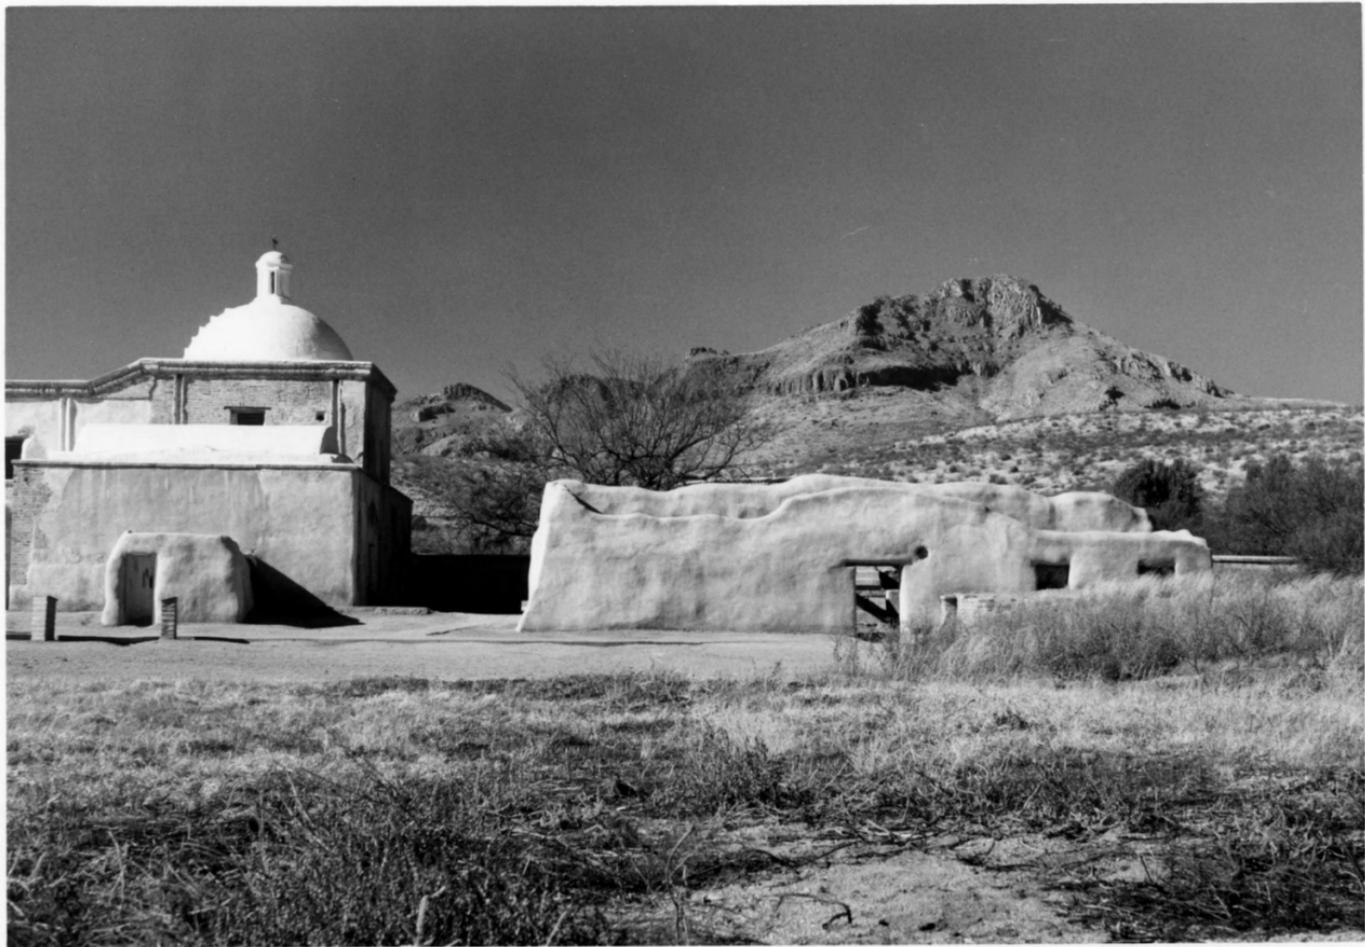
photo. No. 18 of 24

Part of Tumacacori Mission (left)  
and stabilized mission granary (right)

View toward west

Granary - A second part of the large complex which once stood northeast of the mission church, the Granary is a long, rectangular, single-roomed structure with its longer axis oriented north-south, its west wall forming the east wall of a part of the Campo Santo compound directly east of the Mortuary Chapel. Like the other buildings, it was of adobe, now badly weathered and partly dissolved by the rains.

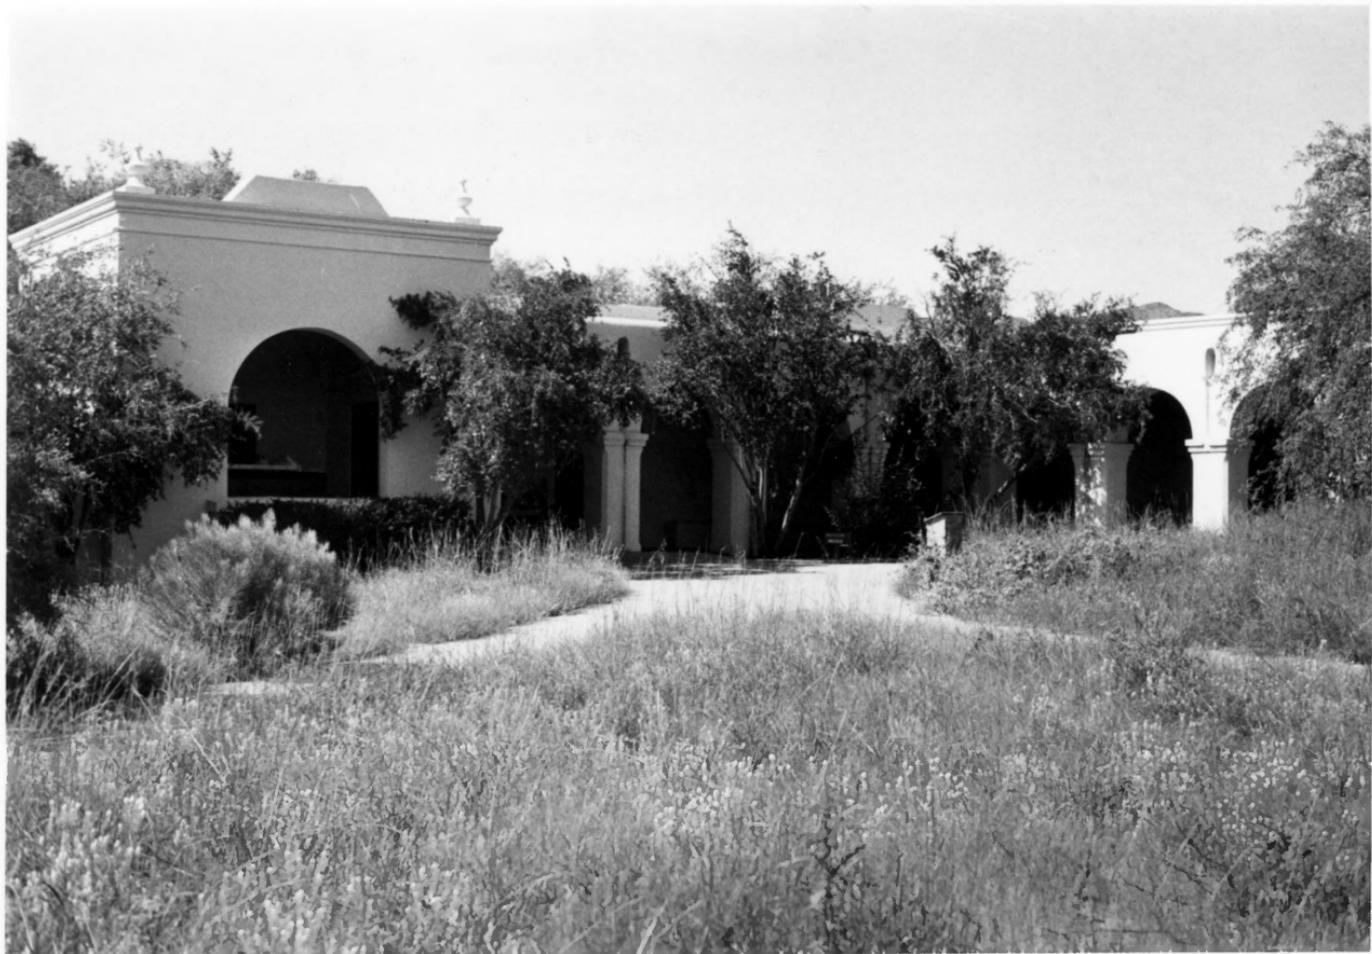
Photo no. 19 of 24

Visitor Center

View southwest of collonade inside  
Monument

Visitor Center - The largest of the structures representing the later "rustic" architecture is the Monument visitor center (Building No. 5), together with its adjoining garden and walls. The building comprises about 5,500 square feet, and contains ten rooms in a roughly T-shaped configuration. It has a partial basement. The building is situated near the southwest corner of the Monument. On the north and south sides, this single story adobe and concrete block structure features arched porches, which allow access to the garden to the south and to the historic mission complex to the north. The roof of the visitor center is flat, and is surrounded by a parapet. The main entrance faces west, and has an arch decorated with a large shell motif above the carved, wooden double doors. The roof has a stepped cap, with flanking finials above the doorway. All the windows are wooden casement, and the rest of the doors are also of hand-carved wood. The ceilings in the building feature exposed beams, with two by six inch sheeting.

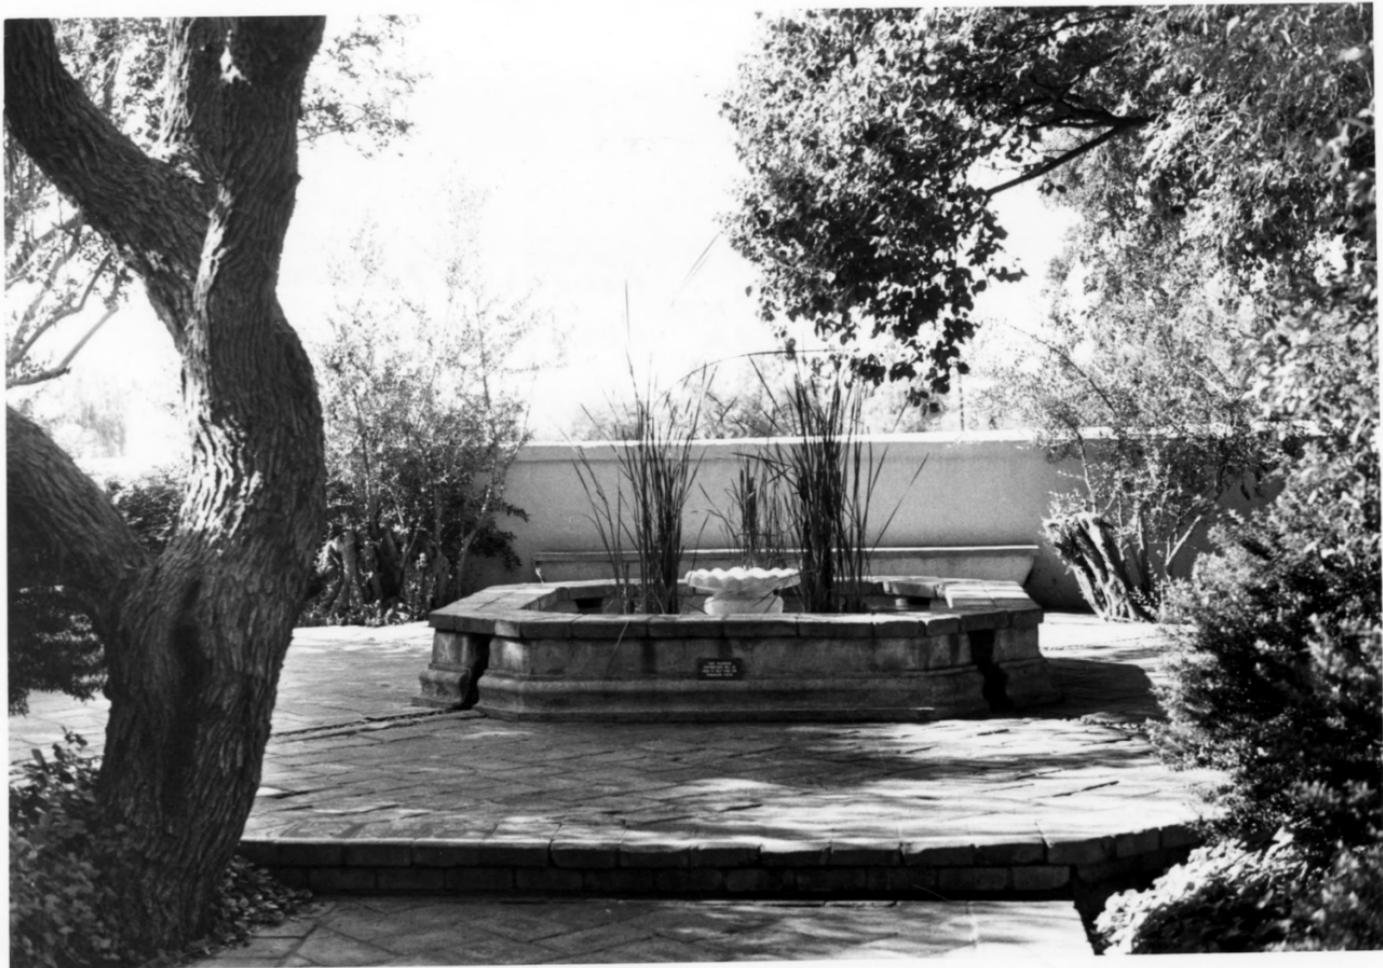
Photo No. 20 of 24

Tumacacori National Monument  
Visitor Center, Formal Garden  
Tumacacori, Arizona

View southward of fountain and garden  
wall

Garden - The symmetrical, formal garden on the south side of the Visitor Center has a fountain, brick walkways, and is surrounded on the south and east by an adobe wall, capped with either flat or arched brick coping. Plantings are native to the area, or are in keeping with known mission-period species.

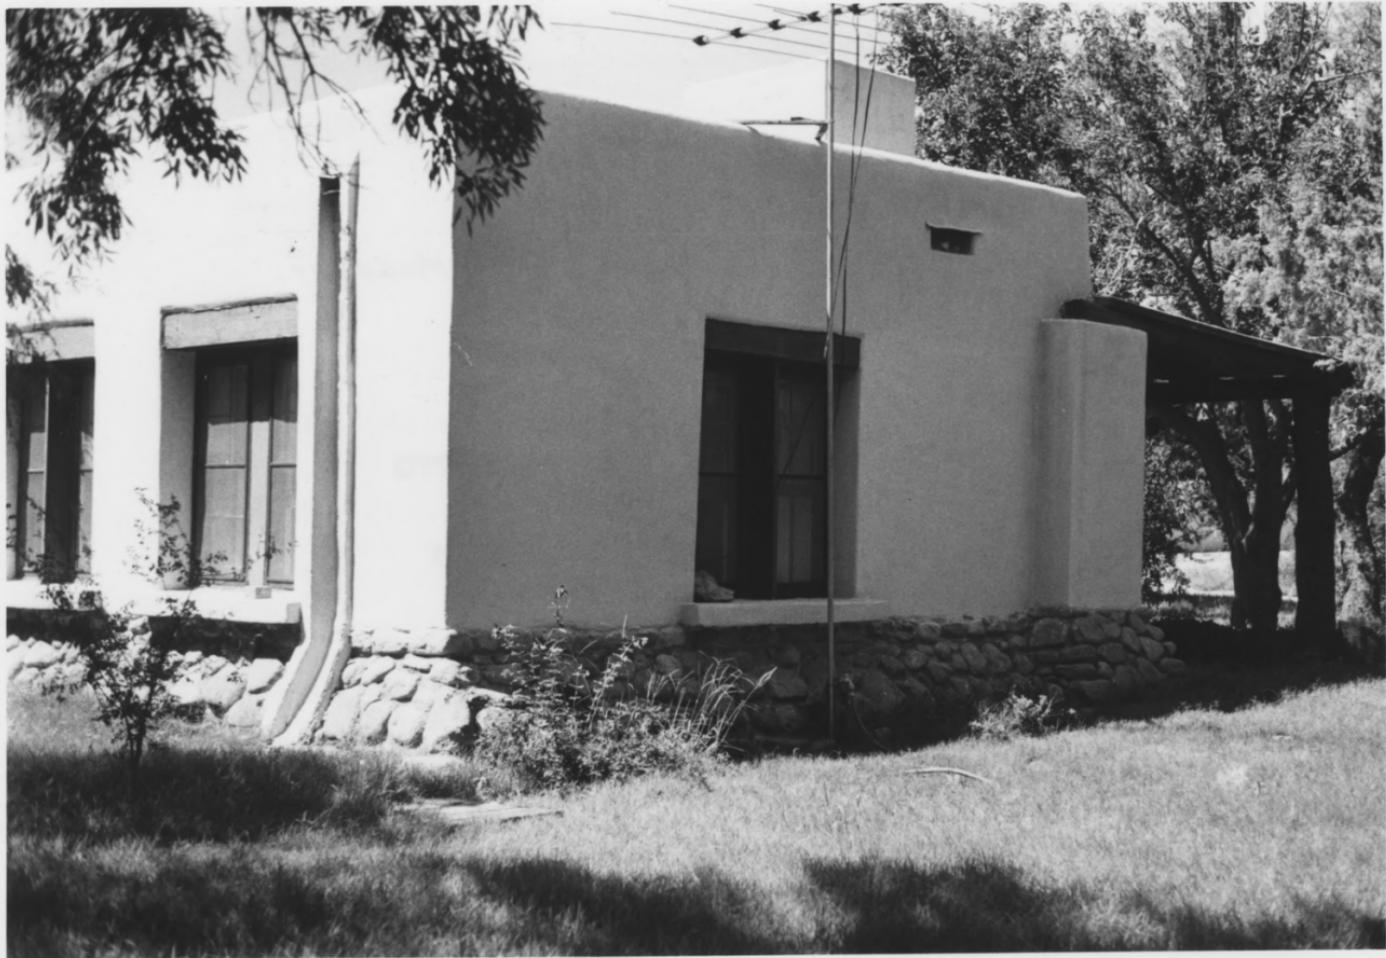
Photo No. 21 of 24

Residence No. 1

View toward southwest of north end  
of building (front view is  
obscured by landscaping)

Residence No. 1 - This residence featured the adobe walls, the flat, parapet roof, the heavy beams or vigas, and the portal typical of Spanish architecture in the Southwest, adapted to a modern residence of the 1930s. A single story adobe house, it has a battered masonry footing. The walls are finished on the interior with a lime plaster and on the exterior with a cement stucco. The doors, windows, and lintels are all of wood. The building has six rooms, and a front porch designed like a ramada, with forked tree trunks supporting the peeled log roof structure. The floors are wood. Landscaping of trees and shrubs make the building difficult to photograph.

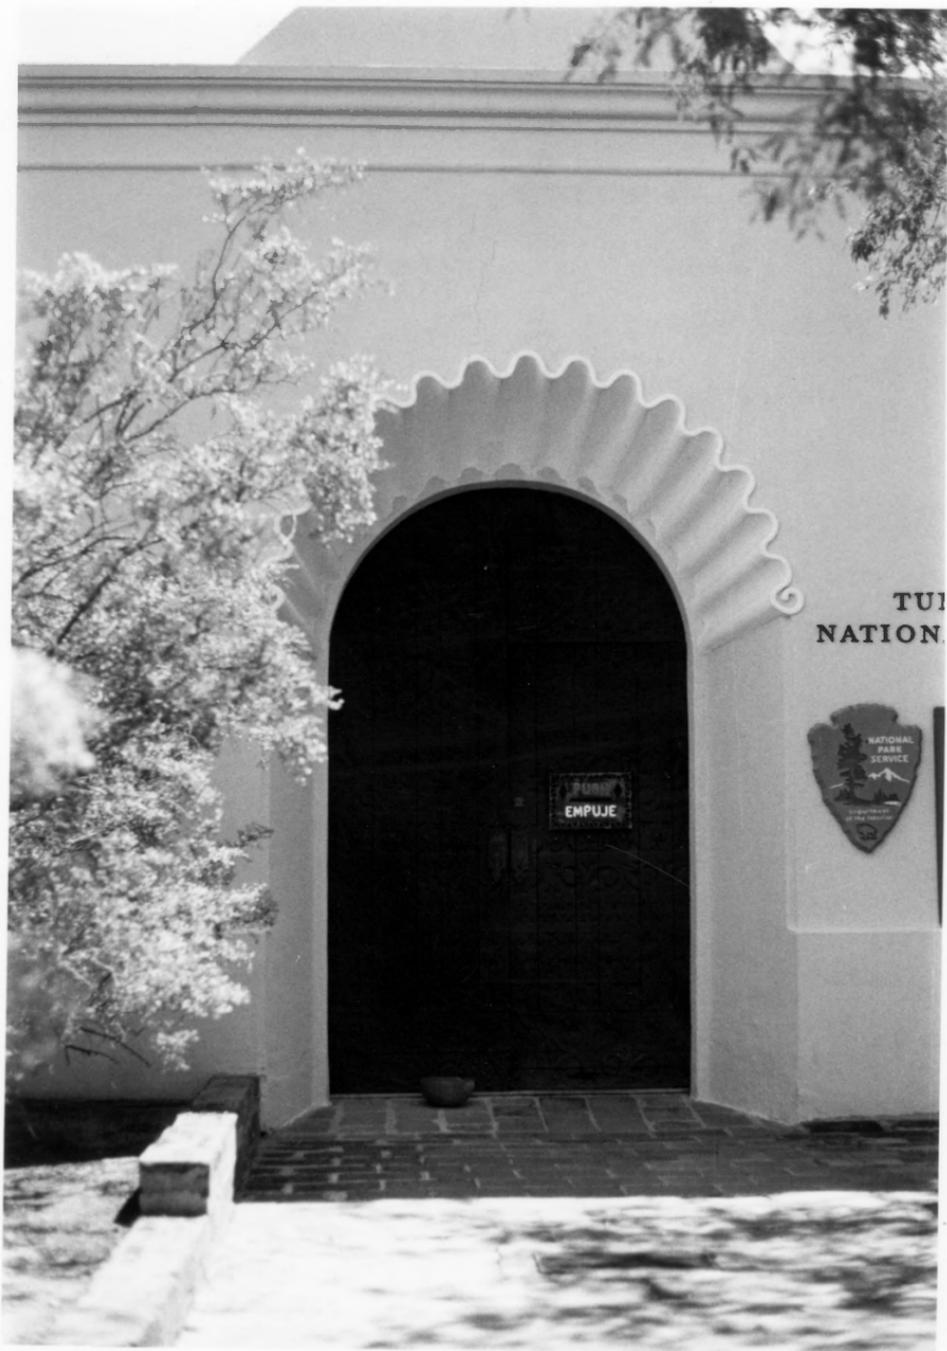
Photo No. 22 of 24

Main entrance to Visitor Center with  
scalloped or seashell motif above  
doorway

View toward east

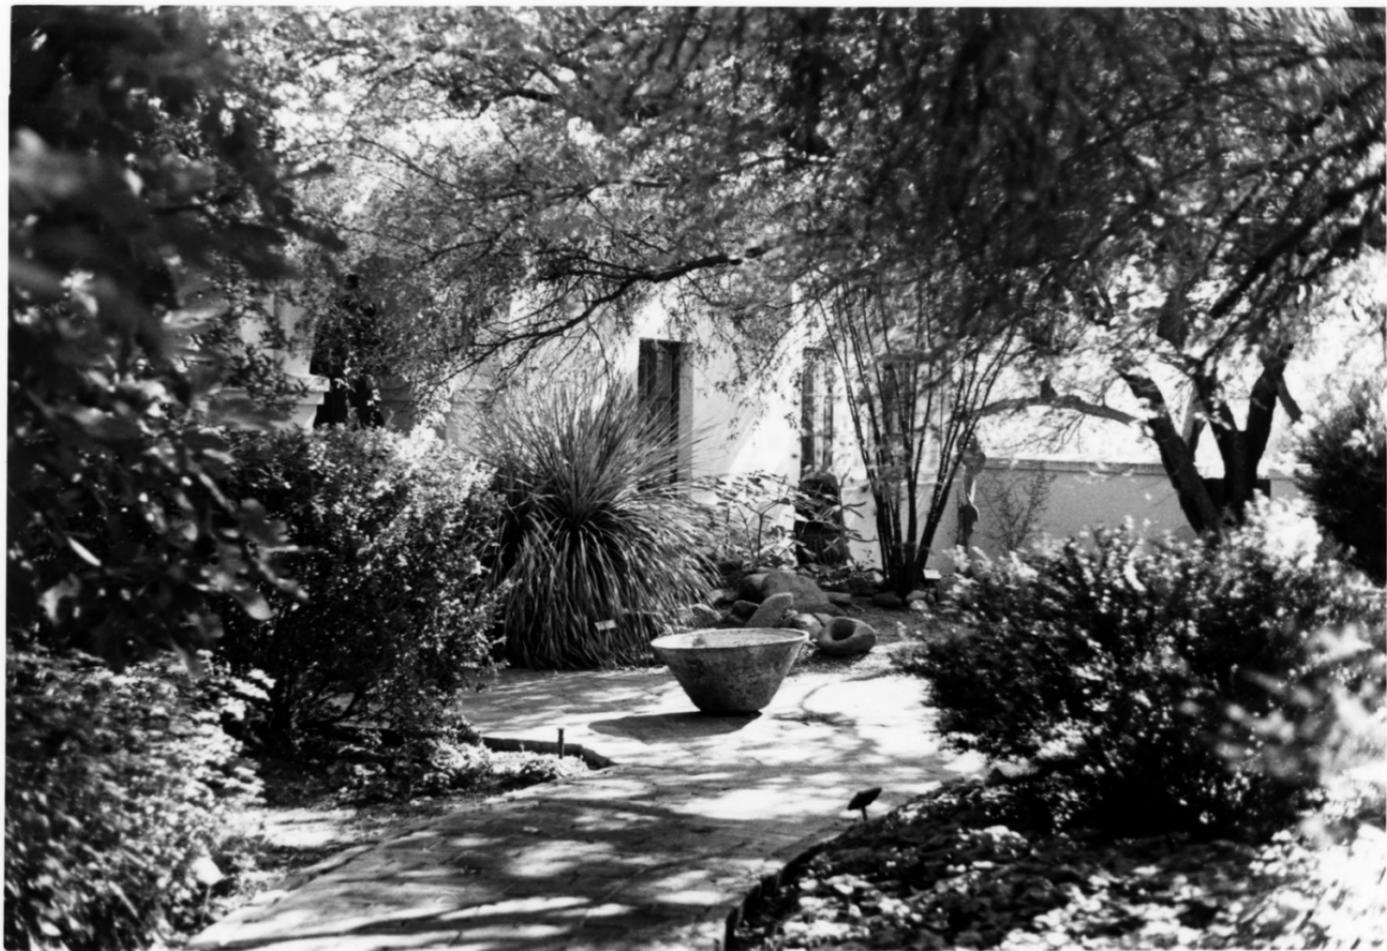
Photo No. 23 of 24

Formal Garden in Visitor Center

View toward east-northeast

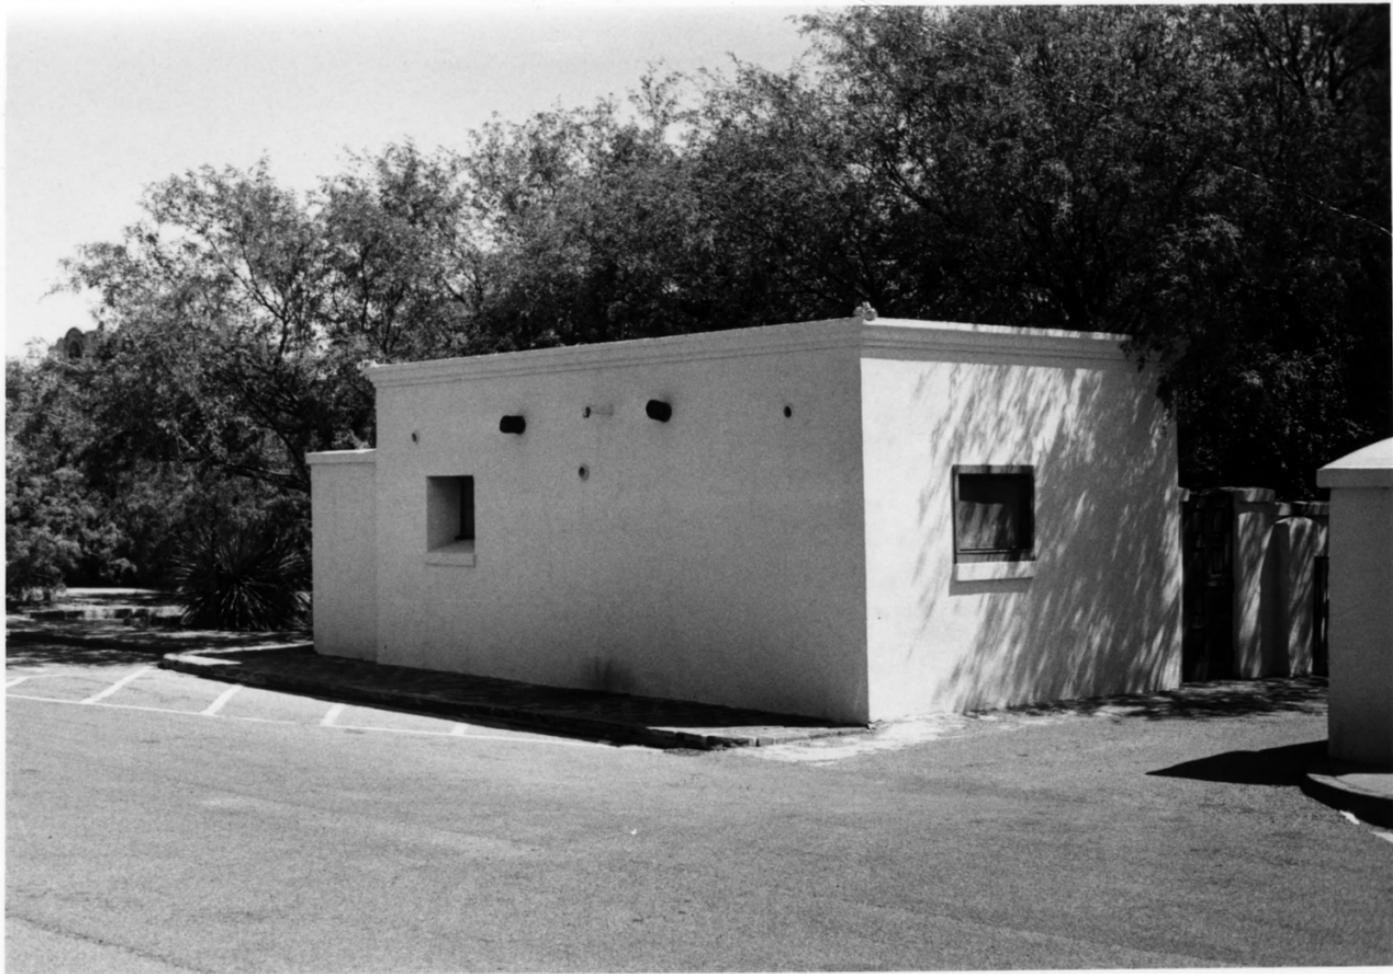
Tumacacori National Monument  
Restroom at Visitor Center - Rear View

Comfort Station - South and west of the visitor center, at the southwest corner of the garden, is the Comfort Station (Building No. 4). A simple, rectangular one-story building, its longer axis running north-south, it forms one edge of the formal garden, and its significance is limited to its exterior, whereas the significance of the other "rustic" buildings extends to interior, as well as exterior, architecture. The comfort station, or restroom, has adobe walls covered with cement stucco, and it sits on a concrete foundation. The roofline is finished with a stepped cap, and resembles that of the Visitor Center. The building is divided in half, with restrooms for men and women, and a plumber's alley between them. Windows are steel casement, doors are wood (vertical tongue and groove), and the flat roof is supported on two by six rafters with viga ends protruding on the exterior for architectural effect. The original doors, of redwood, were replaced with the present ones when the entry was widened to permit handicapped access.
