NATIONAL REGISTER OF HISTORIC PLACES
REGISTRATION FORM

historic name Hasselborg Cabin

other names/site number 49 SIT 322

Admiralty Island Civilian Conservation Corps Canoe Route, 1933-1937

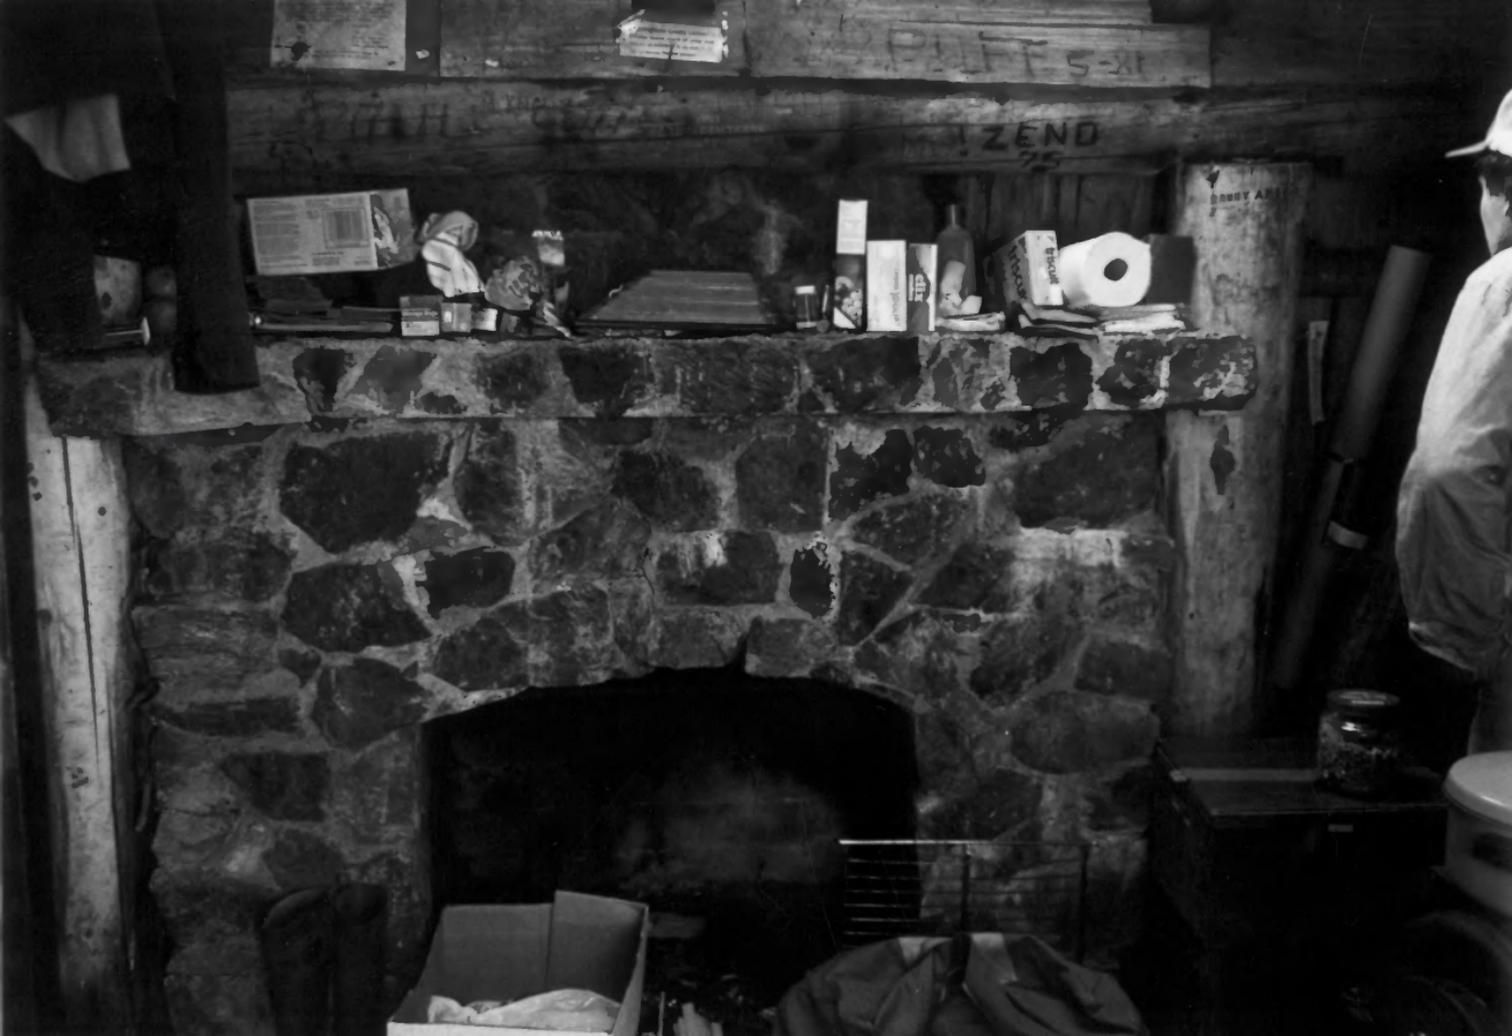
1. Hasselborg ^{River} Cabin
2. Hasselborg Lake, Admiralty Island, Alexander Archipelago, Alaska
3. Conner Sorenson
4. T ¹ : Jun. 1989
5. Tongass National Forest, Chatham Area, Supervisors' Office
204 Siginaika Way, Sitka, AK 99835
6. Stone fireplace inside cabin
7. # 1

Two features distinguish this shelter from others in the canoe route, the floor and a fireplace. Only two of the shelters built for the canoe route had fireplaces. The Hasselborg Cabin has a stone and brick fireplace and chimney built into the west wall. Angular granite stones were used for the fireplace, mantle and chimney while the interior is lined with firebrick. The fireplace is 6'2" wide and 4'4" tall. The chimney is capped by a rectangular concrete spark arrester. Two other structures built by the CCC in the region, Skaters Cabin and the Auke Bay Recreation Area Shelter, have fireplaces that are similar.
