Property Name: Pig Tail Bridge

**NATIONAL REGISTER OF HISTORIC PLACES
REGISTRATION FORM**

Pig Tail Bridge, Wind Cave National Park, Custer County, SD

Wind Cave National Park
Historic Buildings and Structures Survey 1992

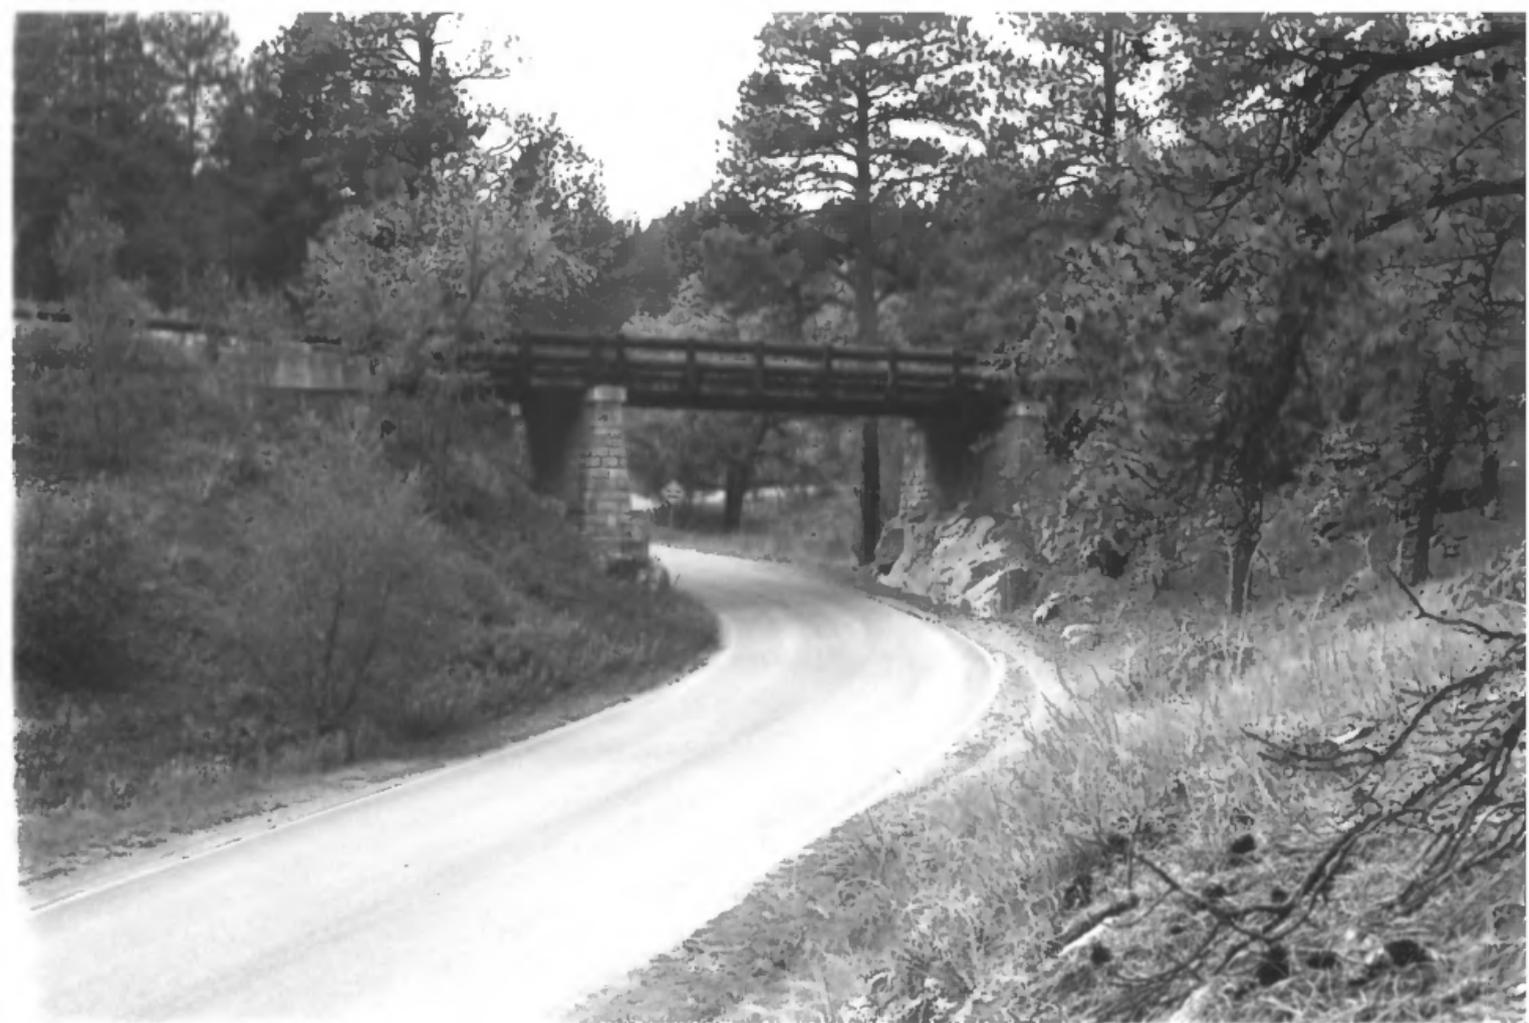
Pig Tail Bridge
Wind Cave National Park
Custer Co., South Dakota
photo #1

<u>Photo #</u>	<u>View</u>	<u>Comments</u>	<u>Roll</u>	<u>Frame</u>
01	E	bridge from road	15	14
03	S	bridge abutment	15	16
04	NW	bridge abutment	15	17
05	NW	detail of abutment showing date	15	18
07	E	bridge abutment and railing	15	20
09	NW	road bed above bridge	15	22

The bridge is a post and lintel design consisting of a single span of 160 feet long. It has an asphalt covered laminated wooden deck which rests on steel I-beams. The I-beams sit on concrete and stone masonry abutments. There is one abutment at each end of the bridge and two additional abutments, 40 feet apart, on each side of the roadbed which passes beneath the bridge. The end abutments have short wing walls on each side. The abutments have concrete bases which are poured on outcrops of native rock. Battered abutments use native sandstone in a coursed ashlar pattern with rock facing. Each abutment has a concrete cap. The date "1940" is cast in the center inside of the northern and southern abutments. Log uprights are regularly spaced along the outside edge of the deck and two logs, one above the other, are bolted to the uprights forming a guardrail. The guardrail extends beyond each end of the bridge serving as a guardrail for the approach. This extended guardrail is on the east side at the south end of the bridge and on the west side at the north end of the bridge.
