NATIONAL REGISTER OF HISTORIC PLACES  
INVENTORY - NOMINATION FORM  
FOR FEDERAL PROPERTIES

Yosemite Valley Bridges

There are 8 granite-faced, concrete arch road bridges on the Valley floor in Yosemite National Park. They were constructed between 1921 and 1933, with five built in 1928. The bridges are similar in design, but vary in size and configuration. All bridges are constructed of reinforced concrete in the form of a semi elliptical or 3-centered arch. The concrete is veneered with rough quarried, rock-faced granite which is laid in an uncoursed rubble bond. The bridges feature finely cut, rock-faced voussoirs and keystones.

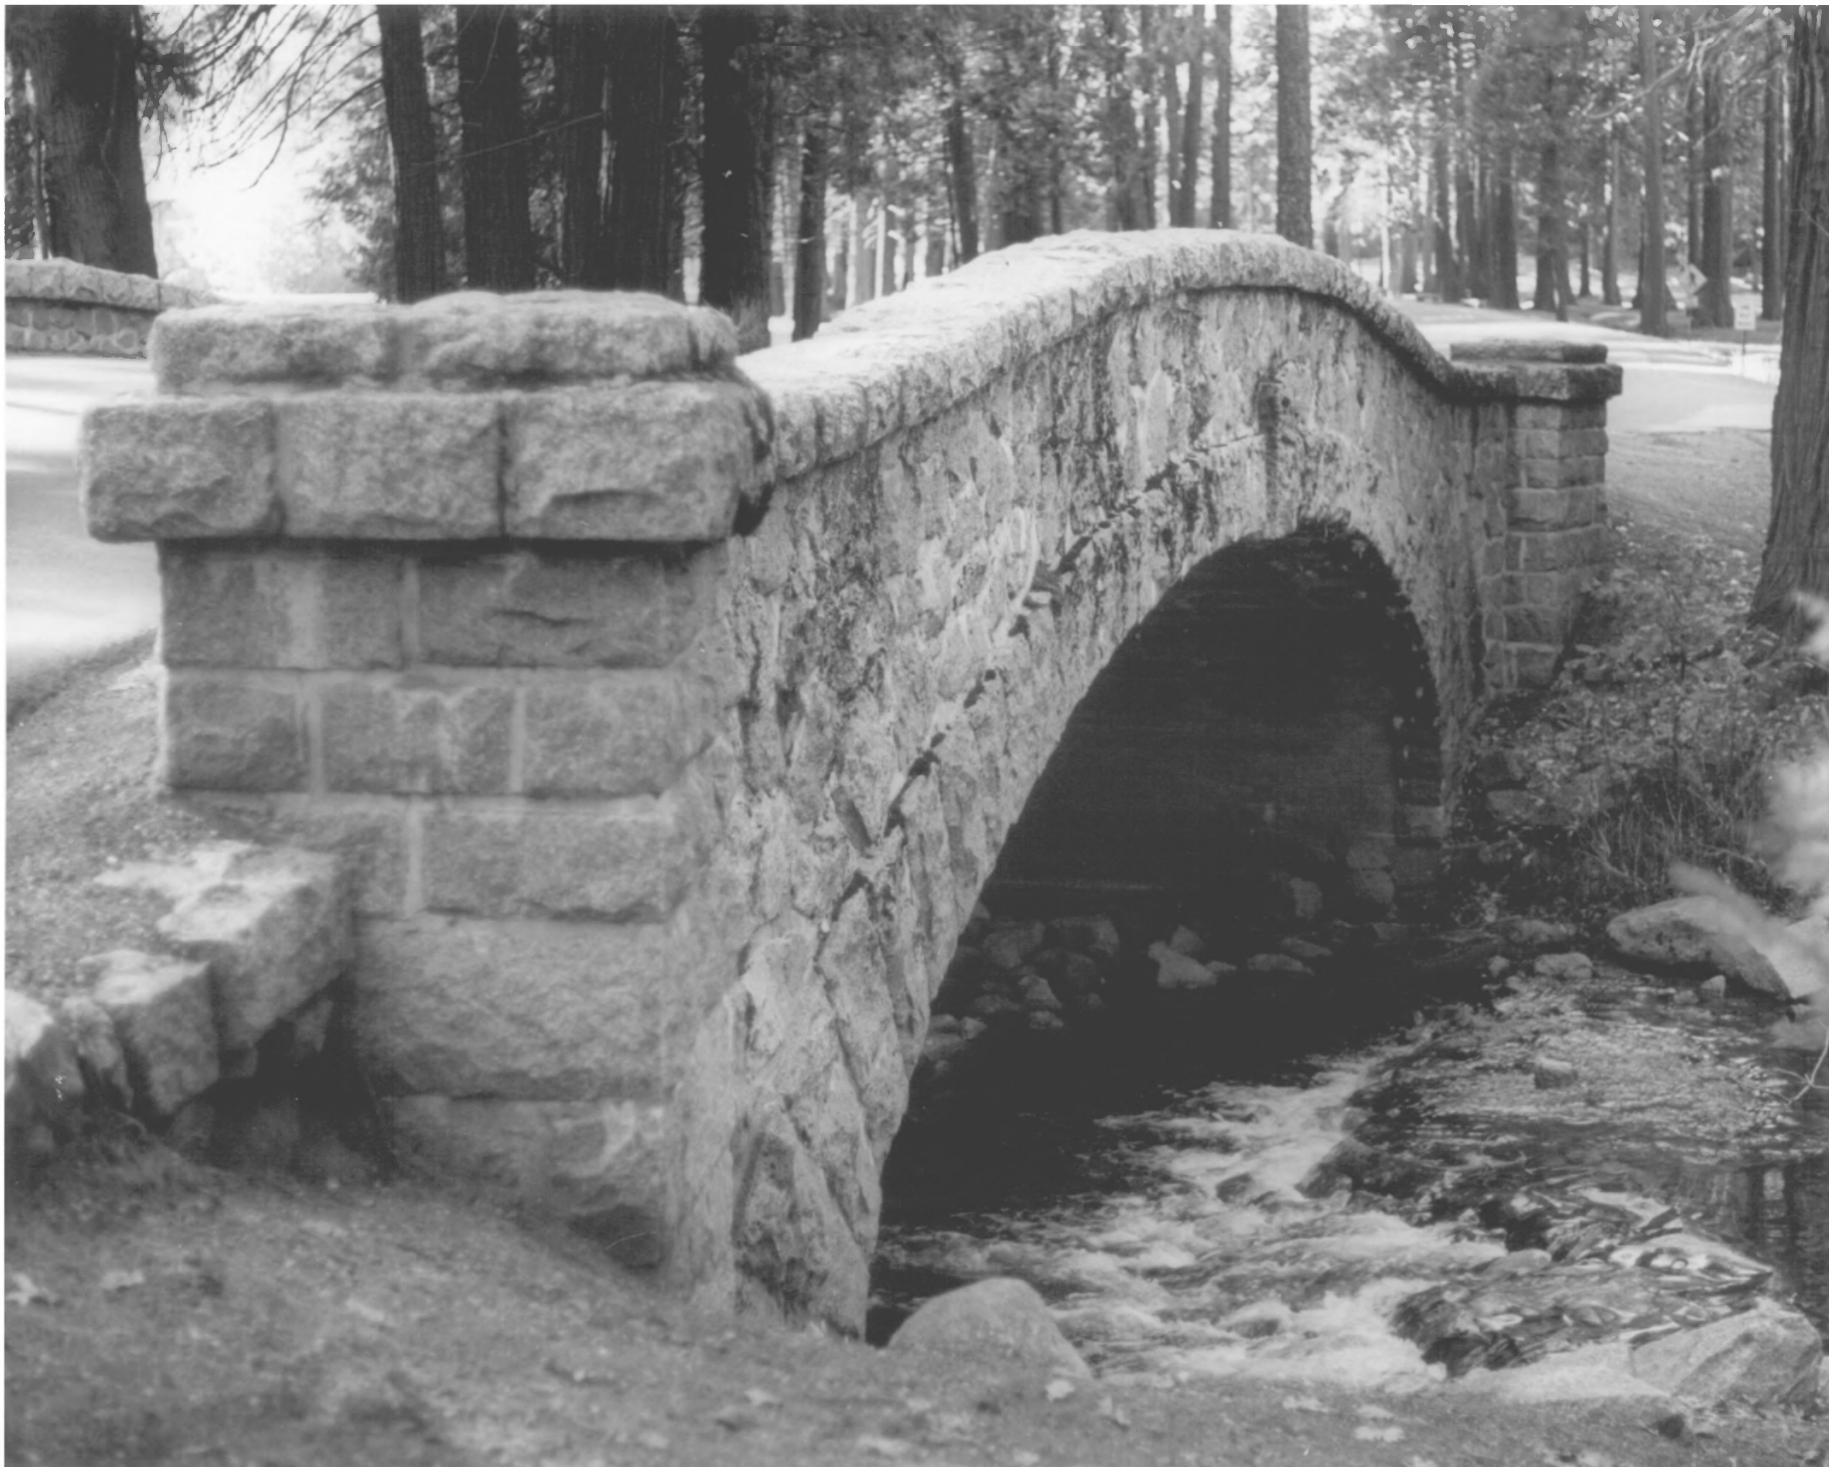
Photo # 1 of 8

Yosemite Creek Bridge

Direction: View to ~~east~~<sup>WEST</sup> shows  
North facade of bridge.

Yosemite Creek Bridge:

Built - 1922  
 Designer - NPS  
 Type - Reinforced concrete arch veneered with native granite  
 Length - 52'  
 Span - 1 - 50'  
 Skew - 0°  
 Width - 24', no sidewalks  
 Traffic lanes - 2  
 Surfacing - asphaltic concrete  
 Original cost - \$32,000.09  
 The bridge is crowned transversely at the center point of the span. The parapets parallel the sloping grade of the roadway. The wing walls and buttresses are skewed slightly, and the buttresses were originally topped with small lanterns. Granite coping stones overhang the parapet walls. This is the oldest of the eight bridges, and original drawings exist in NPS files.

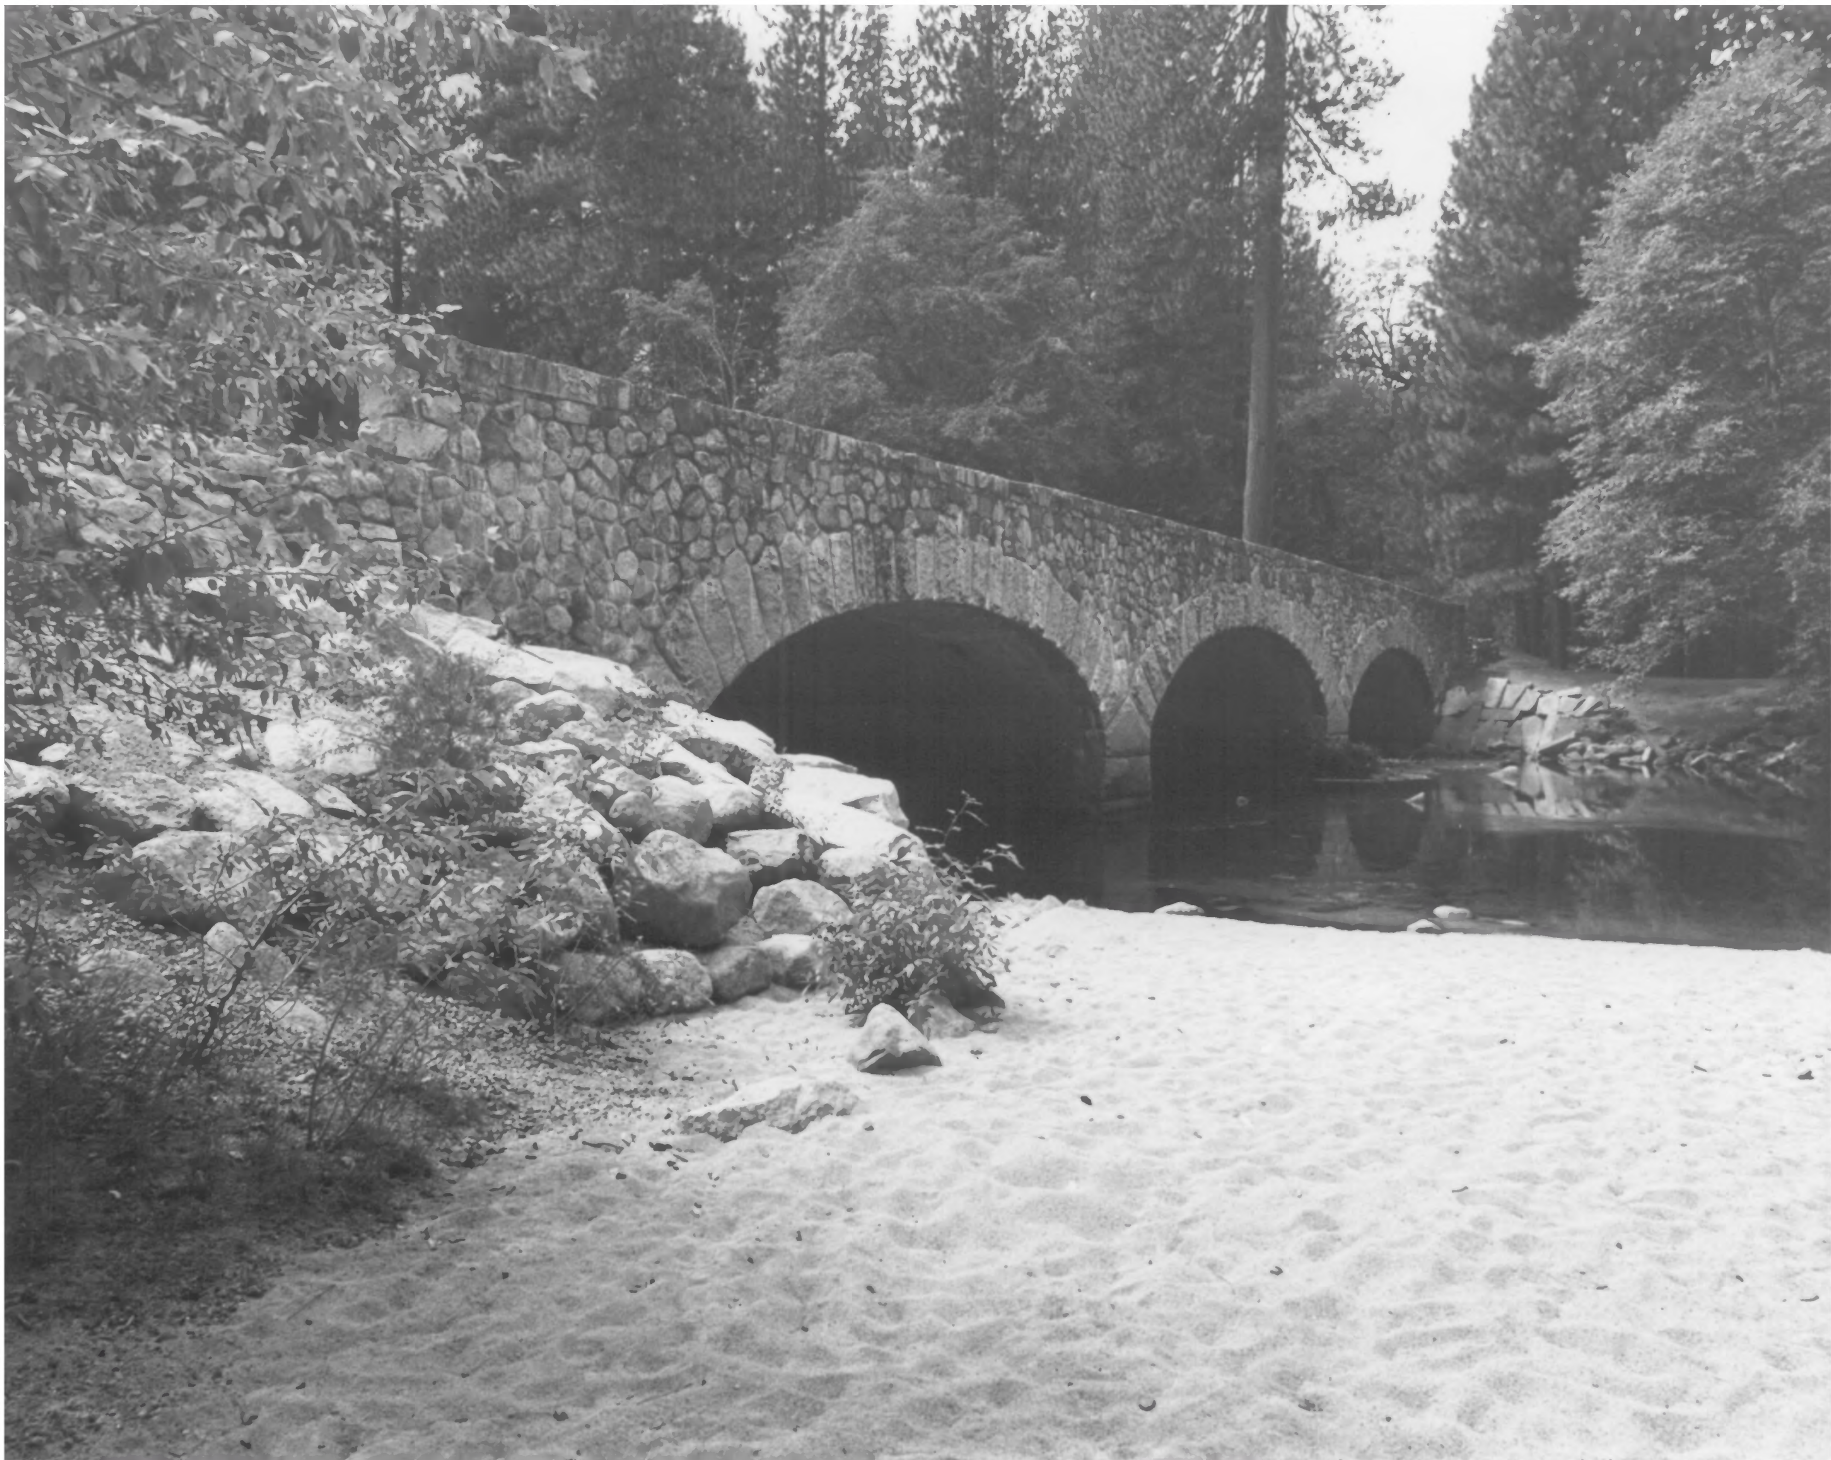
Photo # 298

Ahwahnee Bridge

Direction: View to ~~east~~<sup>west</sup> shows  
North facade of bridge

Ahwahnee Bridge:

Built - 1928  
 Designer - NPS  
 Type - Reinforced concrete arches, veneered with native granite  
 Length - 122'  
 Span - 3: 1-42', 2-39' each  
 Skew - 0°  
 Width - Total 39'; roadway 27', one sidewalk 5', one bridal path 7'  
 Traffic Lanes - 2  
 Surfacing - asphaltic concrete  
 Original cost - \$59,513.03  
 This bridge differs from the others with its triple arched span.

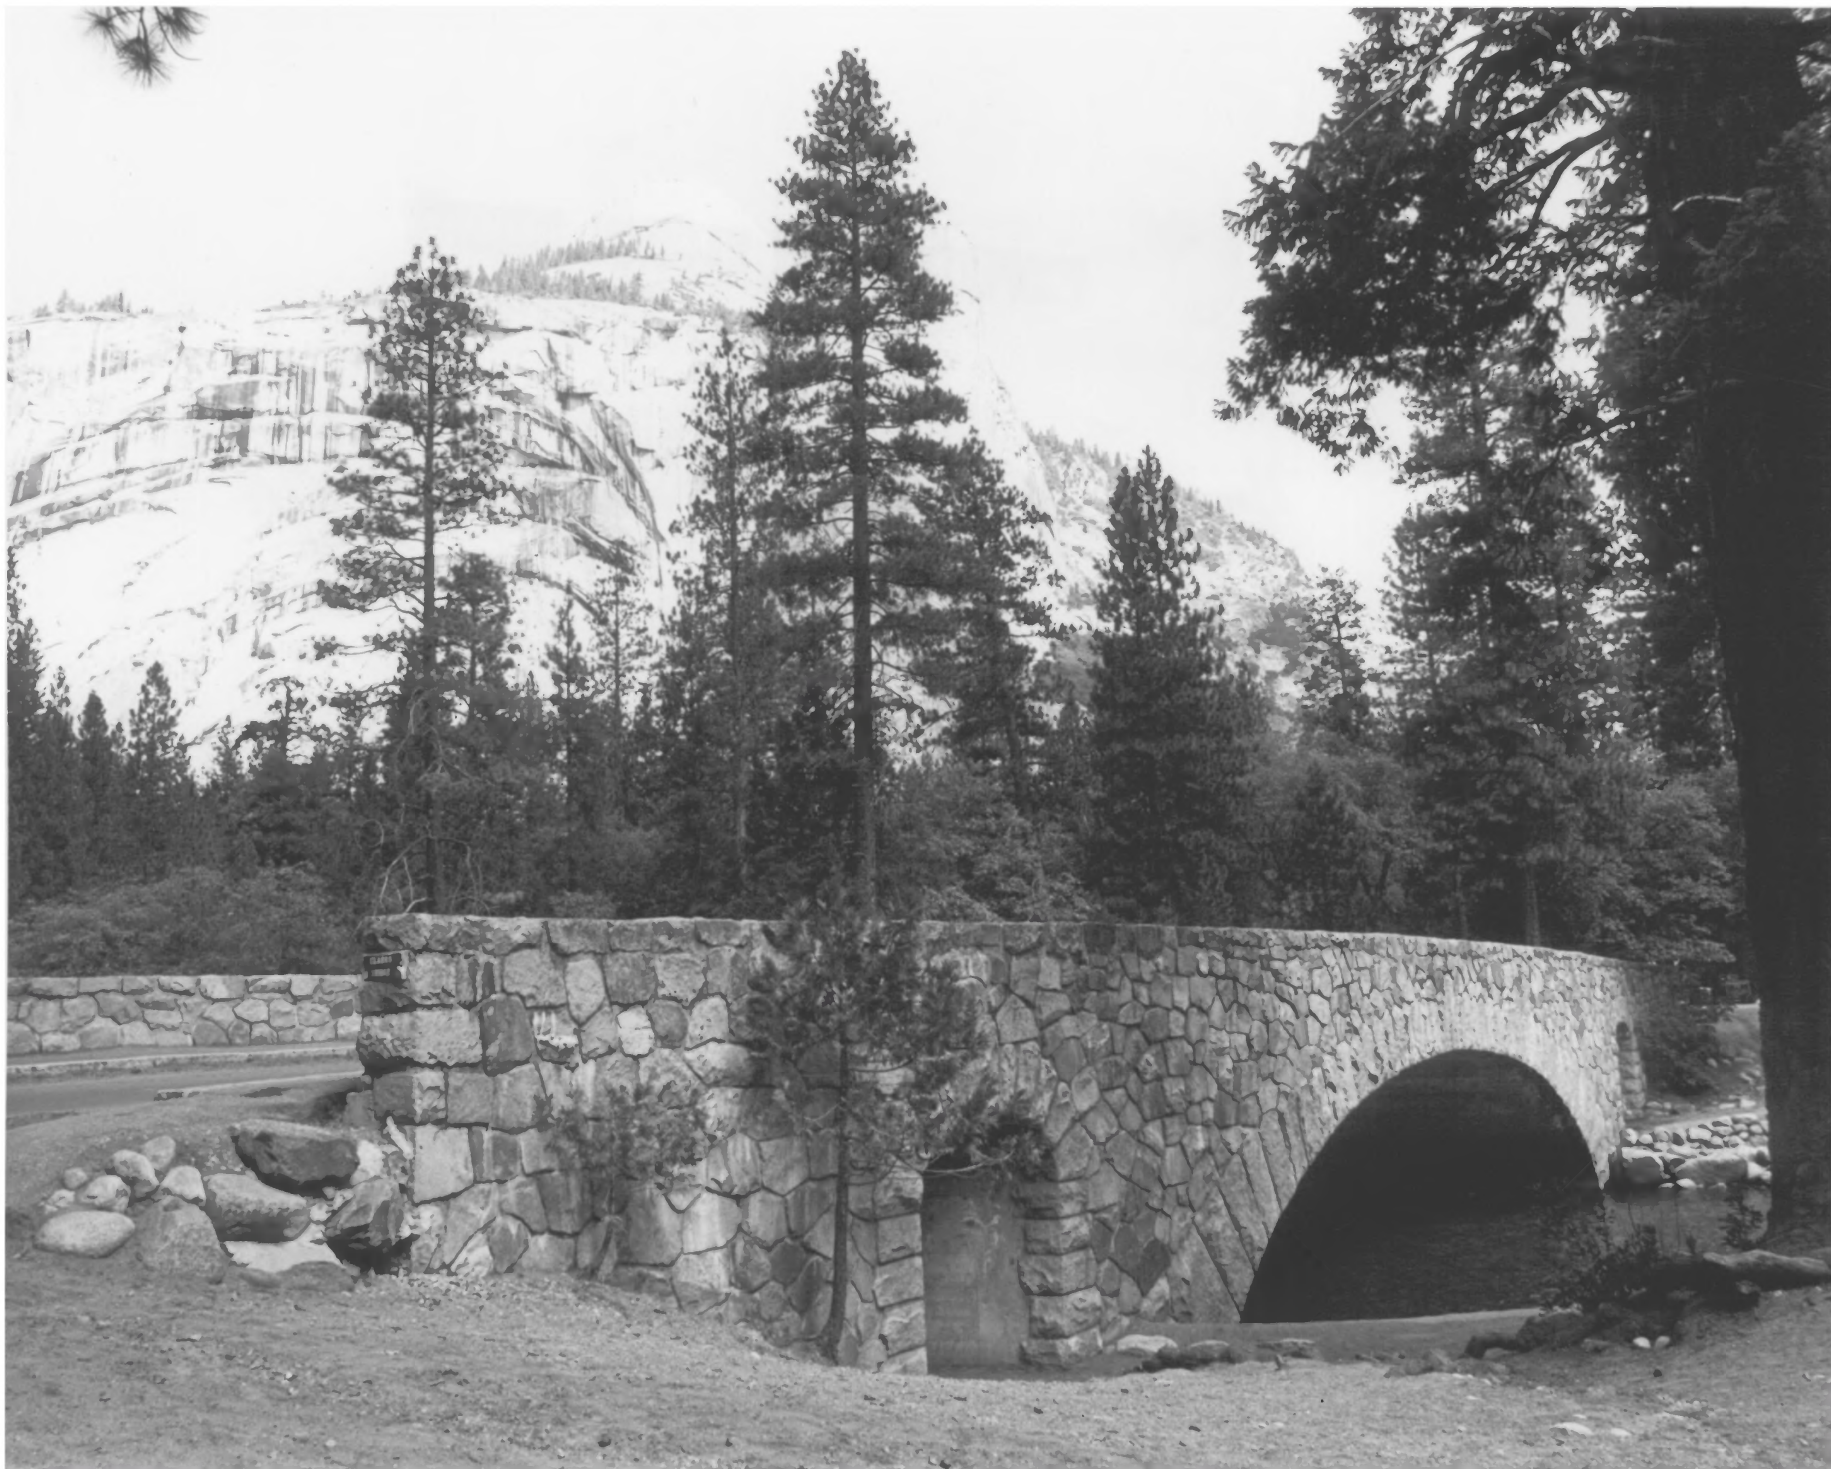
Photo # 3 *078*

Clark's Bridge

Direction: View to North shows <sup>South</sup> East  
facade of bridge w/ Royal Arches  
and Washinton Column in bkgd.

Clark Bridge:

Span - 1 - 75'7"; two equestrian subways, 7' x 11' through abutments

The semi elliptical arch which spans the Merced River is flanked by two round arched equestrian tunnels in the wing walls. The roadway of this bridge and the following six bridges is crowned in the center, along the axis of the bridge; the roadway and parapet walls are horizontal.

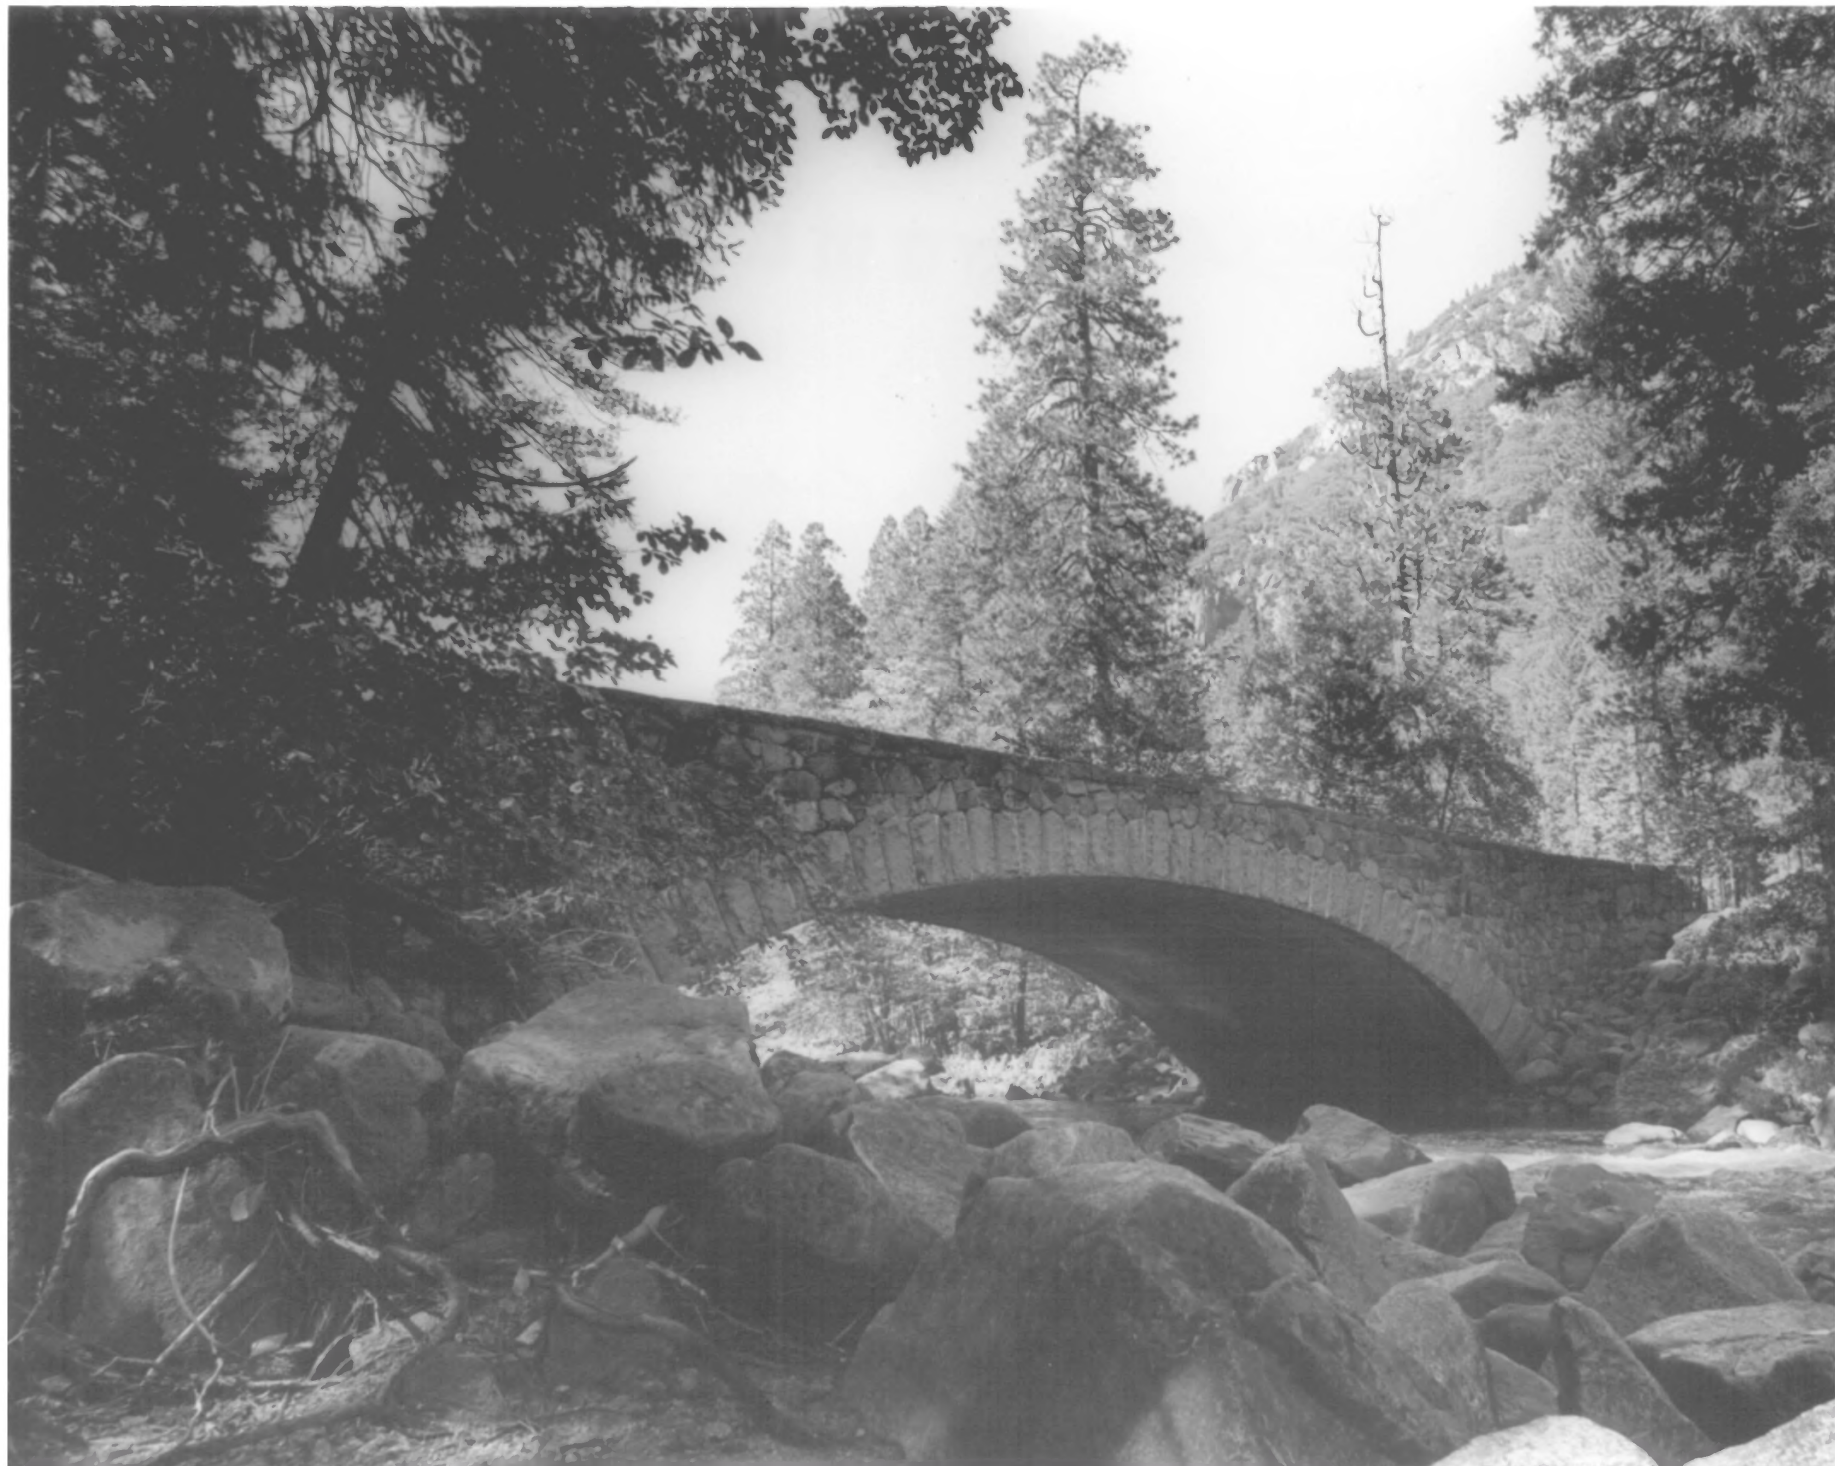
Photo #4 48

Pohono Bridge

Direction: View to Northeast shows

East facade of bridge

Pohono Bridge:

Span - 1 - 80'

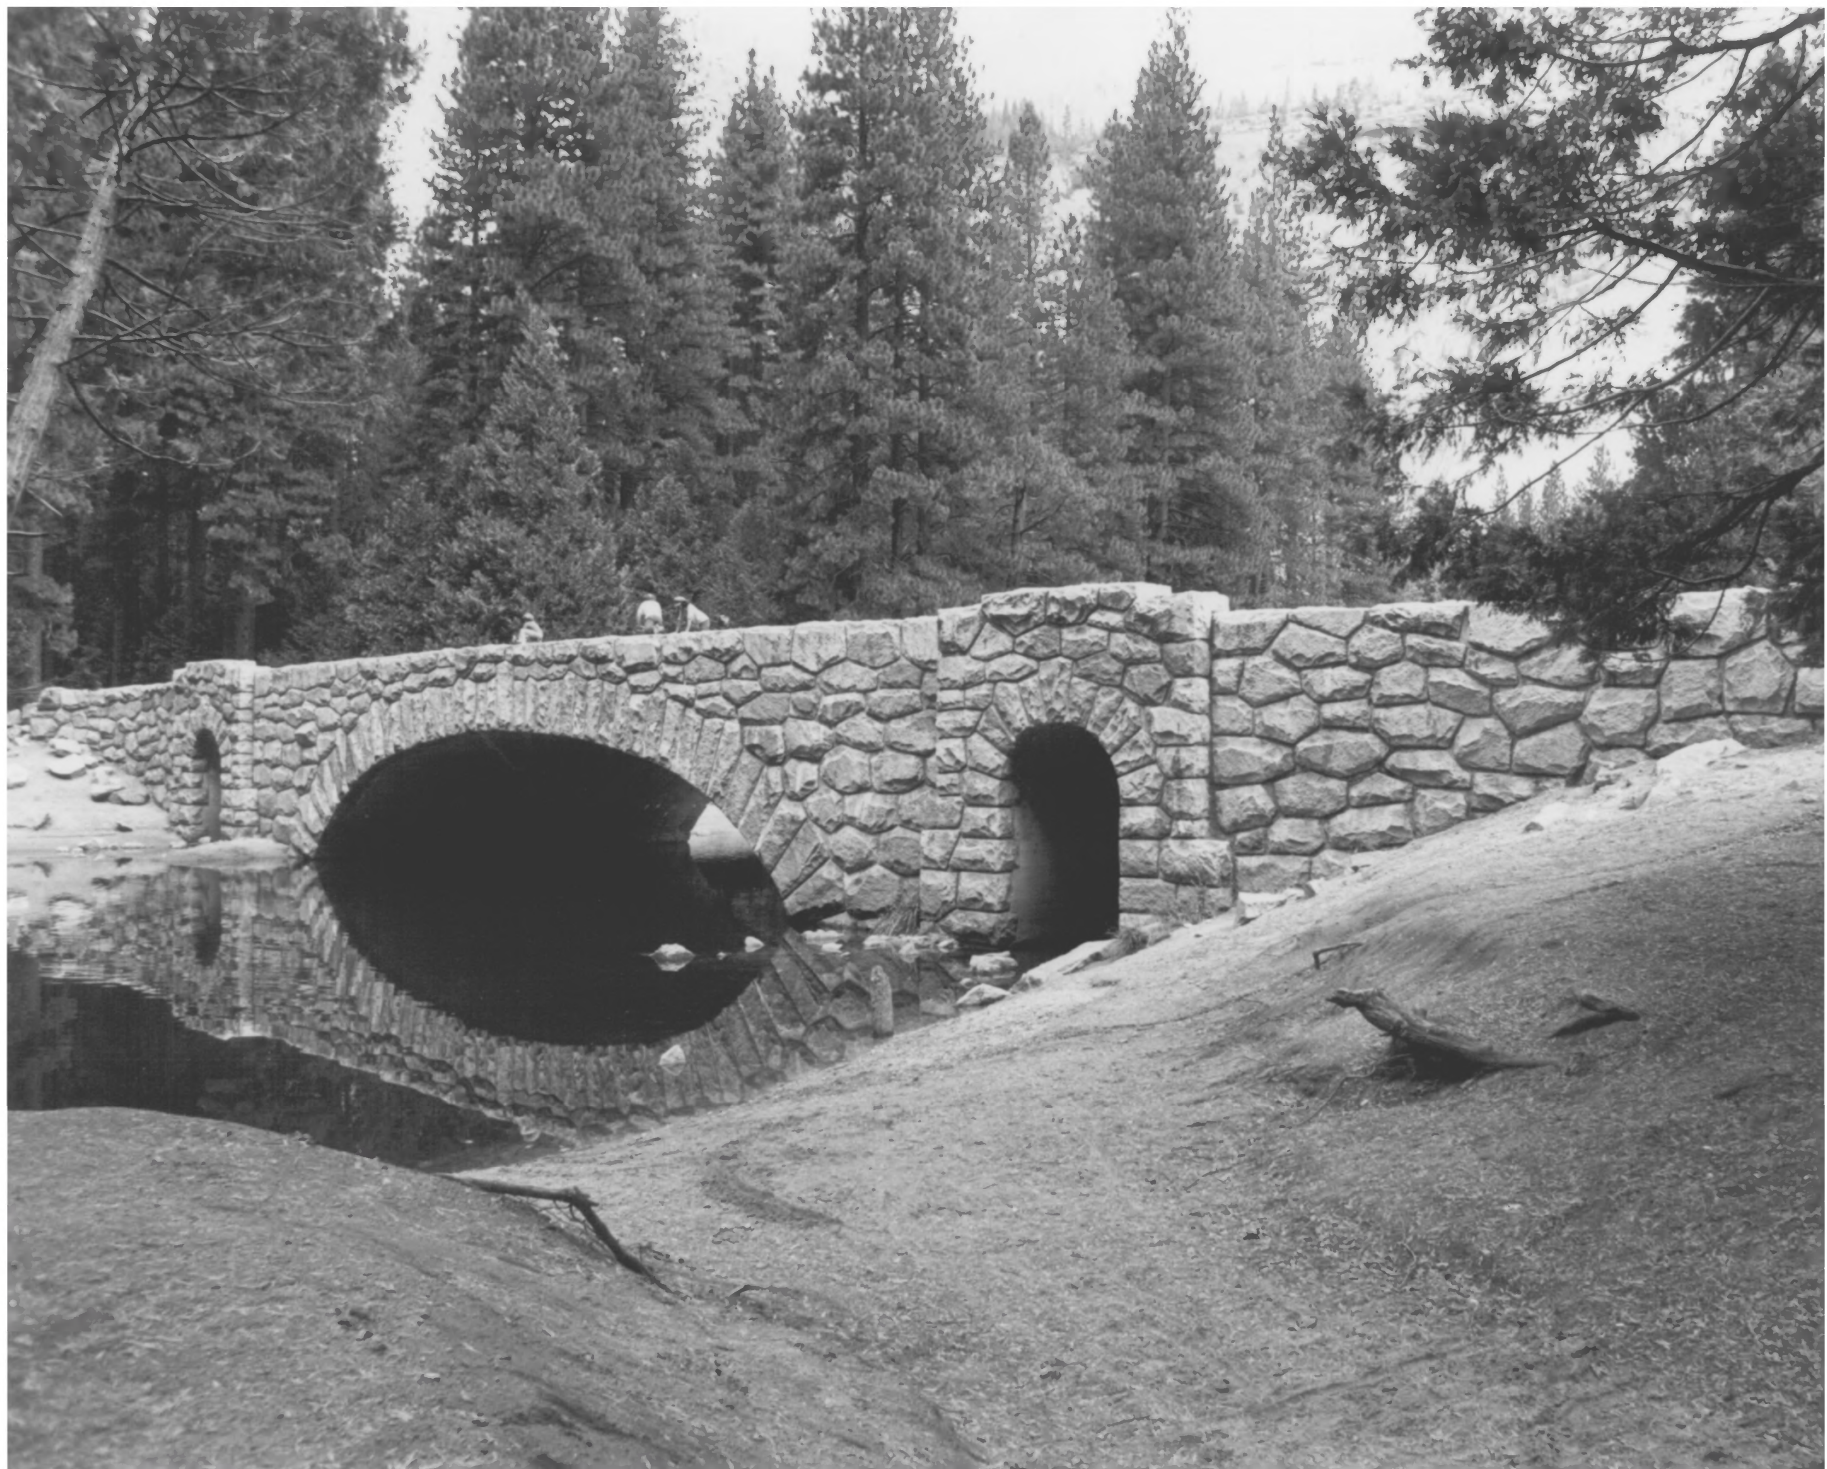
Photo # 8 of 8

Stoneman Bridge

Direction: View to Northwest show  
east facade of bridge

Stoneman Bridge:

Span - 1 - 72', 2 equestrian subways 8'6" x 11' through abutments

The latest to be built, this bridge is similar to the Happy Isles and Clark Bridges, but the equestrian tunnels are built out from the face of the wing walls, for decorative emphasis.
