Zion-Mount Carmel Highway, Virgin River Bridge  
(Virgin River Bridge)

HAER No. UT-39-C

Significance: Although partially reconstructed in 1960, the Virgin River Bridge retains its structural integrity. Attractive and well-executed, the bridge is a three-span 'I' beam structure, which was skillfully camouflaged with 54-inch Redwood slabs to give it a rustic finish.

ADDENDUM TO  
ZION-MOUNT CARMEL HIGHWAY, NORTH FORK VIRGIN RIVER BRIDGE  
Zion National Park  
HAER No. UT-39-C

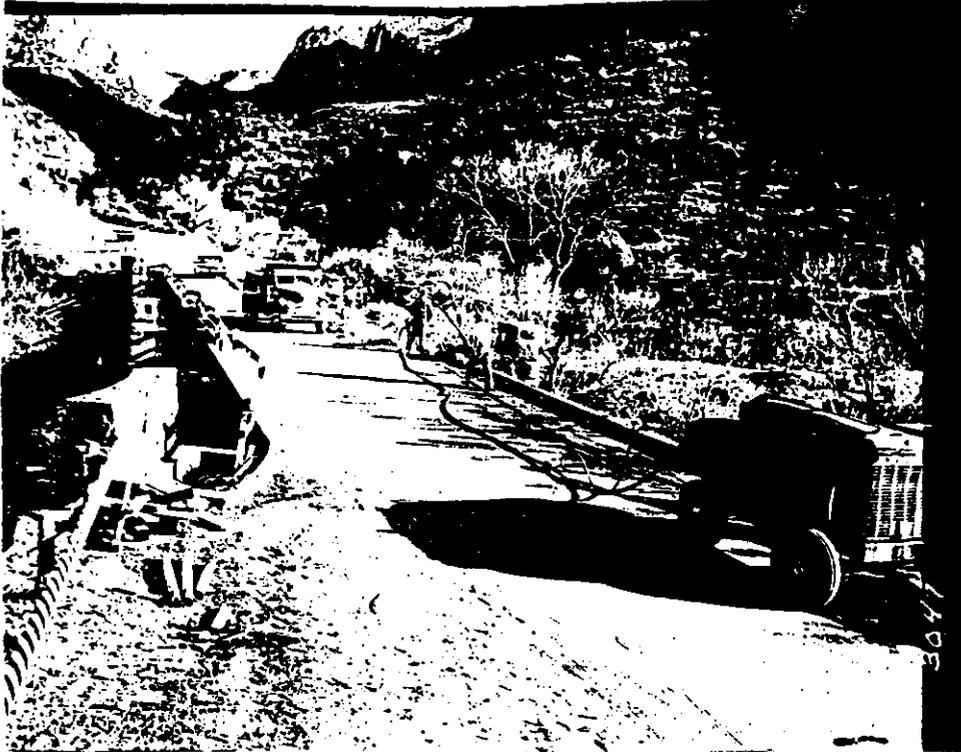
Bridge reconstruction to widen roadway to 30 feet.  
December 1959 - April 1960. (Zion NP archives)

One aspect of major road reconstruction of the park's south entrance road during the Mission 66 years included the widening of the roadway across the North Fork Virgin River Bridge. This work began in December 1959, on the bridge's downstream side where crews blasted and drilled the 5' wooden sidewalk and concrete curb, levelled the edge, placed steel reinforcing bars in the resultant trench, placed forms, then poured concrete to road level. They finished the downstream side in February 1960, then repeated the same construction steps on the other side. The entire project was completed in April 1960, with a new wearing course of asphalt. Photographs of the reconstruction indicate that the bridge's guardrails were reconstructed at this time. Wing walls were also extended at the east end of the bridge in May 1963.<sup>9</sup>

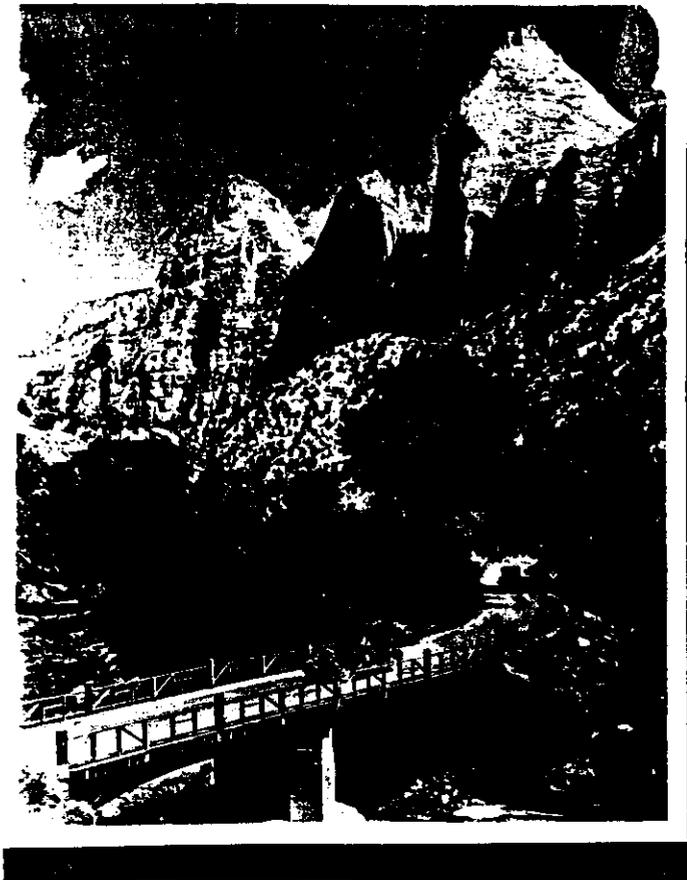
Steel truss bridge  
built in 1924-25  
spanning North Fork  
Virgin River. Re-  
placed by the new  
bridge in 1930.  
(Zion NP archives)
