FORT
MICHILIMACKINAC
ARCHEOLOGICAL
INVESTIGATIONS
1974 AND 1975

ARCHEOLOGICAL COMPLETION REPORT SERIES, NUMBER 7

EXCAVATIONS AT FORT MICHILIMACKINAC, 1974 SEASON:
A PRELIMINARY REPORT ON HISTORICAL PRESERVATION GRANT NUMBER 26-74-00092

EXCAVATIONS AT FORT MICHILIMACKINAC, 1975:
THE POWDER MAGAZINE (GRANT NUMBER 26-74-00092)

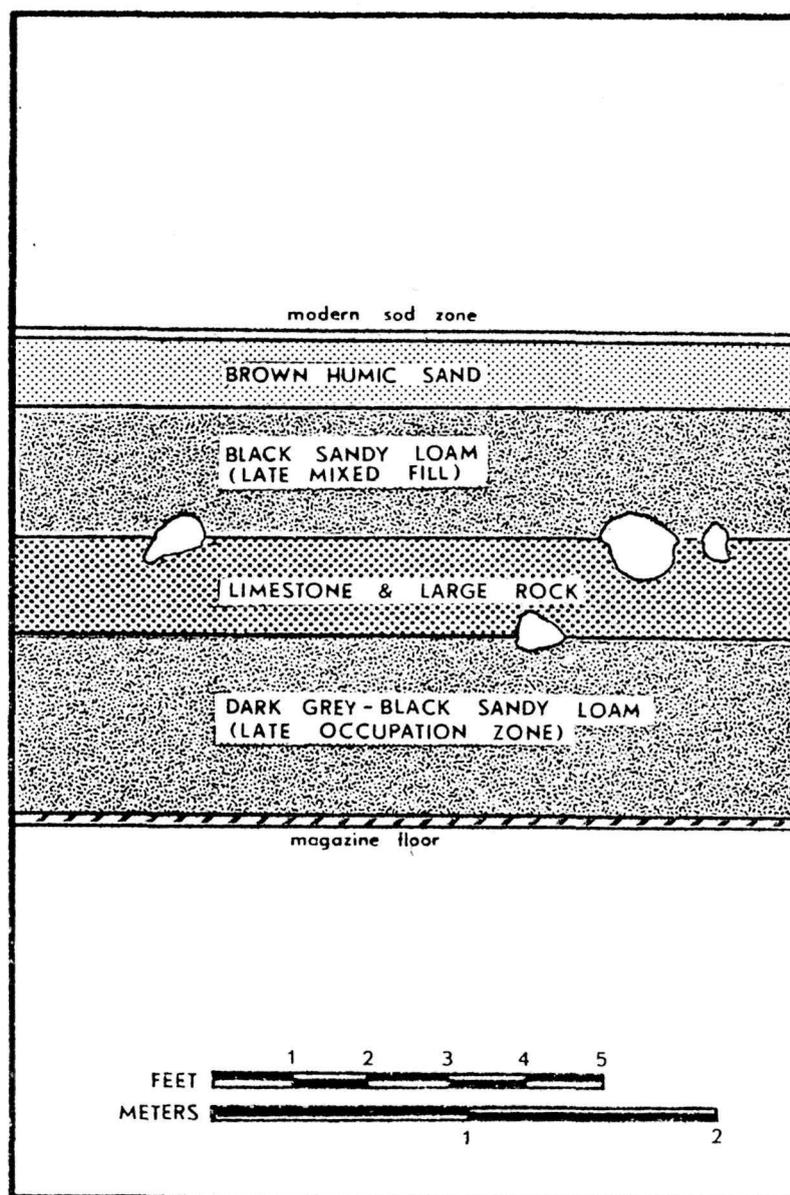
Figure 5. Idealized Magazine Stratigraphic Profile

The following chart lists 1974 stratigraphic finds overlying the powder magazine with stratigraphy reported by Maxwell and Binford (1961) and by Brown (n.d.), and is adopted from Brown (n.d.: 29). That found in 1974 is listed for purposes of comparison:

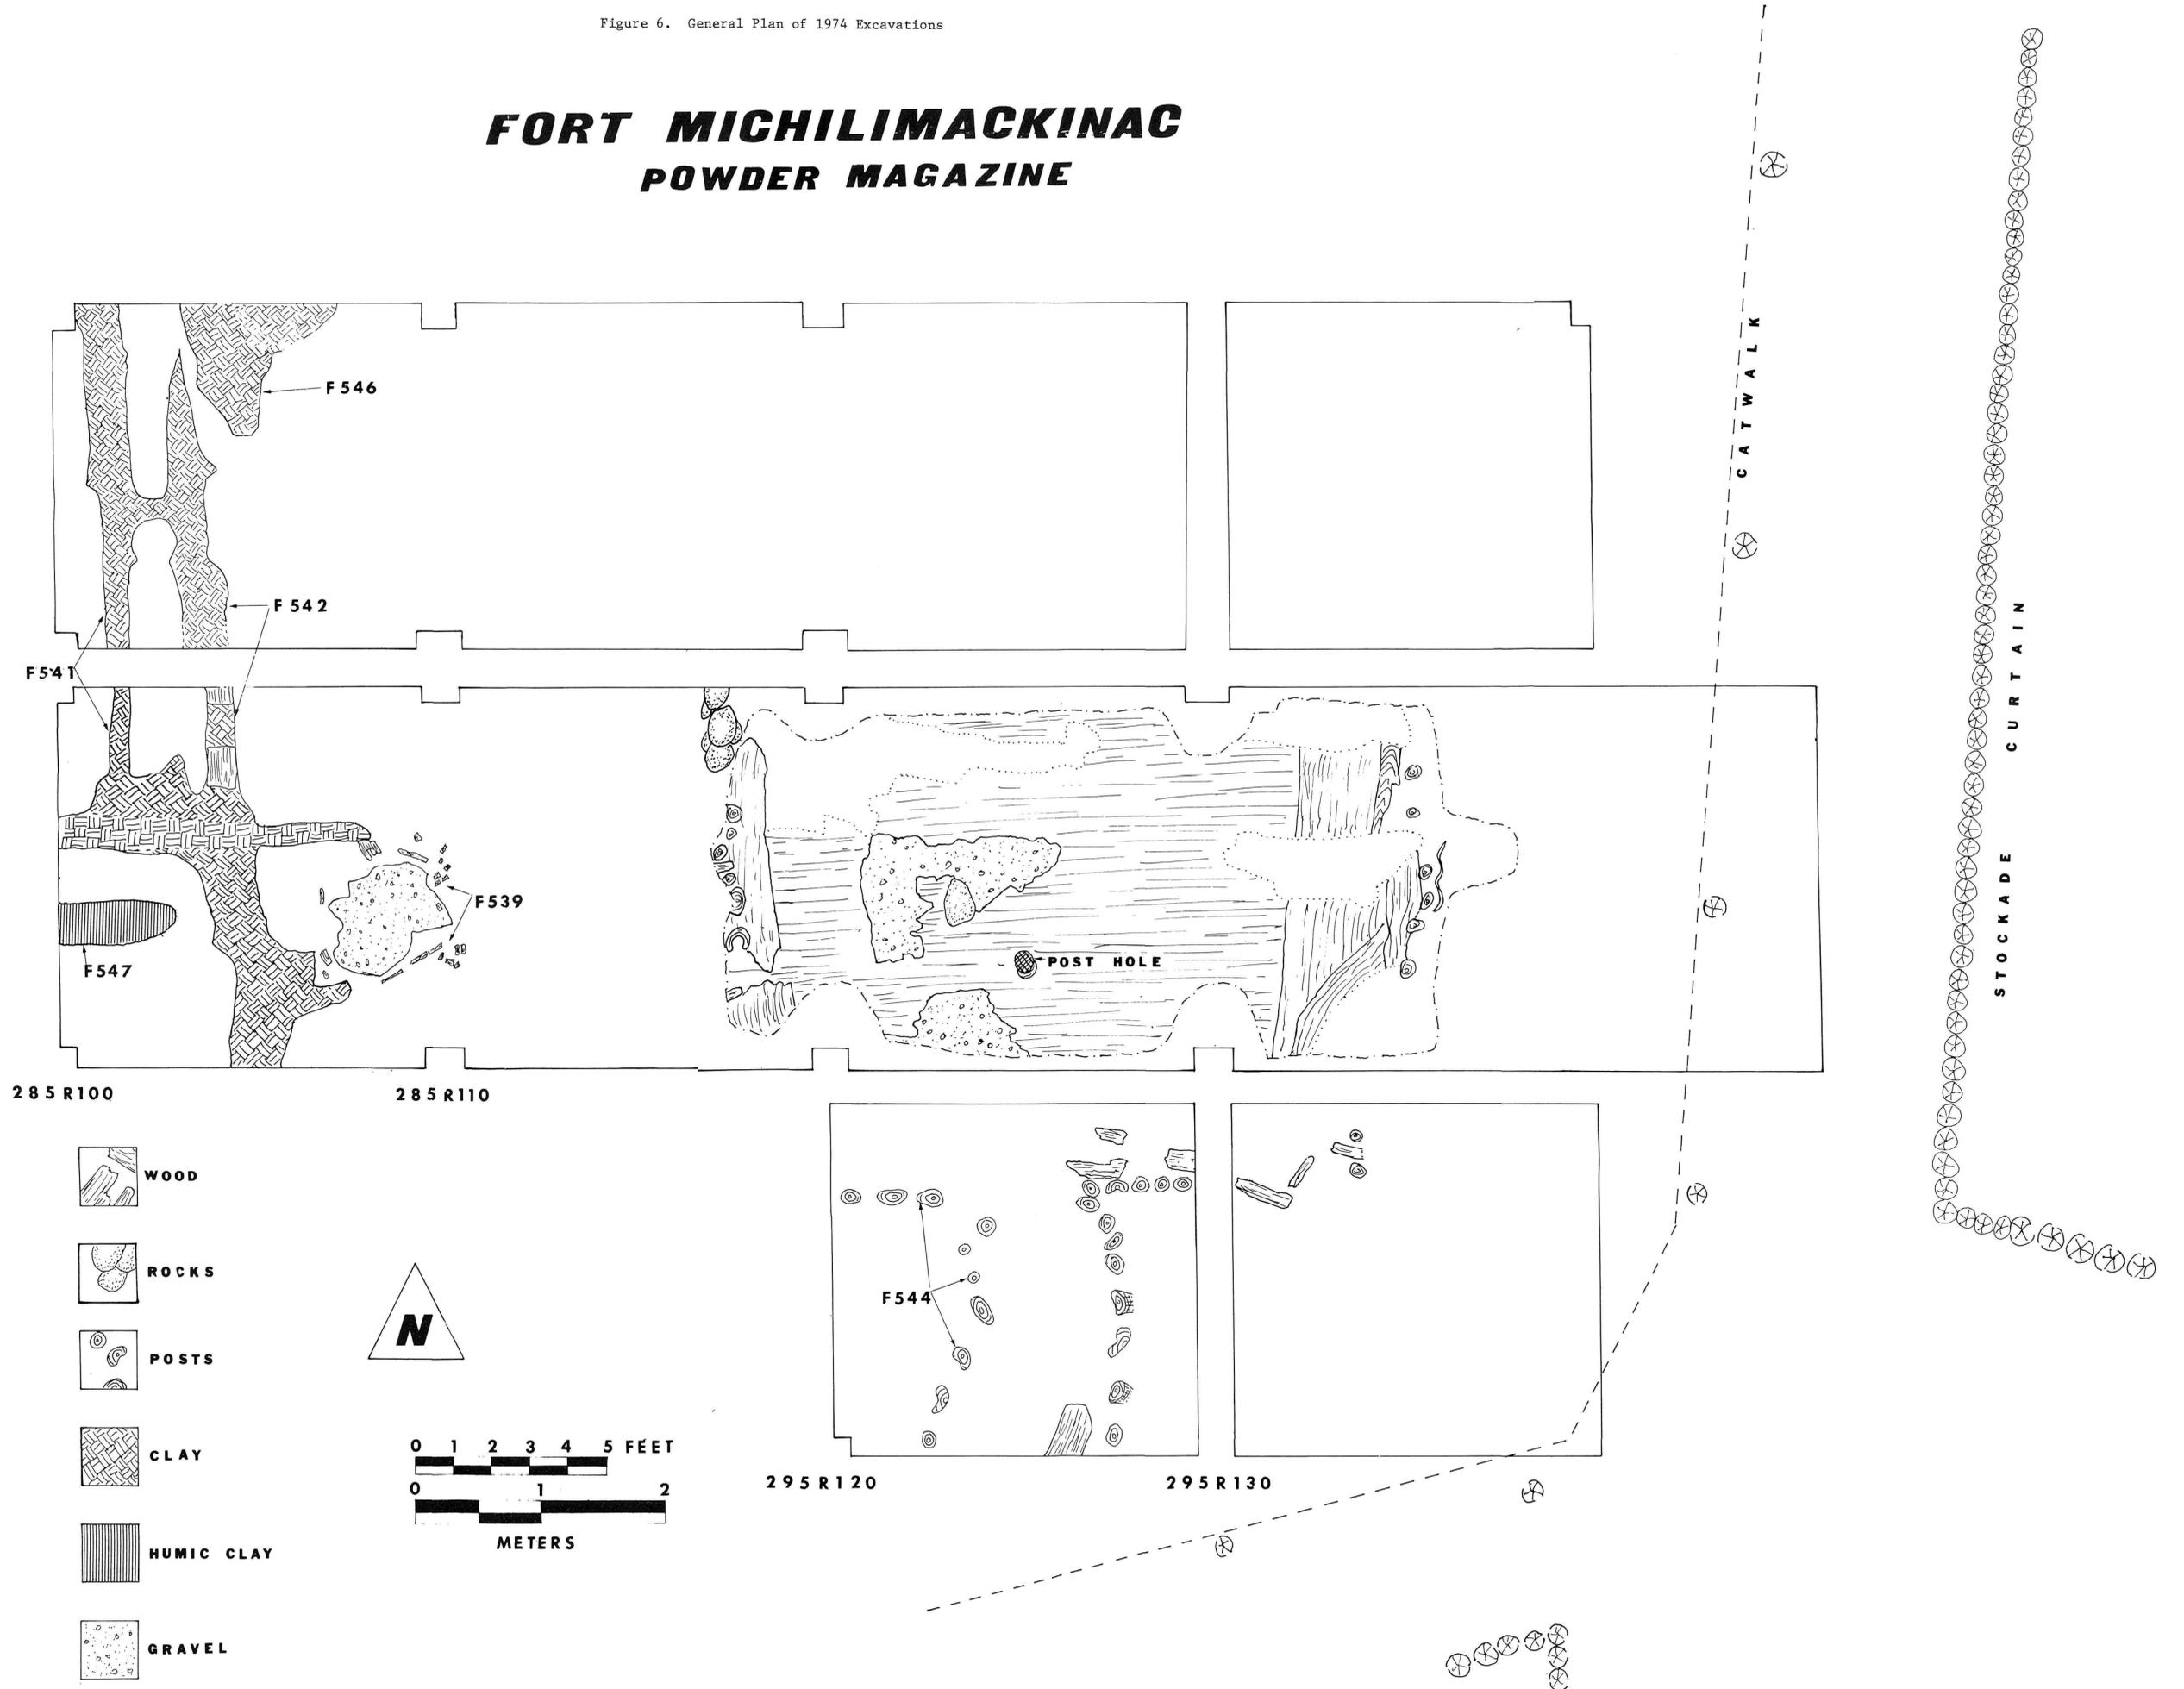
Figure 7. Detail of Magazine
Structural Remains

Structural components identified for the powder magazine include its basement and entrance walls, the basement floor, and some of the super-structure (Figure 7). Construction details inferred from remains include a basement wall or revetment (?), the basement floor, a roof support, and some information on fabrication materials. Because the building burned,

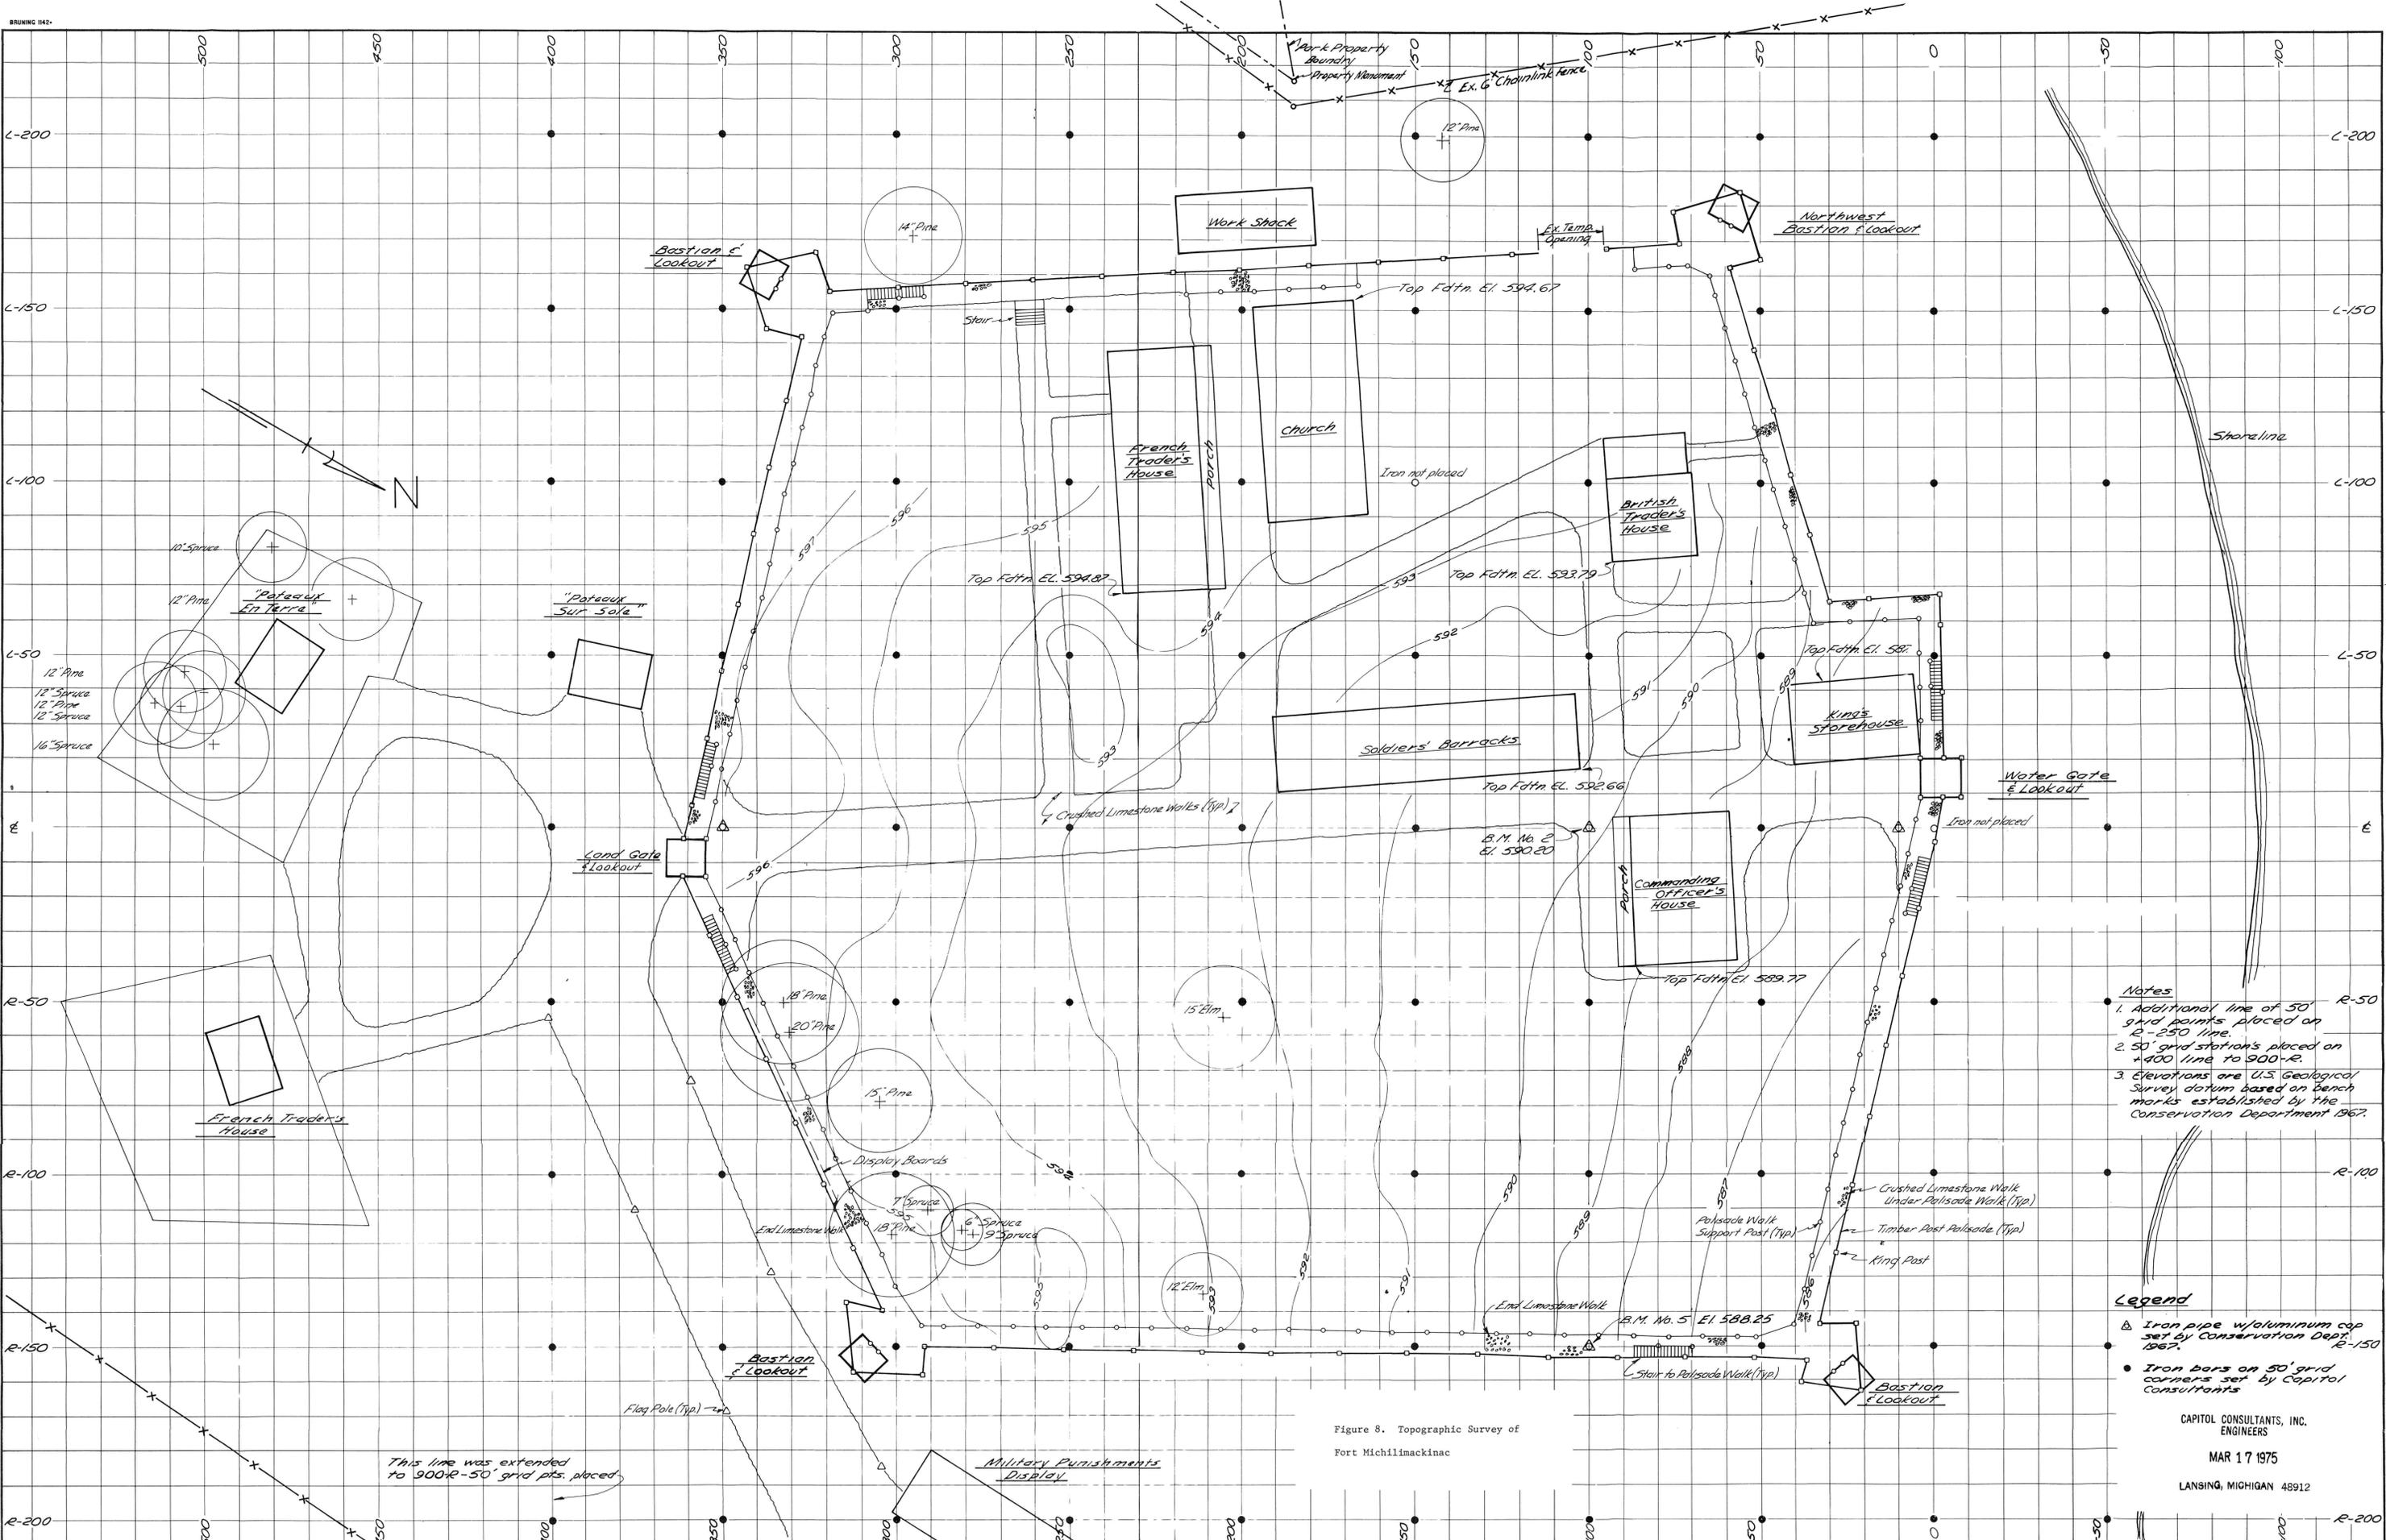
Figure 8. Topographic Survey of Fort Michilimackinac

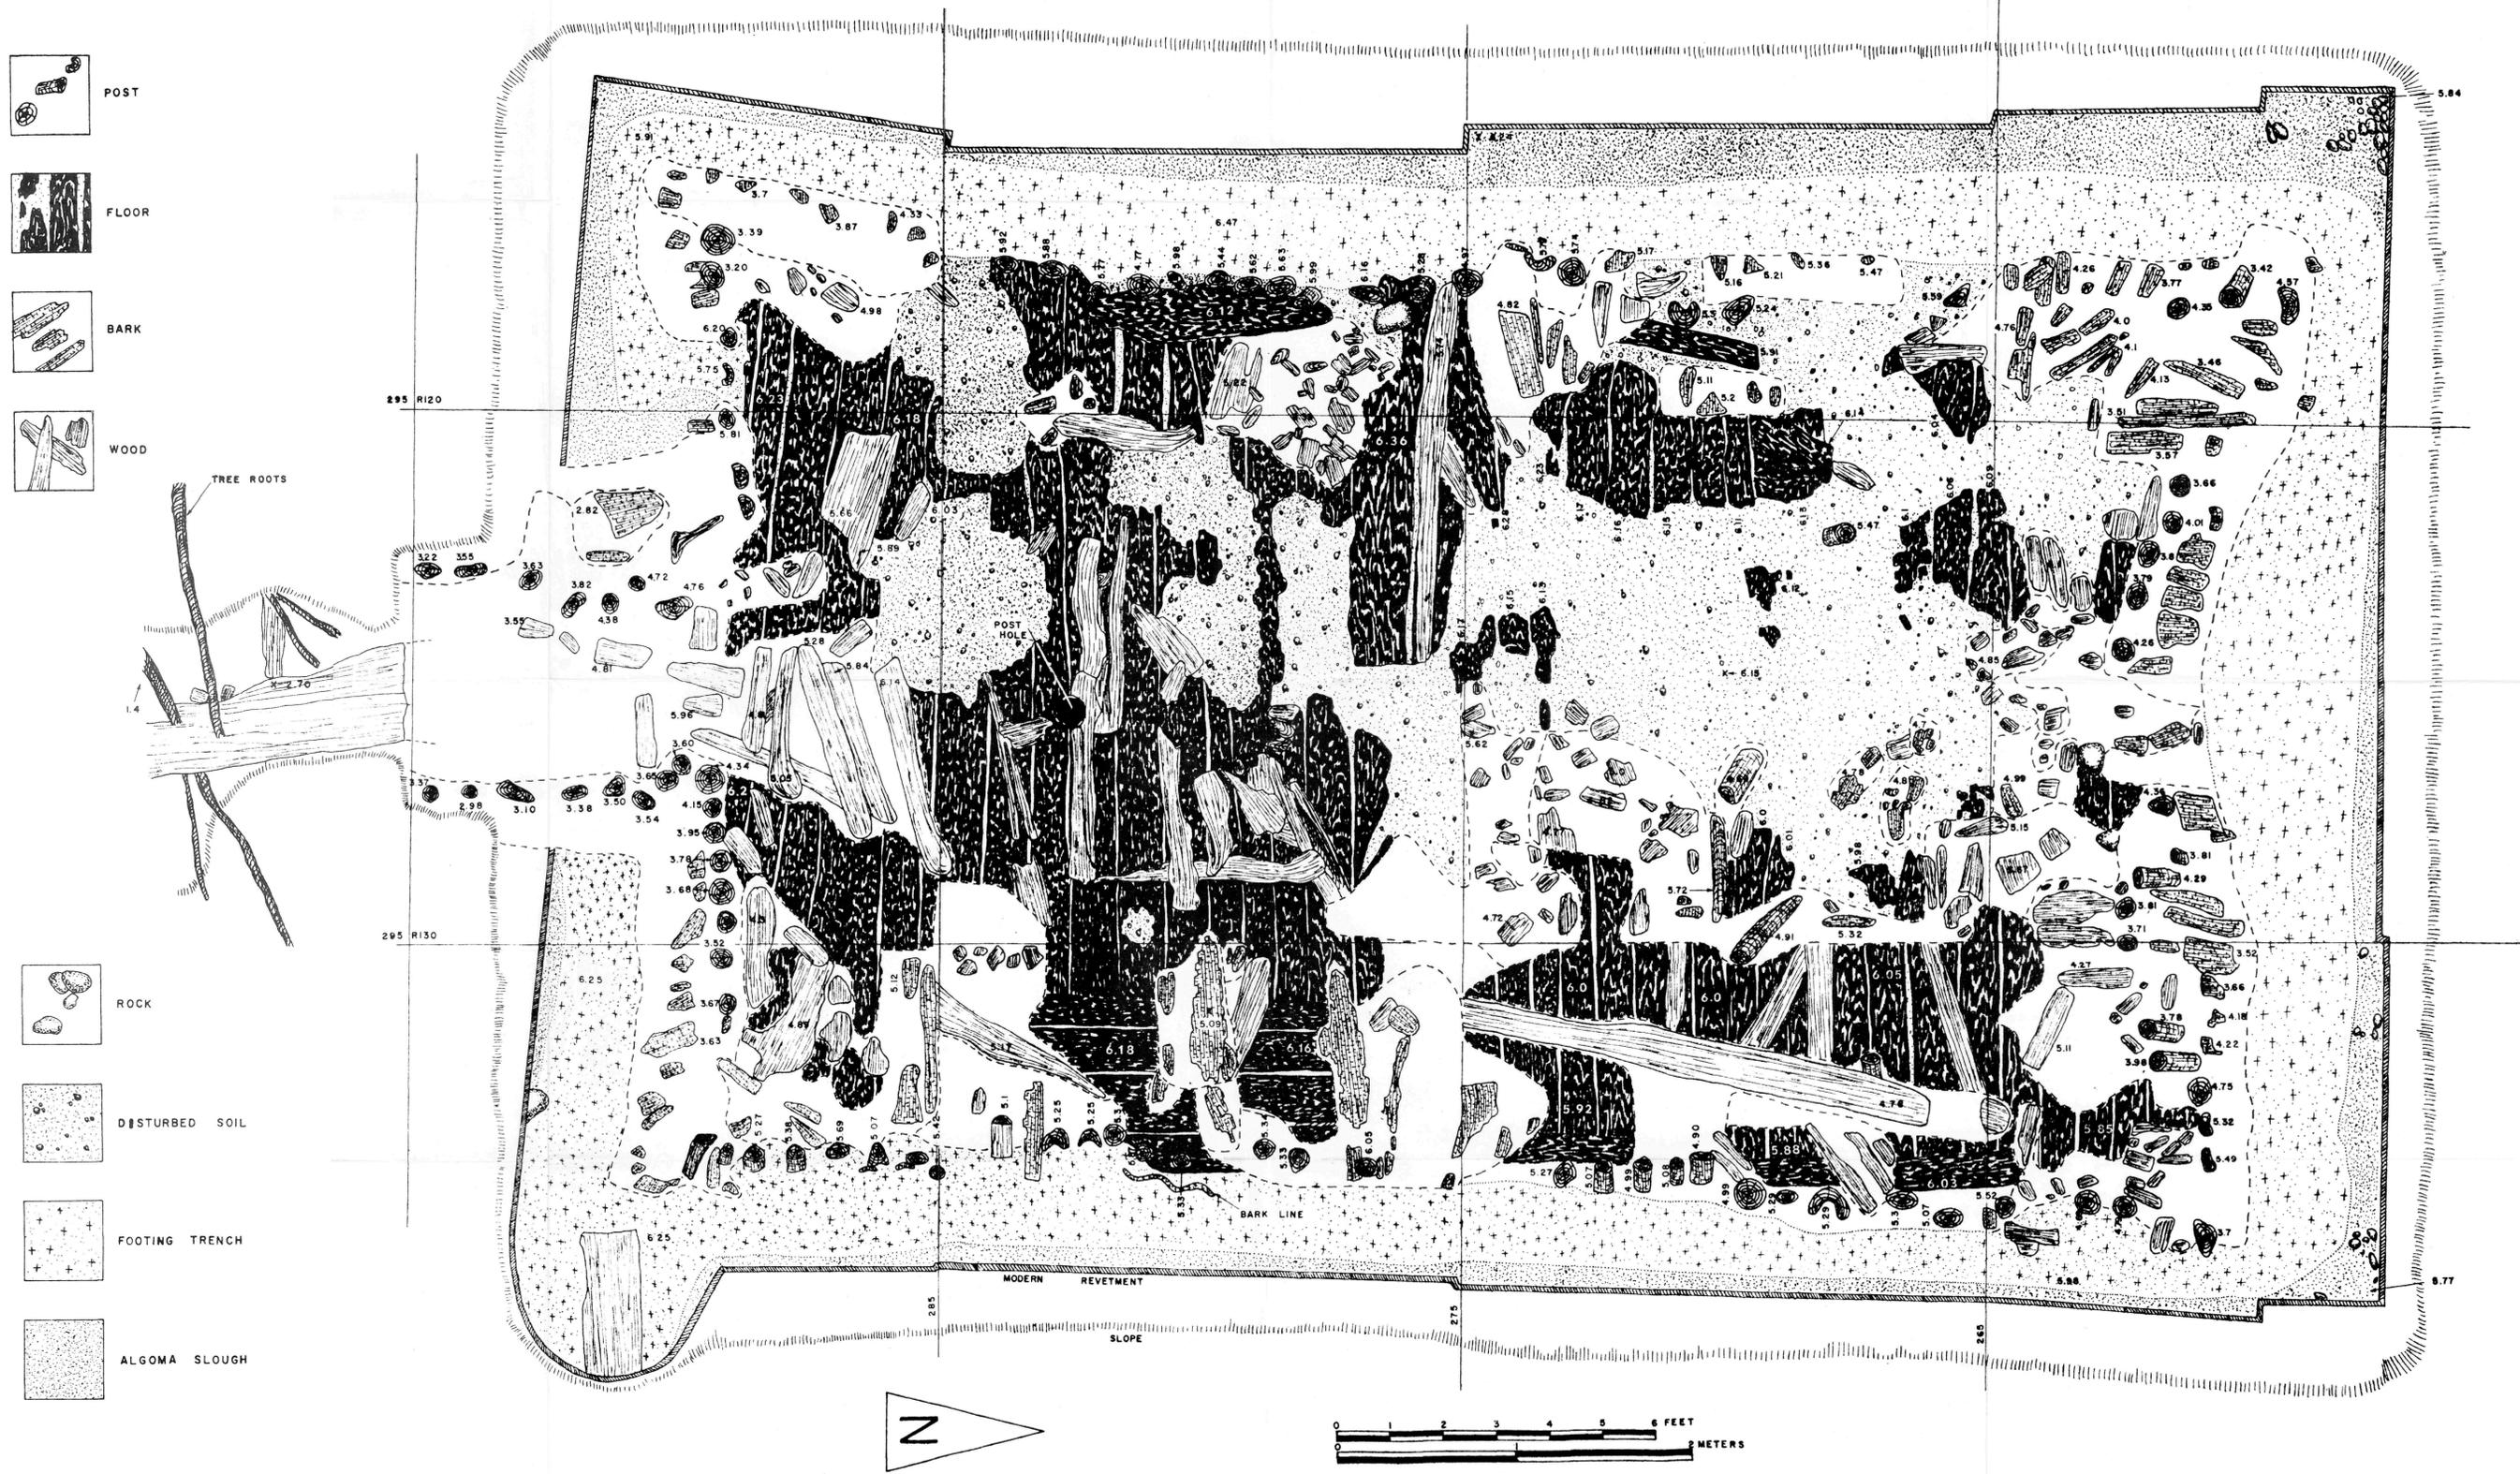
Figure 1. Plan of the powder magazine of Fort Michilimackinac

Excavation of the north wall of the magazine ruin (Figure 1) revealed the uppermost layer or "Black Sandy Loam" deposit, a later fill composed primarily of 19th and 20th century items. This layer follows perfectly the outline of the original foundation excavation of the magazine. In profile along the 255R100 base line (Figure 1), for example, the black sandy loam varied in depth from several inches to over four feet (over 1.2 meters), a circumstance which demonstrated that the entire layer post-dated abandonment of the building. That this was not recognized in 1974 is due to the fact that some colonial items were present within it; hence, it was felt that the deposit could have been contemporaneous with the powder magazine. Only by isolating disturbances resulting from illicit investigations in the magazine early in this century, vandalism that often penetrated the wood floor of the building, was it possible to demonstrate that colonial artifacts had been redeposited and mixed with the later fill above. Figure 1 shows the numerous disturbances and resulting destruction to the wood floor of the powder magazine.

and mound of sod. To remedy this deficiency, the building possessed, in addition to the corner posts, at least two internal supports along the central axis of the magazine floor (Figure 1).

Figure 1 shows floor boards neatly placed next to one another and covering the entire interior surface of the powder magazine. Floor boards rest more or less five feet (1.5 meters) below the surrounding surface of the site. No joists underlie them, for disturbances, that is, pot holes (see Figures 1 and 5) from illicit digging early in the twentieth century (see Stone 1974 : Figure 7) were carefully excavated below edges of the surviving floor boards. Not a single vestige of a joist, not so much as a stain was found. Moreover, no nails are present in the floor, another indication that joists are missing altogether. It thus appears that floor boards rested directly upon sand and gravel of the Algoma beach. Generally in the construction of powder magazines the floor is separated from the underlying surface by a number of joists. Air then circulates freely within the building, providing ventilation. Otherwise, dangerous gas and a high percentage of humidity may build up. It is possible that humidity, more than any other factor, was the cause of frequent repair to the powder magazine.

The position of the surviving beams and rafters is such that there is little doubt that the roof was flat, or that the entire building appeared as a huge rectangular box covered with bark shingles. Sod was placed over the roof and along only the east and west walls by 1765, for the Crown map illustrates the facade of the building. Lotbinière also noted that the "powder magazine is buried and covered with turf" (Gérin-Lajoie 1974 : 7) in 1749, the year he visited and described Michilimackinac for the French governor in Quebec, who wished an accurate survey of the water route between Quebec and Michilimackinac (Gérin-Lajoie : 2-3 and 8). Sod cover may have been a feature of the building throughout its history. At the time the British burned the magazine, it is possible that they removed some or all of the sod. Otherwise, more of the walls and roof would be preserved. Because of the charred and fragmentary nature of the roof, dimensions are meaningless, although remains of rafters and ties may be seen in Figure 1.

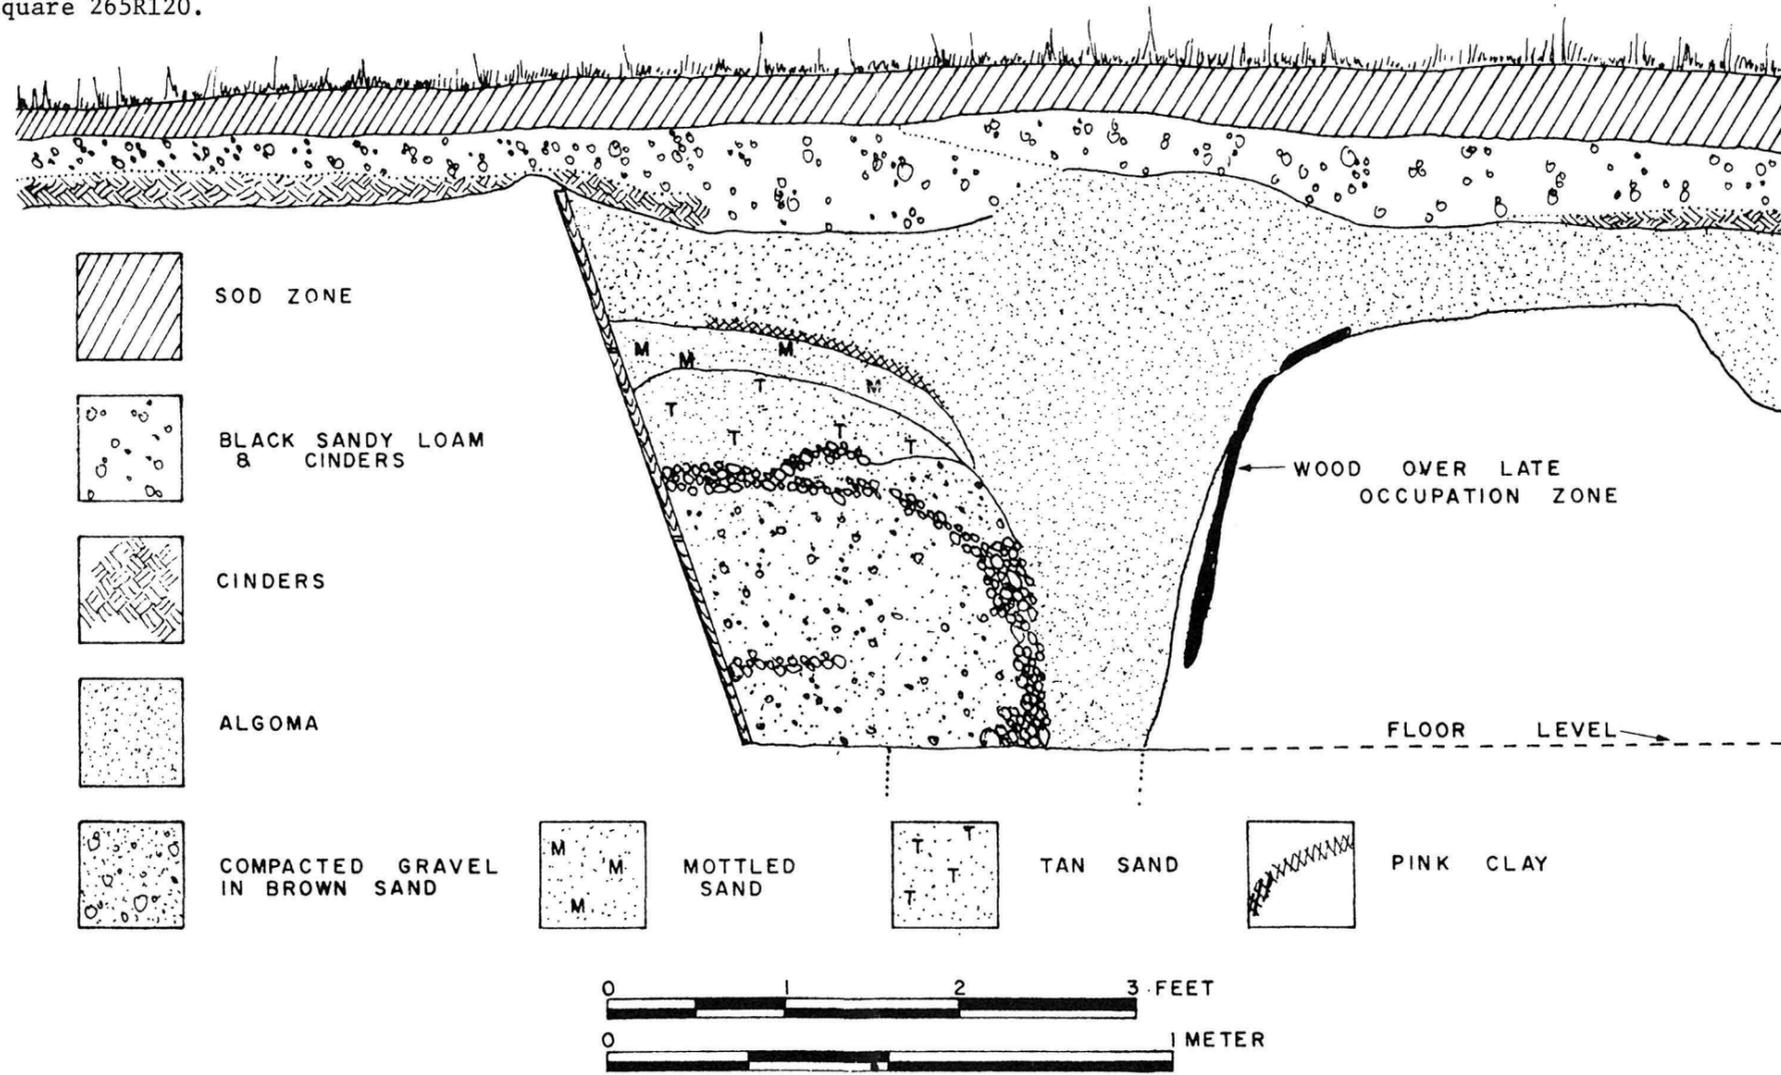
Figure 2. Cross-section of fill overlying the powder magazine ruin in square 265R120.

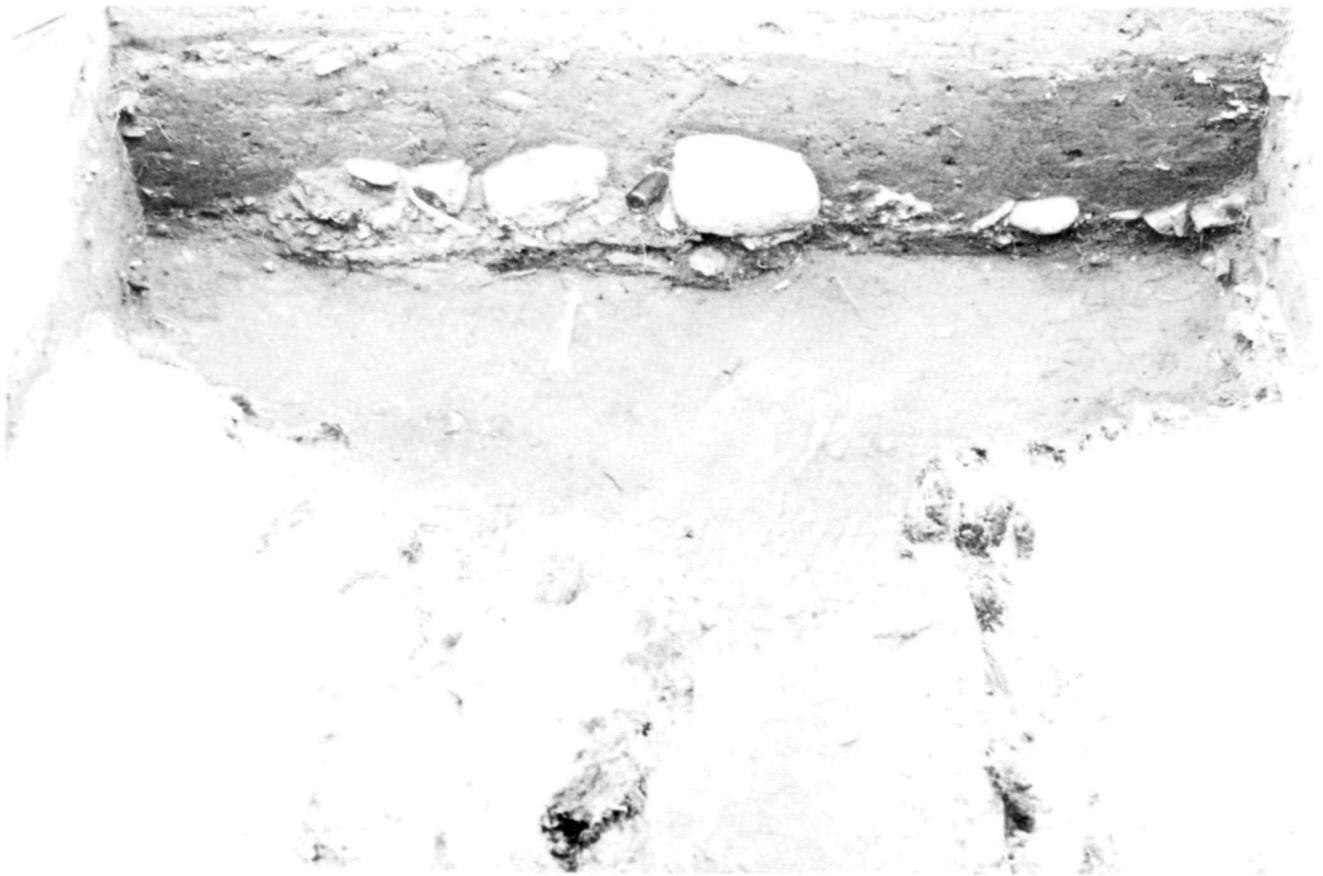
Figure 3. Cross-section of fill overlying the magazine ruin in square 295R120. Note the bottle dating to the turn of this century within the rock layer.

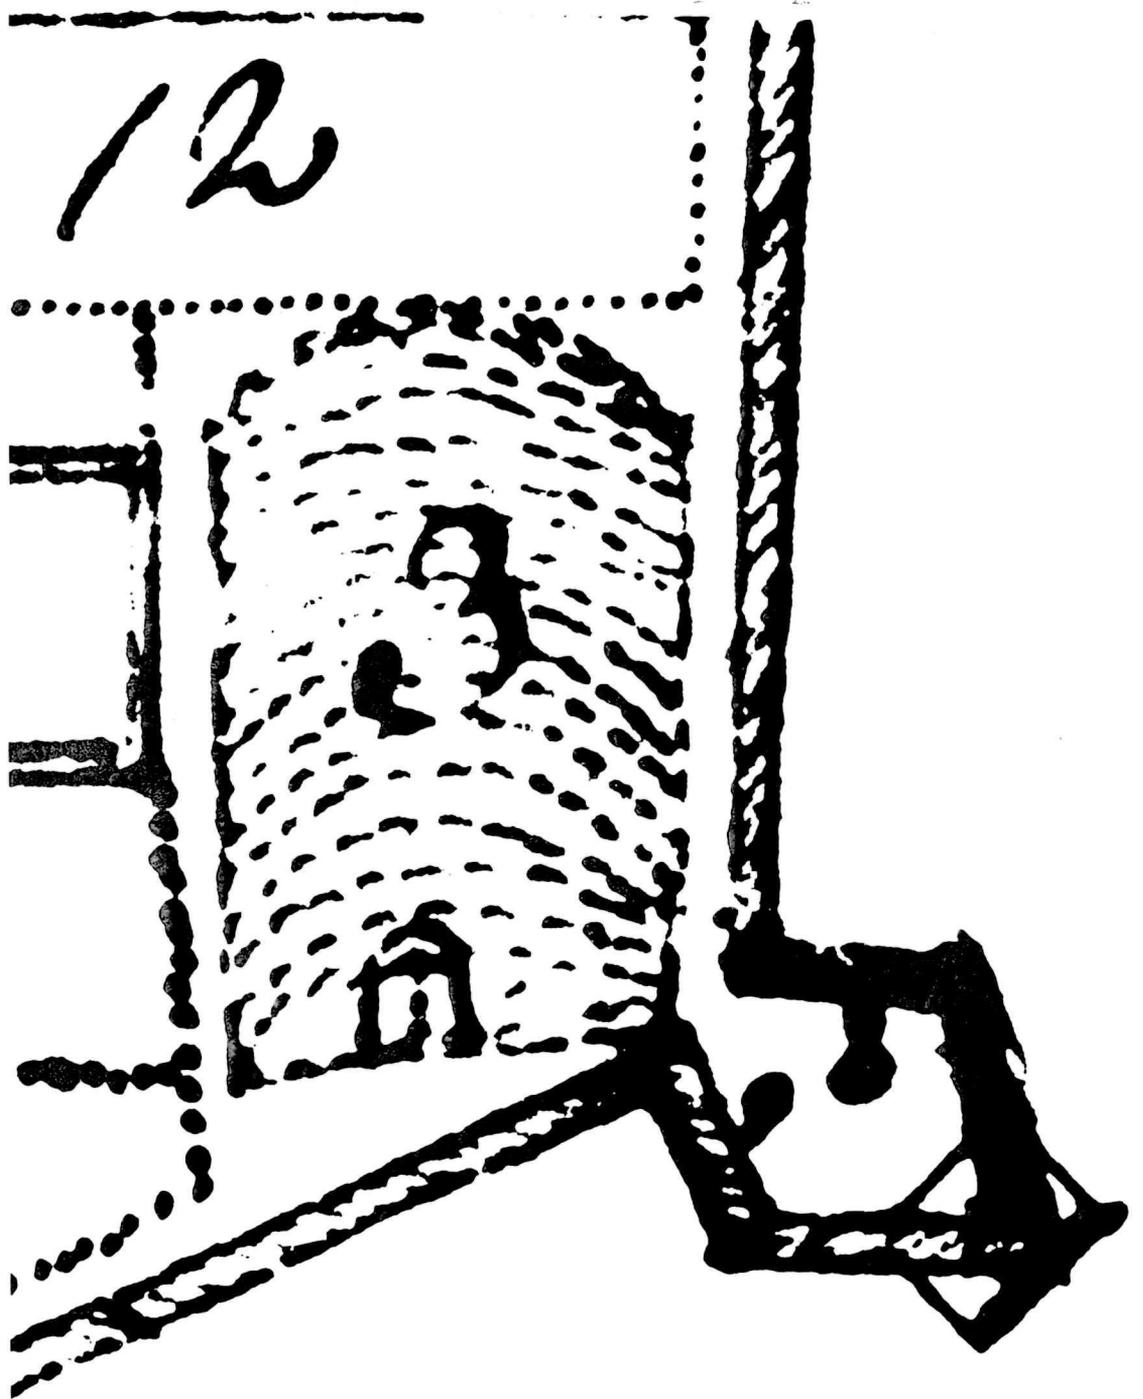
Figure 4. Three-dimensional drawing of the powder magazine in a map of Michilimackinac in the Collections of the Crown (from the original map in the British Public Record Office, C. O. 700/2. Crown copyright material, reproduced with permission).

The map of Michilimackinac in the Crown collection, London, depicts two doors, an overhead lintel probably of hewn timber, and what clearly is an arch above the lintel. It seems certain that the doorway found during the 1975 field work is that illustrated in the Crown map (Figure 4). Moreover, a rotted and fragmentary panel of wood, possibly one of the actual doors illustrated in the drawing, was found lying in the entranceway in square 300R120, level 2. It is unburned. Perhaps at the time of demolition of the powder magazine the doors were freed from the doorway before the building was set ablaze.

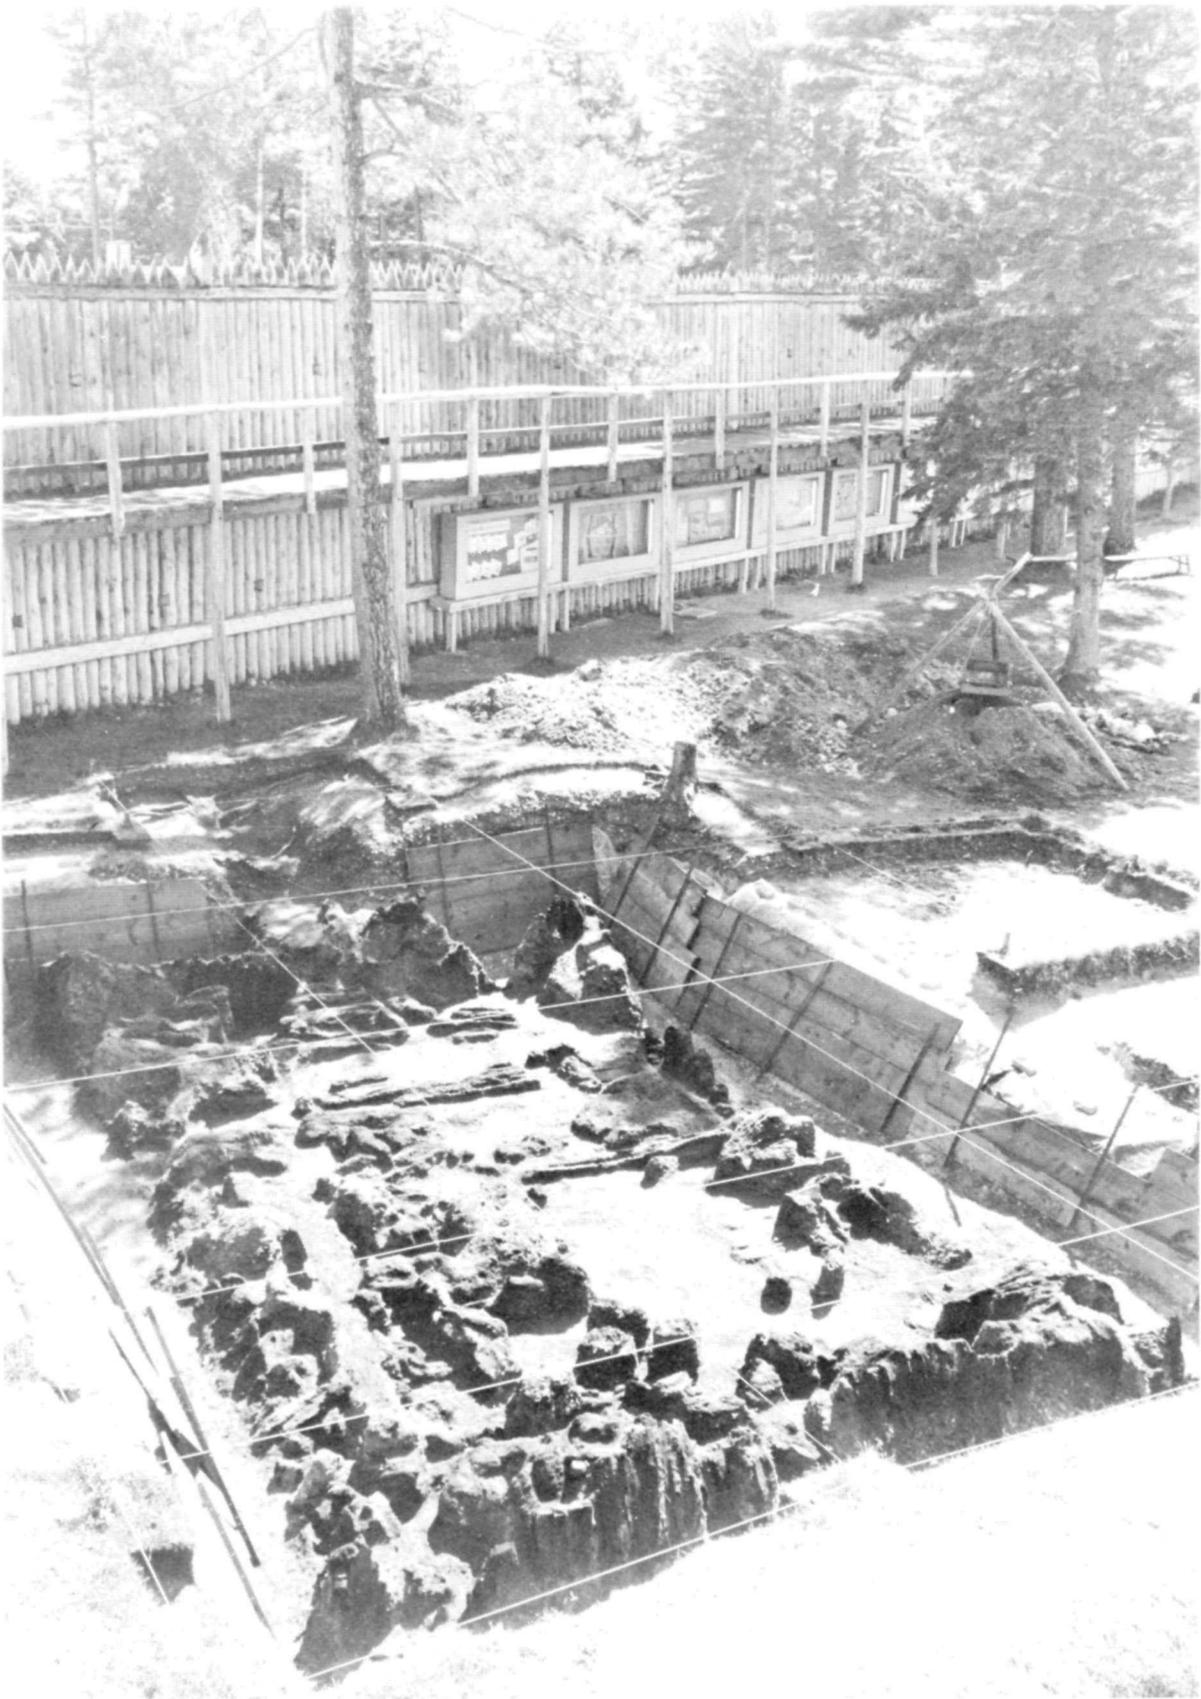
Figure 5. View of the completed excavation from the northeast on the reconstructed catwalk along the palisade wall.

Floor boards vary in width from nine to eleven inches (22.9 to 28 centimeters) and always are cut to the inch (Figures 1, 5, and 13). Because in colonial times as today the British system of measurement included the inch, the floor boards probably are British. They may be seen in plan in Figure 1. It therefore seems reasonable to assume that the British added floor boards, and perhaps the clapboards of the walls and roof as well, in the normal course of repair. One avenue of library research that could clarify these points is a translation of French documents pertaining to the Upper Great Lakes region in general, and Fort Michilimackinac in particular.

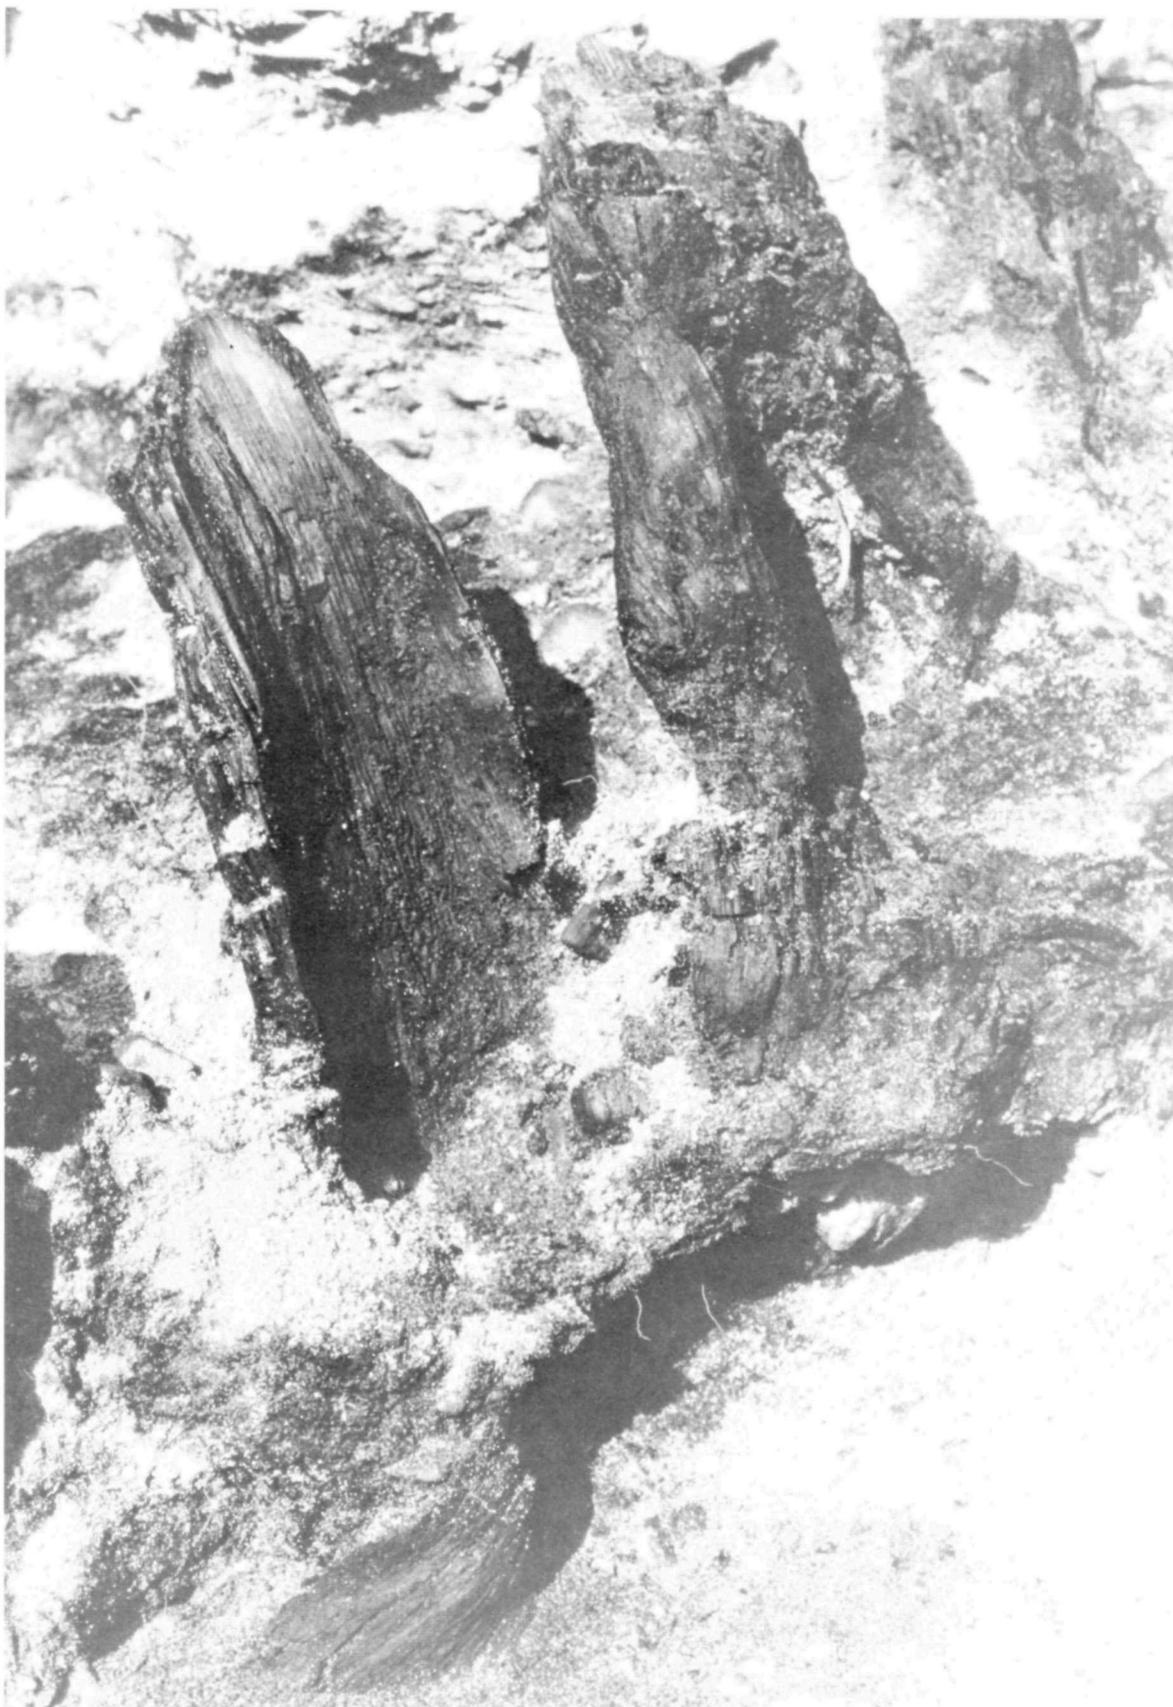
Figure 7. East wall of the powder magazine in square 295R130 showing wattle along the outside wall. View is from the southeast.

In both construction technique and architectural style the powder magazine appears, at first glance, to be French, a poteaux en terre building set into an undisturbed footing ditch (Figures 1, 2, 5, 7, 8, 9, and 14). Because most of the footing ditch has never been disturbed, and because the sloping side wall of the foundation excavation shows no indication whatsoever of architectural remains, it is certain that the powder magazine found in 1974 and 1975 is the only one ever constructed there. One architectural feature almost certainly French is an exterior wall cover of wattle, a construction of woven bark and brush at 5.8 feet (1.75 meters) below datum (in square 275R130, level 5) (Figure 7). Wattle has been found elsewhere at

on the powder magazine is French. No daub was found with the powder magazine, however. Because of the superb conditions of preservation there can be little doubt of this (Figure 7). One is thus led to conclude that only wattle was used in the construction of the powder magazine. A clue to its function may be related to the wood floor within the structure itself and is discussed below.
