FORT
MICHILIMACKINAC
ARCHEOLOGICAL
INVESTIGATIONS
1974 AND 1975

ARCHEOLOGICAL COMPLETION REPORT SERIES, NUMBER 7

EXCAVATIONS AT FORT MICHILIMACKINAC, 1974 SEASON:
A PRELIMINARY REPORT ON HISTORICAL PRESERVATION GRANT NUMBER 26-74-00092

EXCAVATIONS AT FORT MICHILIMACKINAC, 1975:
THE POWDER MAGAZINE (GRANT NUMBER 26-74-00092)

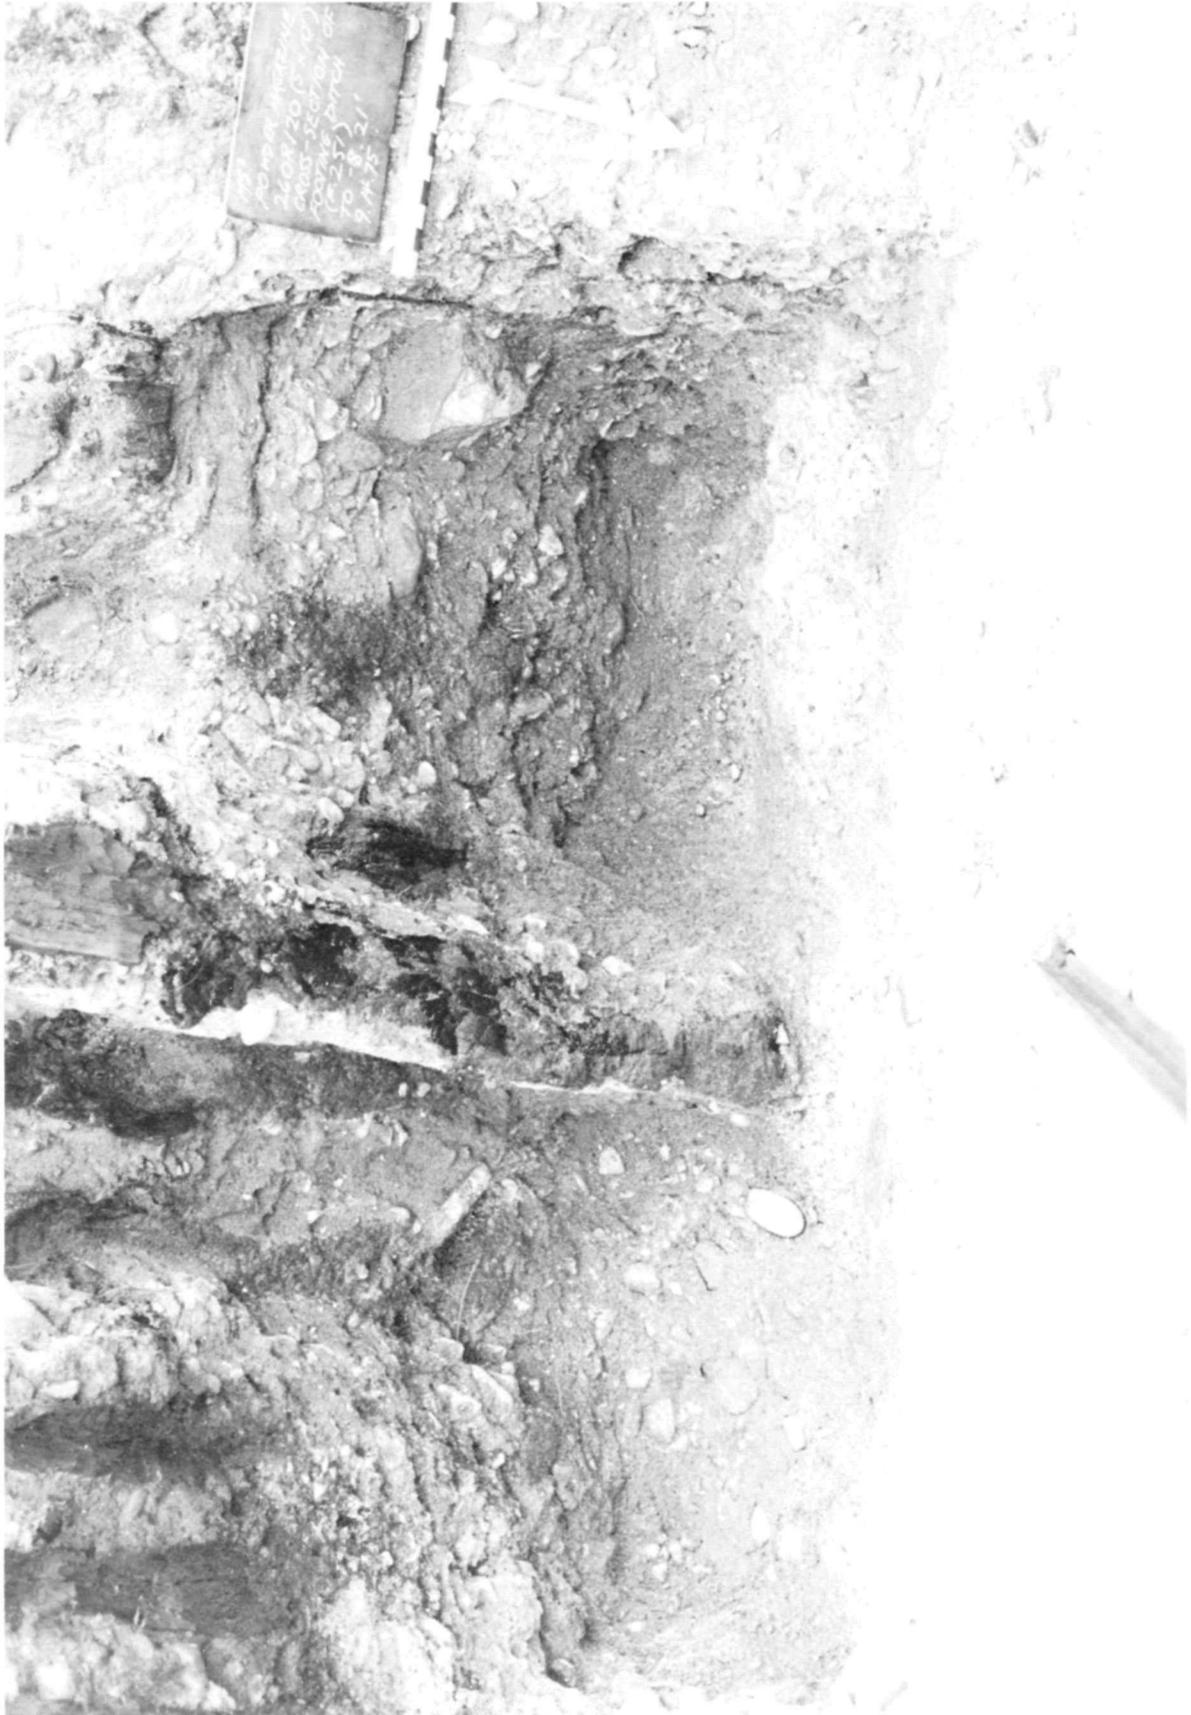
Figure 8. North wall of the powder magazine in 265R120, showing the archaeological test of the footing ditch. View is from the north.

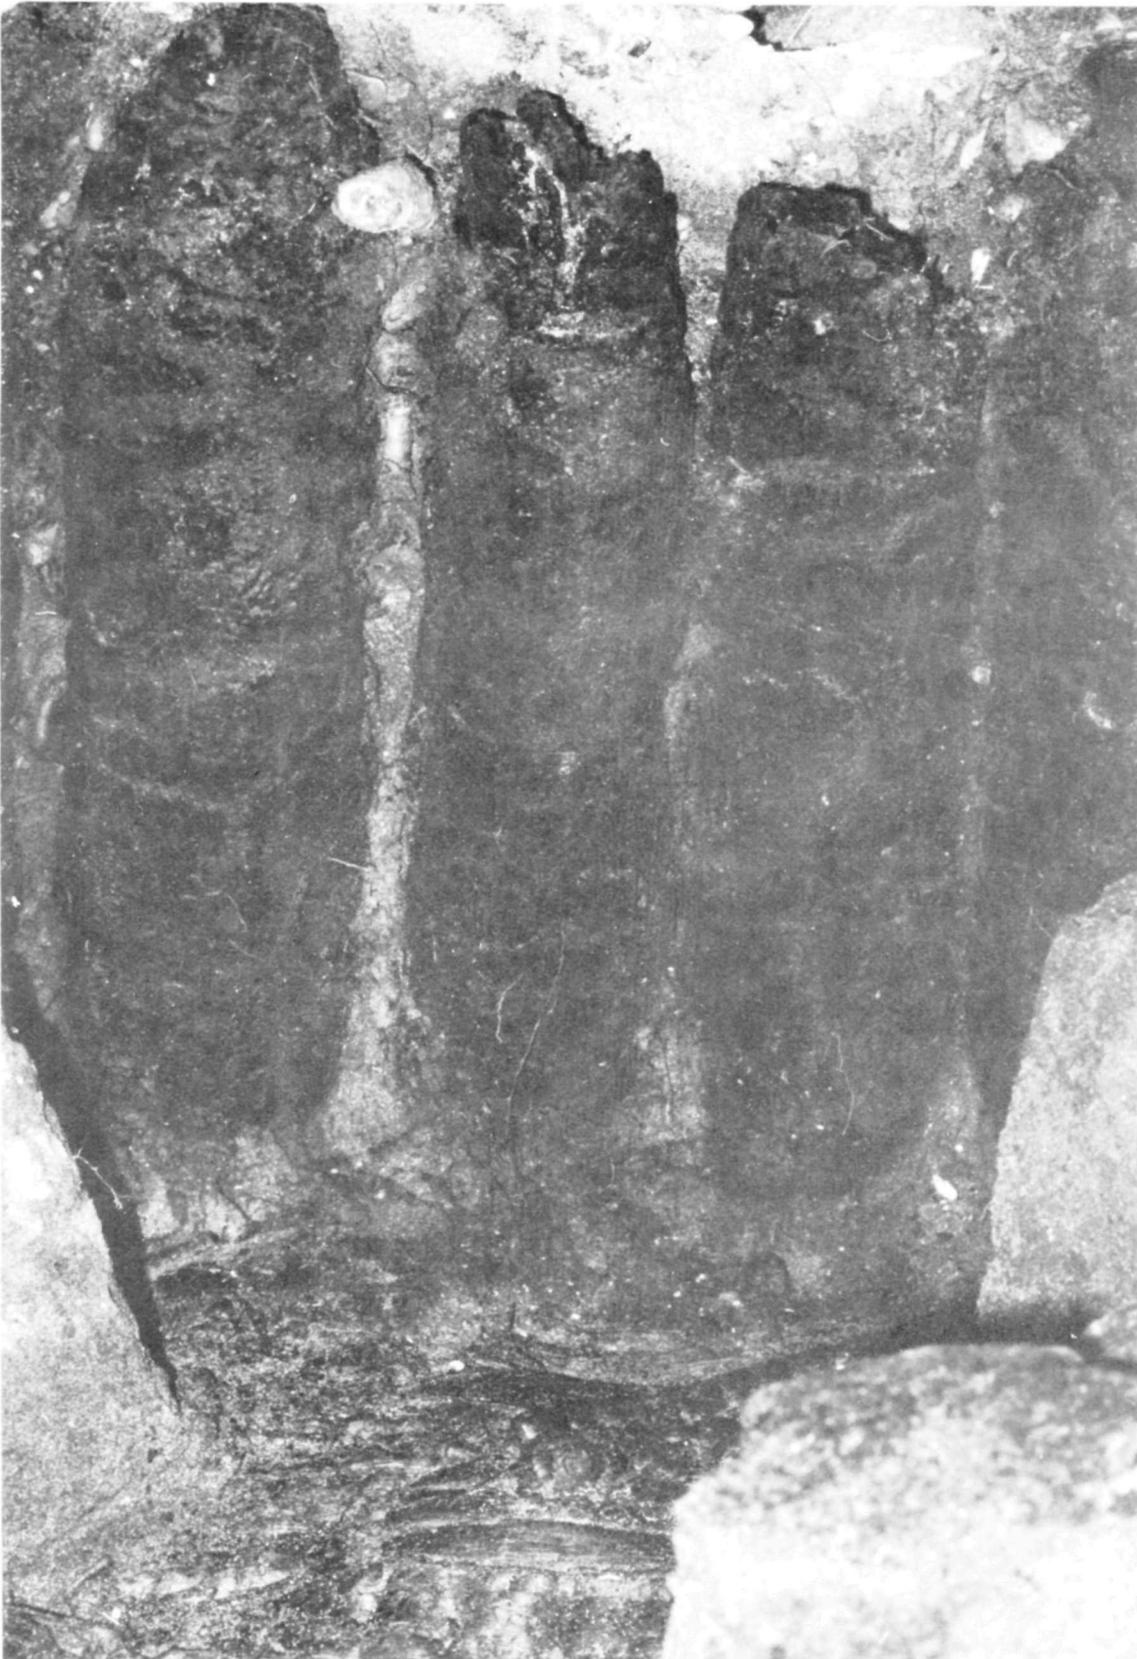
Figure 9. South wall of the powder magazine showing a detail of upright logs charred on the interior surface (in square 295R120). Note also the charred floor boards in the foreground.

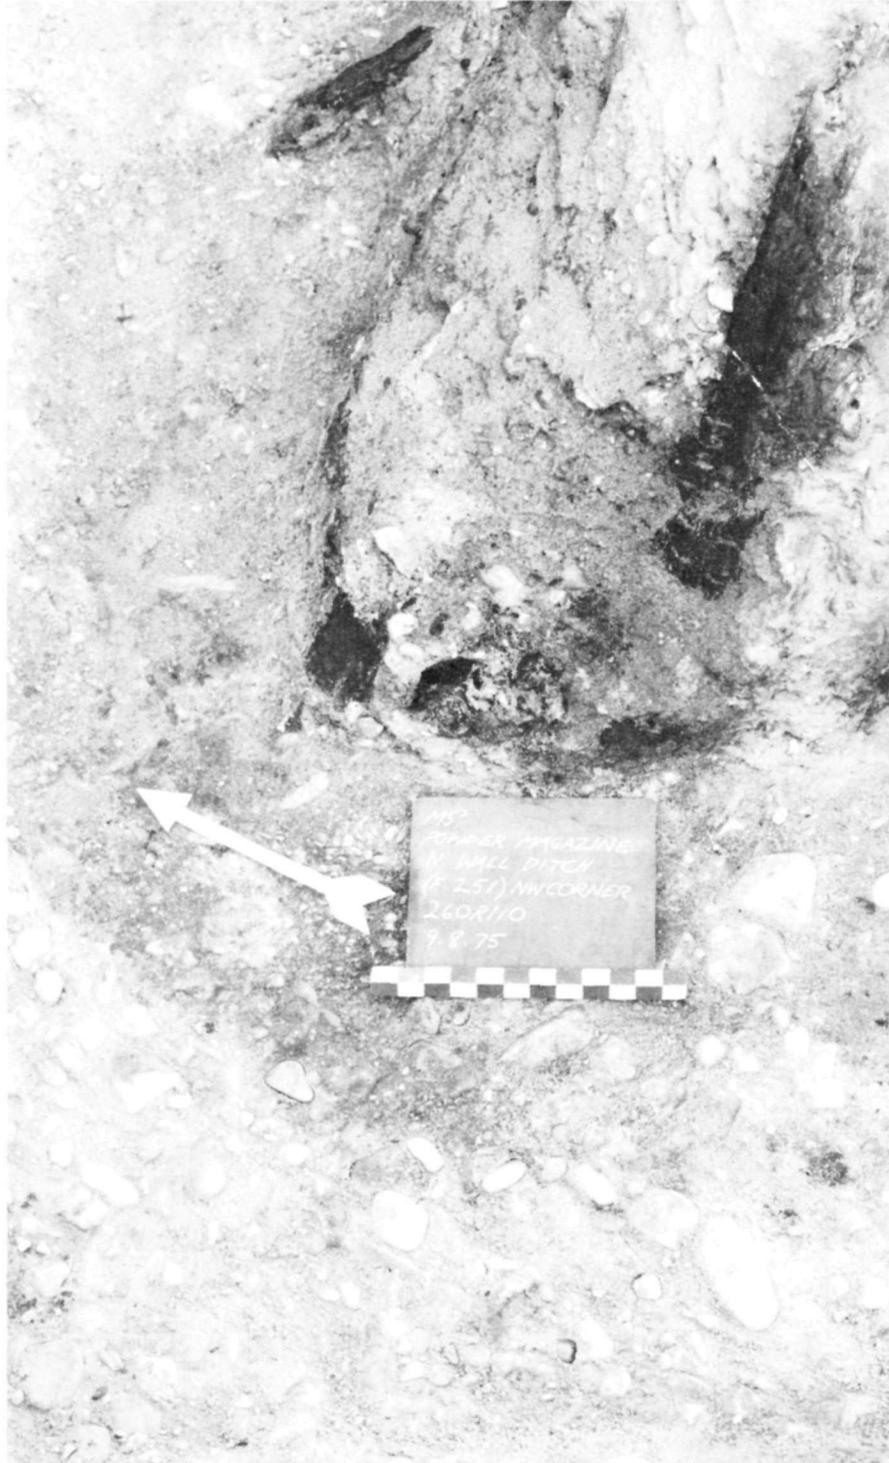
Figure 10. The northwest corner of the powder magazine (in 265R110). Note the undisturbed footing ditch paralleling the corner.

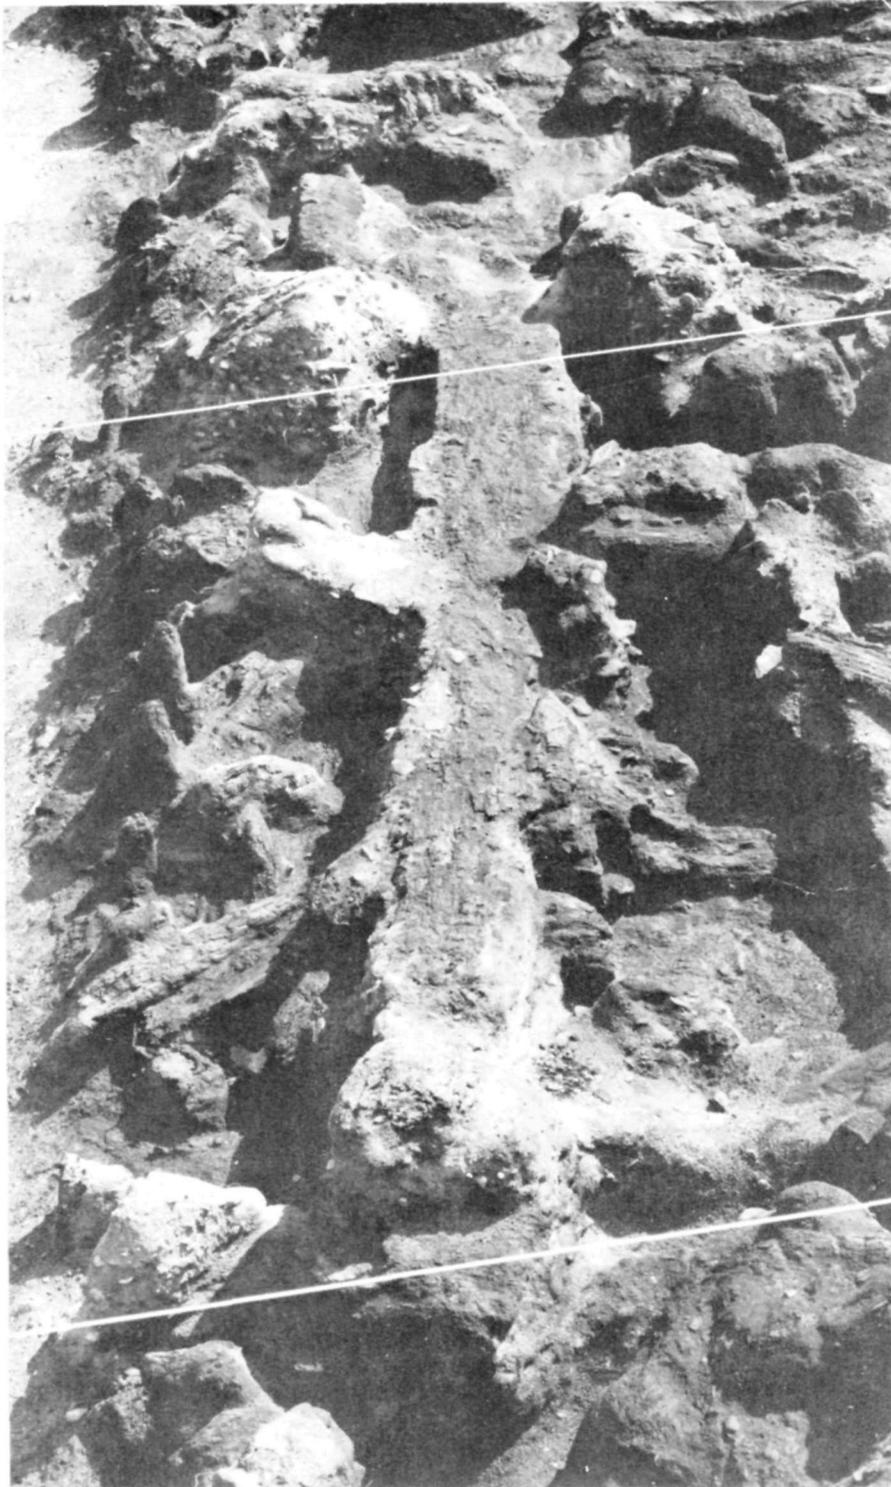
Figure 14. Collapsed and burned east wall in 275R130. View is from the north. Note the large clapboard surviving on the wreckage of the east wall.

Within squares 275R130 and 285R110 (see Figure 1), large fragmentary pieces of charred clapboards survive, obviously one of the basic building materials of the structure (Figures 14 and 15). The example adjacent to and originally a part of the east wall (see Figure 1) shows that clapboards were nailed to the outside wall because the specimen still rests upon a wall section that collapsed and burned on the floor of the magazine (Figures 1 and 14). The clapboard measures about nine to ten inches (22.9 to 25.4 centimeters) in width. It is not a complete specimen, but about nine and one-half feet (2.85 meters) of the original length survive. Although its original height above the wattle cover at the base of the wall is unknown, it must approximate 18 inches (45.7 centimeters), the present distance from the north end of the clapboard to wall posts on the east (Figure 1). Presumably boards covered the roof of the magazine in the same manner, but little evidence of this survives.

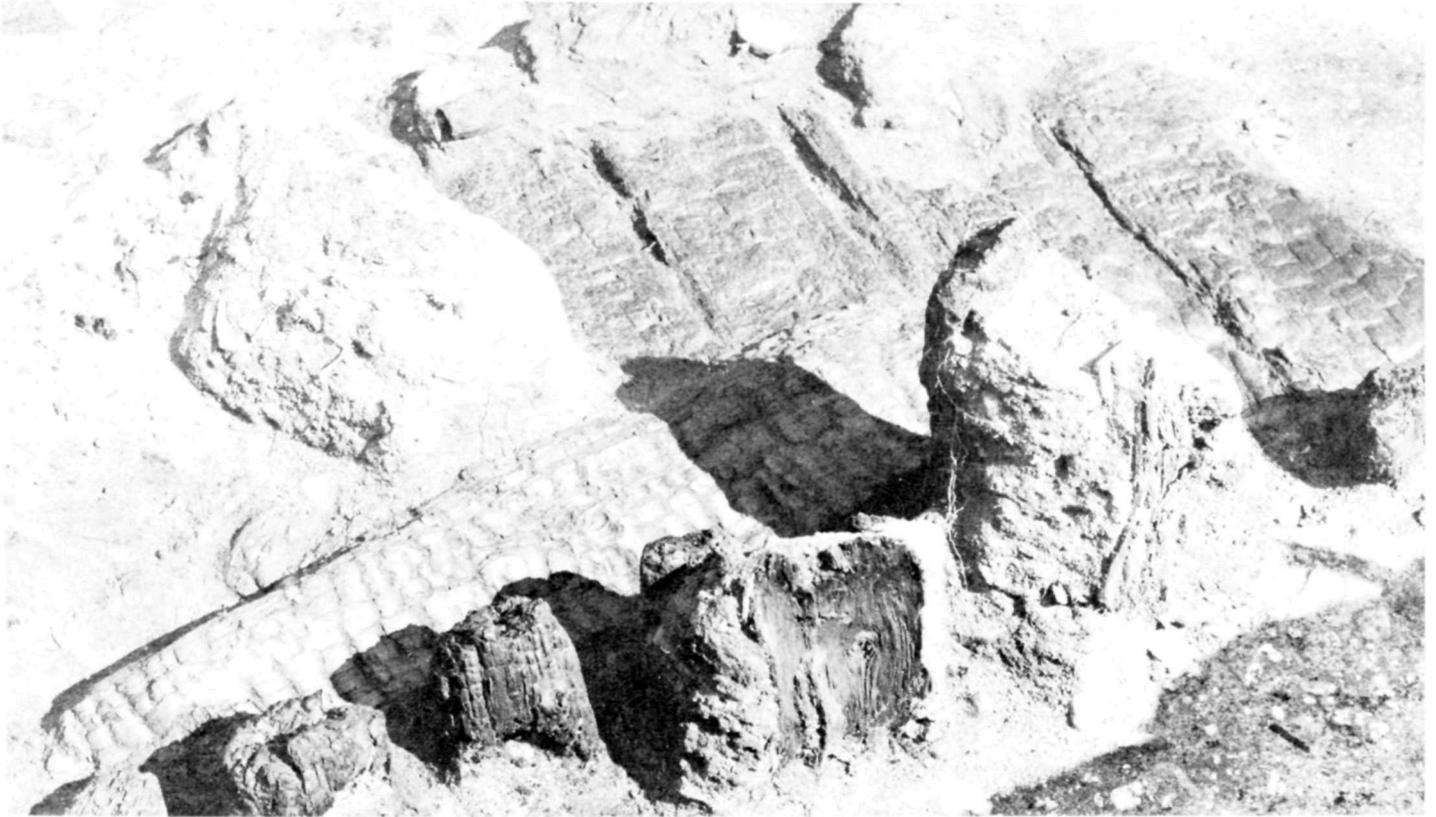
Figure 15. Detail of fragmentary clapboard in square 295R110.
View is from the west.

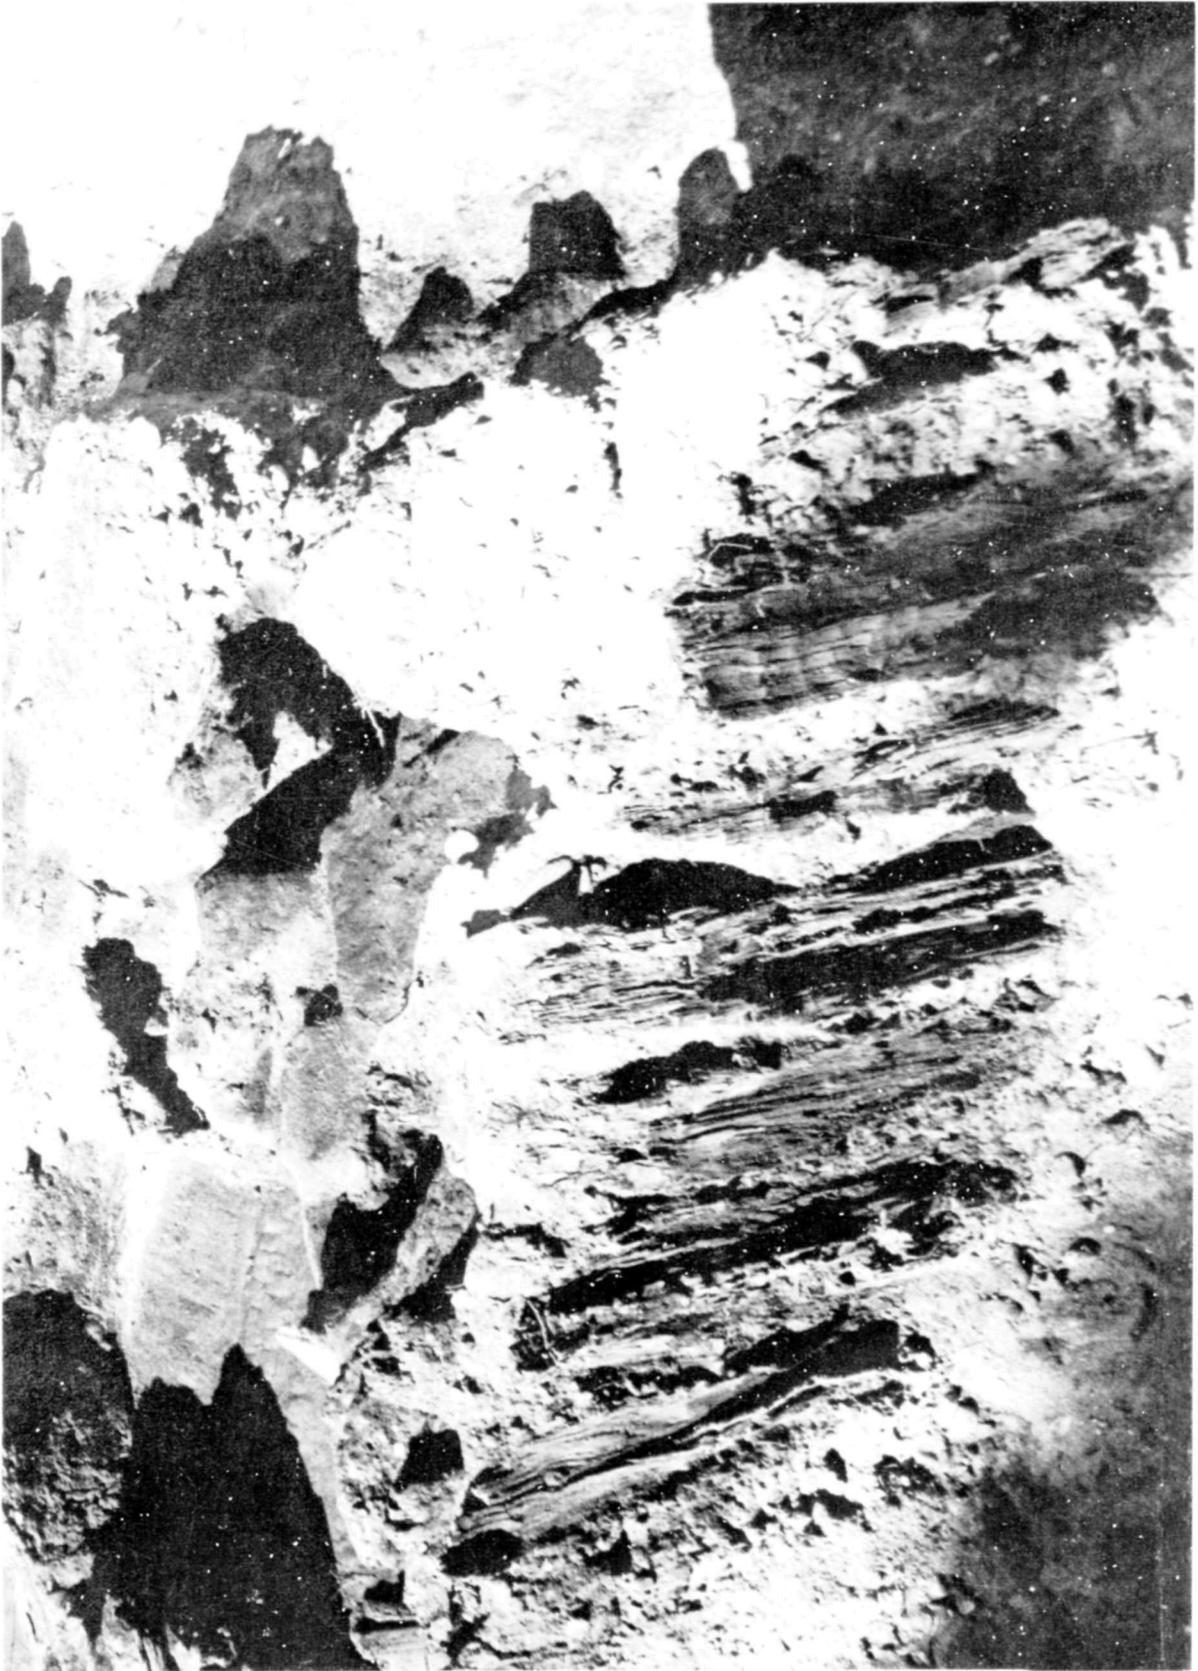
Figure 16. Cedar bark shingles in situ along the outside of the south wall of the powder magazine in squares 295R120 and 295R130. Note the floor boards in the upper left and the east wall on the right.

Northern white cedar shingles (Thuja occidentalis, according to R. C. Koeppen : personal correspondence, September 5, 1975) were in turn nailed to the outside of the clapboards. To judge by their placement along the south wall where, like wall posts mentioned earlier, the condition of preservation is excellent, shingles are placed edge to edge (Figure 16). Long strips of shingles surviving on both the north and south walls are up to two feet (61 centimeters) in length. One strip extended well into the footing ditch in 260R120, as evidenced by a clearly visible organic stain. Shingles served the same function as their modern counterparts.

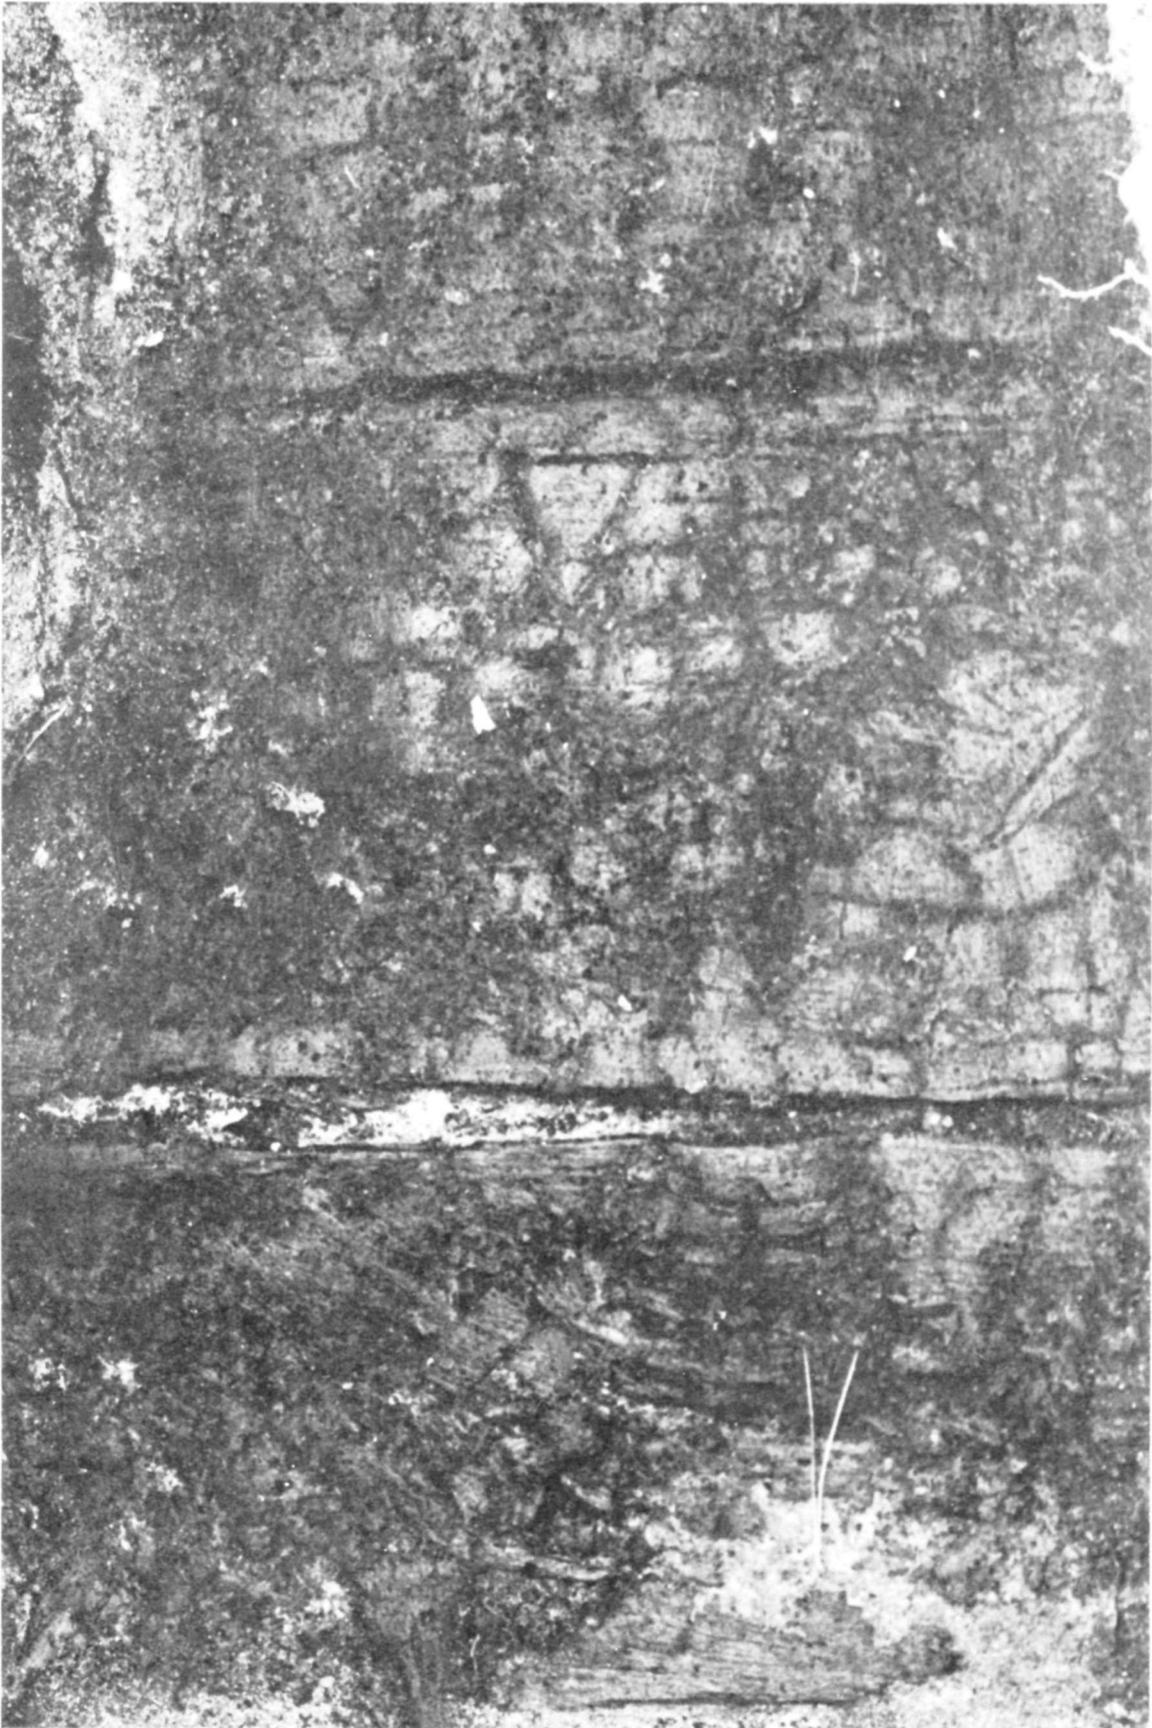
Figure 17. Detail of floor boards in square 295R110.

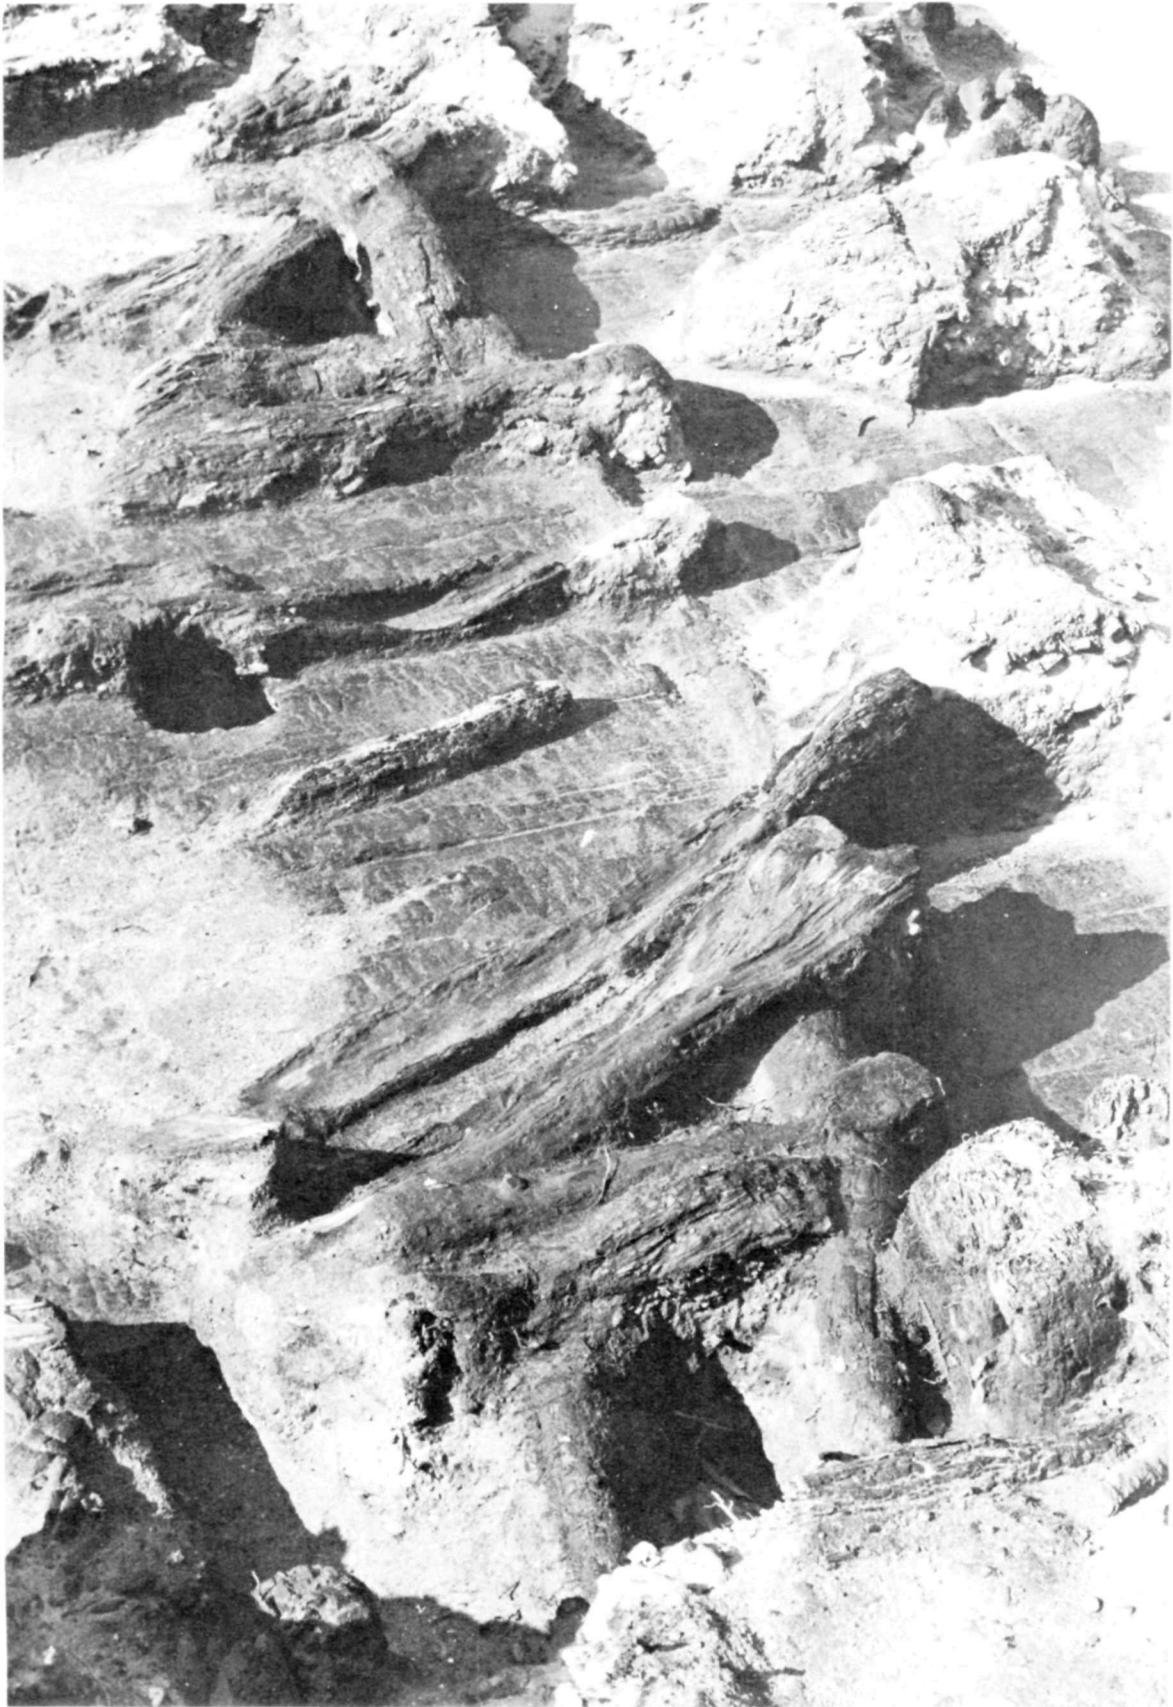
Figure 18. Detail of collapsed roof in squares 285R120 and 295R120. Note that beams are unabled. View is from the south.

The position of the surviving beams and rafters is such that there is little doubt that the roof was flat, or that the entire building appeared as a huge rectangular box covered with bark shingles. Sod was placed over the roof and along only the east and west walls by 1765, for the Crown map illustrates the facade of the building. Lotbinière also noted that the "powder magazine is buried and covered with turf" (Gérin-Lajoie 1974 : 7) in 1749, the year he visited and described Michilimackinac for the French governor in Quebec, who wished an accurate survey of the water route between Quebec and Michilimackinac (Gérin-Lajoie : 2-3 and 8). Sod cover may have been a feature of the building throughout its history. At the time the British burned the magazine, it is possible that they removed some or all of the sod. Otherwise, more of the walls and roof would be preserved. Because of the charred and fragmentary nature of the roof, dimensions are meaningless, although remains of rafters and ties may be seen in Figure 1.

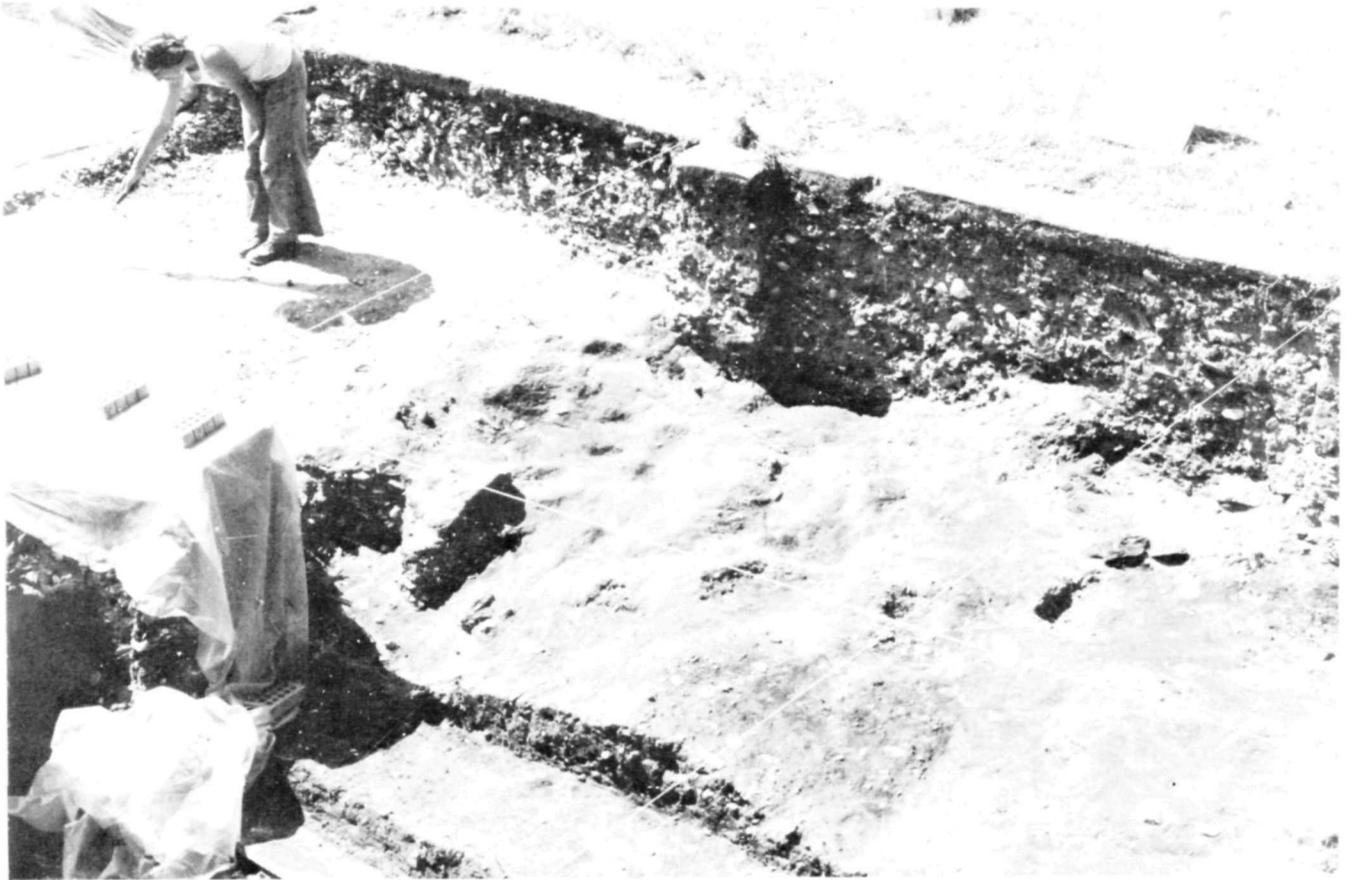
Figure 19. Sand layer under the low earthwork surrounding the powder magazine (in 275R110, level 1). View is from the southeast.

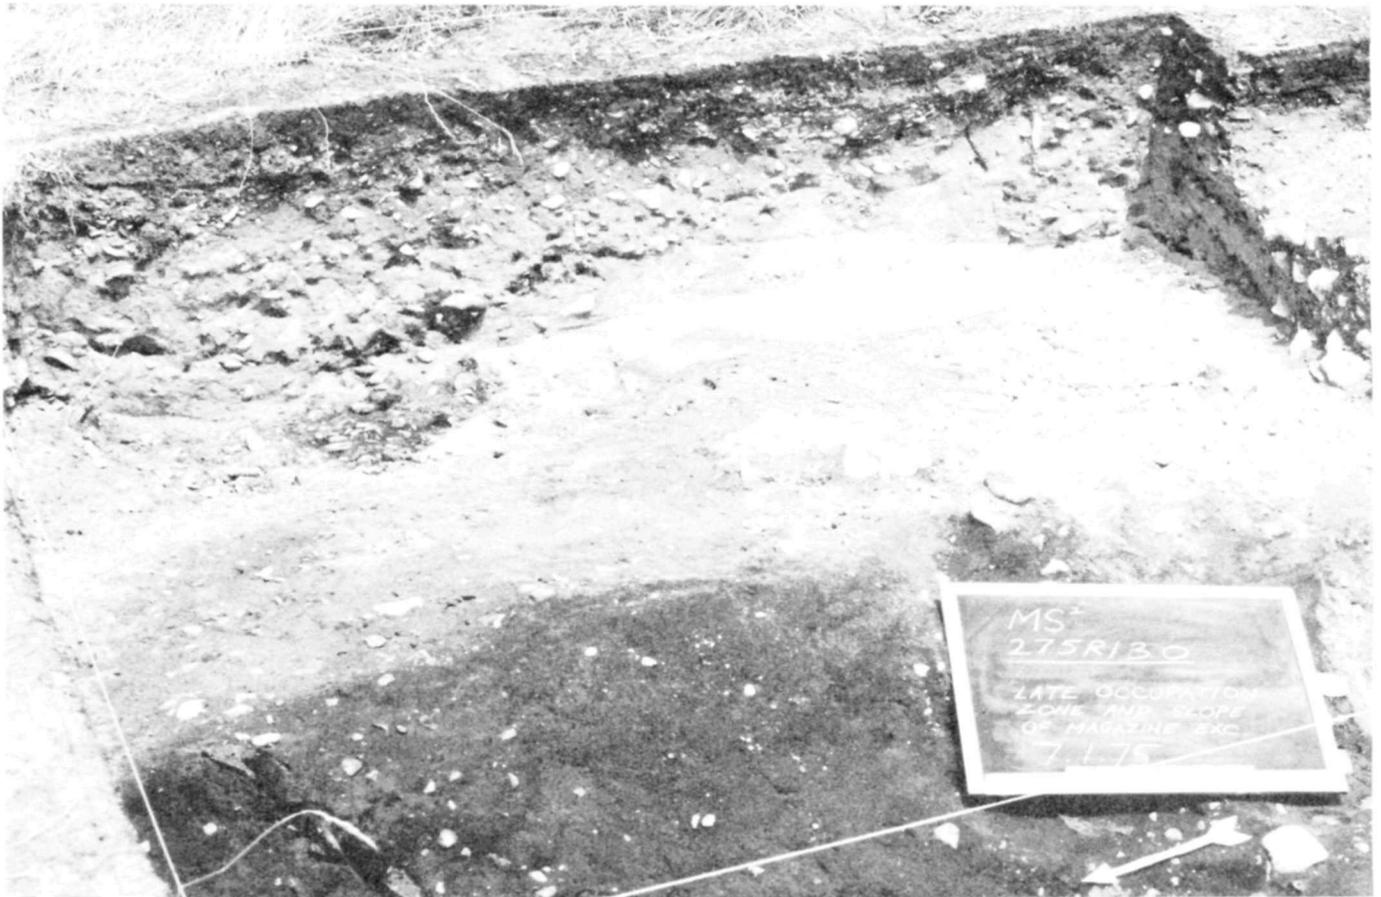
Figure 20. Sand layer under the low earthwork surrounding the powder magazine (in 275R130, level 1). View is from the west.

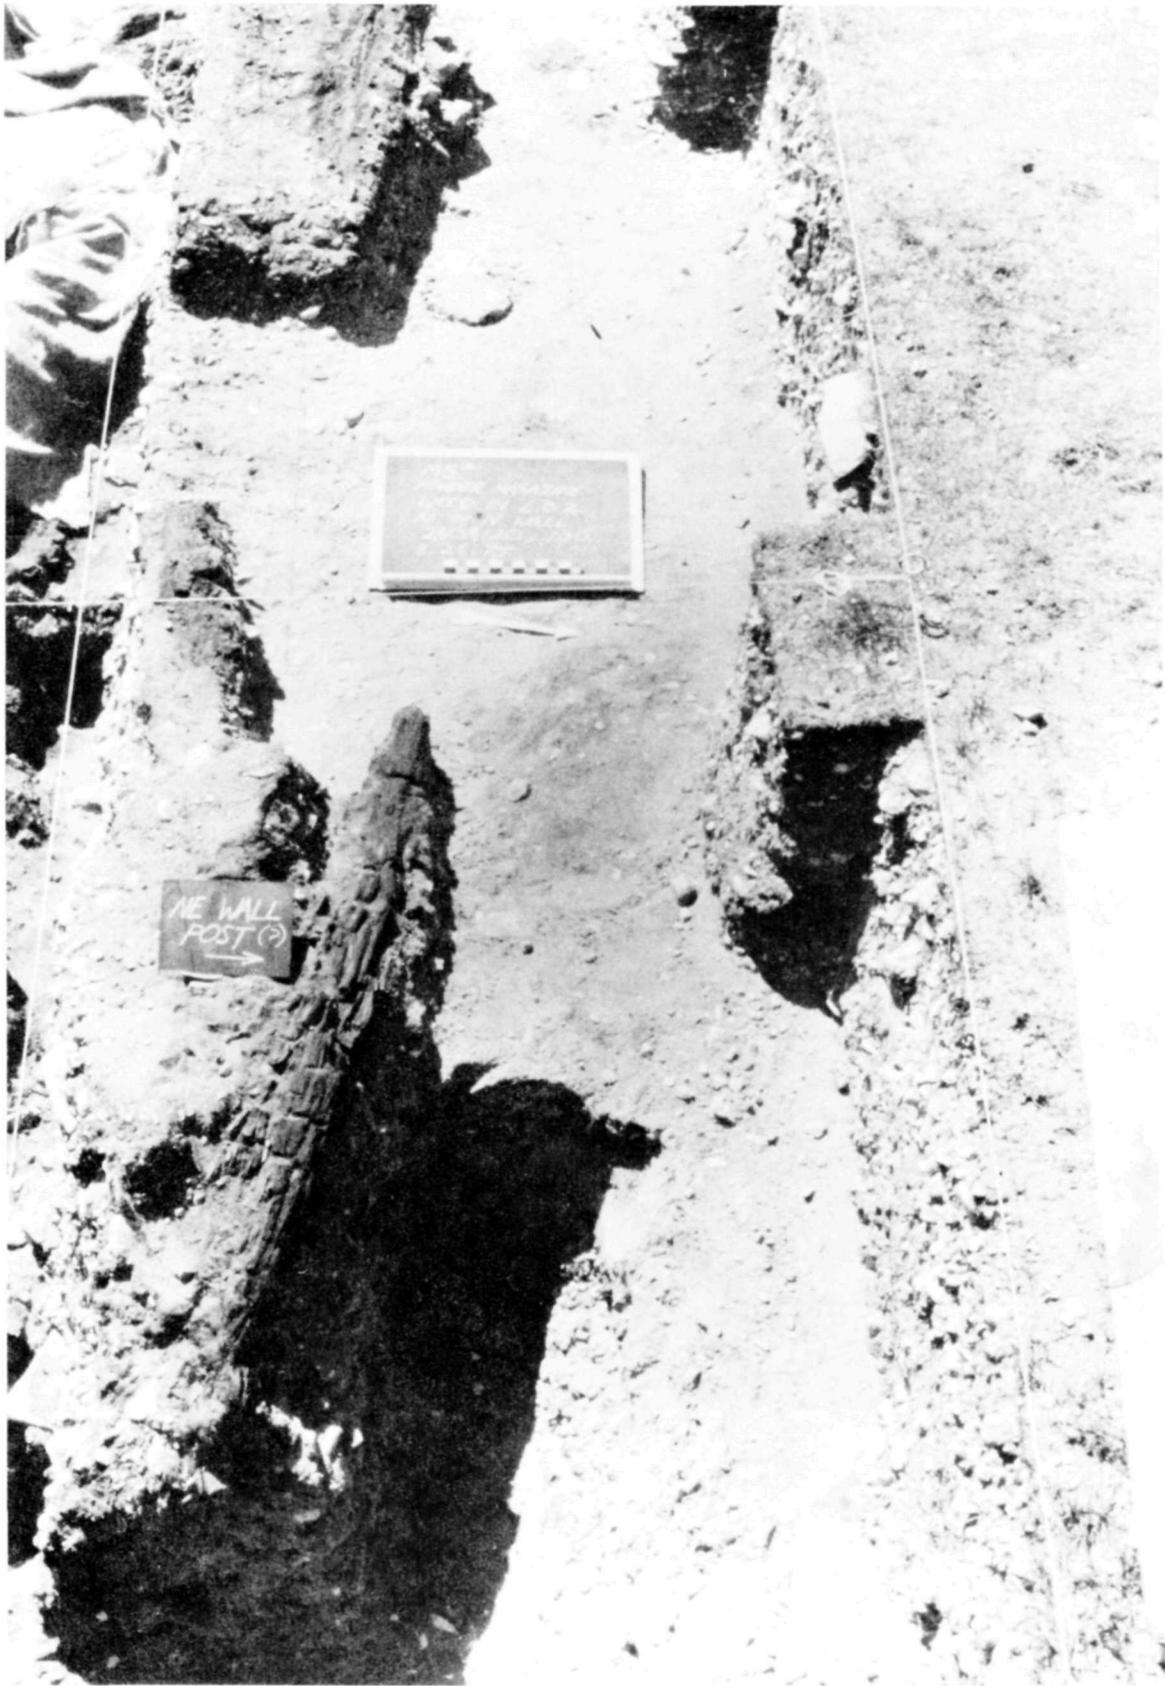
Figure 21. Toppled and fragmentary portion of the northeast corner post in 260R130, level 3 (within beach slough).

Unlike the entranceway, it is possible to estimate the original height of the powder magazine itself because the northwest corner post fell backward at the time the building burned. As a result, the post is preserved (Figure 21) more or less intact. In length it measures about five and one-half feet (1.65 meters). When added to the burned portion of the corner post still within the footing ditch, a height of about one foot (30.5 centimeters), the magazine was slightly more than six feet (1.8 meters) in height.
