SPECIAL REPORT

Area reported on: Dorchester Heights

National Historic Site (proposed)

Report to the Regional Landscape Architect, Region One.  
By Ralph W. Emerson, Resident Architect, Branch of Plans & Design.

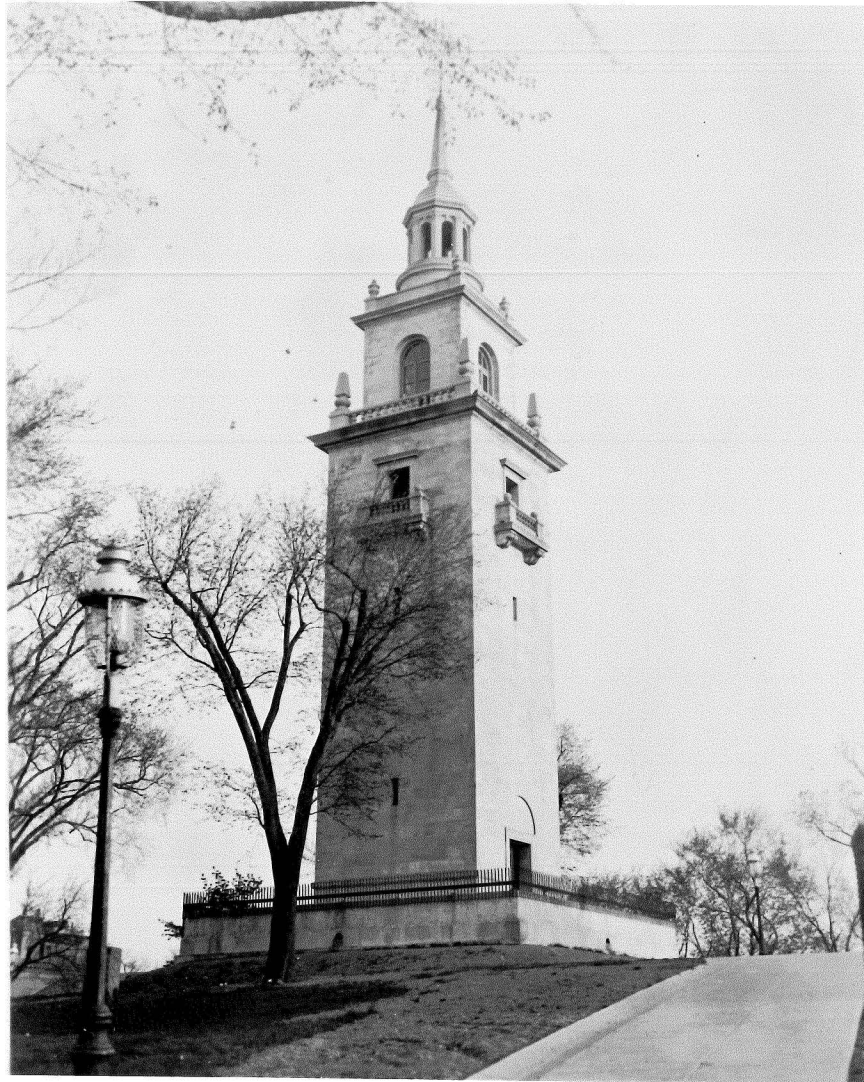
**VIEW NO.1**  
**(See General Plan)**

**Looking toward the memorial tower from the eastern boundary  
of Thomas Park.**

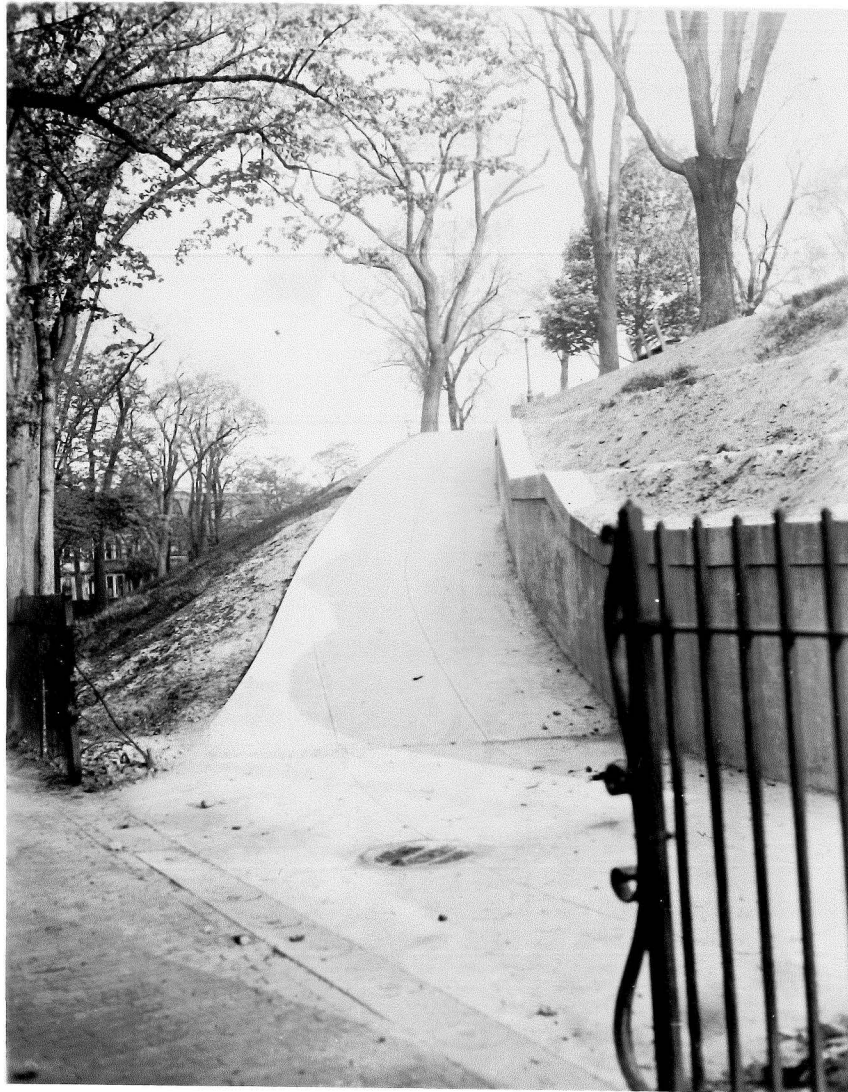
VIEW NO.2  
(See General Plan)

Grounds - The WPA has been active in the recent development of the park. Work of improvement has been underway for the past two years, and about \$72,000 has been expended on the betterment of the grounds. New concrete steps and ramped approaches were constructed to make the grounds accessible to the city streets which border the park on three sides. The old asphalt paving was replaced by a new system of brushed concrete surfaced walks. Concrete gutters were provided to take care of the surface drainage along the walks, and a new sub-surface drainage system was designed and partially installed. Unfortunately, some of the new concrete work was placed in freezing weather and evidence of disintegration is now appearing in certain sections of the park.

A typical ramped approach to Thomas Park.

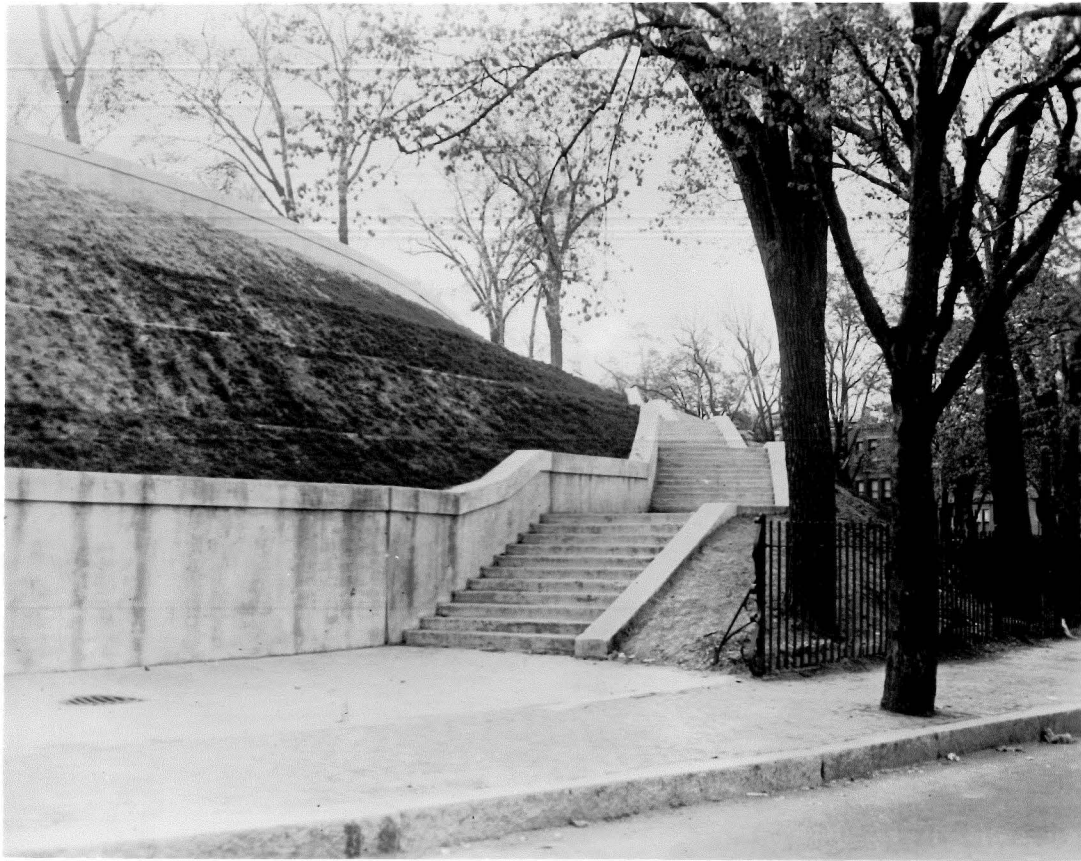
**VIEW NO.3**  
**(See General Plan)**

The problem of erosion control was also given serious consideration in the WPA program. Concrete retaining walls were erected to reduce the steep slopes near the points of access on the perimeter of the park. Some grading was included, and in a few instances it was necessary to terrace the slopes which were subject to heavy surface erosion. This problem has

not been solved completely, and a considerable amount of additional would be required to eliminate the excessive grades of the existing slopes.

**Terraced treatment of slope and typical entrance steps.**
