National Register of Historic Places Registration Form

historic name Entrance Station

street & number Devils Tower National Monument not for publication ☐
city or town Devils Tower vicinity ☐
state Wyoming code WY county Crook code 011 zip code 82714-0010

Entrance Station
Crook County, WY
Devils Tower National Monument
Multiple Property Submission

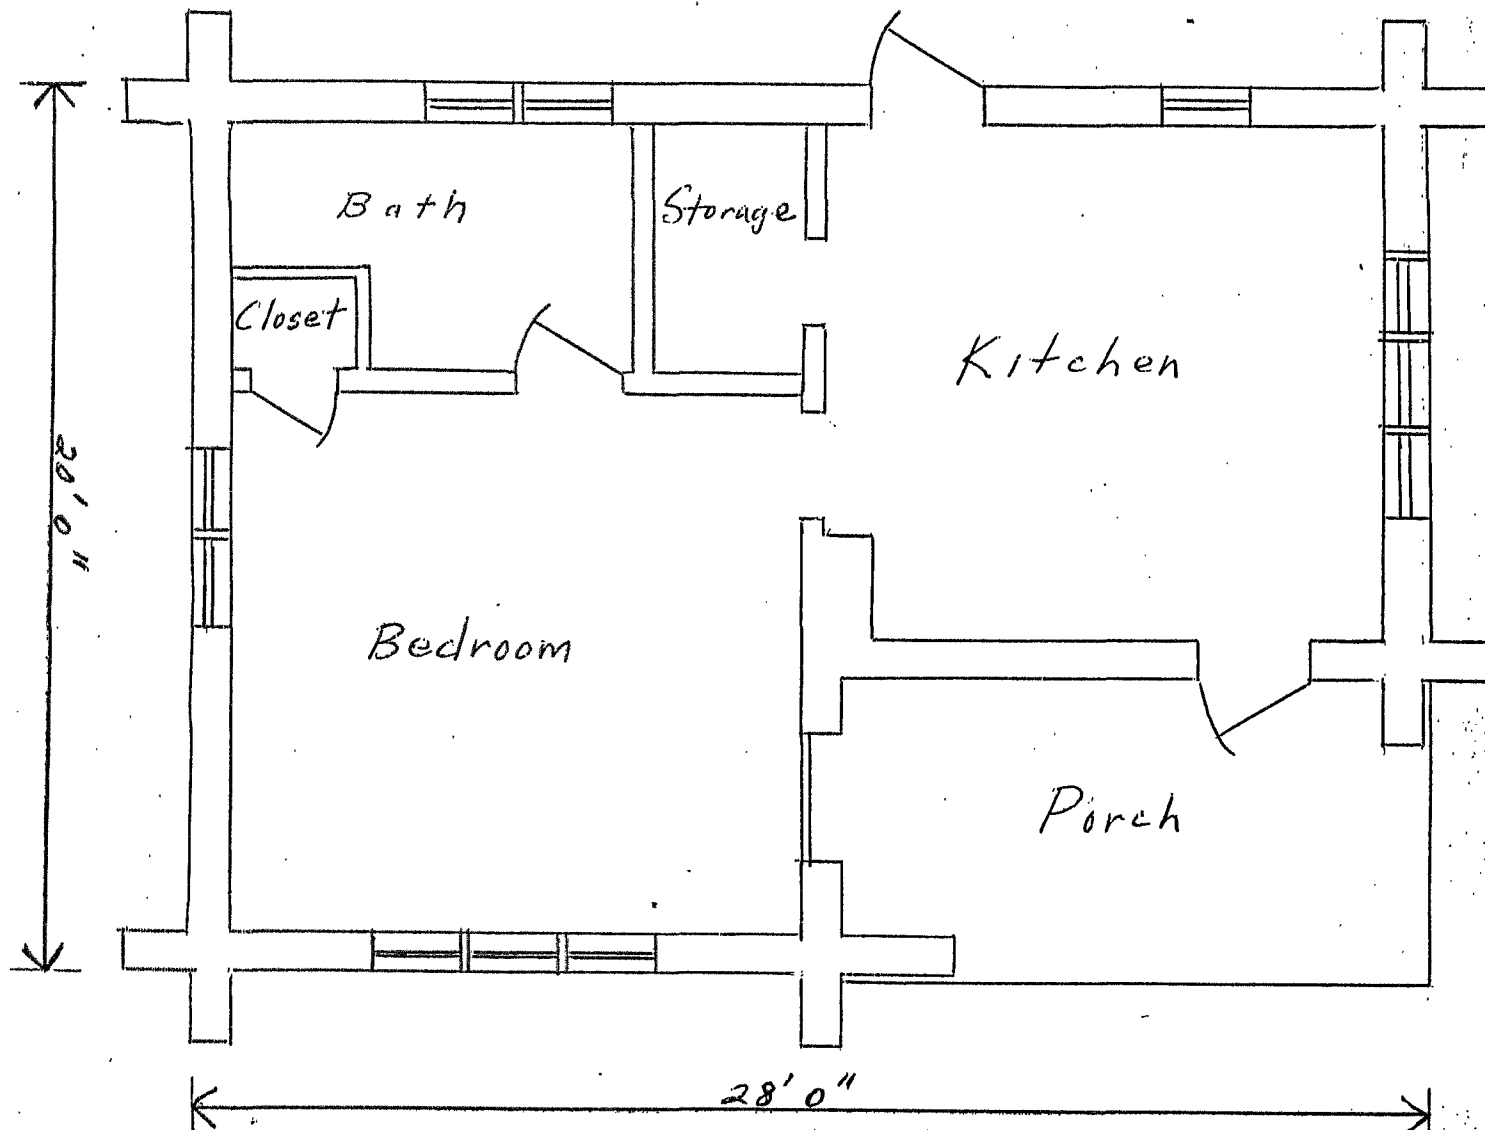
FLOOR PLAN
BLDG NO. 4
ENTRANCE CHECKING STATION
Devils Tower National Monument

As late as 1998, the interior retained some original features and its original floor plan. The layout consisted of a bathroom, bedroom, and small living area that had a small kitchen with built-in wood cabinets. (Other original built-ins were bunk beds and a table, but these were removed at an unknown date.) Interior walls and ceilings were fiberboard with 3-inch fiberboard battens. Floors were varnished 1/2-inch hardwood in the living room and rolled linoleum in the bathroom. While the bathroom had an old sink, it also had a non-historic toilet and metal shower stall. The living/kitchen area floor was linoleum tile over fir. The bedroom and living/kitchen area each retained a historic metal ceiling light fixture, missing original globes. Exposed electrical metal conduit was added to the interior some time after construction.

With a serious shortage of workspace for its employees, the monument undertook extensive rehabilitation on the interior of the entrance station in 1999, thereby converting the interior space into two offices and bathroom.¹ The most important changes are described as follows. In the old living/kitchen area the counter, millwork base, backsplash, sink, cabinets, and linoleum were all removed. Throughout the interior, original interior wall and ceiling finishes were removed and replaced with insulated 1/2-inch gypsum board. All (4) interior doors and doorframes were replaced (the two historic exterior doors were retained). In the bathroom, the linoleum (and wooden subfloor), plumbing fixtures and metal shower stall were removed. The bathroom floor was refinished with sheet vinyl over plywood, a modern toilet and sink were installed, along with storage shelves. Shelves were also installed in a closet and in the old kitchen pantry. The original wood floors in the two living areas (old kitchen and bedroom) were retained and refinished. These two rooms now serve as office spaces, lighted by ceiling-mounted fluorescent fixtures. (The two original light fixtures for these rooms were retained and replaced but are non-working.) A few other modern light fixtures were also installed. The building's plumbing, sewage and electrical systems were replaced and modernized. Propane heating and electrical cooling systems were added, along with modern electrical and phone outlets.
