**STRUCTURE S-12 WATER DISTRIBUTION
TO EVERGLADES NATIONAL PARK**

Report T-650

**National Park Service
South Florida Research Center
Everglades National Park
Homestead, Florida 33030**

February 1982

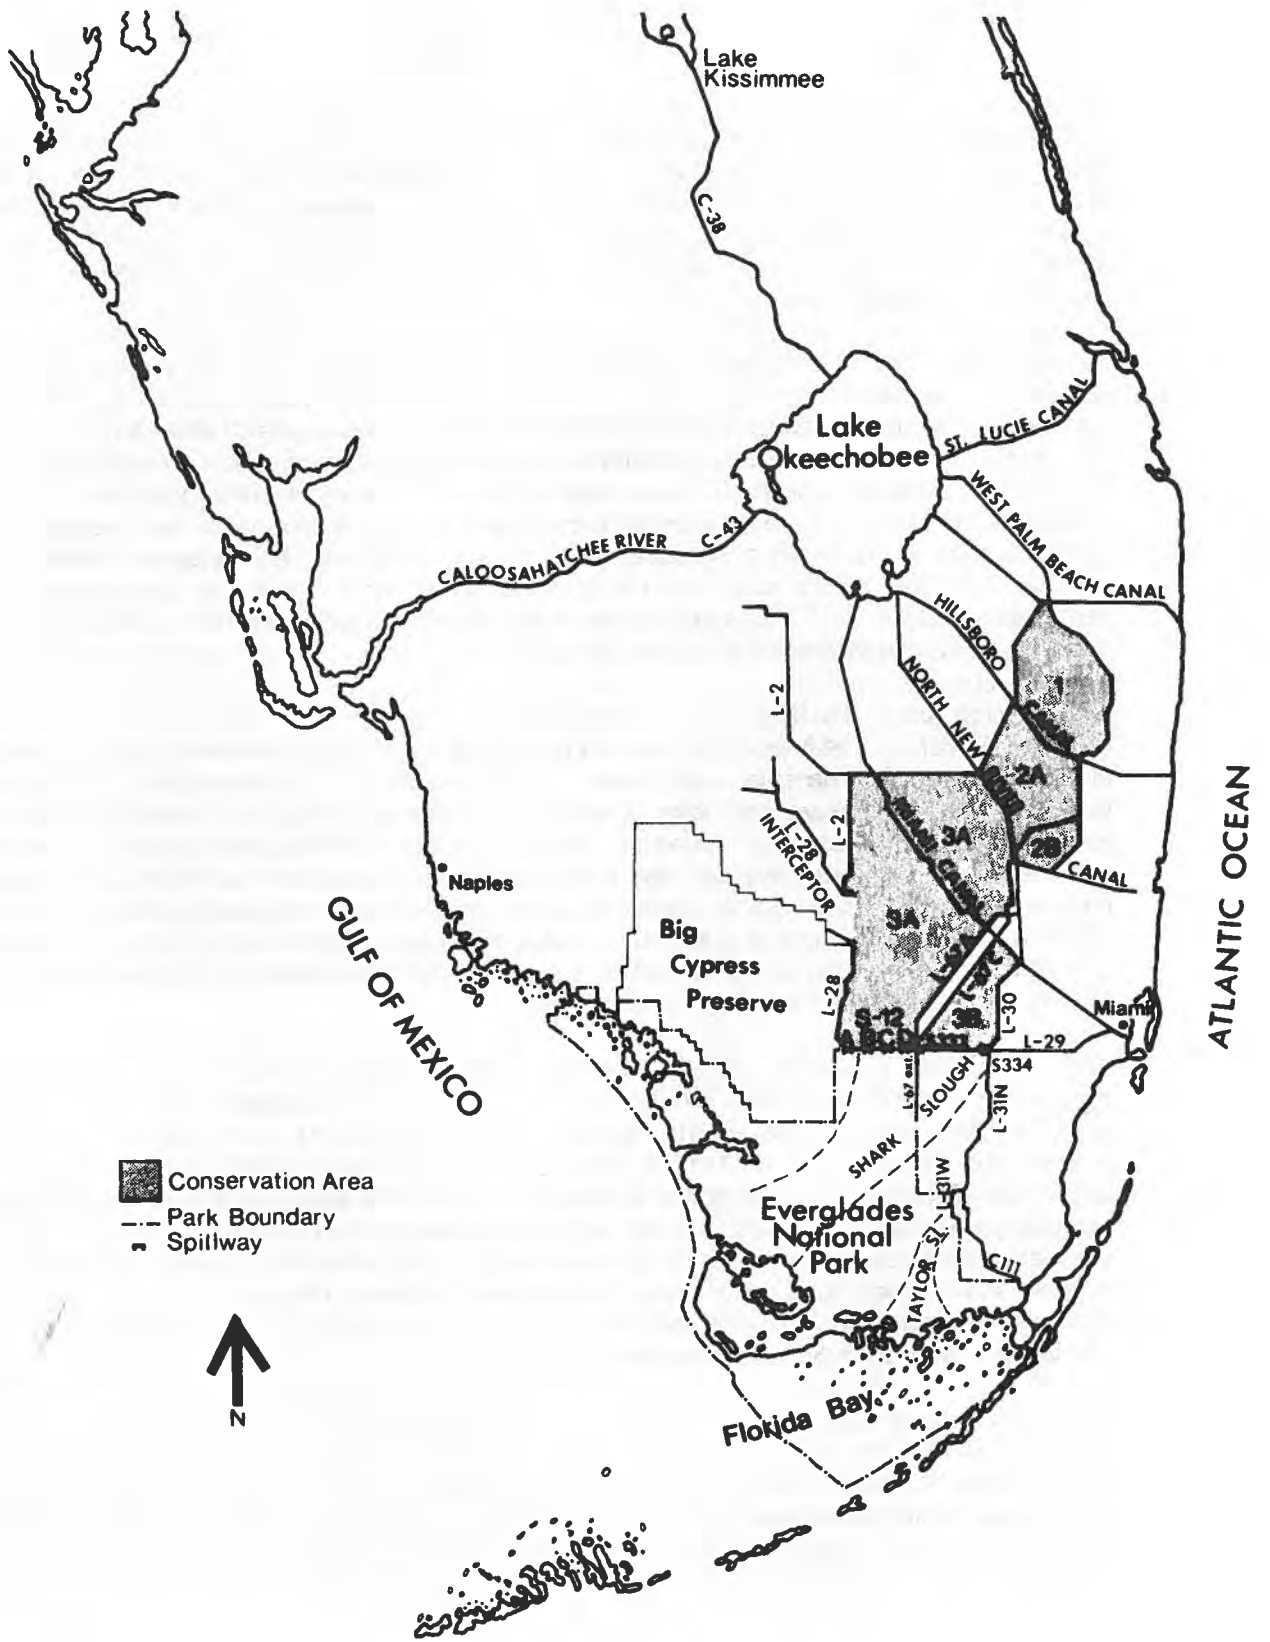
Figure 1 . Major drainage canals in South Florida.

The complex maze of water control works now in place in central and south Florida (Figure 1) exemplifies the degree to which man, in a short time, can alter a drainageway formed over millenia. Once a truly dynamic system responding to the cycles of flood and drought common to subtropical Florida, this waterway is now fully controlled by water management schedules and structures designed to meet the varied needs of man.

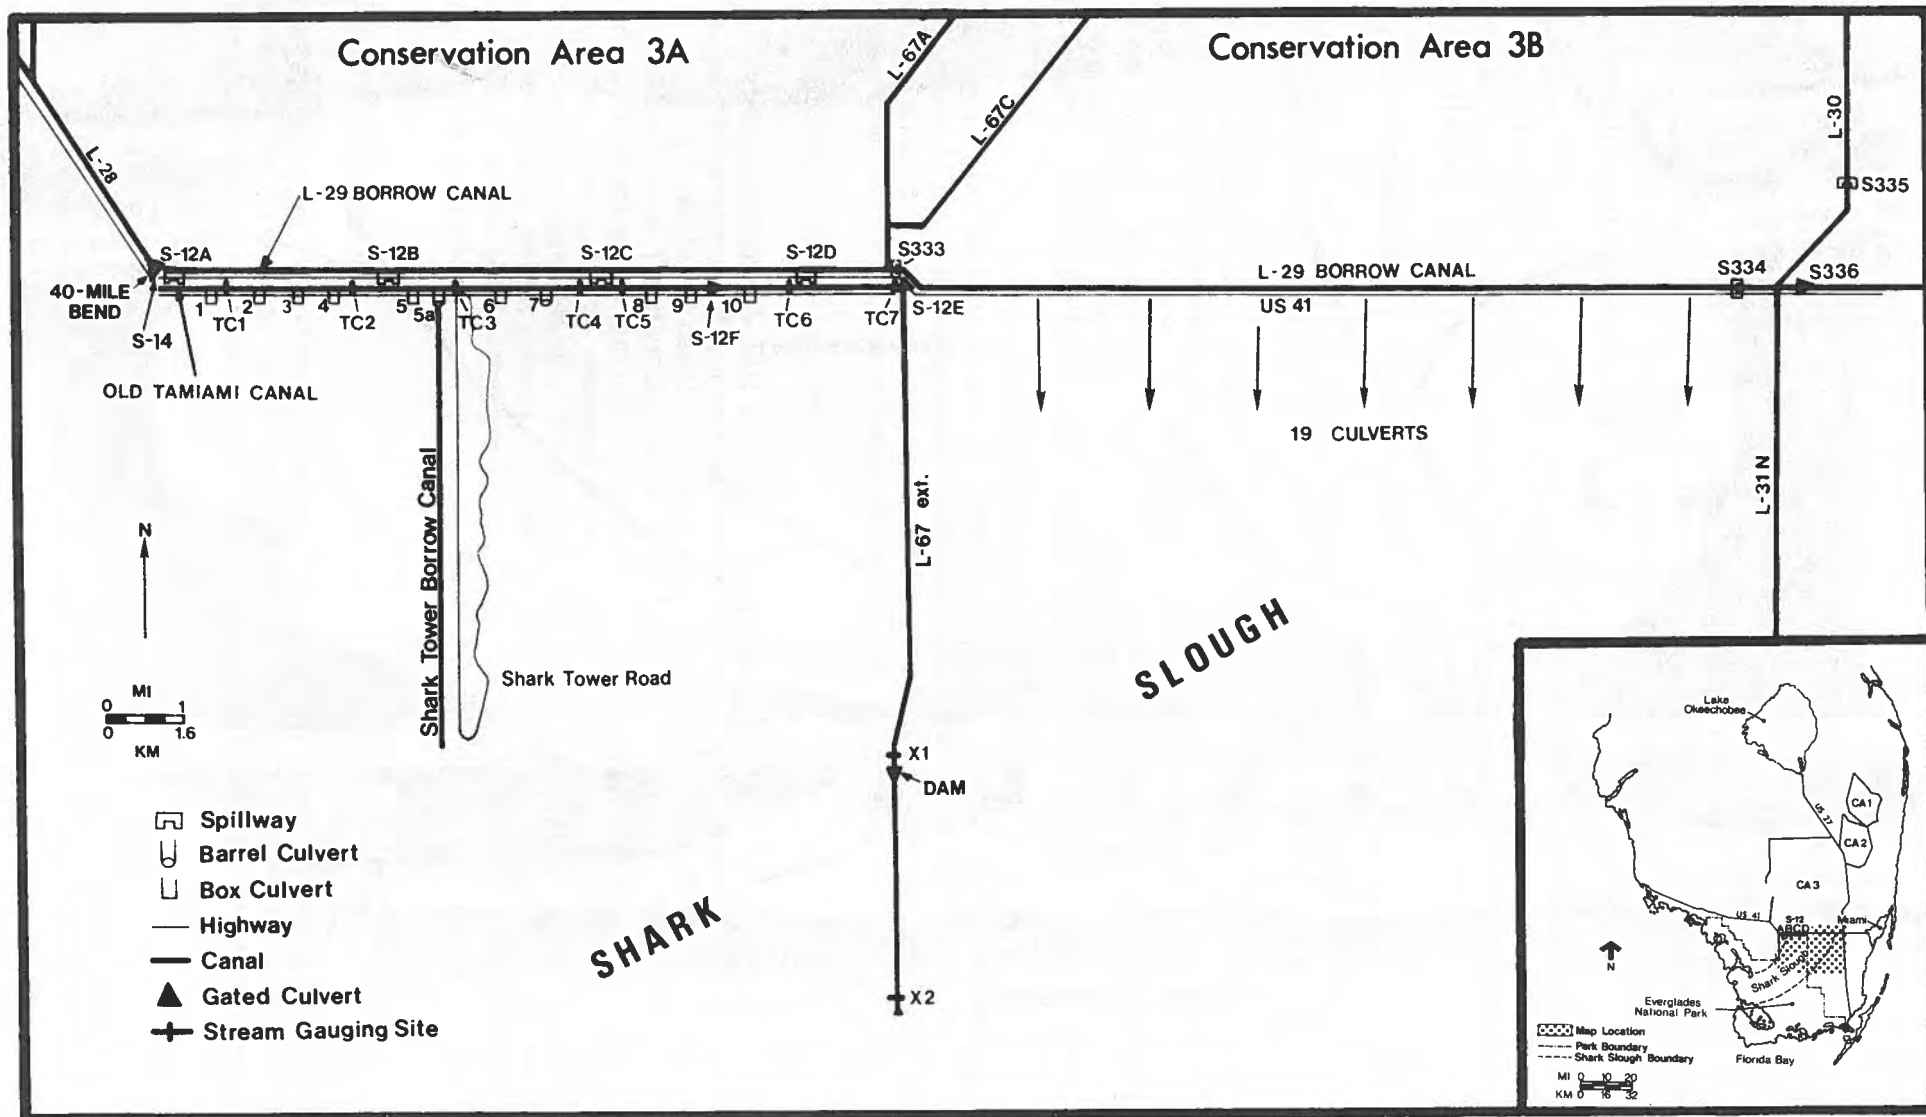
Figure 2. Options for surface water delivery to Shark Slough.

Water moving southward past new Tamiami Trail (U.S. 41) between L-30 and 40-Mile Bend may be distributed to Shark Slough through the numerous structures, canals, and culverts illustrated in Figure 2. The various options for delivery are discussed below, however this section concentrates on delivery through the S-12 structures.

Currently, the most frequently used option for delivering surface water to Shark Slough is release from Conservation Area 3A through four identical "S-12 structures" (Figure 2) located along U.S. 41 between the L-67 canal and 40-Mile Bend, just north of the park boundary. These deliveries cause a rise in the tailwater area immediately south of each structure (Figure 3), forcing gradients toward Shark Slough and in either direction down the old Tamiami canal. A portion of the

The L-67 (ext.) canal reaches southward 9.5 miles from U.S. 41, paralleling and just inside the eastern park boundary (Figure 2). The canal, which is directly linked to the old Tamiami canal, was designed to facilitate movement of surface water

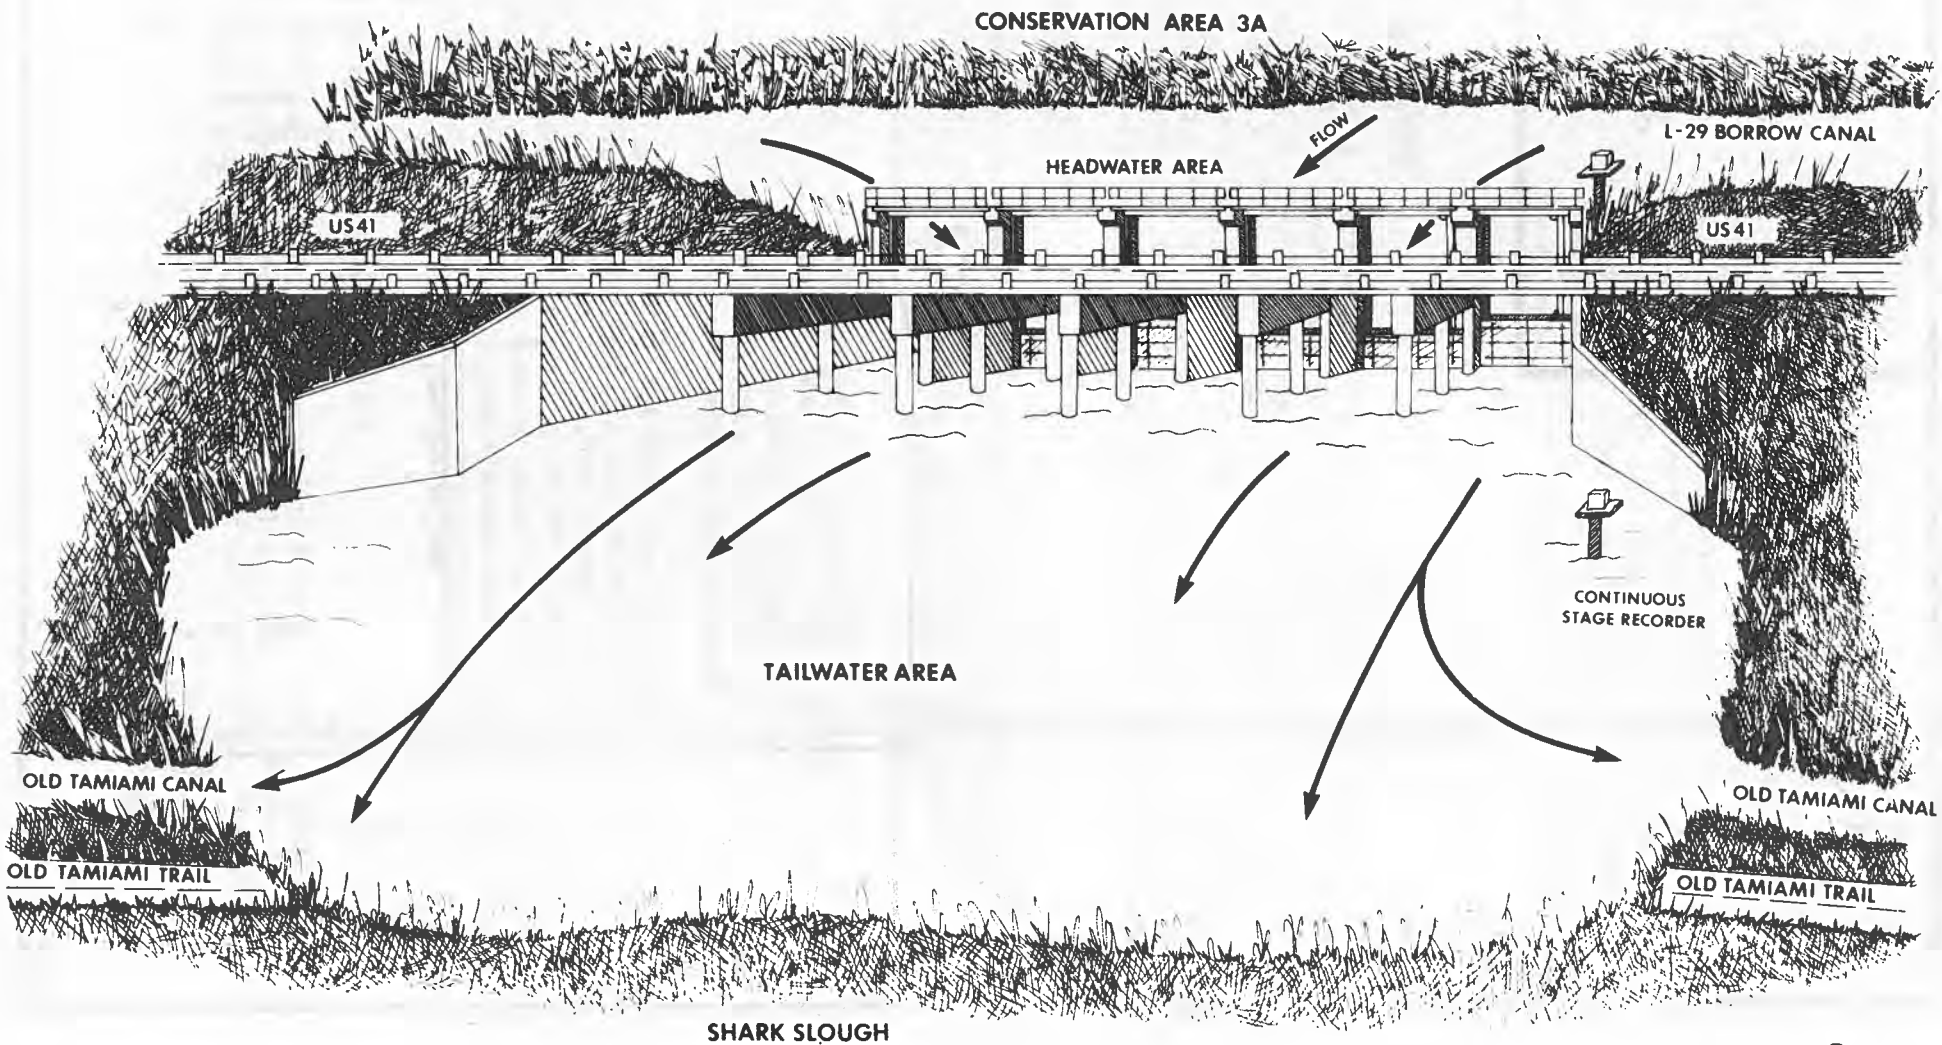
Figure 3. Structure S-12 schematic.

deliveries are distributed directly to the slough through the cutouts in old Tamiami Trail while the rest flows east or west through the canal for distribution through the series of the culverts shown in Figure 2. Portions of deliveries through S-12C and S-12D entering the L-67 extension canal are distributed to the slough at low points along the length of the canal and at its terminus 9.5 miles south of U.S. 41. Small amounts of water may also enter the Shark Valley Tower Road borrow canal and be distributed along its length.

Structure S-12 F in the old Tamiami canal and a structure in the L-67 (ext.) canal are culverted dams with removable stoplogs. These structures provide some additional control over distribution and will be discussed in the section on flow distribution patterns.

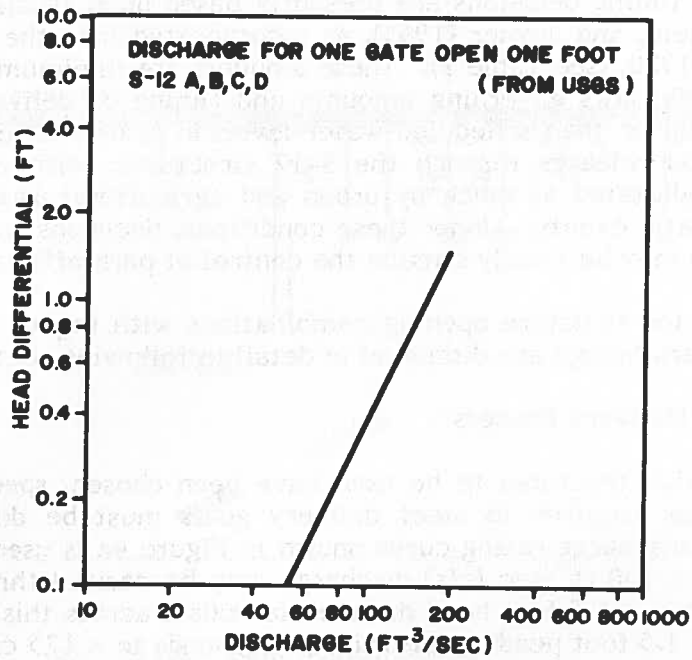
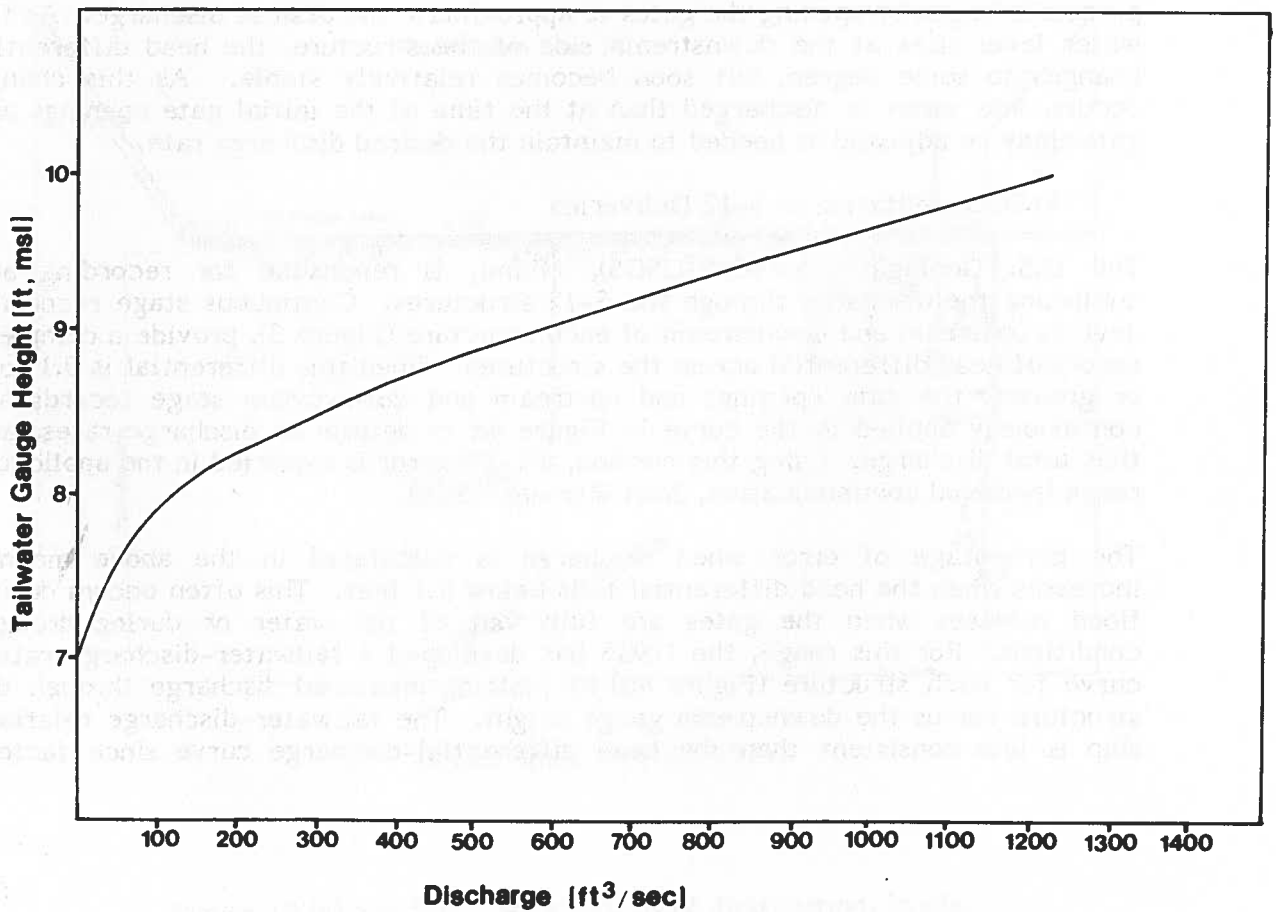
Figure 4. (a) Head differential vs. discharge for structures S-12 A through D.
(b) Tailwater stage vs. discharge at S-12 C.

Once the S-12 structures to be used have been chosen, specific gate openings at the structures required to meet delivery goals must be determined. The head differential-discharge rating curve shown in Figure 4a is used for this purpose. As an example, a 350 ft³/sec (cfs) discharge may be desired through structure S-12C at a time when a 1.5 foot head differential exists across this structure. The curve shows that a 1.5 foot head differential corresponds to a 175 cfs discharge when one gate is open one foot. Therefore, two gates at S-12C may be opened one foot each, or one gate at two feet and so on to reach the 350 cfs goal.

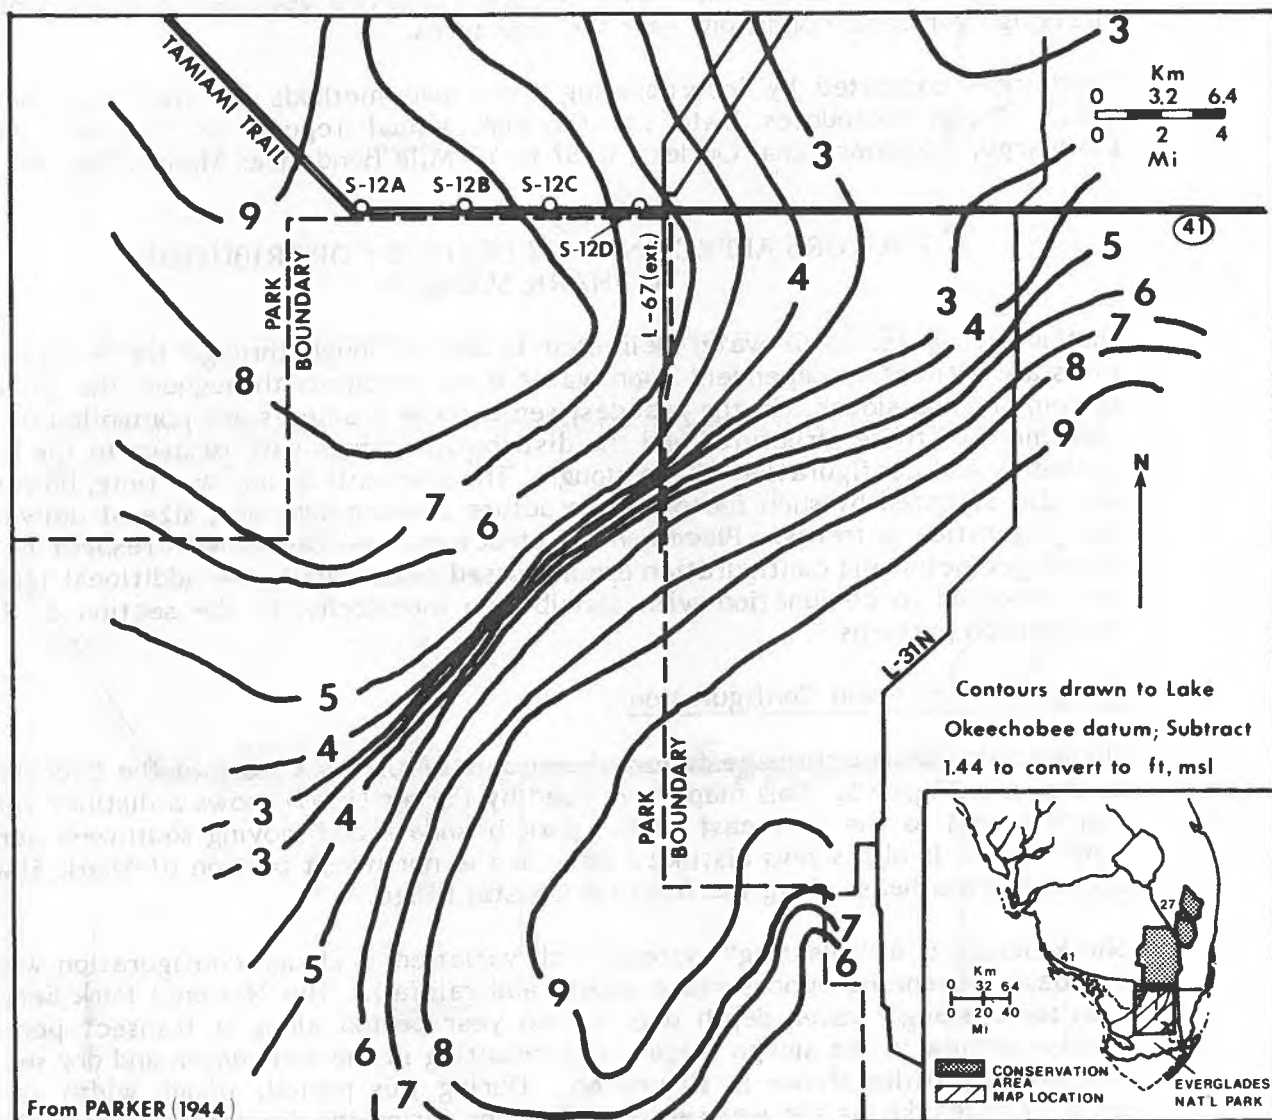
Figure 5. "Rock Floor" elevation in Shark River Slough.

Historically, slough drainage followed contours of the rock floor of the Everglades as shown in Figure 5. This map, developed by Parker (1944) shows a distinct valley starting well to the northeast of the park boundary and moving southwest across L-67 (ext.). It also shows distinct ridges in the northwest portion of Shark Slough and to the southeast along the Atlantic Coastal Ridge.

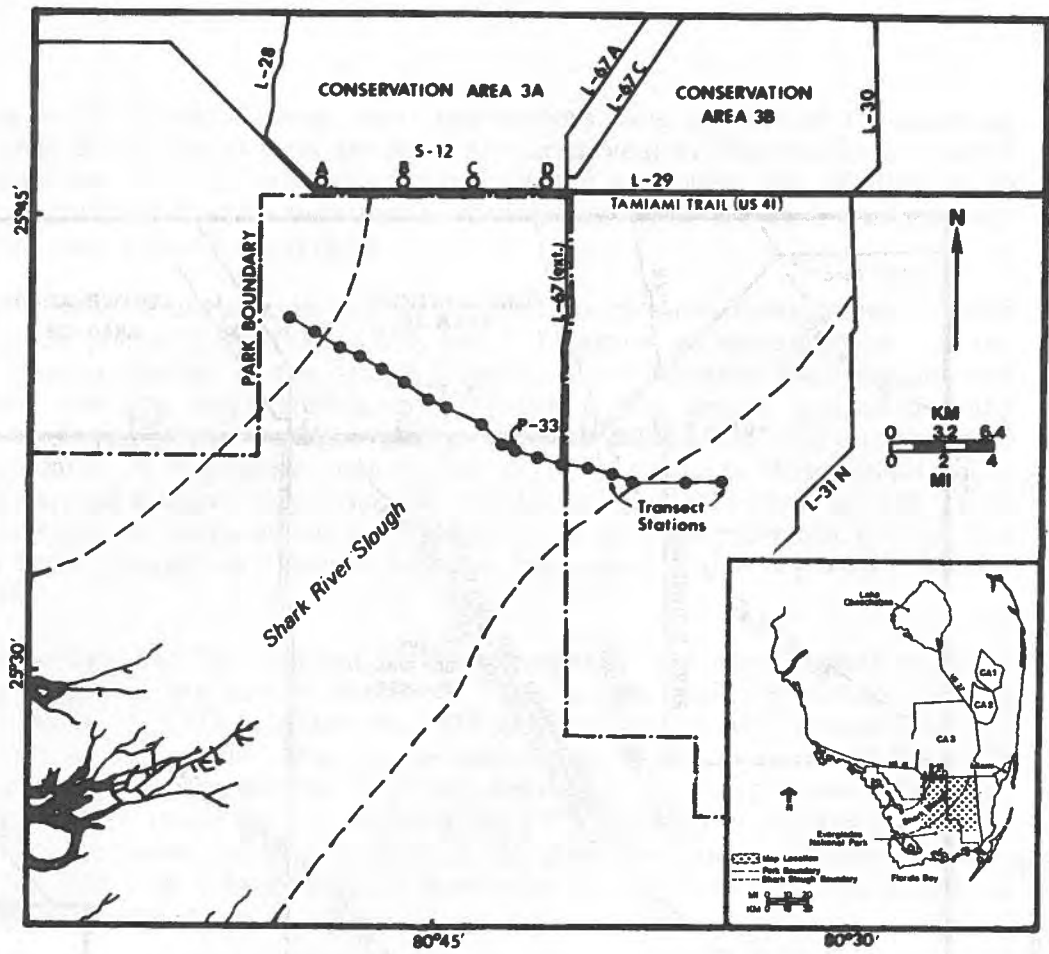
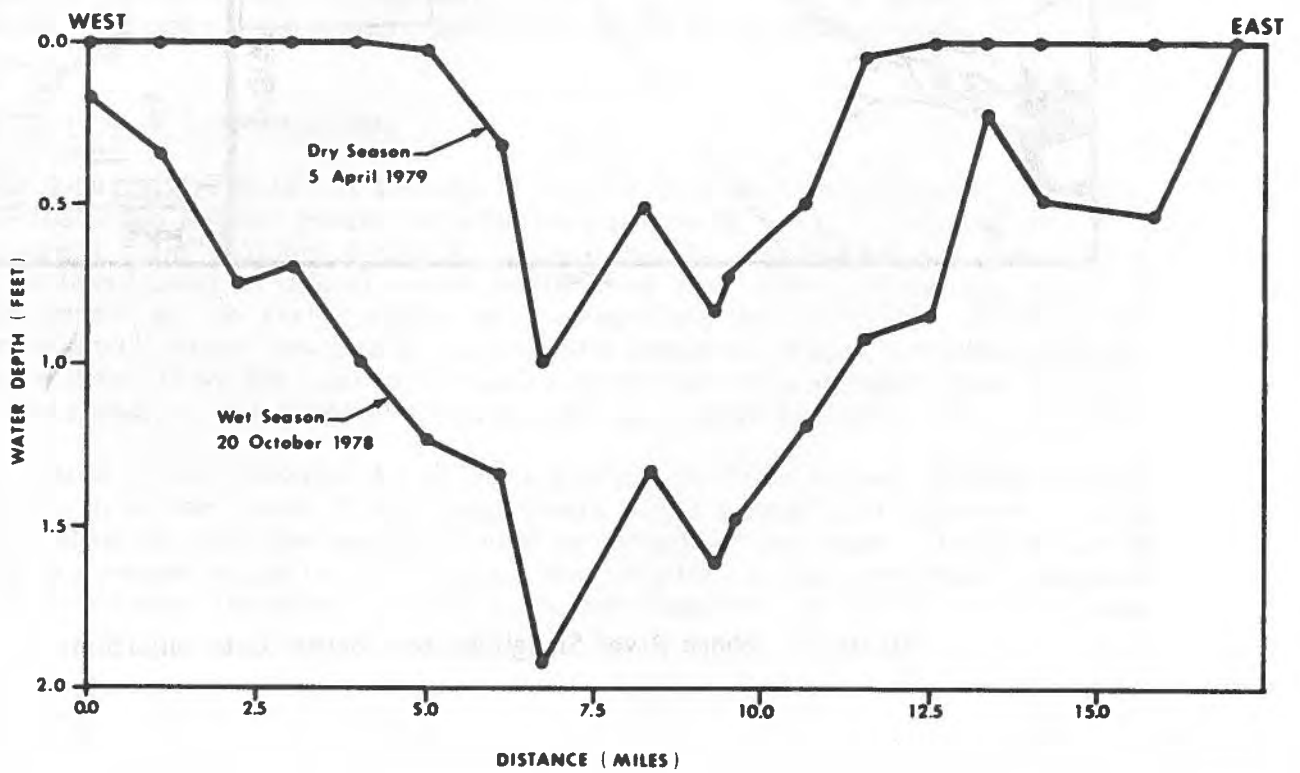
Figure 6. (a) Shark River Slough depth profile monitoring transect. (b) Shark River Slough wet season and dry season depth profiles.

Shark Slough is a "pulsating" system, with variation in slough configuration within the basin depending upon surface inputs and rainfall. The National Park Service monitored slough water depth over a two year period along a transect perpendicular to flow in the slough (Figure 6a), resulting in the wet season and dry season inundation profiles shown in Figure 6b. During this period, slough width varied from 17 miles during the wet season to 8 miles during the dry season. Determining the border configurations of Shark Slough under these changing conditions, especially the western slough border, is important for understanding the location of the S-12 structures with respect to the slough. Such information is useful in determining probable distribution patterns of deliveries through each structure and in turn may be used in choosing structure opening strategies.

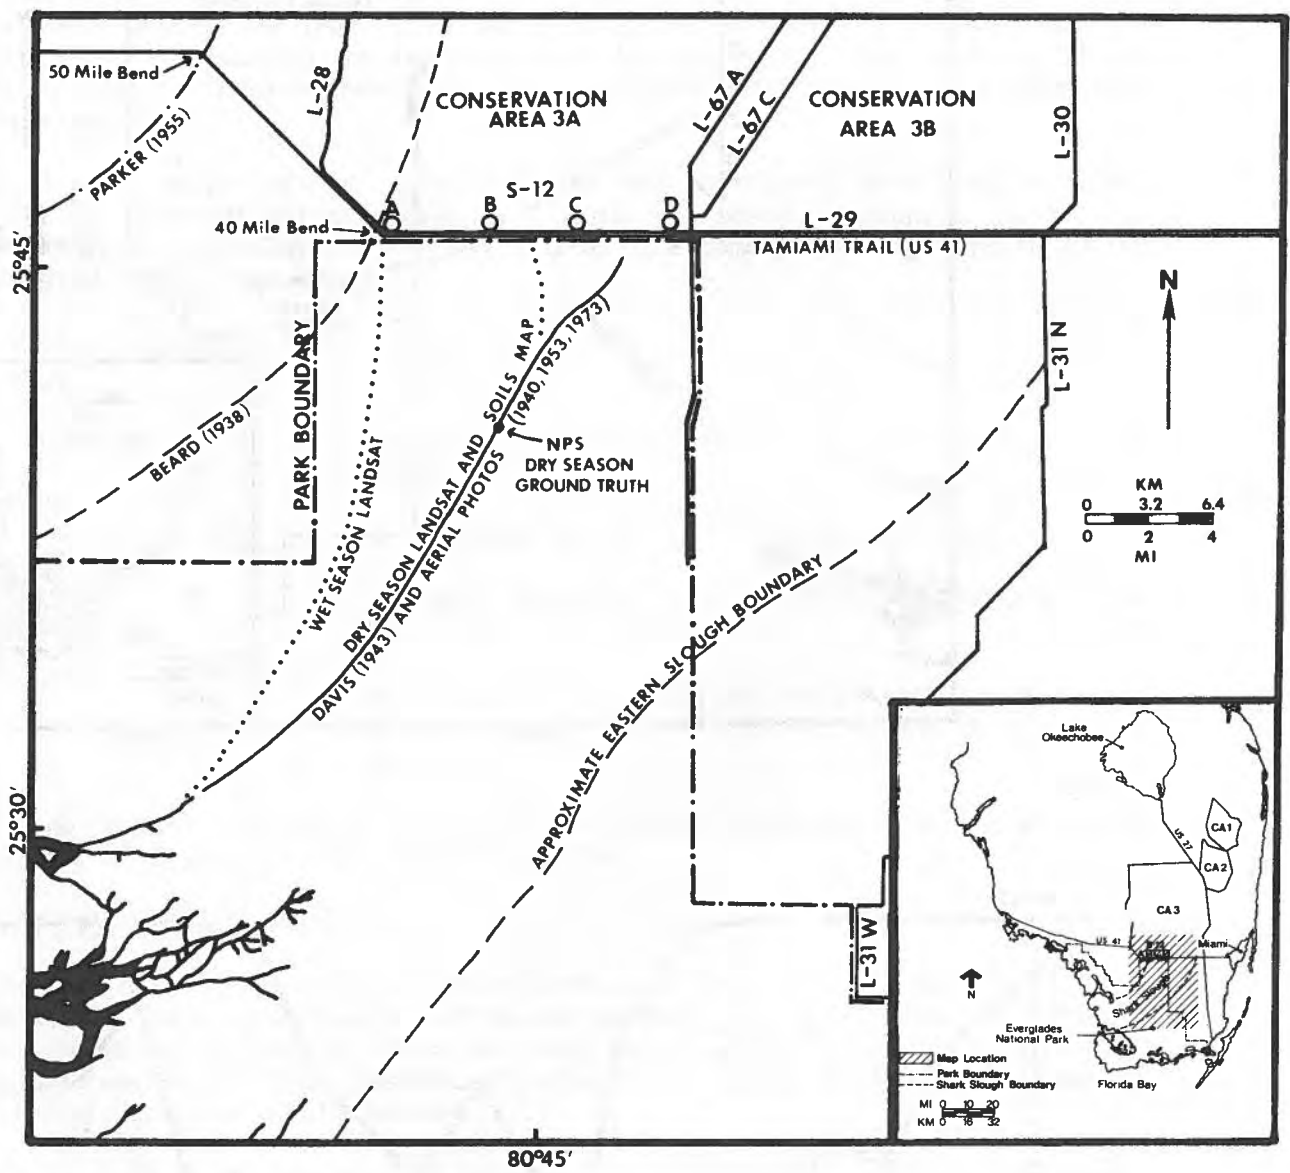
Figure 7. Shark River Slough western border determinations.

Work by Parker (1955) placed the western boundary at 50-Mile Bend along Tamiami Trail (Figure 7). While north-south drainage may indeed follow Parker's flow

Further refinement of dry season and wet season borders has been achieved more recently. Aerial photos from 1940, 1953, and 1973 agree on the placement of the dry season western border of the slough (Figure 7) and National Park Service dry season ground-truthing supports this configuration. Wet season ground-truthing showed the border to be more obscure, with continuous wet areas extending west of the park boundary. A vegetation map by Davis (1943) supports these aerial photo determinations, and a soils analysis of the area by the National Park Service found that the limits of peat soils, which are indicative of long hydroperiods such as the area within Shark Slough's dry season borders, approximate this dry season border configuration.

The wet season western border, as determined from Landsat images during maximum inundation conditions on October 19, 1974, also is shown in Figure 7. In this case, most of the ridge extending along the western park border was still dry. Except for the slough strands which cut across the ridge in times of very high water, this ridge is the western limit of the Shark Slough drainageway.

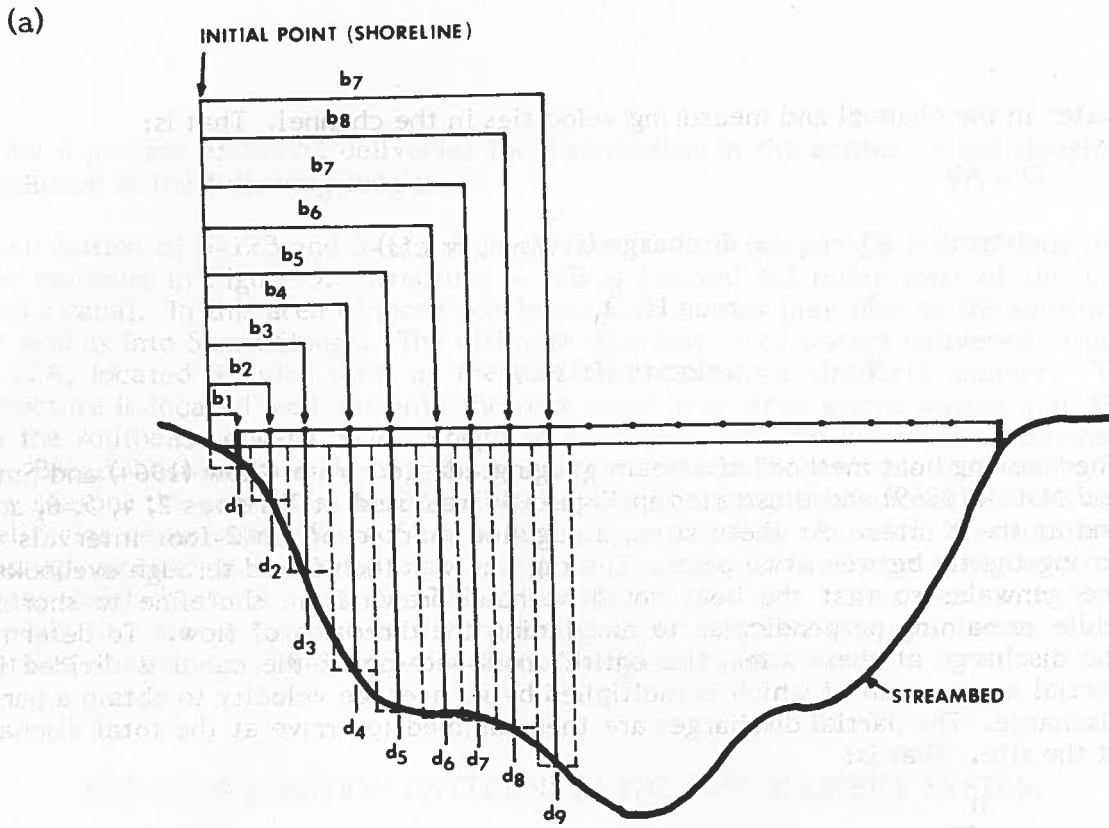
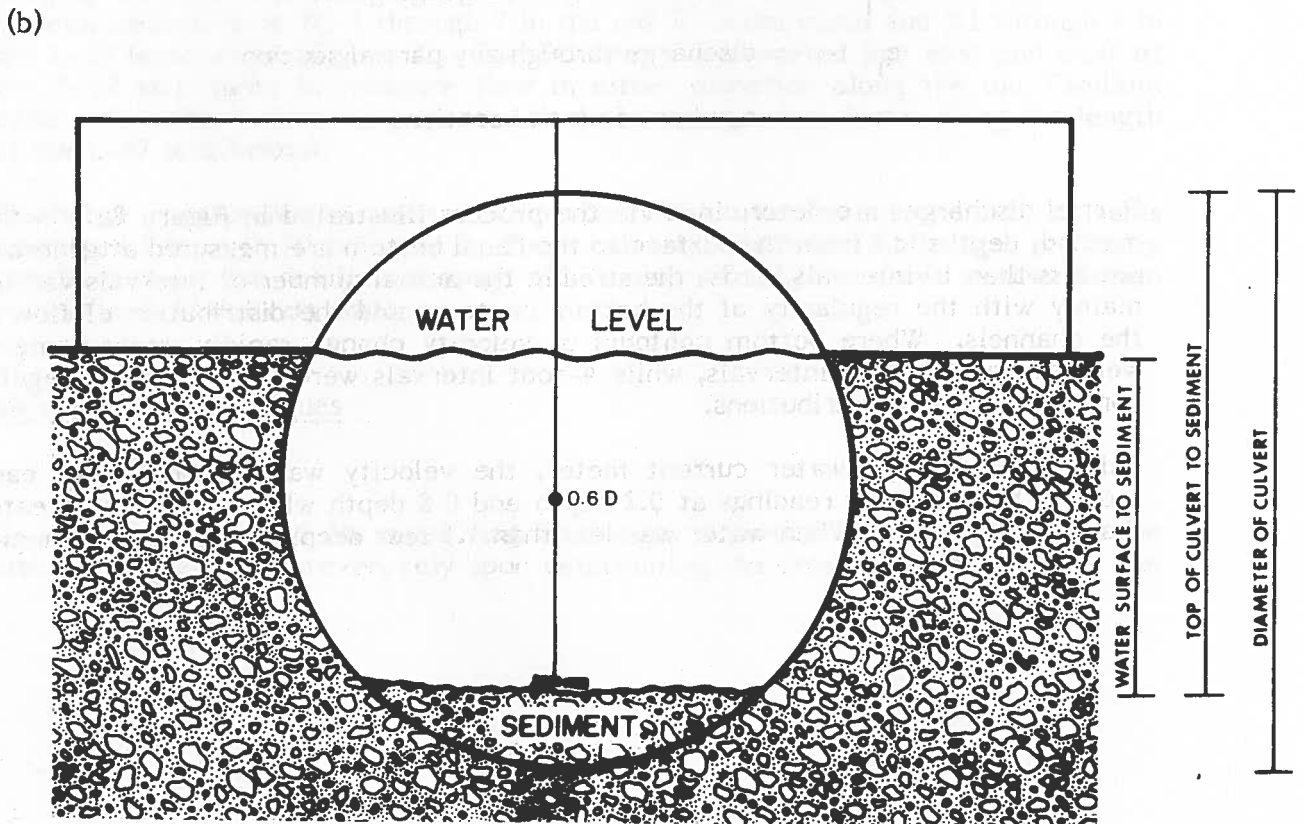
Figure 8. (a) Canal discharge measurement technique.
 (b) Barrel culvert discharge measurement technique.

Partial discharges are determined via the process illustrated in Figure 8a. In this method, depths (d_i) from the surface to the canal bottom are measured at generally not less than 15 intervals across the stream, the actual number of intervals varying mainly with the regularity of the bottom contours and the distribution of flow in the channels. Where bottom contours or velocity change rapidly, measurements were taken at 2-foot intervals, while 4-foot intervals were used for more regular contours and flow distributions.

Using a Price-type water current meter, the velocity was determined at each interval by averaging readings at 0.2 depth and 0.8 depth when water was greater than 1.5 feet deep. When water was less than 1.5 feet deep, one 0.6 depth velocity

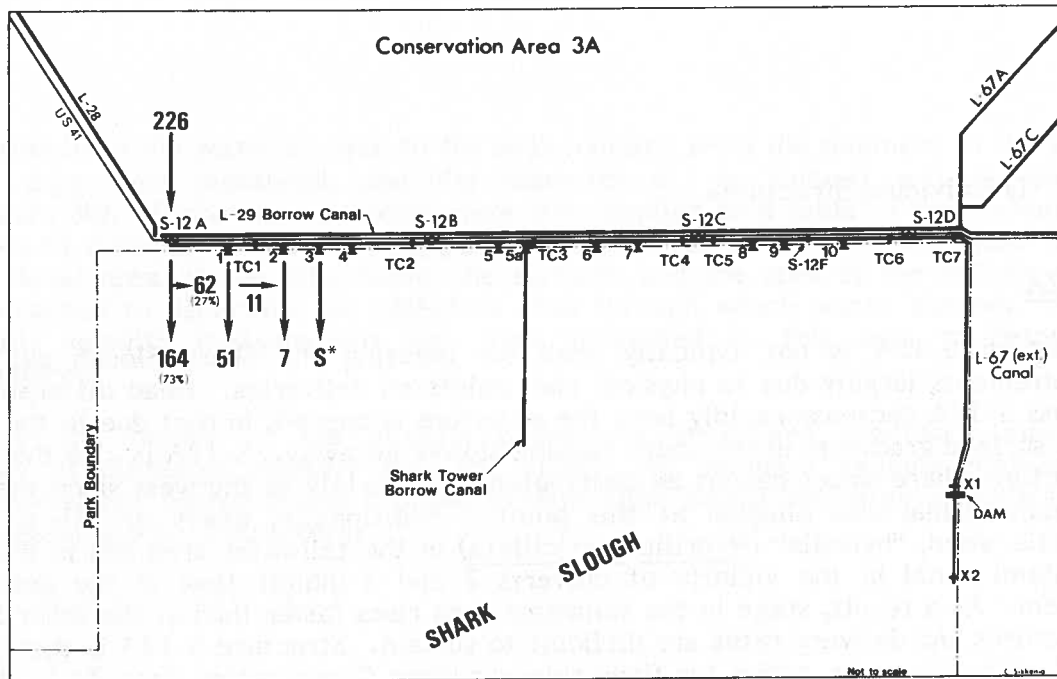
(a) S-12A open, October 3, 1980. Asterisk (*) indicates direction of flow when below threshold of current meter.

Figure 9 (a) and (b). Structure S-12 distribution, in cfs.

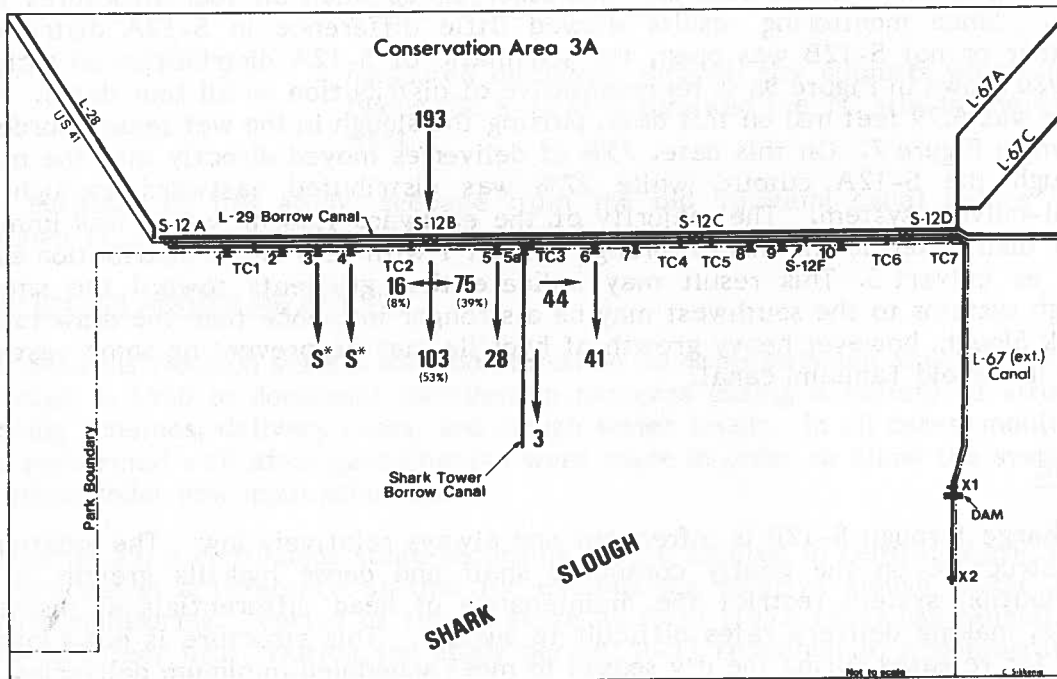
(b) S-12B open, September 12, 1979. Asterisk (*) indicates direction of flow when below threshold of current meter.

The schematic of S-12B distribution from September 12, 1979 (Figure 9b) shows the typical pattern found during monitoring. P-33 stage was 6.32 feet msl, with the slough in the maximum inundation configuration. Only about 8% of flow was distributed to the west, possibly because of heavy growth of vegetation in the canal and culverts to the west. Still, flow was discernable as far west as culvert 3. Thirty-nine percent of deliveries flowed eastward down old Tamiami canal with very small amounts of water (2% of deliveries on this date) flowing through culvert 5a for distribution along the Shark Valley Tower Road borrow canal. The balance of this eastward flow was distributed as far east as culvert 6. Flow would no doubt have been distributed even farther to the east had S-12C not been open at this time, raising water levels in the distribution system near that structure. Upon entering the marsh, these eastward flowing waters may then follow gradients back to the west away from the Slough, however, the farther east S-12B waters are distributed through the culvert-canal system, the more likely they are to enter the main body of Shark Slough.

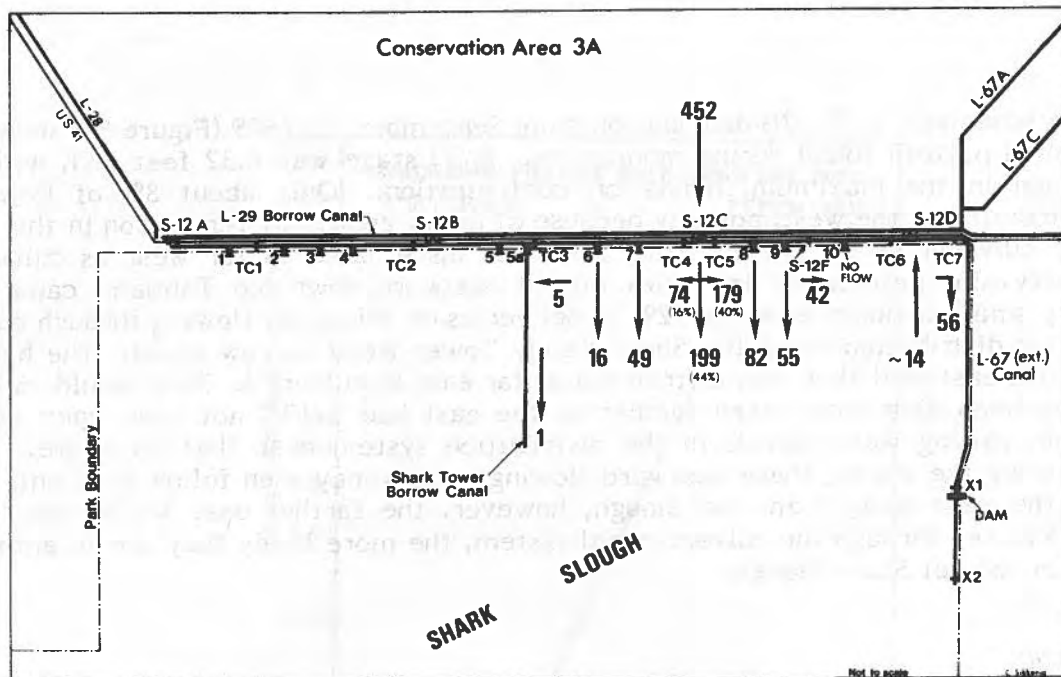
(a) S-12C open, September 5, 1979.

Figure 10 (a) and (b). Structure S-12 distribution, in cfs.

Figure 10a and Table 2 show that S-12F is not always an effective dam. Measurements indicate that gradients toward station TC7 exert enough hydrostatic head to draw water through gaps in the stoplogs, thus bypassing culvert 10 for entry into the L-67 (ext) canal. On July 12, 1979, 57% of the S-12C discharge spilled past S-12F, and on two occasions water was observed flowing north through culvert 10, adding inputs through station TC7. This may indicate that a portion of the S-12C discharge circumvented S-12F through the culverts to the west but then re-entered the old Tamiami canal, following the strong gradient into the L-67 (ext.) canal.

Delivery patterns of water from S-12C, as depicted in Figure 11a, show significant changes from when S-12C is the only structure open (Figure 10a). Westward flowing waters from the large S-12D delivery leak past S-12F and reduce the eastward distribution from S-12C. Deliveries through S-12C tended to move into the slough near that structure on March 4, rather than flowing all the way to the L-67 (ext.) canal as occurred on September 5.

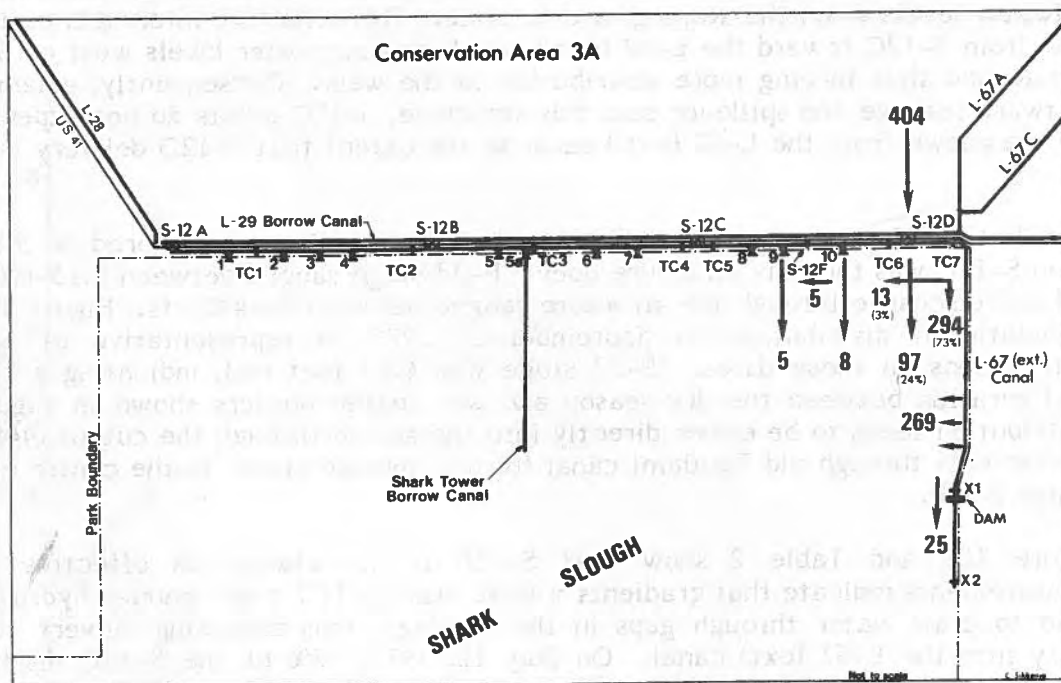
(b) S-12D open, May 22, 1979.

Deliveries when S-12D was the only structure open were monitored on four dates during the study period. The schematic of the distribution on May 22, 1979 shown in Figure 10b is representative of this delivery scheme. Stage at P-33 was 6.18 ft msl, indicating a slough border configuration between the wet season and dry season Landsat determined borders shown in Figure 7. The strong influence of the L-67 ext. canal is apparent, with 73% of discharge drawn into the canal. Distribution along this canal will be discussed further below. Flow westward was minimal, but slight leakage through S-12F was evident. Twenty-four percent of discharge was distributed into the slough through the S-12D cutout.

Distribution patterns at S-12D when all structures were open differed significantly from when S-12D was open alone (Figure 10b). A much smaller percentage of

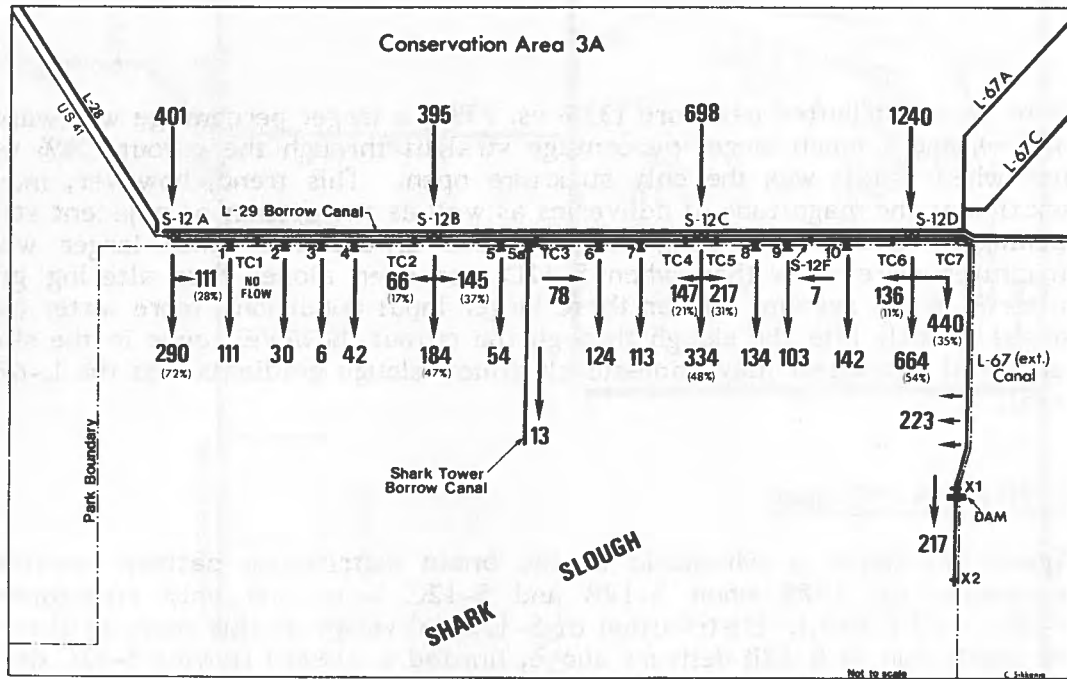
(a) All four structures open, March 4, 1980.

Figure 11. (a) and (b). Structure S-12 distribution, in cfs.

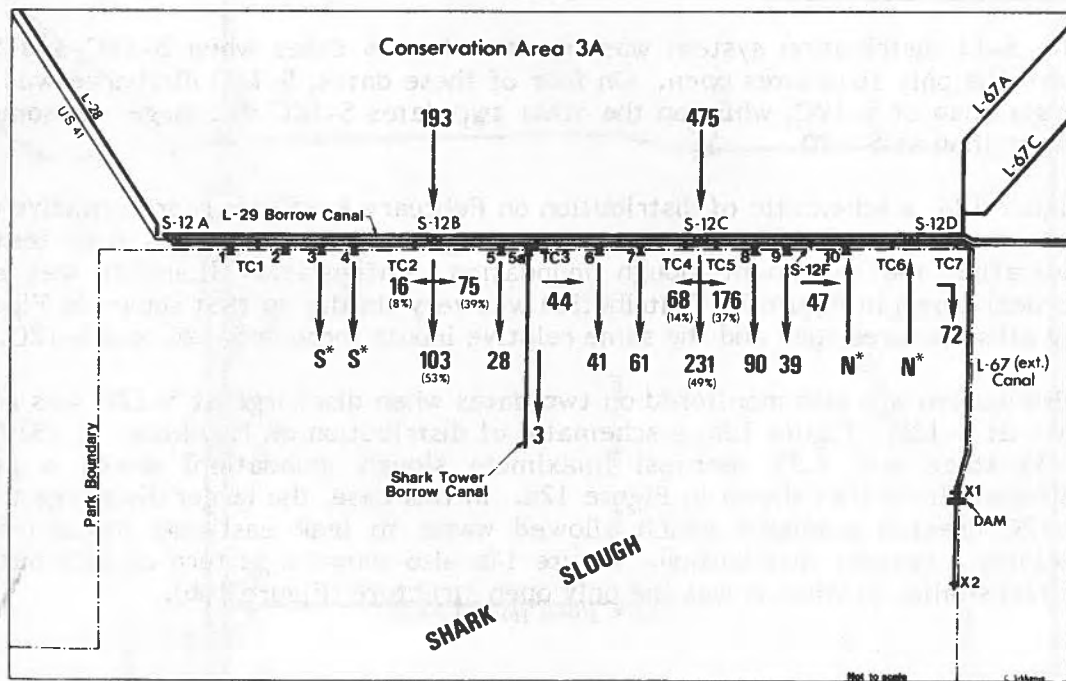
(b). S-12B and S-12C open, September 12, 1979. Asterisk (*) indicates direction of flow when below threshold of current meter.

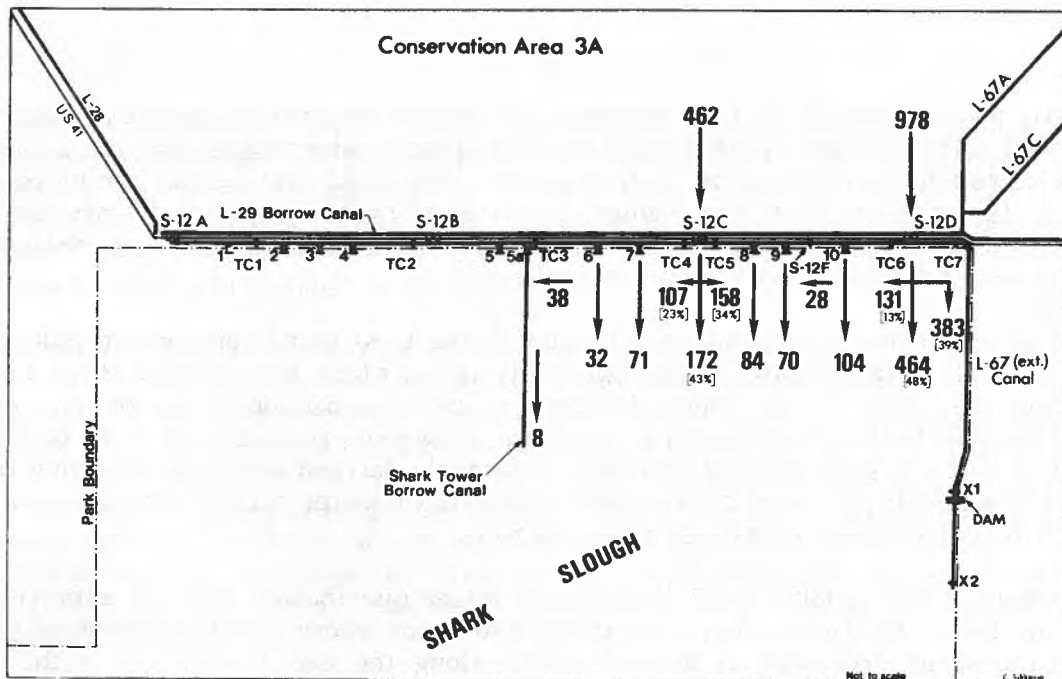
(a) S-12C and S-12D open, larger delivery through S-12D, February 8, 1980.

Figure 12 (a) and (b). Structure S-12 distribution, in cfs.
