**STRUCTURE S-12 WATER DISTRIBUTION
TO EVERGLADES NATIONAL PARK**

Report T-650

**National Park Service
South Florida Research Center
Everglades National Park
Homestead, Florida 33030**

February 1982

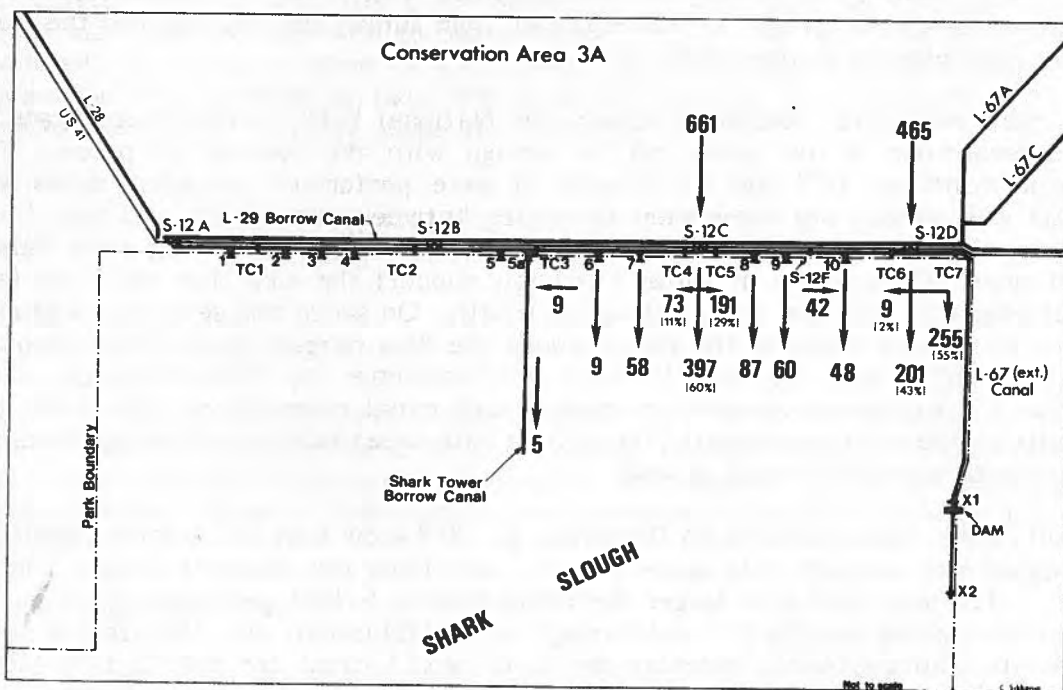
(b). S-12C and S-12D open, larger delivery through S-12C, November 6, 1979.

Distribution was also monitored on two dates when discharge at S-12C was greater than at S-12D. Figure 12b, a schematic of distribution on November 6, 1979 when P-33 stage was 6.73 feet msl (maximum slough inundation) shows a pattern different from that shown in Figure 12a. In this case, the larger discharge through S-12C created gradients which allowed water to leak eastward through S-12F, yielding a broader distribution. Figure 12b also shows a pattern of distribution at S-12D similar to when it was the only open structure (Figure 10b).

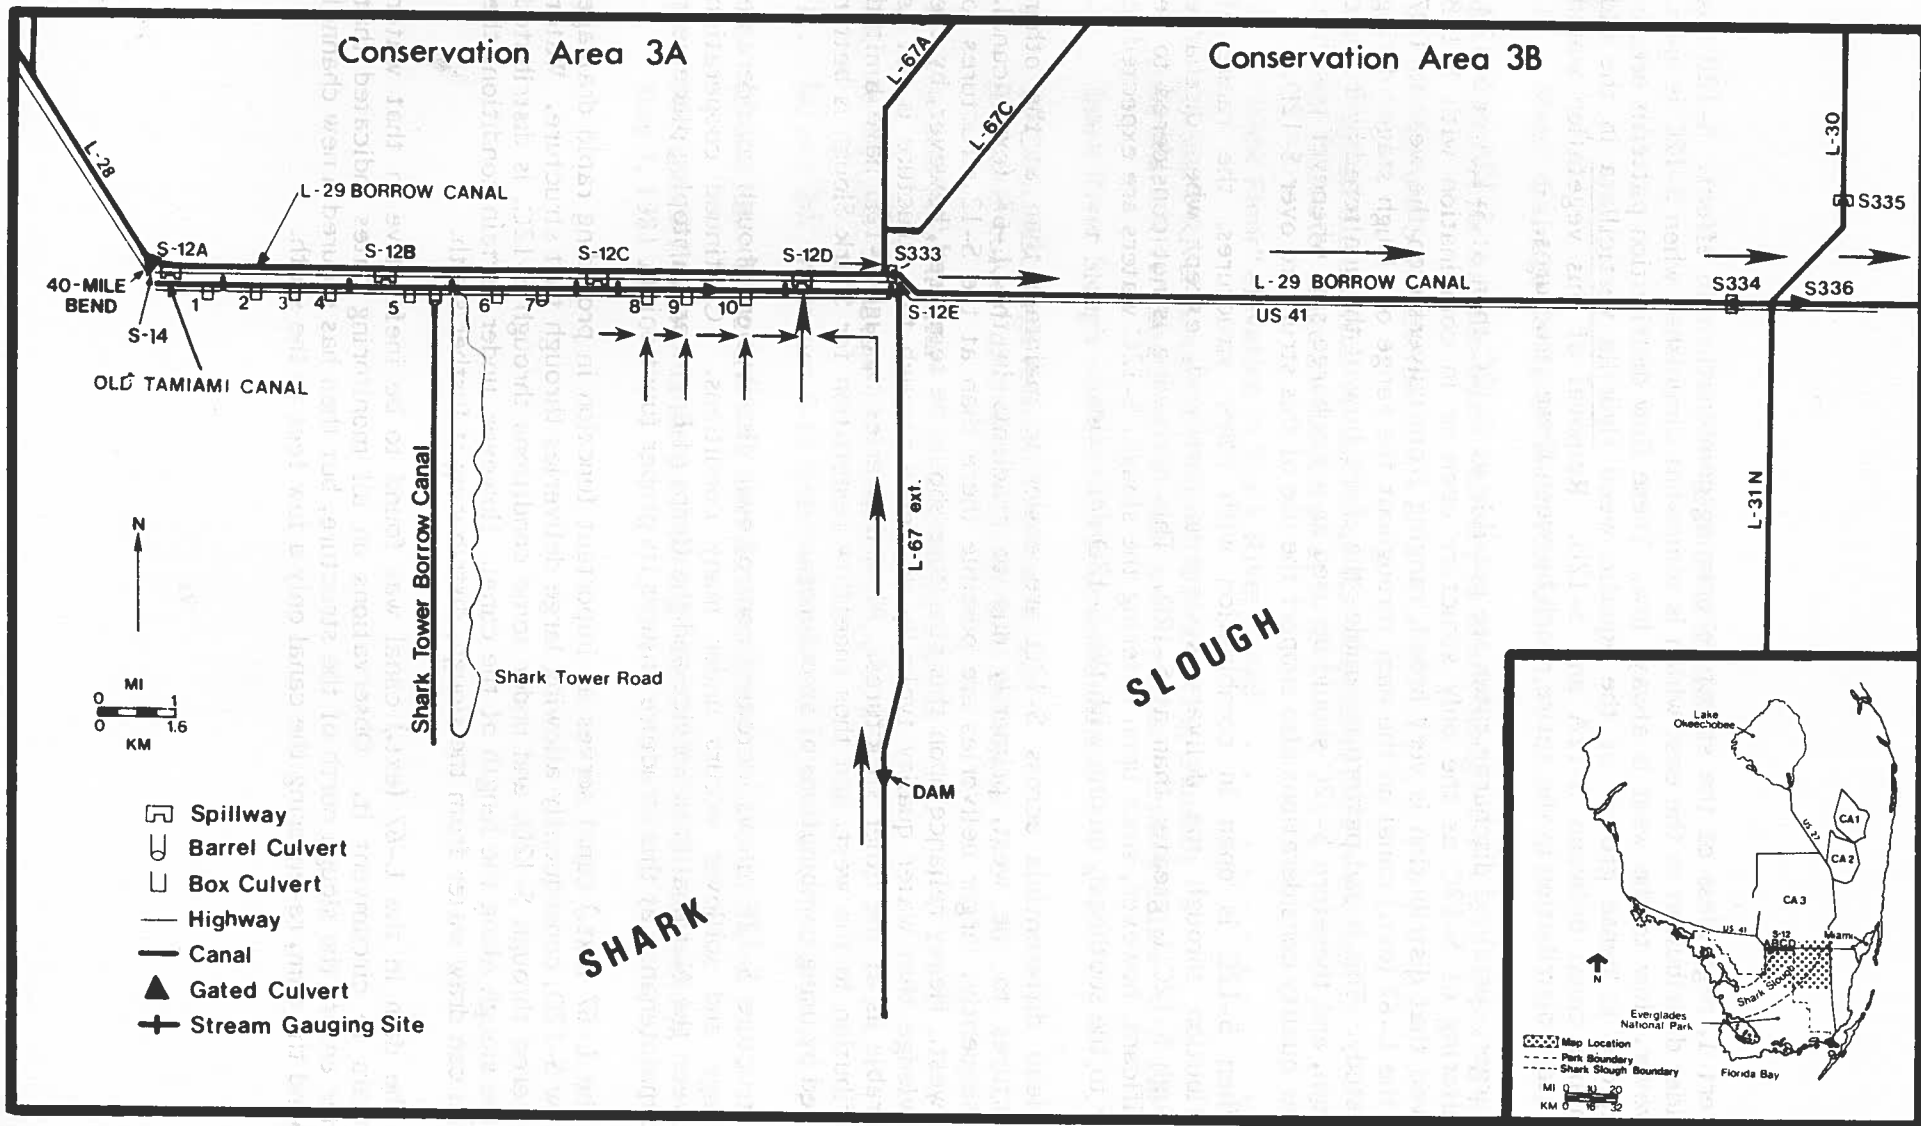
Figure 13. Northward flow out of the Park through the S-12 distribution system, May 7, 1981.

On May 7, 1981, National Park Service personnel monitored the S-12 distribution system using rhodamine tracer dye to investigate possible northward drainage out of the Park. Figure 13 is a schematic of the flow pattern observed on this date at 1400 hours. This schematic shows that a significant portion of Shark Slough was affected, with water not only draining from the slough into the L-67 (ext.) canal, then flowing north toward structure S-12D, but also flowing northward through culverts 8, 9, and 10, and then east down the old Tamiami canal toward the structure. A head-differential of 0.03 feet from south to north was observed across S-12D at this time, and northward flow out of the Park was verified via rhodamine tracer dye. Subsequent examination of strip charts from upstream and downstream stage recorders at S-12D further verified the existence of the observed reversal in head-differential.
