# Modern Landscape Processes Affecting Archaeological Sites along the Colorado River Corridor Downstream of Glen Canyon Dam, Glen Canyon National Recreation Area, Arizona

Scientific Investigations Report 2017–5082

By Amy E. East, Joel B. Sankey, Helen C. Fairley, Joshua J. Caster, and  
Alan Kasprak

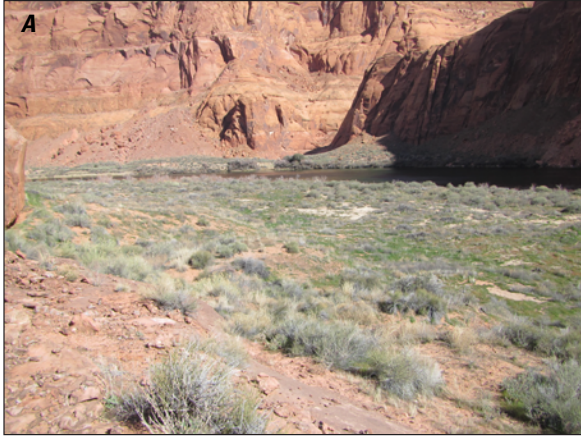
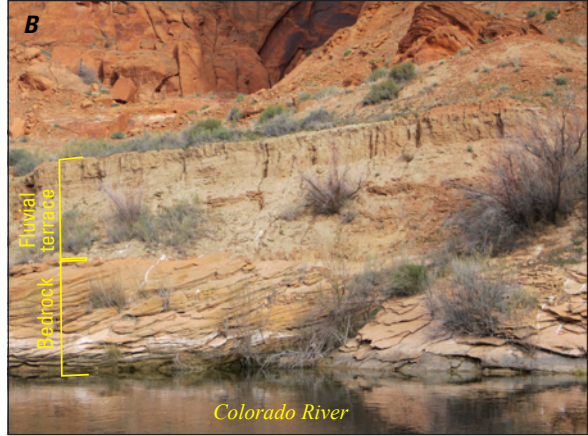
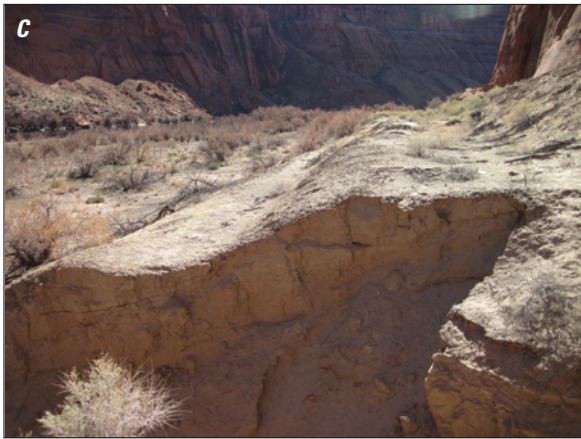
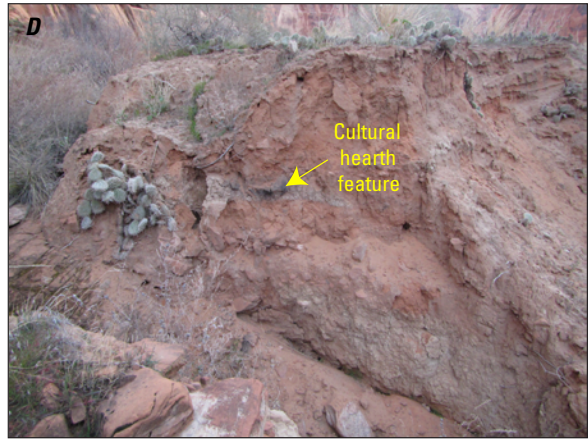
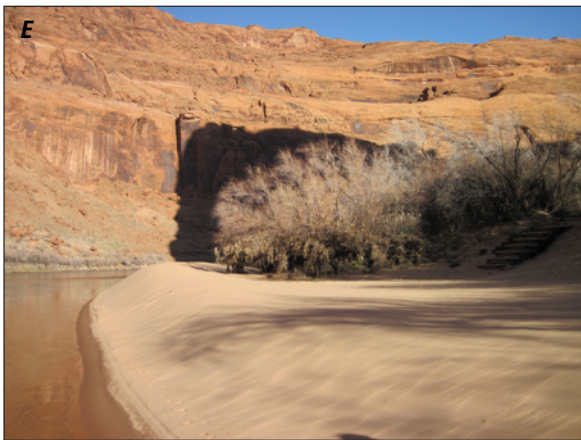
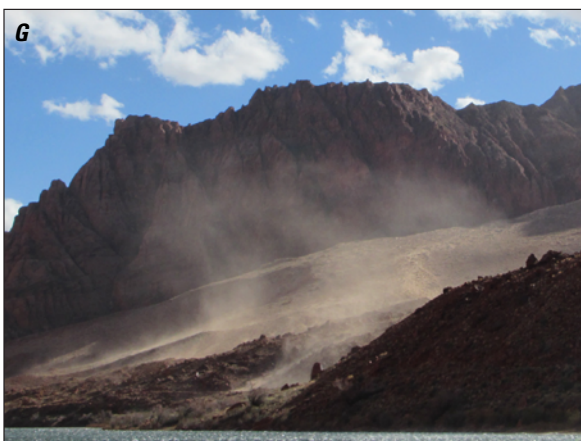
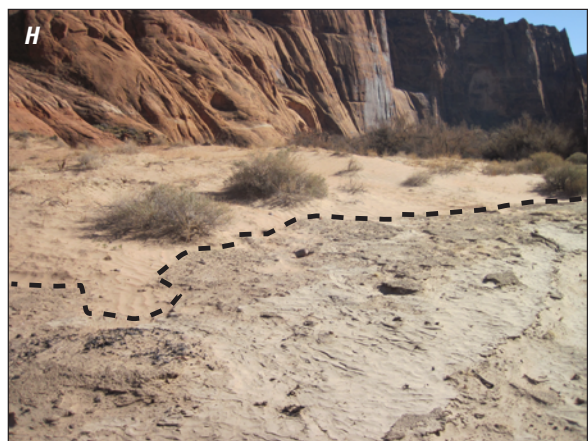
**Figure 2.** Photographs of the modern geomorphic setting and evidence of landscape processes along the Colorado River in Glen Canyon. *A*, Broad terraces composed mostly of relict fluvial sediment line much of the Glen Canyon river corridor. This photograph shows one such terrace (the flat, vegetated area) viewed from a vantage point on a talus slope above the terrace. *B*, Riverward edge of a relict fluvial terrace (middle of image); this terrace has retreated far enough laterally to expose cross-bedded sandstone bedrock at river level. *C*, Relict fluvial terrace incised by a 10-meter-wide arroyo (in foreground) that formed from erosion by overland flow. River is to the left. *D*, Archaeological feature (a charcoal hearth) exposed in the wall of an arroyo. The arroyo incised through a terrace composed of interbedded Colorado River fluvial sediment and locally derived slopewash material. Arroyo wall is approximately 1.5 meters high at this location; hearth is located approximately 0.5 meters below the ground surface. *E*, A rare modern fluvial sandbar along the Colorado River margin in February 2013, three months after a controlled flood deposited the sandbar. Note tamarisk trees at landward margin of the sandbar. Riparian vegetation is nearly ubiquitous in Glen Canyon and reduces the potential for aeolian sand transport from fluvial sandbars to most inland areas. *F*, Sedimentary structures exposed in an arroyo wall (same arroyo as in *D*) are diagnostic of fluvial deposition. These fluvial climbing ripples (Rubin and Carter, 2006) show soft-sediment deformation structures (fluid-escape structures, in upper third of image) that commonly result from rapid deposition during a sediment-rich flow event. The presence of these structures within the majority of the terrace thickness indicates that the sediment originated from Colorado River floods. Pencil shown for scale. *G*, Aeolian sand transport on a windy day in February 2016; the transport direction was from left to right, moving sand upward along a large sand ramp feature that spans from river mile -1.4 to -2.1. Colorado River is in foreground. Suspended-sand transport is visible to a height of approximately 80 meters above the ground surface. *H*, Adjacent areas of aeolian sand deposition (in background, behind dashed line) and aeolian erosion (foreground, in front of dashed line). Wind ripples on the surface of the background sediment indicate recent aeolian sand activity; tan color of recently transported sand implies some derivation from local bedrock sources in addition to Colorado River sediment. Cohesive, beige-gray sediment in foreground displays (upon examination at closer scales than shown in photograph) exposed fluvial climbing ripple structures similar to those in *F* and local “blowout” morphology, indicating that wind erosion sculpted the surface of this relict fluvial deposit.

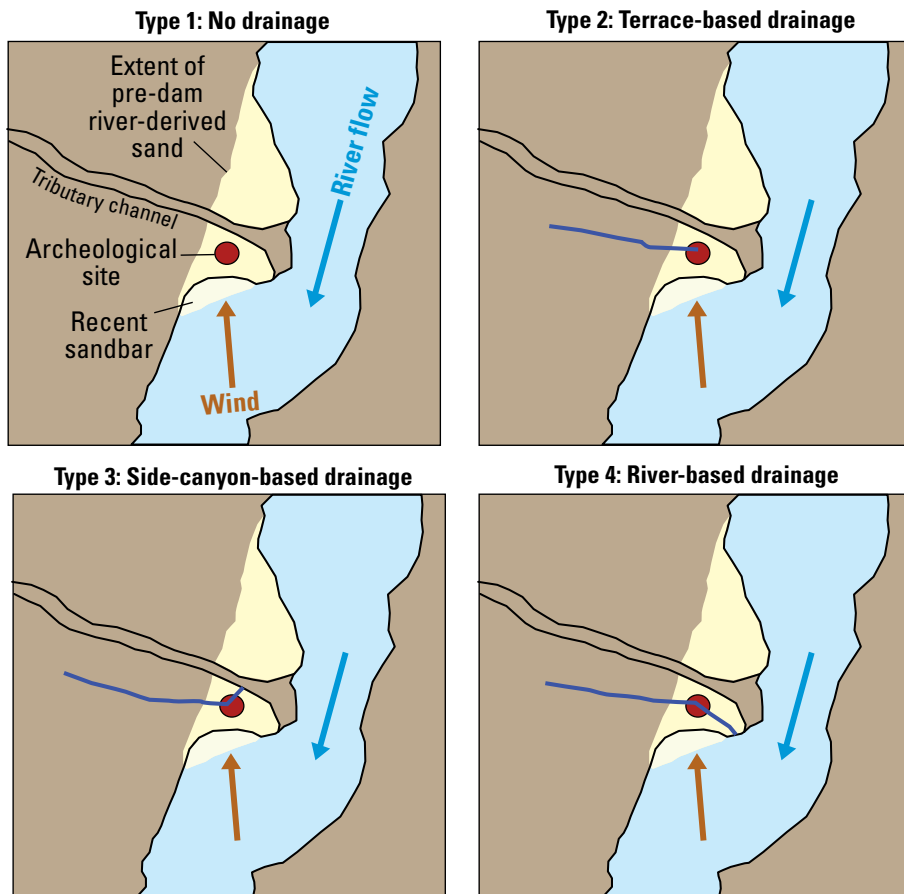
**Figure 4.** Schematic diagram illustrating the classification system used to identify overland-flow drainage erosion affecting archaeological sites. See table 2 for a description of each classification type.

We applied the aeolian and drainage classifications (tables 1, 2; figs. 3, 4) to each of the 54 study sites using direct field observations and we extended the evaluations into the past by analyzing historical aerial photographs. We focused on five discrete time steps.
