National Park Service  
Cultural Landscapes Inventory  
2011

John Fitzgerald Kennedy NHS Landscape  
John Fitzgerald Kennedy National Historic Site

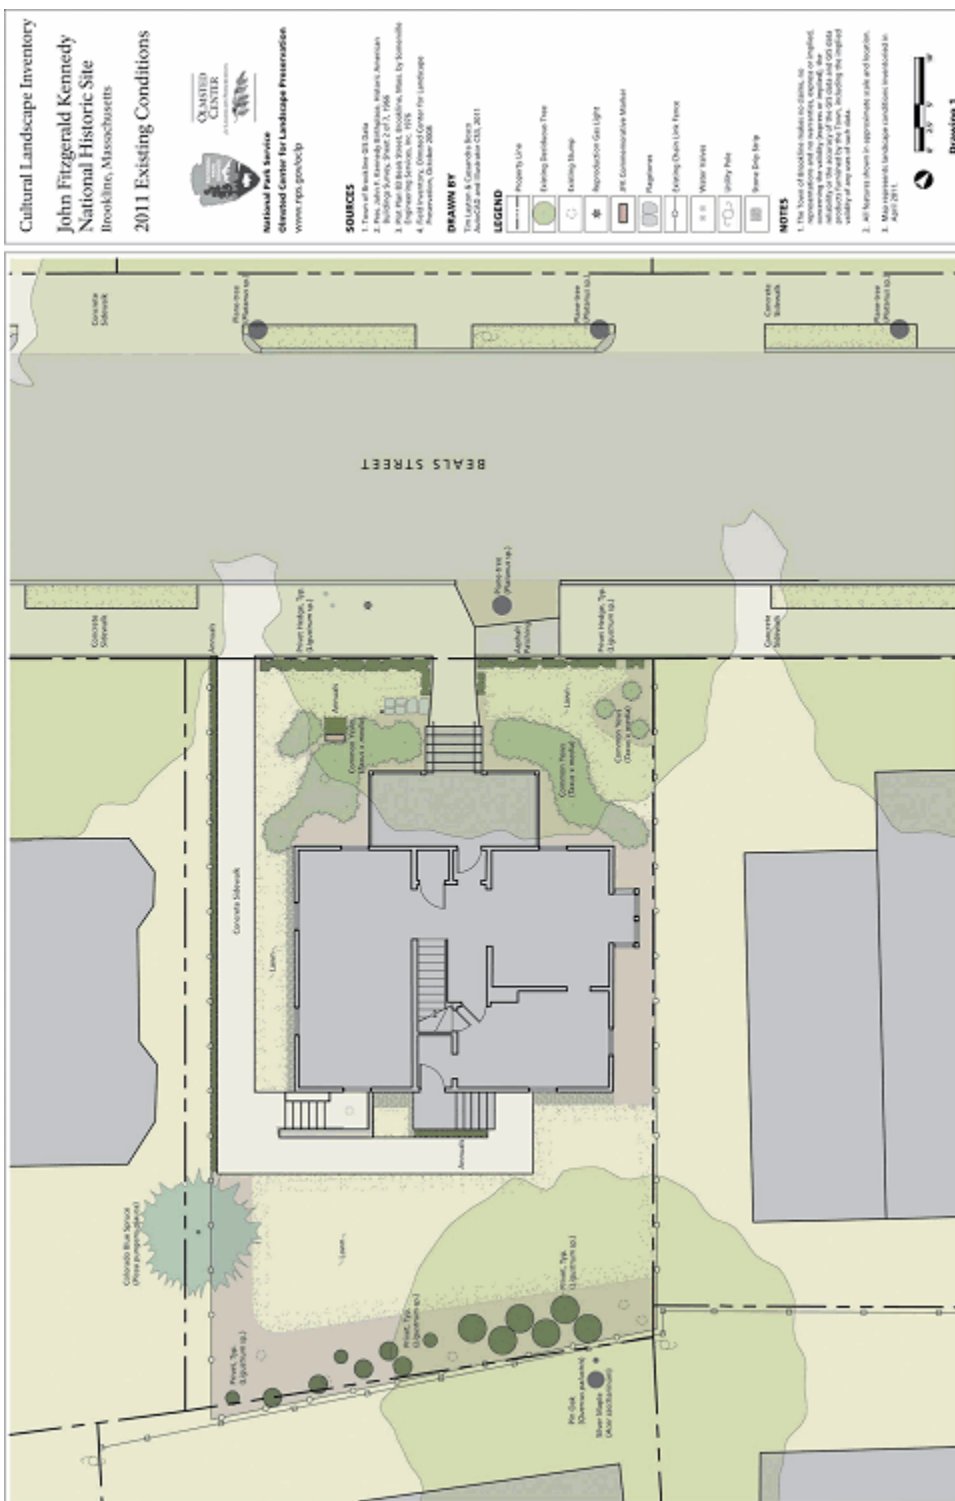
*Plan of Existing Conditions, 2011.*

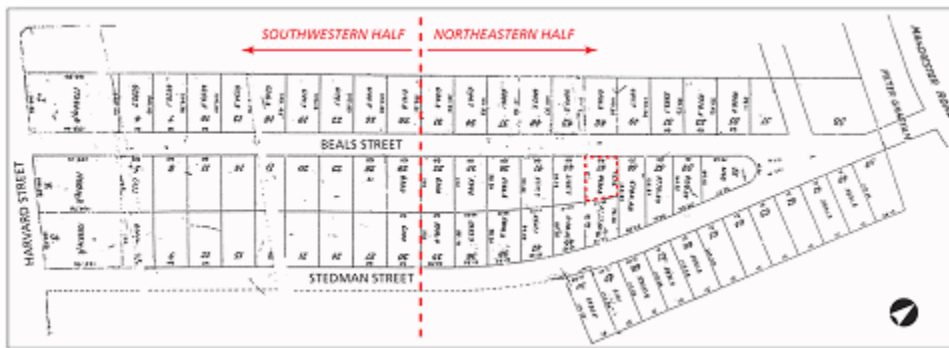
*Figure 1. Digitally enhanced copy of the Beals Estate Subdivision Plan, 1897. The future Kennedy home at 83 Beals Street is outlined in red (Norfolk Registry of Deeds, vol. 800, pg. 640).*

The topography of Brookline is relatively flat, though punctuated by several large drumlins, collectively known as the Brookline Hills. Babcock's Hill, north of the present-day John Fitzgerald Kennedy National Historic Site (from here on referred to as Kennedy National Historic Site), was named for George Babcock, who purchased the land in 1835, which would later become the Beals Estate subdivision (Norfolk Registry of Deeds 150: 44, HSR Research Files). Present-day Babcock Street follows the approximate southern boundary of Babcock's 76-acre property. The property extended north almost to the Boston line and was bounded to the west by Harvard Street and to the east by Manchester Road. Babcock and his family owned the land for over thirty years before selling it to James M. Beals in 1868. Beals then sold the property in 1897 to Benjamin Newhall, who subsequently subdivided the land along two roads, Beals and Stedman streets, which extend between Manchester Road and Harvard Street (Figure 1).

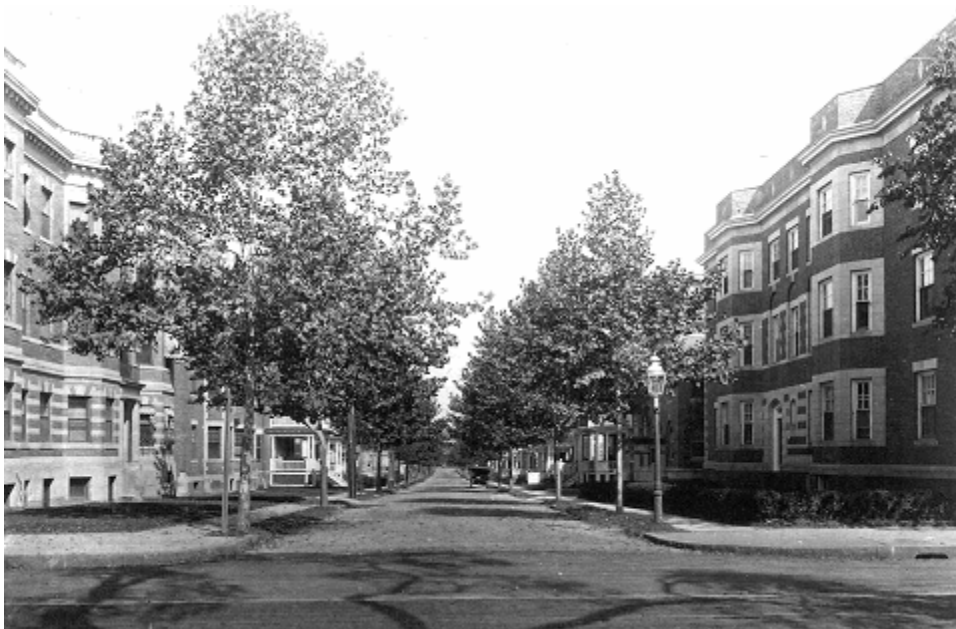
*Figure 2. View from the intersection of Harvard and Beals Streets, looking northeast down Beals Street, circa 1910s. Plane-trees were selected by the town for Beals. At this time, Beals has no curbs or pavement (Stanley Album, Brookline Public Library).*

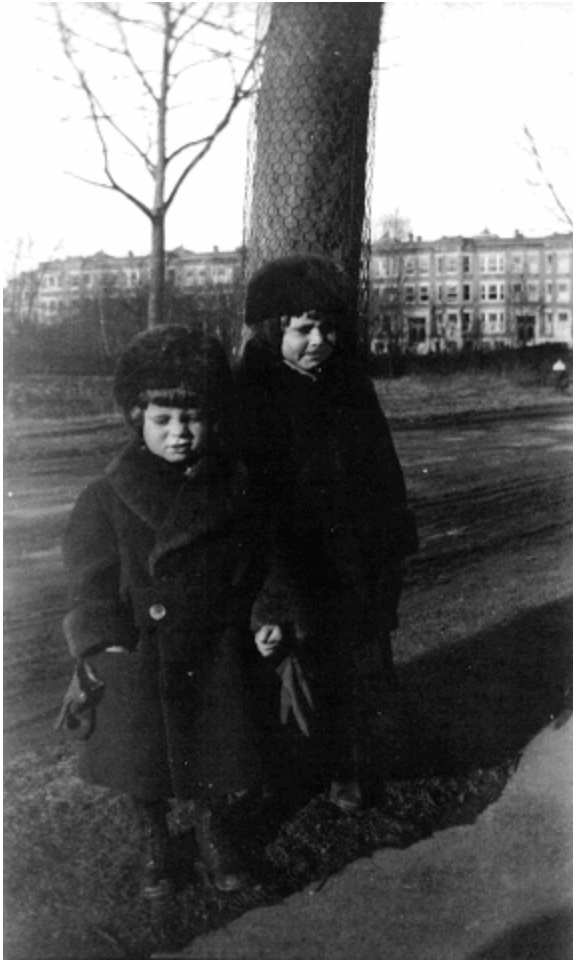
*Figure 4. John F. and Joseph P. Kennedy Jr., 1919, taken from the front of 83 Beals and looking north. The plane-tree has chicken wire around its trunk as a protective measure (Kennedy Family Collection, copyright John F. Kennedy Library Foundation).*

The photographs provide additional information on the street trees along Beals Street and associated tree lawn—the three-foot wide strip of grass set between the street and sidewalk. The plane-tree directly in front of 83 Beals is shown with chicken wire wrapped around its trunk as a protective measure (Figure 4). It was a common practice for the town to install either wood or wire guards to protect street trees from horses that might gnaw on their bark (Cummings, 1938: 14). The plane-trees lined both sides of the street and continued to mature and cast shade along the streets. Individual yards along Beals Street, however, remained unadorned perhaps due to the frequent changes in ownership and the high number of rental units.

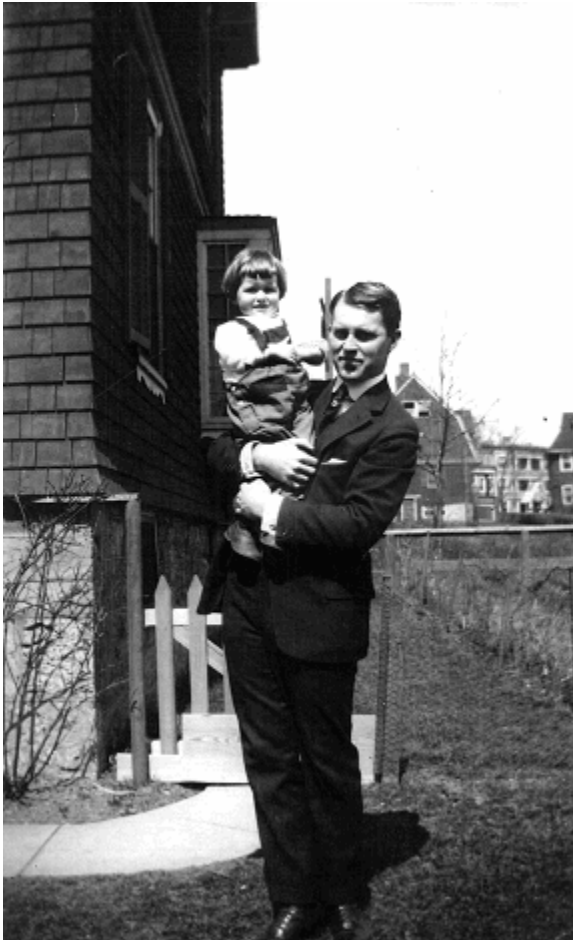
*Figure 5. Joseph P. Kennedy Sr. and Joseph P. Kennedy Jr., undated, likely 1917. By the east corner of the house at 83 Beals, a concrete walk provided access to the rear yard (Kennedy Family Collection, copyright John F. Kennedy Library Foundation).*

Although no photographs or plans exist from the 1910s that capture the front walk, it is likely that a paved walk provided access between the sidewalk and the front porch steps. Other than the sidewalk, front walkway, and walk in the northeast side yard and rear yard, there were no other formal, paved pedestrian or vehicular surfaces installed at 83 Beals. For circulation from the front to rear yards, the northeast side concrete walkway extended perpendicular from the sidewalk and proceeded southeast past the house to the rear yard, back door, and basement. This walk was narrower than the sidewalk and followed the perimeter of the house on the northeast and southeast facades. The walk flared out to form a landing at the wooden stairs for the rear entry and continued southeast of the stairs to provide access to the bulkhead steps and basement (Figure 5, see also Figure 3).

The front yard vegetation included lawn and the plane-tree in the tree lawn along Beals Street, which was the only tree on-site. No foundation plantings were established in the front yard. In a similar fashion, the side yard consisted primarily of lawn with no plantings along the house foundation or property line. The rear yard contained lawn immediately past the concrete walk and foundation plantings in a narrow bed on the northeastern side of the rear facade. The three plants shown in the photograph of the rear yard, two healthy and one struggling, have the branching characteristics of roses (*Rosa* sp.) (see Figure 5).

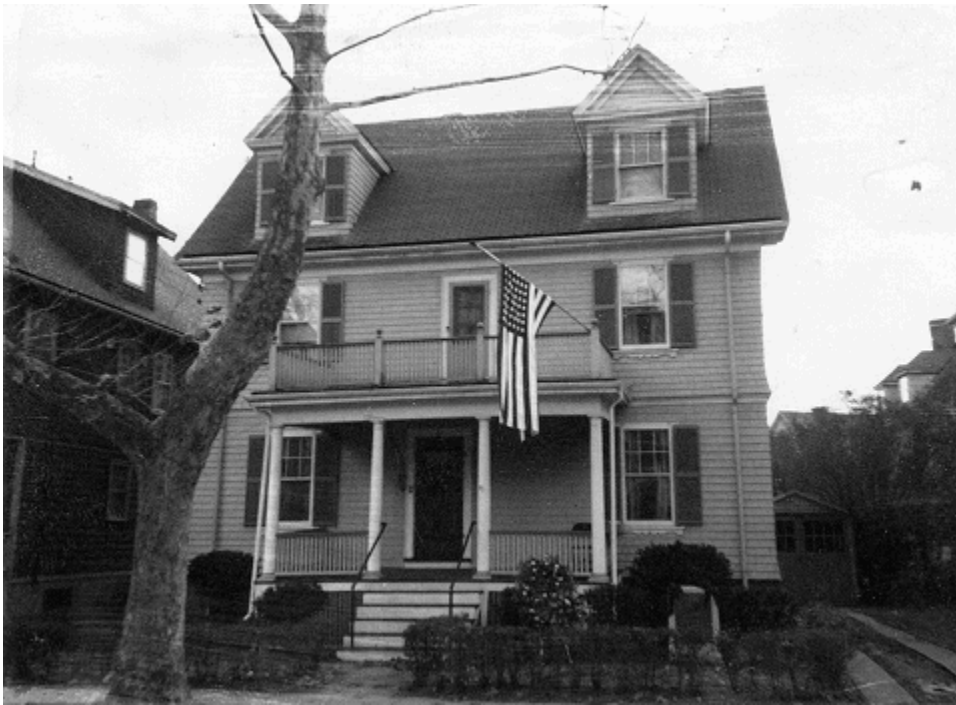
*Figure 6. View of northwest elevation, December 9, 1963, confirming the installation of the privet hedge, commemorative marker, and yew planting. At this time, wreaths were maintained beside the marker, draped in black bunting (JOFI Management Records).*

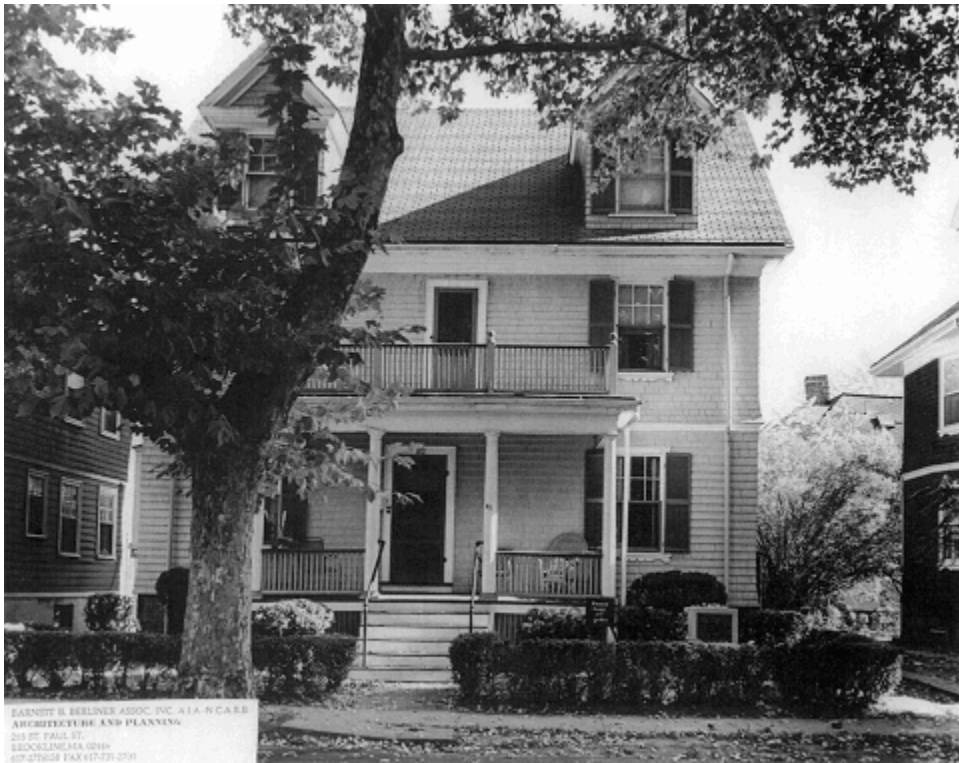
*Figure 8. View of northwest elevation, October 1964, shows the privet hedge, commemorative marker, yew planting, and sod installation (Irene Shwachman, 1964, Private collection of Mr. Robert Berliner, copies reside in the JOFI Management Records).*

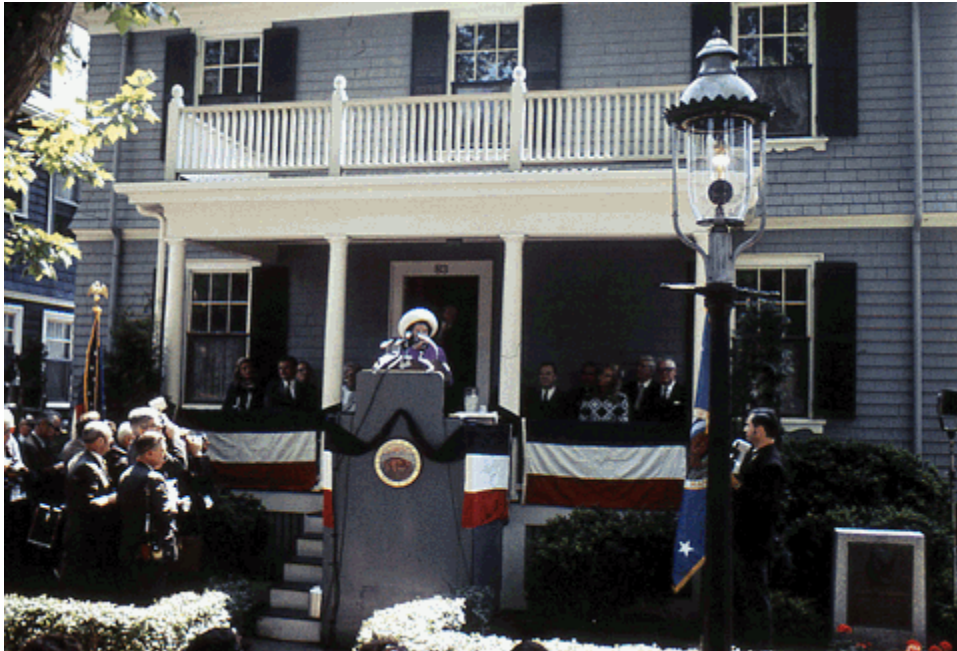
*Figure 11. View of northwest elevation, Dedication Ceremony, May 29, 1969, showing small-scale features and vegetation added during the 1960s: gas light, marker, privet, yew and arborvitae , front lawn, and geraniums (JOFI Management Records).*

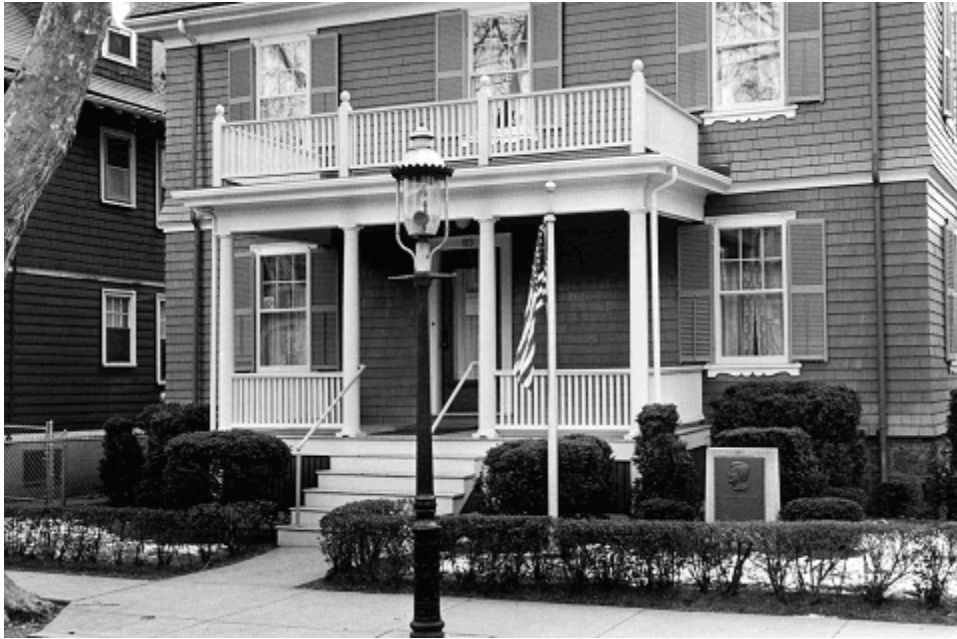
*Figure 13. View of northwest elevation in January 1975. Most arborvitae have been transplanted to the side yard and additional yews have been planted. Note the gas light and flagpole (JOFI Management Records).*

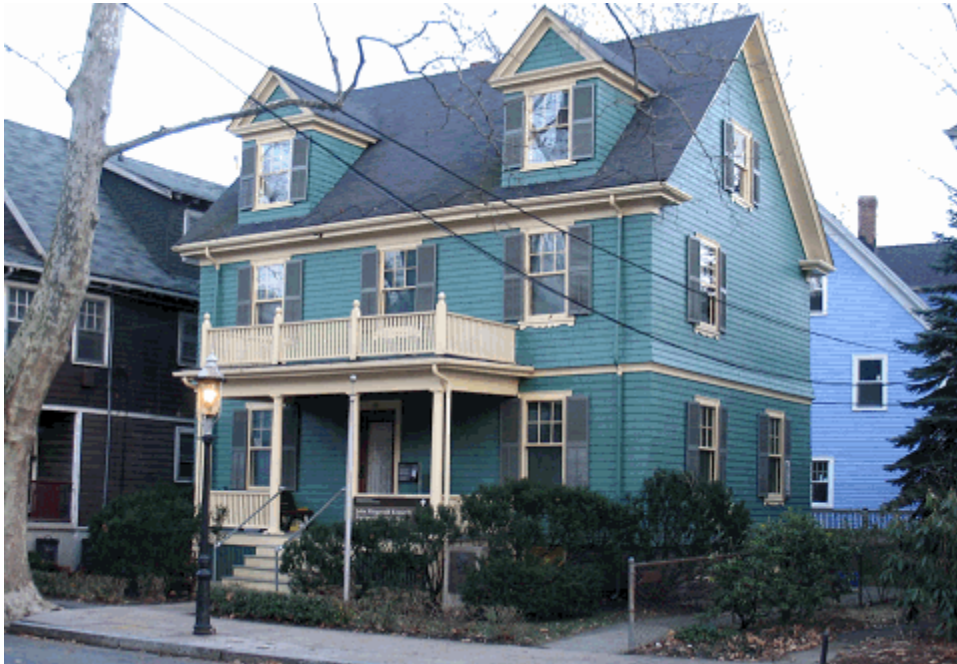
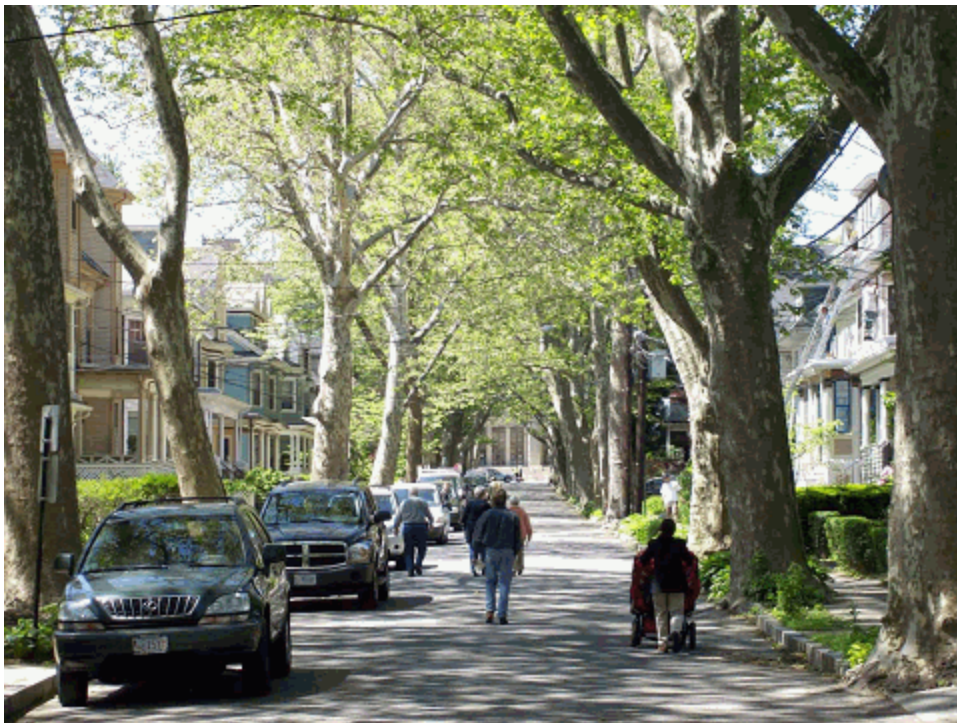
The existing conditions of the site's spatial organization are minimally changed since 1969, but more altered since 1920. The spatial organization of the site reflects its condition in the 1960s, with the lot coverage, setback, and physical relationship of the house to the yard and to Beals Street largely unchanged, and therefore contributes to the character of the historic landscape despite its alteration since 1920 (Figures 14 and 15) (CLR, draft May 2011: 216-217).

*Figure 14. View of 83 Beals Street showing physical relationship to neighboring properties and Beals Street, building setback, and front yard walkway and entrance. Note the plane-tree in tree-lawn area in front of the house (OCLP, 2008).*

*Figure 15. View looking southwest up Beals Street toward Harvard Street showing the similar setback of homes along the street. Note the prominent vertical and overhead spatial definition by the plane-trees (OCLP, 2008).*

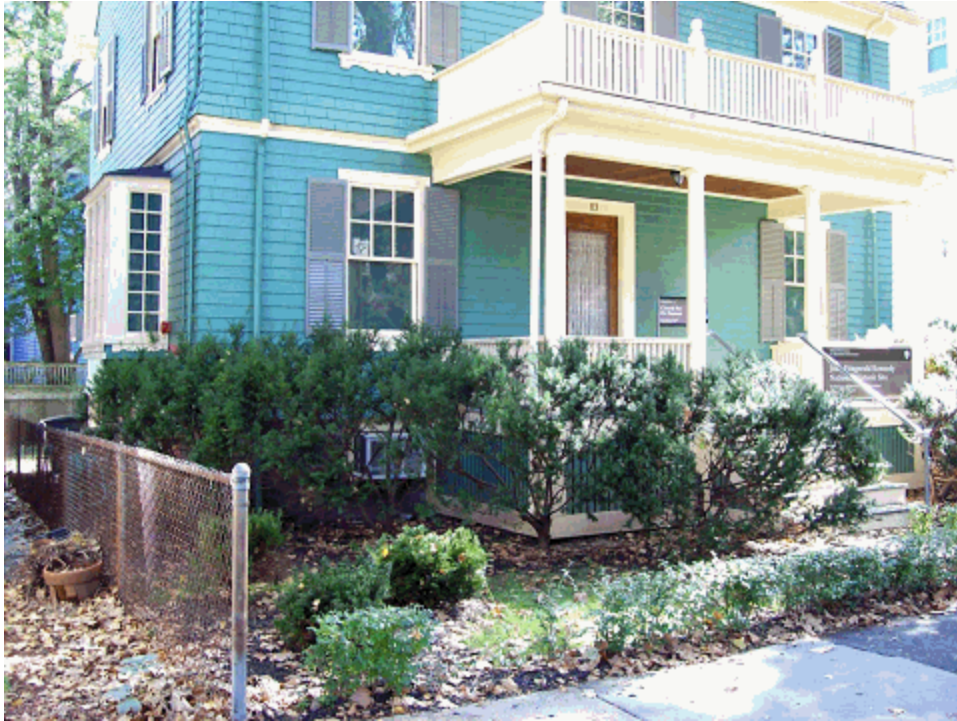
Privet Hedge along Sidewalk. The privet hedge is healthy and well tended at approximately eighteen inches in height and twelve inches in width. Its short height allows views to the marker from many vantage points. Due to the excessive shading in the front yard by the overhanging plane-tree, the hedge appears thin. The separate hedges on both sides of the front yard are not uniform in width and as maintenance has been performed throughout the years, single plants have been removed due to damage or death, leaving holes in the otherwise continuous hedge. The privet hedge was installed by the Town of Brookline as one of the first elements of the commemorative landscape in the 1960s period of significance. This feature therefore contributes to the character of the historic landscape (Figure 16) (CLR, draft May 2011: 217).

*Figure 16. North corner of the front yard showing the porch, partially obscured by a row of yews. An incomplete low privet hedge lines the sidewalk. The property is separated from the neighboring property by a chain link fence (OCLP, 2008).*

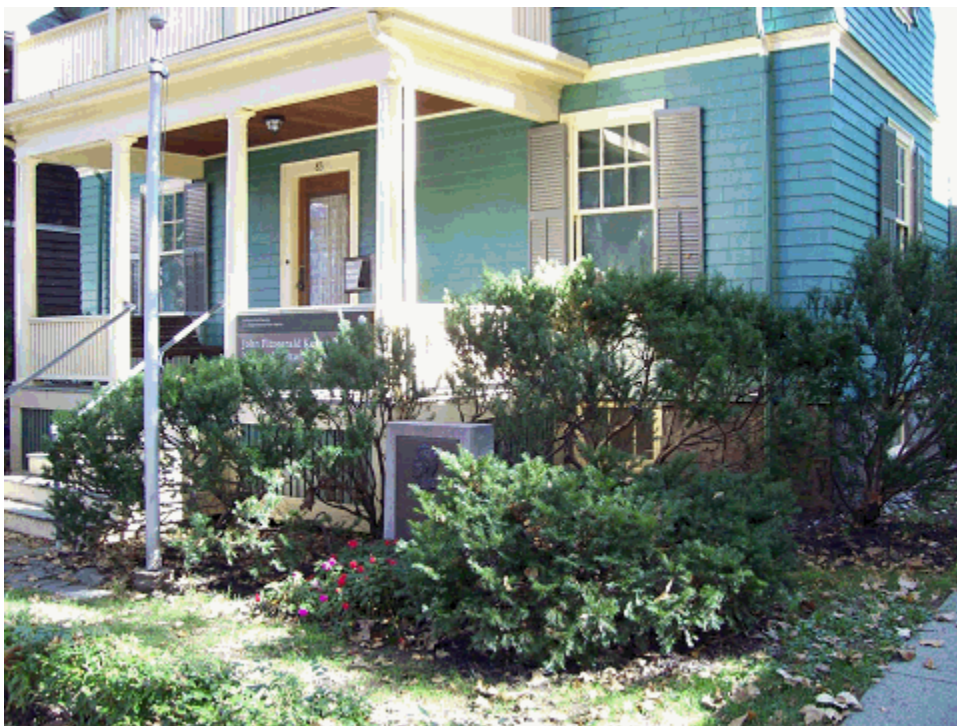
Yews in Front Yard. The National Park Service has performed periodic maintenance of the yews by removal, replanting, and pruning since the site's dedication. Yews tolerate the low light conditions in the front yard and are in good health. However the shrubs are overgrown

and partially obscure the porch, the park sign, and the commemorative marker. In 2008, maintenance crews began a selective pruning program to care for the shrubs. The four yews on the northeast side of the front porch are four and a half to five feet tall. Additionally, at the north corner of the front yard, three yews were recently replaced in kind and are small, but in good condition. The five yews on the northwest side of the front porch are four and a half to six feet tall, plus a low spreading yew on the northwest side of the commemorative marker that is about two and a half feet tall and five feet wide. The yews installed in the front yard form a significant part of the commemorative aspect of the site from the 1960s period of significance. As such, they contribute to the character of the historic landscape (Figure 17) (CLR, draft 2100: 218).

**Annuals by Commemorative Marker.** The practice of planting annuals at the front of the marker has continued to the present day. Currently, the seasonal annuals grow in a two by three foot bed in front of the marker and are in fair condition. They are less affected by the shade than other front yard understory vegetation. The annuals at the commemorative marker were present during the site's dedication ceremony. They directly reflect the association of Rose Kennedy with the memorial aspect of the site and contribute to the character of the historic landscape (see Figure 17) (CLR, draft May 2011: 218).

**Front Lawn.** Following the site's dedication the National Park Service reinstalled lawn in 1969 and has continued to perform periodic replacement and maintenance. Currently, the front lawn is in fair condition though somewhat affected by the shade of the overhanging plane-tree. The front yard lawn is one of the few landscape features present in both periods of significance and contributes to the character of the historic landscape (see Figure 17) (CLR, draft May 2011: 219).

*Figure 17. Southwest side of the front yard at the Kennedy National Historic Site. Note the overgrown yews obscuring the porch, the annuals by the commemorative marker, the front lawn, the NPS sign, and the flagpole (OCLP, 2008).*

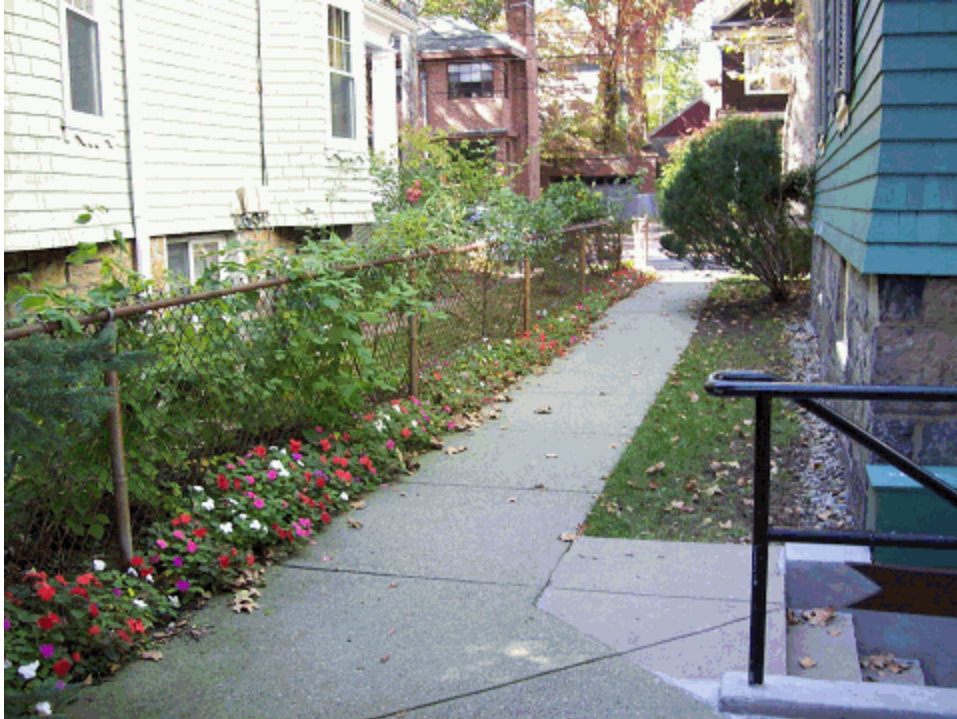
*Figure 18. View from the rear yard of the park toward Beals Street showing the chain-link fence, side yard, and walk used to access the visitor center in the basement (right). The park maintains impatiens along the fence and the neighbor maintains roses,*

**Southwest Side and Rear Yard Concrete Walkway.** The side walkway is presently in good condition with only a few minor cracks. As the most often used walkway at the site, the four-foot-wide connective path from the sidewalk to the rear yard leads to the site's basement entrance and rear landscape area. It serves as the only exterior walkway connecting the three main landscape areas of the site. The southwest side and rear yard concrete walkway was installed after the 1969 dedication ceremony and therefore is not a contributing feature (see Figure 18) (CLR, draft May 2011: 223).

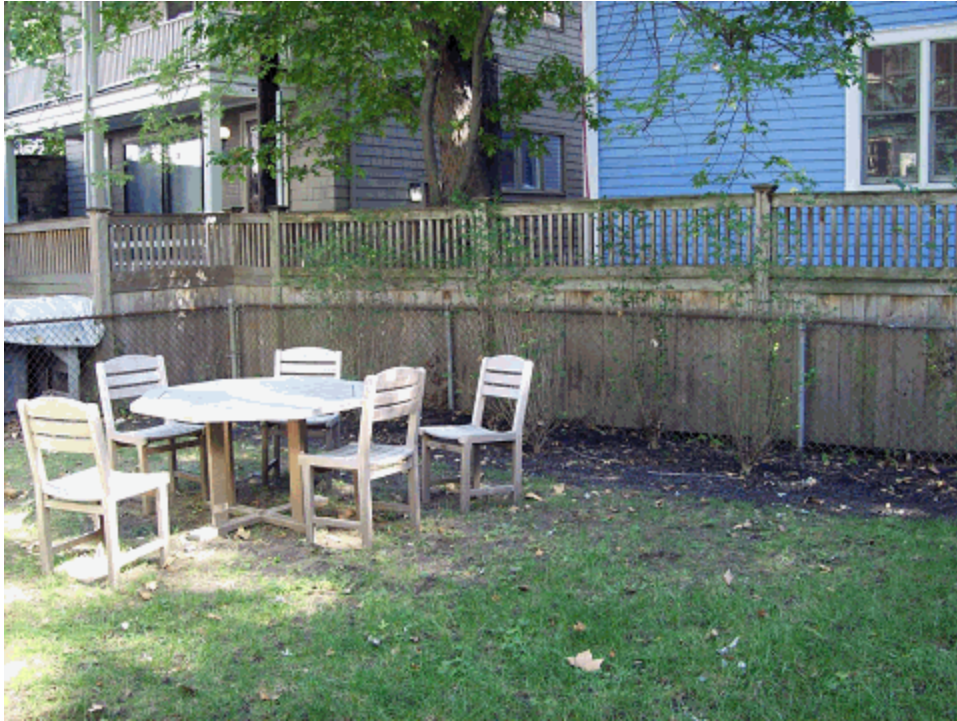
Privet and Mulched Planting Bed. The park installed a staggered row of privets, three feet apart and consisting of fifteen plants in total, in a six foot wide bed at an undetermined date after the dedication ceremony. At present in the rear yard, a large silver maple and a leggy pin oak overhang the property line from the rear adjacent parcel. The trees capture much of the light and soil moisture in the rear yard. Understory plantings, including the row of privet are stressed due to lack of light and moisture. Intended for screening, the privet is thin and ineffective. The privet, known for their hardiness and vigor, appear ragged due to the difficult growing conditions. A large silver maple was recently removed from the neighboring lot at the south corner of the 83 Beals property. Thus, the condition of the privets may improve. The mulched planting bed and privets were planted at an unknown date after the periods of significance and are not contributing features (Figure 19) (CLR, draft May 2011: 220).

*Figure 19. View of the east corner of the rear yard and lawn area. A chain link fence and wood board fence separate the park from the neighboring properties. A row of privets is thin and barely visible in front of the board fence (OCLP, 2008).*

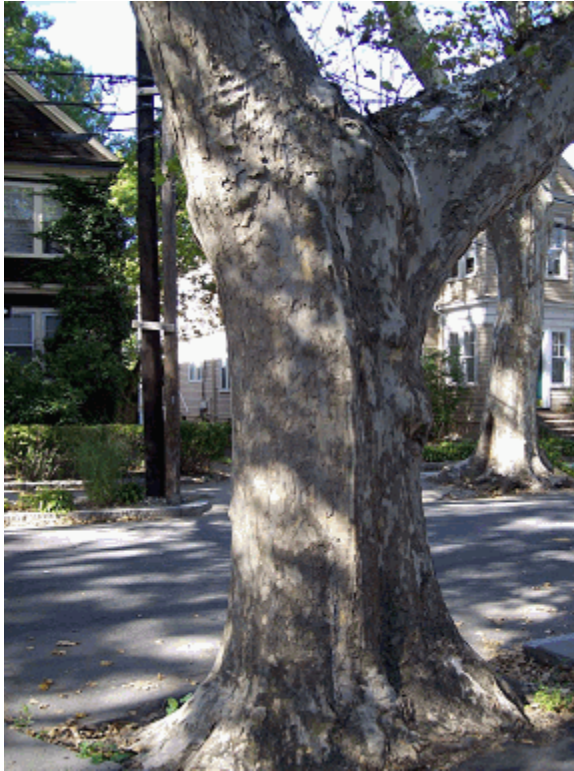
Plane-tree in Tree Lawn along Beals Street. With an over three foot diameter trunk, the plane-tree is now mature and casts significant shade onto the front yard. Like most of the other plane-trees along Beals Street, the curb blocks have been removed and the roots spill into the edge of the street. The roots have lifted the concrete sidewalk and the leaves often clog the gutters, causing other maintenance issues for the site. At the base of the tree, an asphalt patch has replaced a section of the concrete sidewalk. The granite curb that runs along the street is absent for the length of the tree's planting area and is due to the tree's extreme girth and bulging of the root system. While these trees offer a great amount of shade in the summer months and further dramatize the character of the property as well as the street and neighborhood as a whole, attempting to grow any substantial understory vegetation becomes a trying task. The plane-tree has been present in front of 83 Beals since 1900 and therefore contributes to the character of the historic landscape (Figure 20) (CLR, draft May 2011: 222). Note: The plane-tree is outside of the park's boundaries, and therefore is not officially evaluated for purposes of the CLI.

*Figure 20. Plane-tree in the tree-lawn in front of 83 Beals. The tree was planted circa 1900 and continues to thrive (OCLP, 2008).*

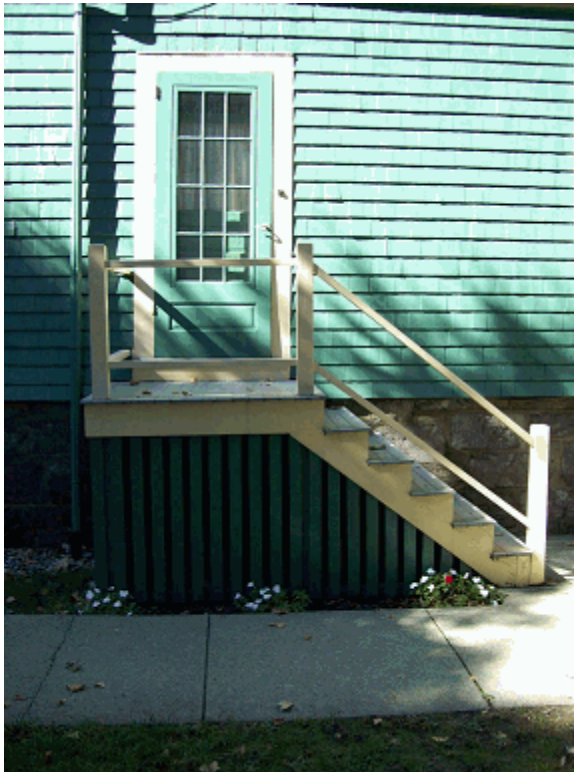
*Figure 21. Wooden steps leading to rear entrance of the house (OCLP, 2008).*

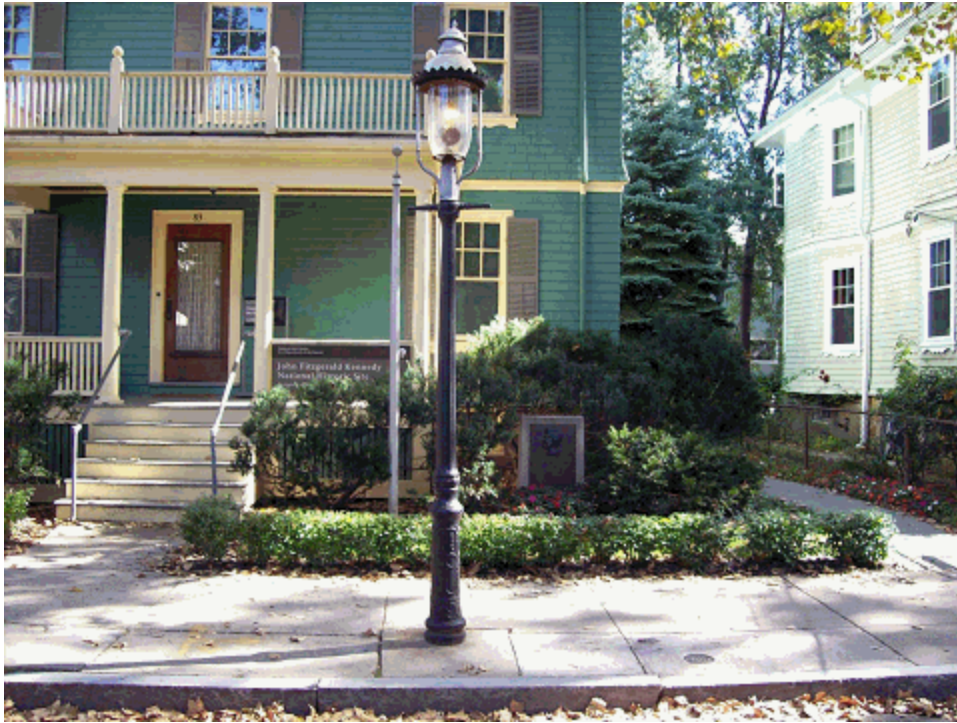
**Front Concrete Walkway.** Currently the front walk extends from the public sidewalk, where it is four and a half feet wide, and bisects the front yard. At the foot of the steps that lead up to the porch and front door, the concrete walkway widens to five and a half feet, where it meets the six-foot-wide porch steps. As of 2006, all tours begin of the front porch of the birthplace. Visible in the 1969 dedication photographs, the front walk is at least forty years old and is in good condition. There are no major cracks or hazards apparent. The front yard walkway has been present throughout both periods of significance and therefore contributes to the character of the historic landscape (Figure 22) (CLR, draft May 2011: 222-223).

*Figure 22. The southwest side of the front yard includes small-scale features that distinguish the house from others on the street: the park sign mounted to the front porch, the commemorative marker, the flagpole, and the gas light (OCLP, 2008).*

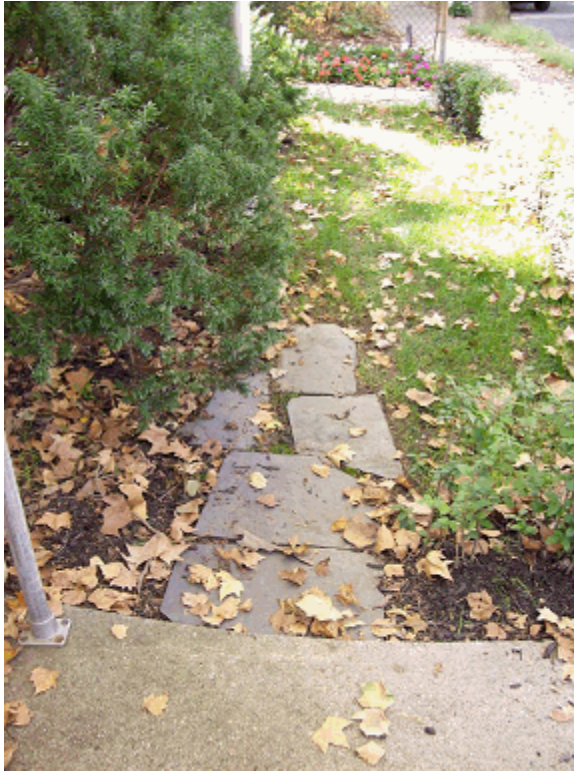
*Figure 23. Close-up of the flagstone pavers on the southwest side of the front yard that lead to the base of the flagpole (OCLP, 2008).*

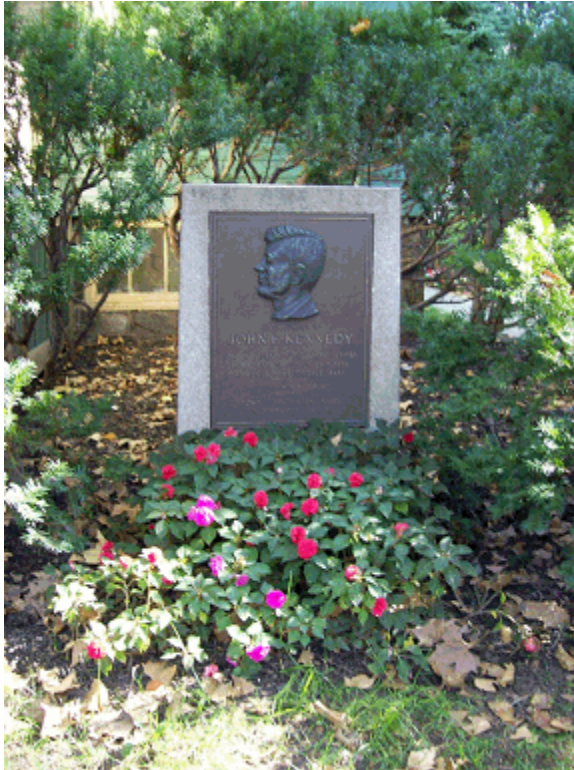
*Figure 24. Commemorative marker in the front yard installed by the Town of Brookline in 1961 with annuals (OCLP, 2008).*

Commemorative Marker. Comprised of a vertically set granite block, fronted with a bronze plaque, the marker measures twenty-four and one-quarter inches wide, by thirty-six inches tall, by nine inches deep. The plaque contains a bas-relief profile of John F. Kennedy, and a brief description recognizing the site as his birthplace. It is located in the front yard, nestled into a mass of common yews. The commemorative marker was installed by the Town of Brookline as one of the first elements of the commemorative landscape in the 1960s period of significance. This feature therefore contributes to the character of the historic landscape (Figure 24) (CLR, draft May 2011: 225-226).
