National Register of Historic Places Registration Form

historic name Maintenance Area District

street & number Mammoth Cave National Park (MACA)

Name of related multiple property listing: Historic Resources of Mammoth Cave National Park

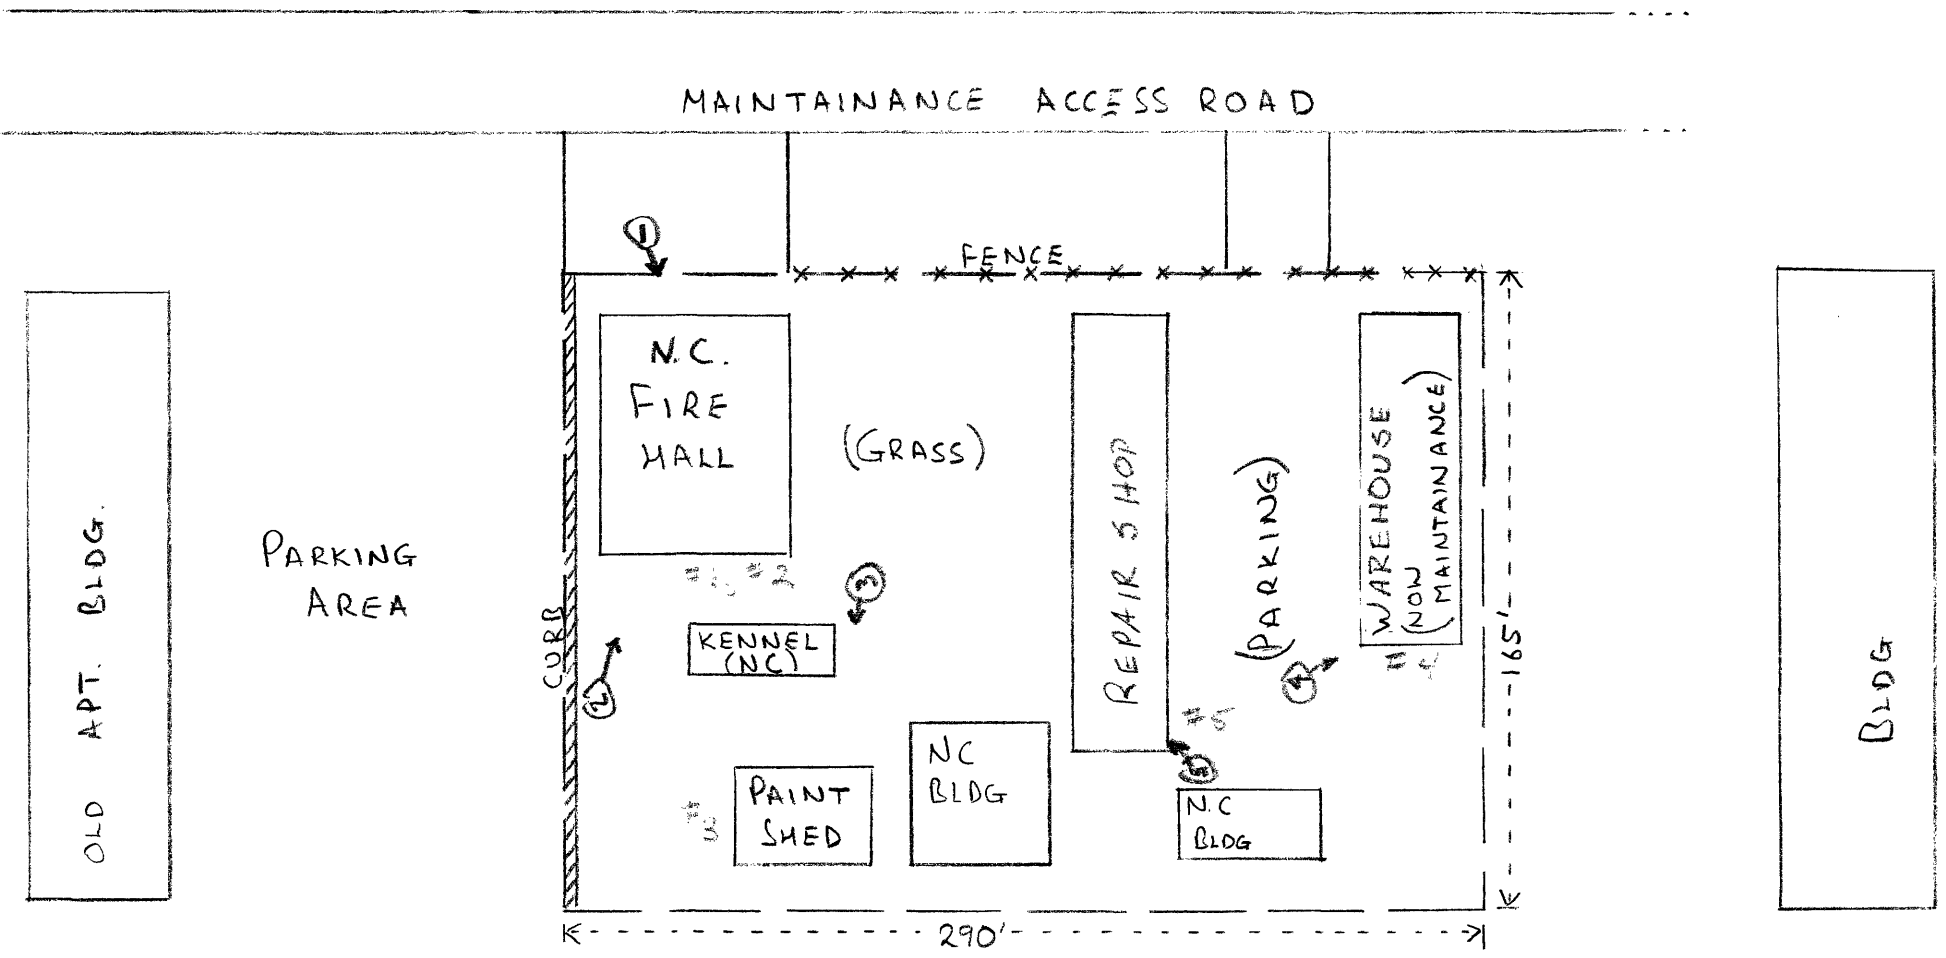
MAINTAINANCE AREA DISTRICT

APPROX. SCALE: 1 INCH = 50 FEET

① = photo number

Beginning at the curb on the northwest corner of the district, proceed east 165'. Next proceed south 290' along the fence on the east side of the district. Then proceed west 165'. Then proceed 290' to the point of origin.

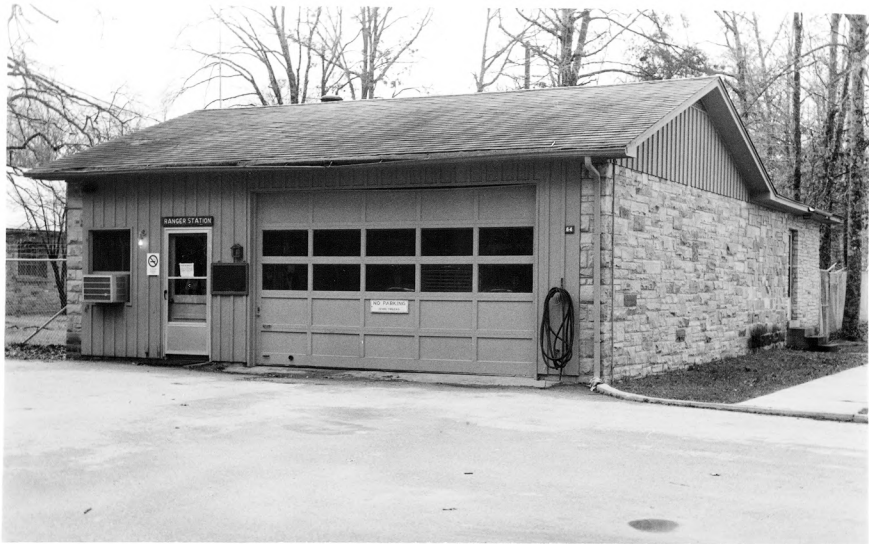
1. Fire Hall (064),  
Maintenance Area District

1. Fire Hall (064) Maintenance Area  
Mammoth Cave National Park, Kentucky

The Fire Hall has served as both fire station and ranger station since its construction around 1958. The entire structure currently has two doors, one overhead door, and three windows. Originally this one story building had two offices and a garage for the park's fire truck. The building faces the Maintenance access road (east). In addition to its thick sandstone walls and asphalt-shingled, gable roof, the original portion of the fire hall has a board and batten front and upper gables and a wood overhead garage door.

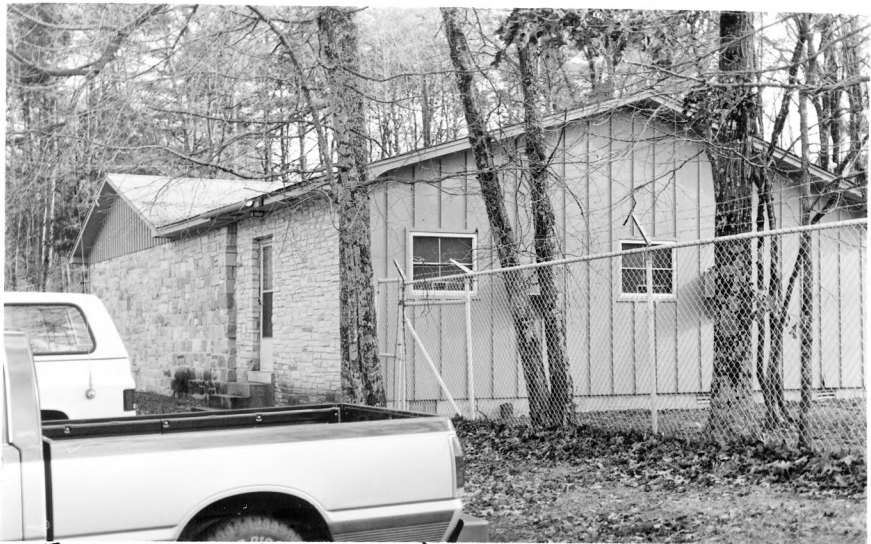
§. 5. The said addition (064),  
Maintenance Area District

2. Fire Hall Addition (064), Maintenance Area  
Mammoth Cave National Park, Kentucky

In the 1960s the Job Corps built a two room addition onto the west side of the building. The addition also has two sandstone walls, one board and batten wall (west wall), and a low pitched, asphalt-shingled, gable roof, which is perpendicular to the roof of the original structure.

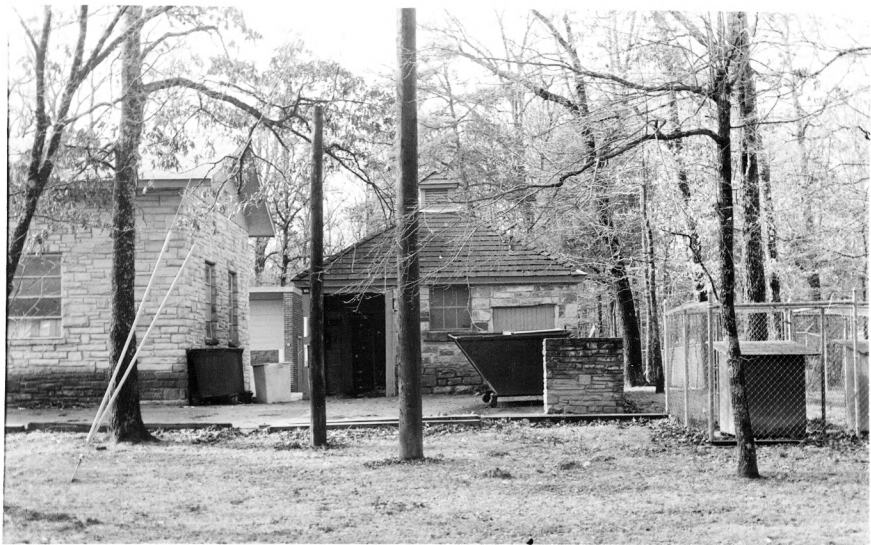
3. Paint Shed (0600),  
Maintenance Area District

3. Paint Shed (060), Maintenance Area  
Mammoth Cave National Park, Kentucky

The paint shed/oil house, measuring 18' X 18', is a one room, one story sandstone building with a pyramidal asphalt-shingled roof, constructed to hold flammable materials, such as paint, gas, and oil. The structure has two six-paned windows, a batten door, and a louvered cupola which, like the larger structure, has a pyramidal roof. The paint shed is unaltered, in excellent condition, and still serves the same function for which it was constructed.

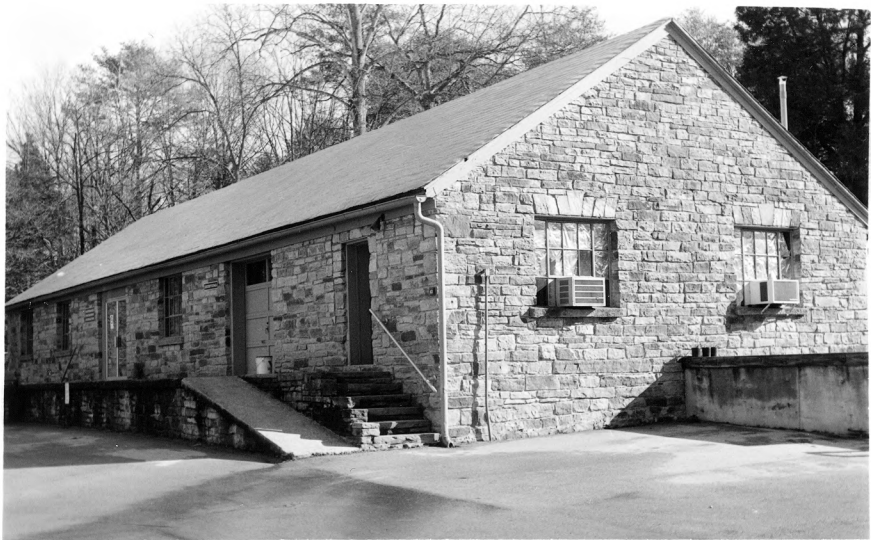
4. Warehouse (0003)  
Maintenance Area District

4. Warehouse (063), Maintenance Area  
Mammoth Cave National Park, Kentucky

Building #63, originally built to serve as a warehouse, now functions as the park's maintenance building. The rectangular sandstone building measures 92'6" by 31'6", has a gabled roof, and faces the Repair shop across the parking lot to the north. The warehouse has a 59' long, 8' wide sandstone loading dock on its front.

Since the building has been converted to office space, one of the two original overhead garage doors has been replaced with glass entry doors, and one of the four front windows has been made into a door. The structure now has a total of thirteen windows, two doors, and one overhead garage door. The original asphalt-shingled roof has been covered with a protective coating which somewhat alters the appearance of the building. The alterations do not adversely affect the historic character of the building.

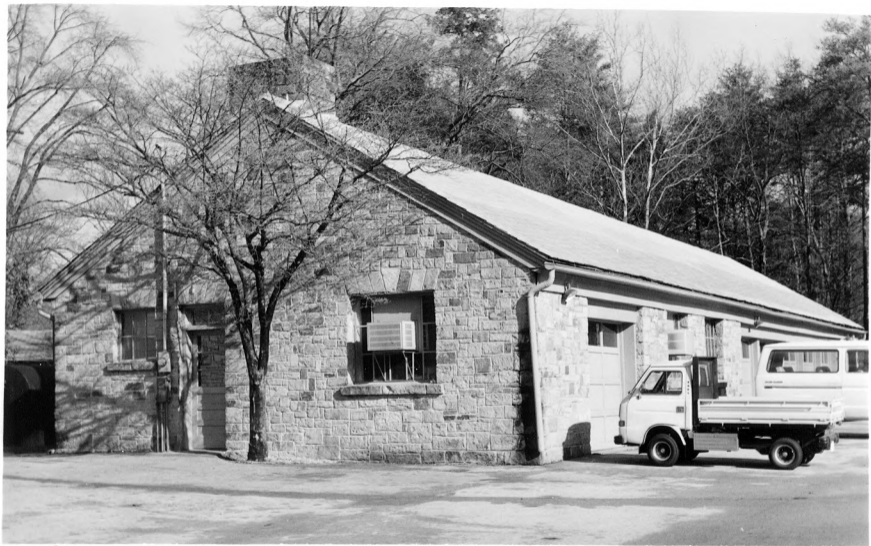
5. Repair Shop (059)  
Maintenance Area District

5. Repair shop (059), Maintenance Area  
Mammoth Cave National Park, Kentucky

The Repair Shop is a one story, rectangular (110' X 32'6") sandstone building which faces south. Constructed to serve as a garage and repair area for National Park Service vehicles and equipment, the shop was constructed with seven rooms, two doors, six overhead garage doors (on the south side of the building) and

sixteen windows (ten of which are on the north side of the building).

One of the original rooms has been divided into two rooms and a hallway within the last decade. The original asphalt-shingled roof was covered with a protective coating in the last few years, which does somewhat change the appearance of the building. Aside from these slight alterations, the building is essentially unchanged, in excellent condition, and still serves the function for which it was constructed.
