LINDENWALD

THE MARTIN VAN BUREN NATIONAL HISTORIC SITE

HABS No. NY-6021

HISTORIC AMERICAN BUILDINGS SURVEY
NATIONAL PARK SERVICE

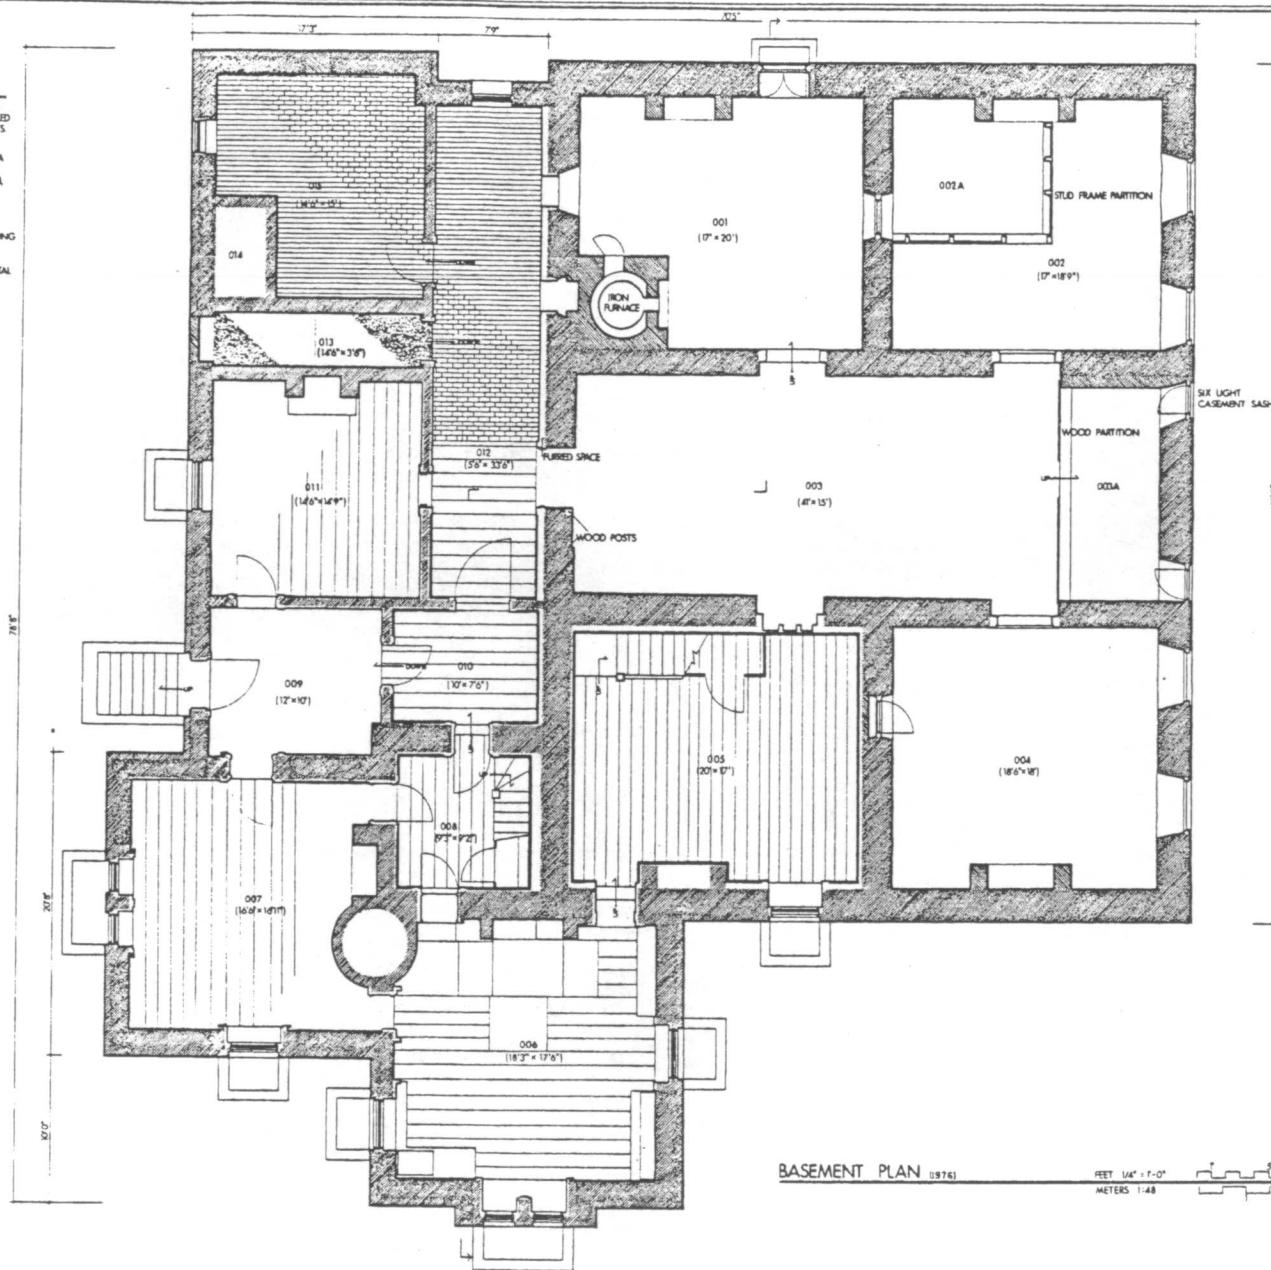
BASEMENT PLAN (1976)

NOTES
EAST WINDOWS ROOMS
002, 004 PARTIALLY BRICKED
UP AND HAVE FIRED LIGHTS
FLOOR MATERIALS:
GARTH 001, 002, 003, 004
CONCRETE 002, 004
WOOD 002, 004, 002, 004,
003, 001, 002
BRICK 002, 003
COBBLESTONE 003
TUNNEL VALVE BRICK CEILING
ROOM 003
BRICK PIERS WITH SEGMENTAL
ARCH ABOVE: 001, 002, 004

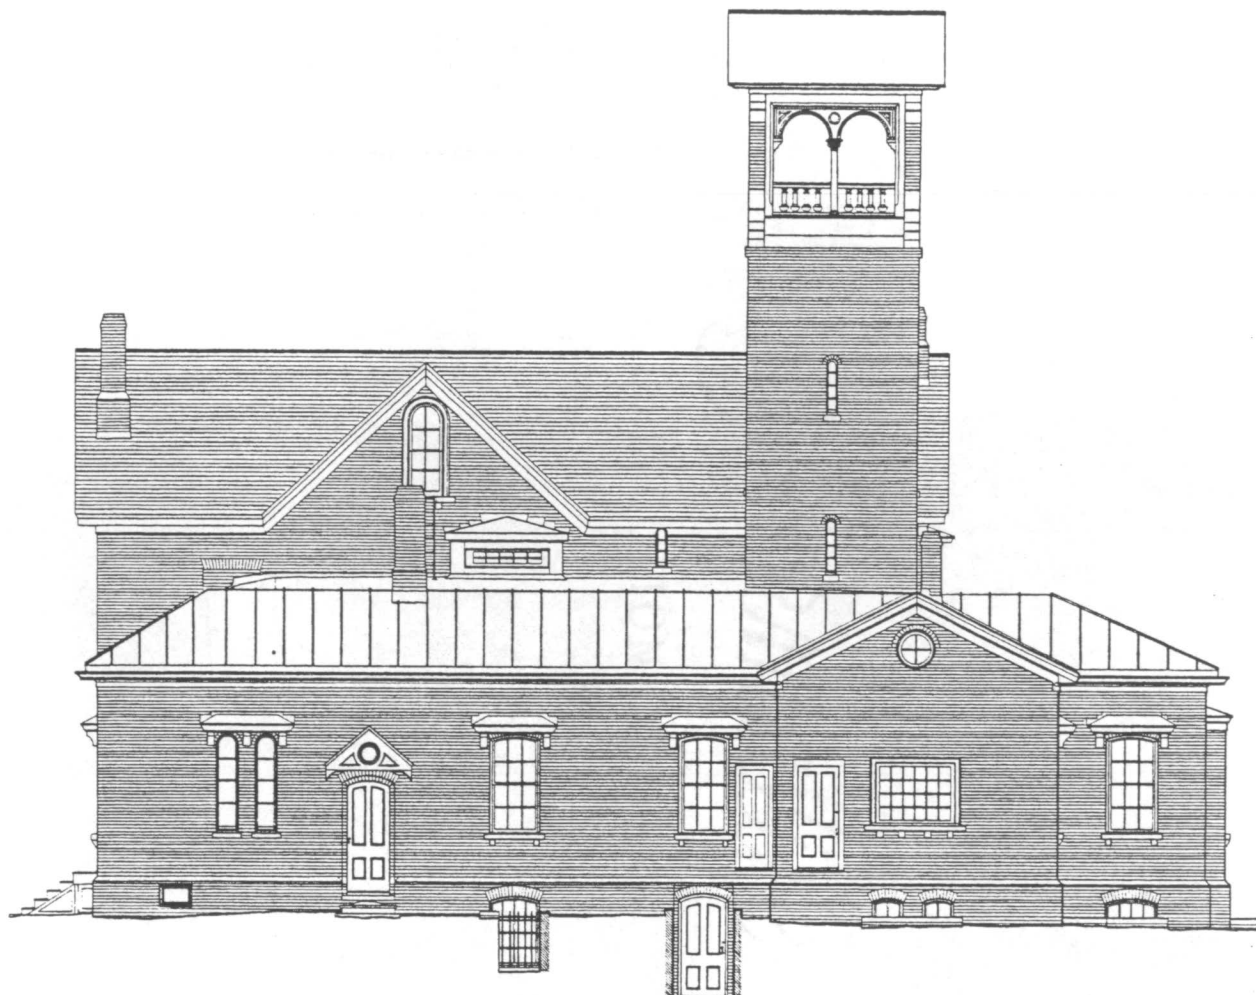
WEST ELEVATION (1976)

CA.1957 WEST PORCH NOT
SHOWN. HOOD AND SEGMENTAL
ARCH OVER CENTRAL WINDOW
SHOWN RECONSTRUCTED.

CA.1957 RECTANGULAR WINDOW
REPLACES DUAL 7'6" ARCH-ED
WINDOWS.

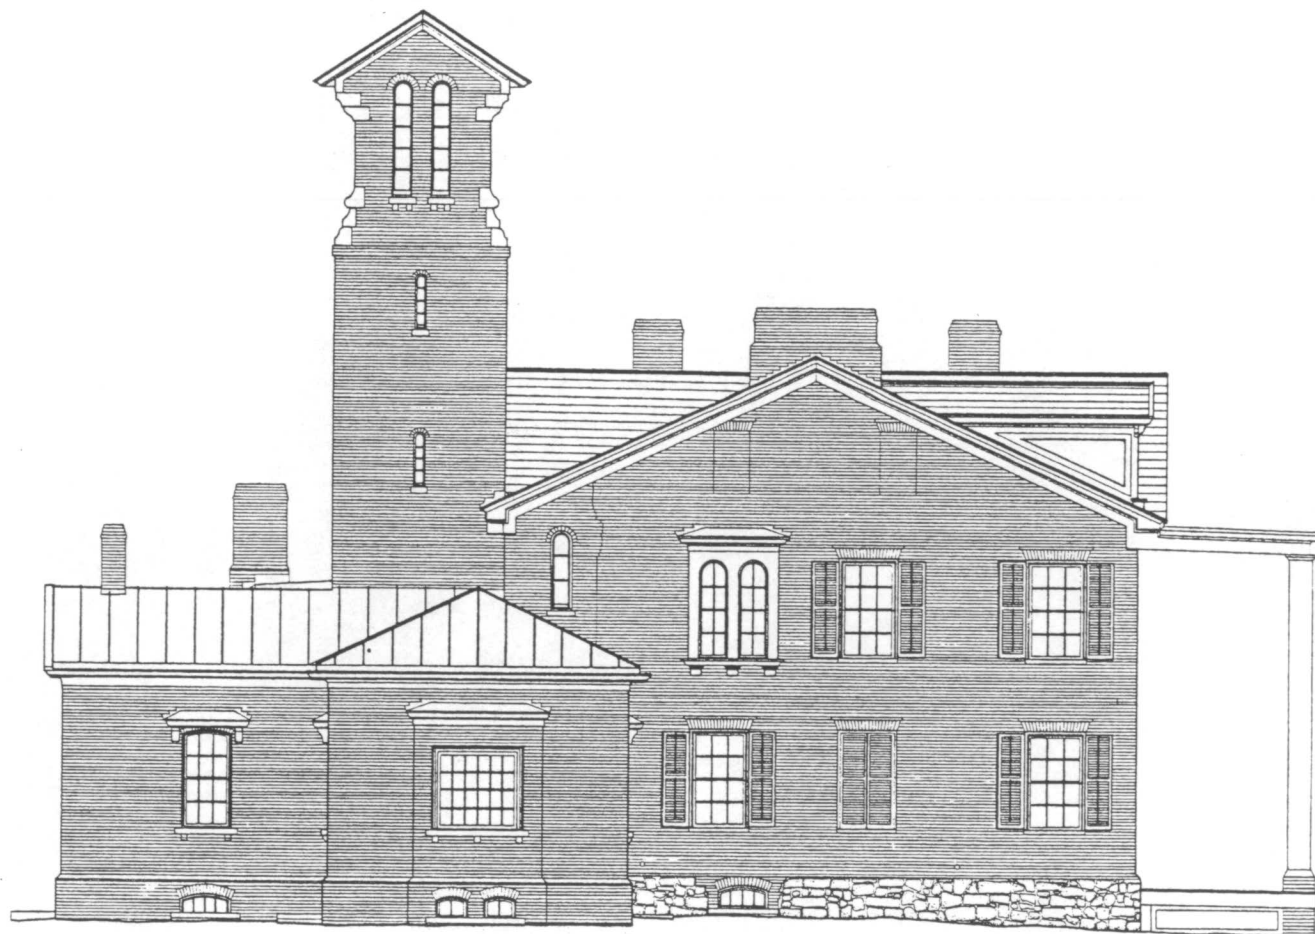
SOUTH ELEVATION (1976)

NOTES
 MAIN FACADE FLEMISH BOND,
 WING AND TOWER AMERICAN.
 CIRCULAR METAL PLATES ON
 BRICK JUST ABOVE FOUNDATION.

CA 1957 WEST PORCH NOT
 SHOWN.

CA 1957 RECTANGULAR WINDOW
 REPLACES DUAL 7'6" ARCHED
 WINDOWS.

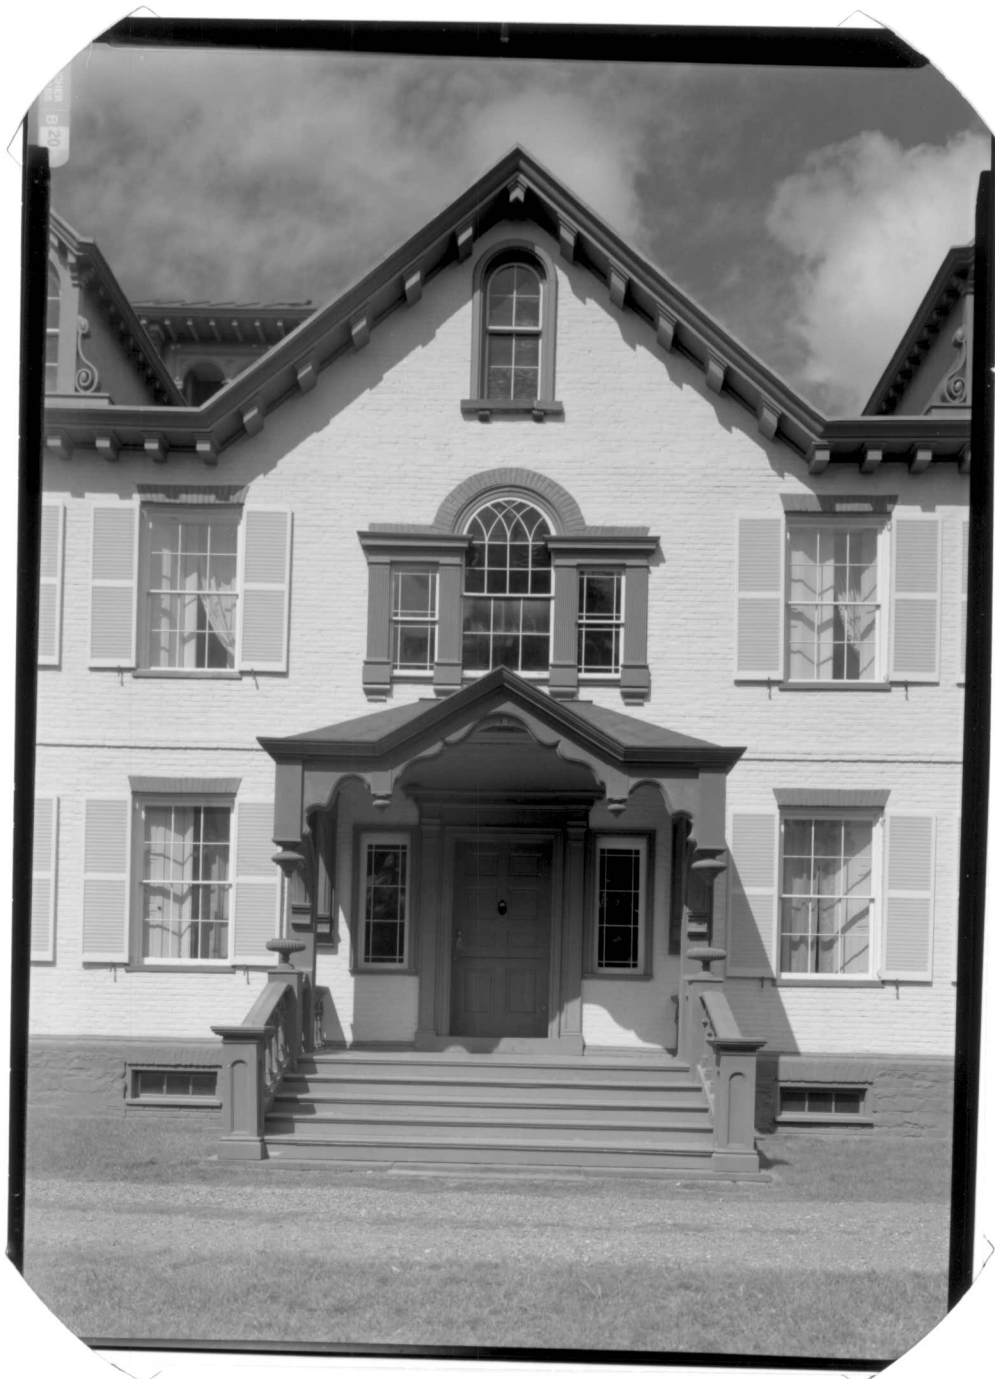
HABS No. *NY. 6021.14*

| NY-6021-14 | DETAIL VIEW OF SOUTHEAST ELEVATION, SHOWING THE ENTRANCE AND WINDOW ABOVE (WINDOW OFTEN DESCRIBED AS AN EXAMPLE OF THE "PALLADIAN MOTIF" OR "SERLIANA" AFTER THE ARCHITECTURAL TREATISES BY SERLIO AND PALLADIO) |

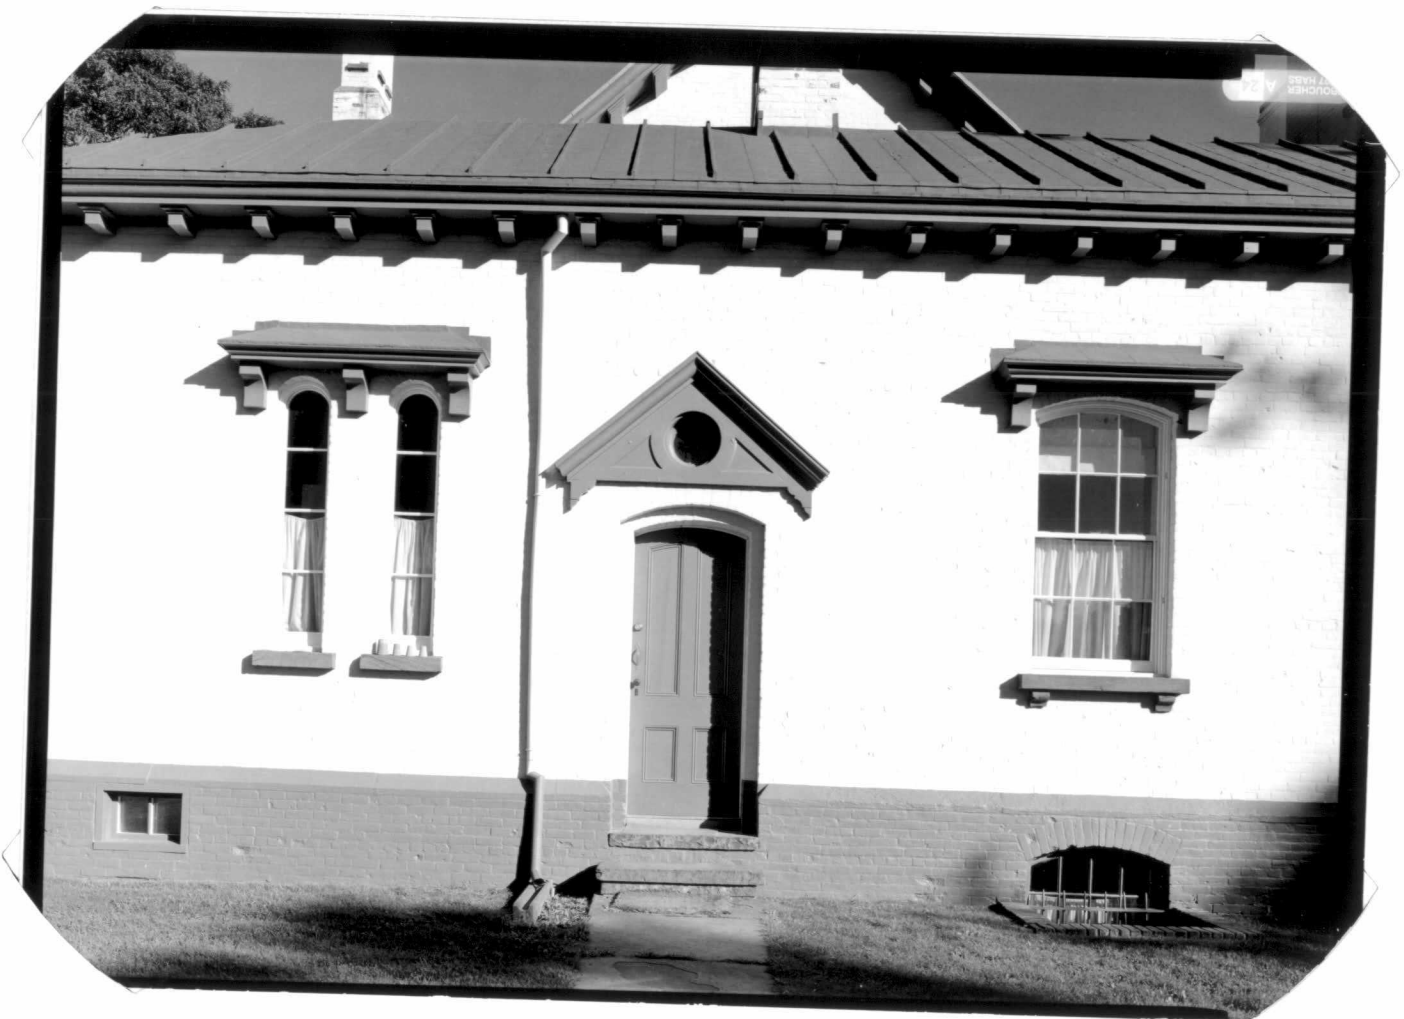
HISTORIC AMERICAN BUILDINGS SURVEY
SEE INDEX TO PHOTOGRAPHS FOR CAPTION
HABS No. M. 6021-22

- NY-6021-20 VIEW OF NORTHWEST (REAR) ELEVATION
- NY-6021-21 VIEW OF NORTHWEST ELEVATION, WITH SCALE
- NY-6021-22 DETAIL VIEW OF NORTHWEST ELEVATION SHOWING THE NORTH END
DOOR WITH PEDIMENT ABOVE AND THE FLANKING (BUT NON-MATCHING)
WINDOWS

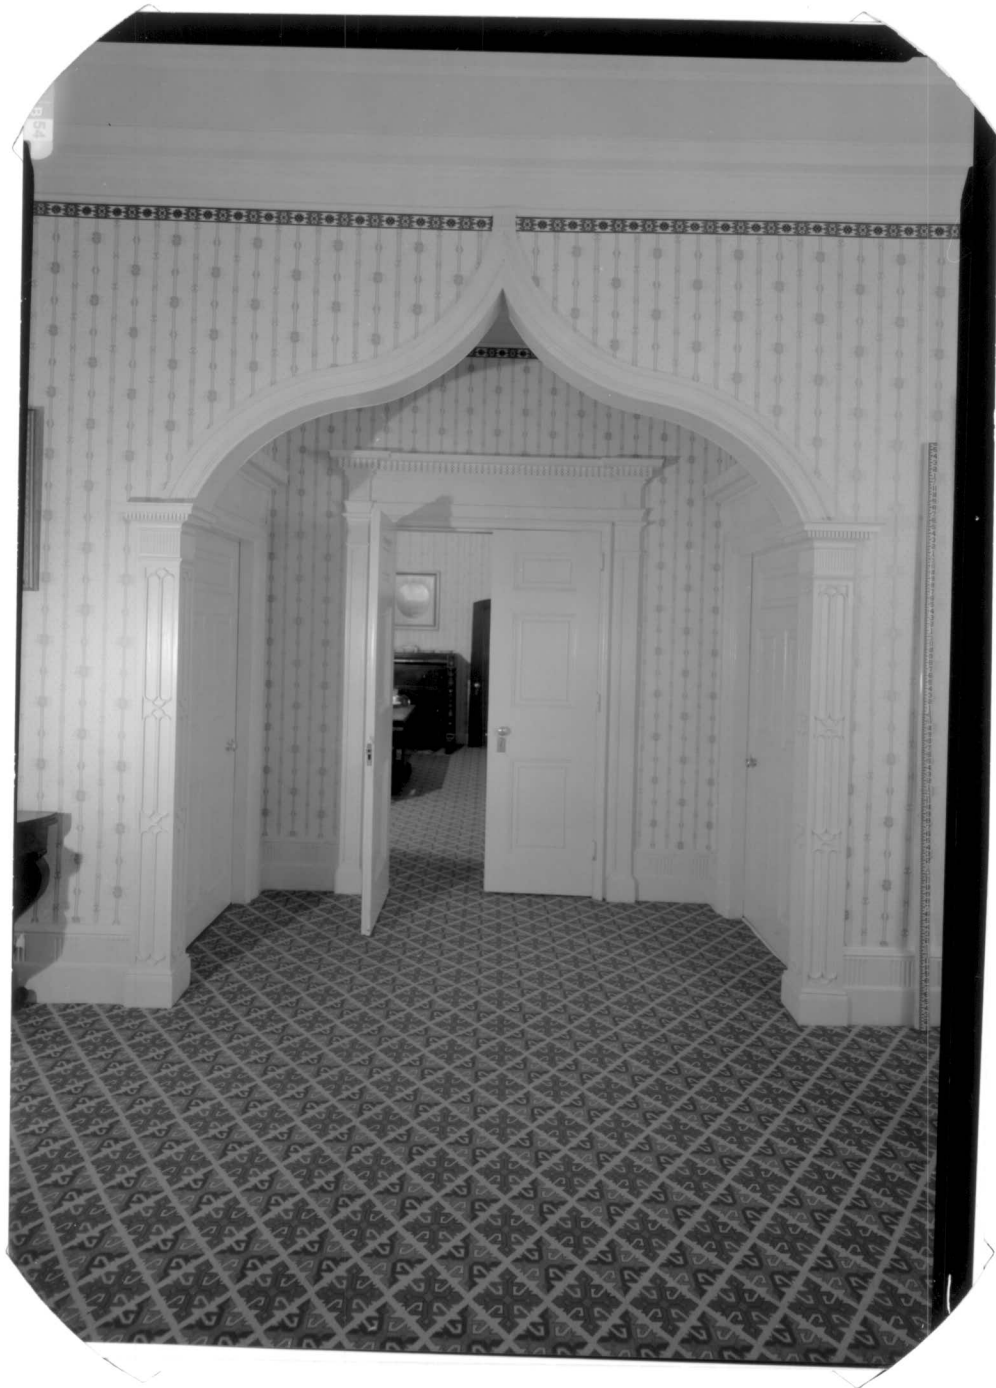
HABS No. NY-6021-46

- NY-6021-45 INTERIOR, FIRST FLOOR, VIEW FROM EAST CORNER OF ROOM 106 TO SHOW BOTH THE OGEE ARCH AND THE FIREPLACE
- NY-6021-46 INTERIOR, FIRST FLOOR, VIEW OF THE OGEE ARCH LOOKING TO THE SOUTHEAST OR GENERALLY FROM ROOM 106 TO ROOM 109, WITH SCALE
