By the early eighteenth century, tabby was used both here and in West Africa. It is unclear whether tabby's origins lie in the coastal southeast or whether the technique was brought from West Africa through the slave trade.

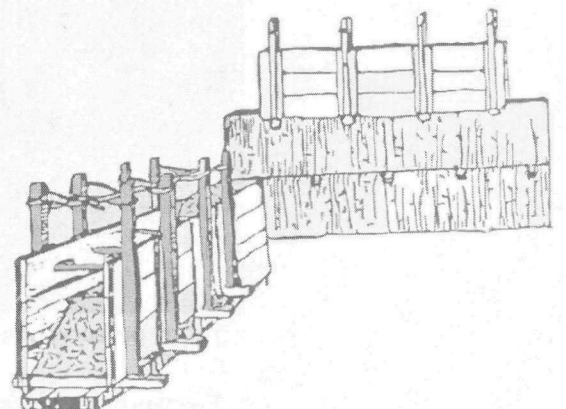
Tabby was poured one layer at a time into a wooden mold held in place with spreader pins.

There are holes in the walls of the slave cabins because wooden spreader pins were used to hold the frame parallel during construction. Once the pins were removed, the holes were filled in, but the filler has since deteriorated.

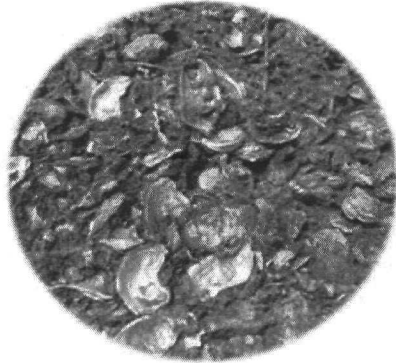
A close-up photograph of tabby (NPS)

Tabby was created entirely from locally available materials. Oyster shells piled into middens by the Timucua were burned and ground for lime. Sand and water were mixed in, and often whole shells were added to speed the hardening of the tabby and to increase volume and durability.

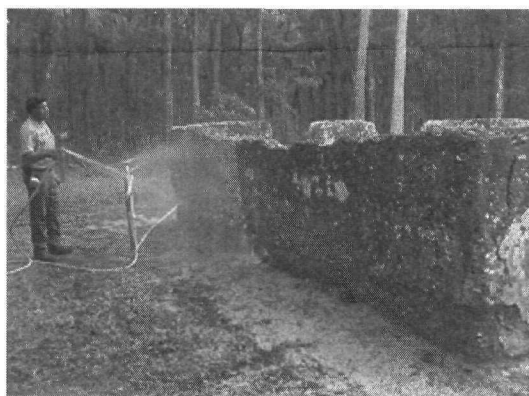
Tabby preservation in progress (NPS)

The tabby preservation project protects the historical craftsmanship and prevents further erosion due to environmental processes by cleaning the buildings and replacing the lime putty coating that the structures had originally.
