HISTORIC STRUCTURE REPORT  
ARCHITECTURAL DATA SECTION  
(VOLUME II - SYSTEMS ANALYSIS)

June 1988

OLD STATE HOUSE  
BOSTON NATIONAL HISTORICAL PARK

John B. Marsh  
and  
Morgan Phillips

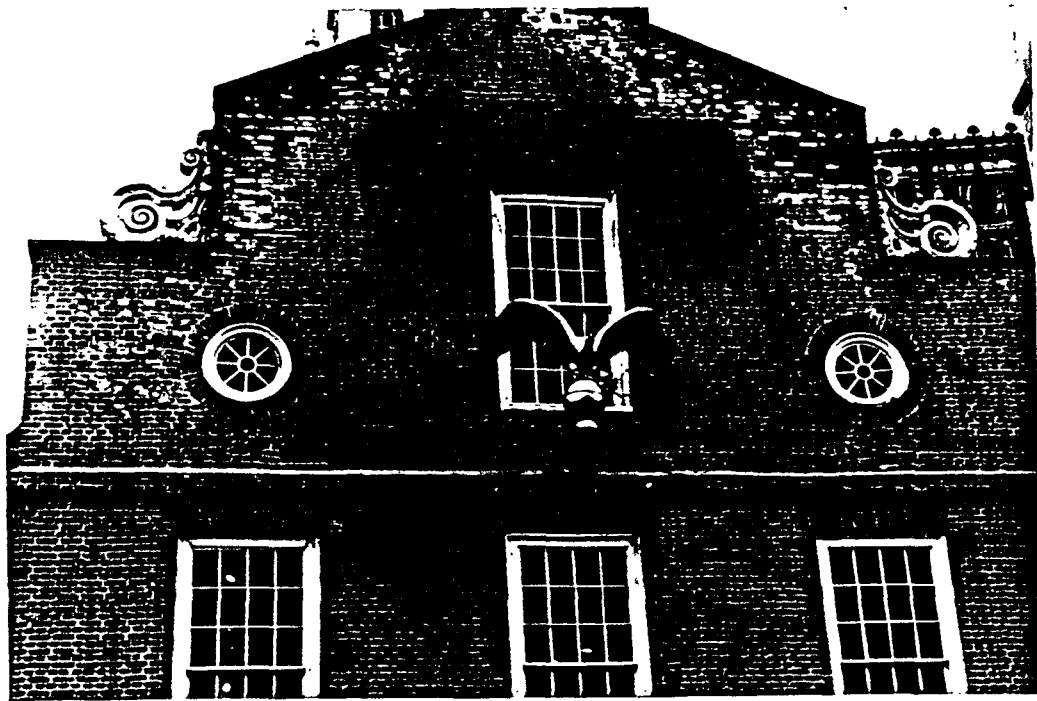
ILLUSTRATION 12. OLD STATE HOUSE: WEST WALL, PARAPET EFFLORESCENCE, 1987.

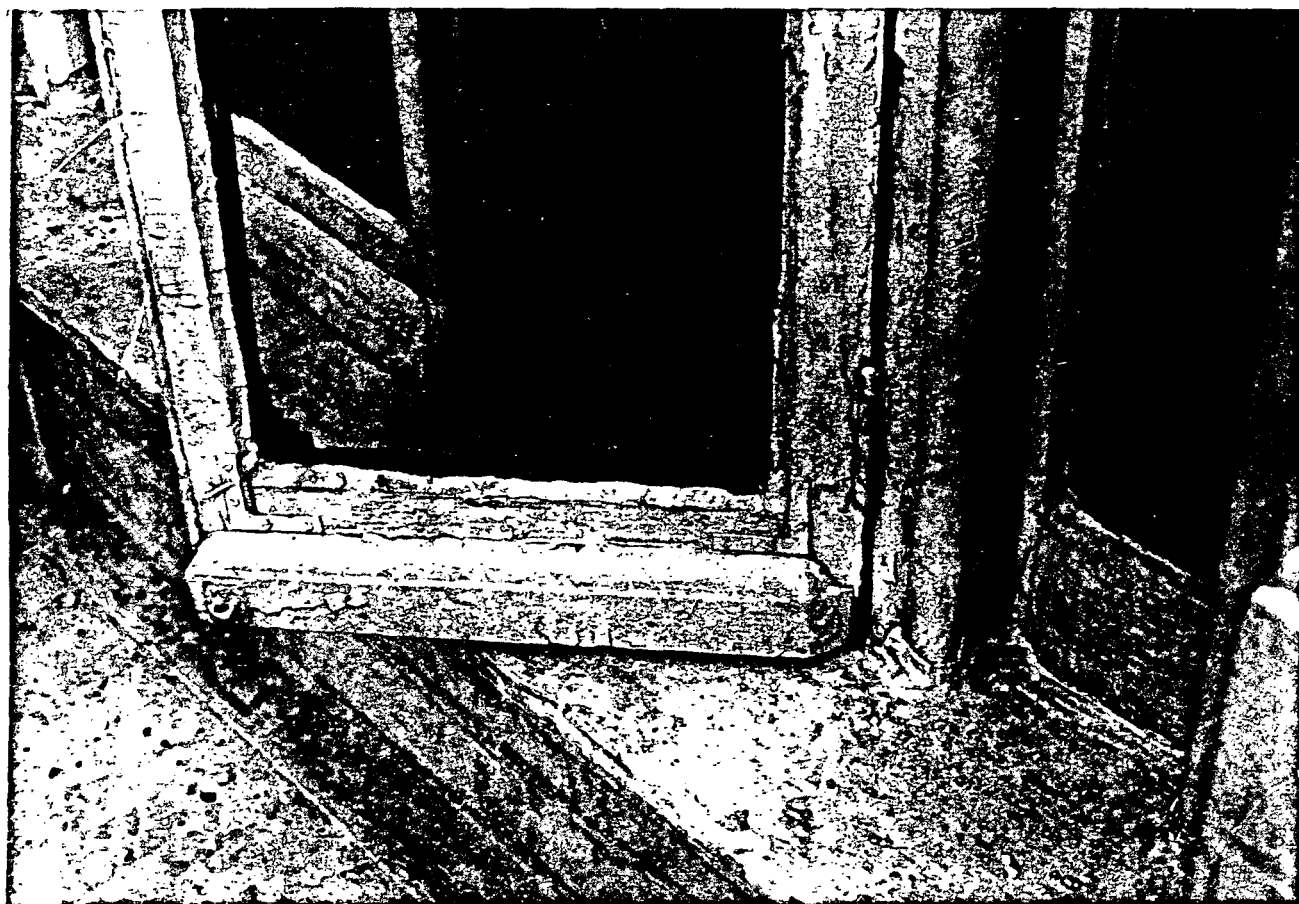
ILLUSTRATION 23. OLD STATE HOUSE: EAST WALL, DOOR OPENING ONTO BALCONY, SASH CONDITIONS, 1987.

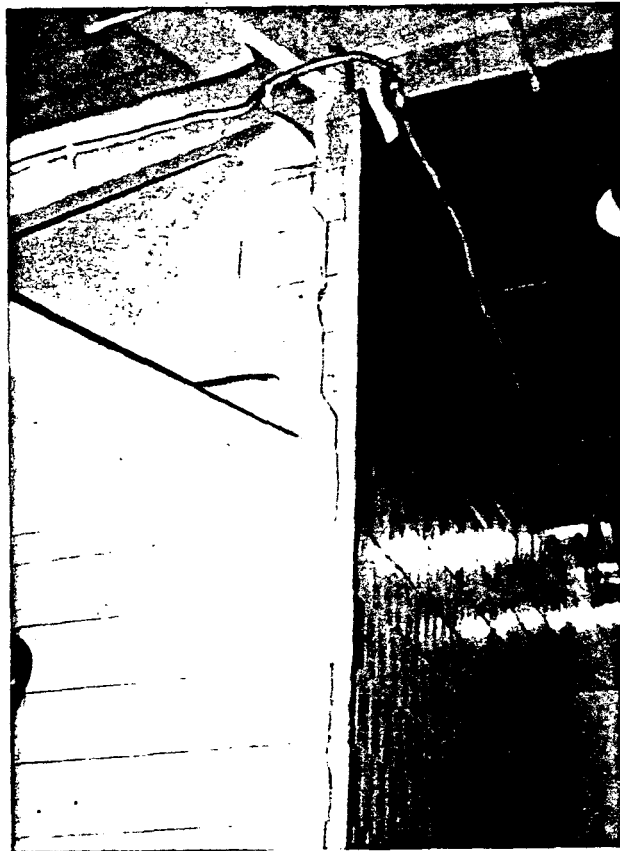
ILLUSTRATION 63. OLD STATE HOUSE: UPPER PART OF WALL SHOWN IN ILLUSTRATION 62, 1987.

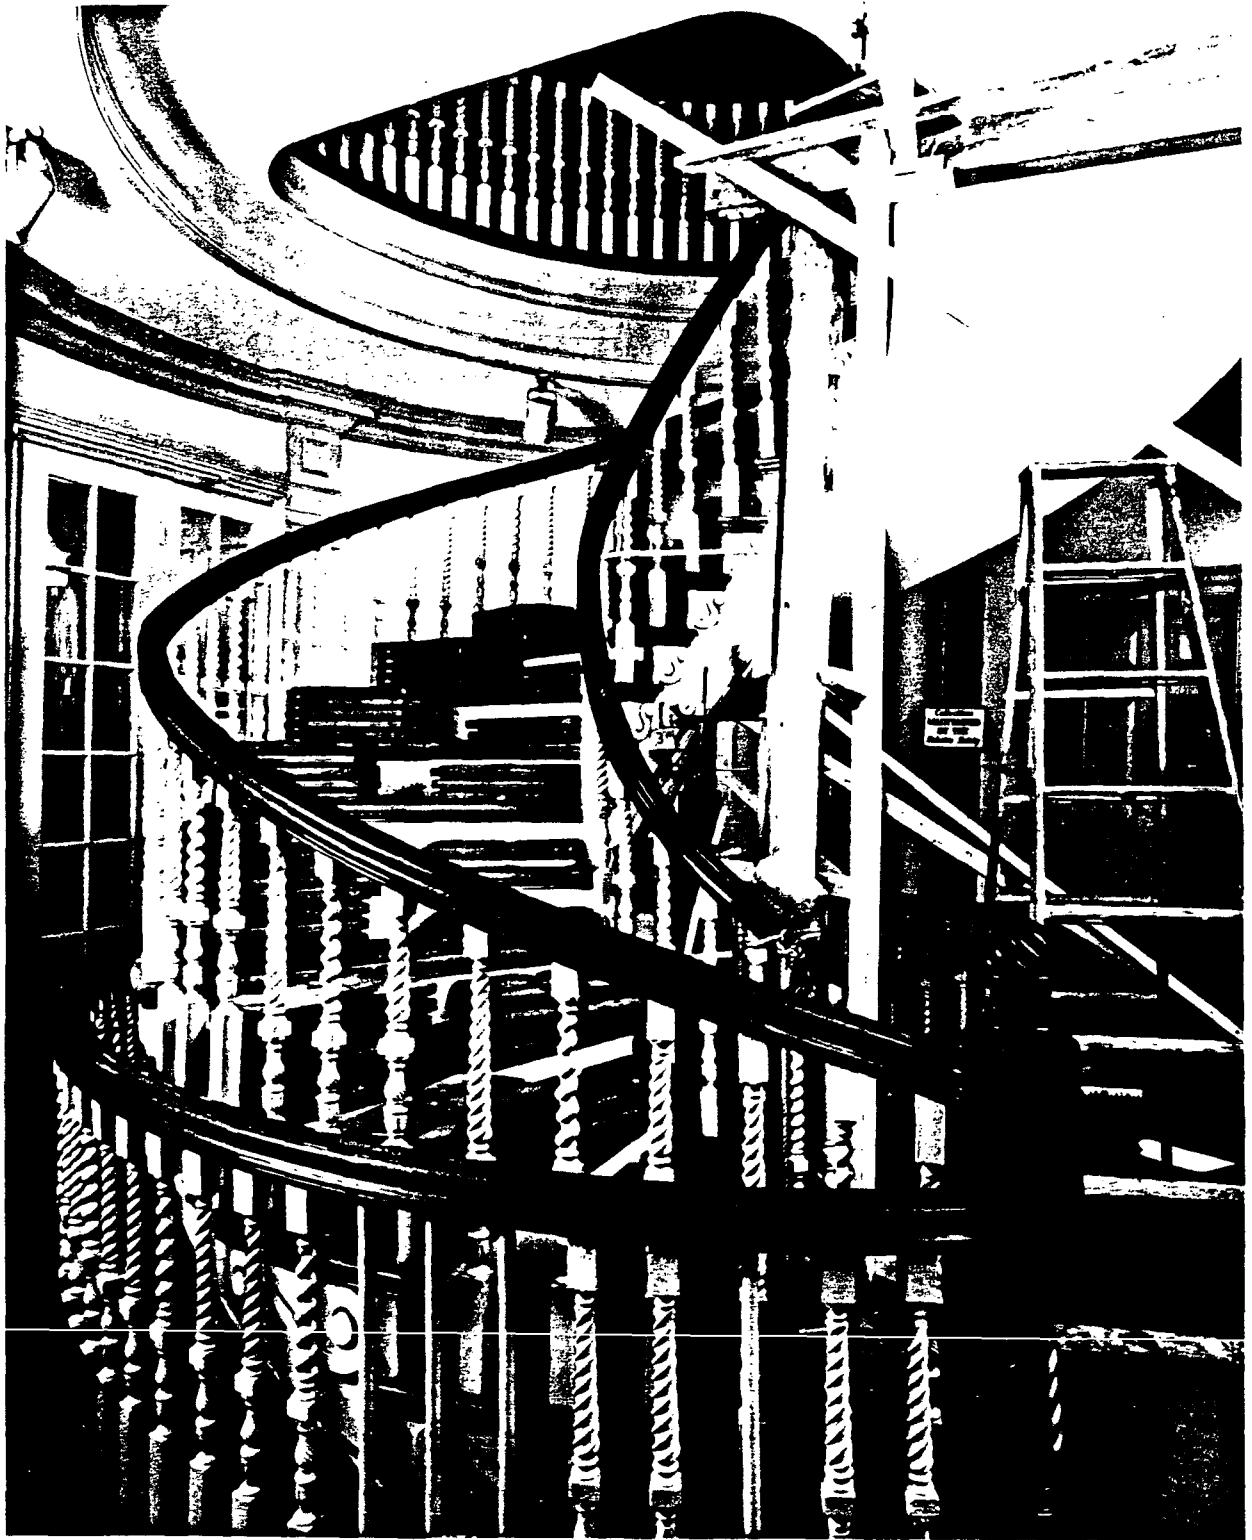
PHOTO A

Stairway on Entrance Level  
Showing Full Load Applied  
Left is designated "Outside"  
Right is designated "Inside"  
#5 Dial shown at Ceiling

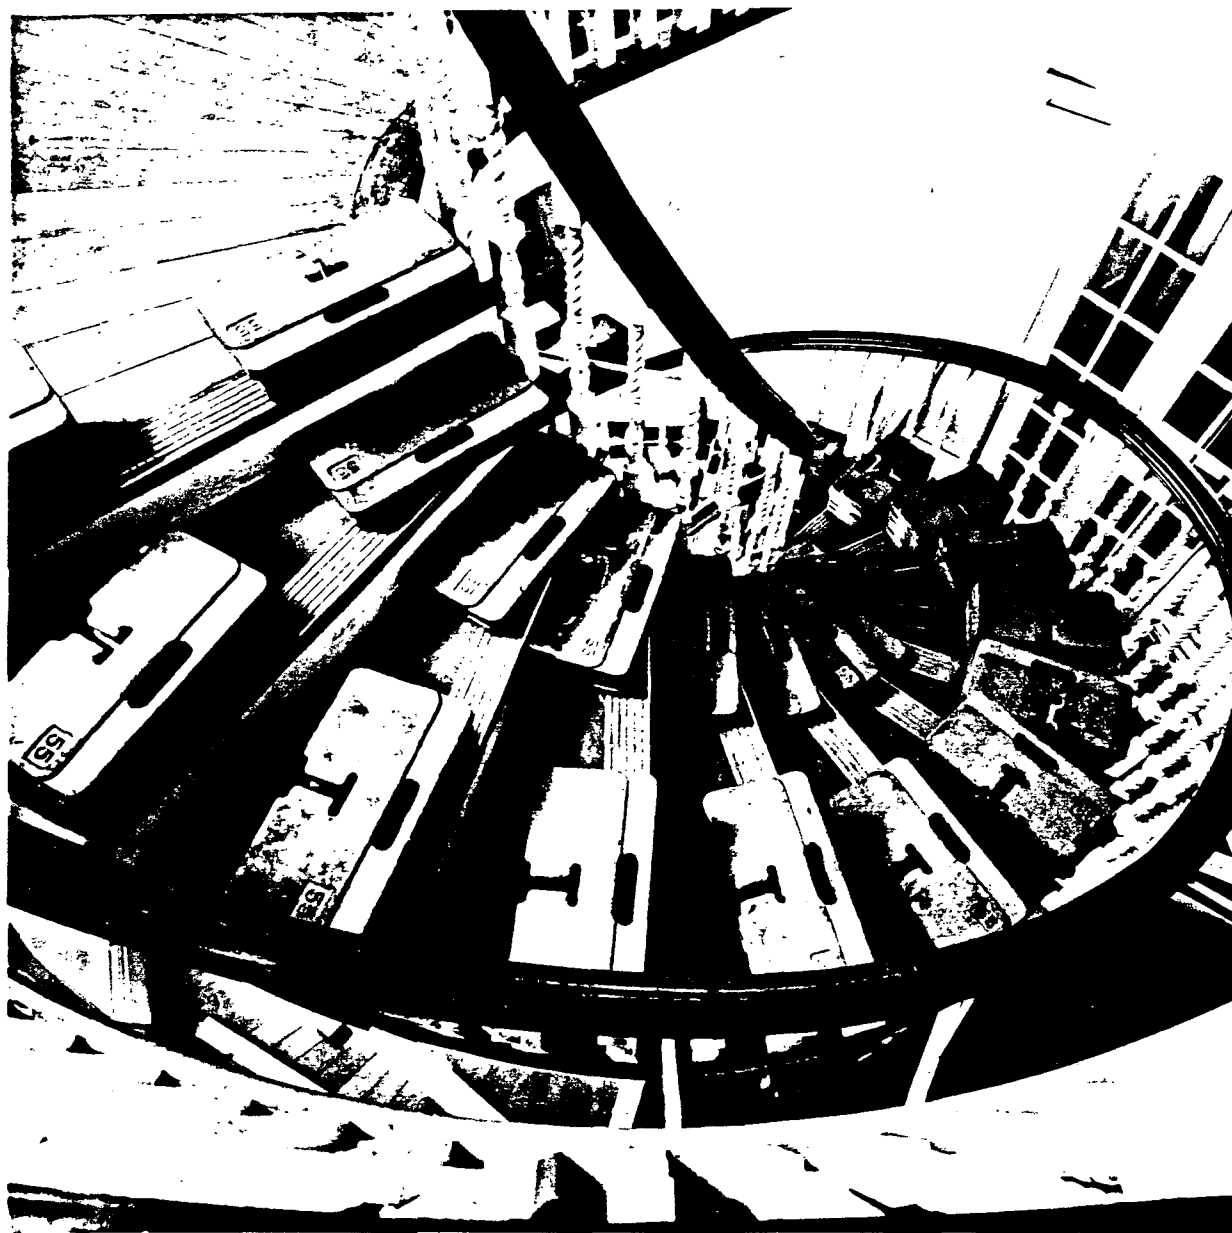
PHOTO B

Stairway Looking Down  
Showing Full Load Applied
