Mason-Willis-Dixon House
Portsmouth Village
Cape Lookout National Seashore

Historic Structure Report

December 2015

JOSEPH K. OPPERMAN-ARCHITECT, P.A.

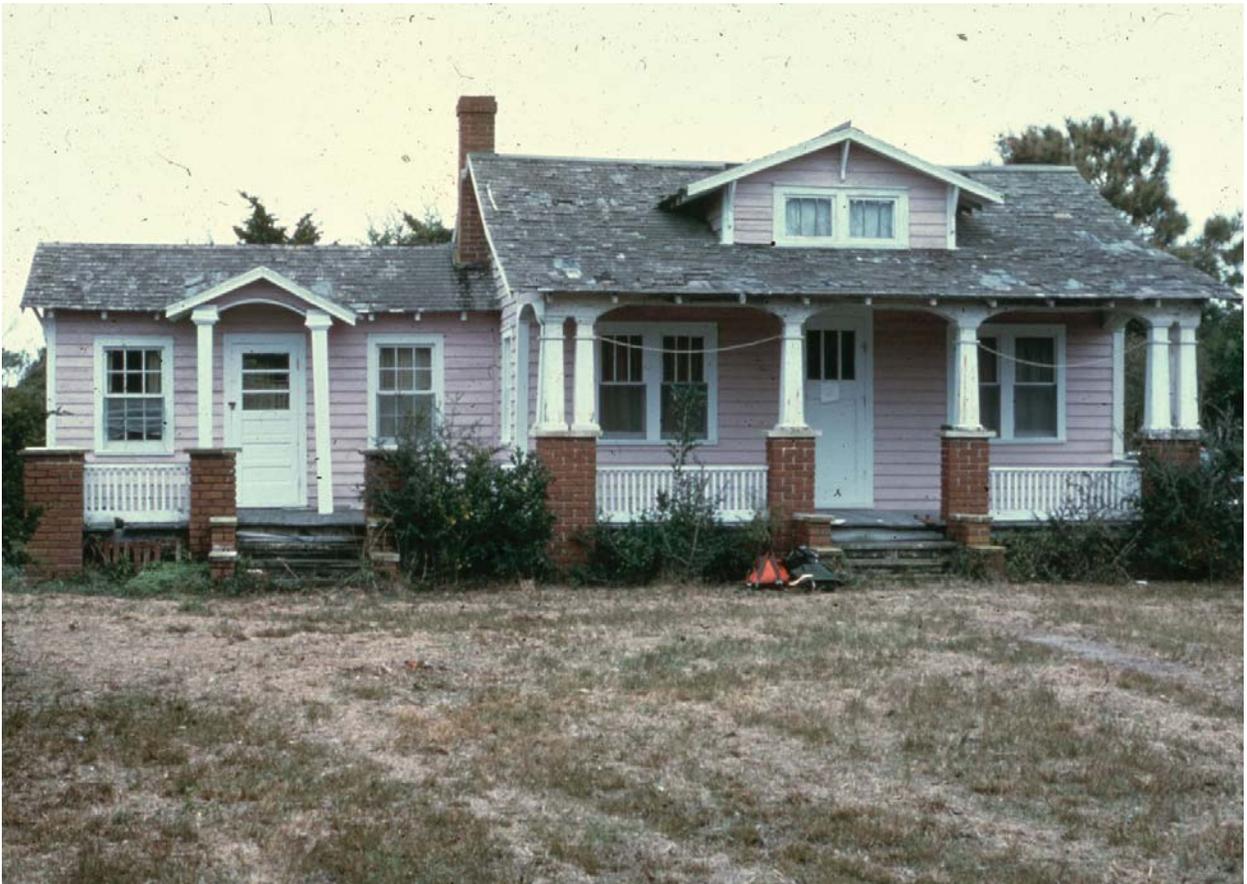
Figure 29. Condition of the house in 1977, also showing the 1960s replacement doors, the 1960s replacement six-over-six sash of the west wing, and the retained Craftsmen-style vertical-pane sash beneath the front porch. (CALO acc. 03355)

A group of photographs taken in 1977 shows the house, still painted pink, before the Park Service began its repairs, a baseline for their future work (*Figs. 29-31*). Most features of the house are unchanged from the photographs taken during the Dixons' time there. It retains its Craftsman form of roofline with deep eaves and front dormer, as well as the piers and posts of the porch and west deck. Railings front the outer bays of both the porch and deck, and a two-section stepped railing is at the west end of the deck, divided by a square capped wood post. The most notable changes from the Dixon photographs are the replacement west door and the six-over-six sash that replaced the vertical

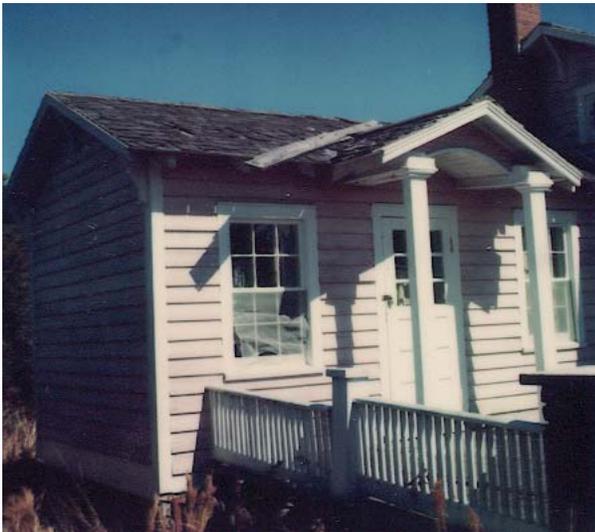
Figure 31. West wing and stepped railing in 1977. (CALO Coll. f80)

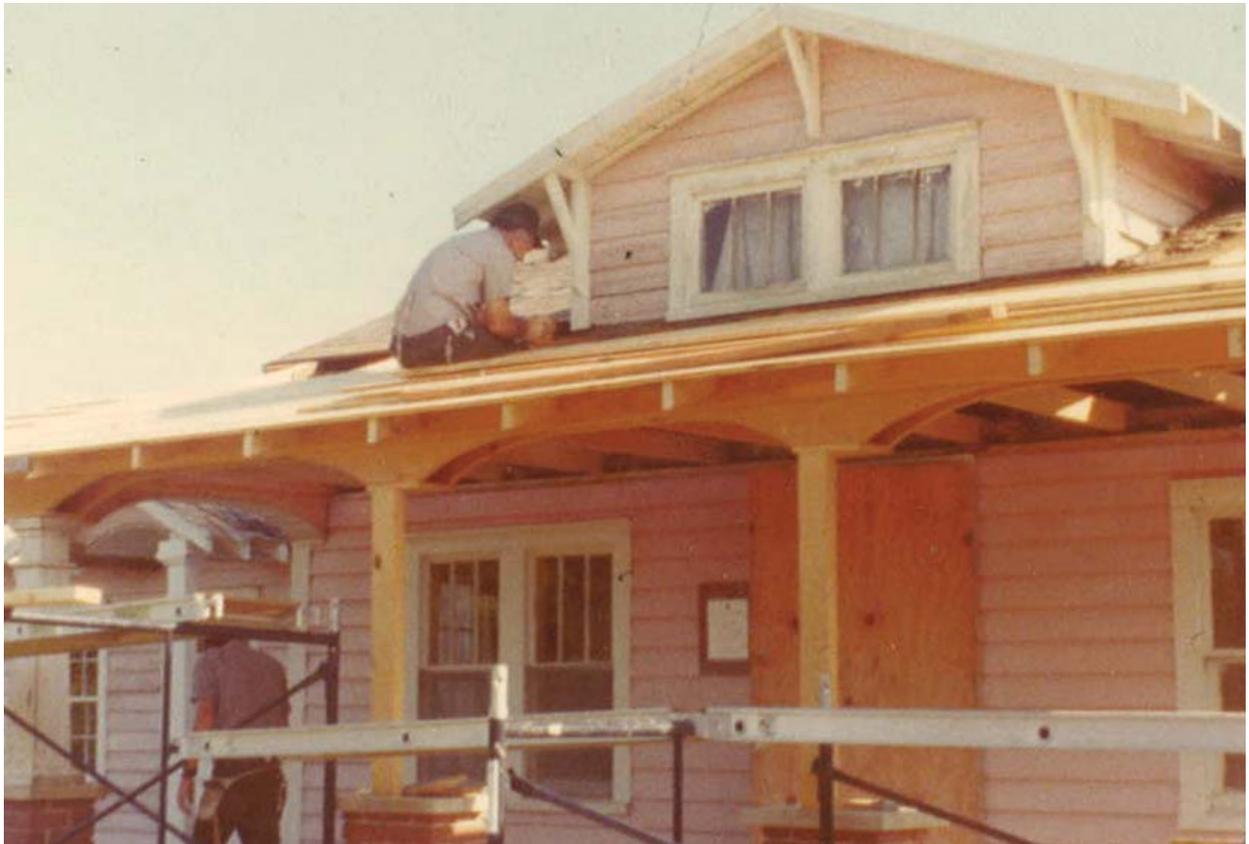
Figure 36. Replacing porch roof, arches, posts, 1979. (CALO Polaroid album)

In June and July, an NPS crew replaced most wood features of the porch and deck, which suffered from the more extensive rot and termite damage (*Figs. 32-36*). The subframe of both was replaced and new floorboards installed. The rafters of Harry Dixon's engaged roof extension were replaced, and a new ceiling installed. Also replaced were the two center box columns and all arches, which photographs show were severely damaged by termites. The 1928 tripled corner posts were able to be retained, and the posts and portions of the west portico were also replaced. Some railings were reused and most others replaced, and

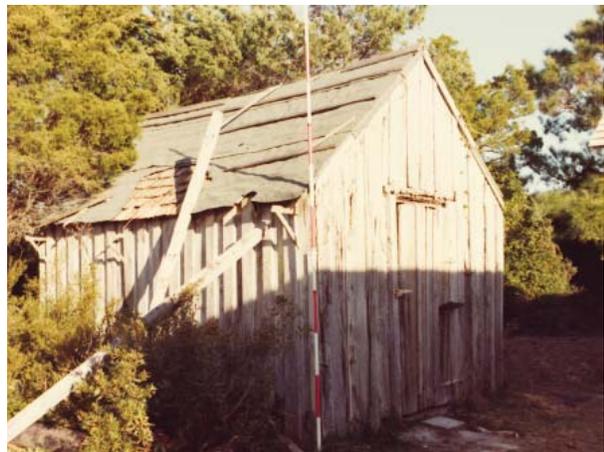
Figure 39. Front and west side of shed before work, 1979. (CALO coll. f289)

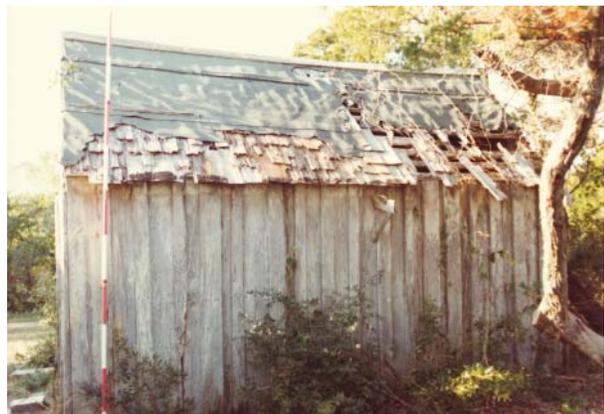
Figure 40. East side of shed before work, 1979. (CALO Coll. f290)

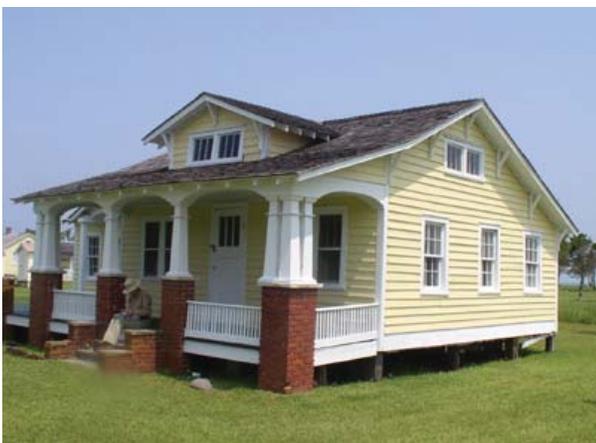
In 2005 a NPS crew spent two years of concentrated work repairing the buildings of Portsmouth. The next year an NPS survey assessed the house in good condition. Photographs allow a comparison of the condition in 1977 and thirty years later (Figs. 45-46). In contrast, by 2007 the shed was noted in the 2007 Cultural Landscape Report as being dilapidated and in need of repair, with large portions of the siding missing.⁸⁶ Later that year the shed was rebuilt. Ricky Daniels of Cedar Island signed the interior west wall, documenting that he “rebuilt this old shack.”

Figure 46. Front and east elevations in 2007. (NPS List of Classified Structures [LCS])

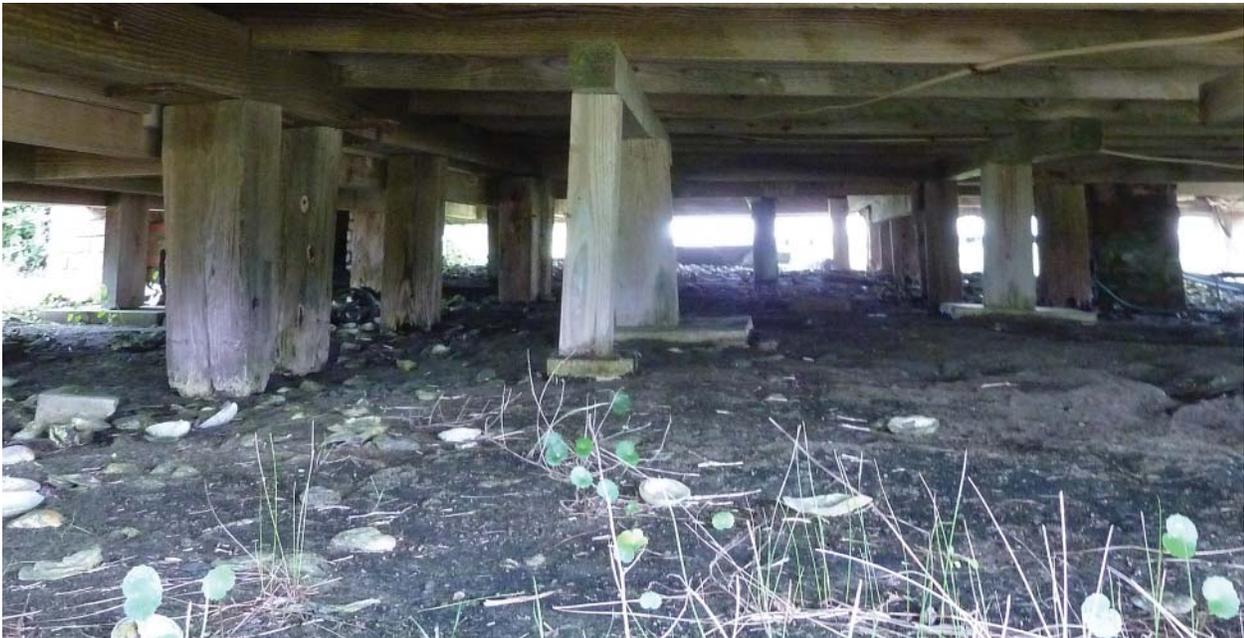
Poor drainage is characteristic of most of Portsmouth, but the natural process of decay of vegetation and generation of new humus has created a bowl-like depression beneath the house, trapping water and keeping the area damp for extended periods of time. This not only contributes to rotting of wood posts but also creates ideal conditions for termite infestation.

Figure 55. Looking north under west side of front porch and main block, showing historic wood posts at left.

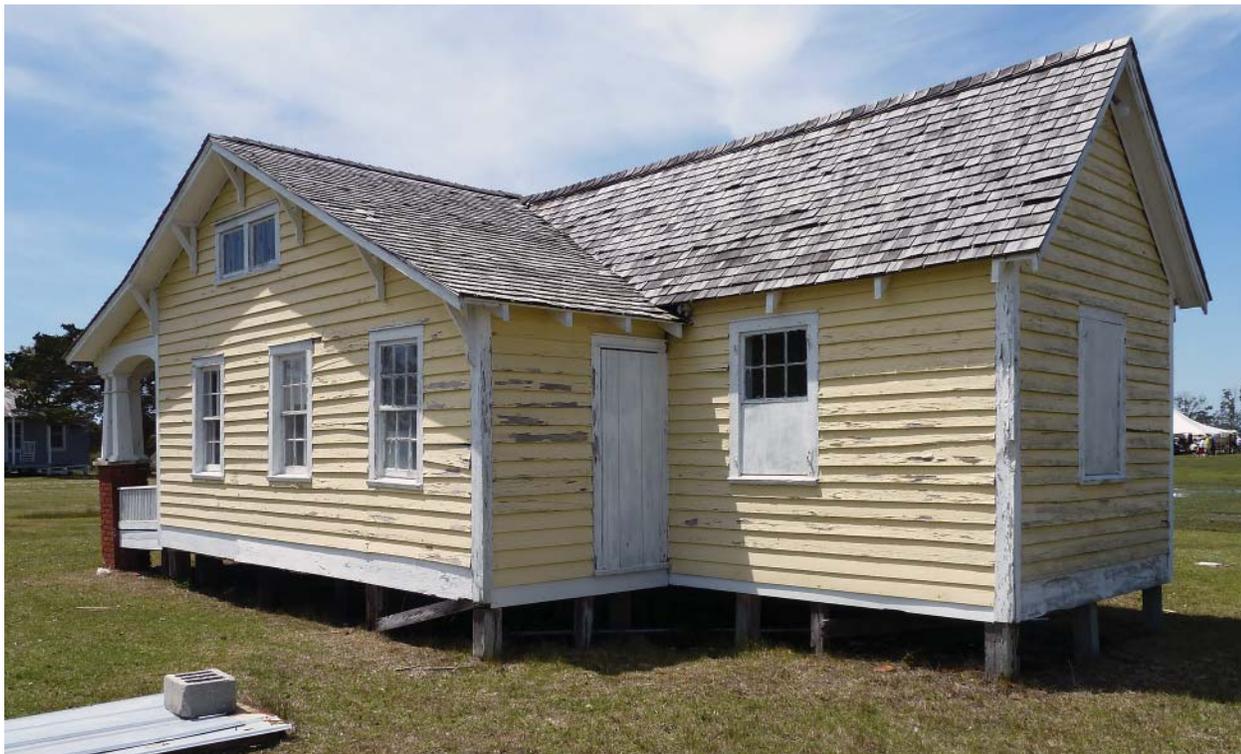
Most of the house's exterior woodwork is in fair condition. Painted finishes are peeling and bare

wood is being exposed at various locations all around the house. Some siding and most of the crown molding in the gables should be railed.

Figure 82. East side and north end of the house.

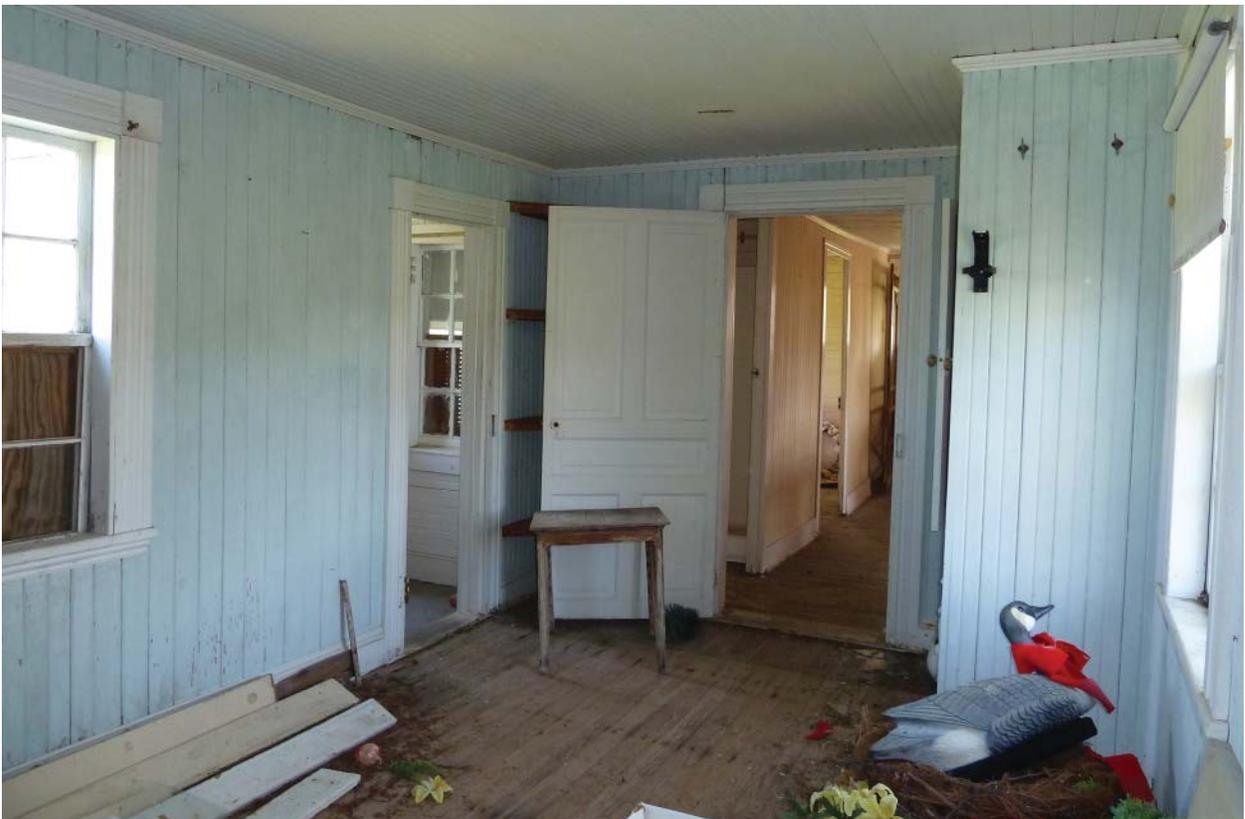
Figure 106. Looking south in Room 105.

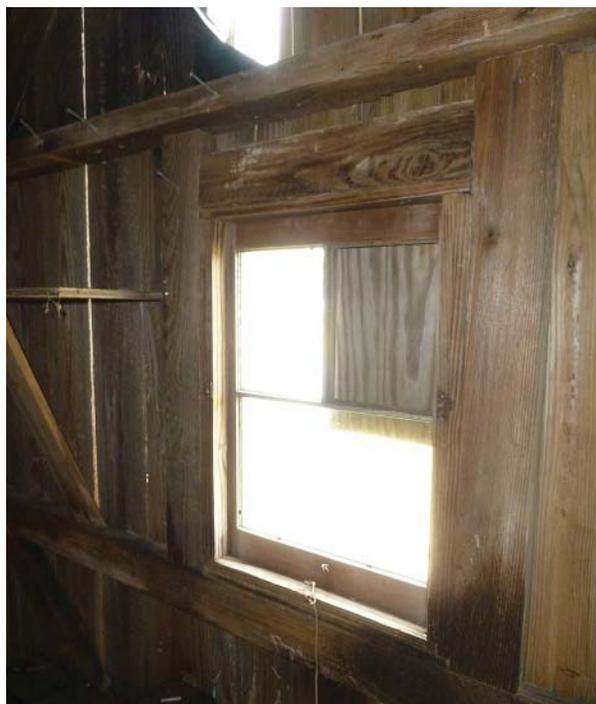
Figure 124. Window at north shed wall.
